STRUCTURAL AUDIT REPORT
FOR
“VISHAL SAHYADRI CO – OP HSG. SOC. LTD”,
“D2 – H WING”
SITUATED AT
SAHYADRI NAGAR, CHARKOP,
KANDIVALI (W) MUMBAI – 400 067

978/D2/LSS/2021

JULY 24, 2021

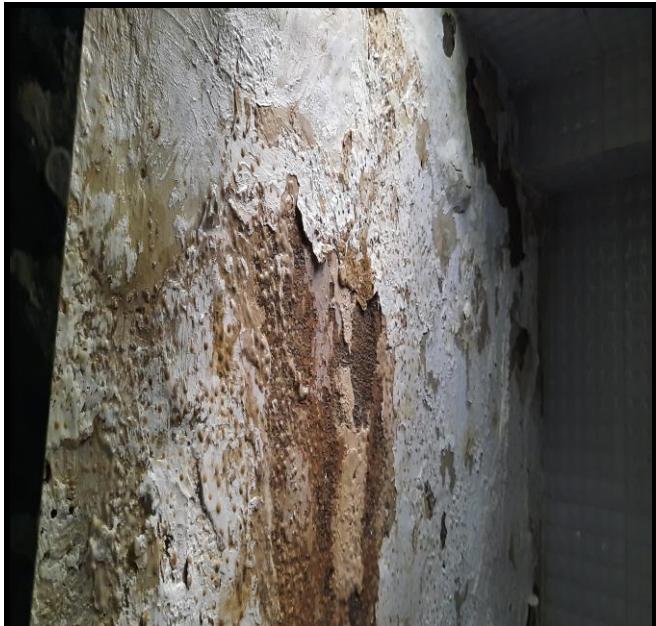
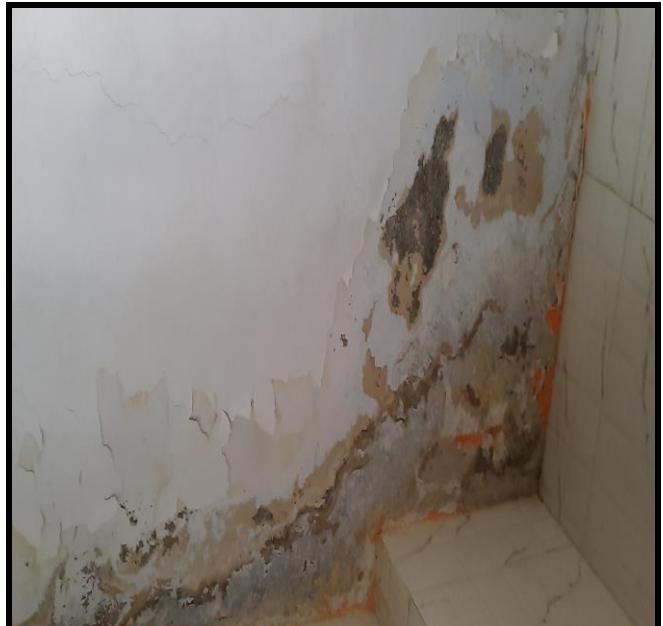
FLAT NO – 203

- ❖ **HALL** – O.K.
- ❖ **KITCHEN** – Leakage mark observed on ceiling.
- ❖ **PASSAGE** – O.K.
- ❖ **TOILET & BATH ROOM** – Dampness observed on ceiling.

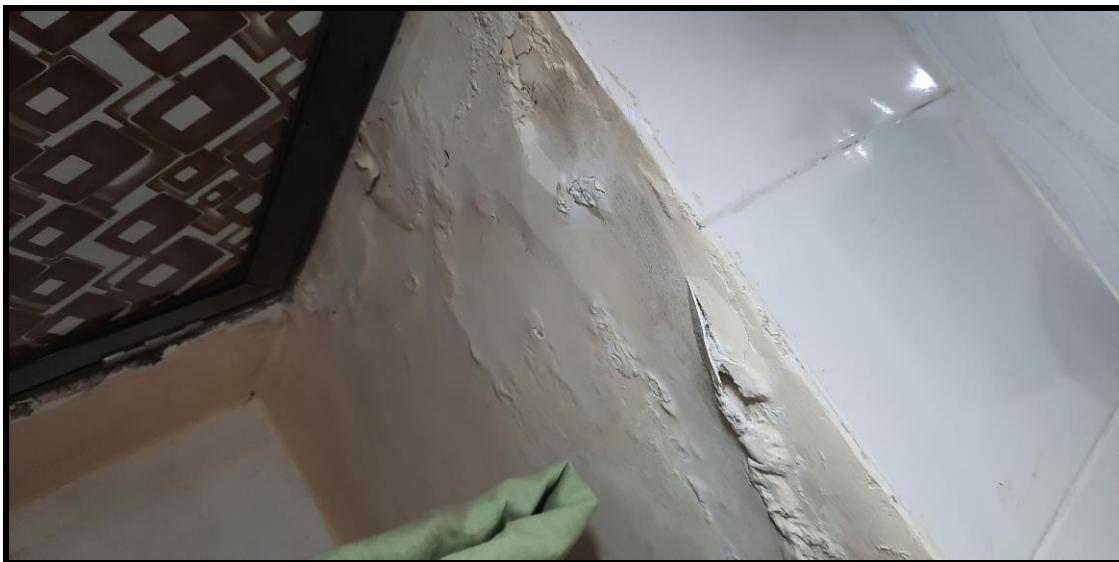
FLAT NO – 301

- ❖ **HALL** – O.K.
- ❖ **KITCHEN** – O.K.
- ❖ **PASSAGE** – Leakage mark observed on wall.
- ❖ **TOILET & BATH ROOM** – O.K.

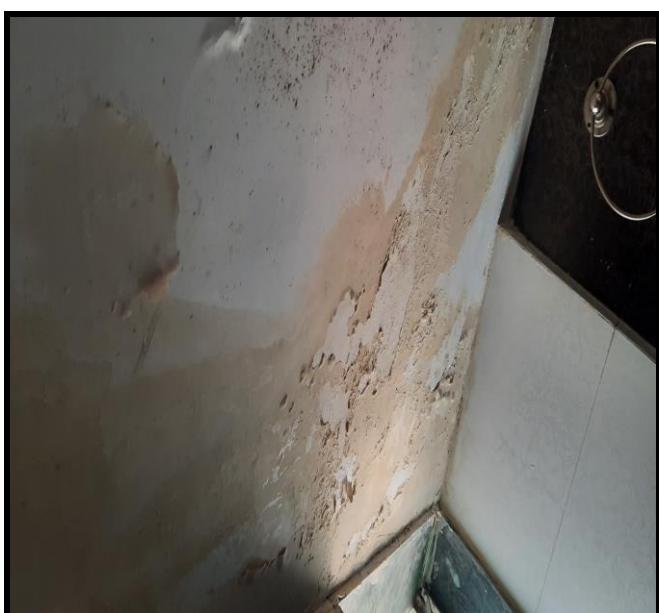
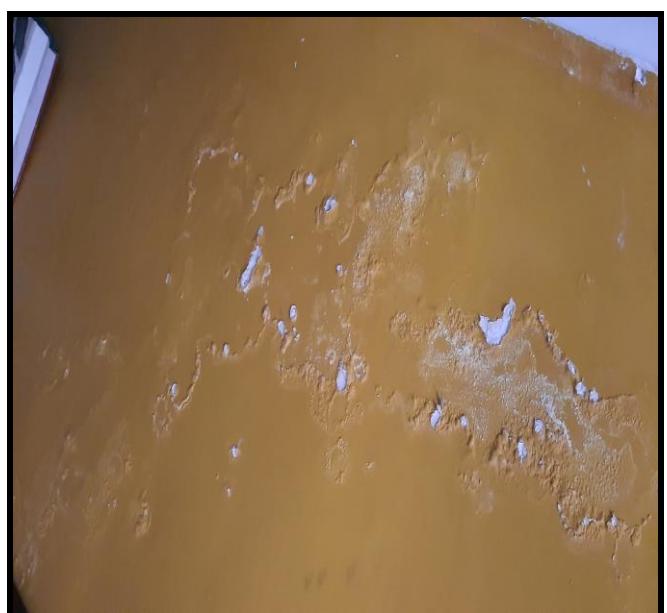
FLAT NO – 303

- ❖ **HALL** – Seepage observed on wall.
- ❖ **KITCHEN** – O.K.
- ❖ **PASSAGE** – O.K.
- ❖ **TOILET & BATH ROOM** – Leakage mark observed on ceiling.

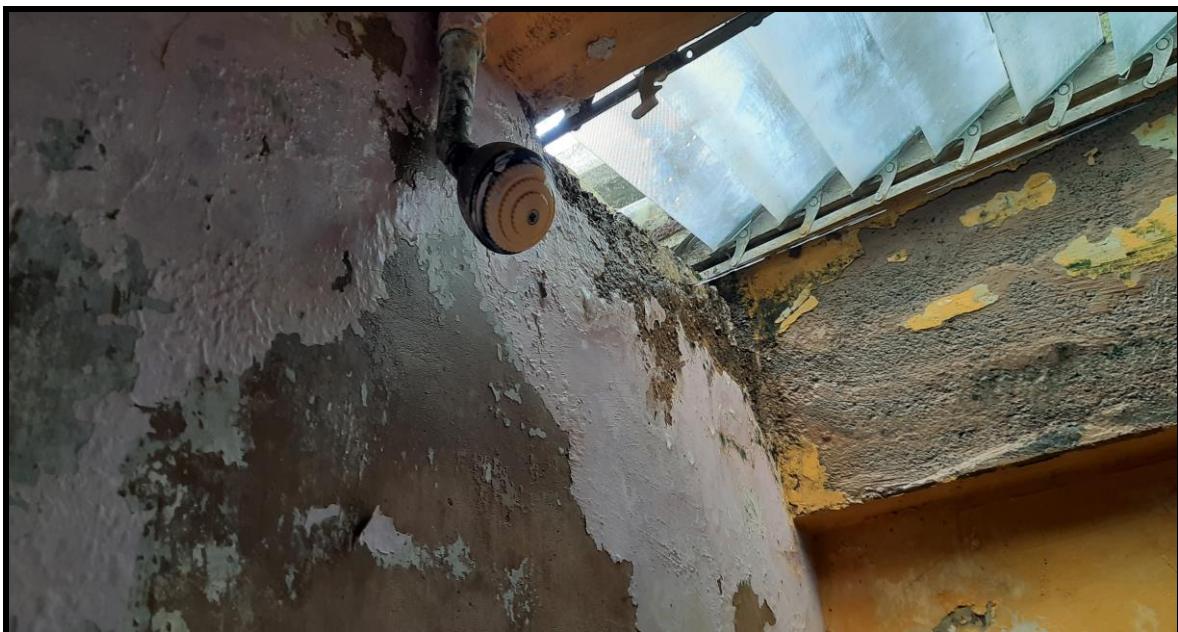
FLAT NO – 604

- ❖ **HALL** – O.K.
- ❖ **KITCHEN** – Dampness observed on wall in monsoon.
- ❖ **PASSAGE** – O.K.
- ❖ **TOILET & BATH ROOM** – Leakage observed on ceiling.

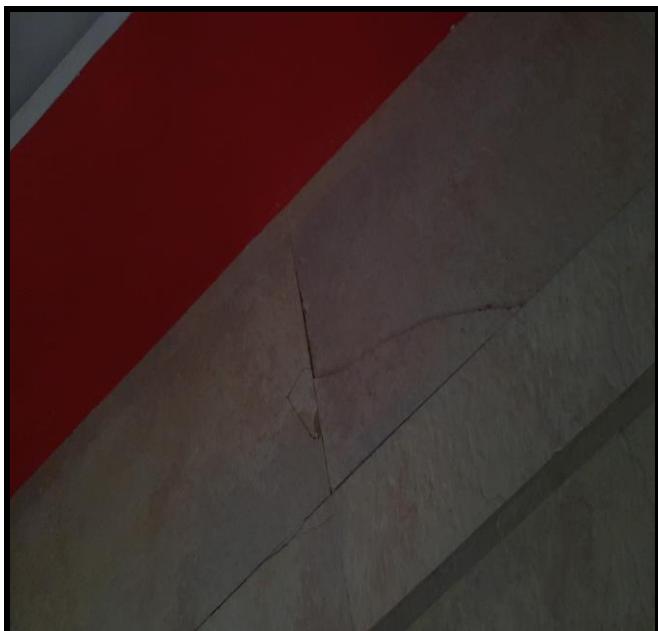
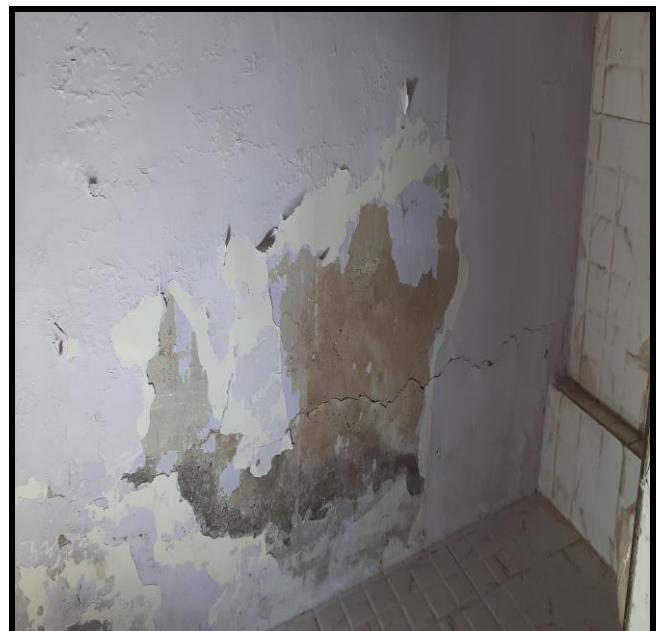
FLAT NO – 704

- ❖ **HALL** – Structural crack observed on beam.
- ❖ **KITCHEN** – Leakage mark observed on ceiling.
 - Structural crack observed on ceiling.
- ❖ **PASSAGE** – Leakage observed on ceiling in monsoon.
- ❖ **TOILET & BATH ROOM** – Leakage observed on ceiling in monsoon.

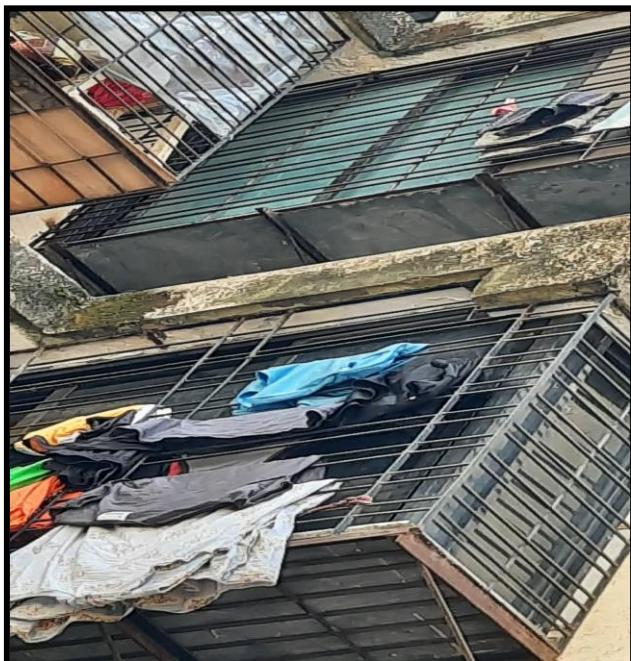
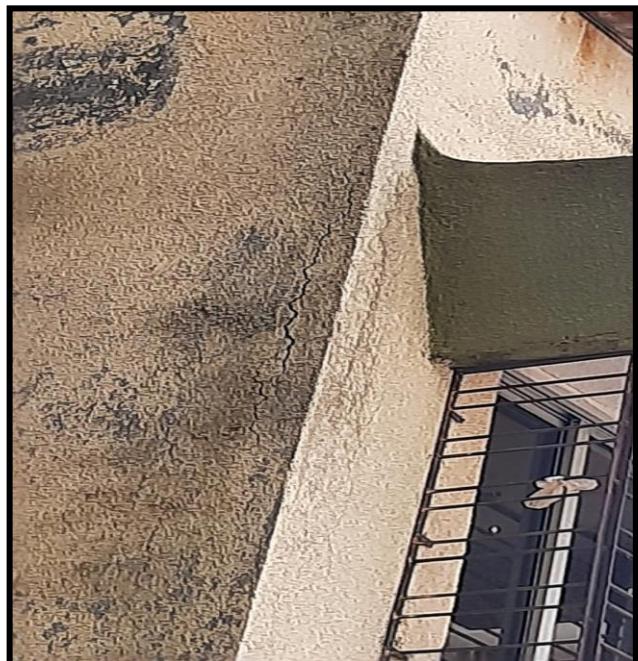
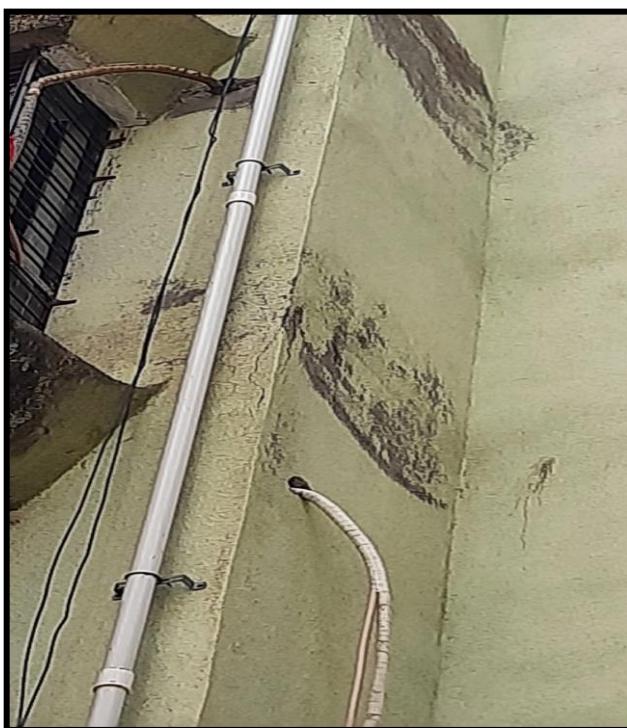
FRONT SIDE

- ❖ Structural crack observed at several places on column & chajjas.

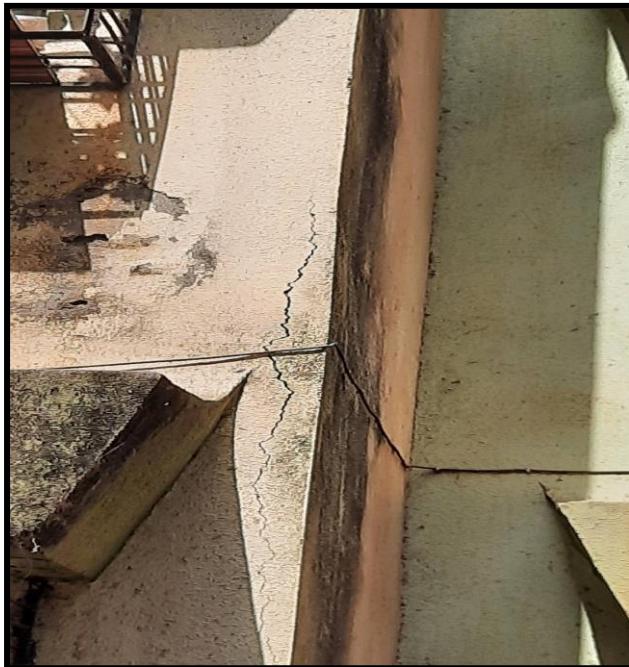
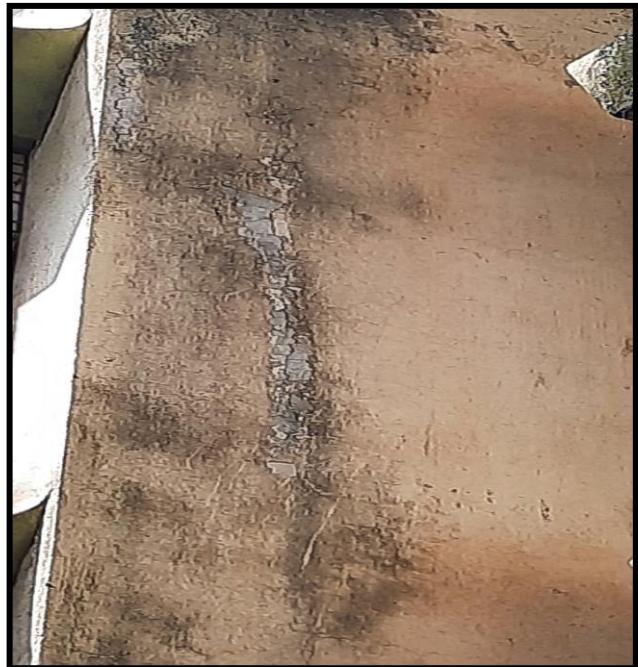
BACK SIDE

- ❖ Structural crack observed at several places on column.

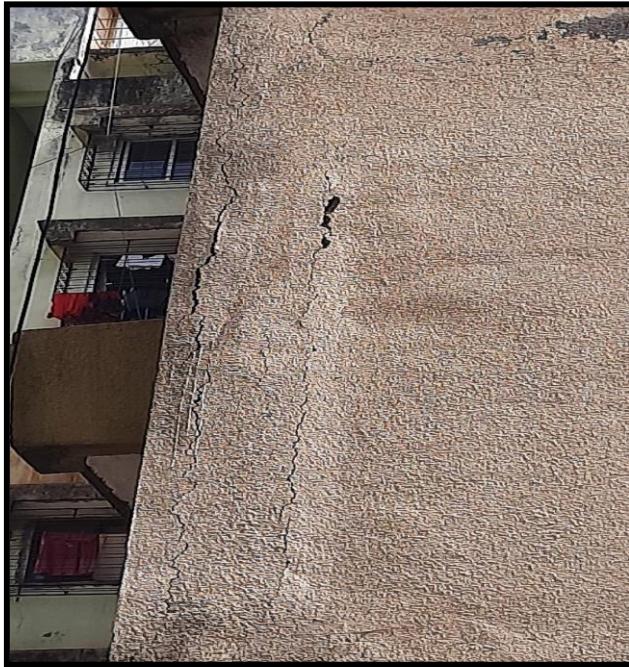
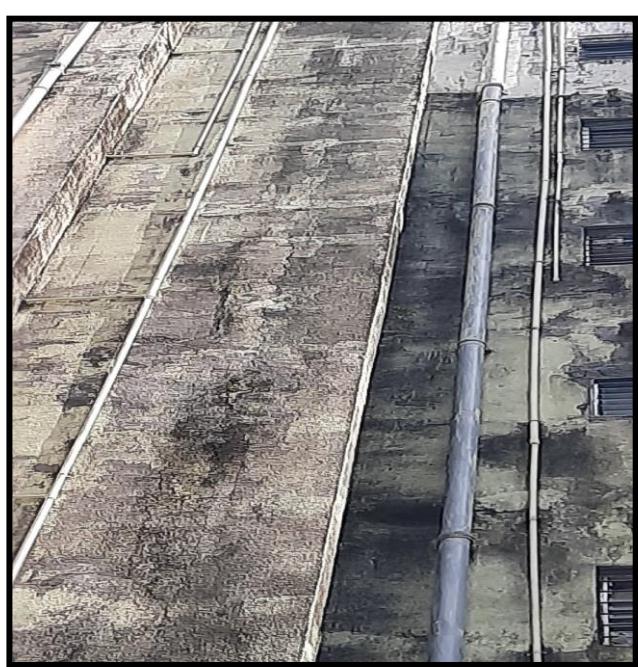
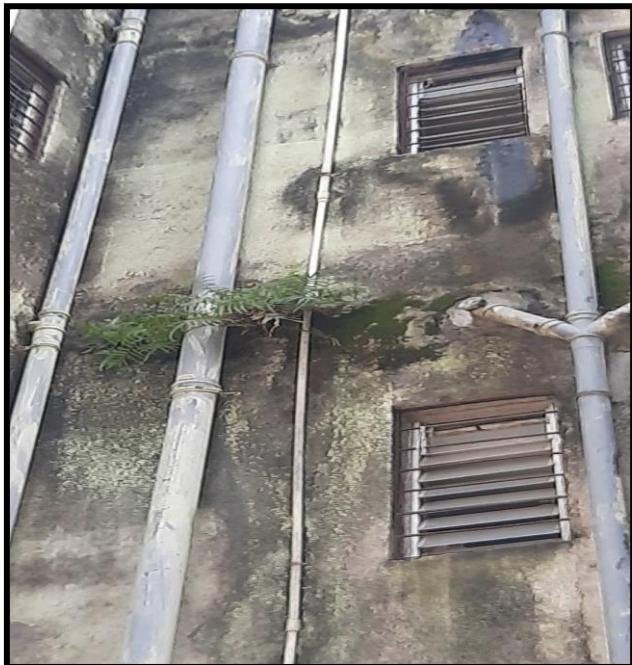
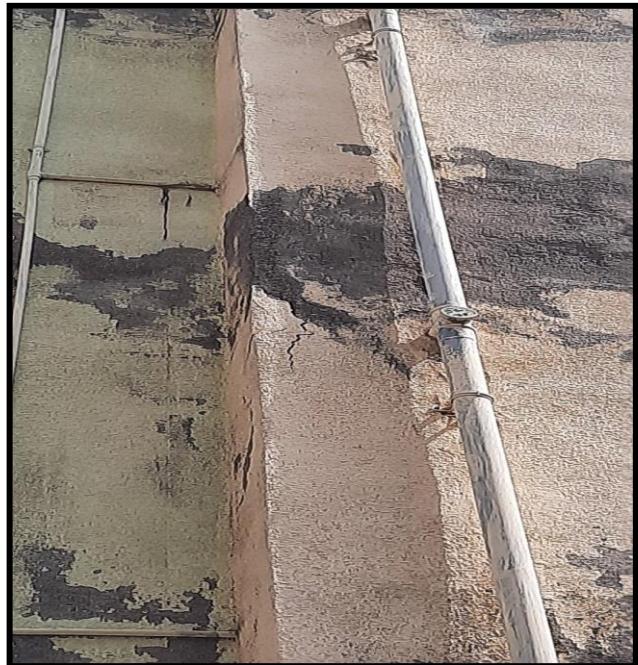
NORTH SIDE

- ❖ Structural crack observed at several places on column.
- ❖ Algae observed at several places on wall.
- ❖ Vegetation growth observed at several places on wall.

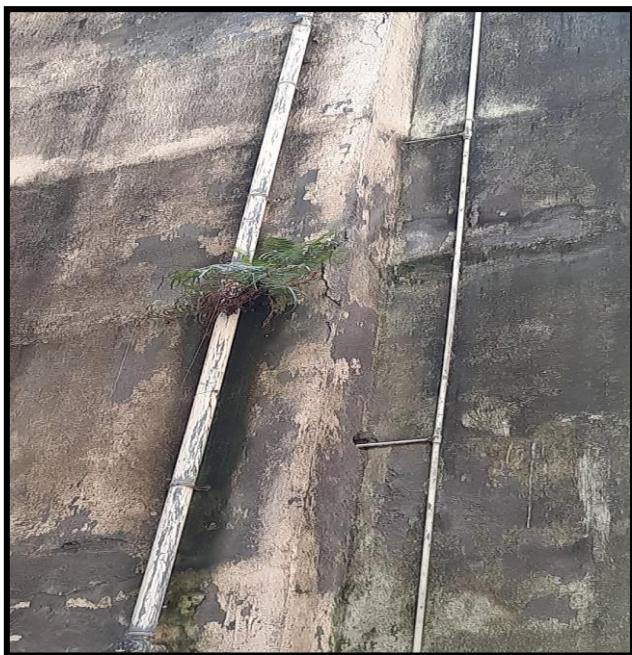
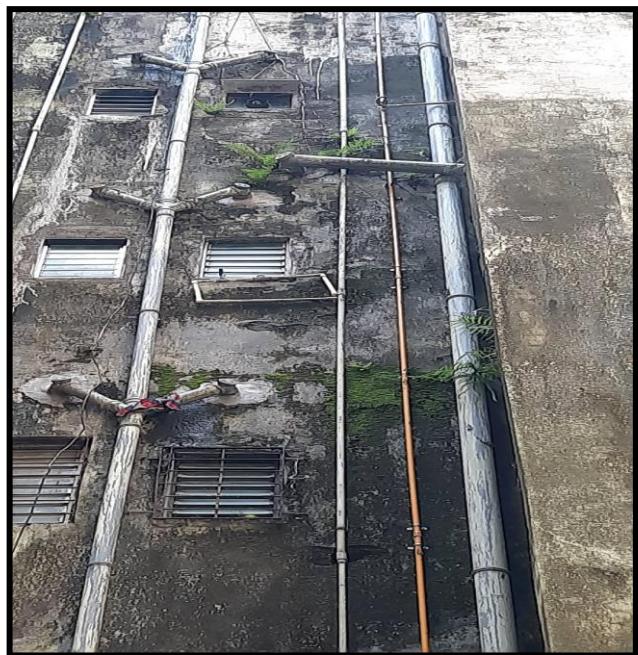
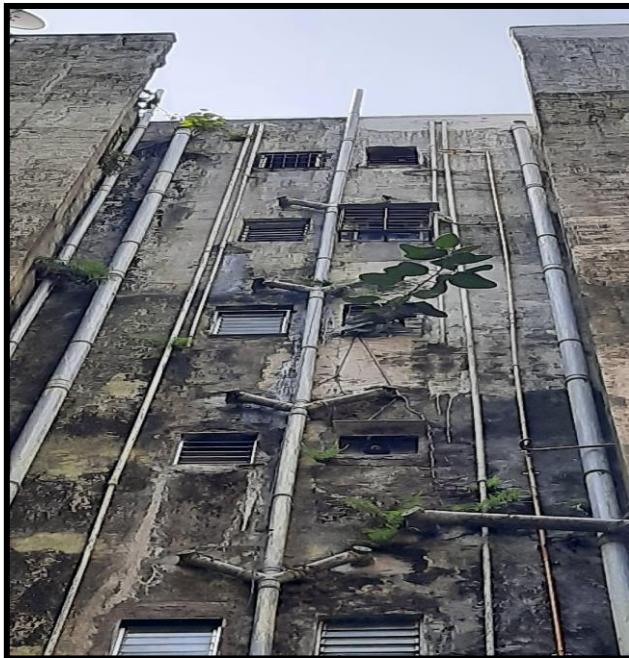
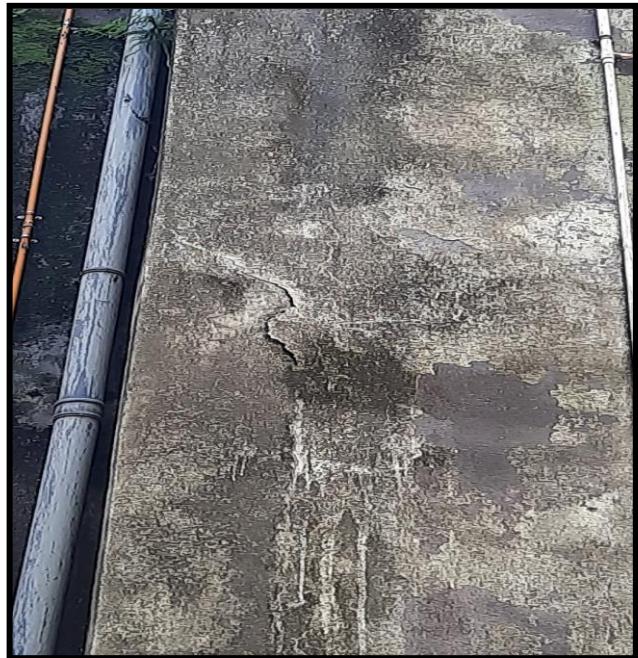
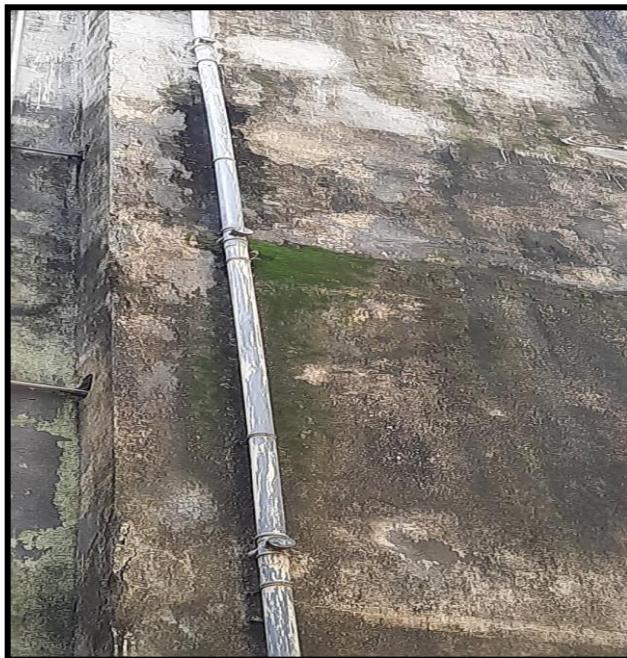
SOUTH SIDE

- ❖ Structural crack observed at several places on column.
- ❖ Algae observed at several places on wall.
- ❖ Vegetation growth observed at several places on wall.
