STRUCTURAL AUDIT REPORT  
FOR  
**“VISHAL SAHYADRI CO – OP HSG. SOC. LTD”,**  
**“D2 – K WING”**  
SITUATED AT  
SAHYADRI NAGAR, CHARKOP,  
KANDIVALI (W) MUMBAI – 400 067

978/D2/LSS/2021

JULY 24, 2021

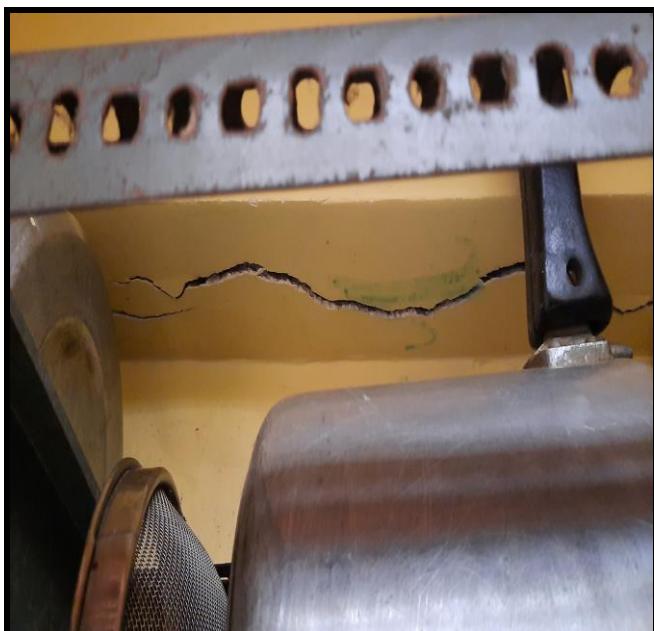
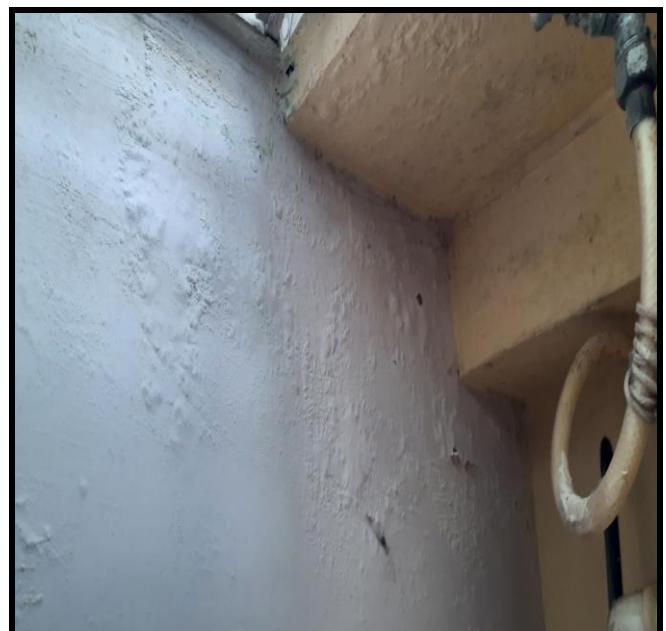
### FLAT NO – 101

- ❖ **HALL** – O.K.
- ❖ **KITCHEN** – Leakage observed on wall in monsoon.
  - Structural crack observed on column.
- ❖ **PASSAGE** – O.K.
- ❖ **TOILET & BATH ROOM** – Leakage mark observed on ceiling.

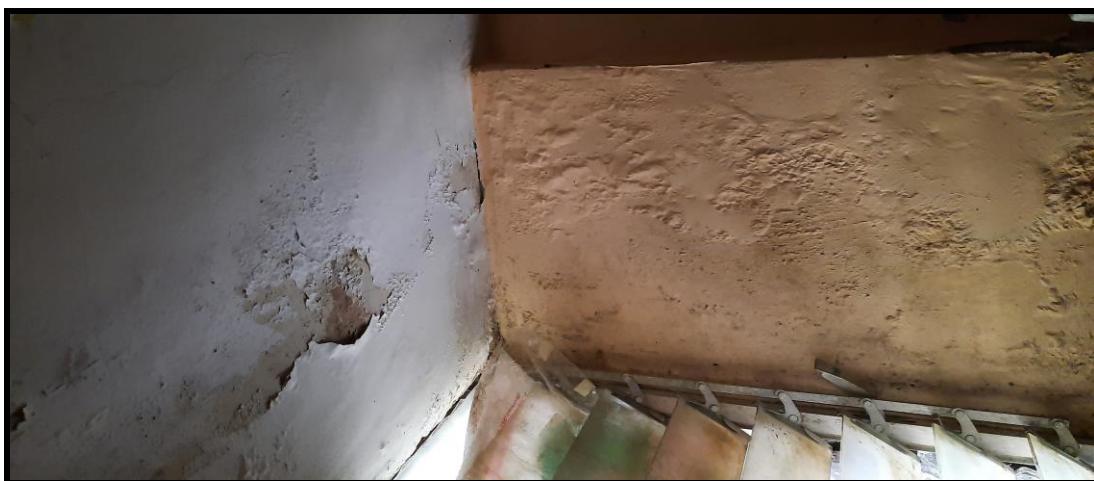
### FLAT NO – 103

- ❖ **HALL** – O.K.
- ❖ **KITCHEN** – Leakage observed on wall in monsoon.
- ❖ **PASSAGE** – O.K.
- ❖ **TOILET & BATH ROOM** – Leakage mark observed on column & ceiling.

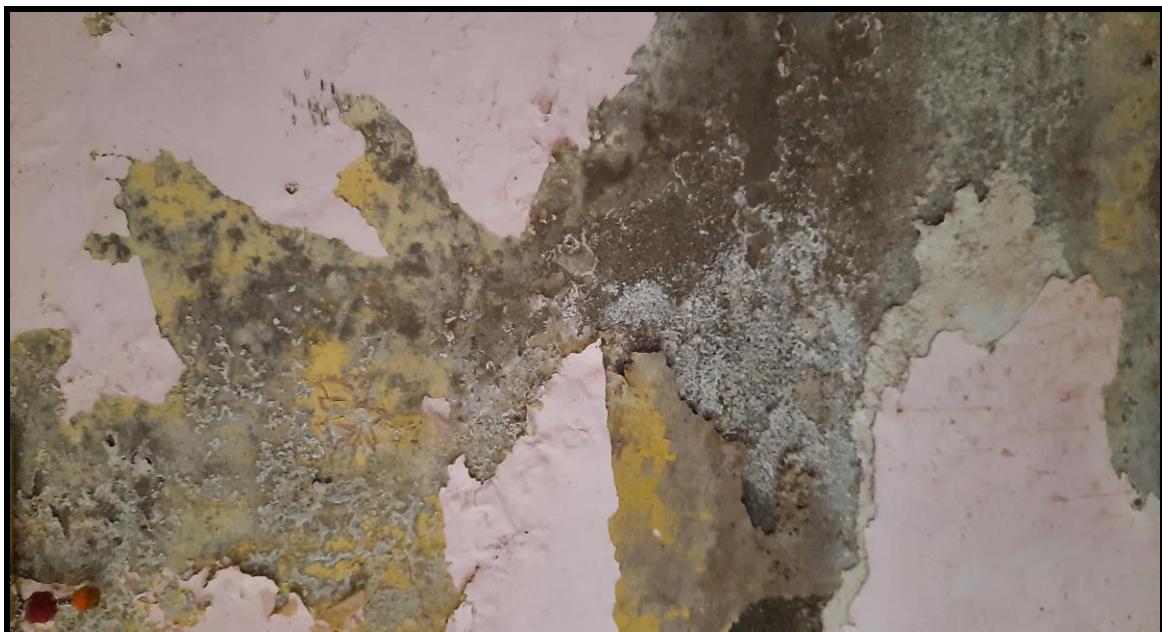
### FLAT NO – 303

- ❖ **HALL** – Leakage mark observed on wall.
- ❖ **KITCHEN** – O.K.
- ❖ **PASSAGE** – O.K.
- ❖ **TOILET & BATH ROOM** – Leakage mark observed on ceiling.

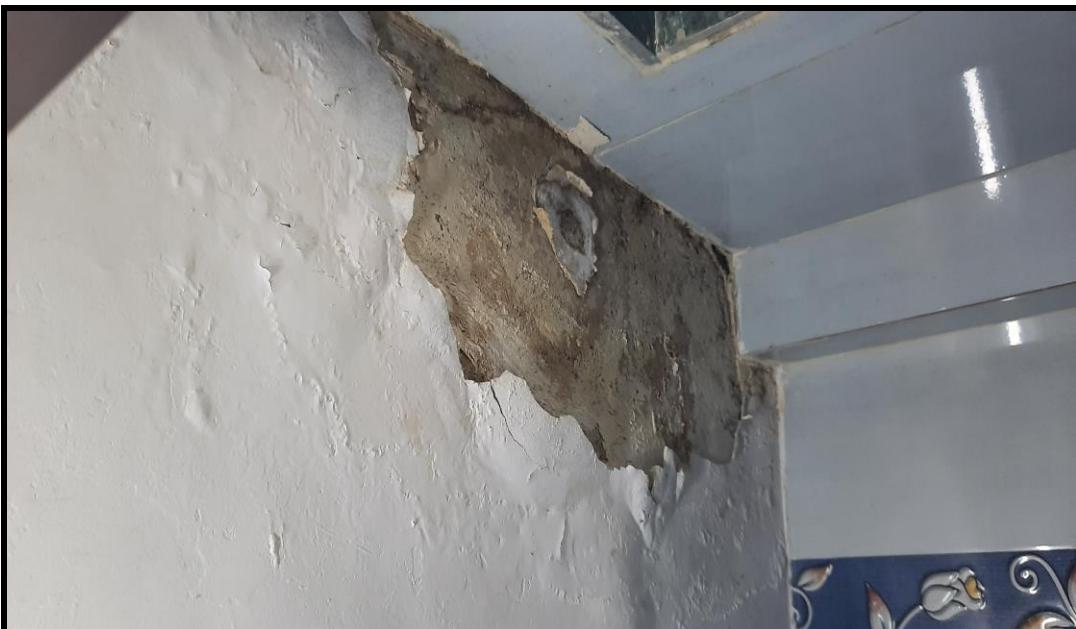
### FLAT NO – 401

- ❖ **HALL** – Dampness observed on wall in monsoon.
- ❖ **KITCHEN** – Leakage observed on wall in monsoon.
- ❖ **PASSAGE** – O.K.
- ❖ **TOILET & BATH ROOM** – Leakage mark observed on ceiling.

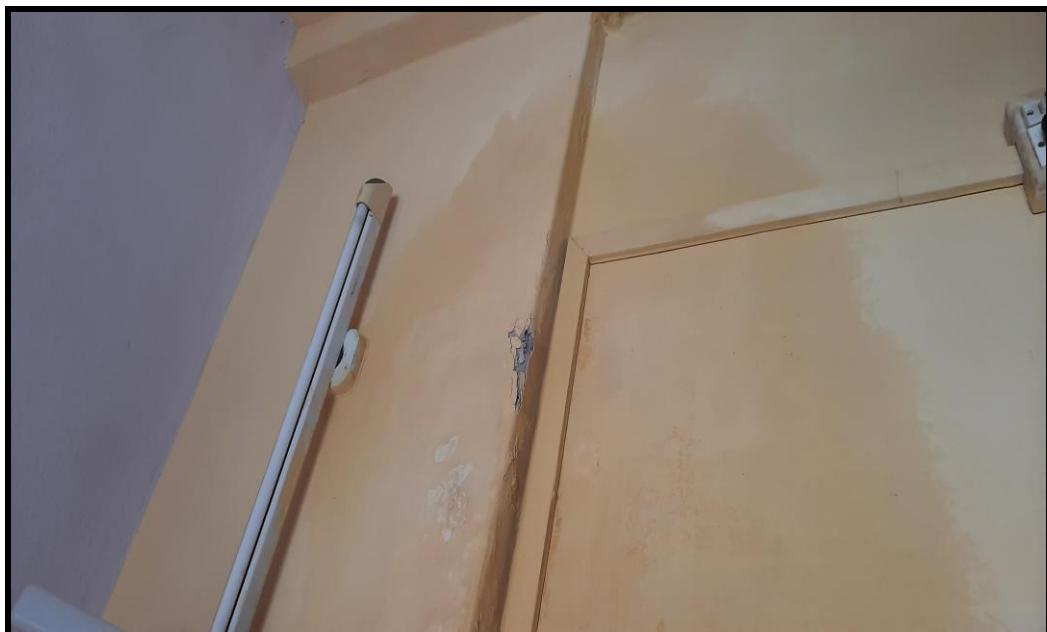
### FLAT NO – 504

- ❖ **HALL** – O.K.
- ❖ **KITCHEN** – Dampness observed on wall.
- ❖ **PASSAGE** – O.K.
- ❖ **TOILET & BATH ROOM** – Dampness observed on ceiling in monsoon.

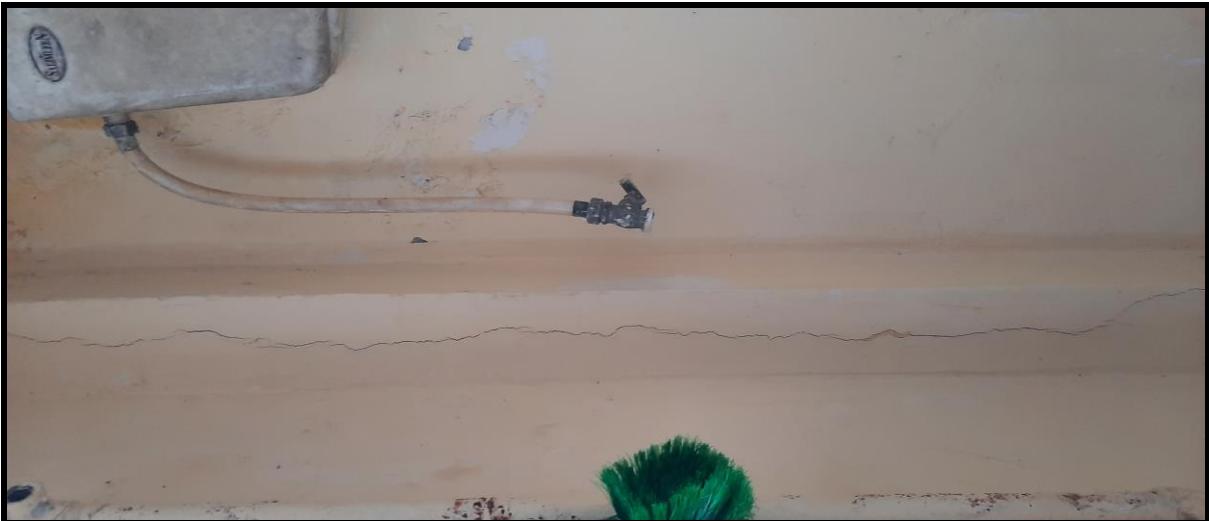
### FLAT NO – 602

- ❖ **HALL** – Leakage observed on ceiling in monsoon.
- ❖ **KITCHEN** – O.K.
- ❖ **PASSAGE** – O.K.
- ❖ **TOILET & BATH ROOM** – Structural crack observed on column.

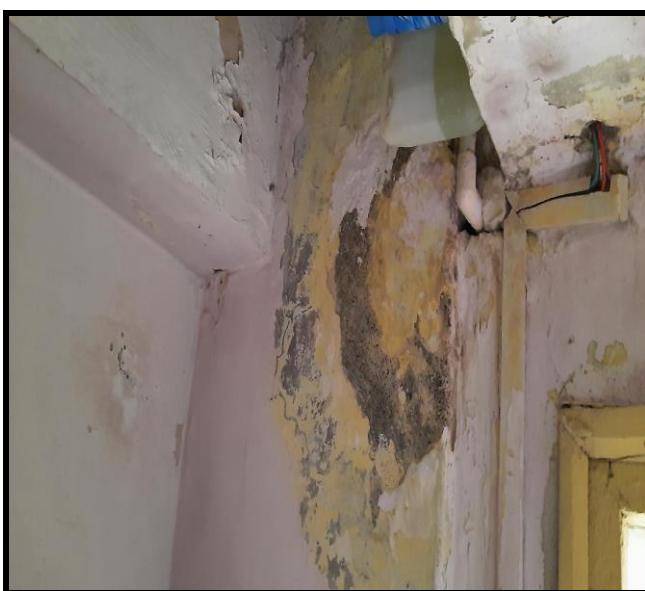
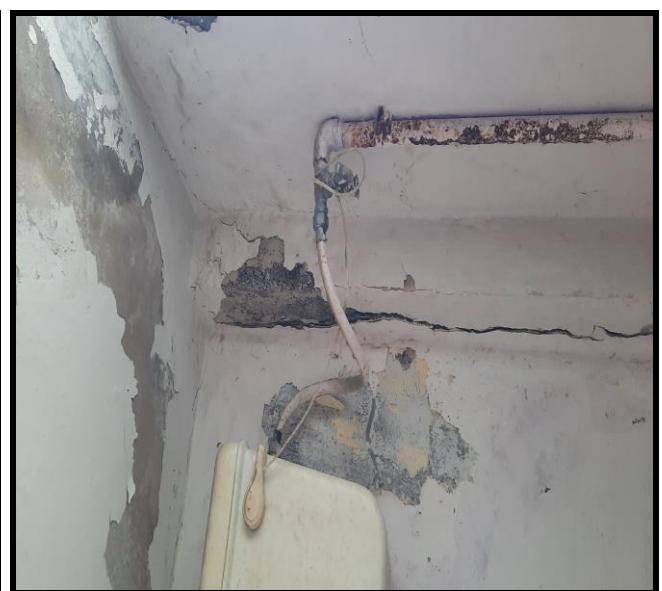
### FLAT NO – 603

- ❖ **HALL** – O.K.
- ❖ **KITCHEN** – O.K.
- ❖ **PASSAGE** – Leakage mark observed on wall & ceiling.
- ❖ **TOILET & BATH ROOM** – Structural crack observed on column.
  - Leakage mark observed on wall & ceiling.

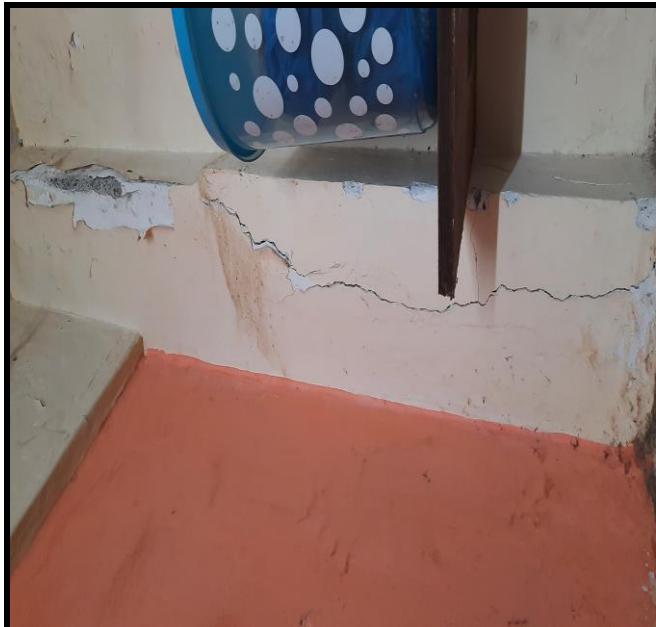
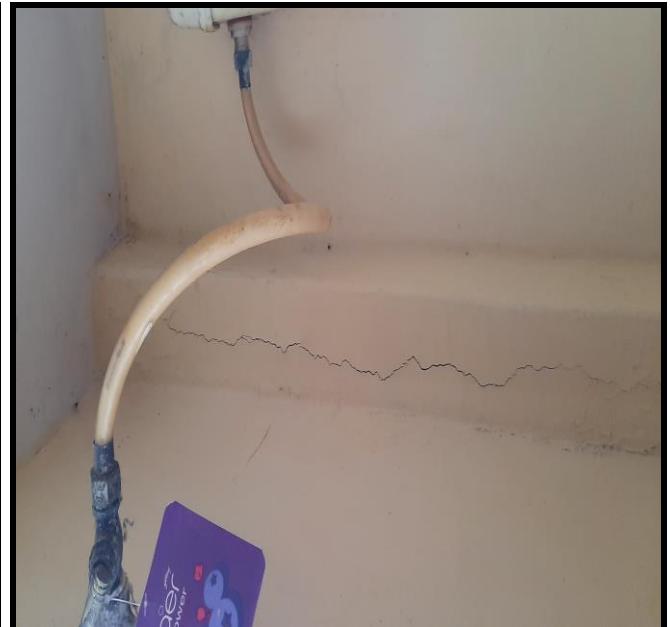
## FLAT NO – 604

- ❖ **HALL** – Dampness observed on wall in monsoon.
- ❖ **KITCHEN** – Dampness observed on wall in monsoon.
  - Structural crack observed on column.
- ❖ **PASSAGE** – O.K.
- ❖ **TOILET & BATH ROOM** – Structural crack observed on column.

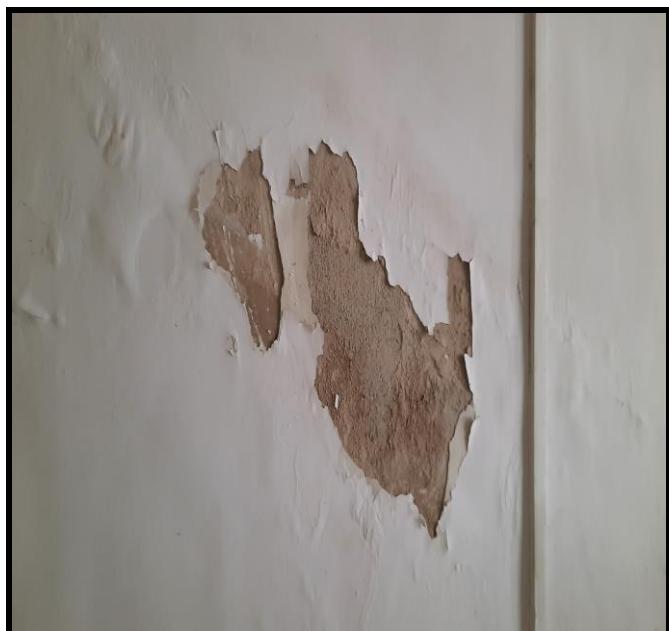
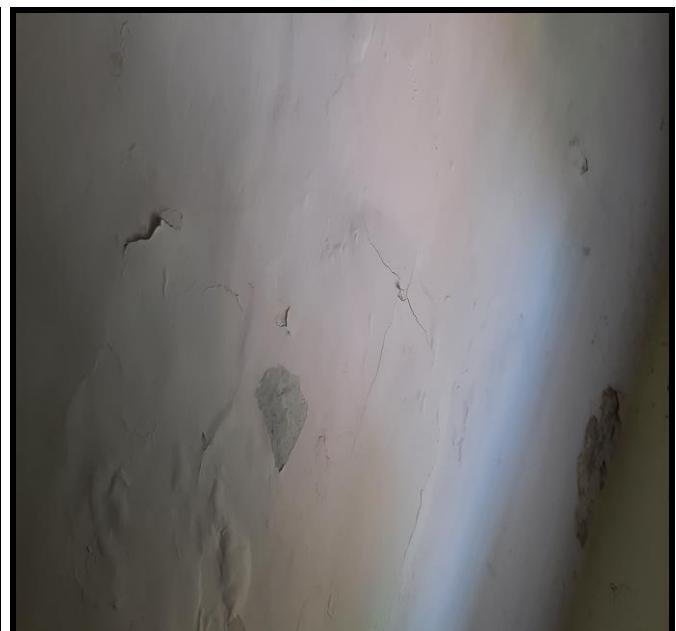
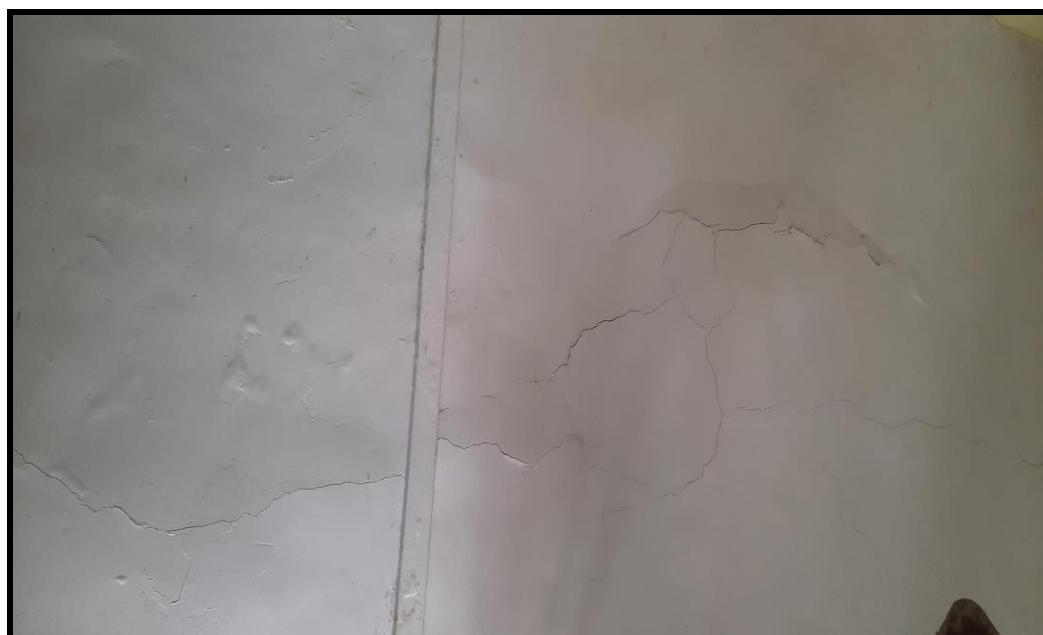
### FLAT NO – 703

- ❖ **HALL** – Leakage mark observed on ceiling.
- ❖ **KITCHEN** – Leakage mark observed on ceiling.
  - Structural crack observed on ceiling.
- ❖ **PASSAGE** – O.K.
- ❖ **TOILET & BATH ROOM** – O.K.

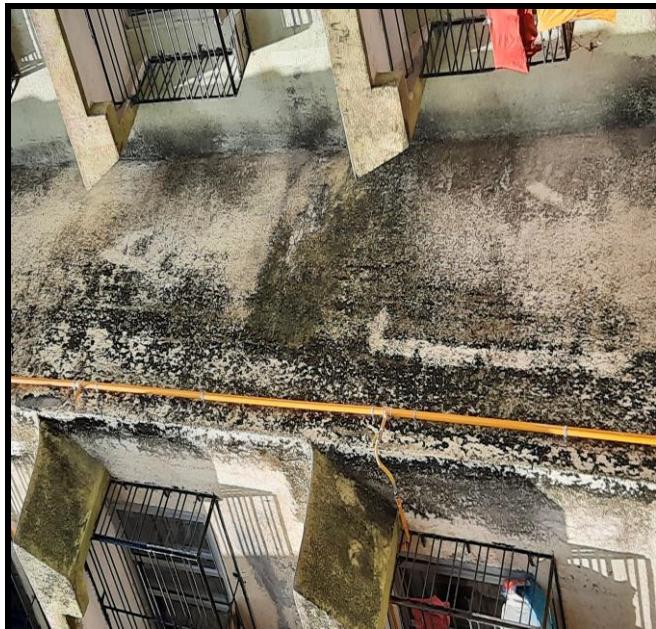
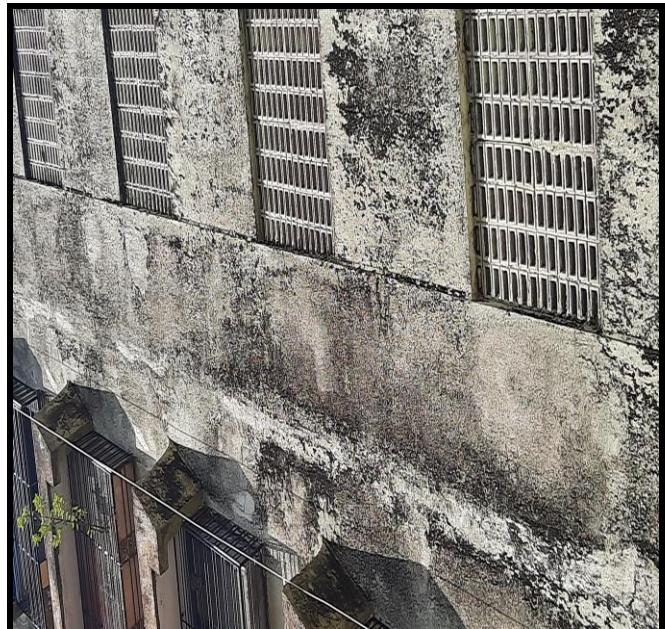
### FRONT SIDE

- ❖ Algae observed at several places on wall.

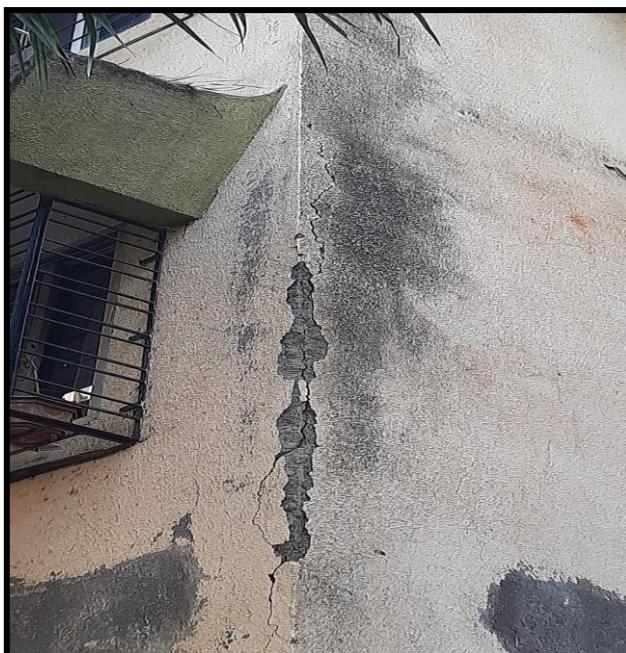
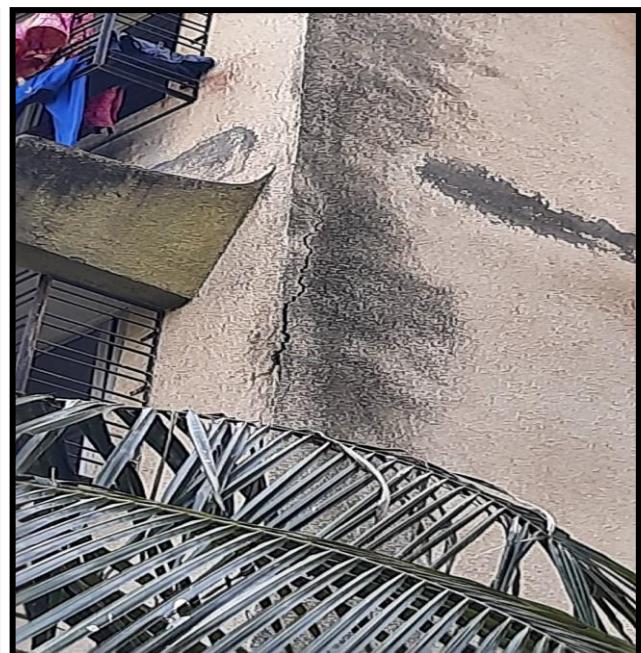
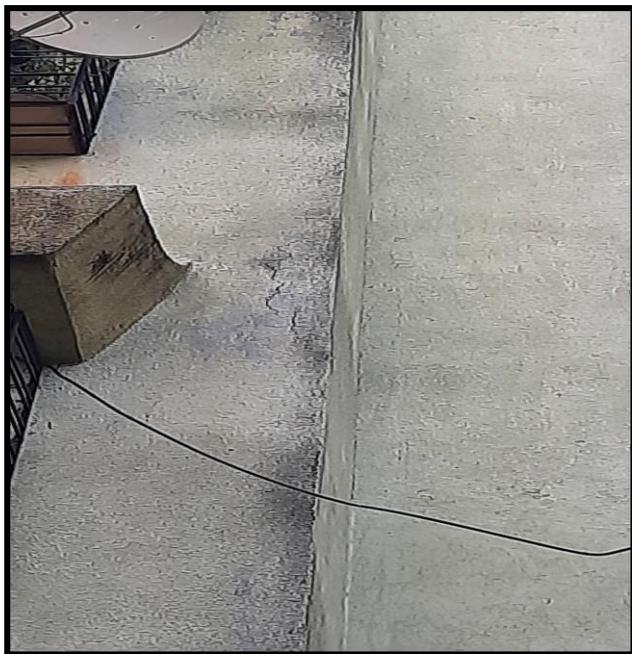
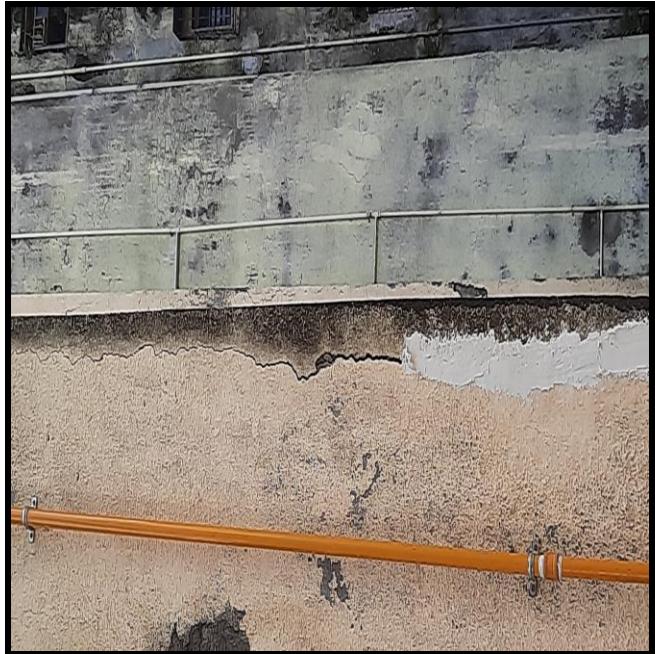
### BACK SIDE

- ❖ Structural crack observed at several places on column.

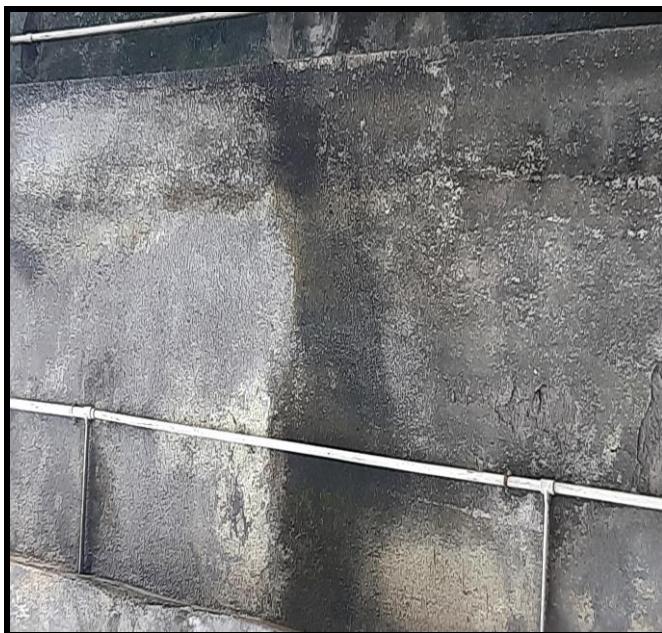
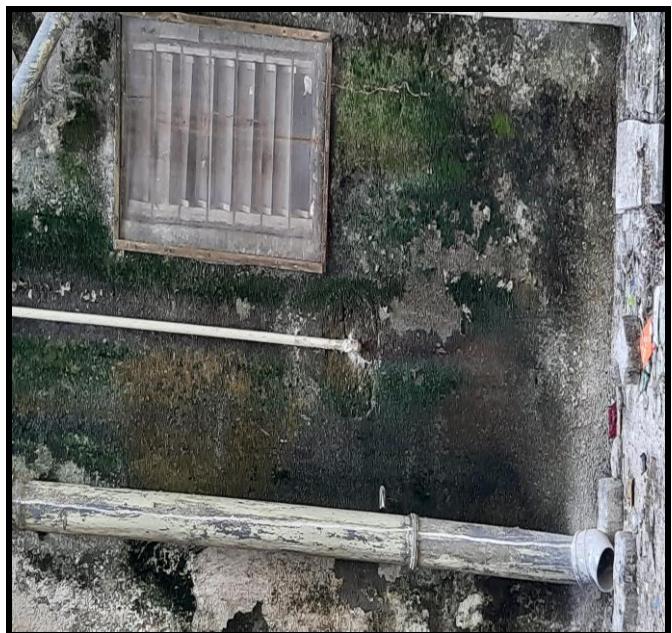
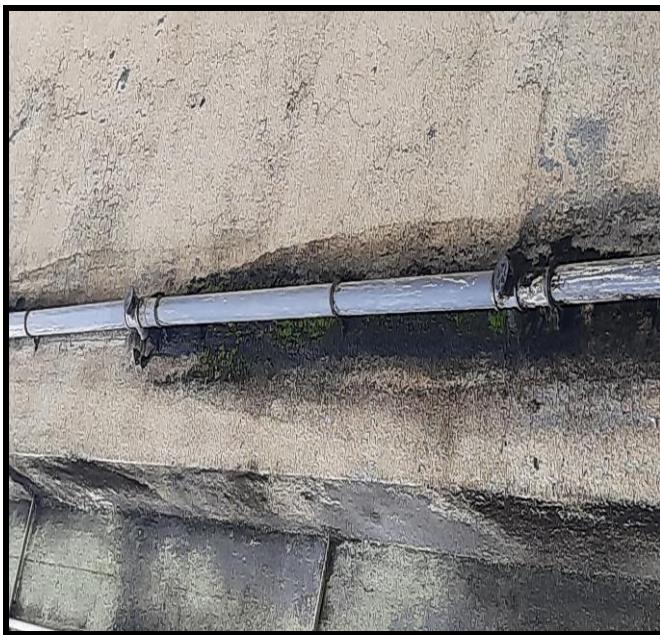
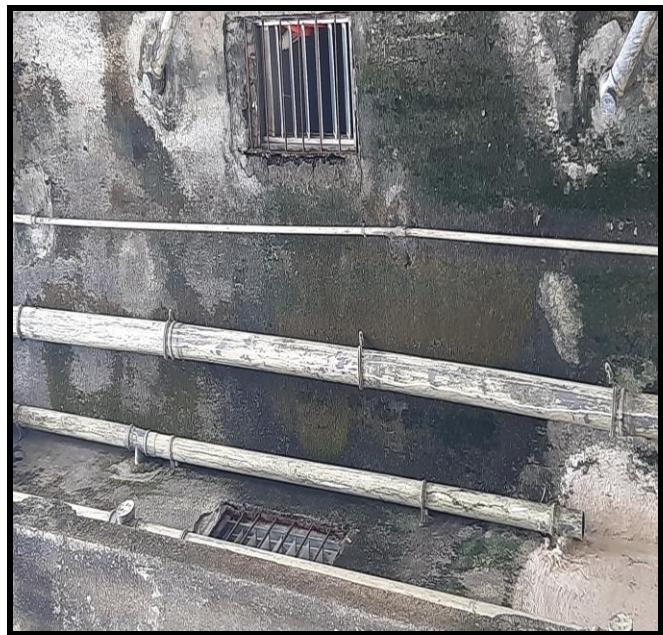
## NORTH SIDE

- ❖ Algae observed at several places on wall.

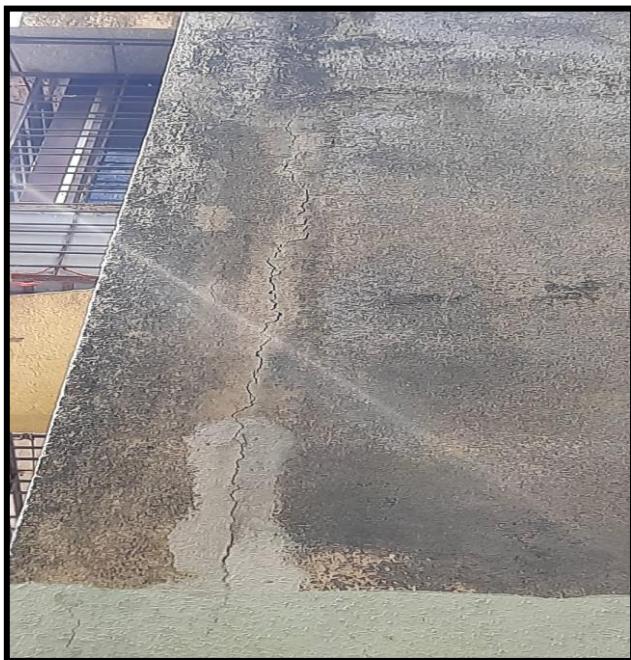
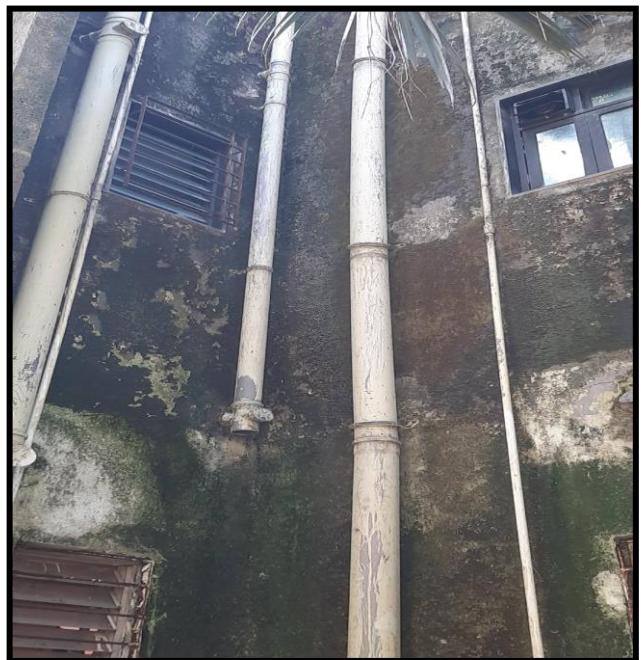
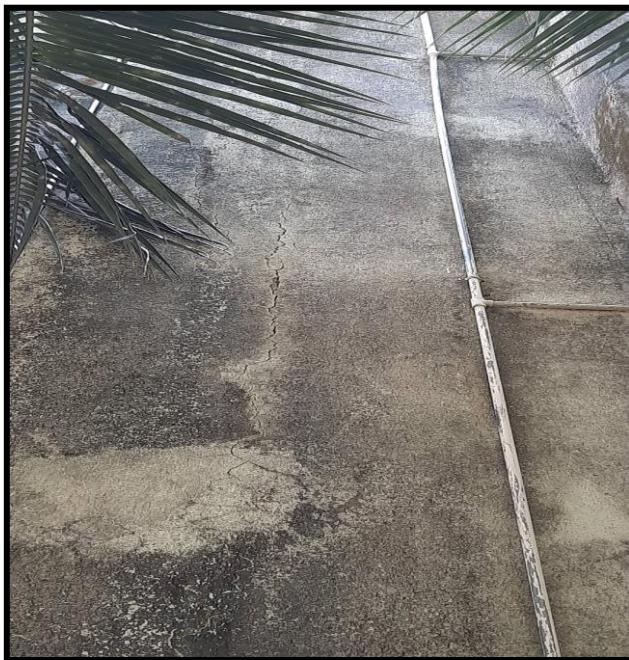
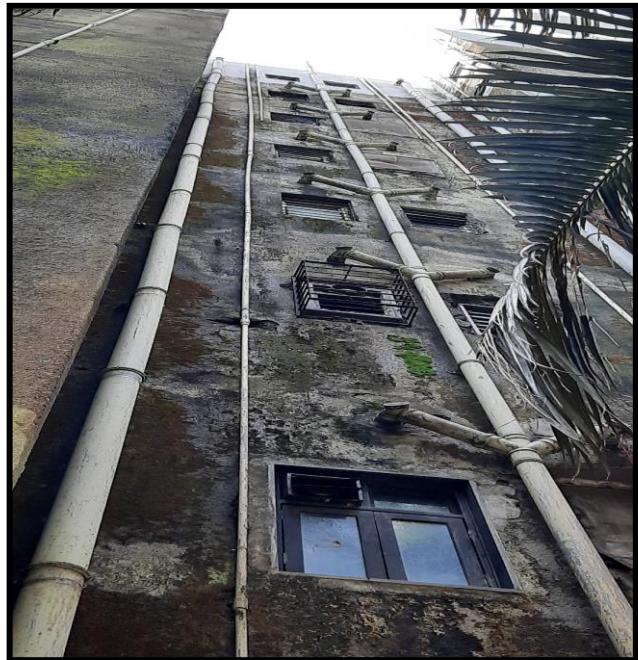
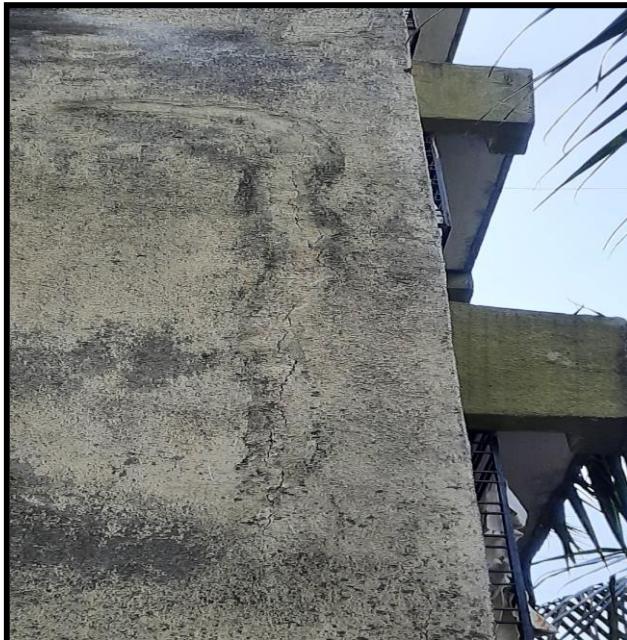
## SOUTH SIDE

- ❖ Structural crack observed at several places on column.
- ❖ Major crack observed at several places on wall.
- ❖ Algae observed at several places on wall.
