STRUCTURAL AUDIT REPORT
FOR
“VISHAL SAHYADRI CO – OP HSG. SOC. LTD”,
“C5 – WING”
SITUATED AT
SAHYADRI NAGAR, CHARKOP,
KANDIVALI (W) MUMBAI – 400 067

PREPARED BY
LATESH S. SANKLECHA
CONSULTING STRUCTURAL ENGINEERS

978/C5/LSS/2021

JUNE 21, 2021

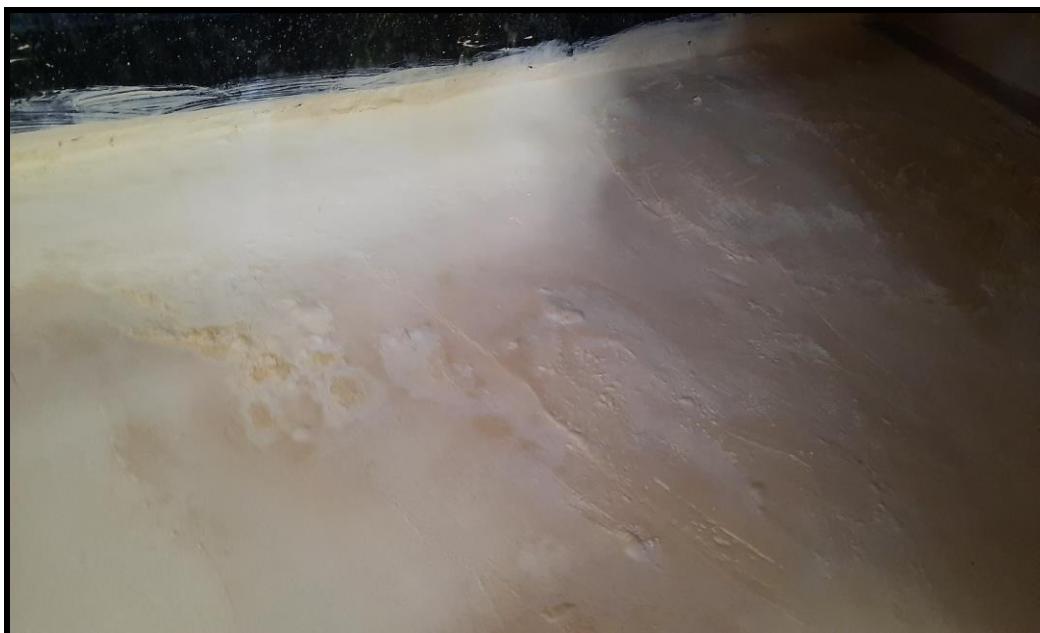
FLAT NO – 02

- ❖ **HALL** – Hollow sound observed on column.
 - Leakage mark observed on wall.
- ❖ **KITCHEN** – O.K.
- ❖ **PASSAGE** – O.K.
- ❖ **TOILET & BATH ROOM** – O.K.

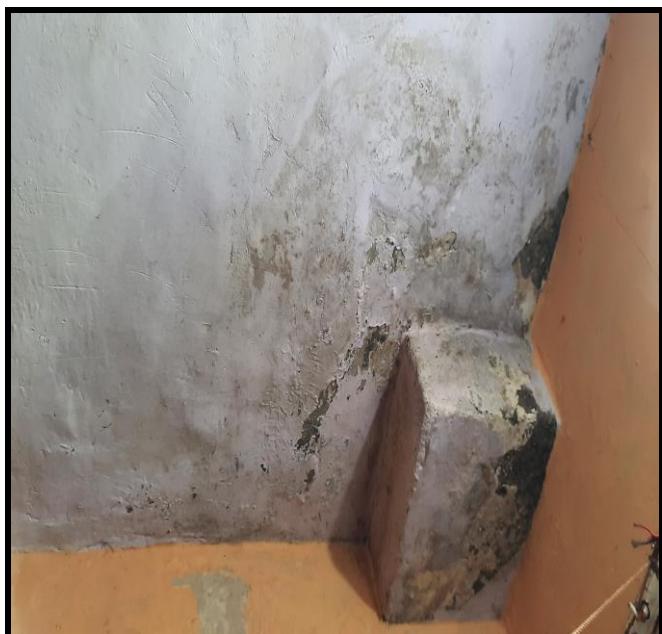
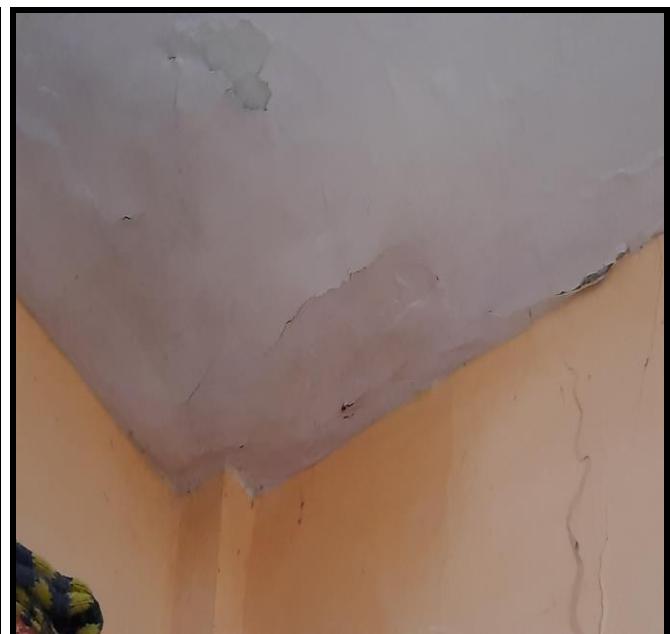
FLAT NO – 08

- ❖ **HALL** – Dampness observed on ceiling.
 - Structural crack observed on ceiling.
- ❖ **KITCHEN** – Dampness observed on ceiling.
- ❖ **PASSAGE** – O.K.
- ❖ **TOILET & BATH ROOM** – O.K.

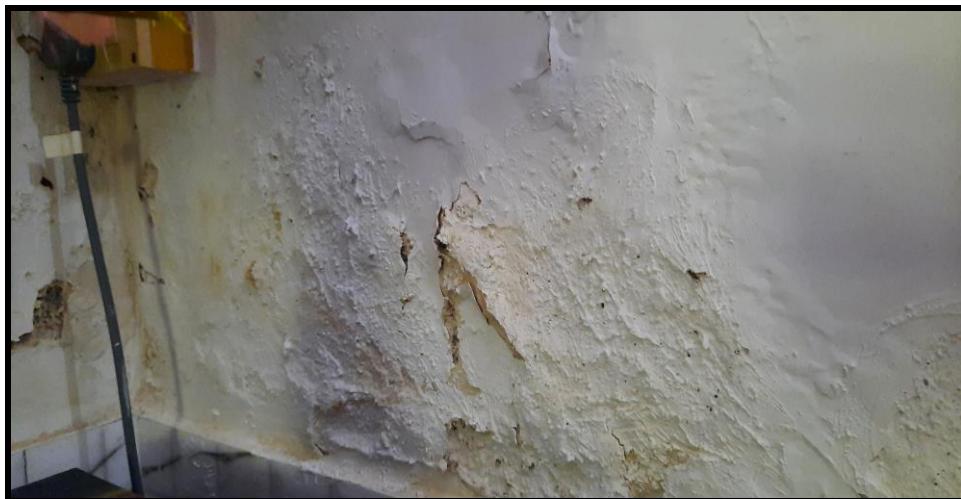
FLAT NO – 11

- ❖ **HALL** – Dampness observed on wall in monsoon.
- ❖ **KITCHEN** – Seepage observed on wall.
- ❖ **PASSAGE** – O.K.
- ❖ **TOILET & BATH ROOM** – Leakage observed on ceiling in monsoon.

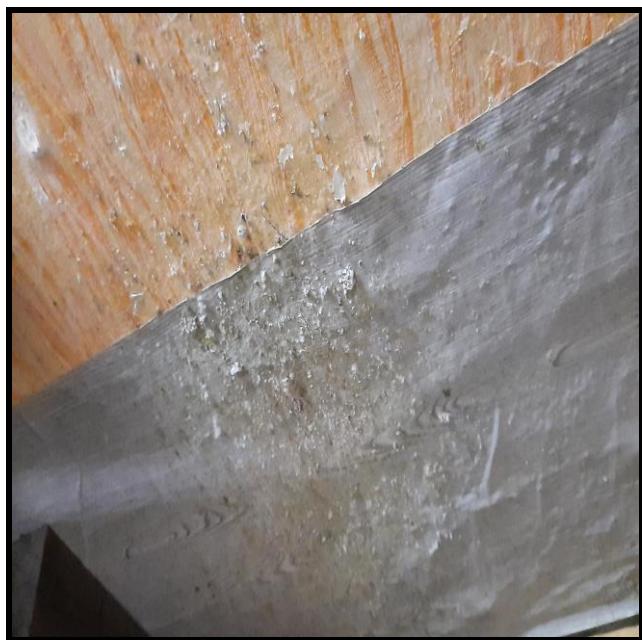
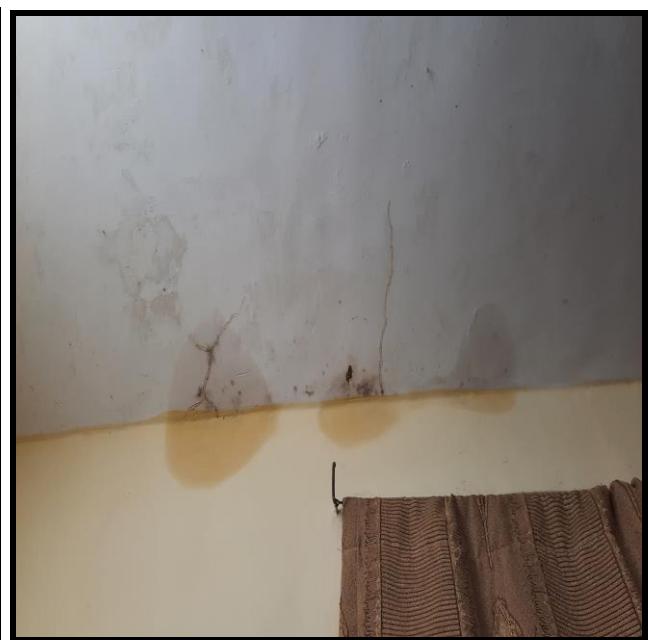
FLAT NO – 14

- ❖ **HALL** – Seepage observed on wall.
- ❖ **KITCHEN** – Dampness observed on ceiling.
- ❖ **PASSAGE** – O.K.
- ❖ **TOILET & BATH ROOM** – O.K.

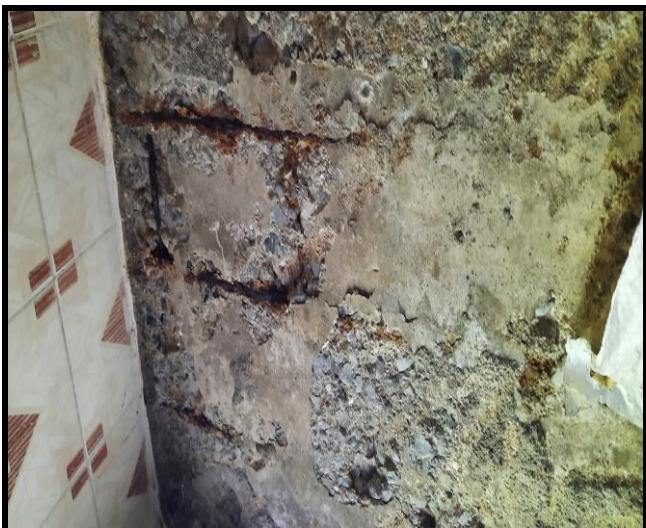
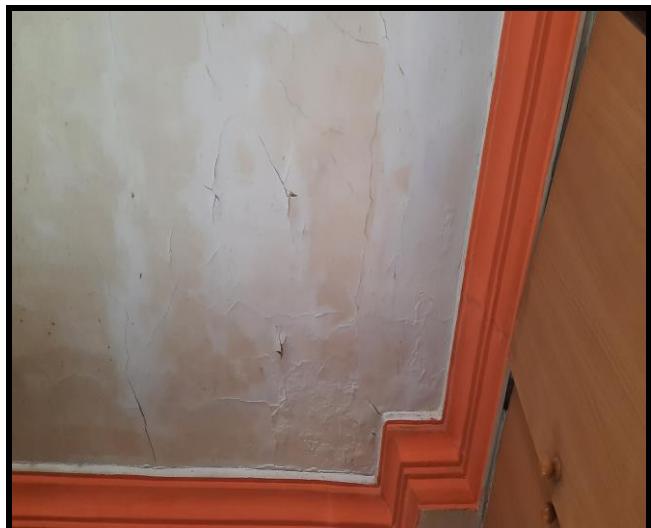
FLAT NO – 17

- ❖ **HALL** – O.K.
- ❖ **KITCHEN** – Structural damage observed on ceiling.
- ❖ **PASSAGE** – O.K.
- ❖ **TOILET & BATH ROOM** – Ceiling plaster get damaged & steel get exposed & corroded.

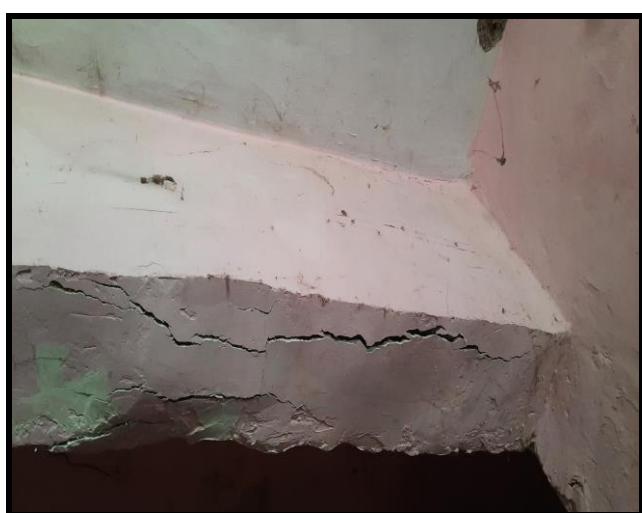
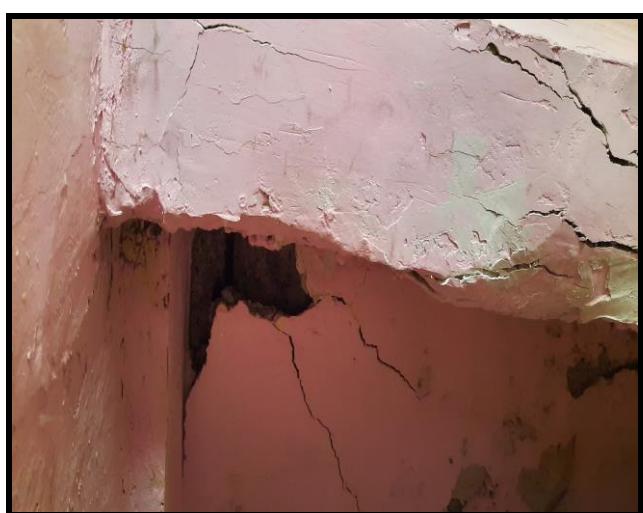
FLAT NO – 18

- ❖ **HALL** – O.K.
- ❖ **KITCHEN** – Leakage mark observed on wall.
 - Structural crack observed on beam.
 - Ceiling plaster get damaged & steel get exposed & corroded.
- ❖ **PASSAGE** – O.K.
- ❖ **TOILET & BATH ROOM** – O.K.

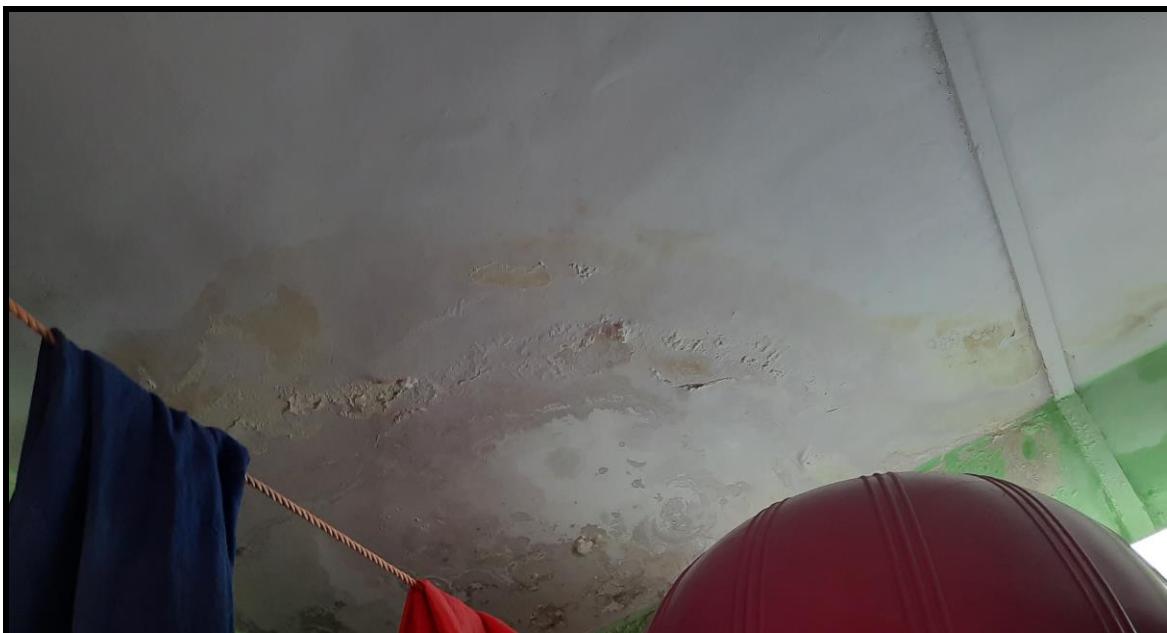
FLAT NO – 23

- ❖ **HALL** – O.K.
- ❖ **KITCHEN** – Dampness observed on wall & ceiling.
- ❖ **PASSAGE** – O.K.
- ❖ **TOILET & BATH ROOM** – O.K.

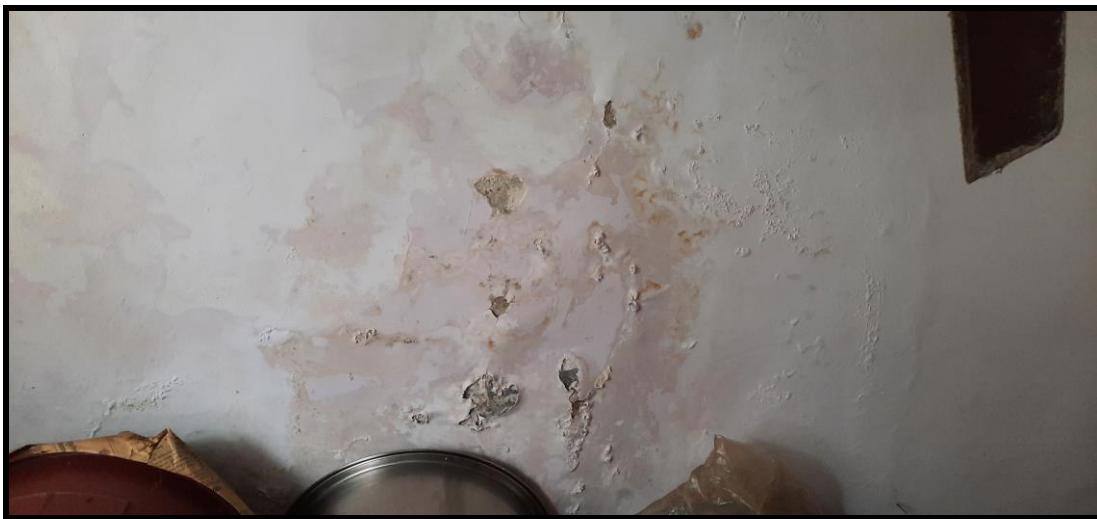
FLAT NO – 28

- ❖ **HALL** – O.K.
- ❖ **KITCHEN** – Dampness observed on ceiling.
- ❖ **PASSAGE** – O.K.
- ❖ **TOILET & BATH ROOM** – O.K.

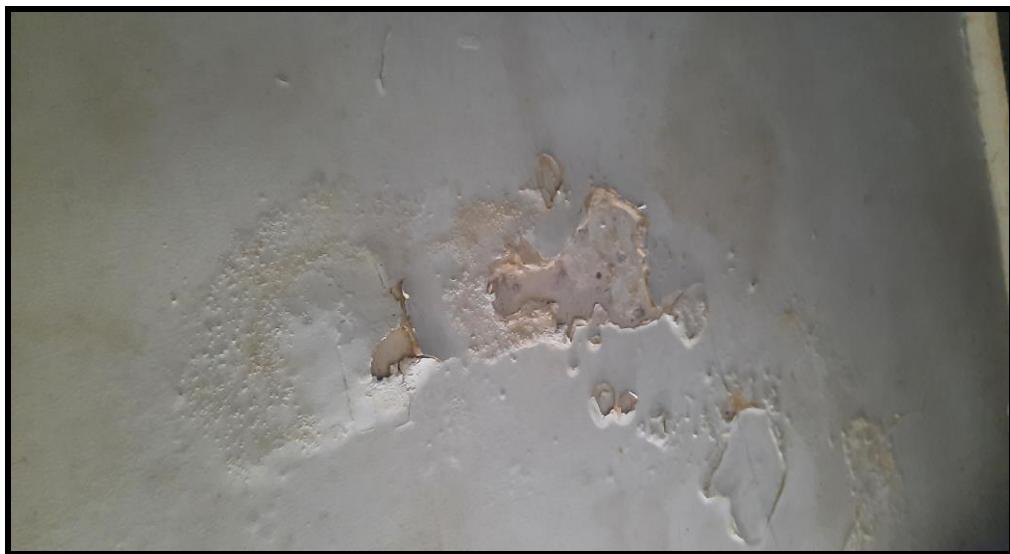
FLAT NO – 32

- ❖ **HALL** – Seepage observed on wall.
- ❖ **KITCHEN** – O.K.
- ❖ **PASSAGE** – O.K.
- ❖ **TOILET & BATH ROOM** – O.K.

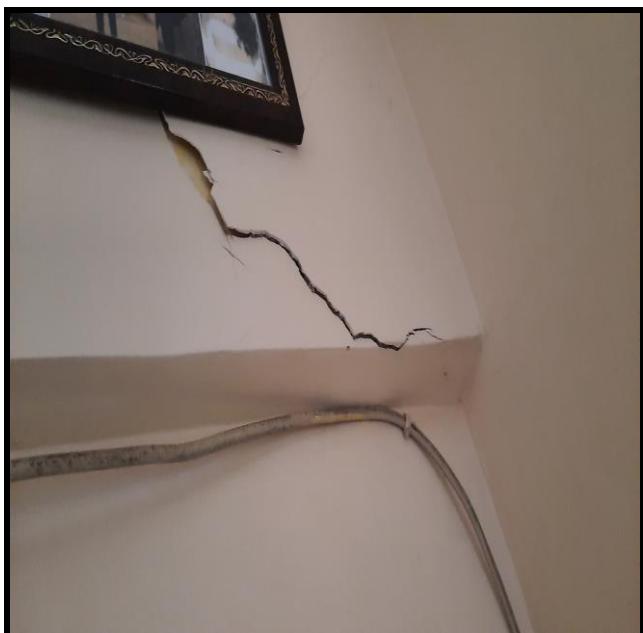
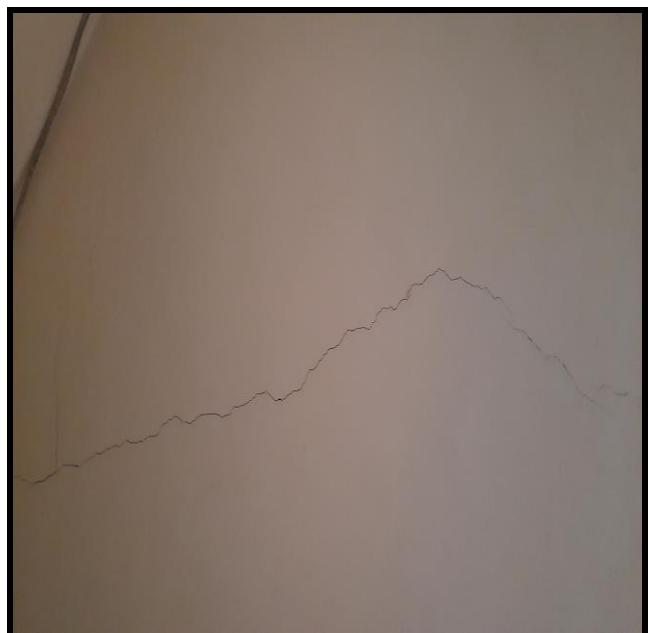
FLAT NO – 33

- ❖ **HALL** – Structural crack observed on beam.
 - Major crack observed on wall.
- ❖ **KITCHEN** – O.K.
- ❖ **PASSAGE** – O.K.
- ❖ **TOILET & BATH ROOM** – O.K.

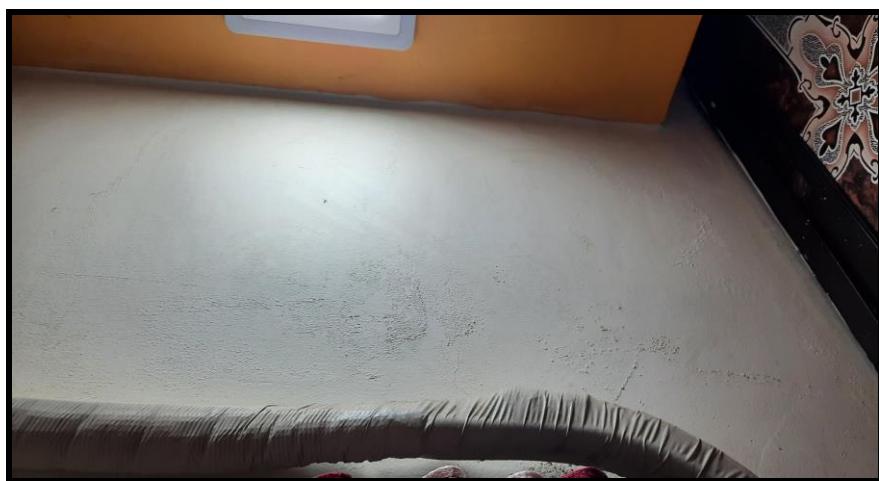
FLAT NO – 35

- ❖ **HALL** – Leakage mark observed on beam.
- ❖ **KITCHEN** – O.K.
- ❖ **PASSAGE** – O.K.
- ❖ **TOILET & BATH ROOM** – O.K.

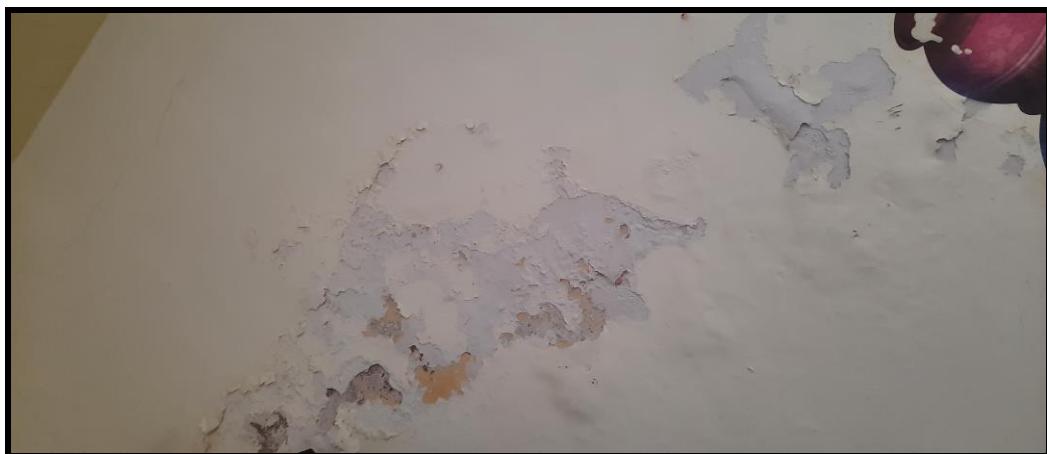
FLAT NO – 37

- ❖ **HALL** – Leakage mark observed on wall.
- ❖ **KITCHEN** – O.K.
- ❖ **PASSAGE** – O.K.
- ❖ **TOILET & BATH ROOM** – O.K.

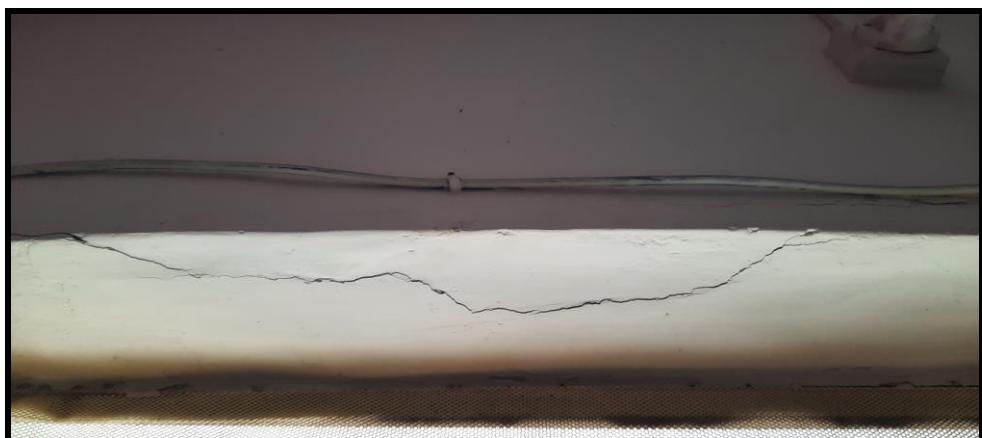
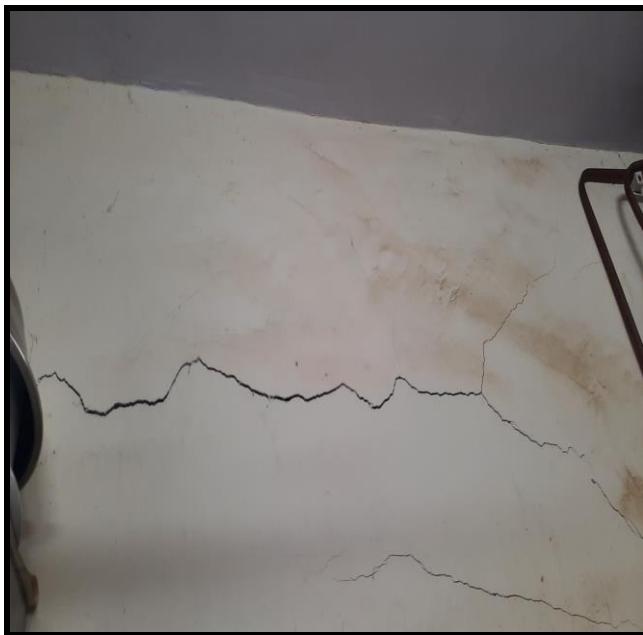
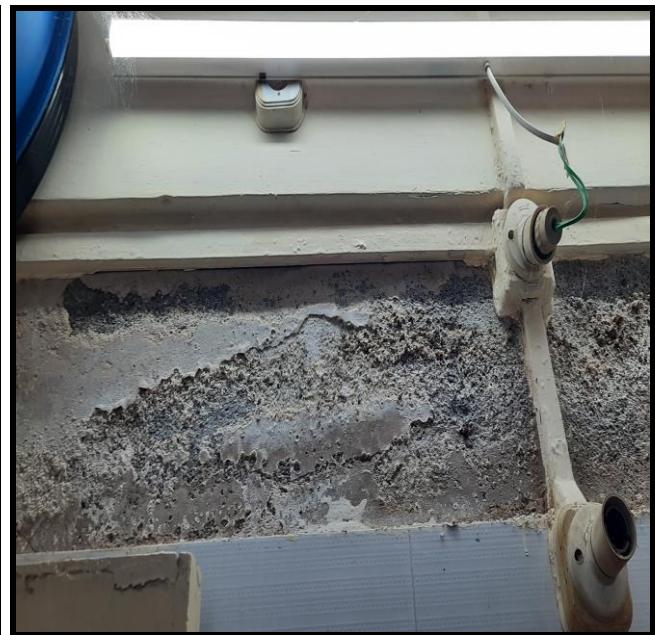
FLAT NO – 38

- ❖ **HALL** – Structural crack observed on beam.
 - Seepage observed on wall.
- ❖ **KITCHEN** – Structural crack observed on beam.
- ❖ **PASSAGE** – O.K.
- ❖ **TOILET & BATH ROOM** – O.K.

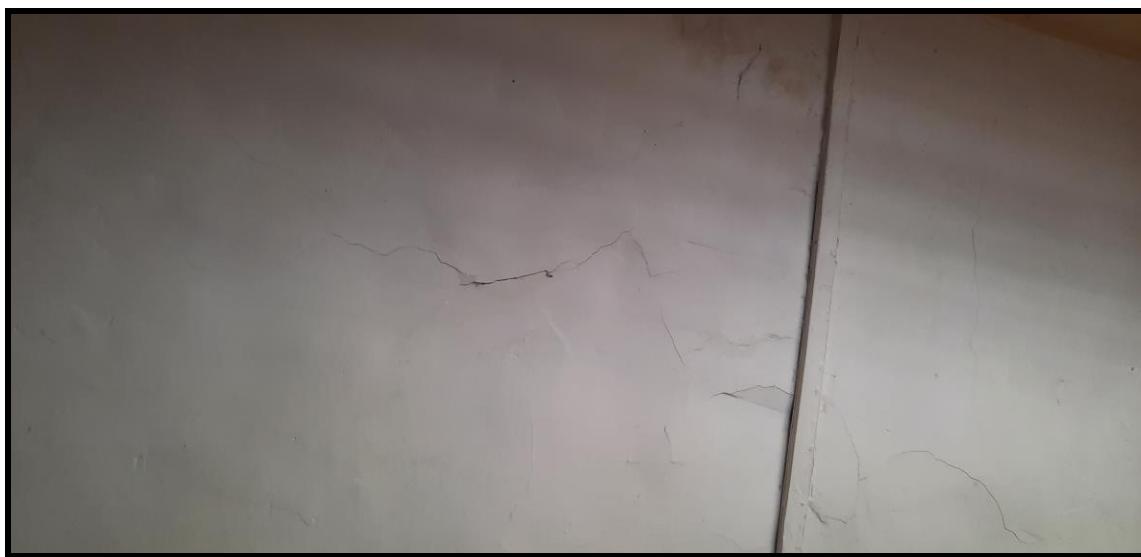
FLAT NO – 40

- ❖ **HALL** – Structural crack observed on ceiling.
 - Leakage observed on ceiling in monsoon.
- ❖ **KITCHEN** – O.K.
- ❖ **PASSAGE** – O.K.
- ❖ **TOILET & BATH ROOM** – O.K.

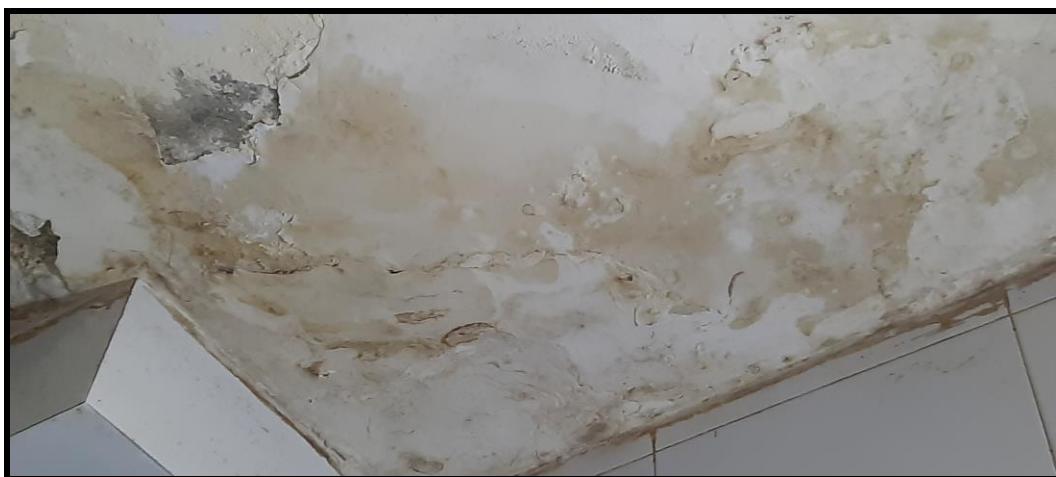
FLAT NO – 47

- ❖ **HALL** – O.K.
- ❖ **KITCHEN** – Leakage mark observed on ceiling.
- ❖ **PASSAGE** – O.K.
- ❖ **TOILET & BATH ROOM** – O.K.

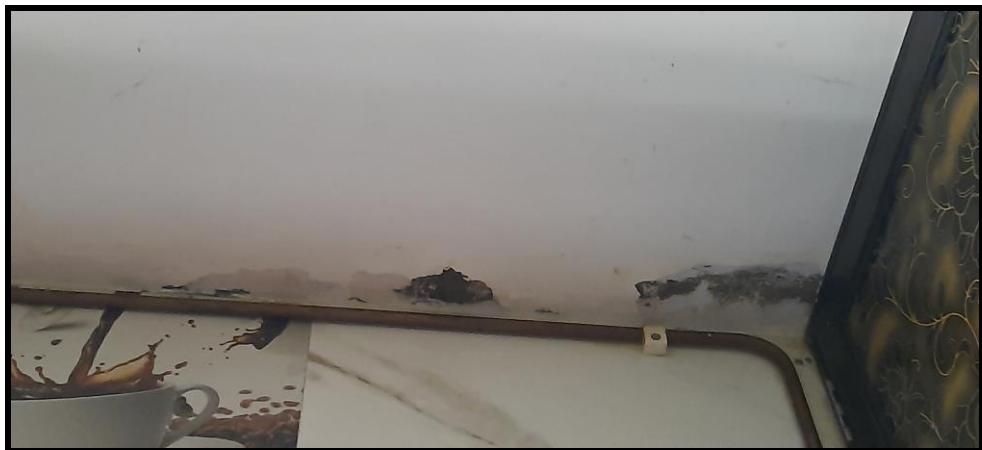
FLAT NO – 51

- ❖ **HALL** – O.K.
- ❖ **KITCHEN** – Leakage observed on ceiling in monsoon.
- ❖ **PASSAGE** – O.K.
- ❖ **TOILET & BATH ROOM** – O.K.

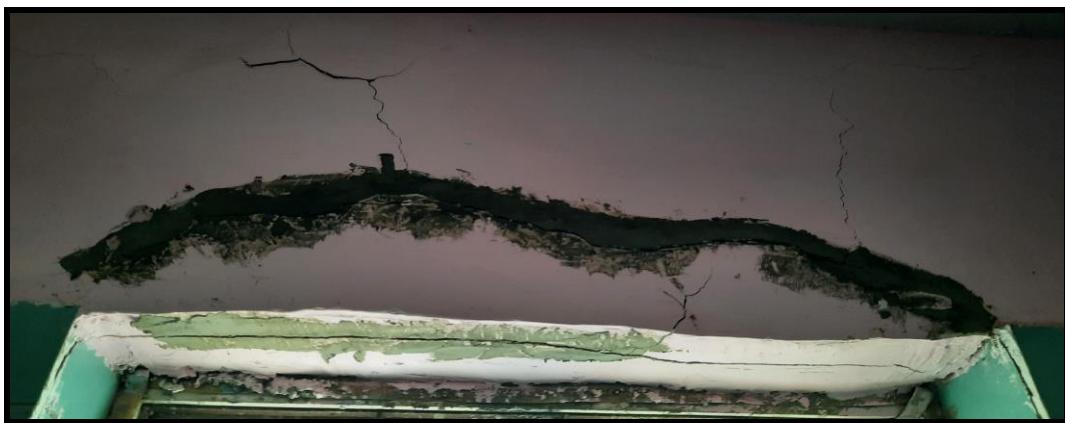
FLAT NO – 53

- ❖ **HALL** – O.K.
- ❖ **KITCHEN** – Structural crack observed on beam.
- ❖ **PASSAGE** – O.K.
- ❖ **TOILET & BATH ROOM** – O.K.

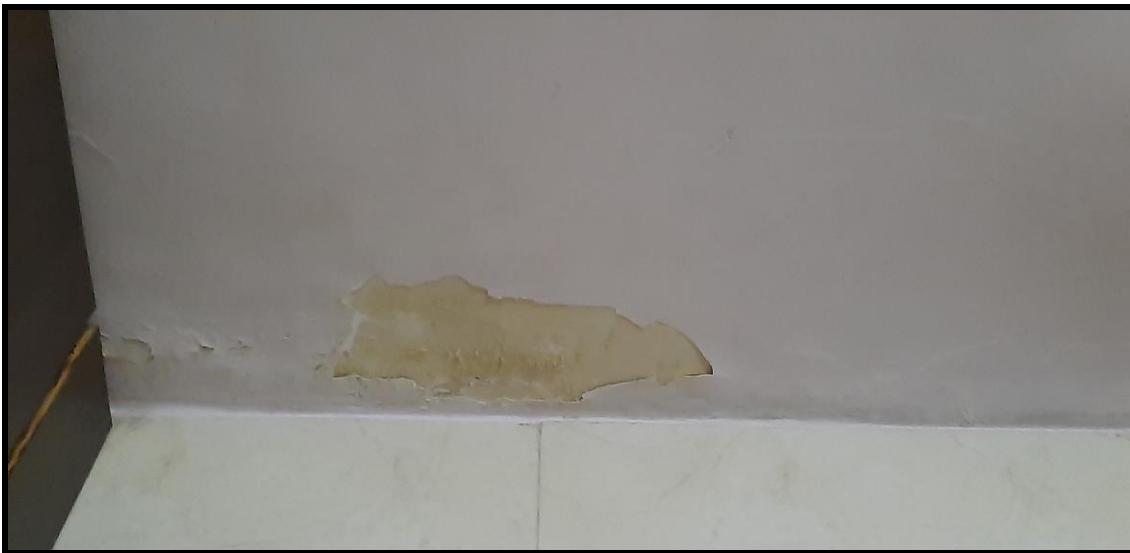
FLAT NO – 56

- ❖ **HALL** – Leakage observed on ceiling in monsoon.
- ❖ **KITCHEN** – Leakage observed on ceiling in monsoon.
- ❖ **PASSAGE** – O.K.
- ❖ **TOILET & BATH ROOM** – O.K.

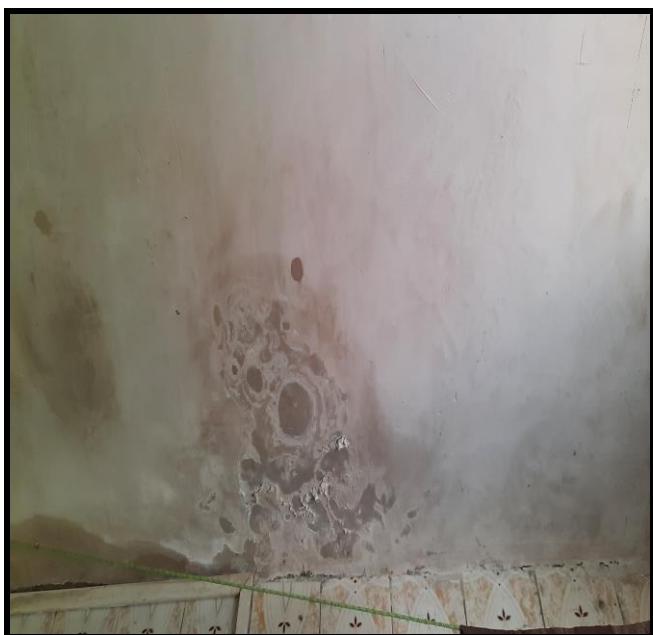
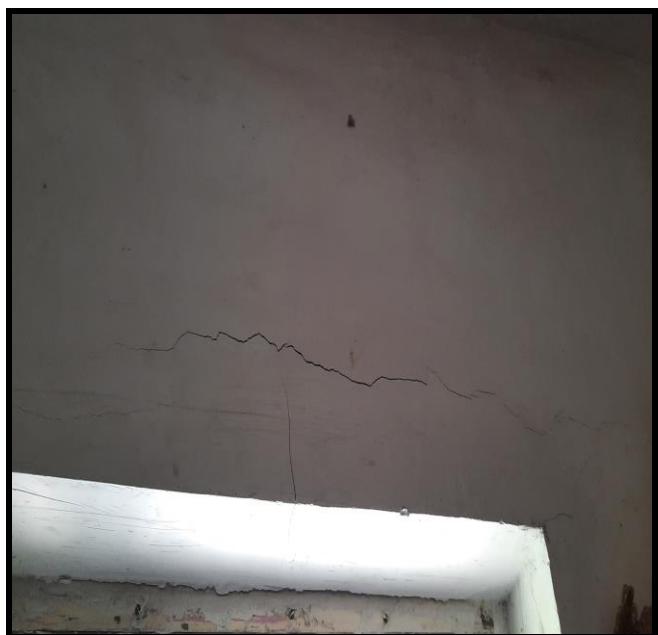
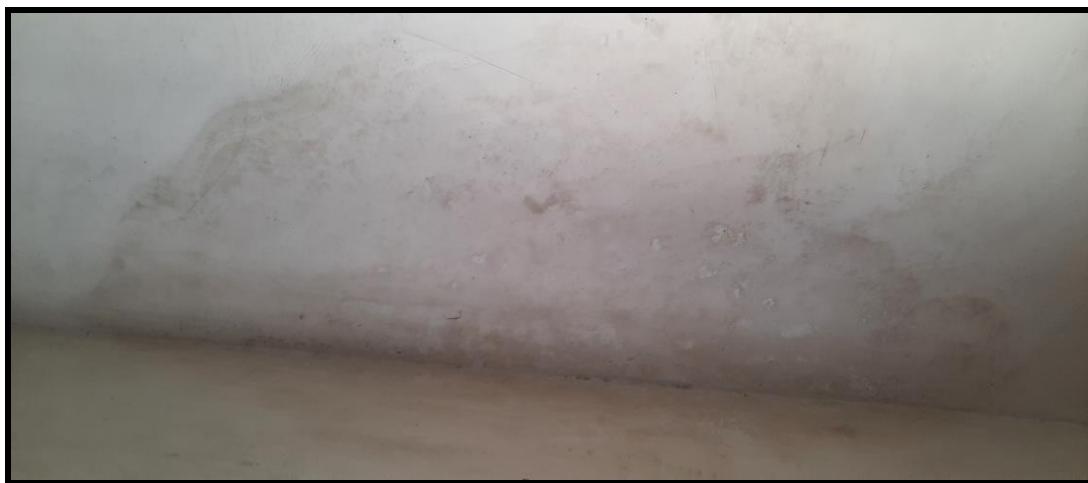
FLAT NO – 59

- ❖ **HALL** – Dampness observed on ceiling.
 - Structural crack observed on beam.
- ❖ **KITCHEN** – Leakage observed on ceiling in monsoon.
- ❖ **PASSAGE** – O.K.
- ❖ **TOILET & BATH ROOM** – O.K.

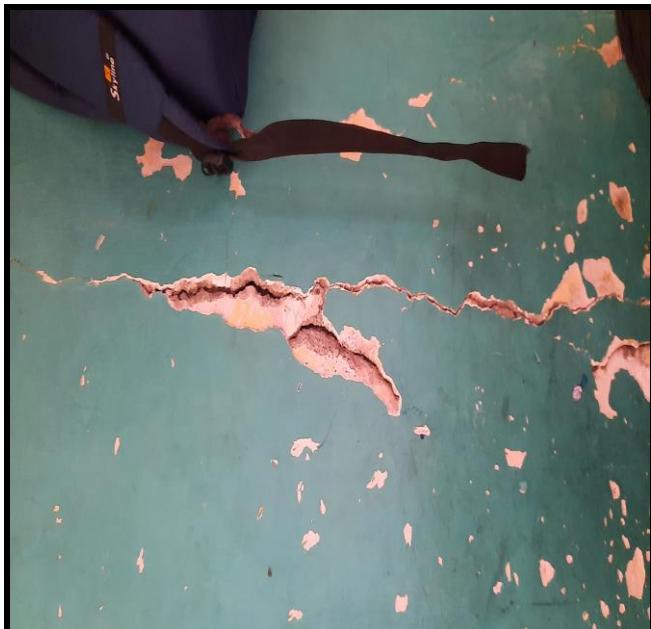
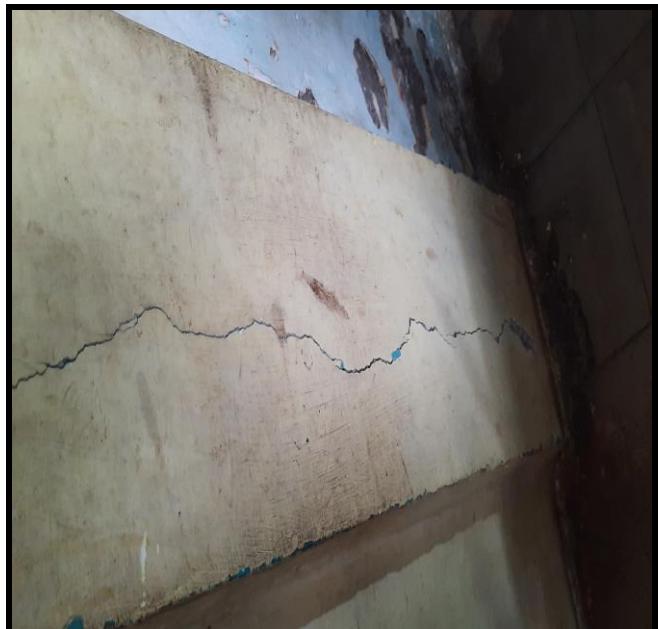
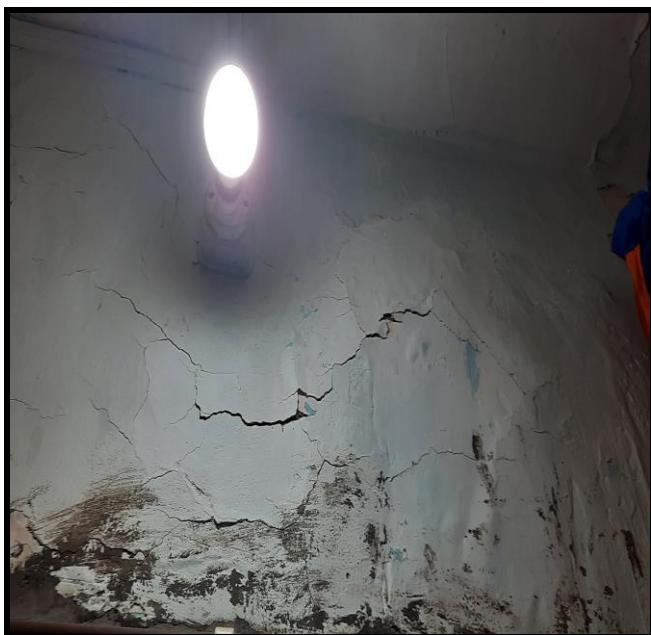
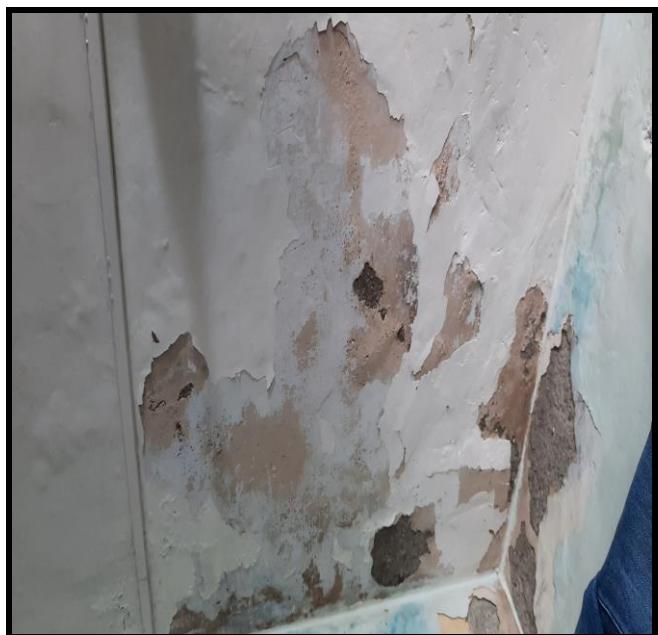
FLAT NO – 61

- ❖ **HALL** – Structural crack observed on column.
- ❖ **KITCHEN** – Structural crack observed on beam.
 - Leakage mark observed on ceiling.
- ❖ **PASSAGE** – O.K.
- ❖ **TOILET & BATH ROOM** – O.K.

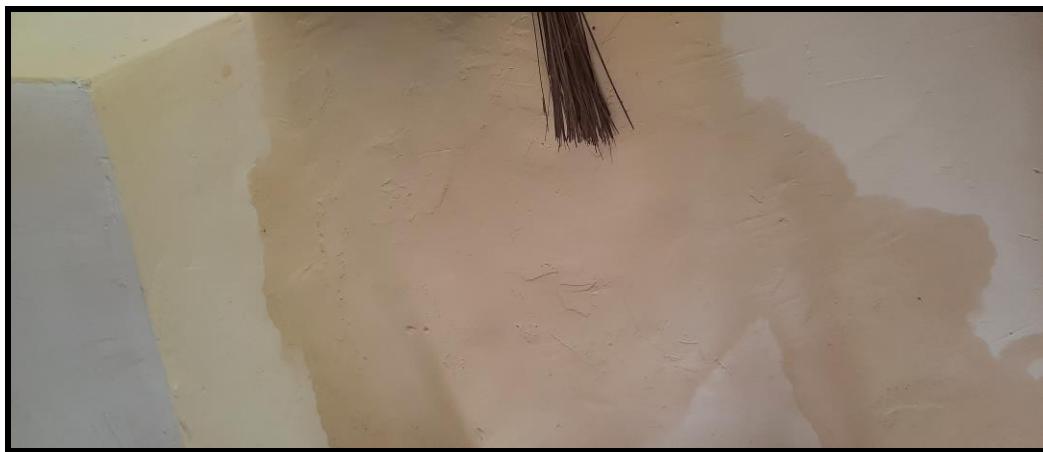
FLAT NO – 66

- ❖ **HALL** – O.K.
- ❖ **KITCHEN** – Dampness observed on wall.
- ❖ **PASSAGE** – O.K.
- ❖ **TOILET & BATH ROOM** – O.K.

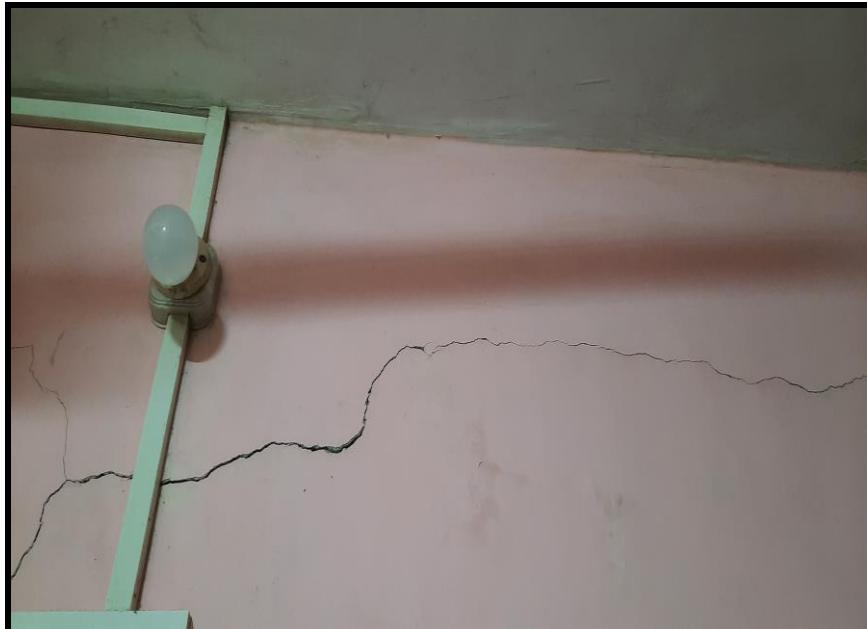
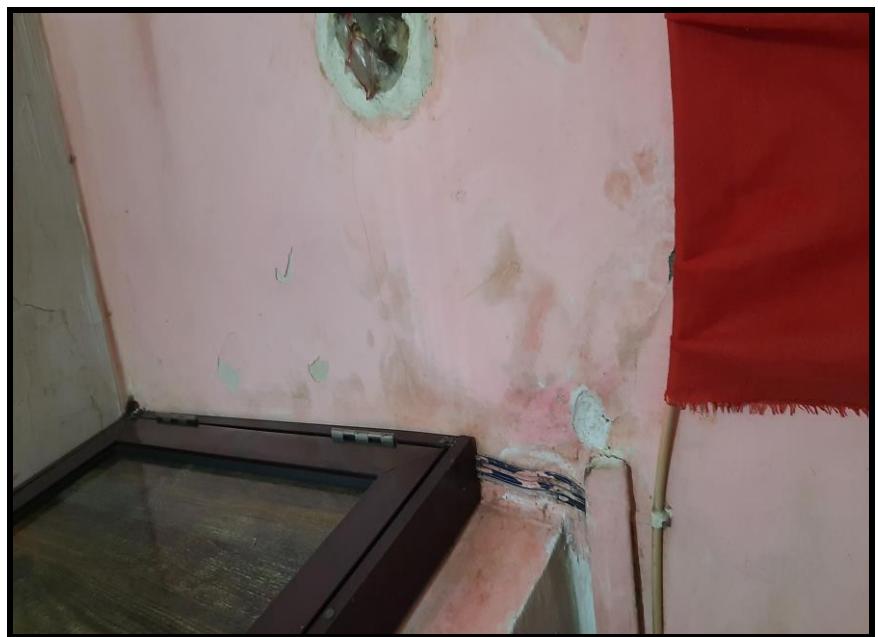
FLAT NO – 79

- ❖ **HALL** – Leakage mark observed on wall.
 - Structural crack observed on beam & ceiling.
- ❖ **KITCHEN** – O.K.
- ❖ **PASSAGE** – O.K.
- ❖ **TOILET & BATH ROOM** – O.K.

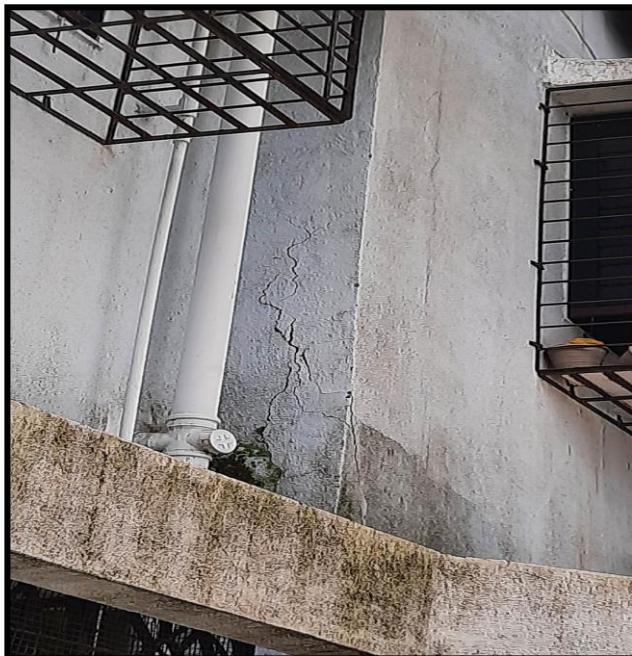
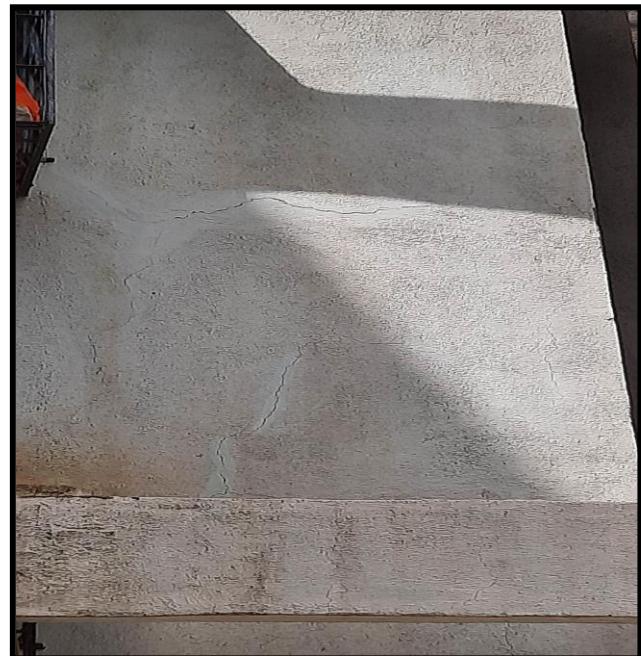
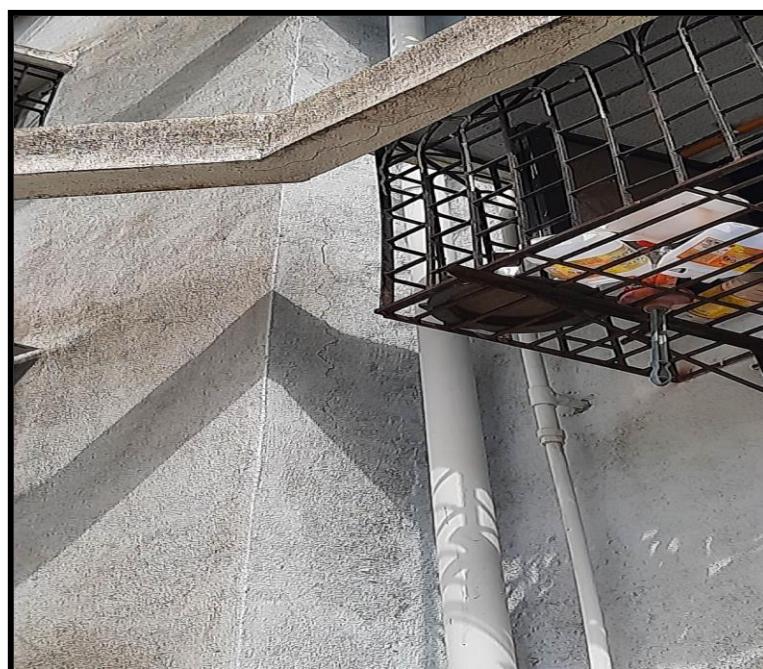
FRONT SIDE

- ❖ Structural crack observed at several places on column & chajjas.
- ❖ Major crack observed at several places on wall.

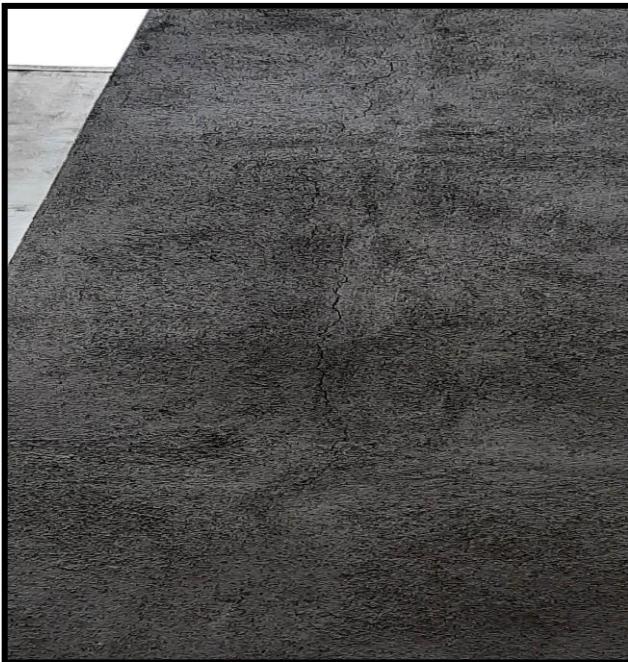
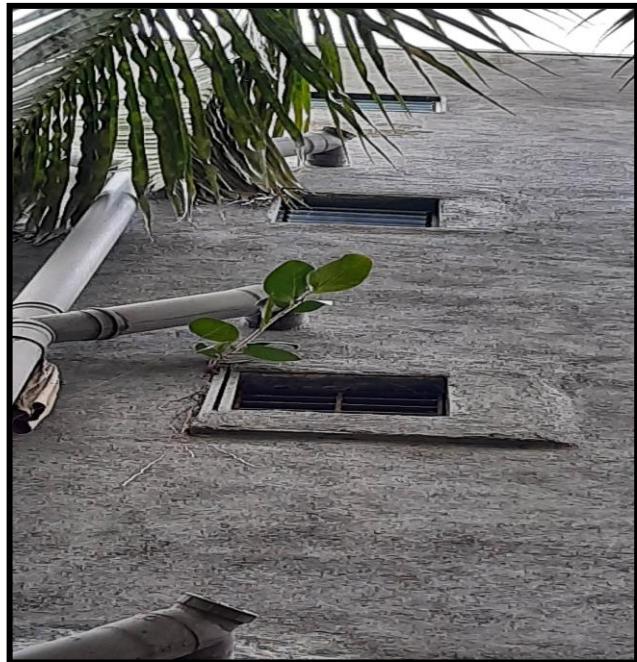
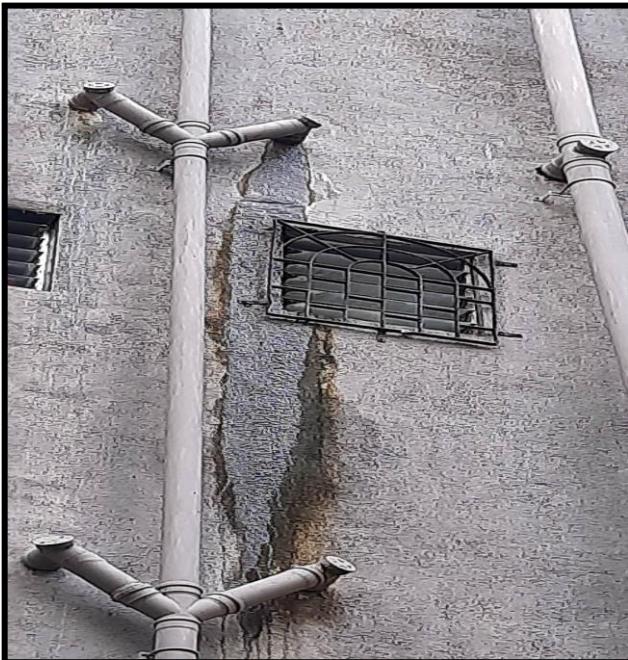
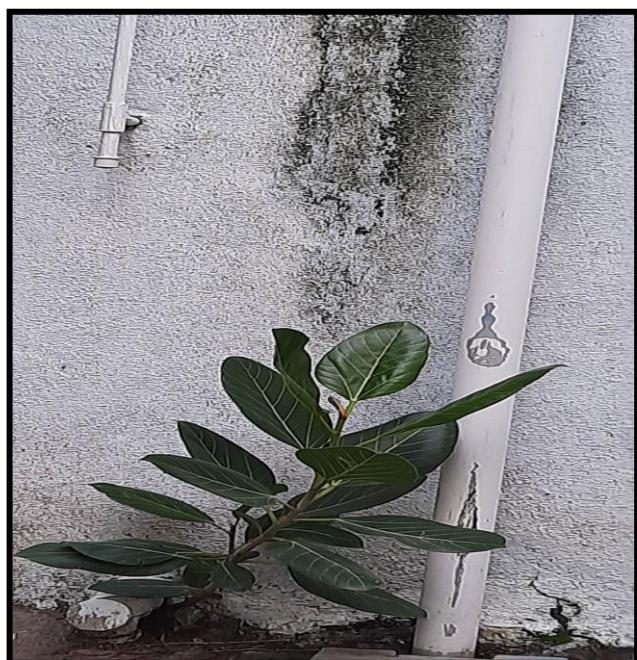
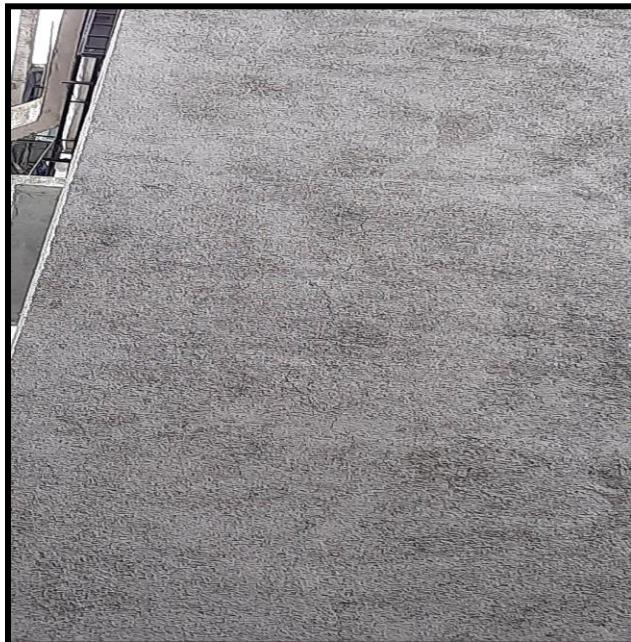
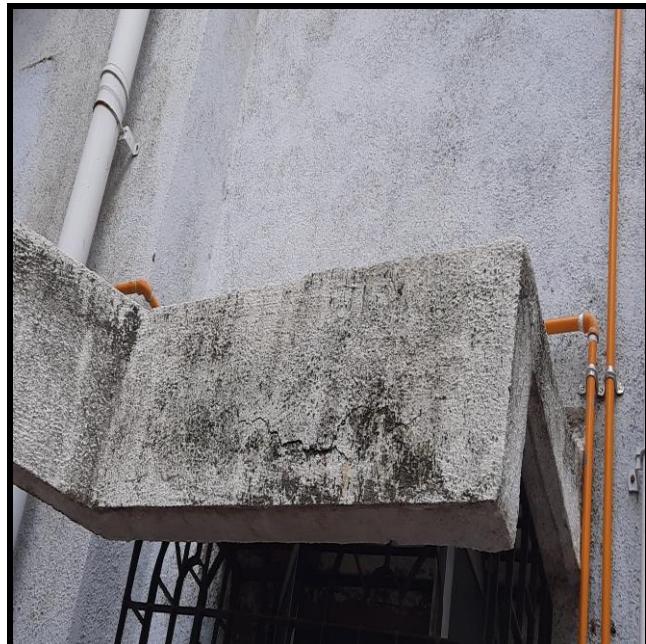
BACK SIDE

- ❖ Structural crack observed at several places on column.
- ❖ Major crack observed at several places on wall.
- ❖ Vegetation growth observed at several places on wall.
- ❖ Column & chajja plaster get damaged & steel get exposed & corroded.

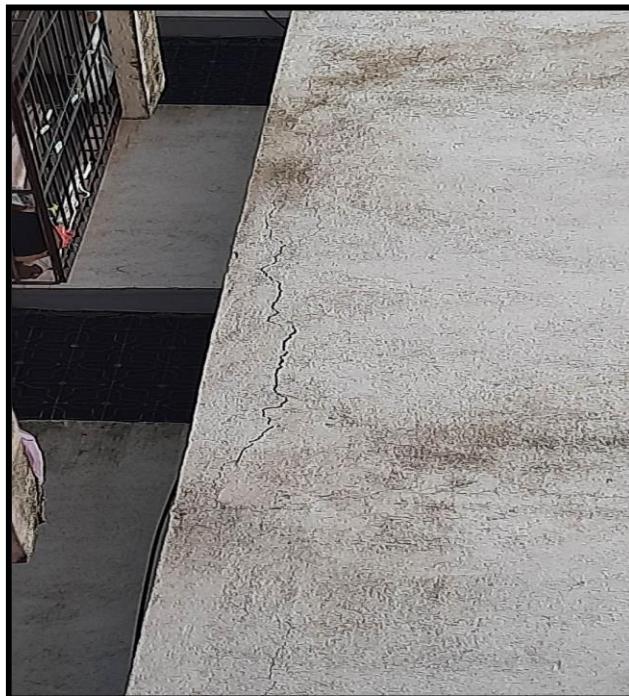
NORTH SIDE

- ❖ Structural crack observed at several places on column & chajjas.
- ❖ Major crack observed at several places on wall.
