STRUCTURAL AUDIT REPORT
FOR
“VISHAL SAHYADRI CO – OP HSG. SOC. LTD”,
“C5 – WING”
SITUATED AT
SAHYADRI NAGAR, CHARKOP,
KANDIVALI (W) MUMBAI – 400 067

PREPARED BY
LATESH S. SANKLECHA
CONSULTING STRUCTURAL ENGINEERS

978/C5/LSS/2021

JUNE 21, 2021

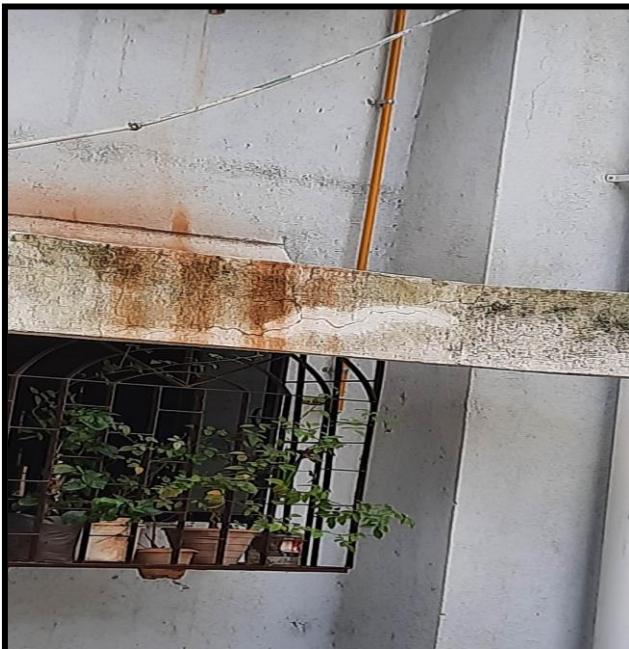
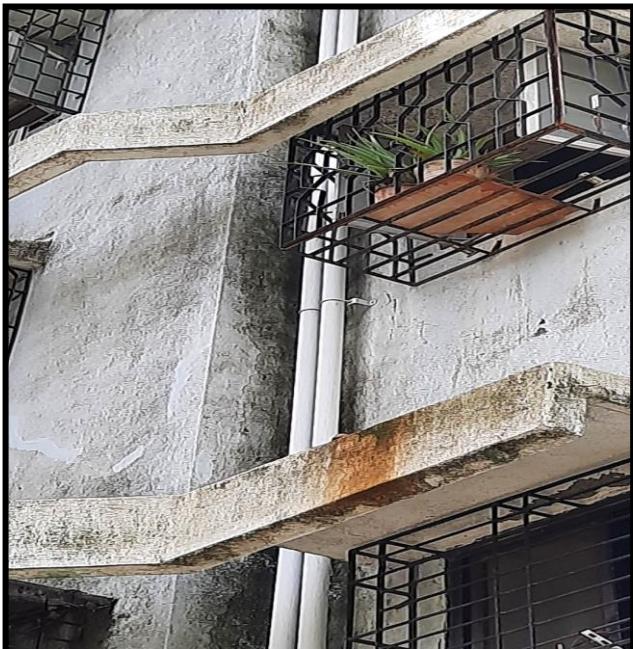
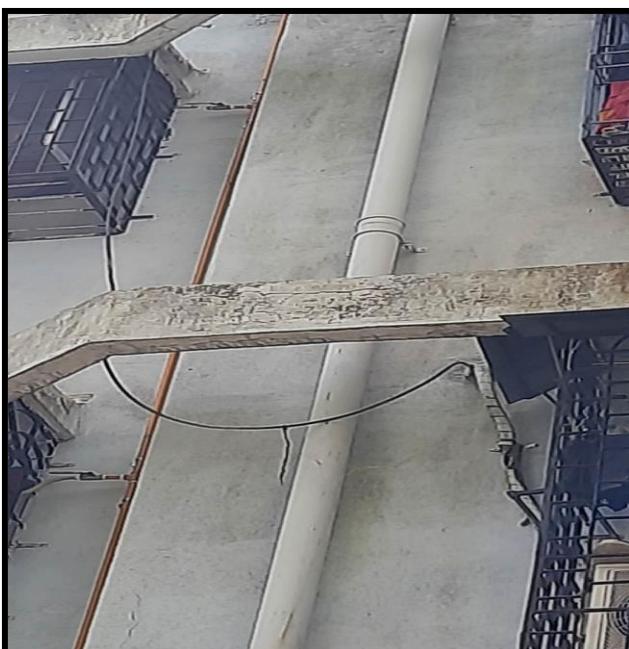
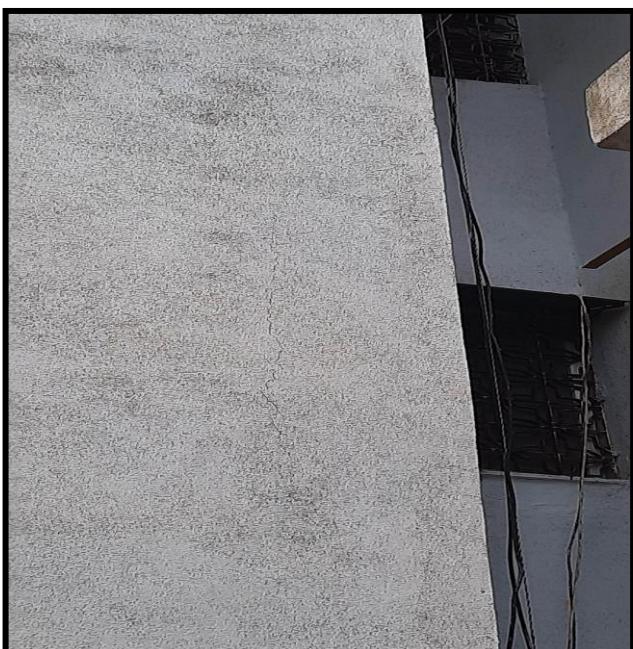
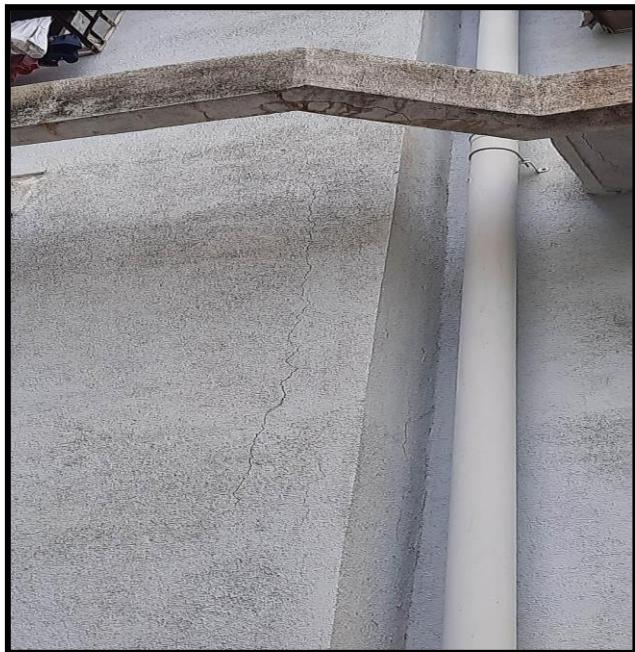
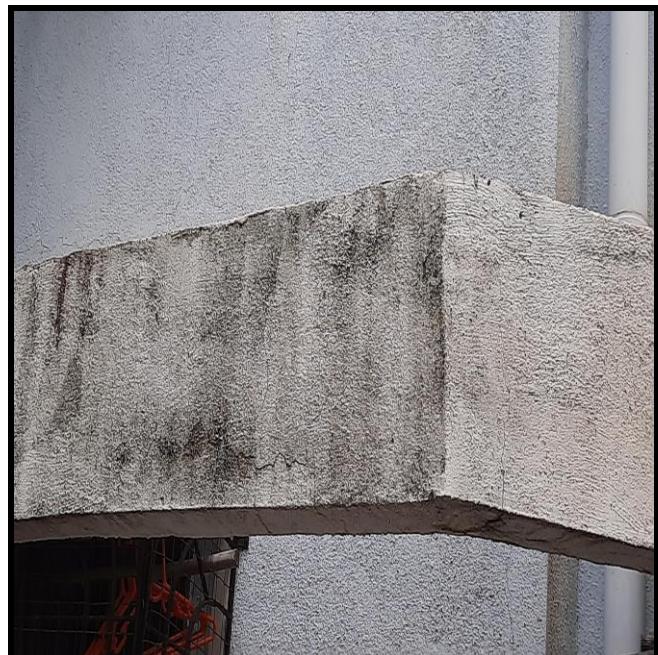
SOUTH SIDE

- ❖ Structural crack observed at several places on column & chajjas.
- ❖ Major crack observed at several places on wall.
