STRUCTURAL AUDIT REPORT
FOR
“VISHAL SAHYADRI CO – OP HSG. SOC. LTD”,
“B17 – WING”
SITUATED AT
SAHYADRI NAGAR, CHARKOP,
KANDIVALI (W) MUMBAI – 400 067

978/B17/LSS/2021

JULY 24, 2021

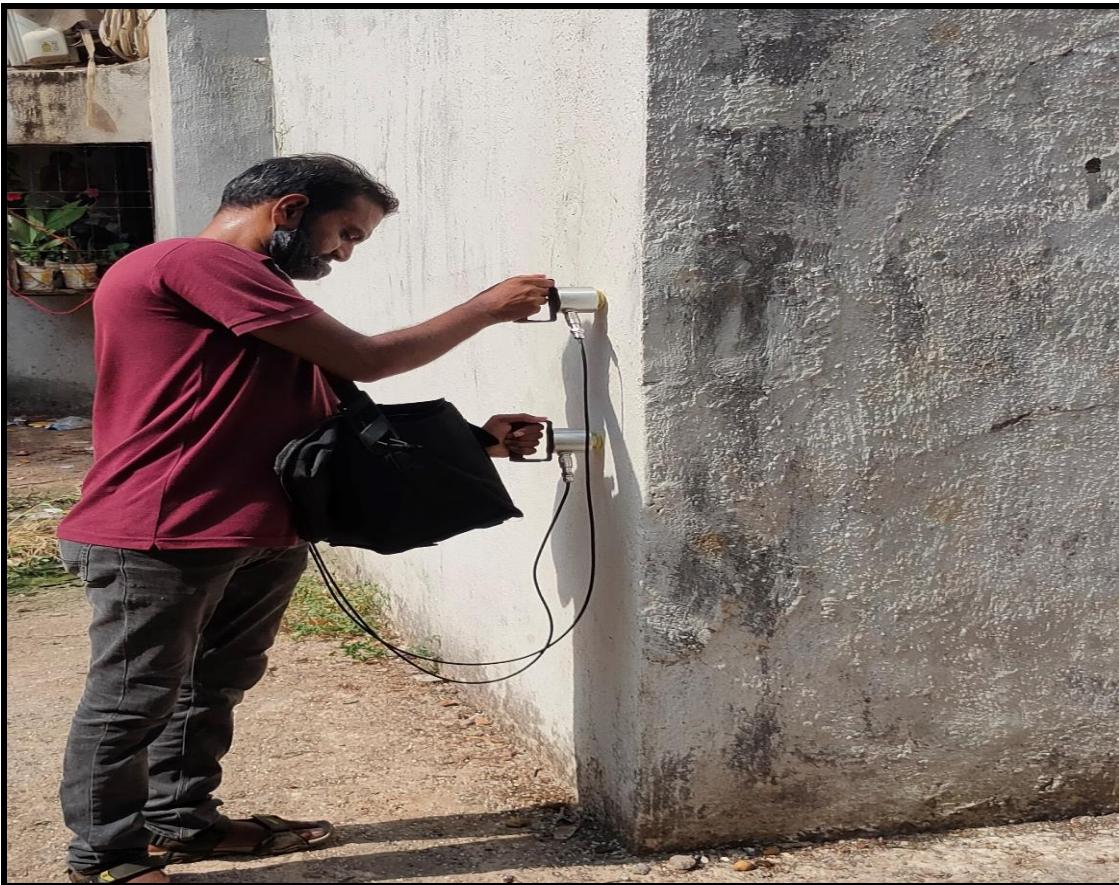
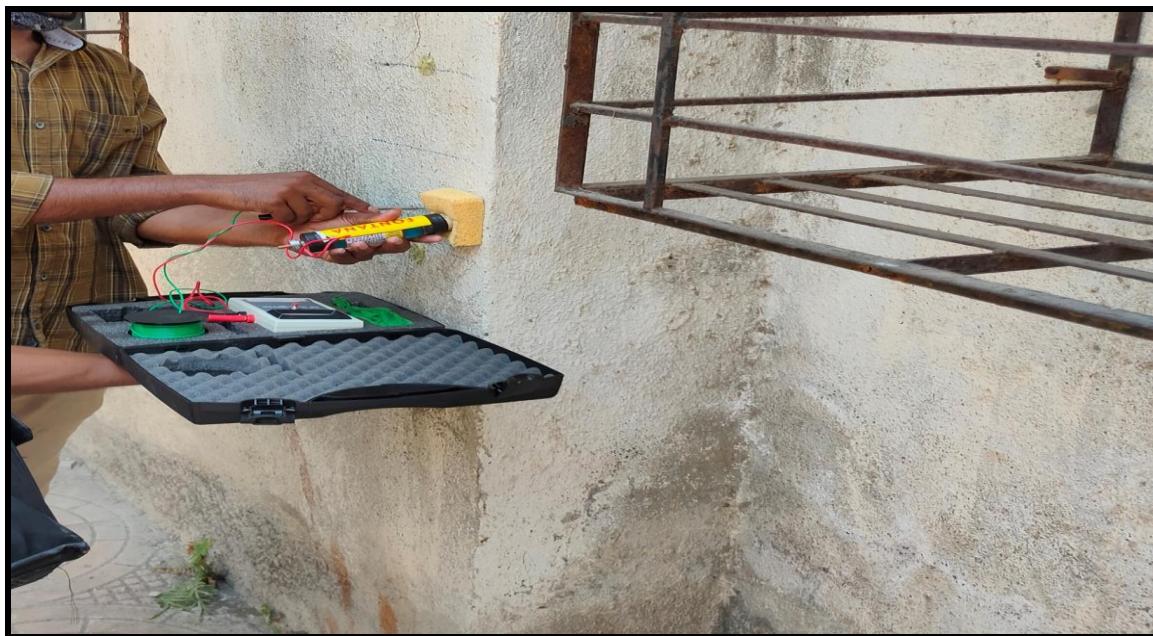
NON – DESTRUCTIVE TEST PHOTO

Rebound Hammer was tested for compressive strength at surface by Schmidt rebound hammer. Results indicate the compressive strength at surface of all the RCC columns is ranging between 12.50 MPa to 17.50 MPa.

The UPV values are ranging between 2.0 Km/Sec to 2.50 Km/Sec.

Out of 4 locations all 4 locations was below 3.0 Km/Sec means concrete quality is poor.

This indicates there are progressive internal cracks in the RCC members due to corrosion of reinforced steel. These members are under distress condition.

Half Cell Potential tested for corrosion activity by half – cell potential tests. Values are taken on Column. The result on tested column is – 337 mV.

Carbonation test was conducted to assess carbonation depth. Readings are taken on Column. Result indicates the carbonation penetration depth is 35.00 mm. Carbonation depths have reached to the reinforcement level in all of the RCC elements. It is essential to give a suitable anti-corrosion treatment to all the RCC members to stop further carbonation and corrosion of concrete.

RCC elements indicating UPV values less than 3 Km/sec needs immediate attention.

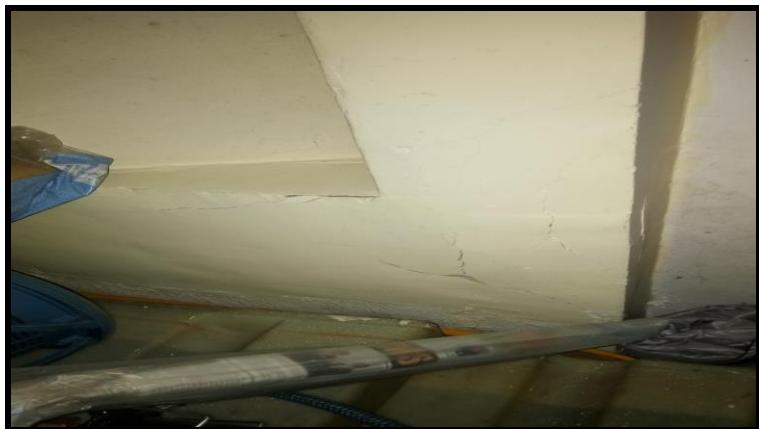
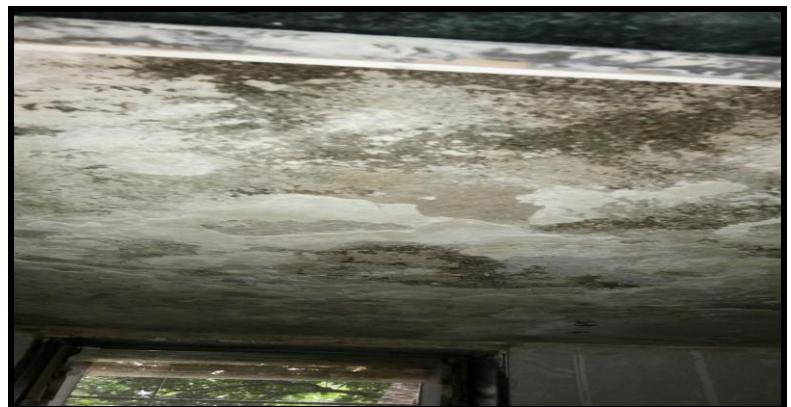
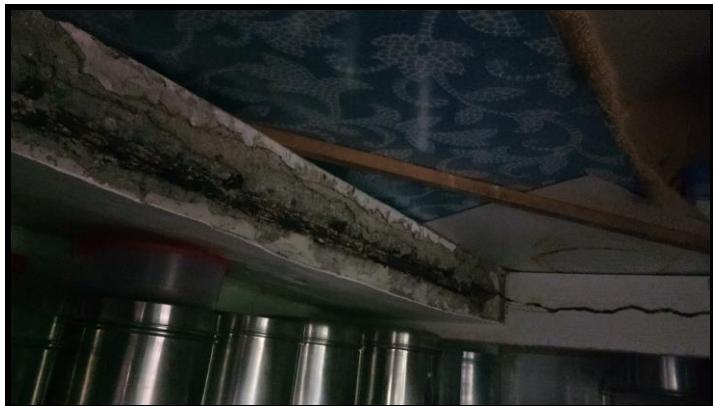
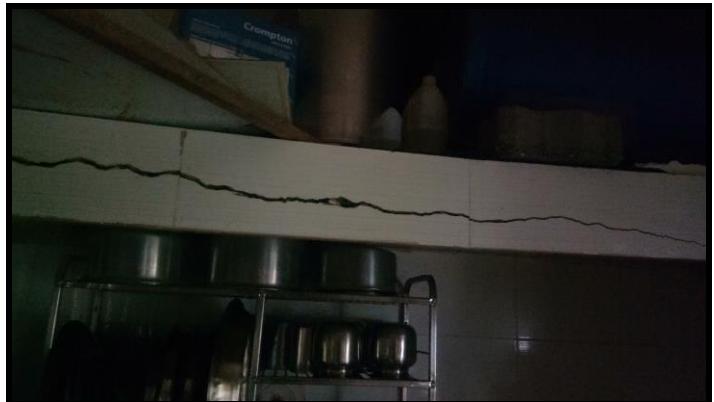
FLAT NO – 11

- ❖ **HALL** – Major structural crack observed on wall.
 - Major leakage mark observed on ceiling.
- ❖ **KITCHEN** – Plaster gets removed and steel gets exposed. (It may fall)
- ❖ **PASSAGE** – Seepage mark observed on wall.
 - Peeling of paint observed on ceiling.
- ❖ **TOILET & BATH ROOM** – Peeling of paint observed on ceiling.
 - Seepage mark observed on ceiling.
 - Dampness observed on wall.

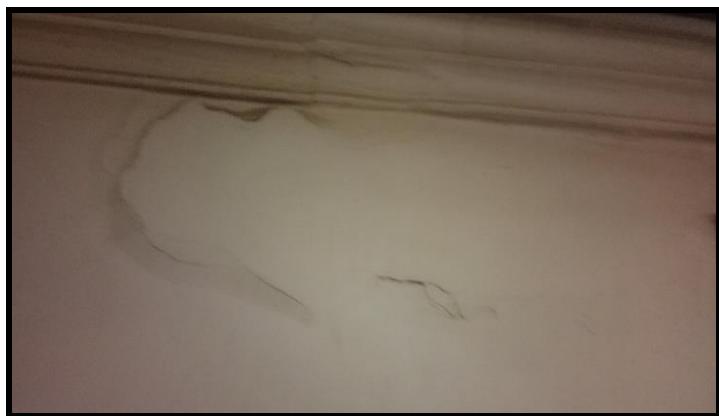
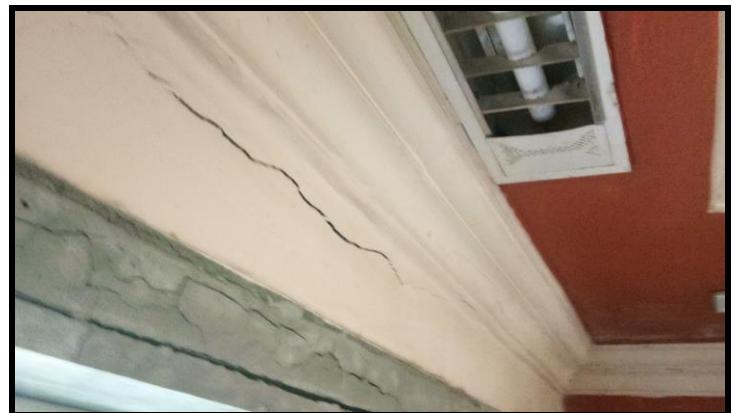
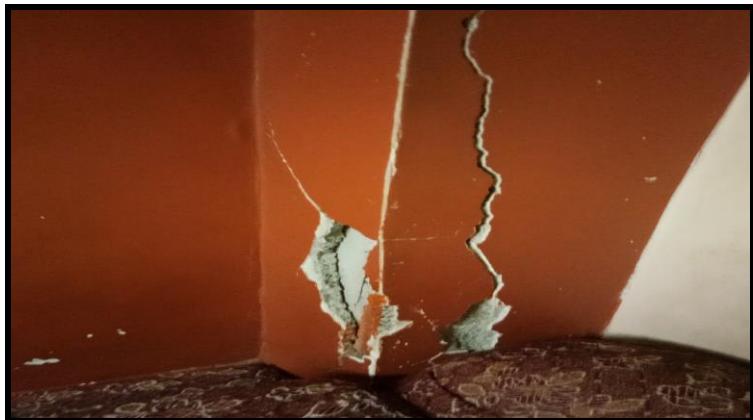
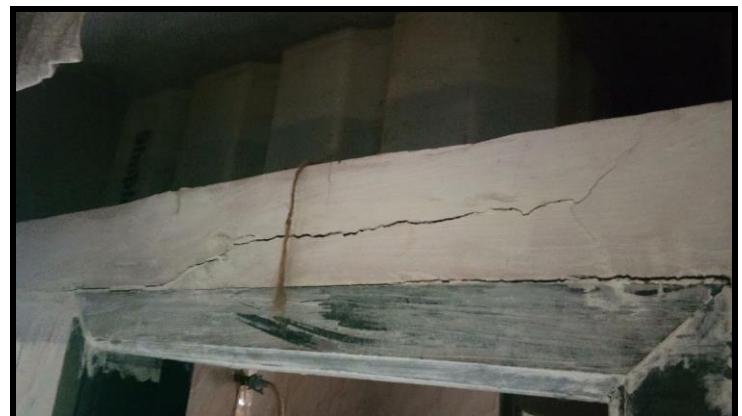
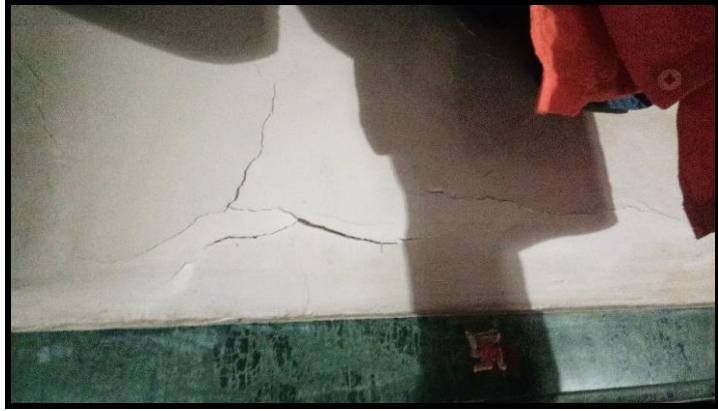
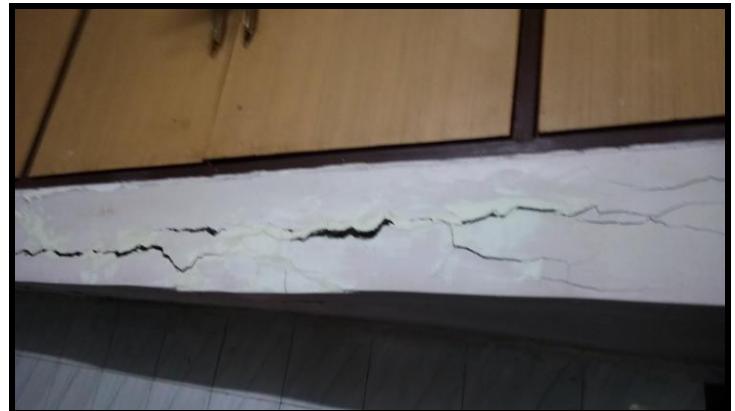
FLAT NO – 15, 16

- ❖ **HALL** – Hallow sound observed on wall.
 - Major structural crack observed on wall.
 - Major structural crack observed on beam.
 - Major structural crack observed on column.
- ❖ **KITCHEN** – Seepage mark observed on wall.
- ❖ **PASSAGE NO.01** – Major structural crack observed on beam.
 - Seepage mark observed on wall.
- ❖ **TOILET & BATH ROOM** – Seepage mark observed on wall.
- ❖ **BEDROOM NO.01** – Major structural crack observed on column.
 - Seepage mark observed on wall.
 - Peeling of paint observed on beam.
- ❖ **BEDROOM NO.02** – Major structural crack observed on beam.
 - Peeling of paint observed on wall.

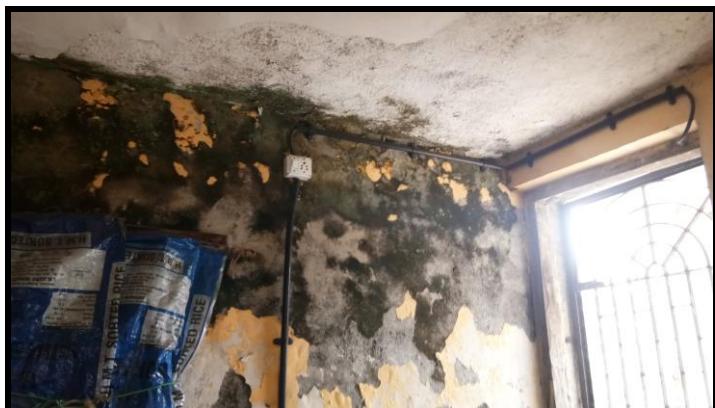
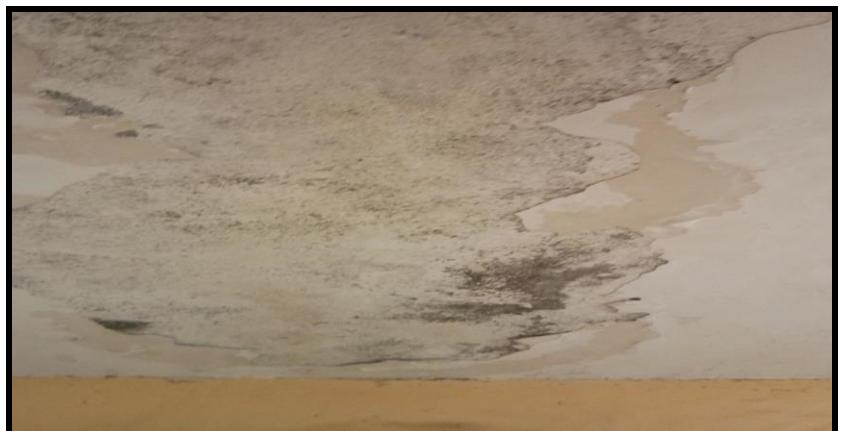
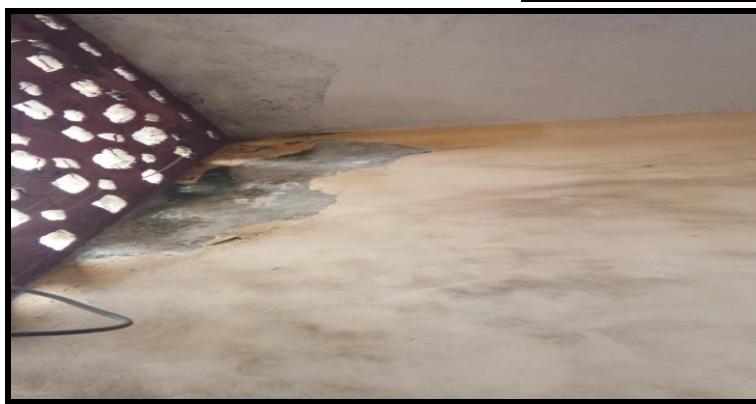
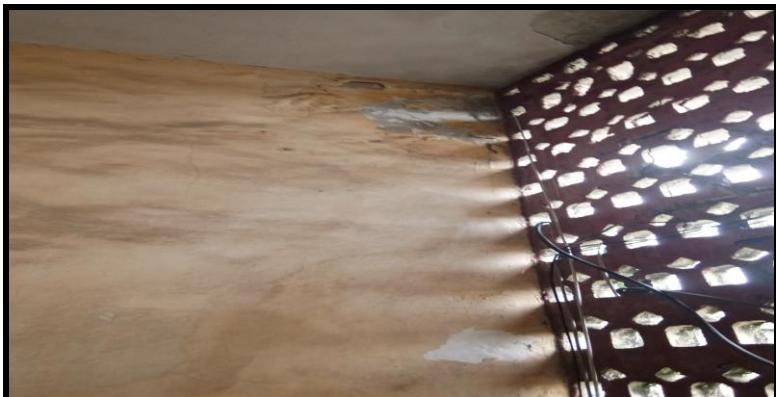
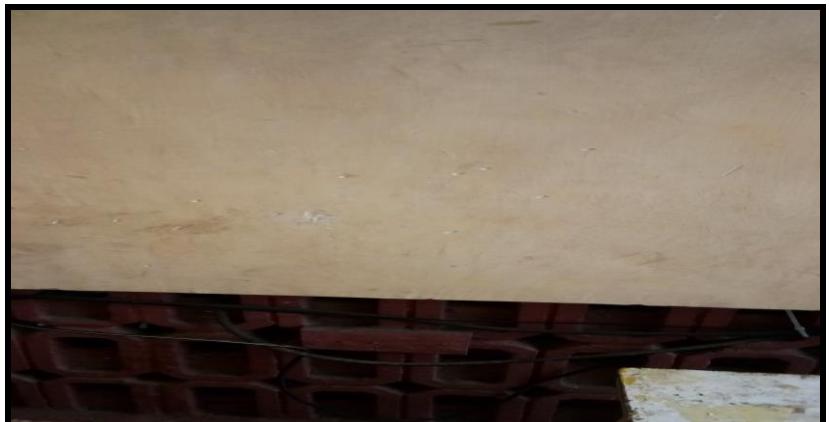
Terrace to Fourth floor:-

- ❖ Peeling of paint observed on wall.
- ❖ Seepage mark observed on wall.
- ❖ Algae formation observed on wall.
- ❖ Hallow sound observed on wall after tapping.

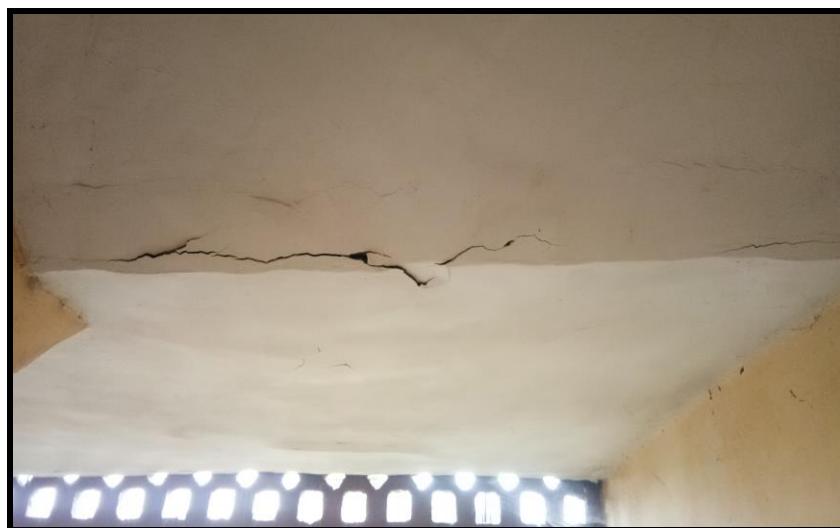
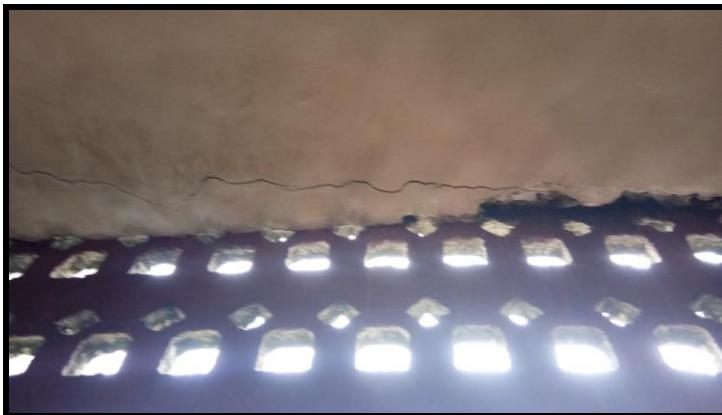
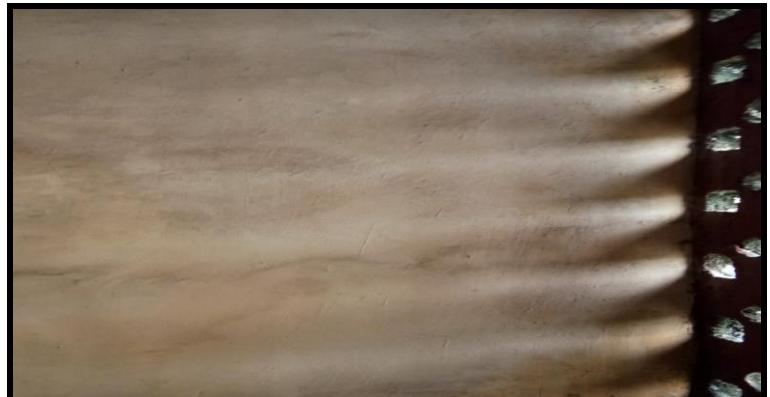
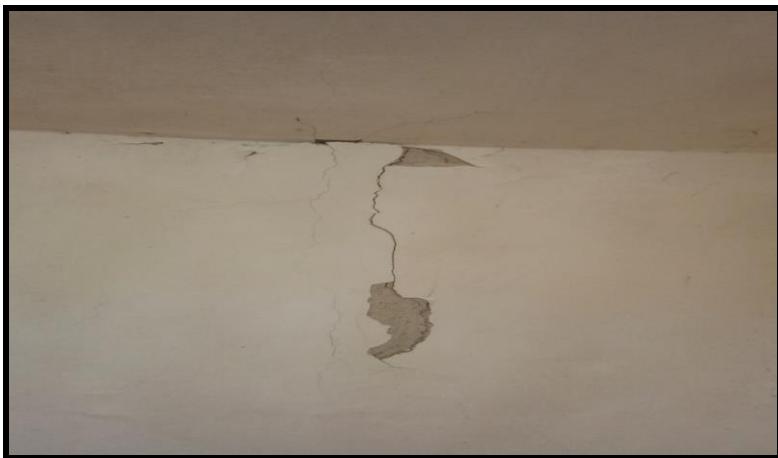
Fourth floor to third floor:-

- ❖ Major structural crack observed on beam.
- ❖ Major structural crack observed on wall.
- ❖ Major crack observed on ceiling.
- ❖ Peeling of paint observed on wall.

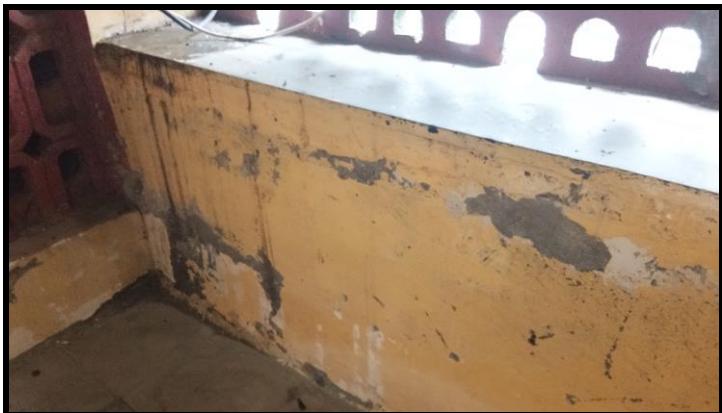
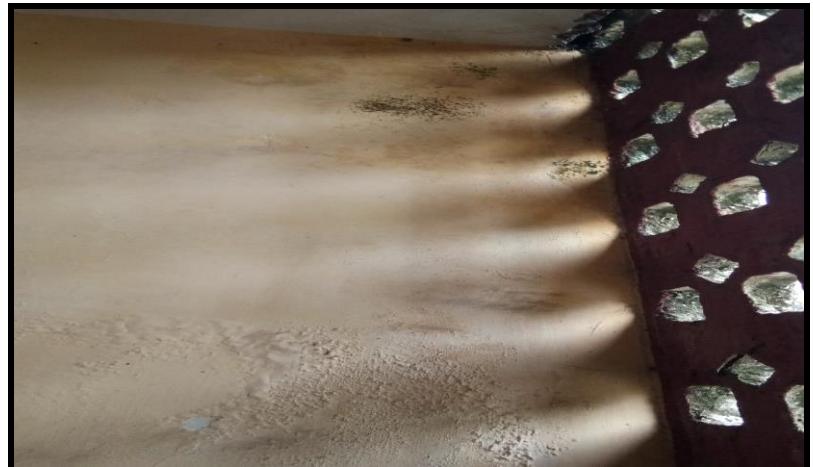
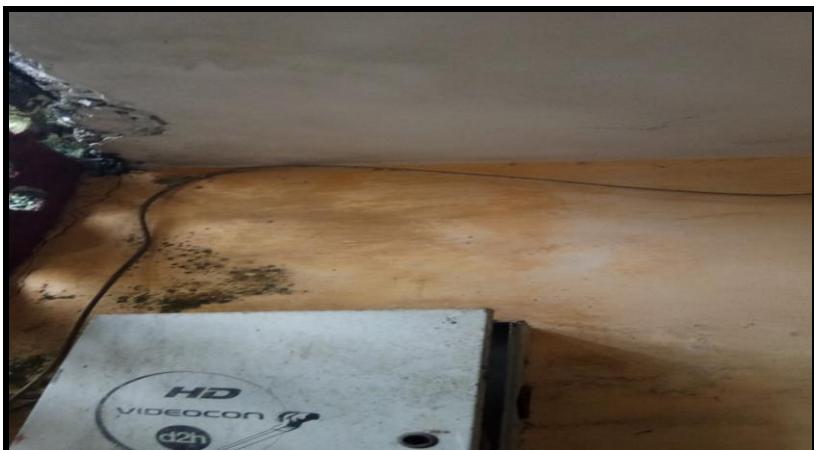
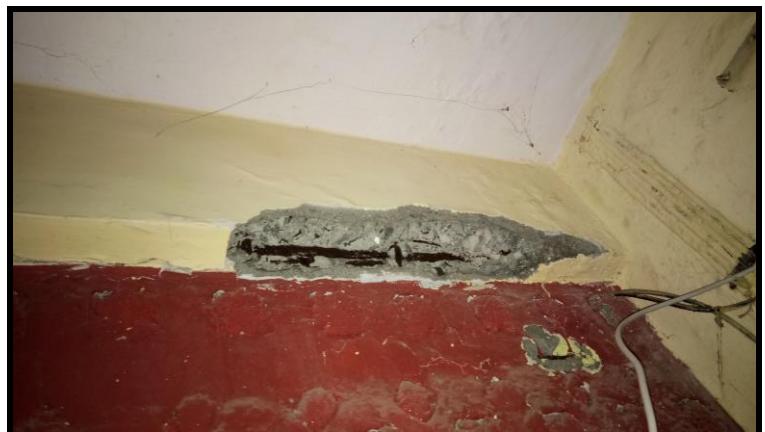
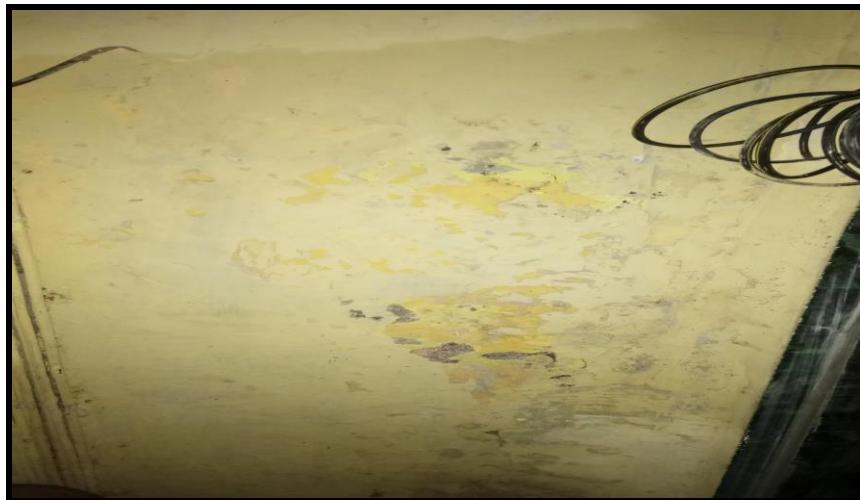
Third floor to Second floor:-

- ❖ Major leakage mark observed on wall.
- ❖ Major leakage mark observed on ceiling.
- ❖ Major structural crack observed on ceiling.
- ❖ Peeling of paint observed on wall.

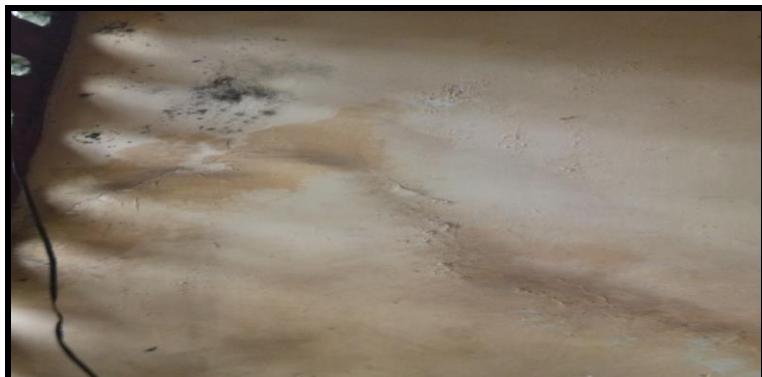
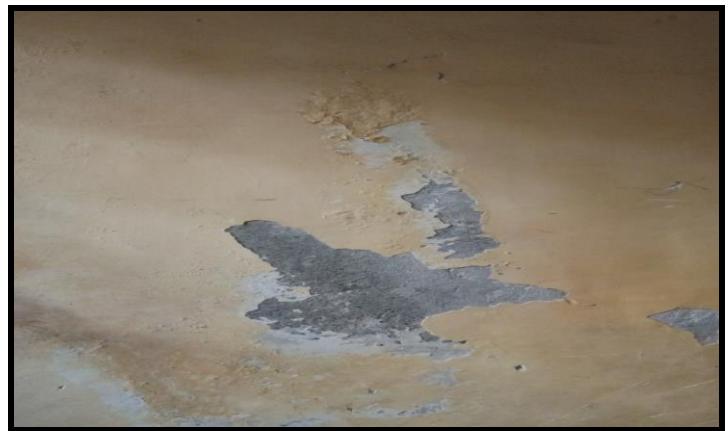
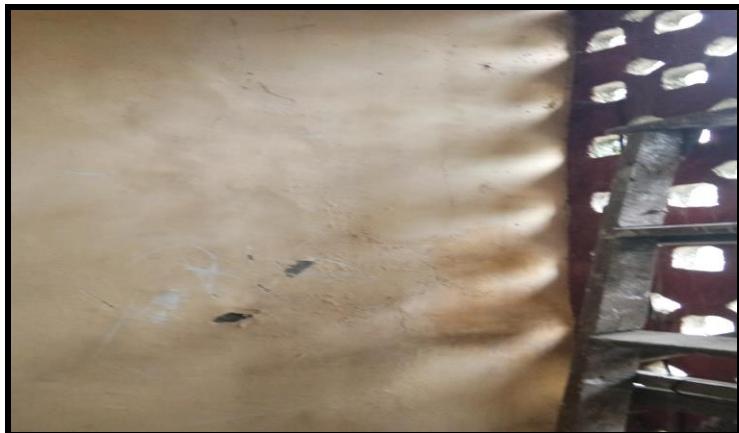
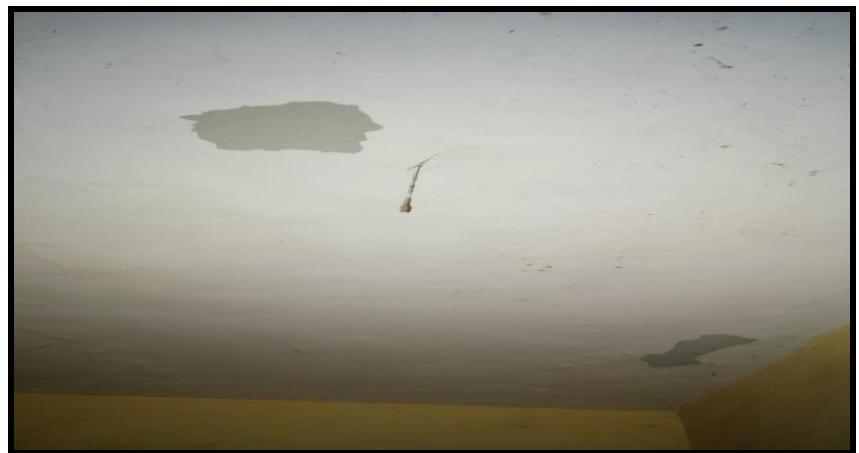
Second floor to First floor:-

- ❖ Major leakage mark observed on wall.
- ❖ Peeling of paint observed on wall.
- ❖ Major seepage mark observed on ceiling.

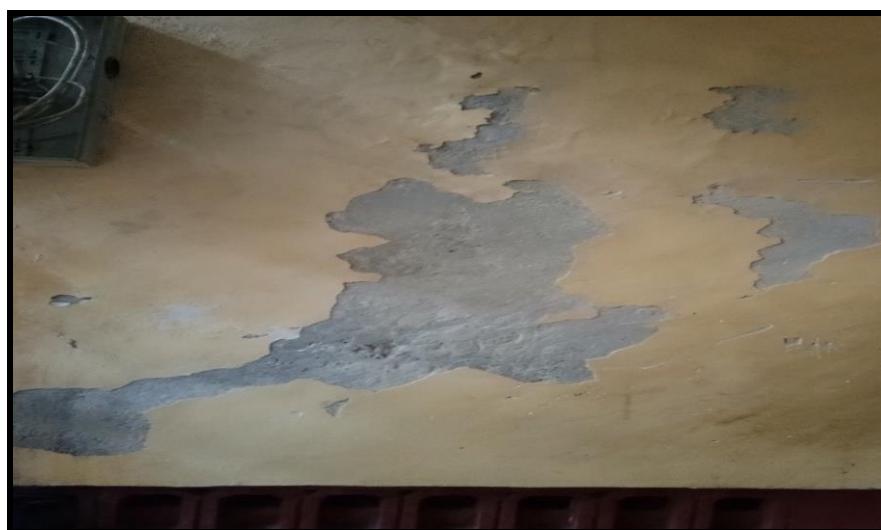
First floor to Ground floor:-

- ❖ Seepage mark observed on wall.
- ❖ Peeling of paint observed on wall.
- ❖ Major structural crack observed on wall.
- ❖ Crack filling observed on beam.
- ❖ Hallow sound observed on ceiling after tapping.

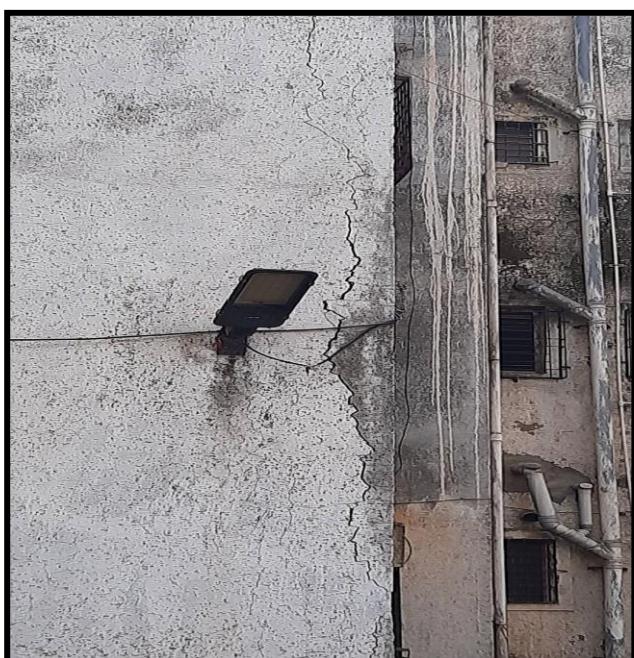
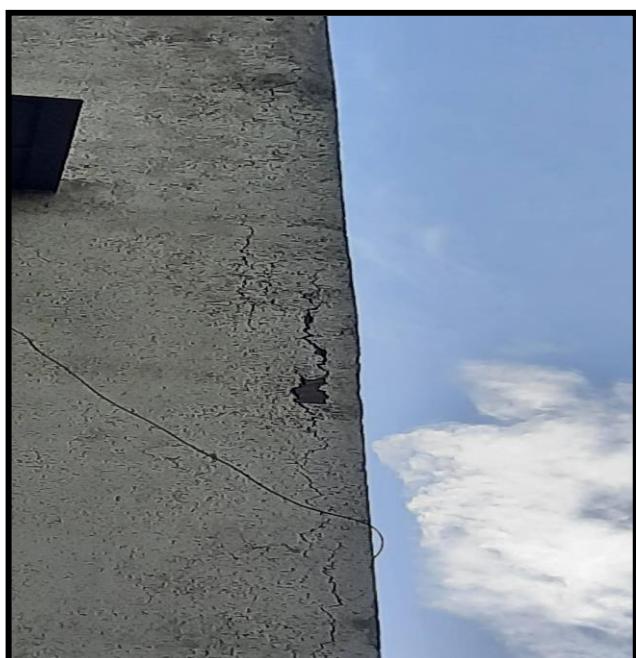
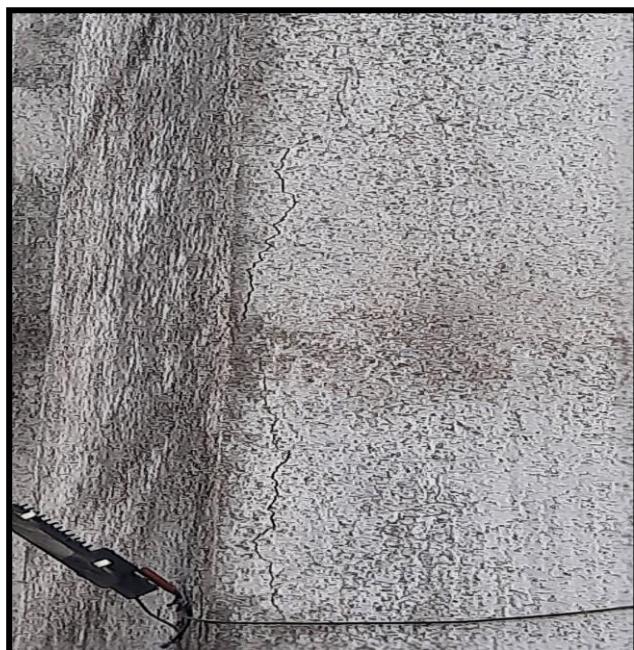
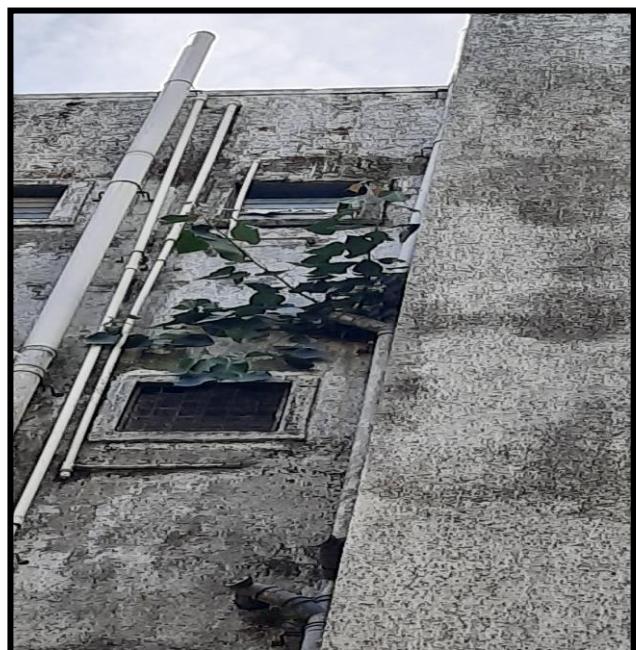
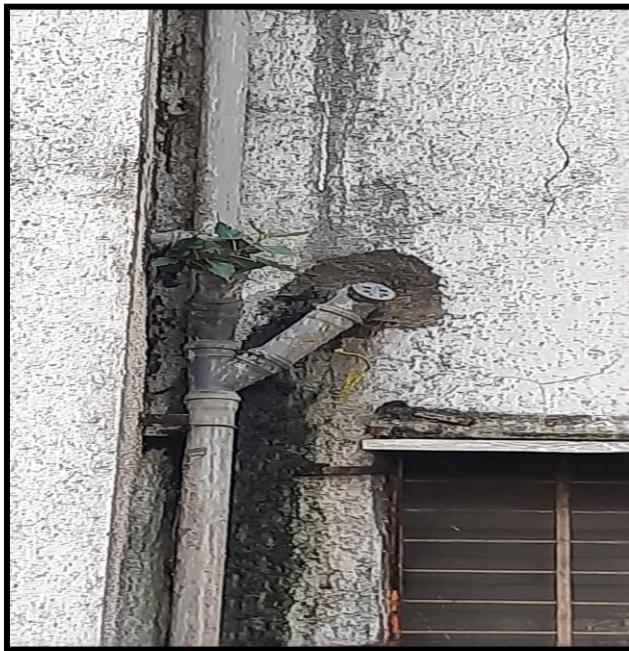
BACK SIDE

- ❖ Structural crack observed at several places on column.
- ❖ Vegetation growth observed at several places on wall.

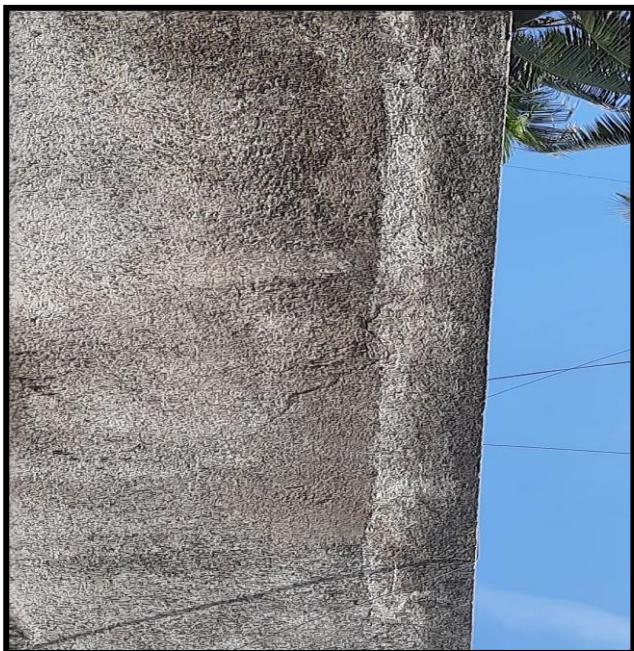
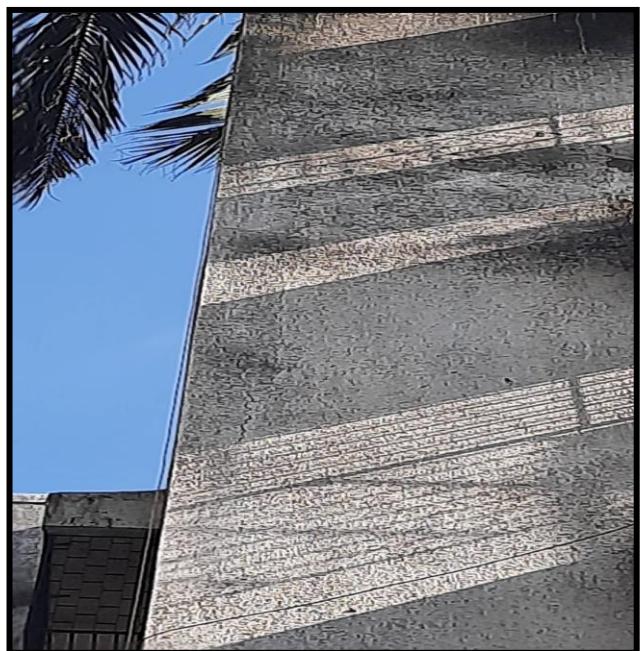
NORTH SIDE

- ❖ Structural crack observed at several places on column.

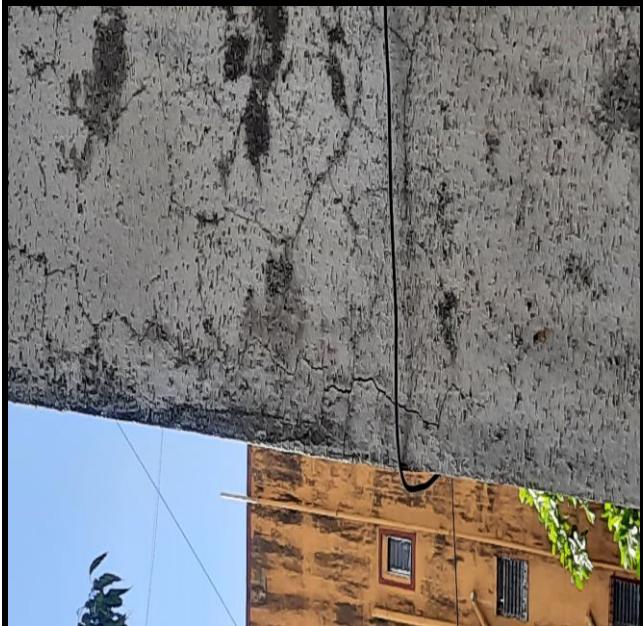
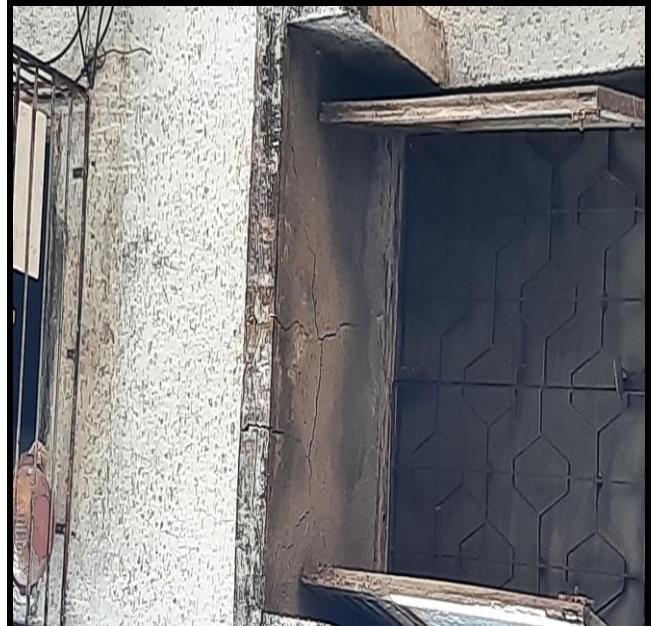
SOUTH SIDE

- ❖ Structural crack observed at several places on column & chajja.
