STRUCTURAL AUDIT REPORT
FOR
“VISHAL SAHYADRI CO – OP HSG. SOC. LTD”,
“B7 – WING”
SITUATED AT
SAHYADRI NAGAR, CHARKOP,
KANDIVALI (W) MUMBAI – 400 067

PREPARED BY
LATESH S. SANKLECHA
CONSULTING STRUCTURAL ENGINEERS

978/B7/LSS/2021

JULY 19, 2021

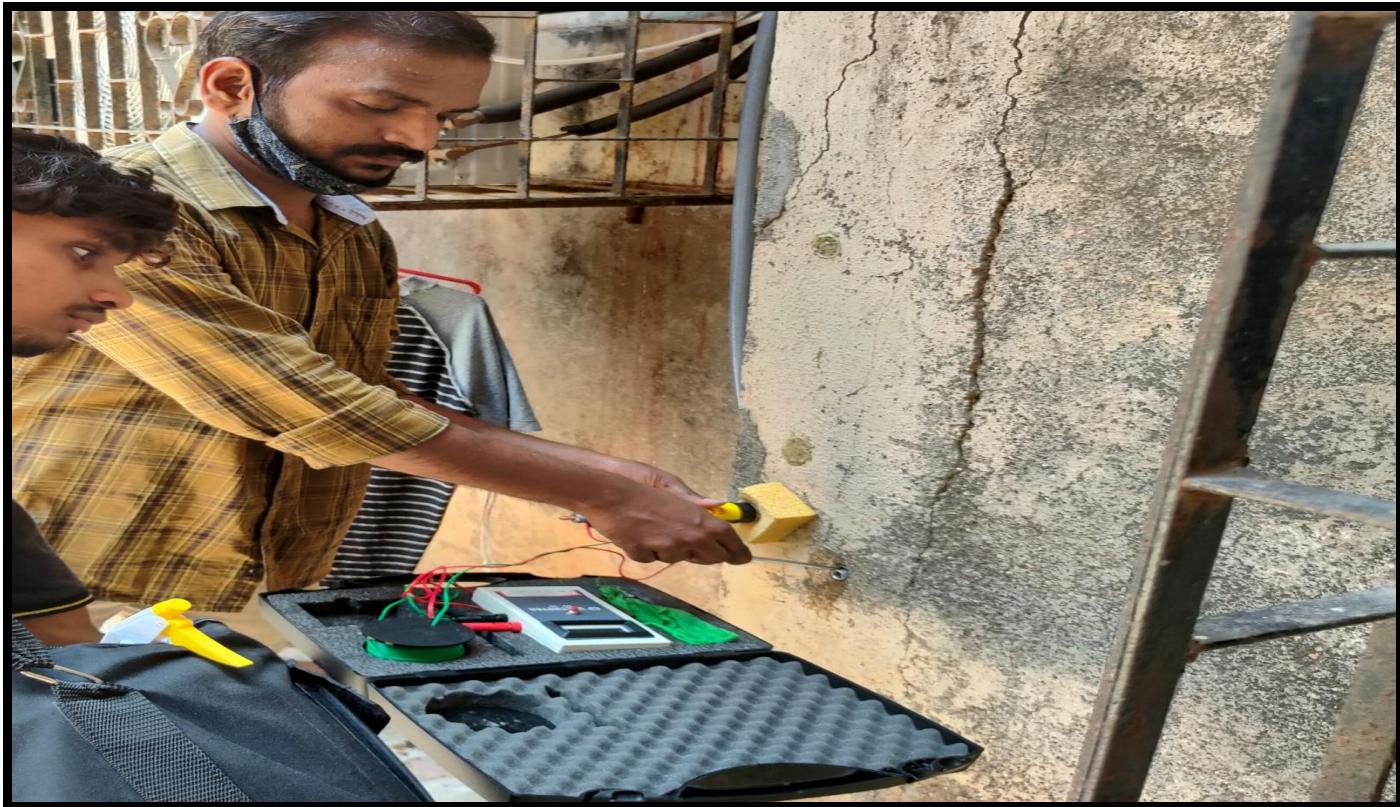
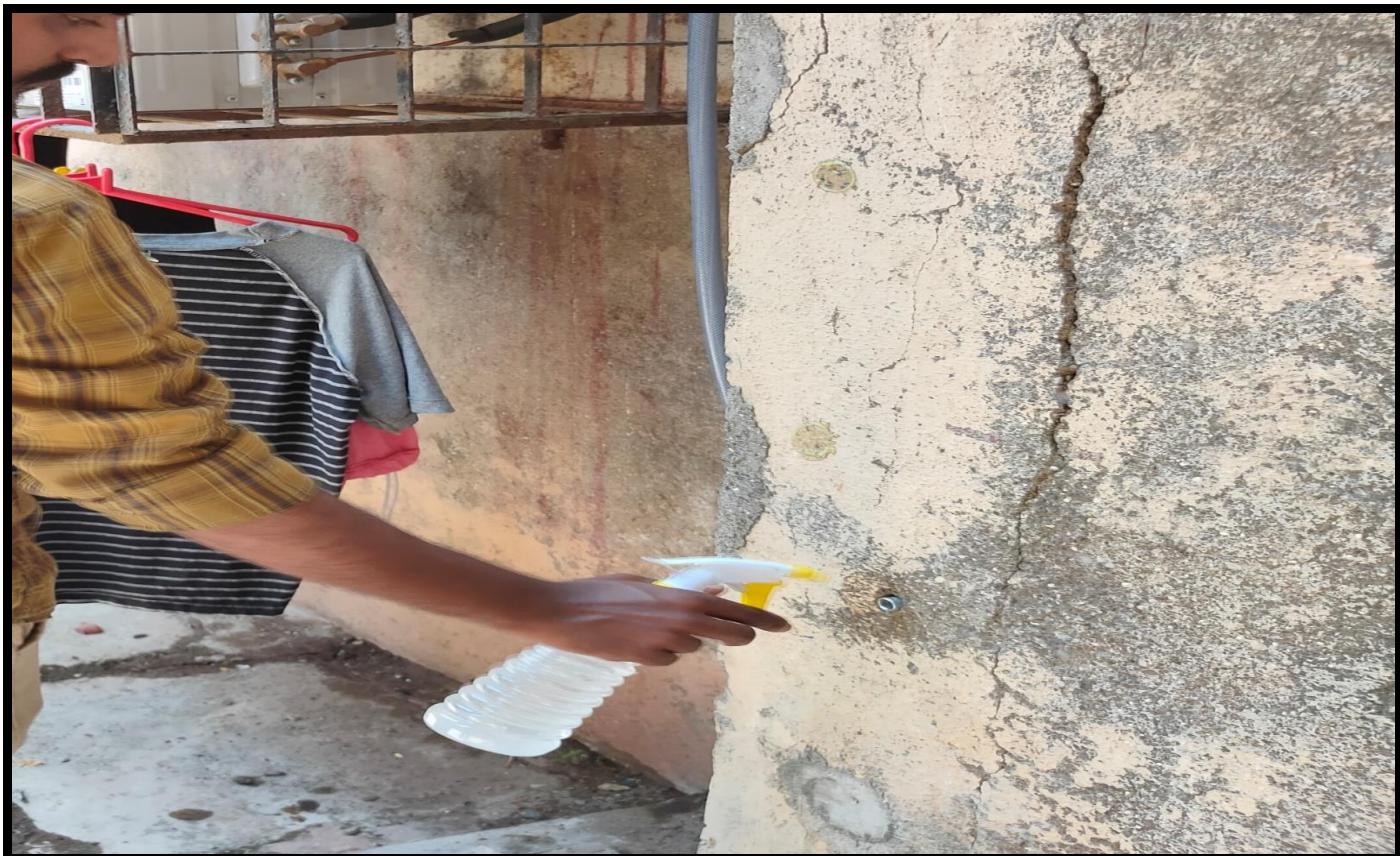
NON -DESTRUCTIVE TEST PHOTO

Rebound Hammer was tested for compressive strength at surface by Schmidt rebound hammer. Results indicate the compressive strength at surface of all the RCC columns is ranging between 10.30 MPa to 12.50 MPa.

The UPV values are ranging between 1.10 Km/Sec to 1.70 Km/Sec.

Out of 4 locations all 4 locations was below 3.0 Km/Sec means concrete quality is poor.

This indicates there are progressive internal cracks in the RCC members due to corrosion of reinforced steel. These members are under distress condition.

Half Cell Potential tested for corrosion activity by half – cell potential tests. Values are taken on Column. The result on tested column is – 410 mV.

This indicates the probability of corrosion is 90% on tested column steel reinforcement.

Carbonation test was conducted to assess carbonation depth. Readings are taken on Column. Result indicates the carbonation penetration depth is 45.00 mm. Carbonation depths have reached to the reinforcement level in all of the RCC elements. It is essential to give a suitable anti-corrosion treatment to all the RCC members to stop further carbonation and corrosion of concrete.

Overall, condition of concrete is good, but distressed RCC member's needs immediate repair with suitable repair system.

RCC elements indicating UPV values less than 3 Km/sec needs immediate attention.

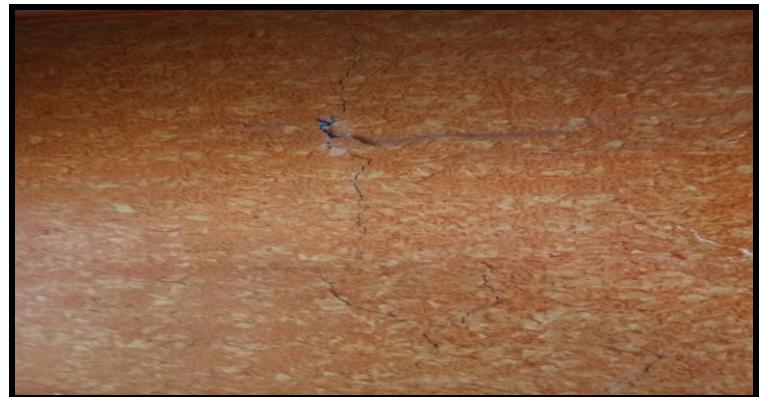
FLAT NO – 03

- ❖ **HALL** – Major structural crack observed on beam.
 - Major structural crack observed on wall. (**It may fall**)
 - Ceiling gets damage. (**It may fall**)
 - Major leakage mark observed on wall.
 - Hollow sound observed on wall. (**It may fall**)
- ❖ **KITCHEN** – Plaster gets removed and steel gets exposed. (**It may fall**)
 - Major structural crack observed on wall. (**It may fall**)
- ❖ **PASSAGE** – Major structural crack observed on beam. (**It may fall**)
- ❖ **TOILET & BATH ROOM** – Seepage mark observed on wall.
 - Peeling of paint observed on wall.

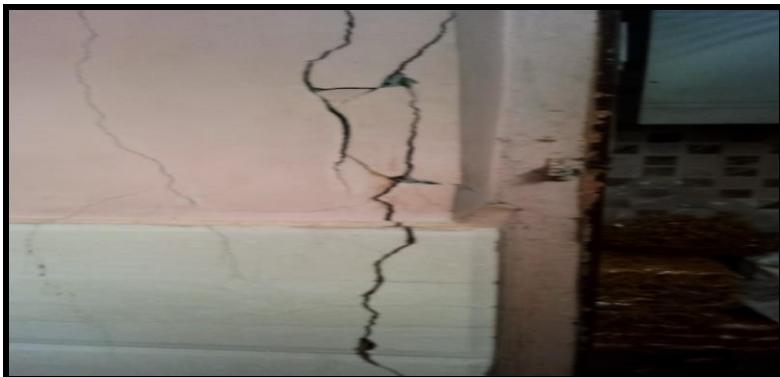
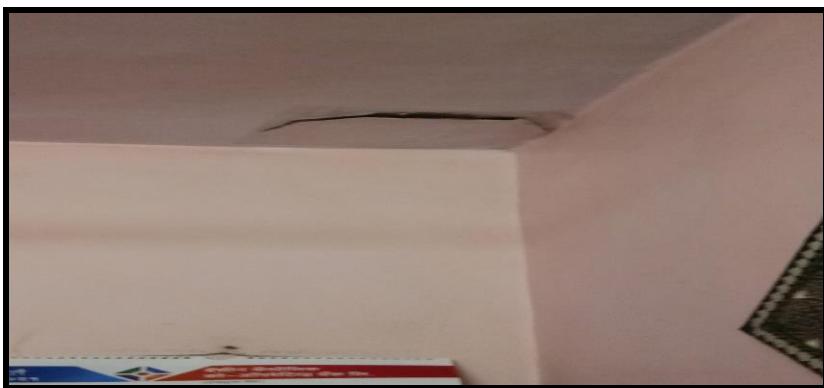
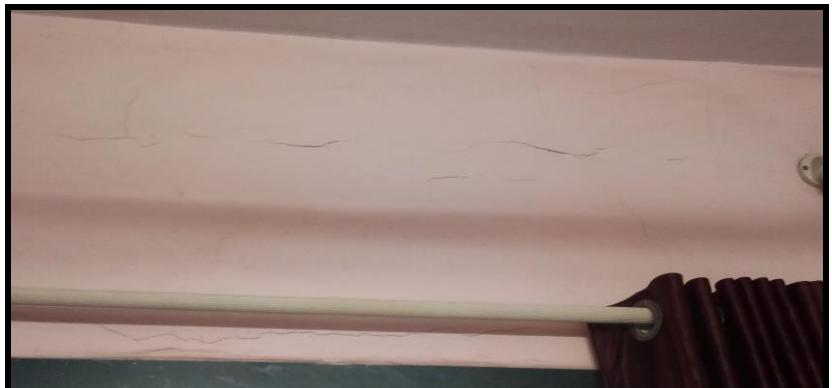
FLAT NO – 06

- ❖ **HALL** – Major structural crack observed on beam. (It may fall)
 - Major structural crack observed on column. (It may fall)
 - Hallow sound observed on wall.
 - Ceiling gets damage.
- ❖ **KITCHEN** – Crack observed on tiles.
- ❖ **PASSAGE** – Peeling of paint observed on wall.

❖ **TOILET & BATH ROOM** – Dampness observed on wall.

- Seepage mark observed on ceiling.

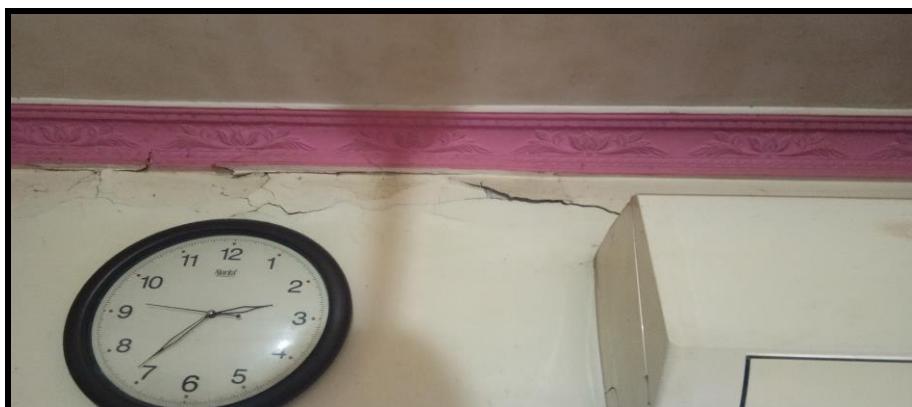
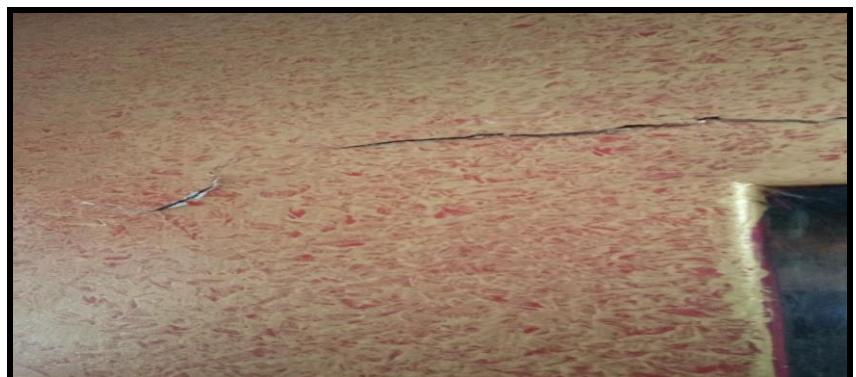
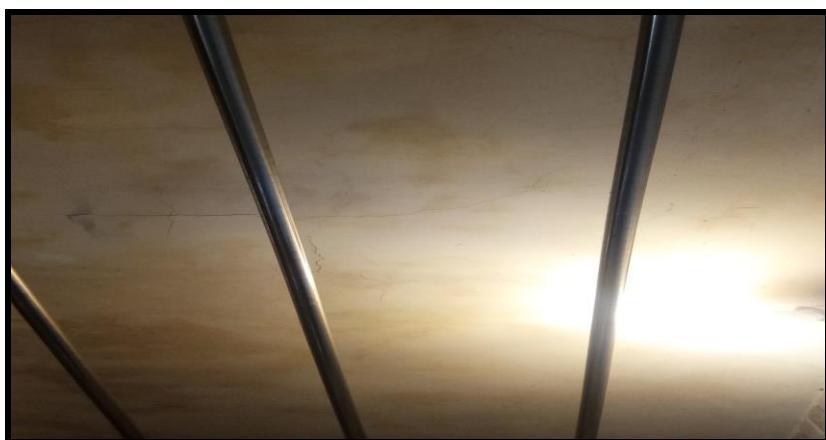
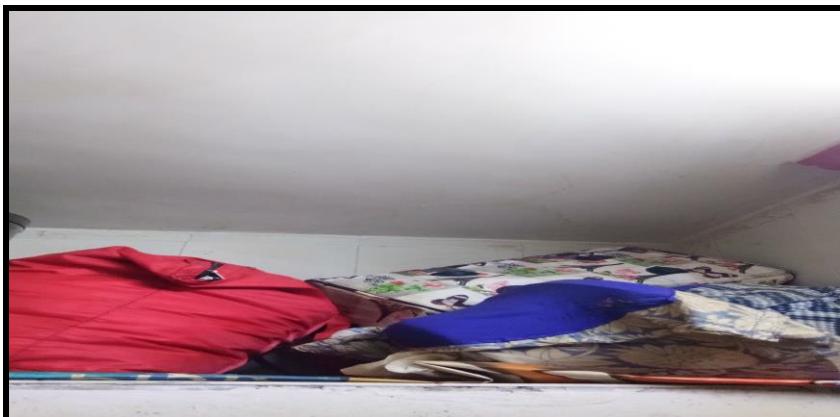
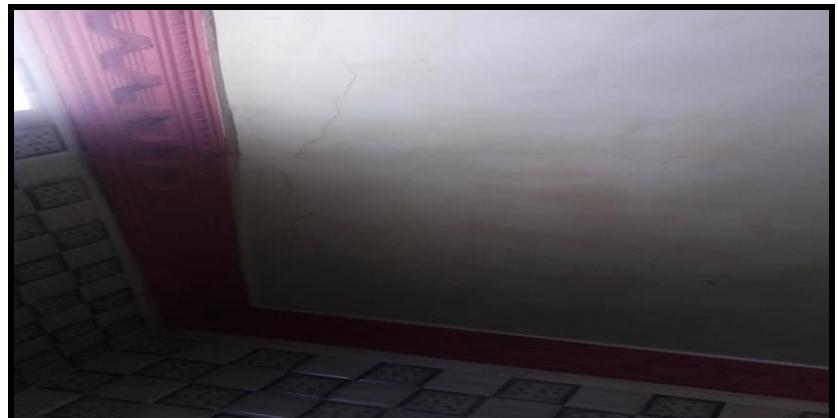
FLAT NO – 09

- ❖ **HALL** – Major structural crack observed on wall. (It may fall)
 - Hallow sound observed on wall.
 - Peeling of paint observed on wall.
- ❖ **KITCHEN** – Dampness observed on wall.
- ❖ **PASSAGE** – Hallow sound observed on ceiling.
- ❖ **TOILET & BATH ROOM** – Seepage mark observed on wall.
 - Leakage mark observed on ceiling.

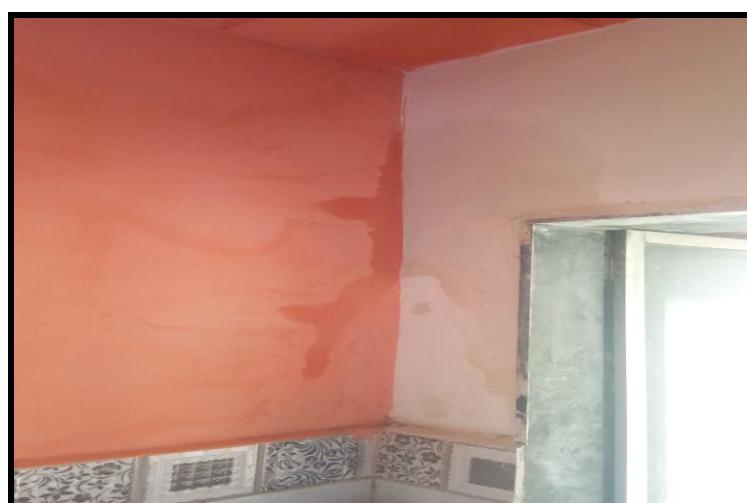
FLAT NO – 10

- ❖ **HALL** – Leakage mark observed on ceiling.
 - Seepage mark observed on wall.
 - Peeling of paint observed on wall.
- ❖ **KITCHEN** – O.K.
- ❖ **PASSAGE** – Peeling of paint observed on beam.
- ❖ **TOILET & BATH ROOM** – Leakage mark observed on wall.

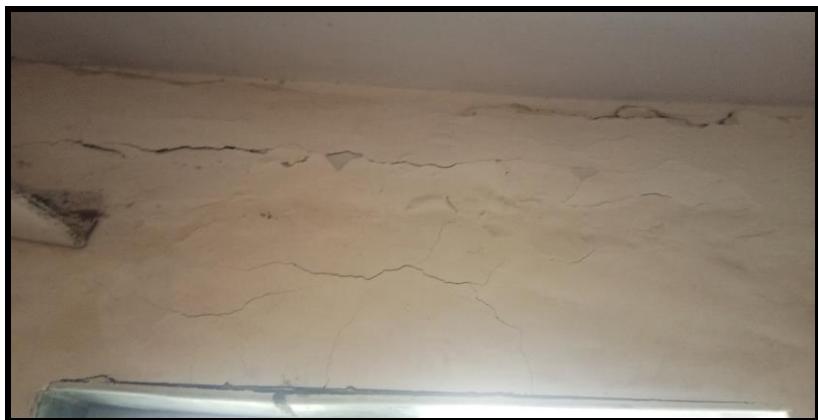
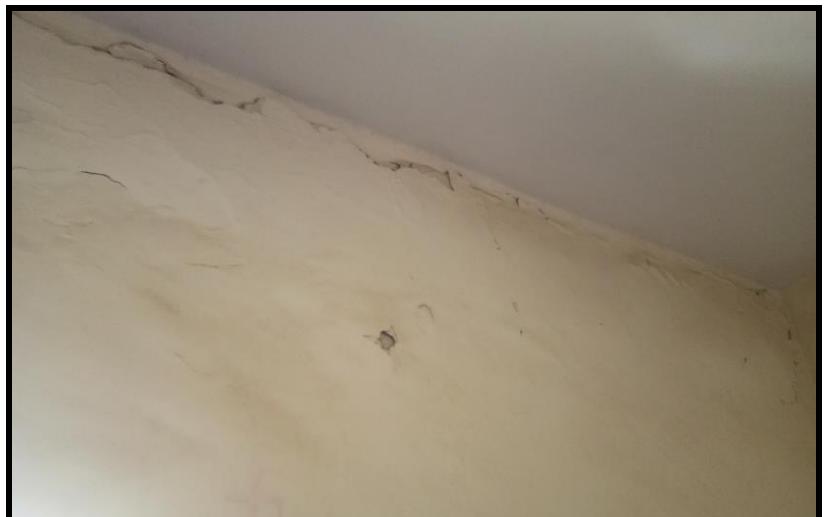
FLAT NO – 16

- ❖ **HALL** – Major structural crack observed on wall. (**It may fall**)
 - Ceiling gets damage. (**It may fall**)
 - Plaster gets removed and steel gets exposed. (**It may fall**)
 - Major structural crack observed on beam. (**It may fall**)
 - Major structural crack observed on column. (**It may fall**)
- ❖ **KITCHEN** – Ceiling gets damage. (**It may fall**)
 - Plaster gets removed and steel gets exposed. (**It may fall**)
 - Major structural crack observed on beam. (**It may fall**)
- ❖ **PASSAGE** – Leakage mark observed on ceiling.
- ❖ **TOILET & BATH ROOM** – Seepage mark observed on wall.
 - Peeling of paint observed on wall.

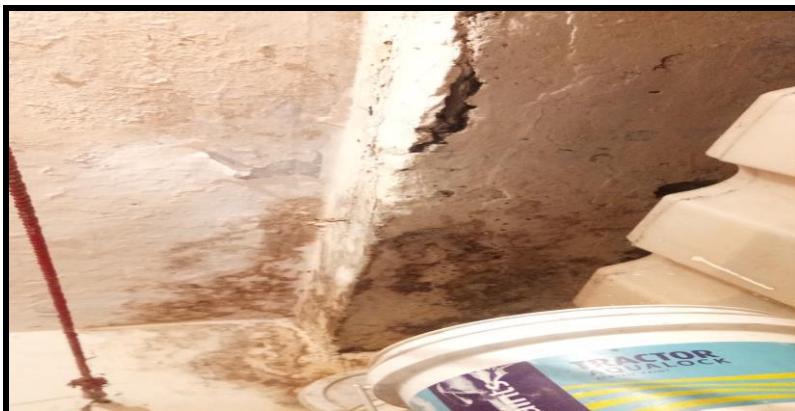
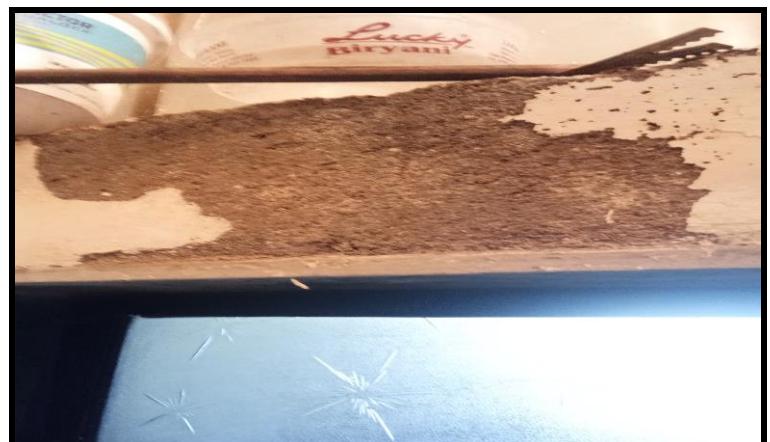
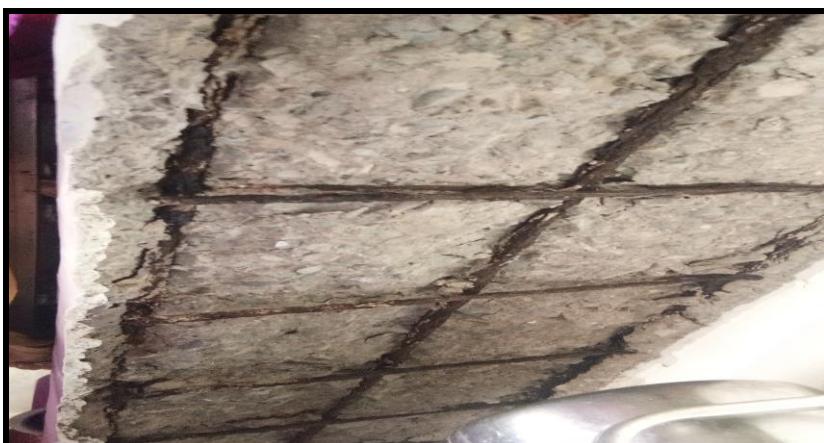
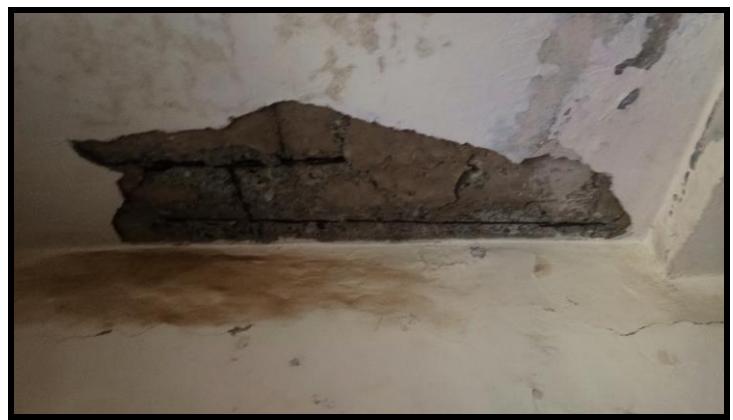
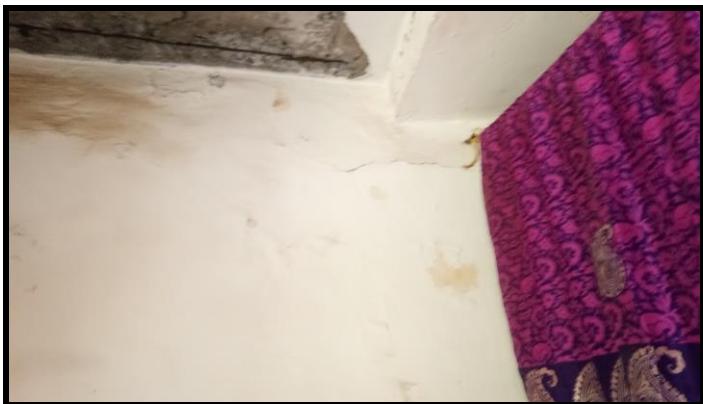
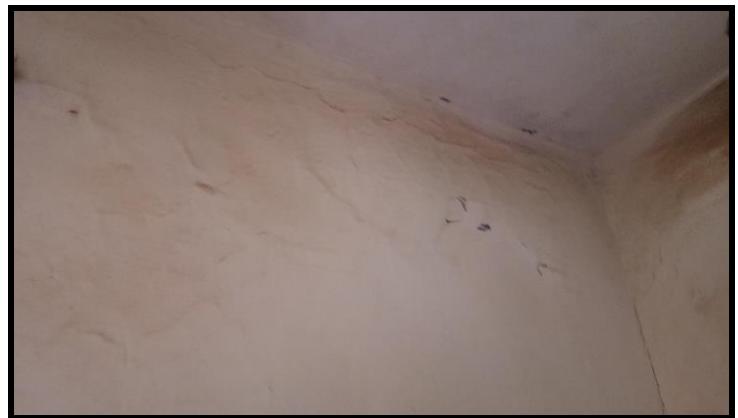
FLAT NO - 17

- ❖ **HALL** – Hallow sound observed on ceiling. (**It may fall**)
 - ❖ Ceiling gets damage. (**It may fall**)
 - ❖ Major structural crack observed on beam.
 - ❖ Major structural crack observed on column.
- ❖ **KITCHEN** – Plaster gets removed and steel gets exposed.
- ❖ **PASSAGE** – Seepage mark observed on wall.
- ❖ **TOILET & BATH ROOM** – Peeling of paint observed on wall.

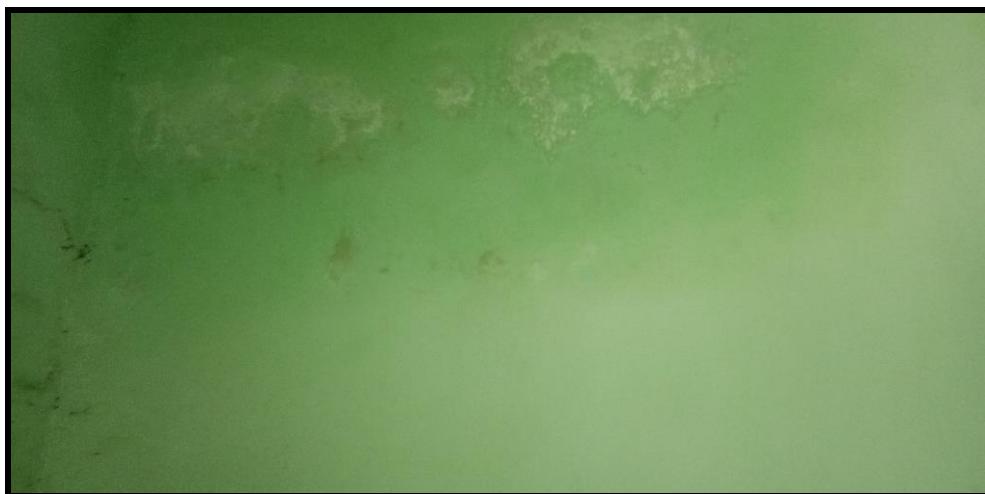
FLAT NO – 22

- ❖ **HALL** – Major structural crack observed on column.
 - Major Leakage mark observed on wall.
- ❖ **KITCHEN** – O.K.
- ❖ **PASSAGE** – O.K.
- ❖ **TOILET & BATH ROOM** – O.K.

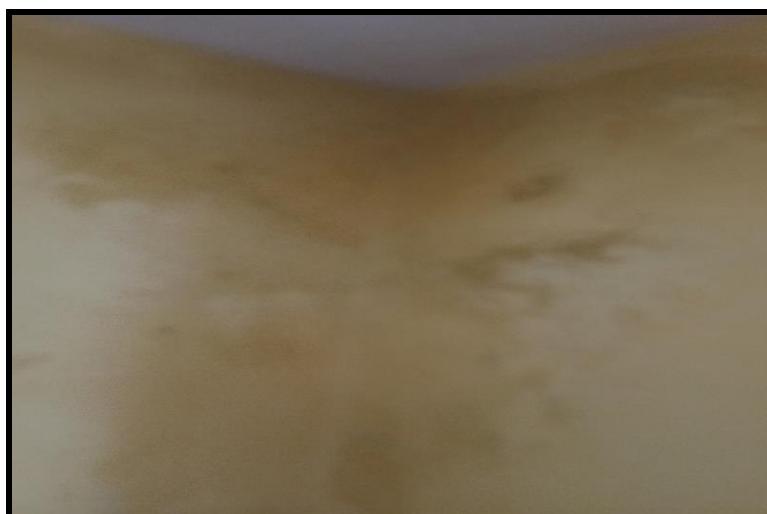
FLAT NO – 24

- ❖ **HALL** – Leakage mark observed on ceiling.
 - Structural crack observed on wall.
 - Structural crack observed on beam.
- ❖ **KITCHEN** – Leakage mark observed on wall.
- ❖ **PASSAGE** – O.K.
- ❖ **TOILET & BATH ROOM** – O.K.

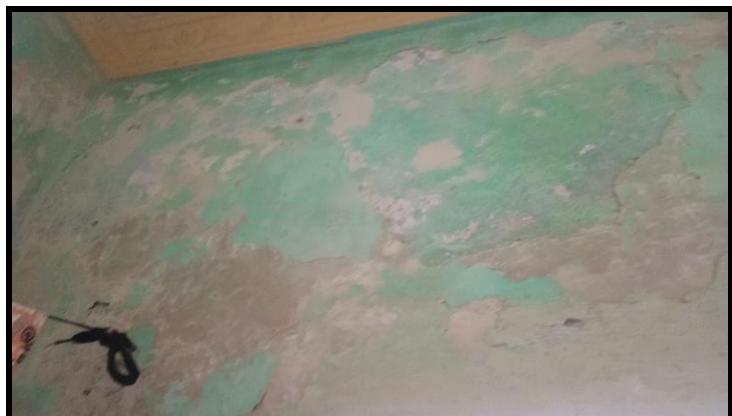
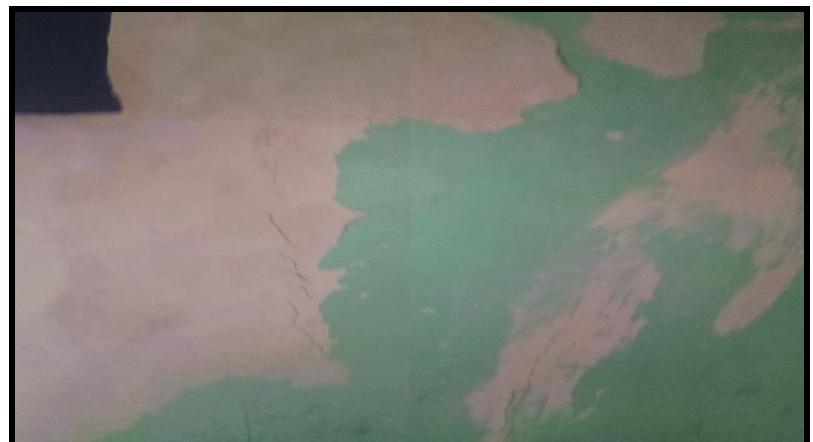
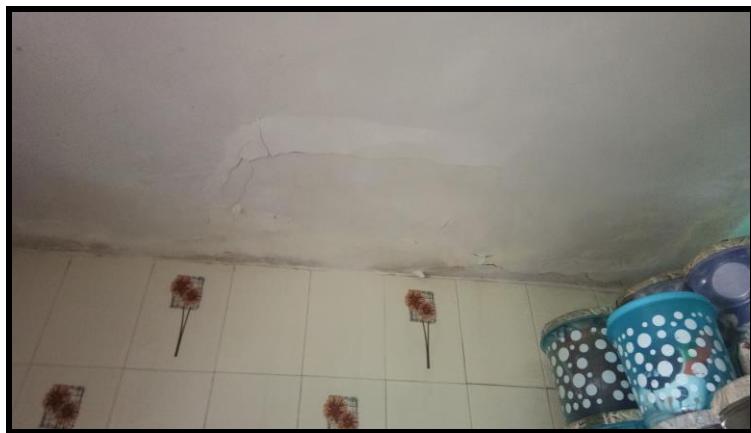
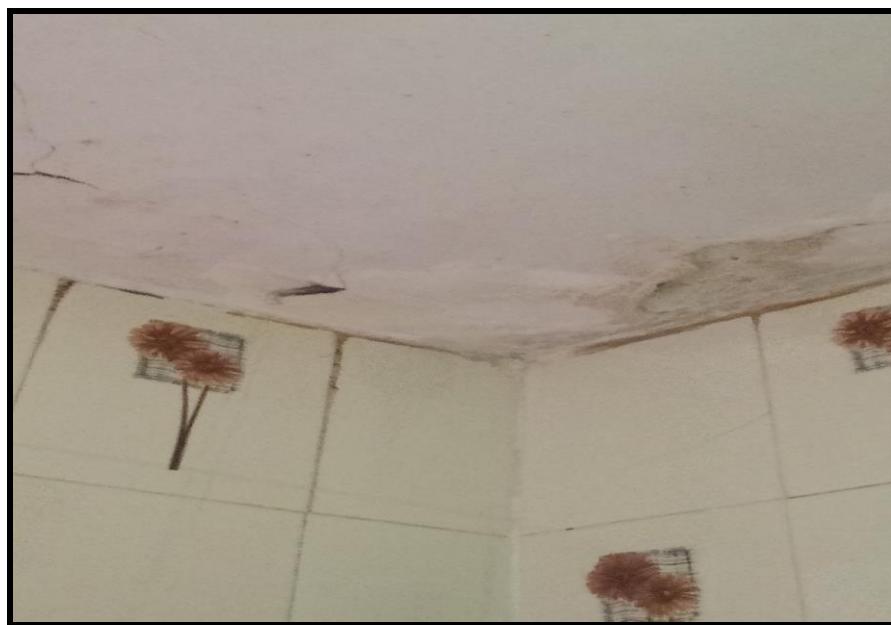
FLAT NO – 26

- ❖ **HALL** – Leakage mark observed on ceiling.
 - Leakage mark observed on wall.
- ❖ **KITCHEN** – Ceiling gets damage
- ❖ **PASSAGE** – Seepage mark observed on wall.
- ❖ **TOILET & BATH ROOM** – O.K.

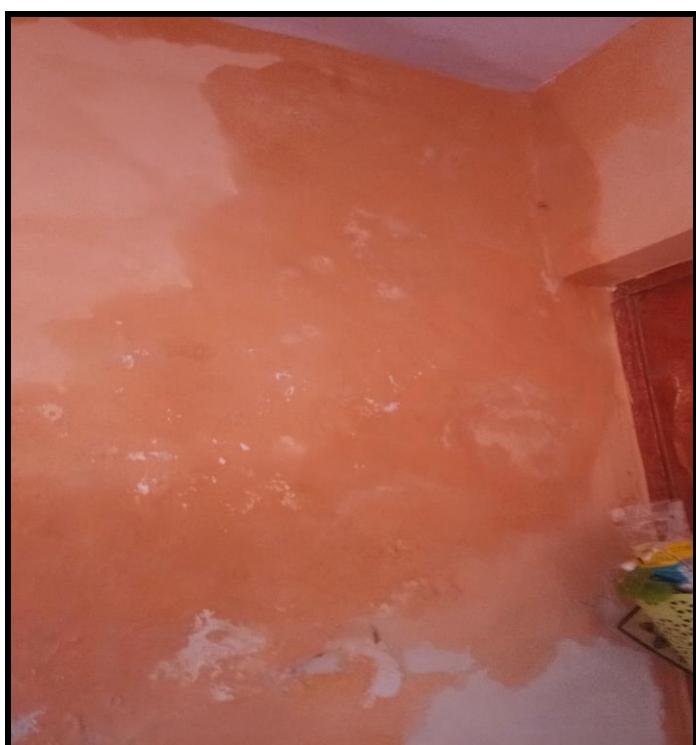
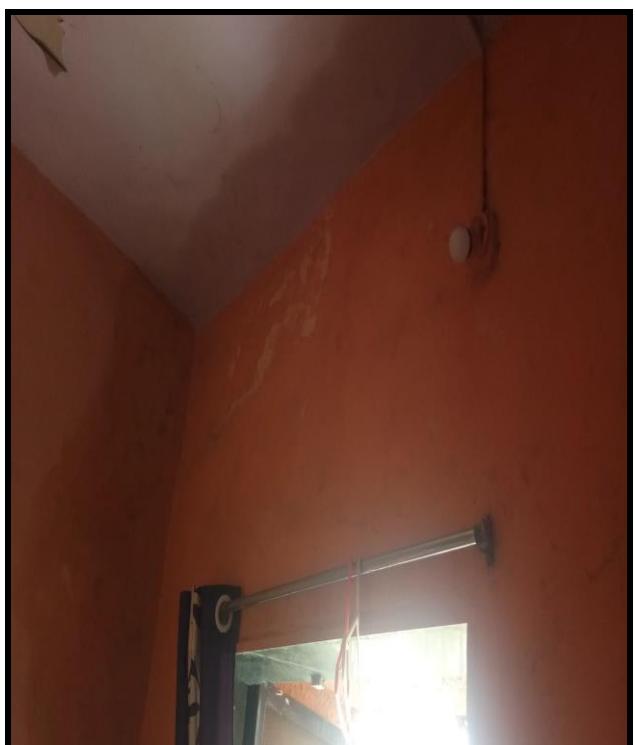
FLAT NO – 27

- ❖ **HALL** – Leakage mark observed on ceiling.
 - Leakage mark observed on beam.
- ❖ **KITCHEN** – O.K.
- ❖ **PASSAGE** – O.K.
- ❖ **TOILET & BATH ROOM** – O.K.

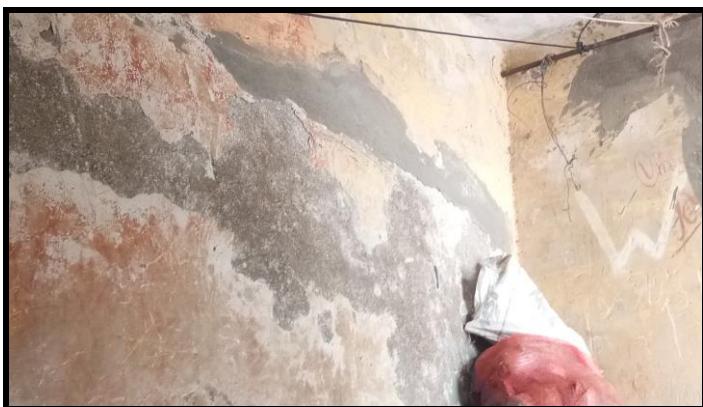
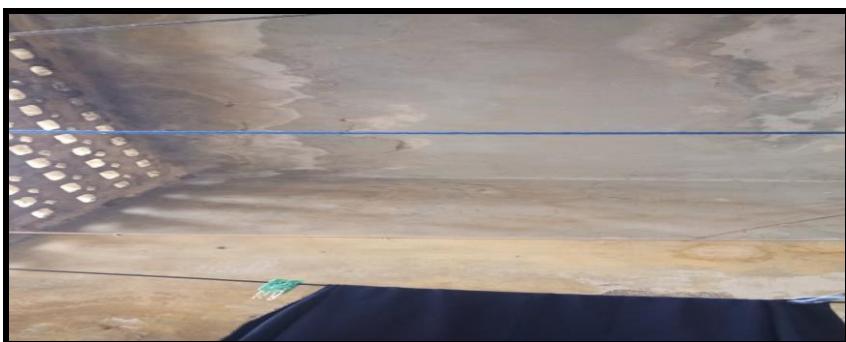
Terrace to Fourth floor:-

- ❖ Peeling of paint observed on wall.
- ❖ Crack observed on wall.
- ❖ Structural crack observed on beam.
- ❖ Plaster gets removed.

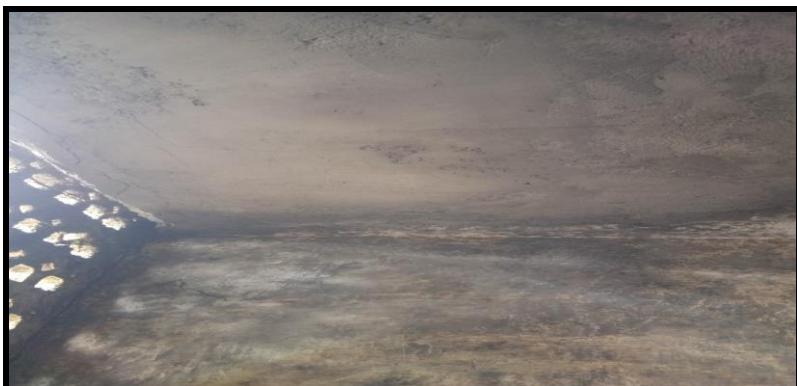
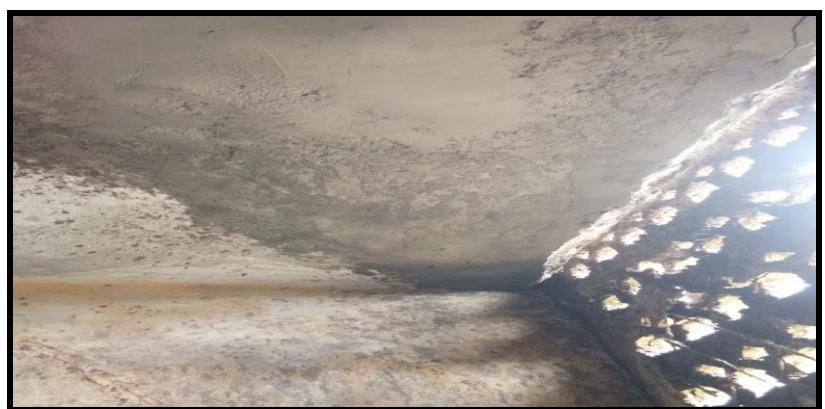
Fourth floor to Third floor:-

- ❖ Patch work observed on wall.
- ❖ Patch work observed on ceiling.

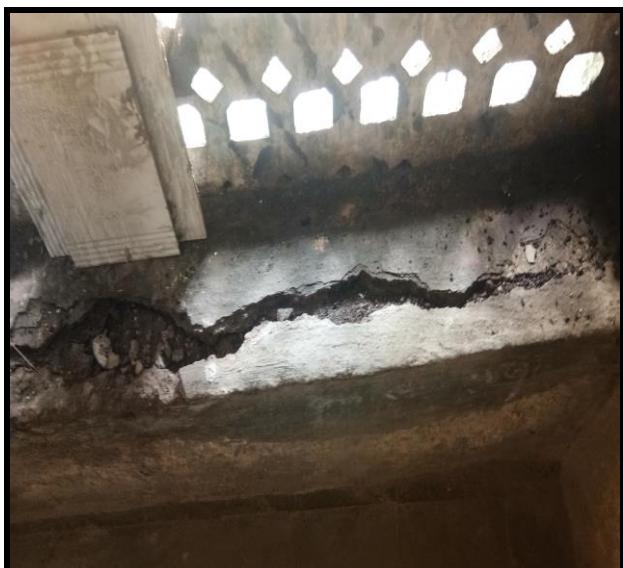
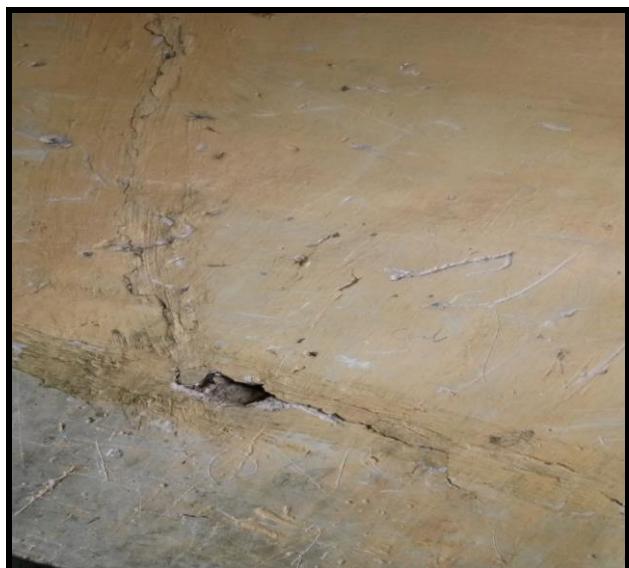
Third floor to Second floor:-

- ❖ Major structural crack observed on wall.
- ❖ Major structural crack observed on cantilever beam.

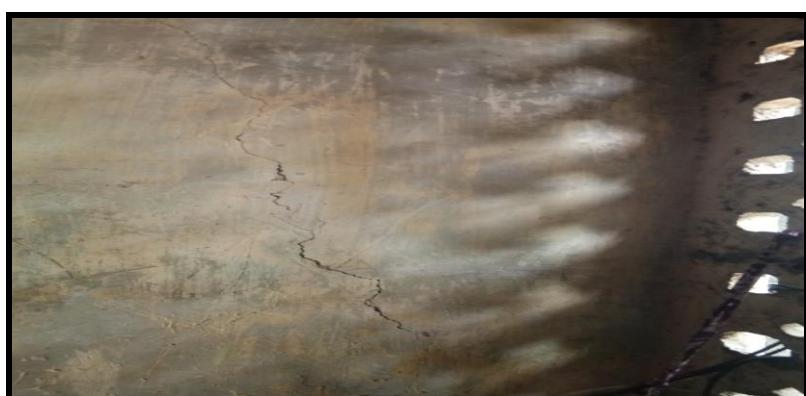
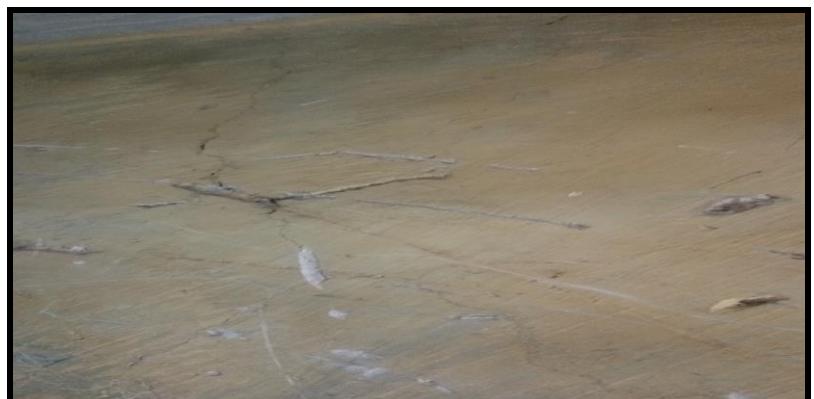
Second floor to First floor:-

- ❖ Crack observed on wall.
- ❖ Peeling of paint observed on wall.

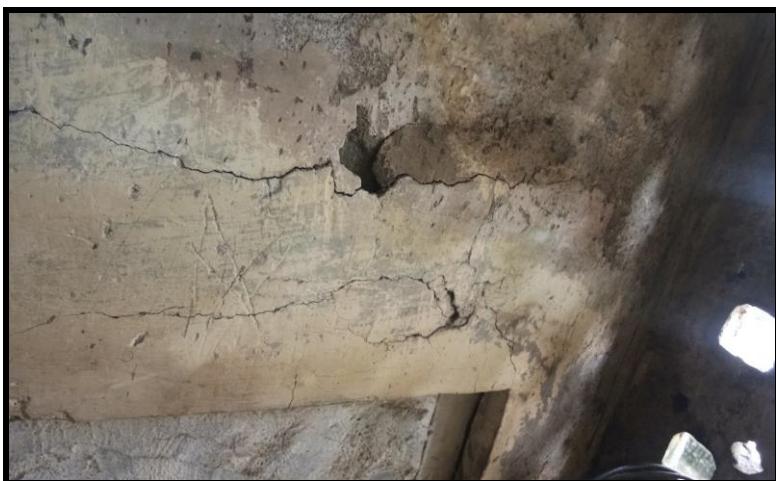
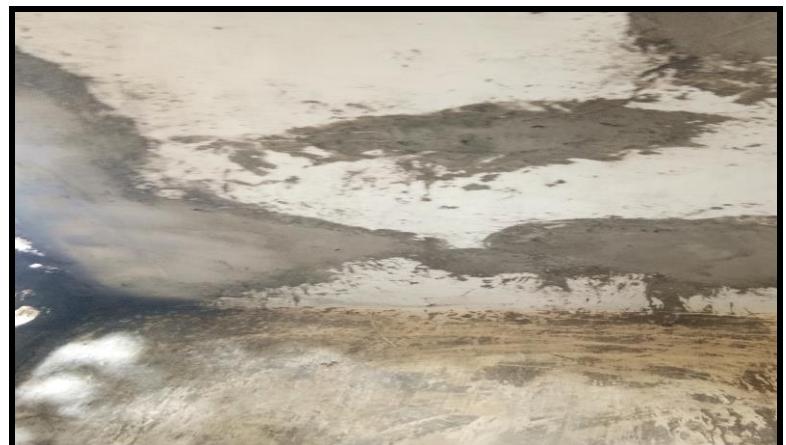
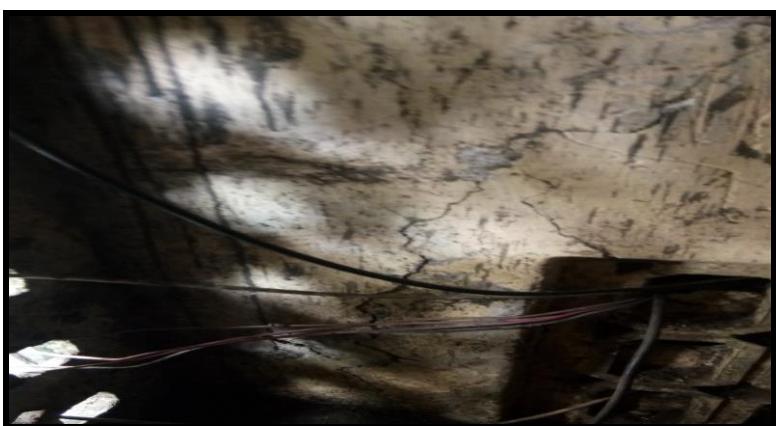
First floor to Ground floor:-

- ❖ Major structural crack observed on wall.
- ❖ Hallow sound observed on beam after tapping.
- ❖ Patch work observed on wall.
- ❖ Patch work observed on ceiling.

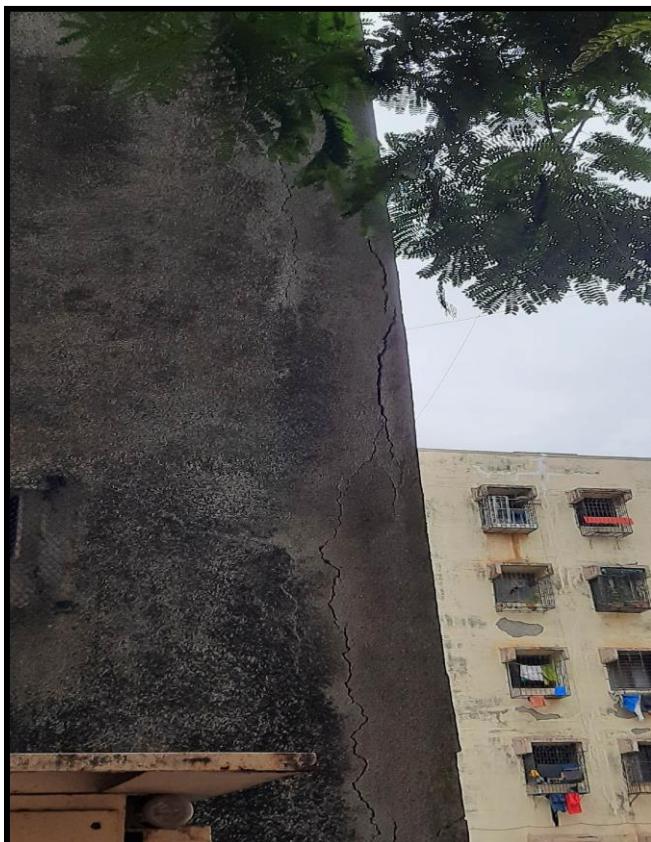
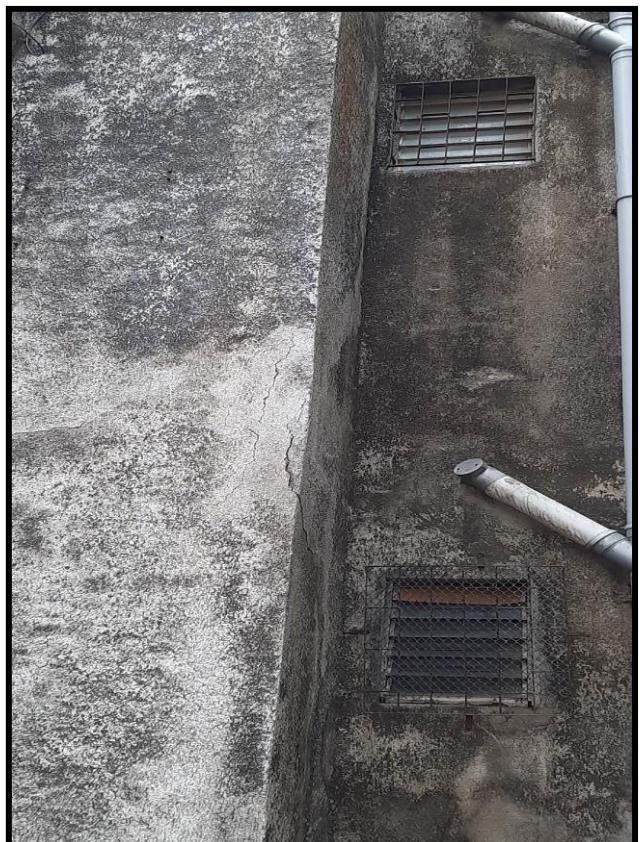
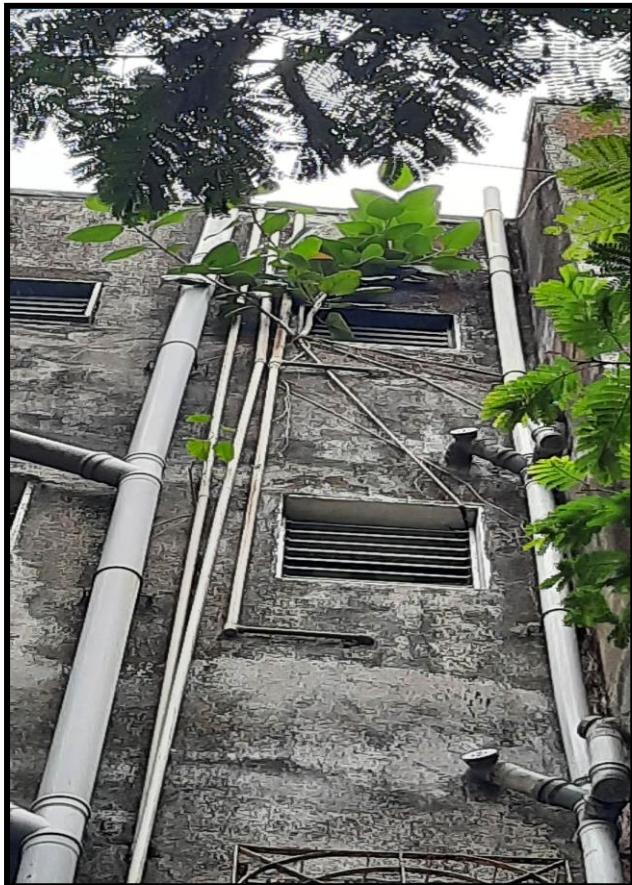
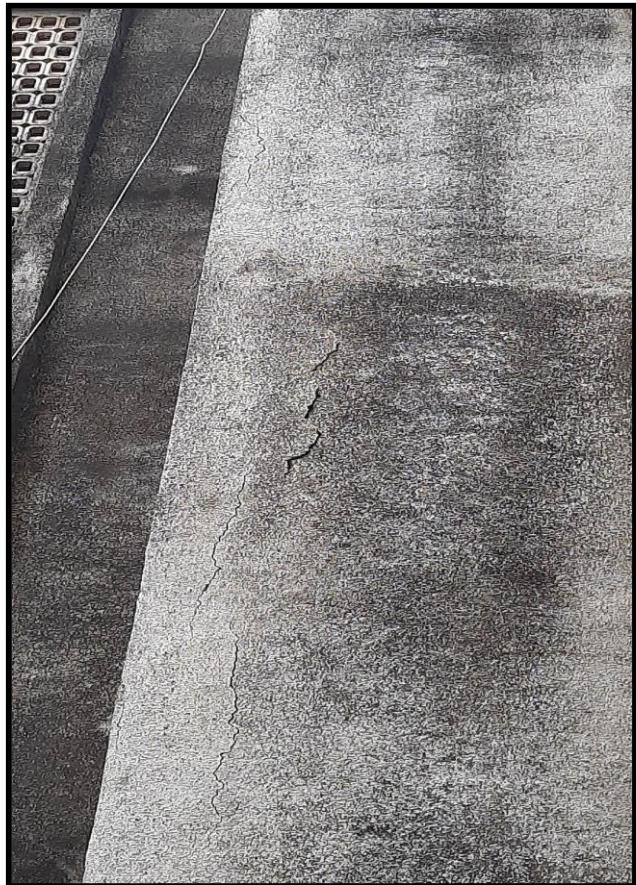
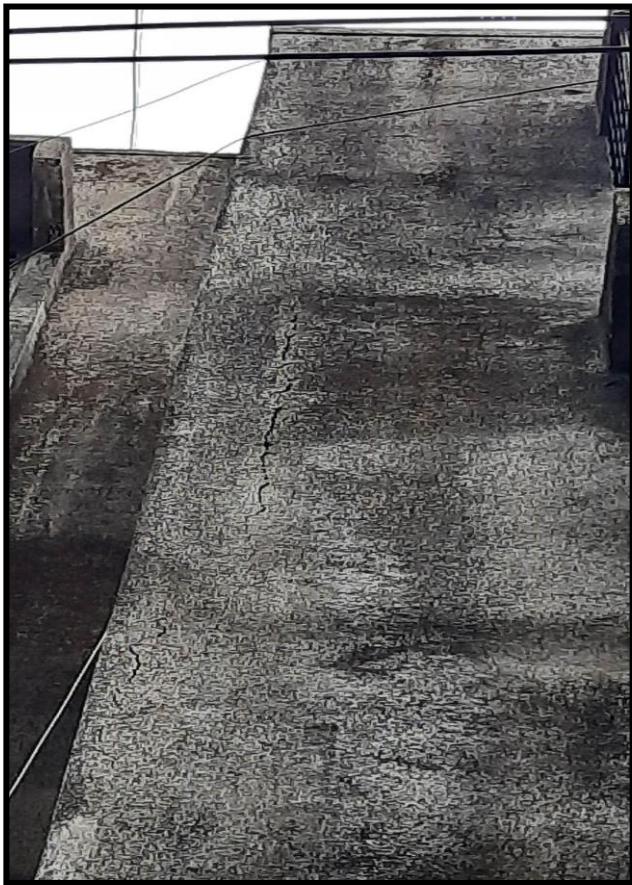
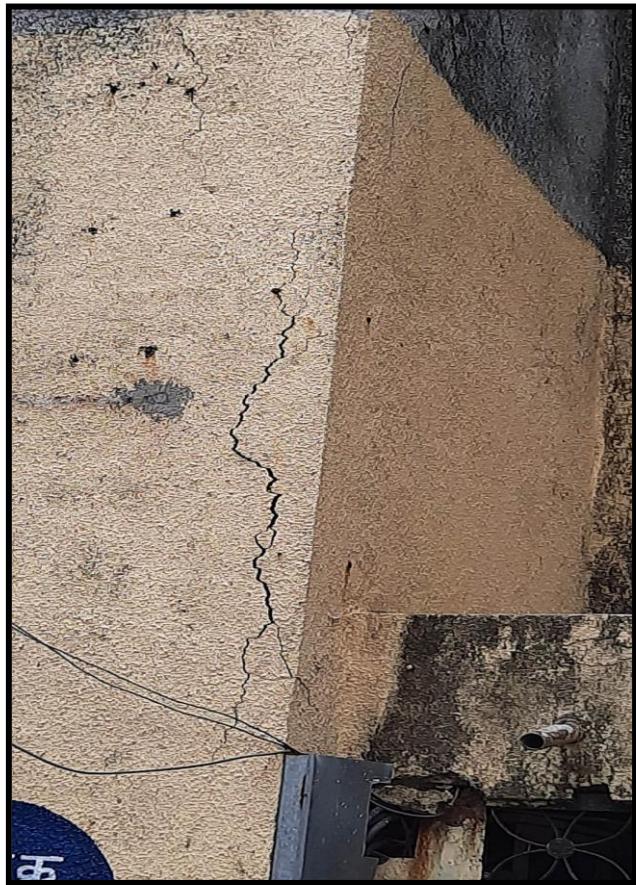
FRONT SIDE

- ❖ Structural crack observed at several places on column.
- ❖ Major crack observed at several places on wall.
- ❖ Vegetation growth observed at several places on wall.
