STRUCTURAL AUDIT REPORT
FOR
“VISHAL SAHYADRI CO – OP HSG. SOC. LTD”,
“B7 – WING”
SITUATED AT
SAHYADRI NAGAR, CHARKOP,
KANDIVALI (W) MUMBAI – 400 067

PREPARED BY
LATESH S. SANKLECHA
CONSULTING STRUCTURAL ENGINEERS

978/B7/LSS/2021

JULY 19, 2021

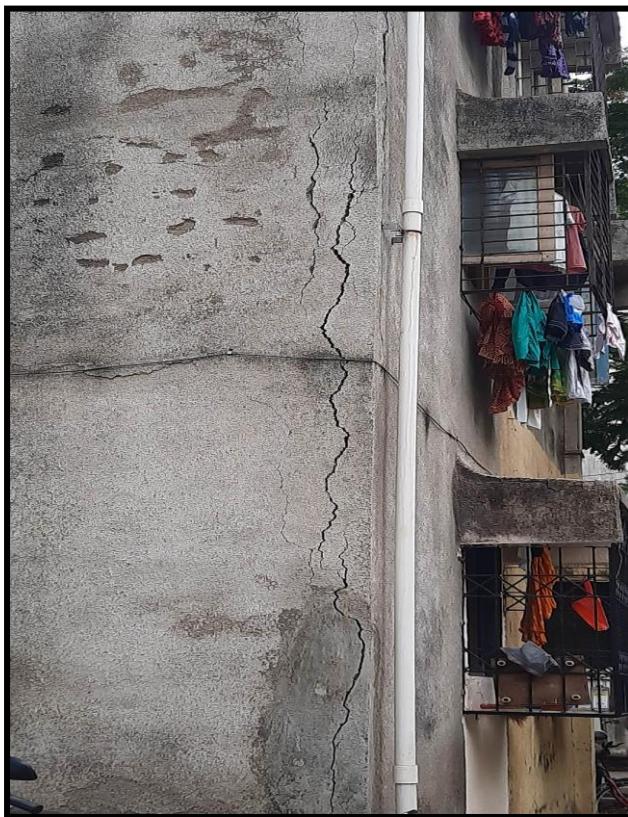
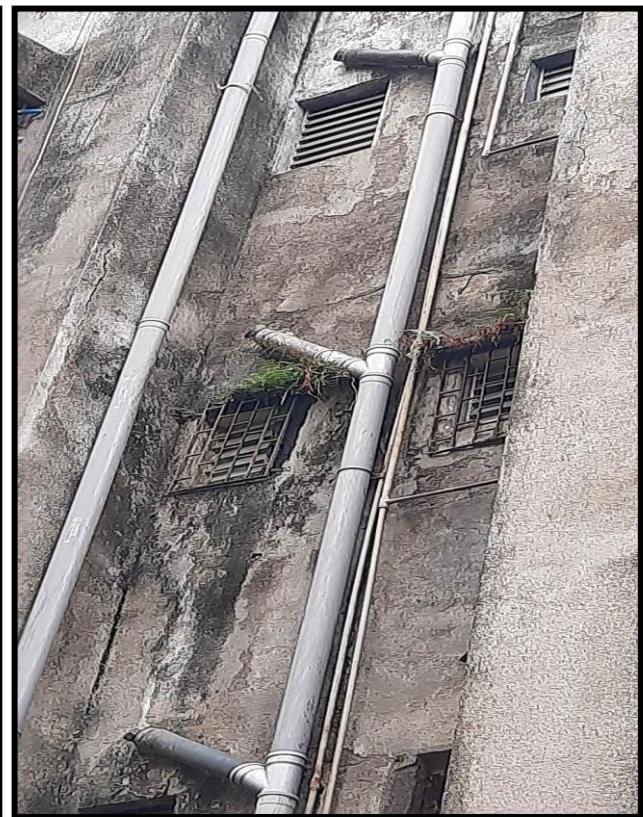
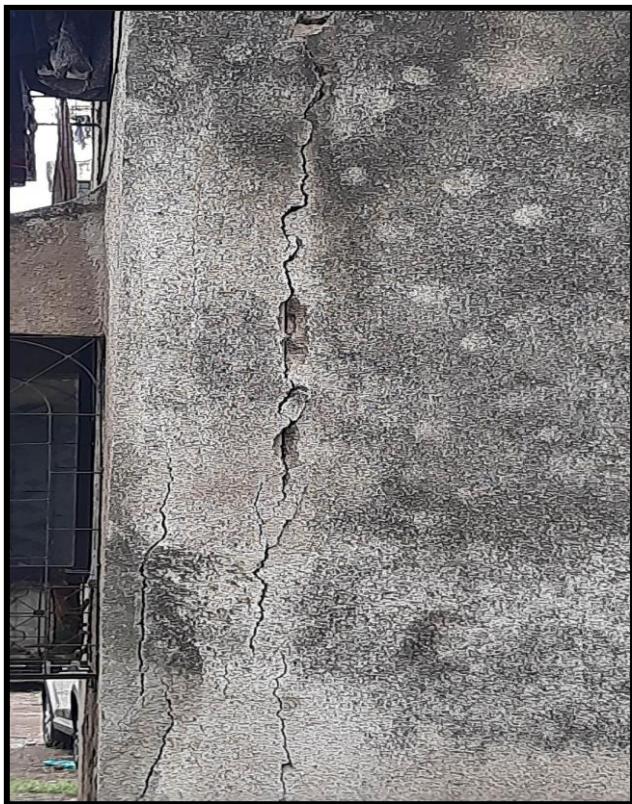
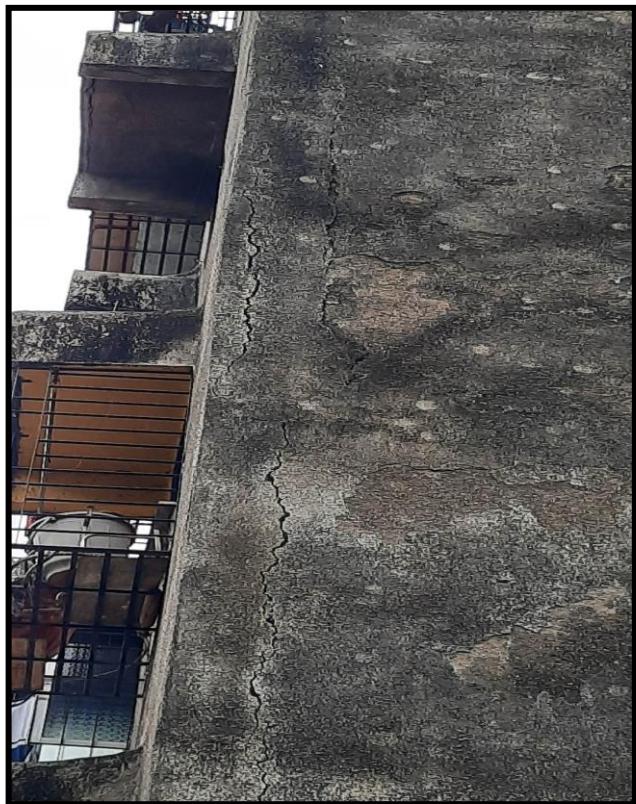
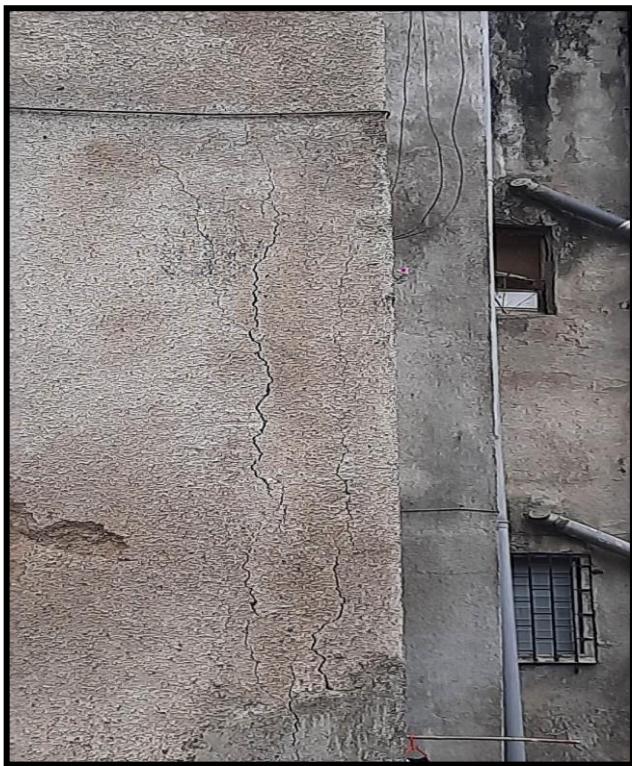
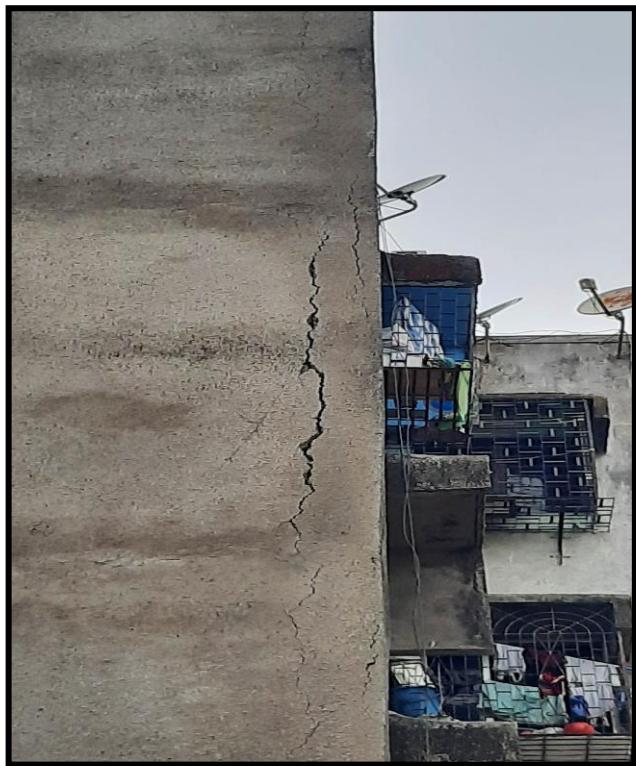
BACK SIDE

- ❖ Structural crack observed at several places on column.
- ❖ Major crack observed at several places on wall.
- ❖ Vegetation growth observed at several places on wall.

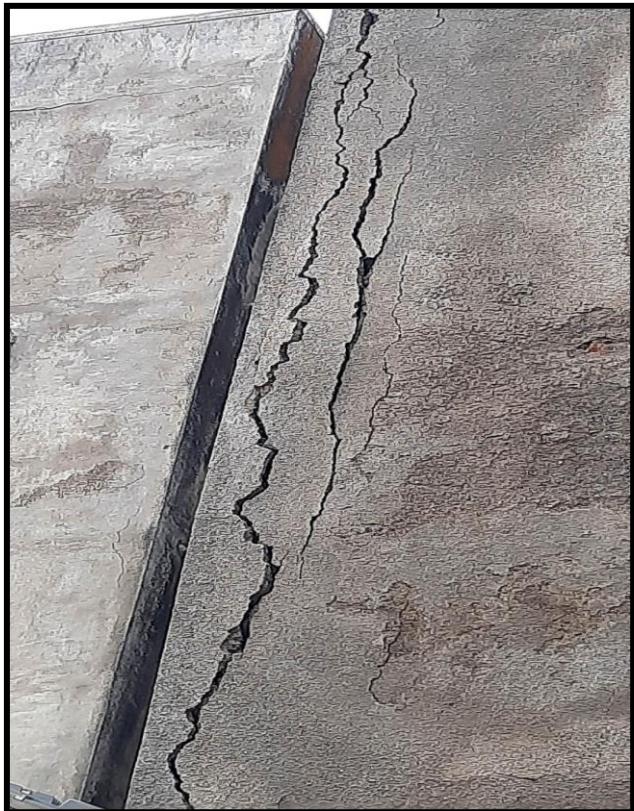
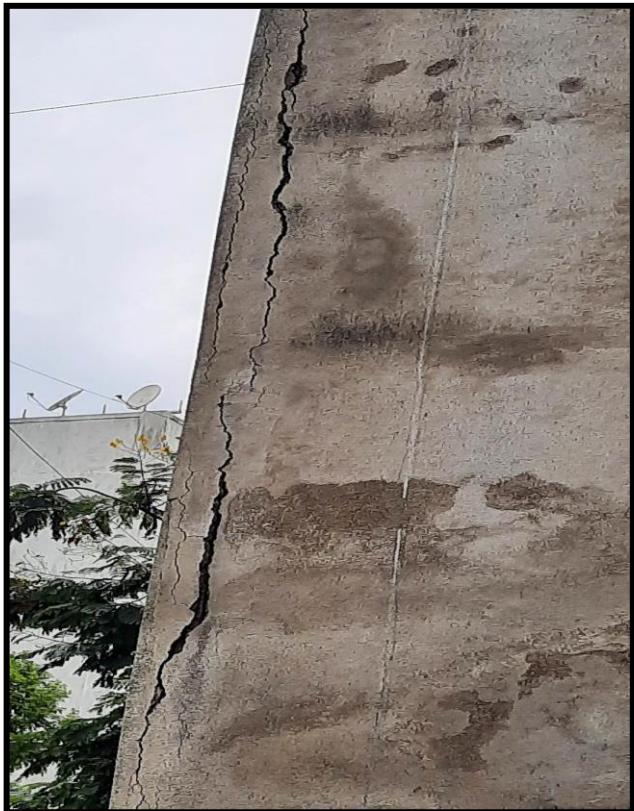
NORTH SIDE

- ❖ Structural crack observed at several places on column.
- ❖ Major crack observed at several places on wall.
- ❖ Vegetation growth observed at several places on wall.

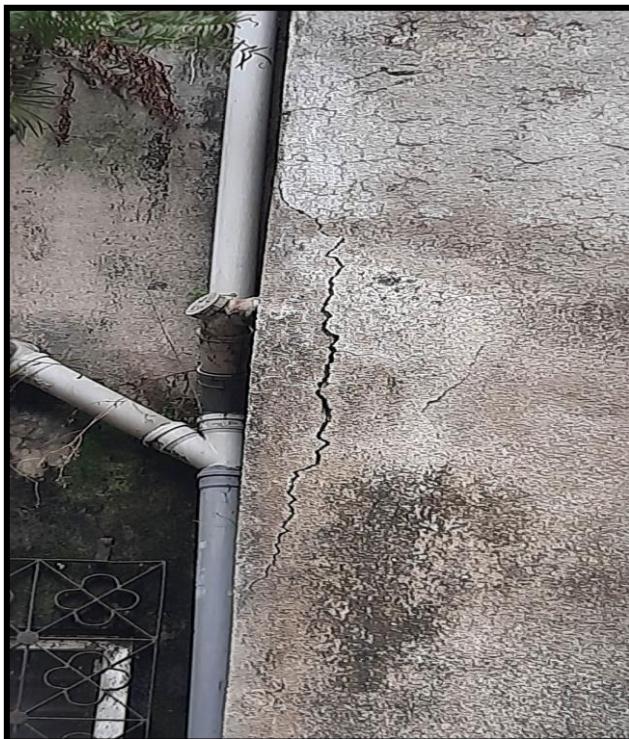
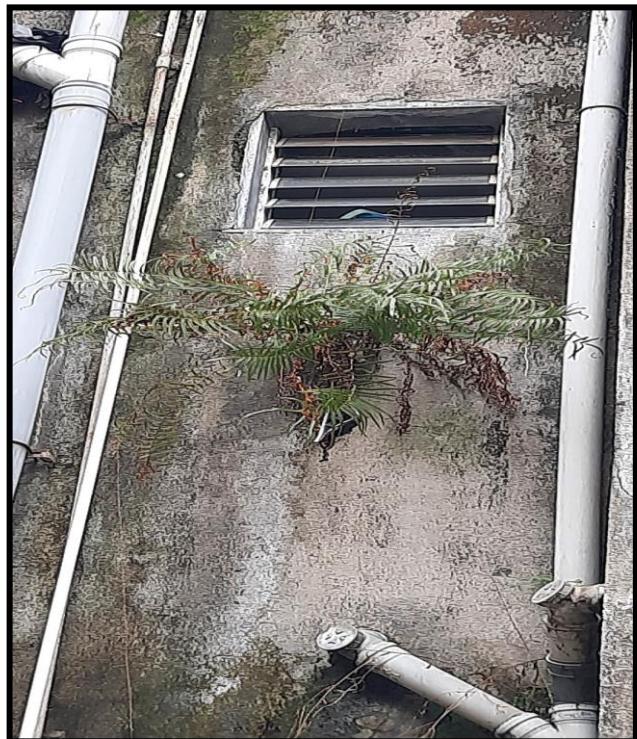
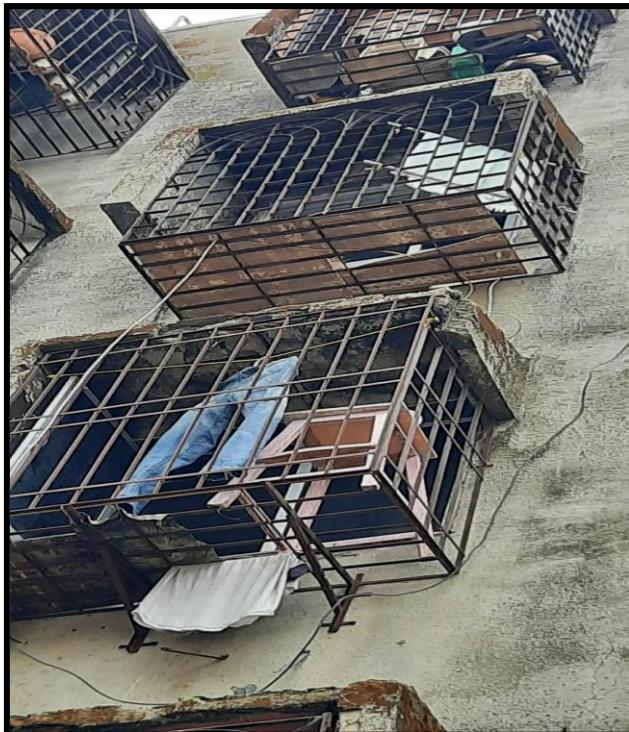
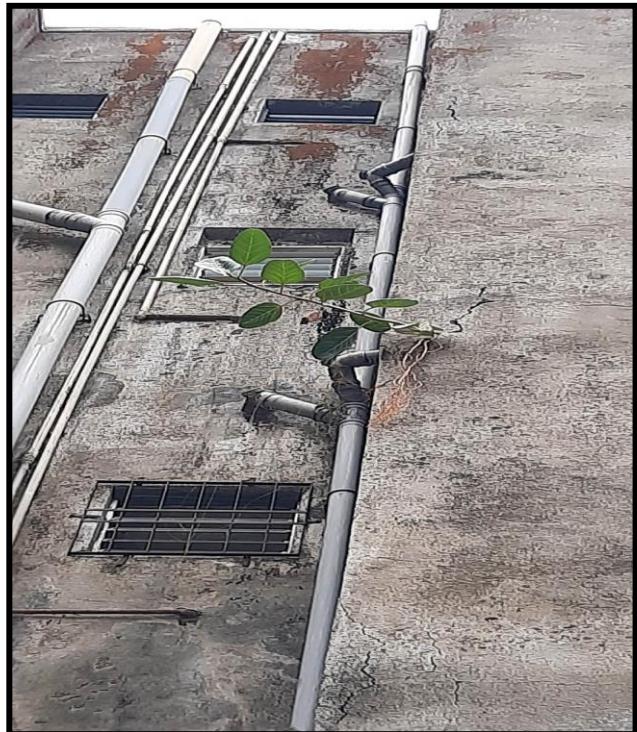
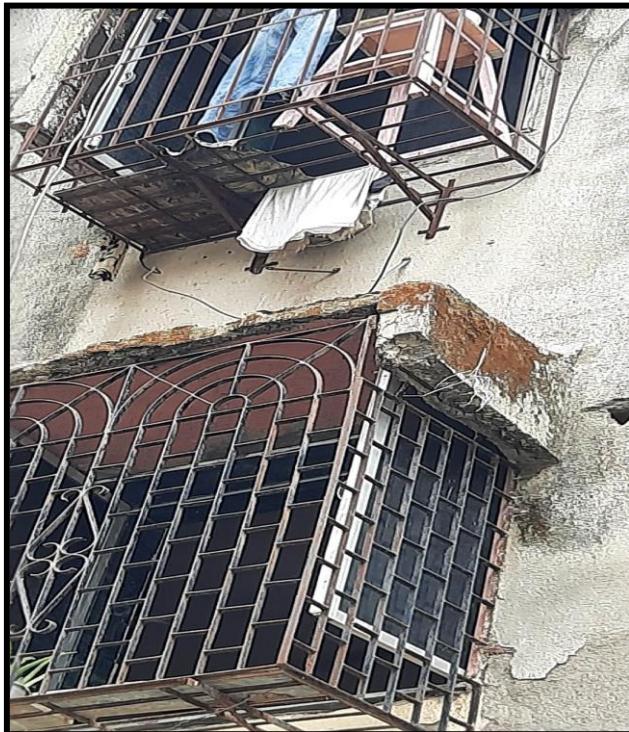
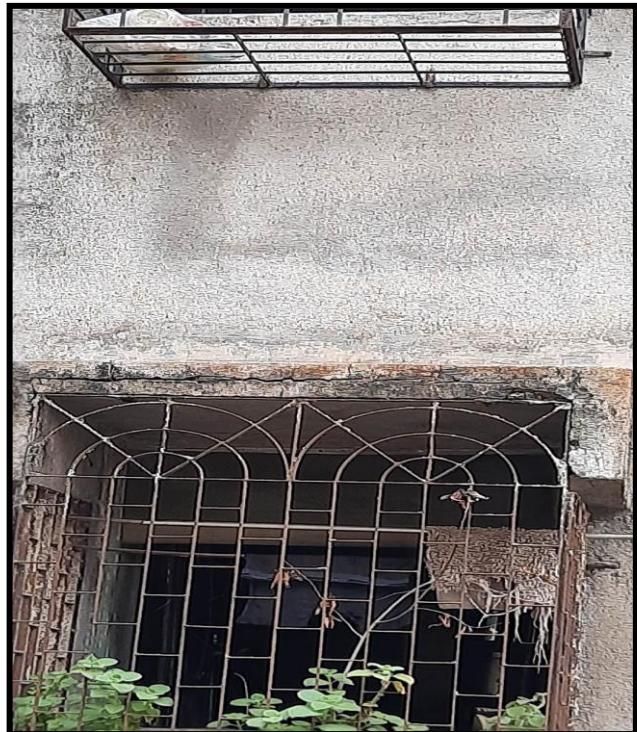
SOUTH SIDE

- ❖ Structural crack observed at several places on column.
- ❖ Major crack observed at several places on wall.
- ❖ Vegetation growth observed at several places on wall.
