Pest Inspection Report (Entopest)

Post-Inspection Report / 0501 Family Mart Wangsa Link / 17 Jul 2025

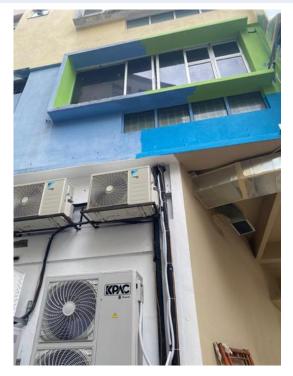
Photo 1

Found gap in between the air cond piping and wall.

Recommend to seal the highlighted gap

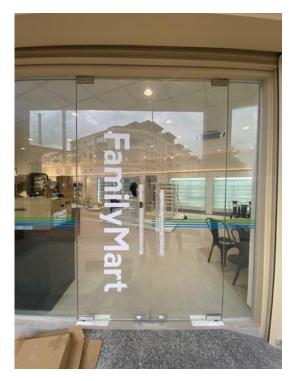
Photo 5

Gaps were observed in between the doors

Kindly to seal the gap

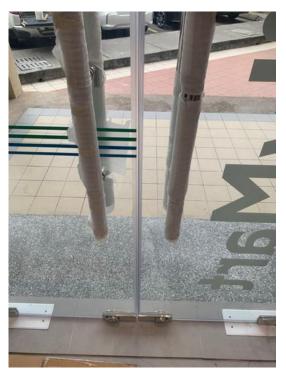
Photo 9

Gap was observed in between piping and ceiling

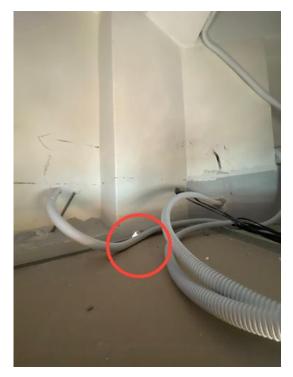
Photo 17

Gaps was observed in between wall and ceiling

Kindly seal the highlighted gaps

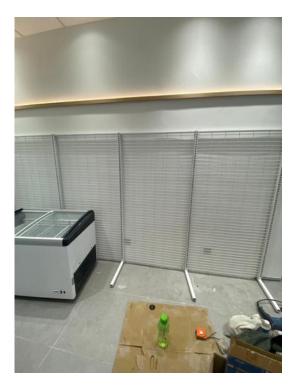
Photo 21

Found gap in between wall and floor tiles

Kindly to seal the gaps

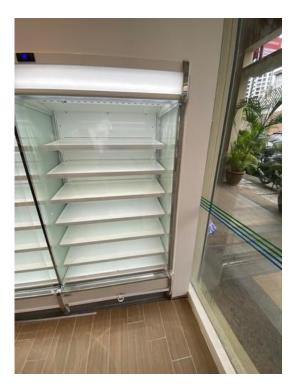
Photo 25

Gaps were observed at the wall and chiller base.

Recommend to seal the highlighted gap

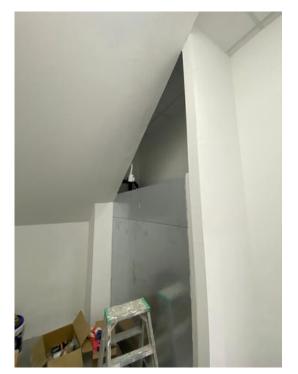
Photo 31

Found gap in between the piping and wall

Kindly seal the highlighted gap

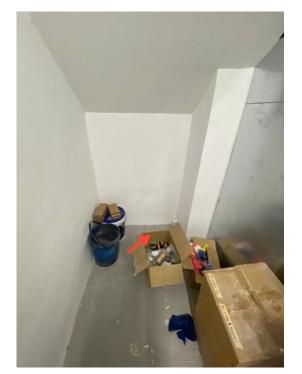
Photo 39

Gap between floor titles was observed

Kindly seal the gap

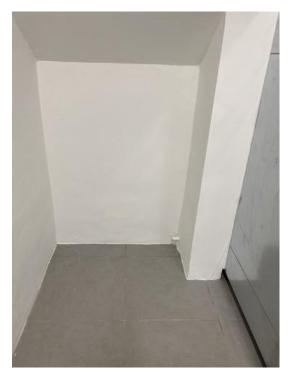
Photo 42

Gap between floor titles was observed

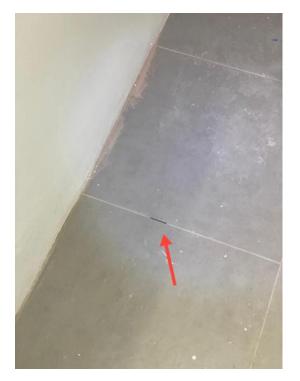
Detached rubber strip, potential pest hiding spot

Kindly fix the detached part of the rubber strip

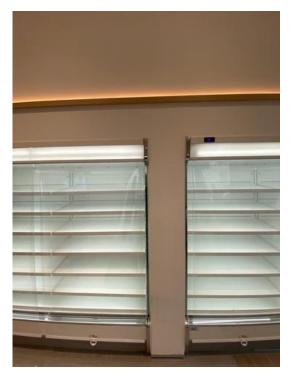
Photo 53

Gap was observed in between the wall and the chiller top

Kindly seal the gap as highlighted

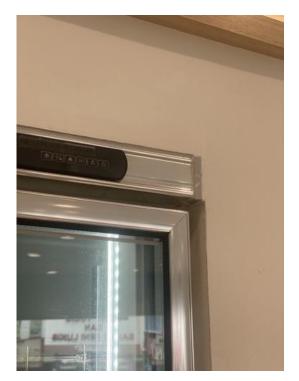
Photo 56

Found open piping, potential pest pathway

Recommend to seal the open piping

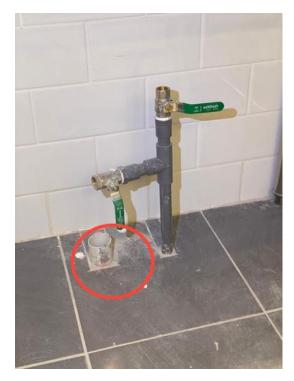
Photo 63

Gap was observed between the wiring hole and the wall tiles

Recommend to seal the gap when the LCD was installed

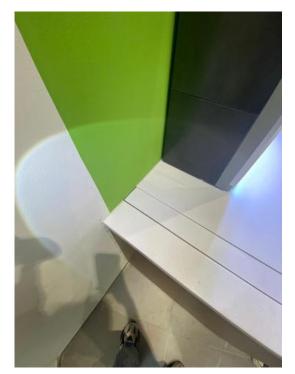
Photo 71

Gaps between cabinet will provide pest hiding spot

Recommend to seal the gaps

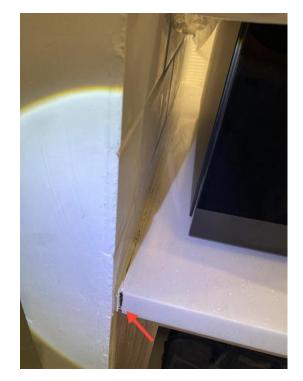
Found gaps at the corner of the tabletop

Recommend to seal the highlighted gaps

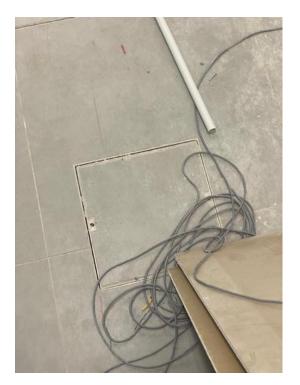
Gap between the cover and the tiles

Recommend to seal the gaps if

possible.

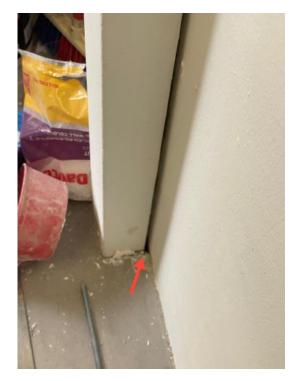
Photo 108

Found gap behind the trunking/wire casing, there was gap between the wire casing and

Recommend to seal the gap

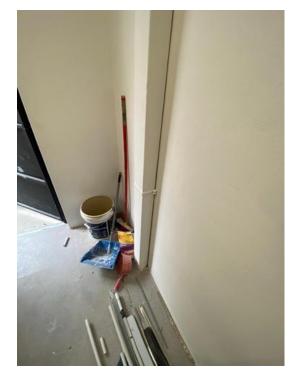
floor tiles
