Pest Inspection Report (Entopest)

Post-Inspection Report / MFM0523 FamilyMart AEON Taiping / 29 Jul 2025

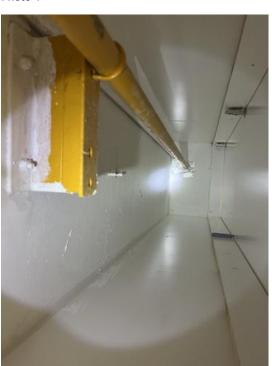
Photo 4

Gap noted around yellow piping.

Kindly seal off the gap to prevent pest entry into internal area.

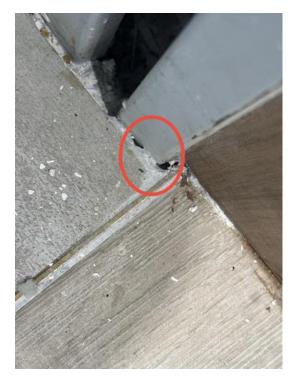
Photo 65

Hole was observed on the wall.

Kindly seal off the hole using silicone as highlighted.

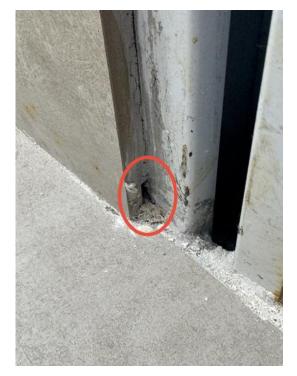
Photo 69

Hole was observed on the side of wall.

Kindly seal off the hole using silicone as highlighted.
