Pest Inspection Report

Post-Inspection Report / MFM0125 Gelang Patah / 22 Jul 2025

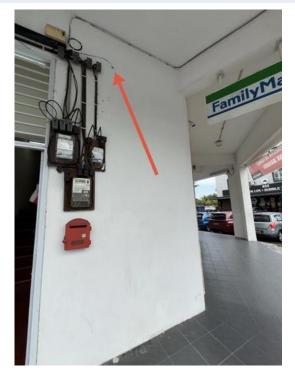
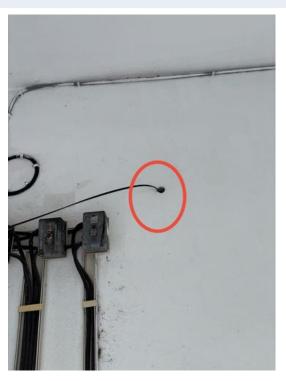
Location Front store

Gaps at the wiring into the wall

To seal the gaps

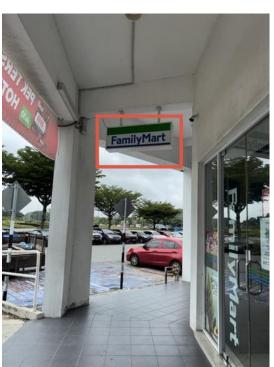
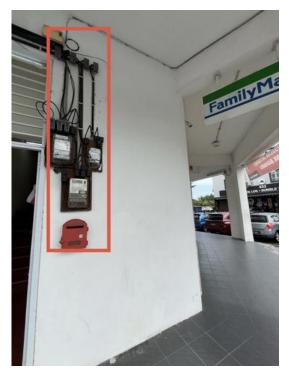
Location Front store

Noted bird activity at the FamilyMart signage and at the TNB meter

To install bird spike

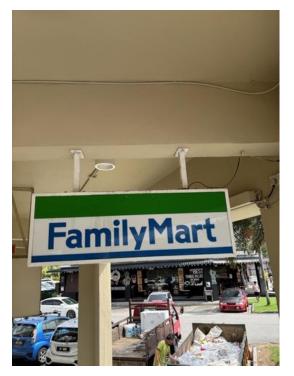
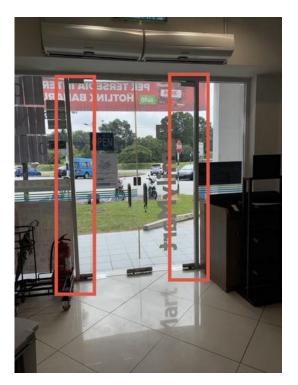
Location Front door

Findings Glass door with gaps

Gap is at minimum level, unable to install rubber strip

Recommendation To install door strip

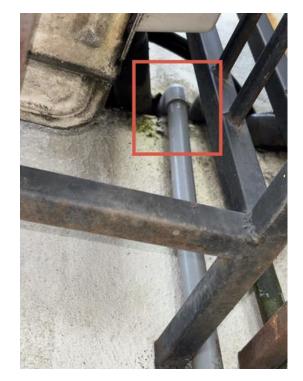
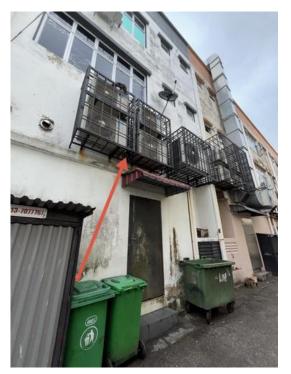
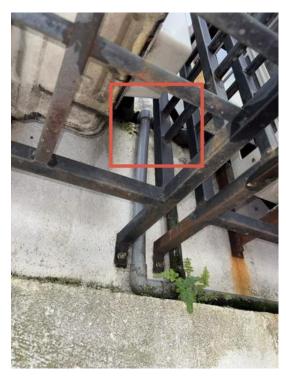
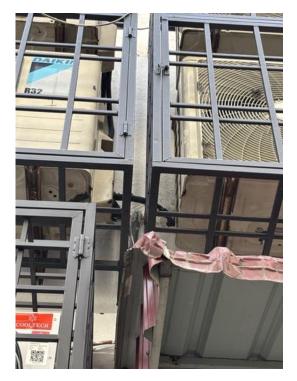
Location Back store

Gaps at the pipping into wall

Recommendation To seal the gaps

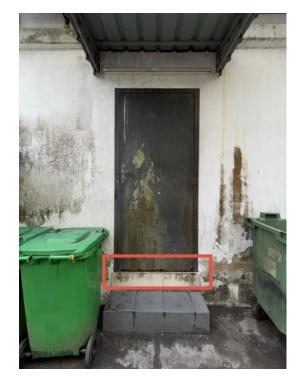
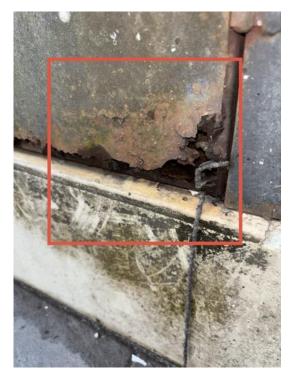
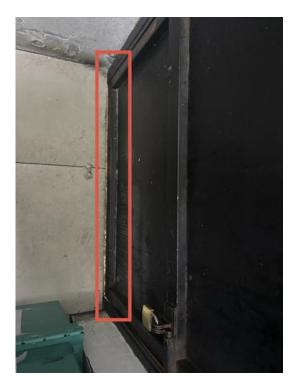
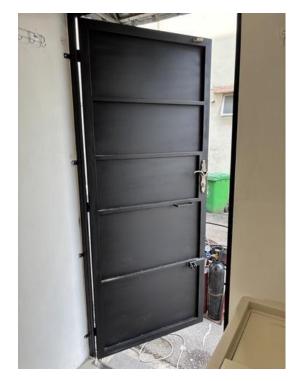
Location Backdoor

Backdoor bottom part rusty and damaged

To change a new door with door strip

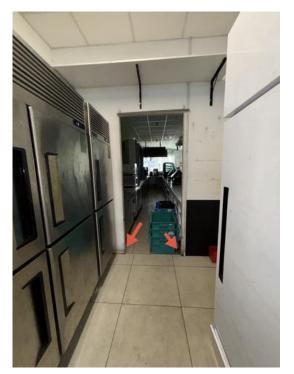
Location Kitchen partition

Partition with gaps

Recommendation To seal the gaps

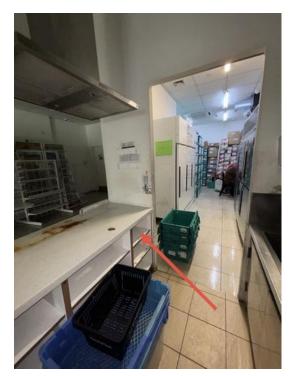
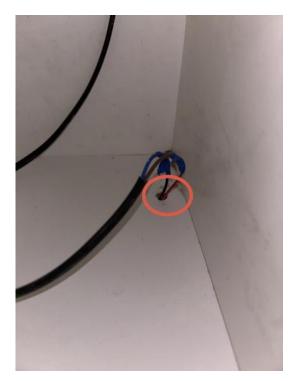
Location Kitchen cabinet

Cabinet with exposed partition

To seal the gaps

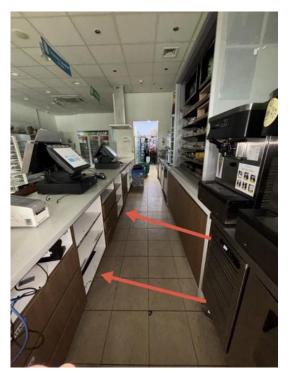
Location Kitchen cabinet skirting

Findings Skirting with gaps

Recommendation To seal the gaps

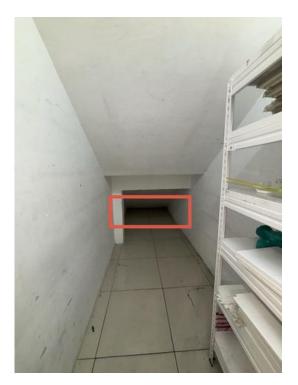
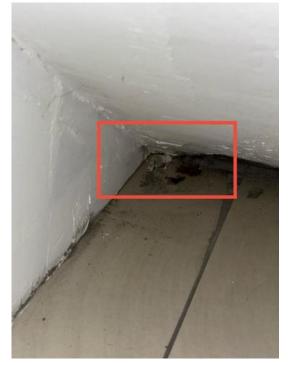
Location Small store room

Findings Gaps underneath stairs

Recommendation To seal the gaps

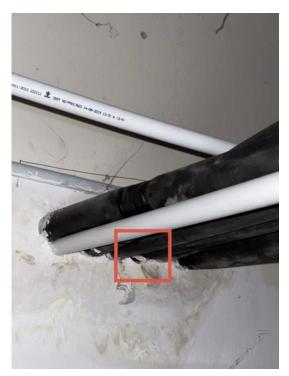
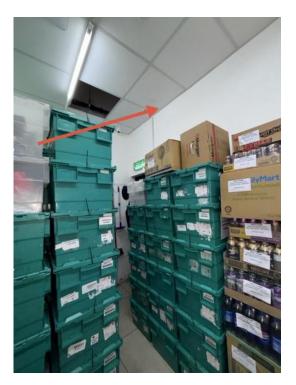
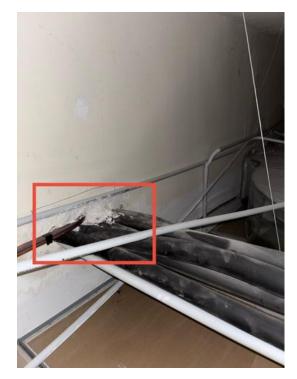
Location Above ceiling - Backroom

Findings Gaps at the pipping

Recommendation To seal the gaps

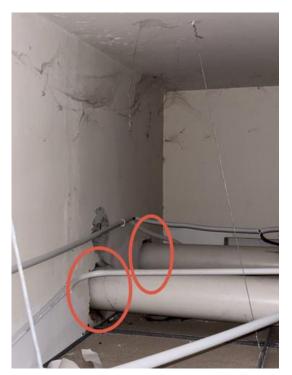
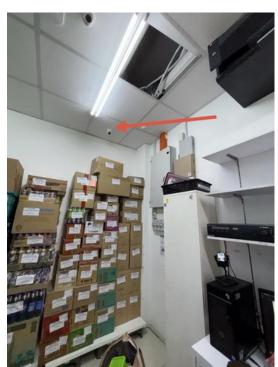
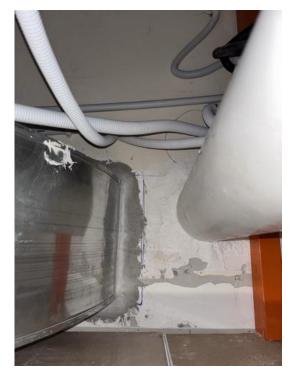
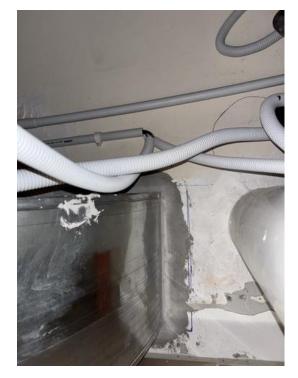
Location Above ceiling - backroom

Gaps at the pipping to the wall

1 white pipe is closed left only 1 white pipe

To seal the gaps

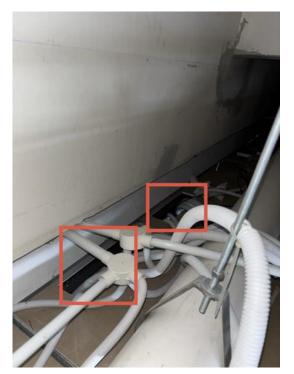
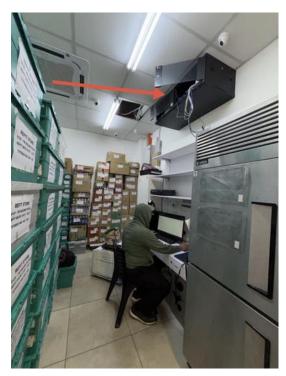
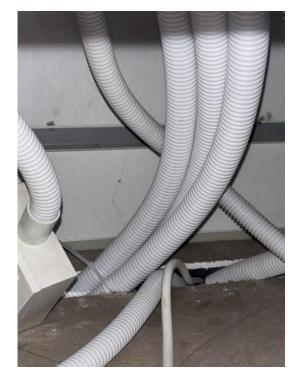
Above ceiling - backroom

Gaps at the ceiling for the server wiring

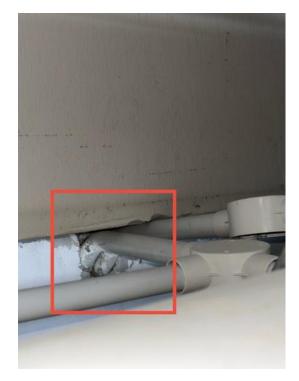
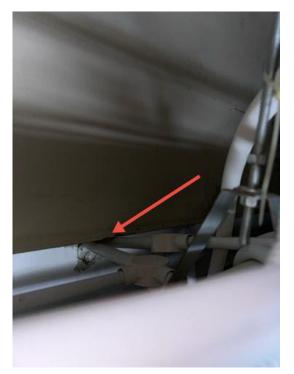
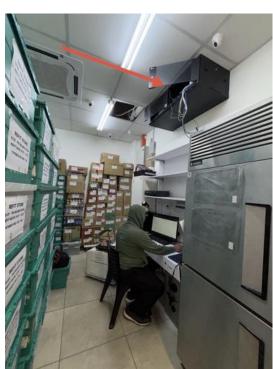
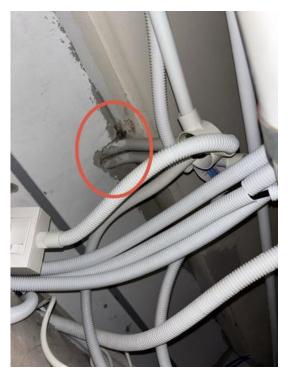
Above ceiling - backroom

Gaps at the wiring to the wall

To seal the gaps

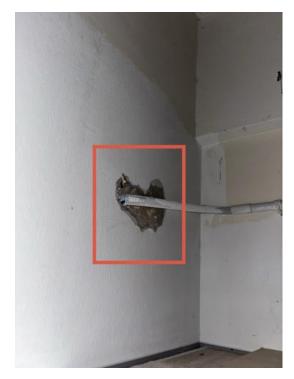
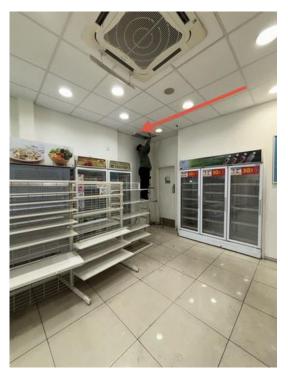
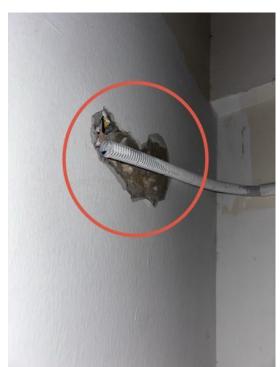
Above ceiling - in front of customer toilet

Gaps at the wiring

To seal the gaps

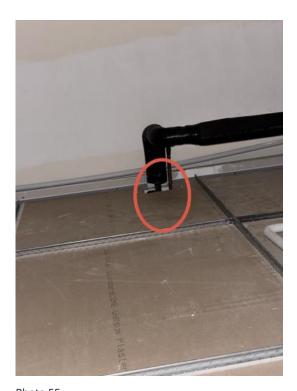
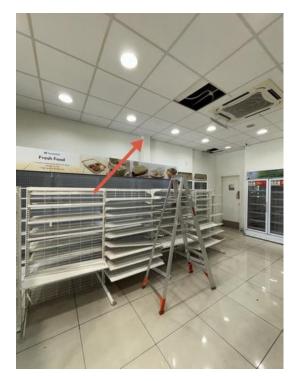
Above ceiling - OCC

Gaps at the ceiling down to OCC pipping

To seal the gaps

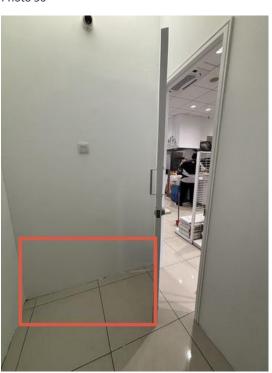
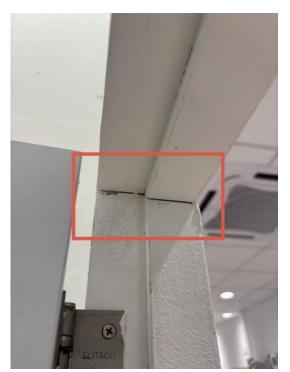
Location Small store room

New partition with gaps at the wall and floor

To seal the gaps

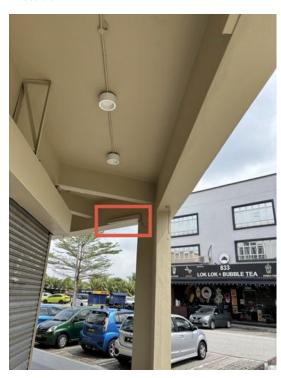
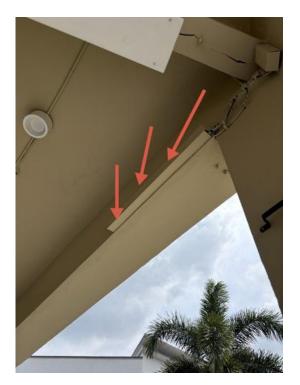
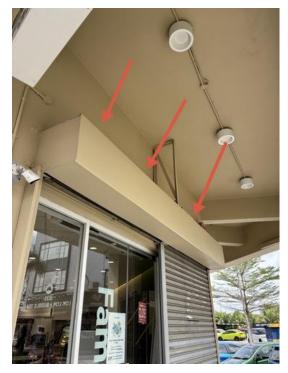
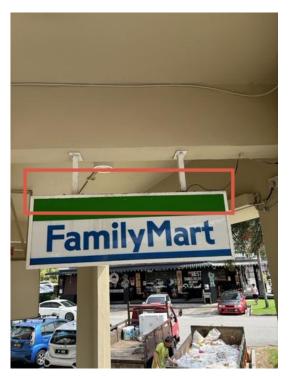
External store

Status	New Findings
Recommendation	To install bird spike as well
Findings	Additional location for bird spike
