**Property Address:** 2839 Pendleton Dr, San Jose, CA 95148

**Inspector:** Dennis Spencer

**Company:** WIN Home Inspection Santa Cruz  
dba  
(831) 214-8805  
dspencer@wini.com

Extended Full Home Inspection

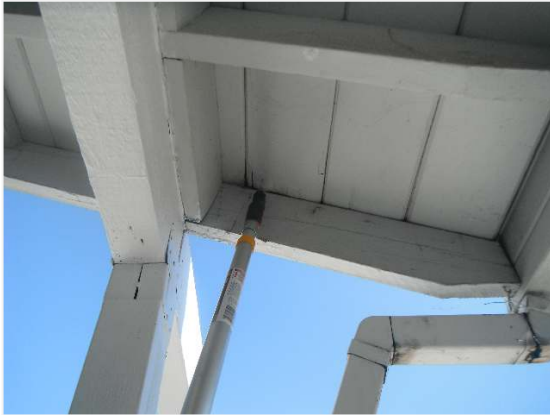
The roof sheathing at the front porch and at the northwest corner of the structure is damaged. Damage in this area is typically caused by leaks in the roof cover or gutter systems. Recommend removal and replacement of the damaged portions. Contact a licensed contractor for further evaluation and repairs. Referring to the current pest report for additional findings is advised.

Damaged sheathing at the front porch.

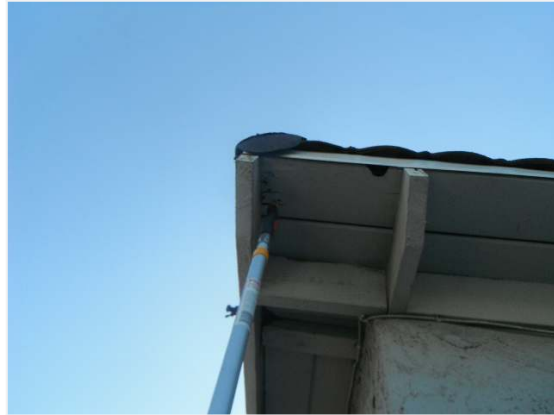
Damaged sheathing at the northwest corner.

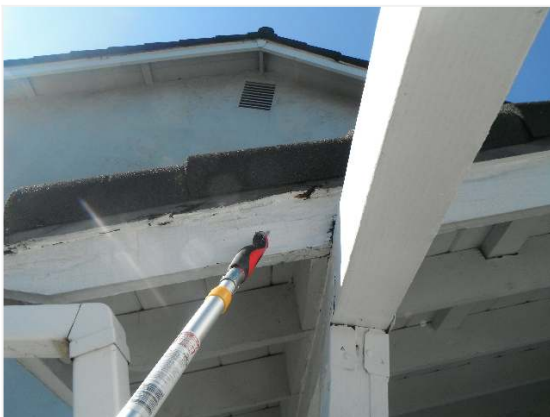
The varge rafters at the front porch and at the northwest corner of the structure are damaged from moisture intrusion or wood damaging organisms. Recommend removal and replacement of the damaged portions. Contact the appropriate trade for further evaluation and repairs. Referring to the current pest report for additional findings is advised.

Damaged varge rafter at the front porch.

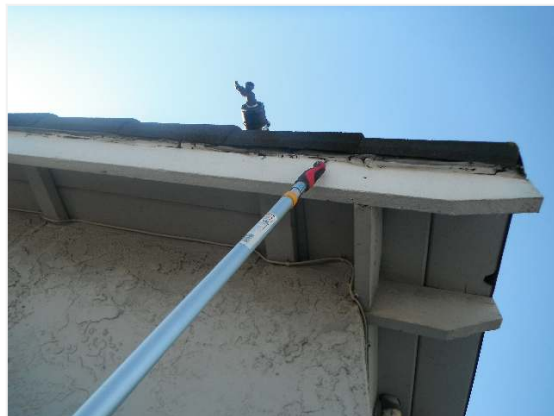
Damaged varge rafter and trim at the northeast corner of the structure.

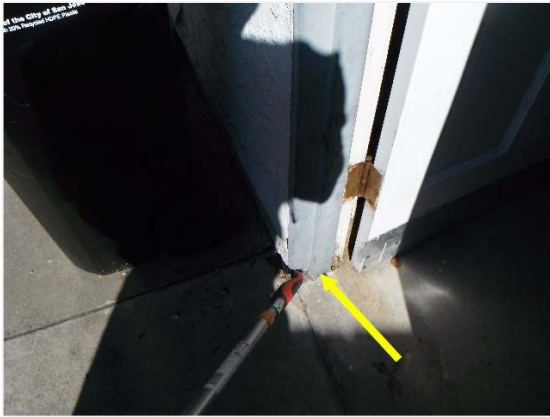
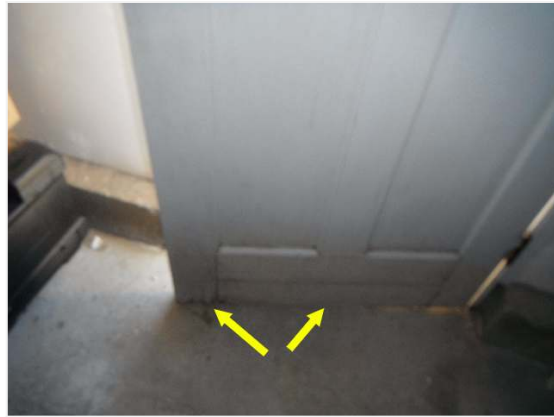
The inspector noted some damage to the base of the trim at the garage exterior passage door, and in

addition there is some damage to the base of door. Recommend repairing the damaged trim and door in order to prevent further deterioration and moisture intrusion. Contact a qualified handyperson for repairs.

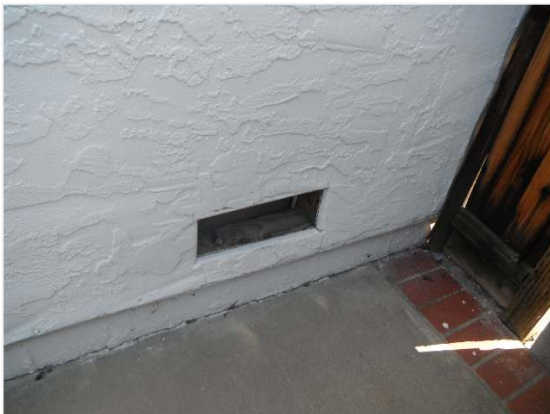
There is a missing foundation vent screen at the garage. The opening may allow vermin access into the garage space. Contact a qualified handyperson to install a foundation vent screen as a preventative maintenance measure.

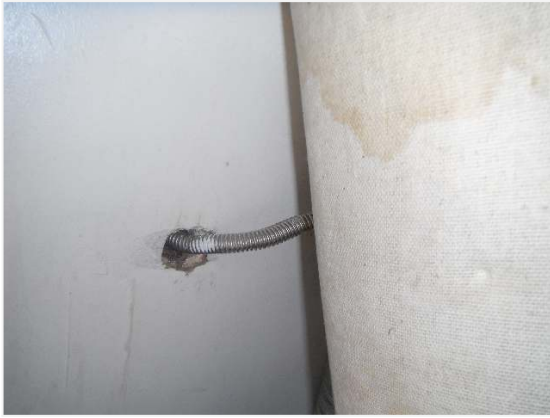
Flexible gas line passes through the rear garage wall. This is a substandard installation as gas lines that pass through walls are required to be rigid pipe. Recommend changing the flexible line with rigid pipe. Contact the appropriate trade for repairs.

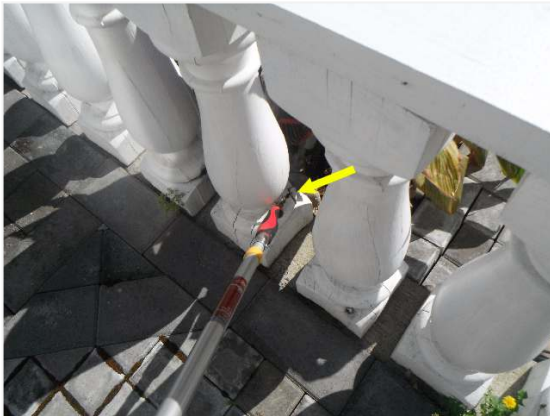
There is a damaged wood baluster at the front porch area. Recommend repair or replacement to prevent ongoing deterioration. Contact the appropriate trade for repairs.

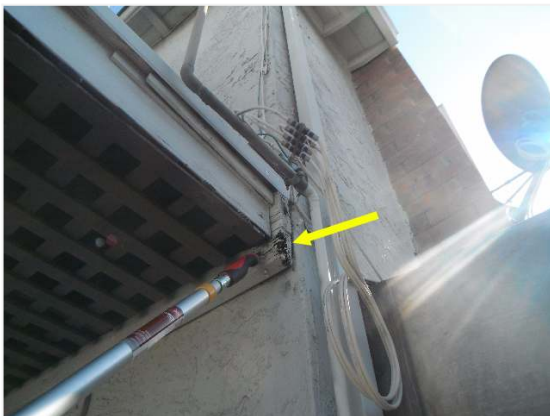
There is some damage at the rear patio cover ledger board. Recommend monitoring and anticipating repairs in the future should the condition worsen.

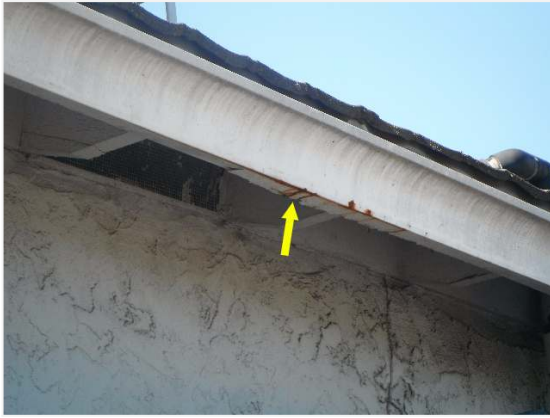
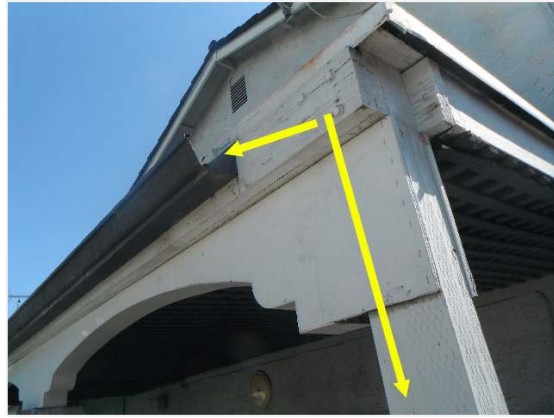
There are rust stains and perforations in the gutter system at the upper north roof edge indicating advanced aging and probable leaks. Sealing the gutters from the interior may extend the gutters service life. Budgeting for replacement of the gutters in the near future is advised.

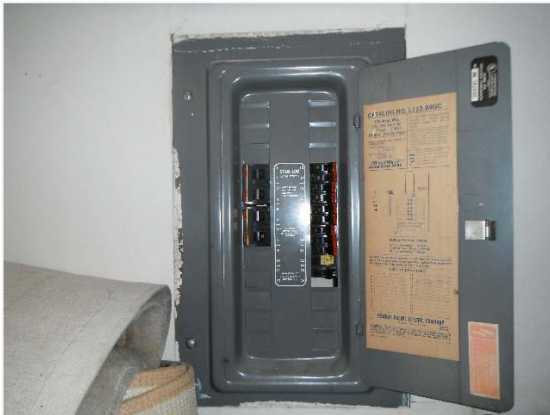
The main electrical panel and the sub panel are Federal Pacific Electric (FPE) brand panels with Stab-Lock circuit breakers. Reports of failure with this equipment have been reported. Failure included breakers failing to trip at the stated ratings and breakers that still have power when turned to the "off" position. These panels also have poor breaker connections to bus bars, and some of these panels have insufficient wire bending space and insufficient gutter space. There are also incompatible metals between the bus bars and the breakers that may lead to deterioration over time. Consulting a licensed, qualified electrician for further evaluation is recommended.

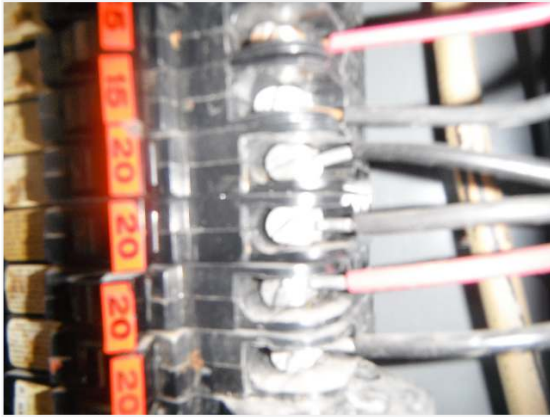
Some of the electrical circuit wiring is aluminum and the inspector does not invasively inspect the outlets, switches and connectors to determine if they are rated for aluminum wiring. The breakers are CU/AL (copper or aluminum) rated. Consideration should be given to having a licensed electrician remove and inspect the outlets, switches and connectors to determine if they are rated for aluminum wire for fire safety considerations.

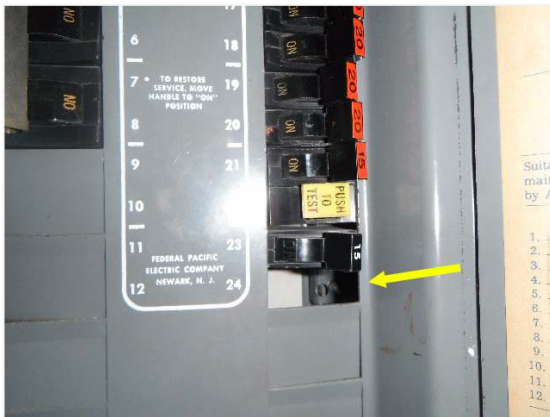
The inspector noted that there was an open slot on the sub panel cover. Installing a plastic blank in the open slot is recommended as a preventive safety consideration. Plastic breaker blanks can be purchased from a home improvement center and can be installed by a qualified handyperson or electrician.

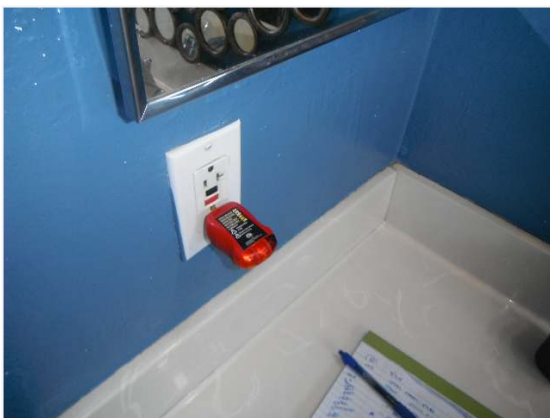
The ground fault circuit interrupters (G.F.C.I.)'s were spot tested and there appears to be a malfunction in the hall bathroom receptacle. The unit would not trip when tested. Recommend replacement of the receptacle so that it may function as intended. Contact a qualified person to make the repair.

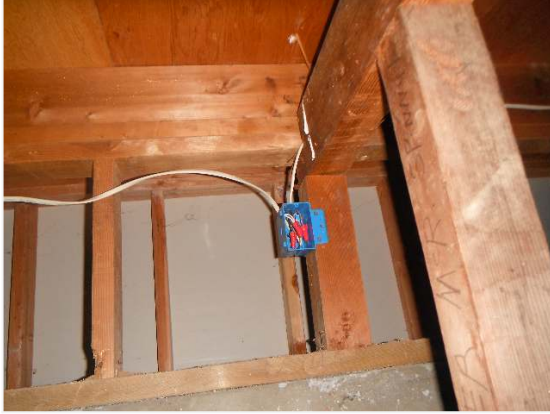
There is an open electrical junction box in the crawl space below the family room. Junction boxes are required to have a proper cover installed to prevent shock hazard and provide containment of sparks

should arcing occur. Contact a qualified handyperson or electrician for installation of covers.

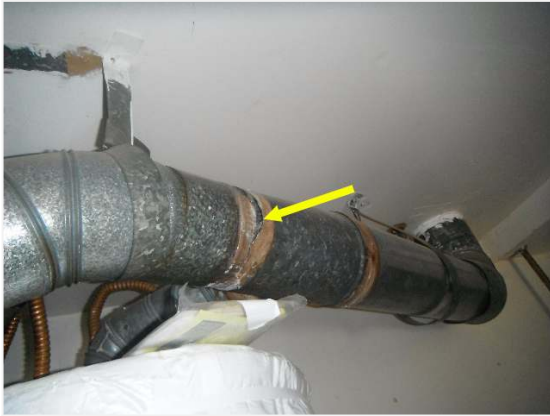
The furnace exhaust flue is partially detached at a junction in the garage. This may allow spent gasses to exit the flue. Recommend sealing the open area. Contact the appropriate trade for repairs.

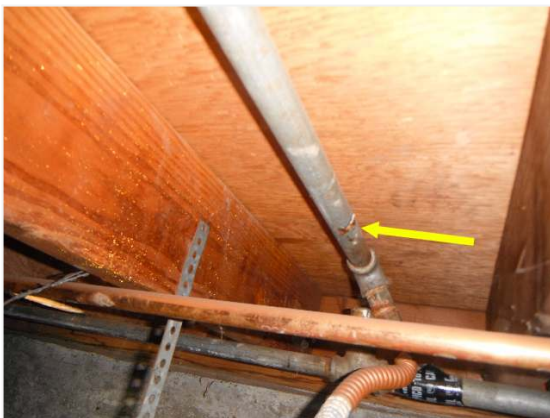
There is an encrustation on the galvanized water supply pipe in the crawl space. Encrustations are an indication that the pipe is failing and leakage or blockage is imminent. Contact a licensed plumber to evaluate and make needed repairs.

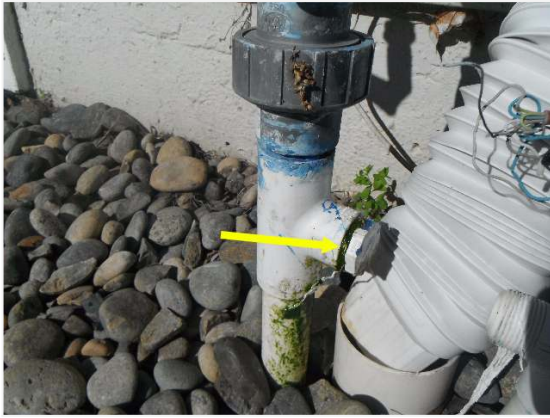
There is a leak at the incoming water supply pipe at the front of the structure near the shut-off valve. Contact the appropriate trade for repairs.

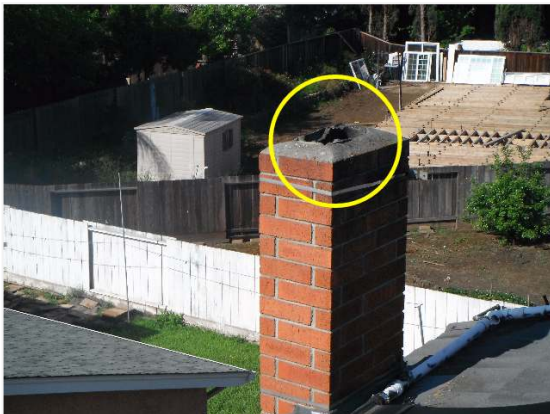
There is no spark arrester or rain cap on the chimney of this structure. Conditions may exist that may require a spark arrester for safe operation. Recommend checking with the local authority having jurisdiction to determine if spark arresters are required. Contact a qualified handyperson or chimney expert to install an approved spark arrester and rain cap if they are deemed to be required.

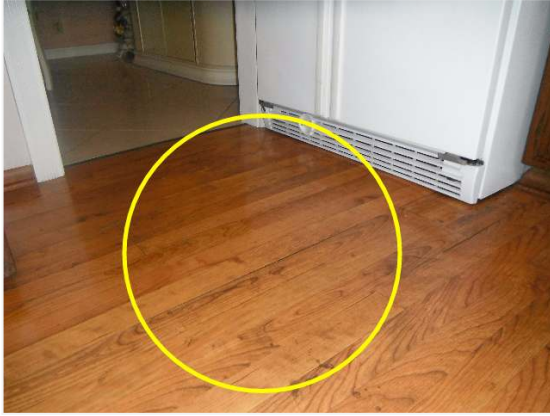
There is some warping present in the kitchen floor in front of the refrigerator which would indicate a water leak in the area at some time in the past. Recommend questioning the seller to determine if they are aware of any leaks in the area during their ownership and if they were repaired. The inspector did not note any moisture in the area at the time of the inspection.

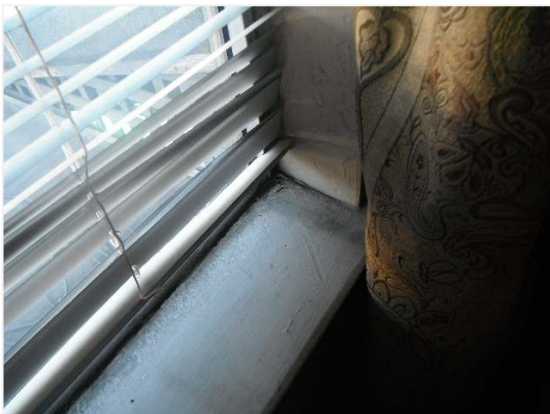
There are damaged window sills in the master bedroom. Recommend repair or replacement to prevent ongoing deterioration. Contact a qualified handyperson or appropriate trade for repairs.

Example of damaged window sills.

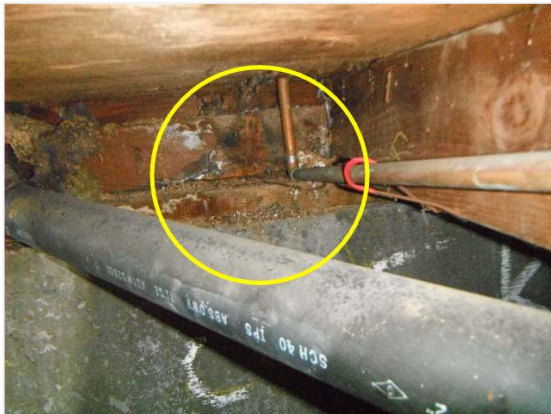
There are moisture stains on the rim joist beneath the kitchen that were dry at the time of the inspection. No damage was noted in these areas. Refer to the current pest report for additional information and any treatment recommendations that may be needed.

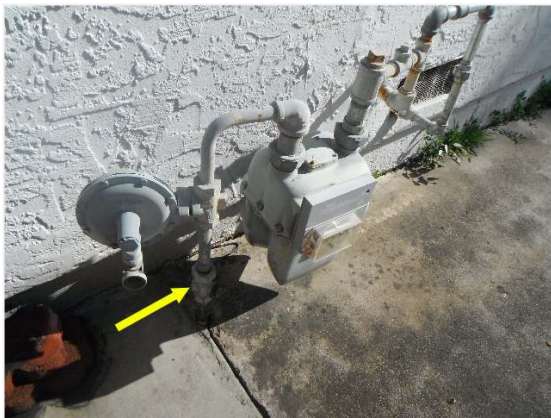
The shut off for the gas meter is located on the incoming gas line near the gas meter. When the shut-off valve is aligned with the pipe it is in the on position. When perpendicular it is in the off position. Storing a wrench near the meter needed to operate the valve is advised.

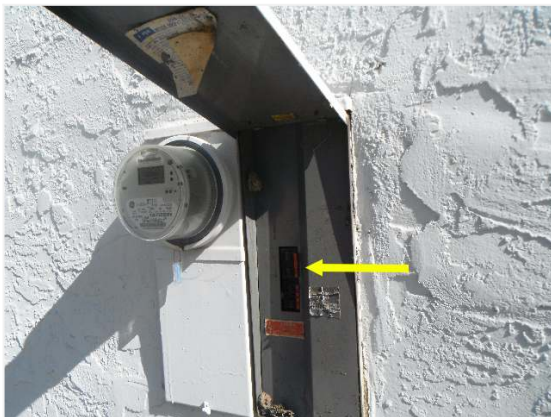
The main electrical panel and service disconnect is located at the southeast corner of the structure. The sub panel is located in the garage.

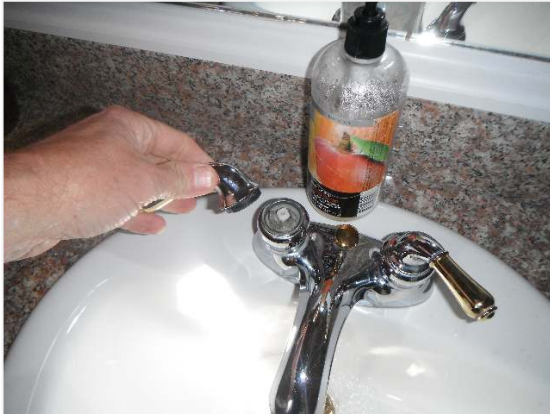
The hot water faucet handle in the half-bathroom is damaged and does not function. Contact the appropriate trade for repairs.
