# HOME INSPECTION REPORT

Inspector: Patricia Nguyen, ASHI #189234  
Property: 456 Test Ave, San Jose CA 95123  
Date: June 13, 2026

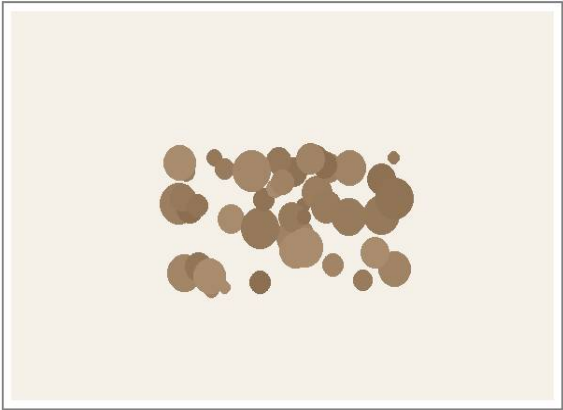
**Condition: DEFICIENT**

Composition shingle roof, approximately 25 years old.  
Multiple areas of curling and missing shingles observed.

Photo 1: Water stain on master bedroom ceiling

Brownish water stain ~2ft diameter

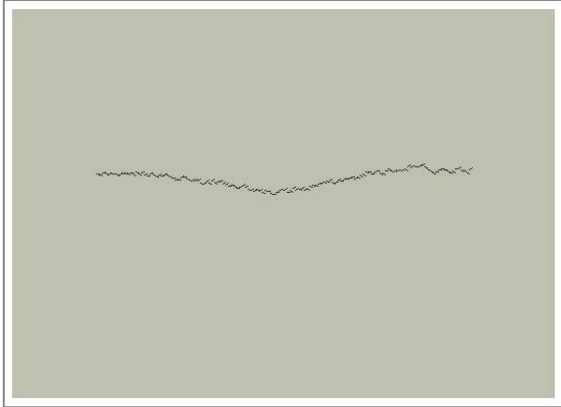
### Condition: MARGINAL

Hairline crack on east wall, approximately 3 feet long.

Photo 2: Foundation crack, east wall exterior

Hairline crack running horizontally

No vertical displacement. Monitor recommended.
