GOTHAM
WATERPROOFING & RESTORATION
PROTECTING YOUR REAL ESTATE

Re: 40 E Hanover Ave, Morris Plains, NJ 07950

Scopes of Work: 1. Repair to one parking garage drain and immediate perimeter concrete (16 SF); 2. Repair to parking lot deck concrete at expansion joint, (20 LF x 2.5 feet wide); 3. New pedestrian traffic coating on eight decks (approximately 8 'x 6'each) on main building.

HIGHLANDS, Morris PLAINS

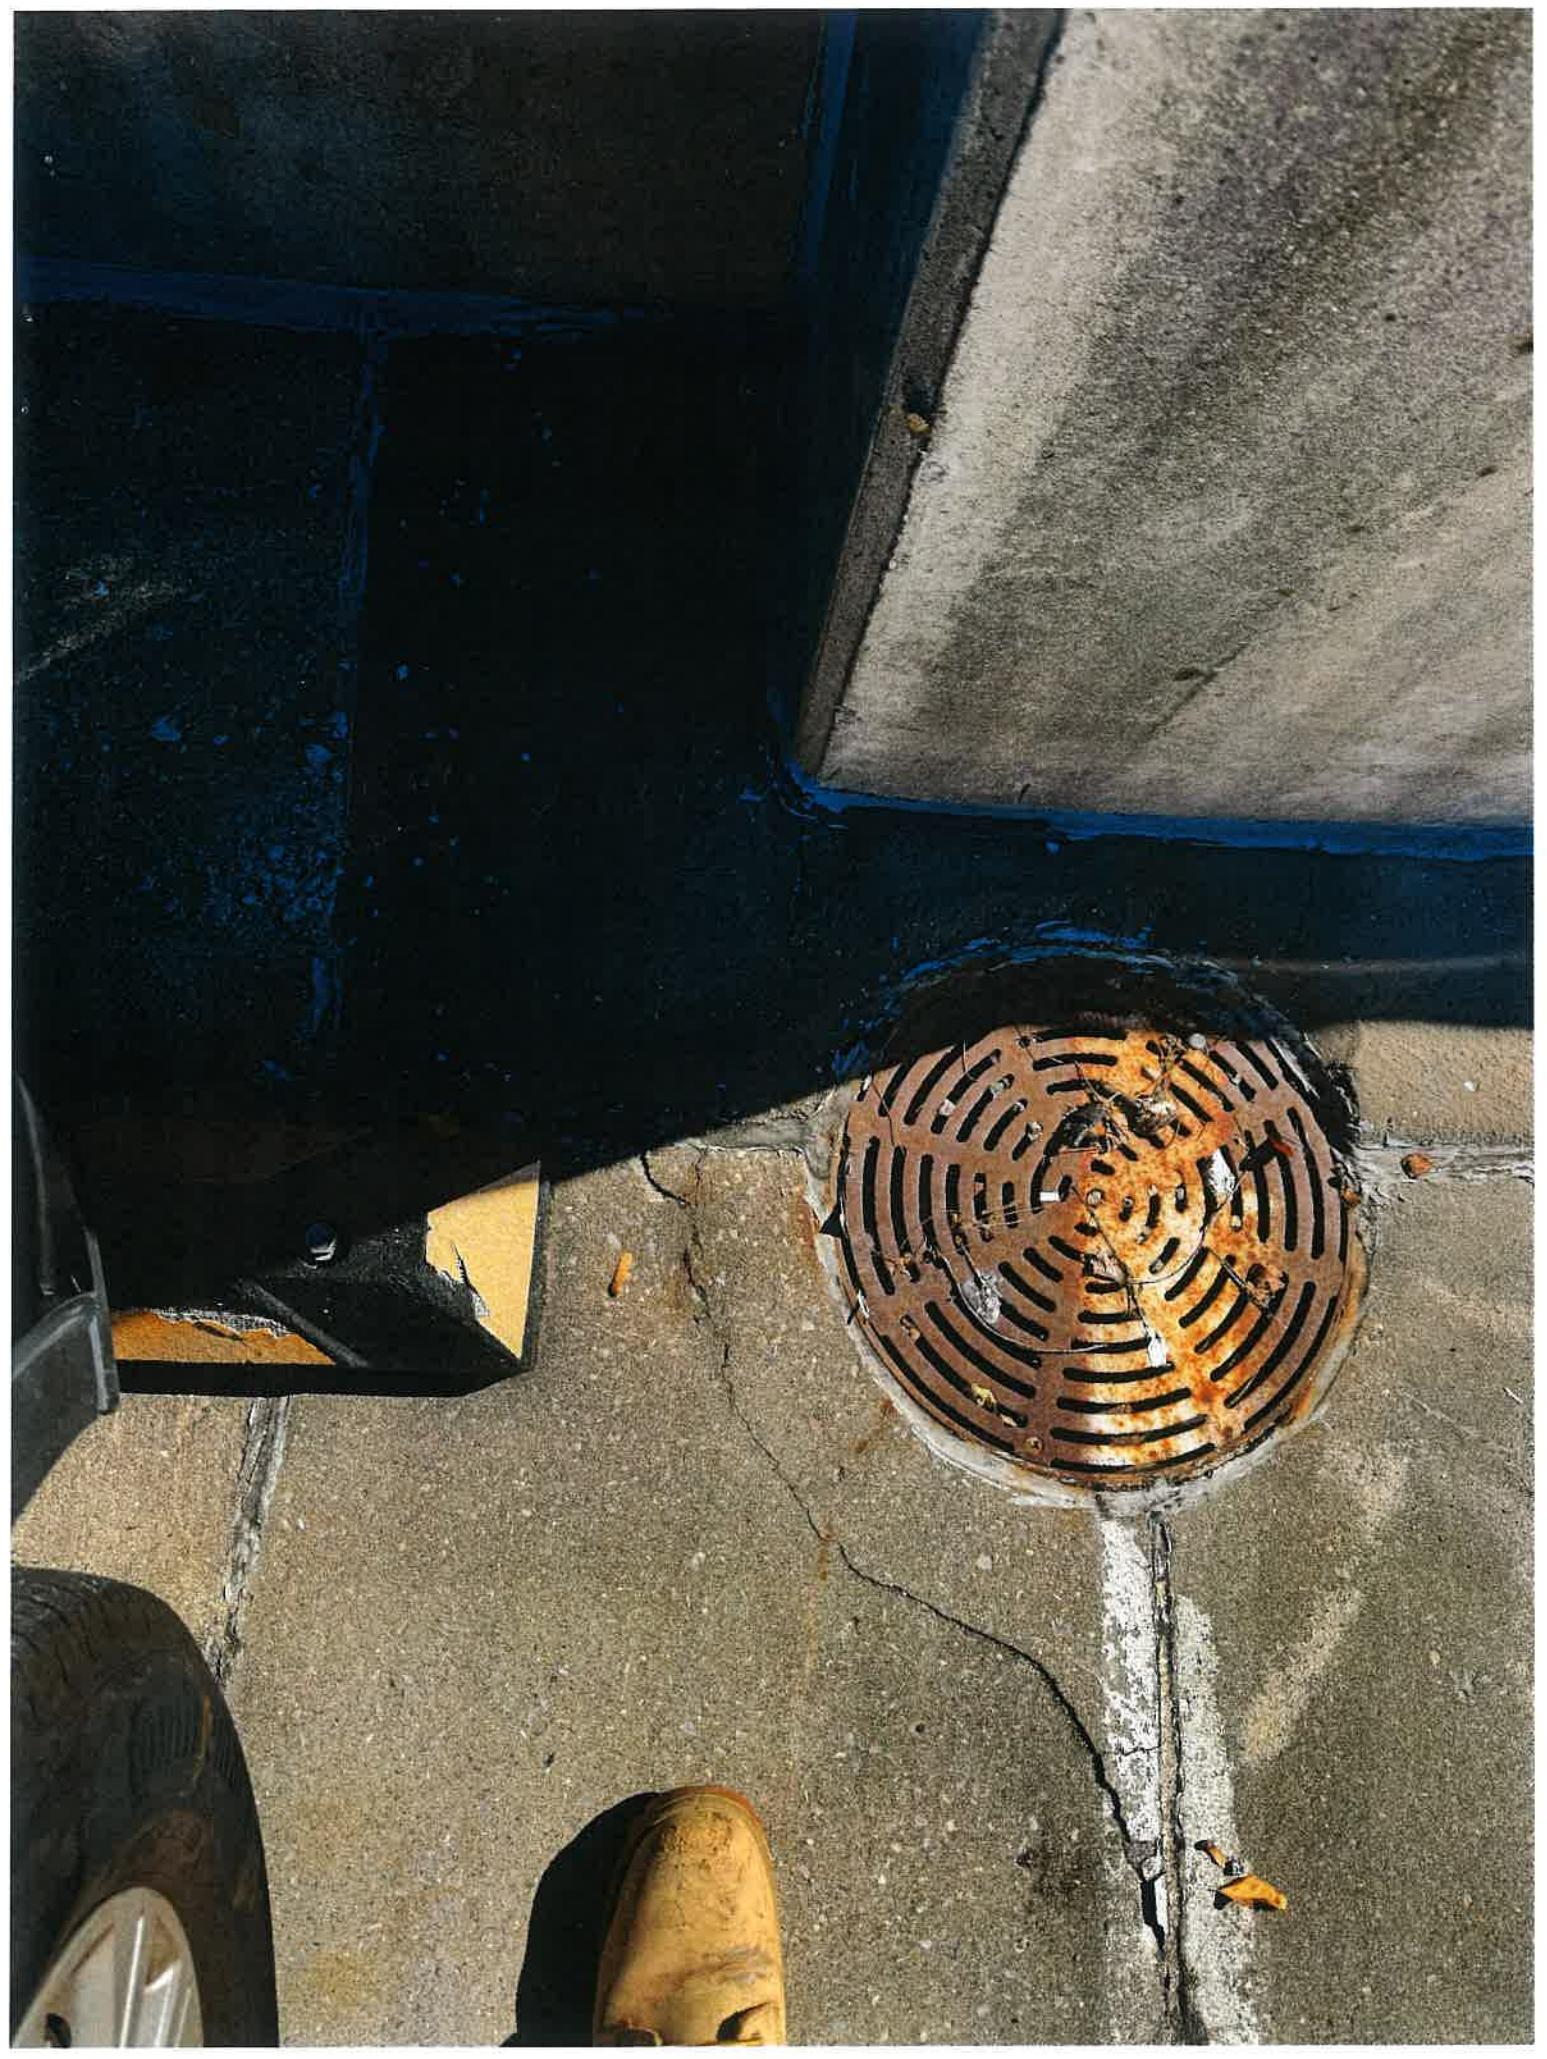
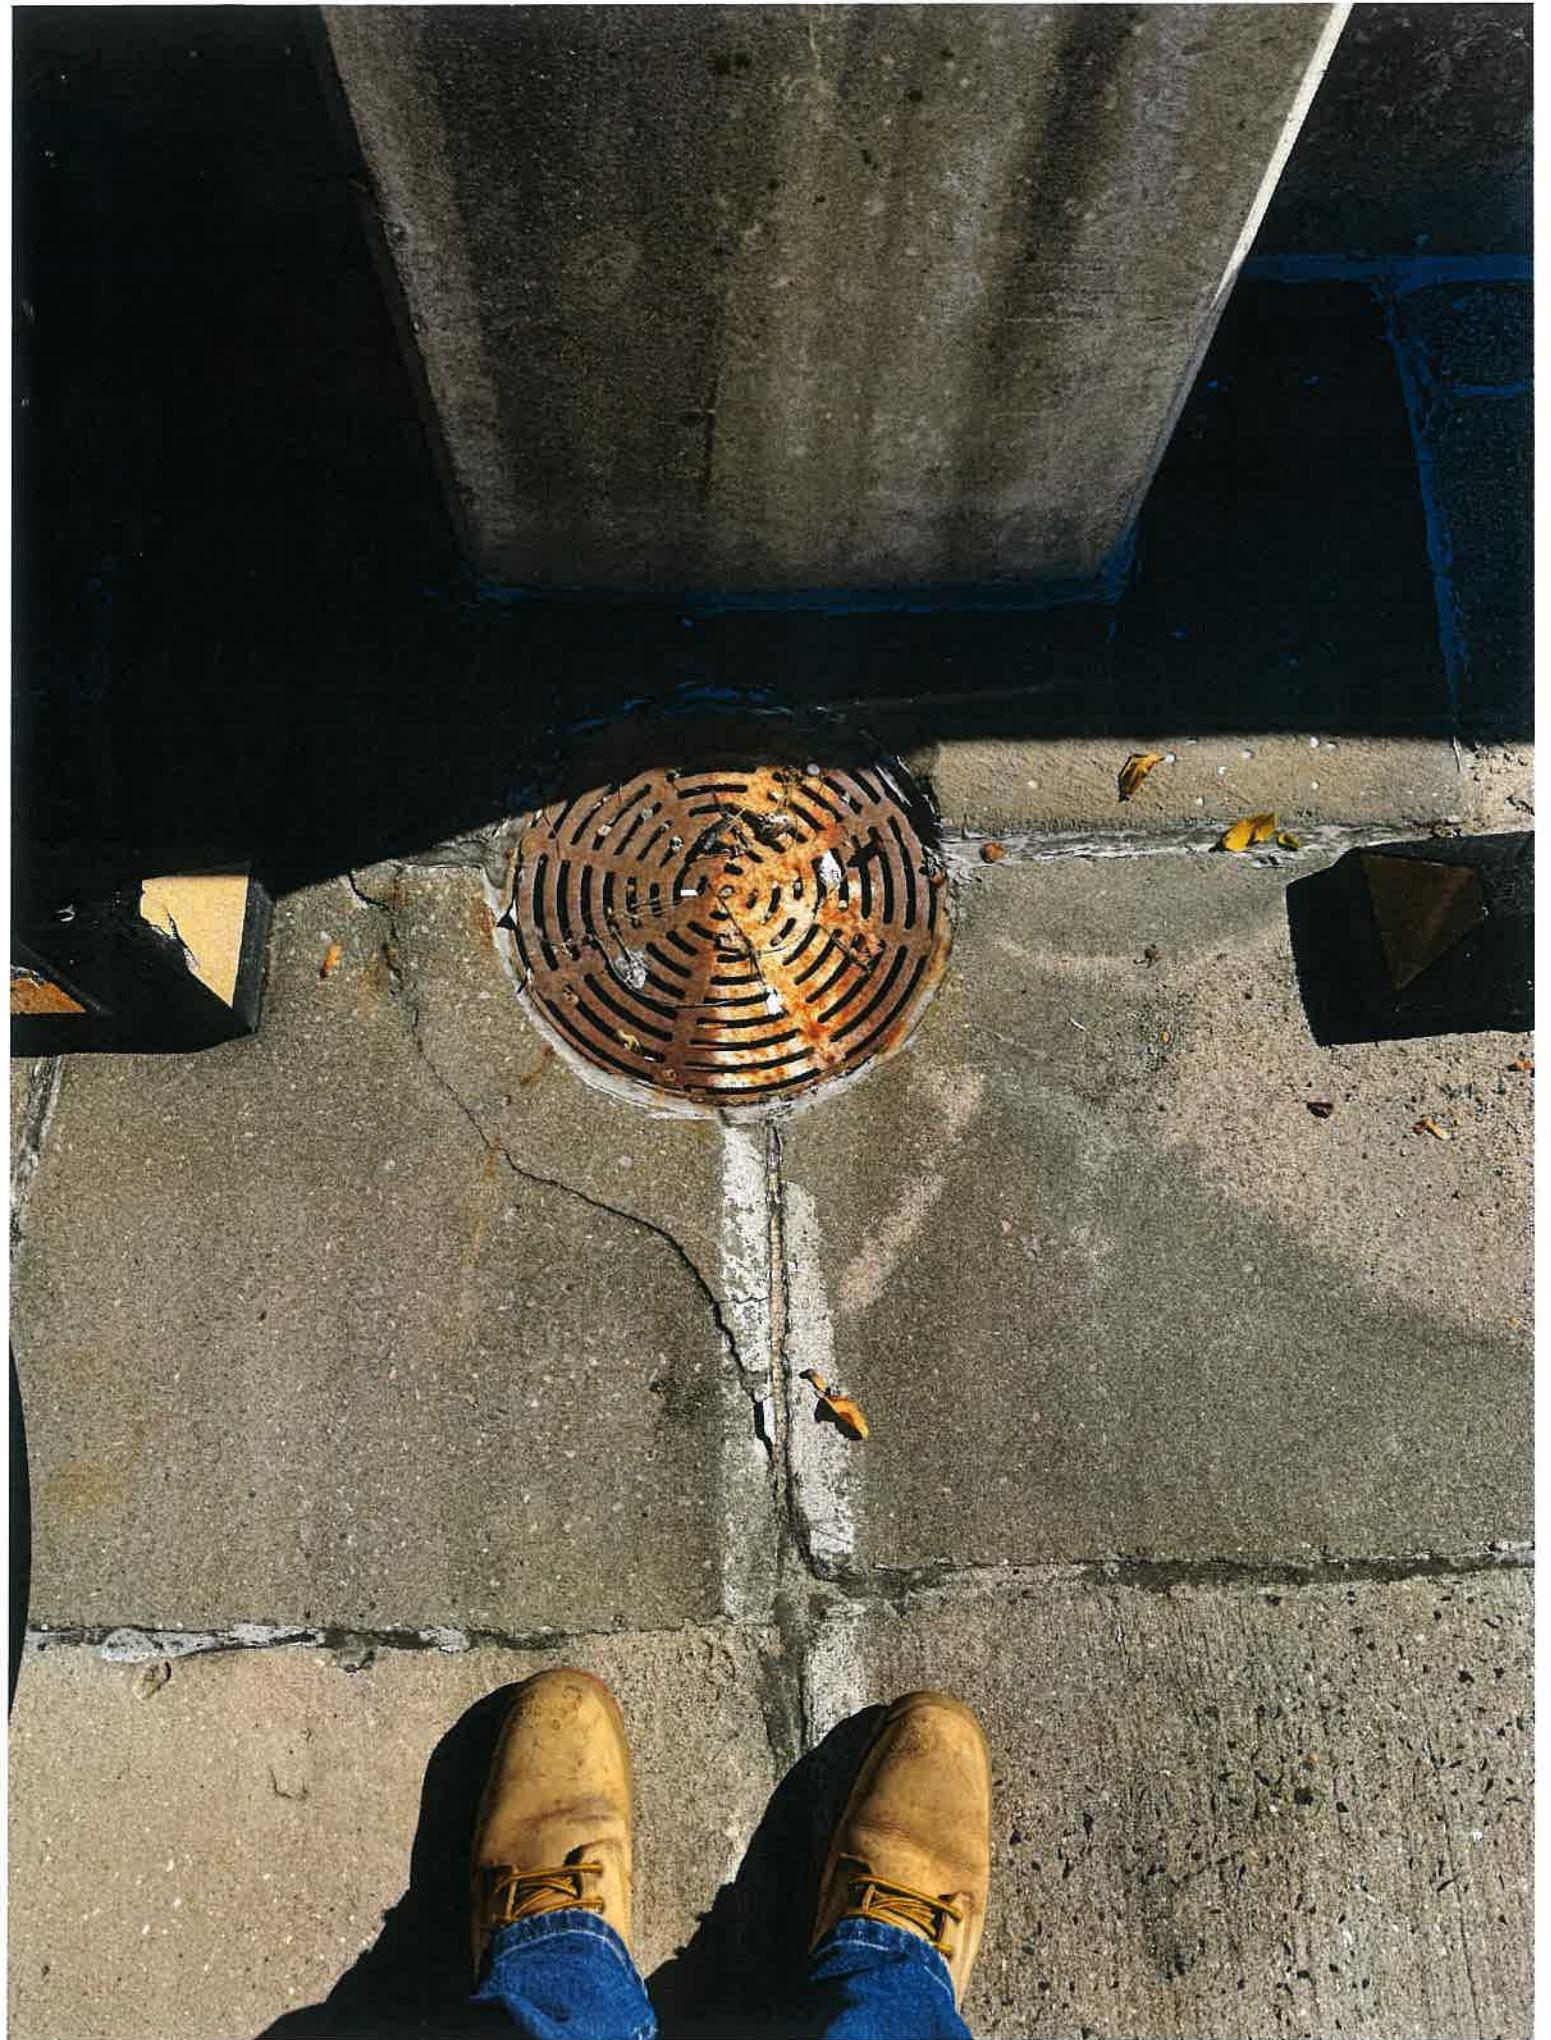
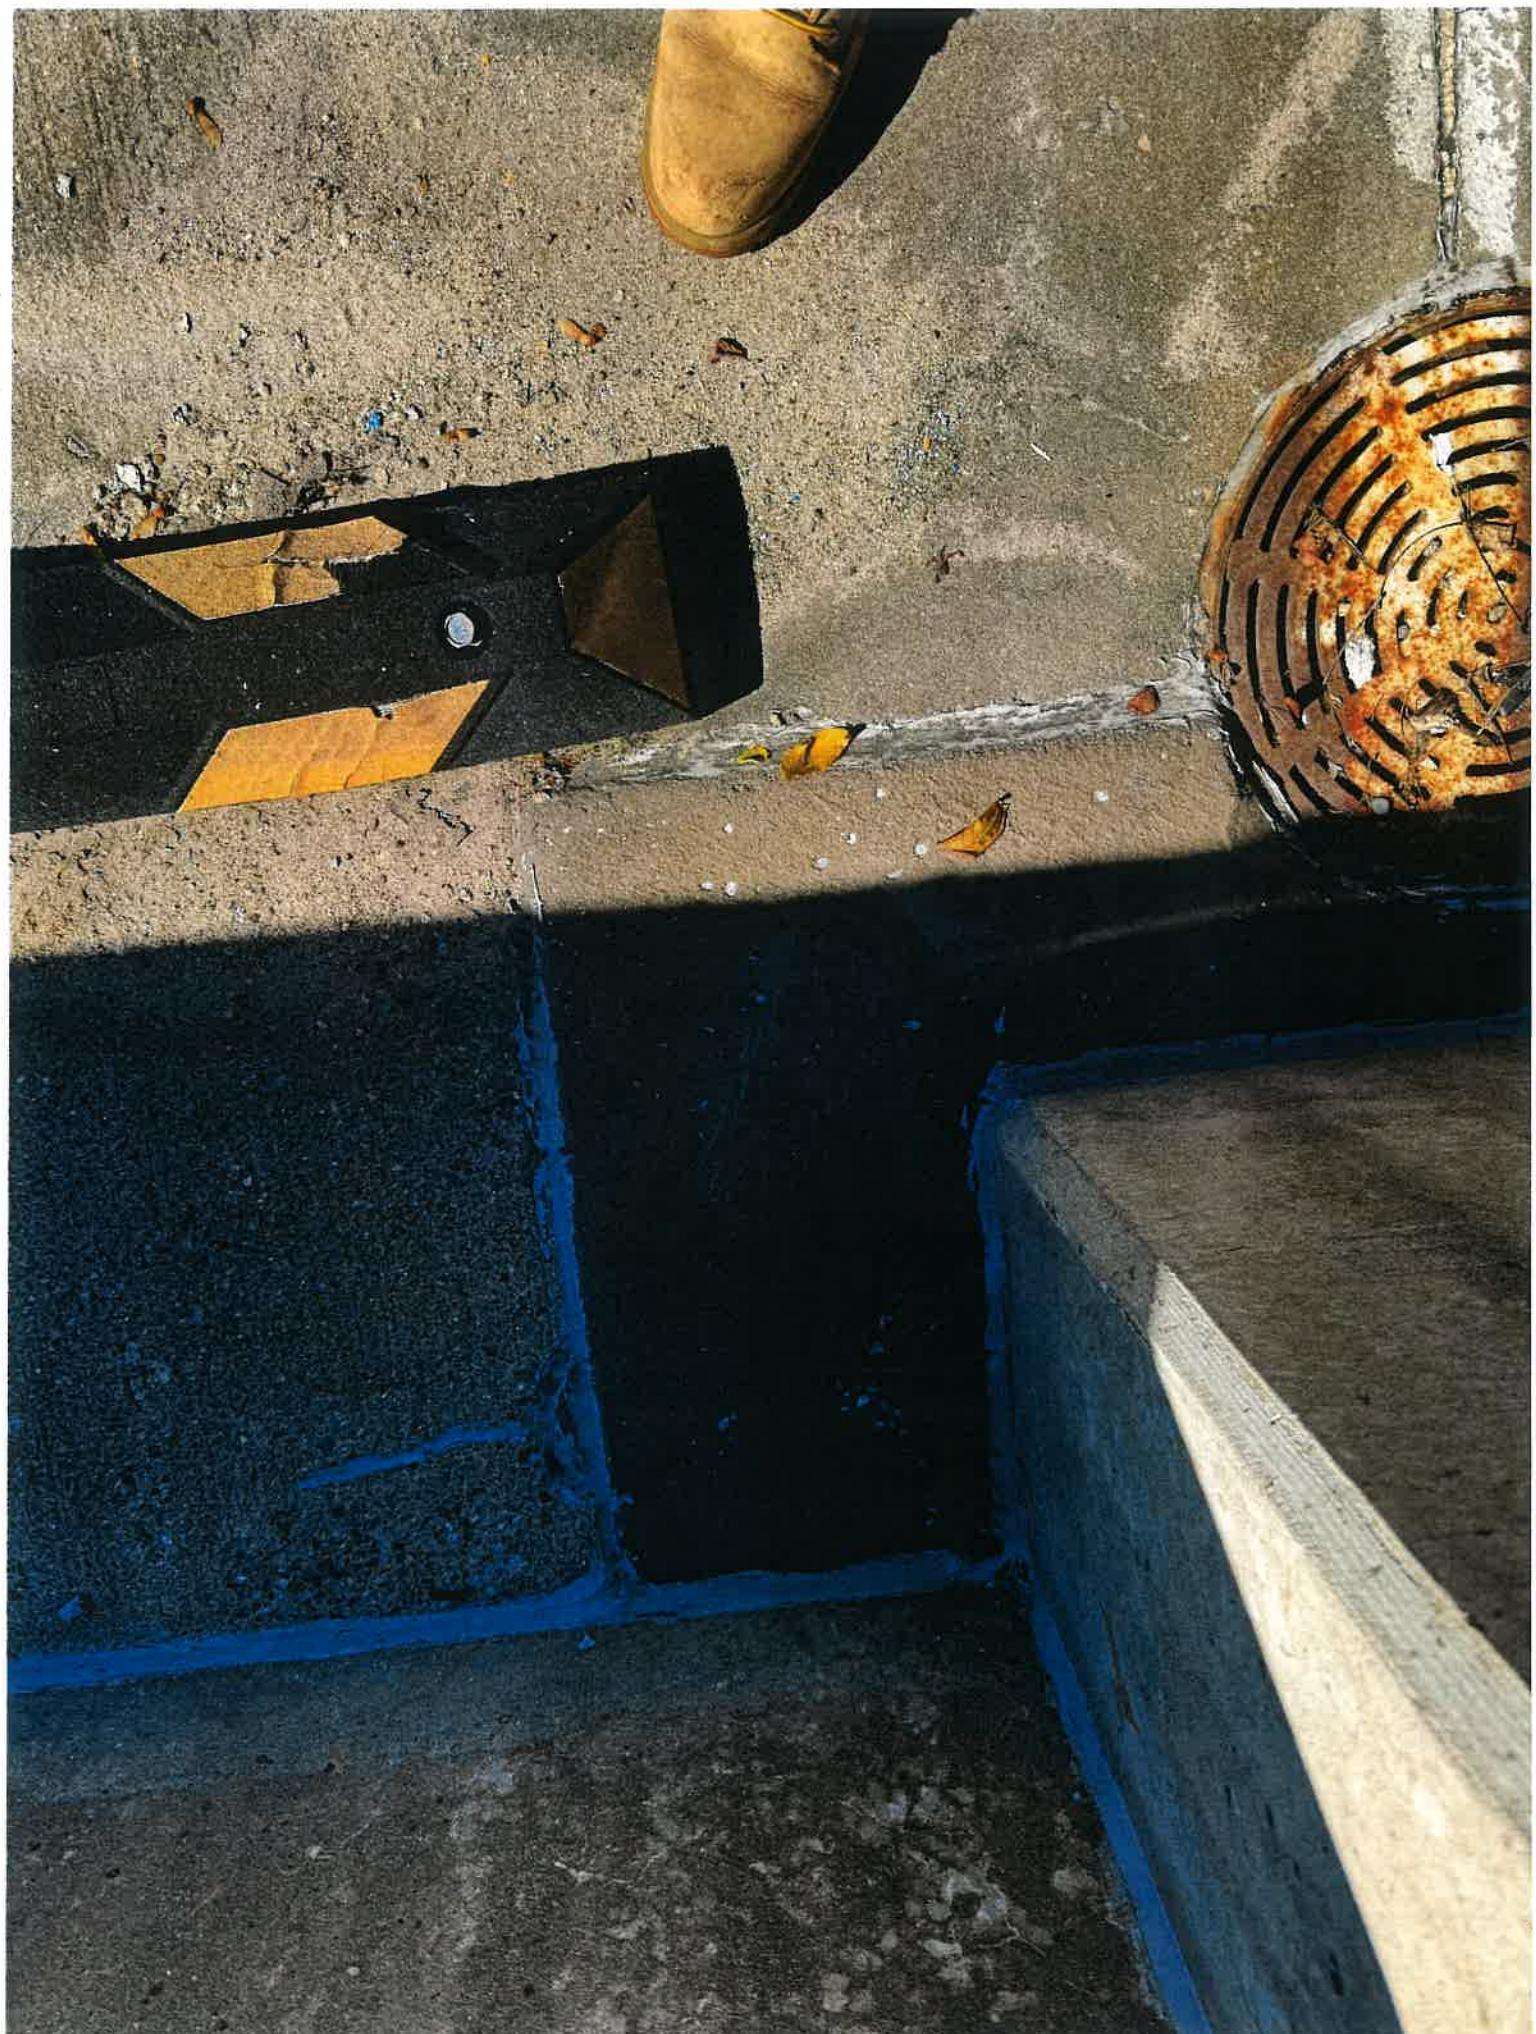
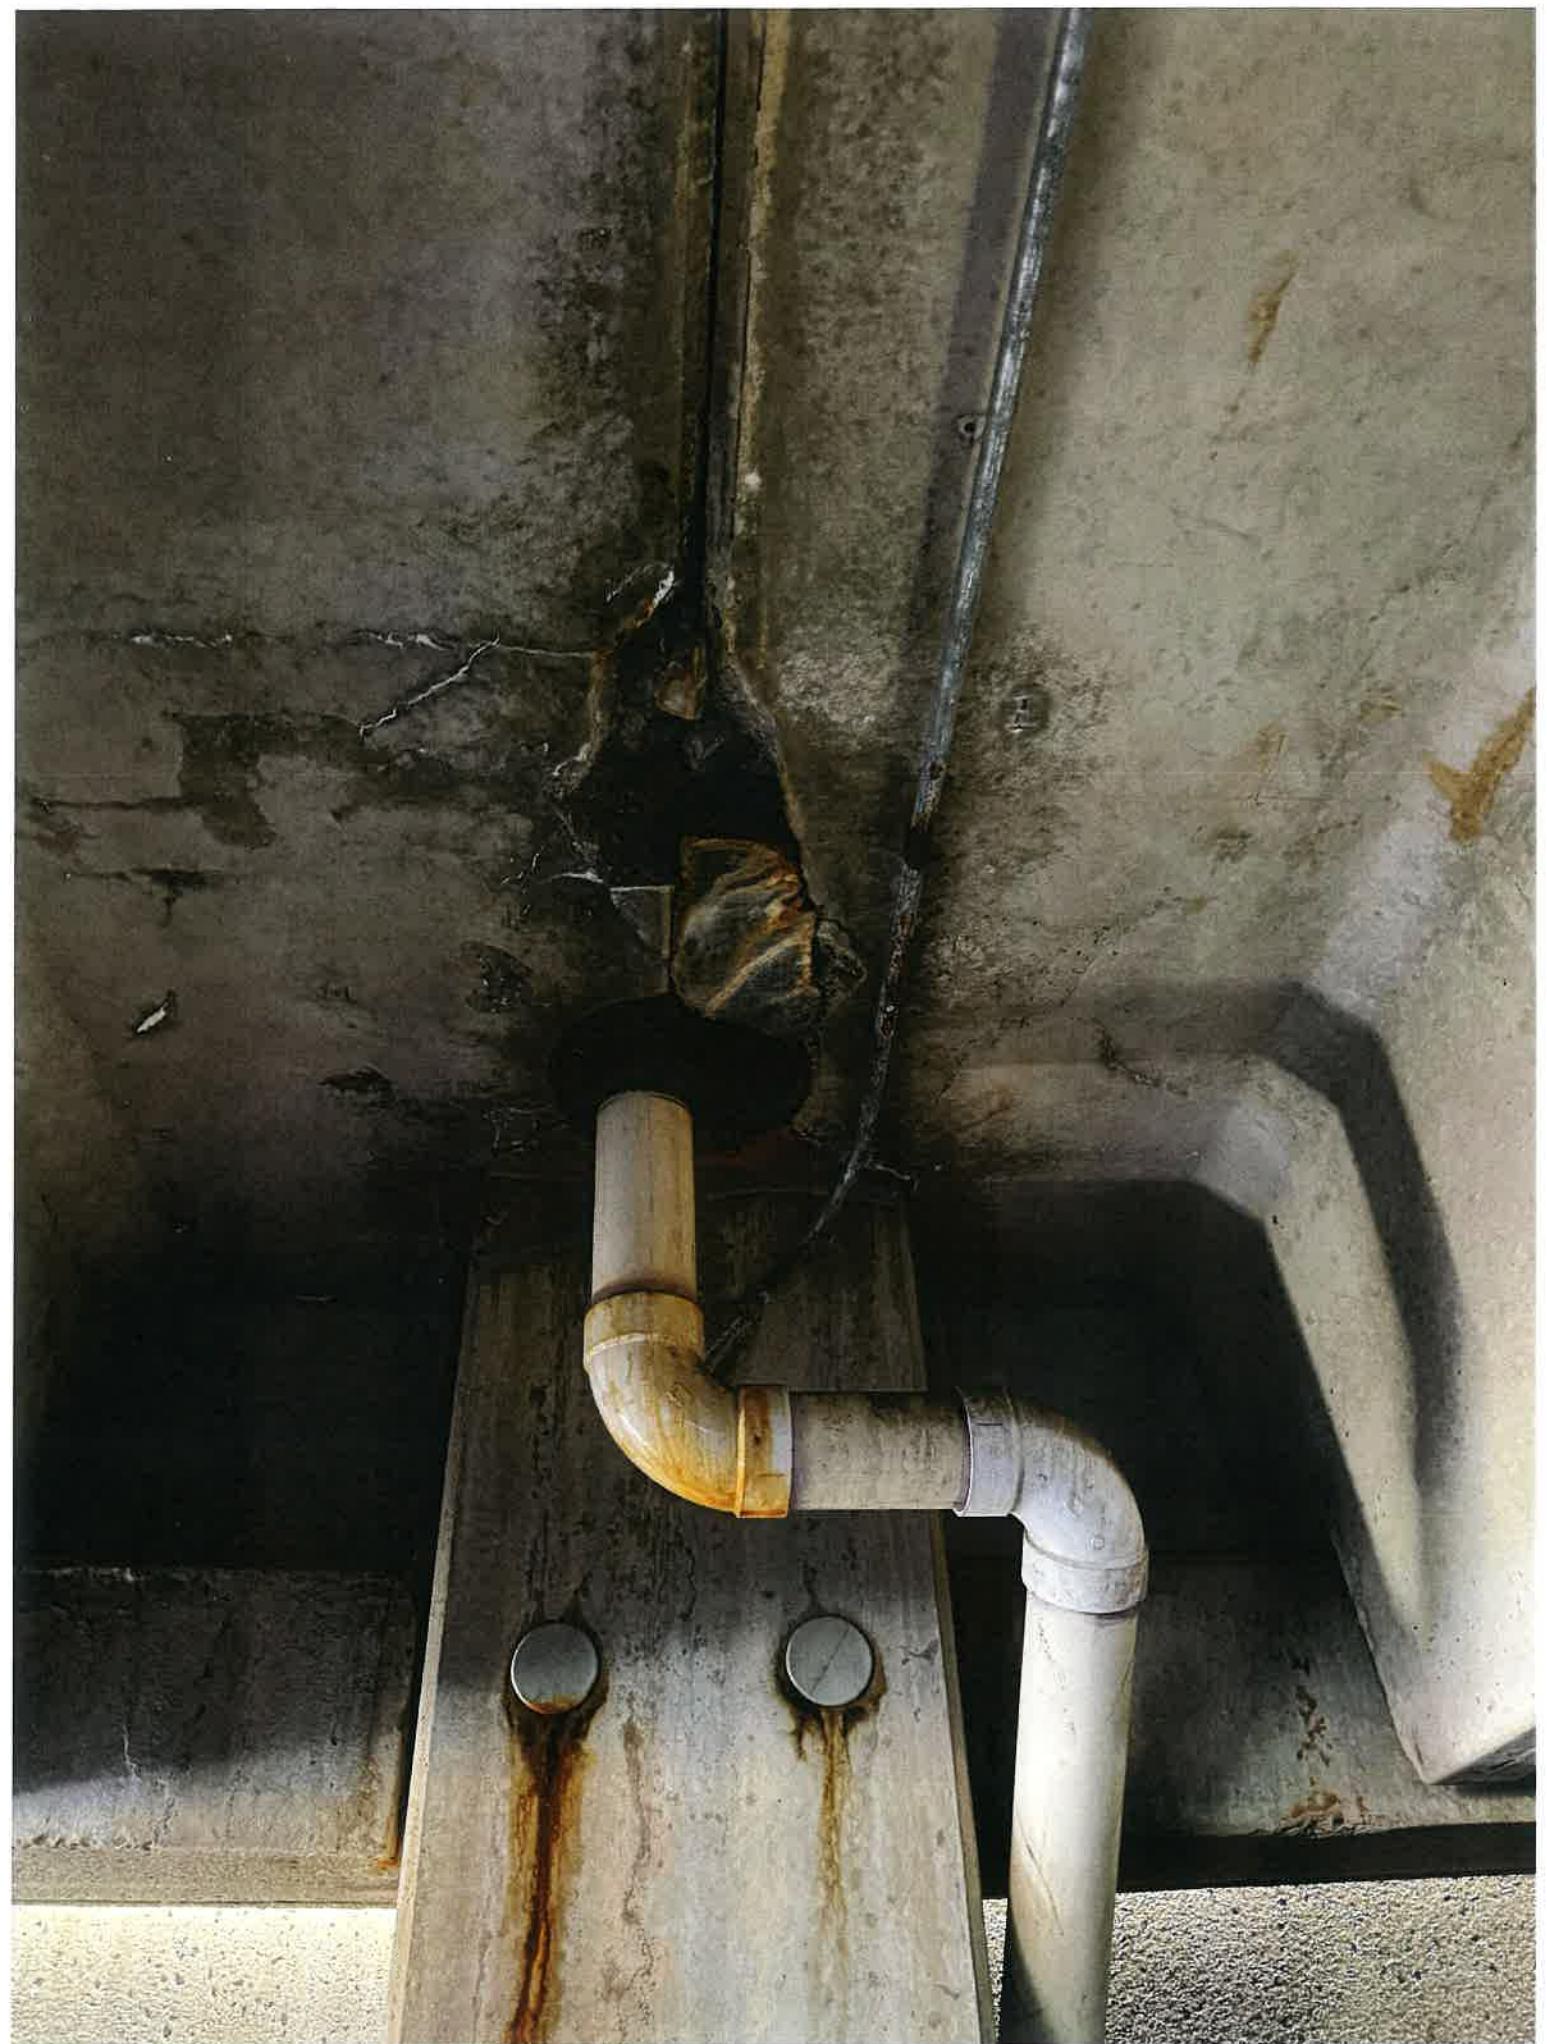
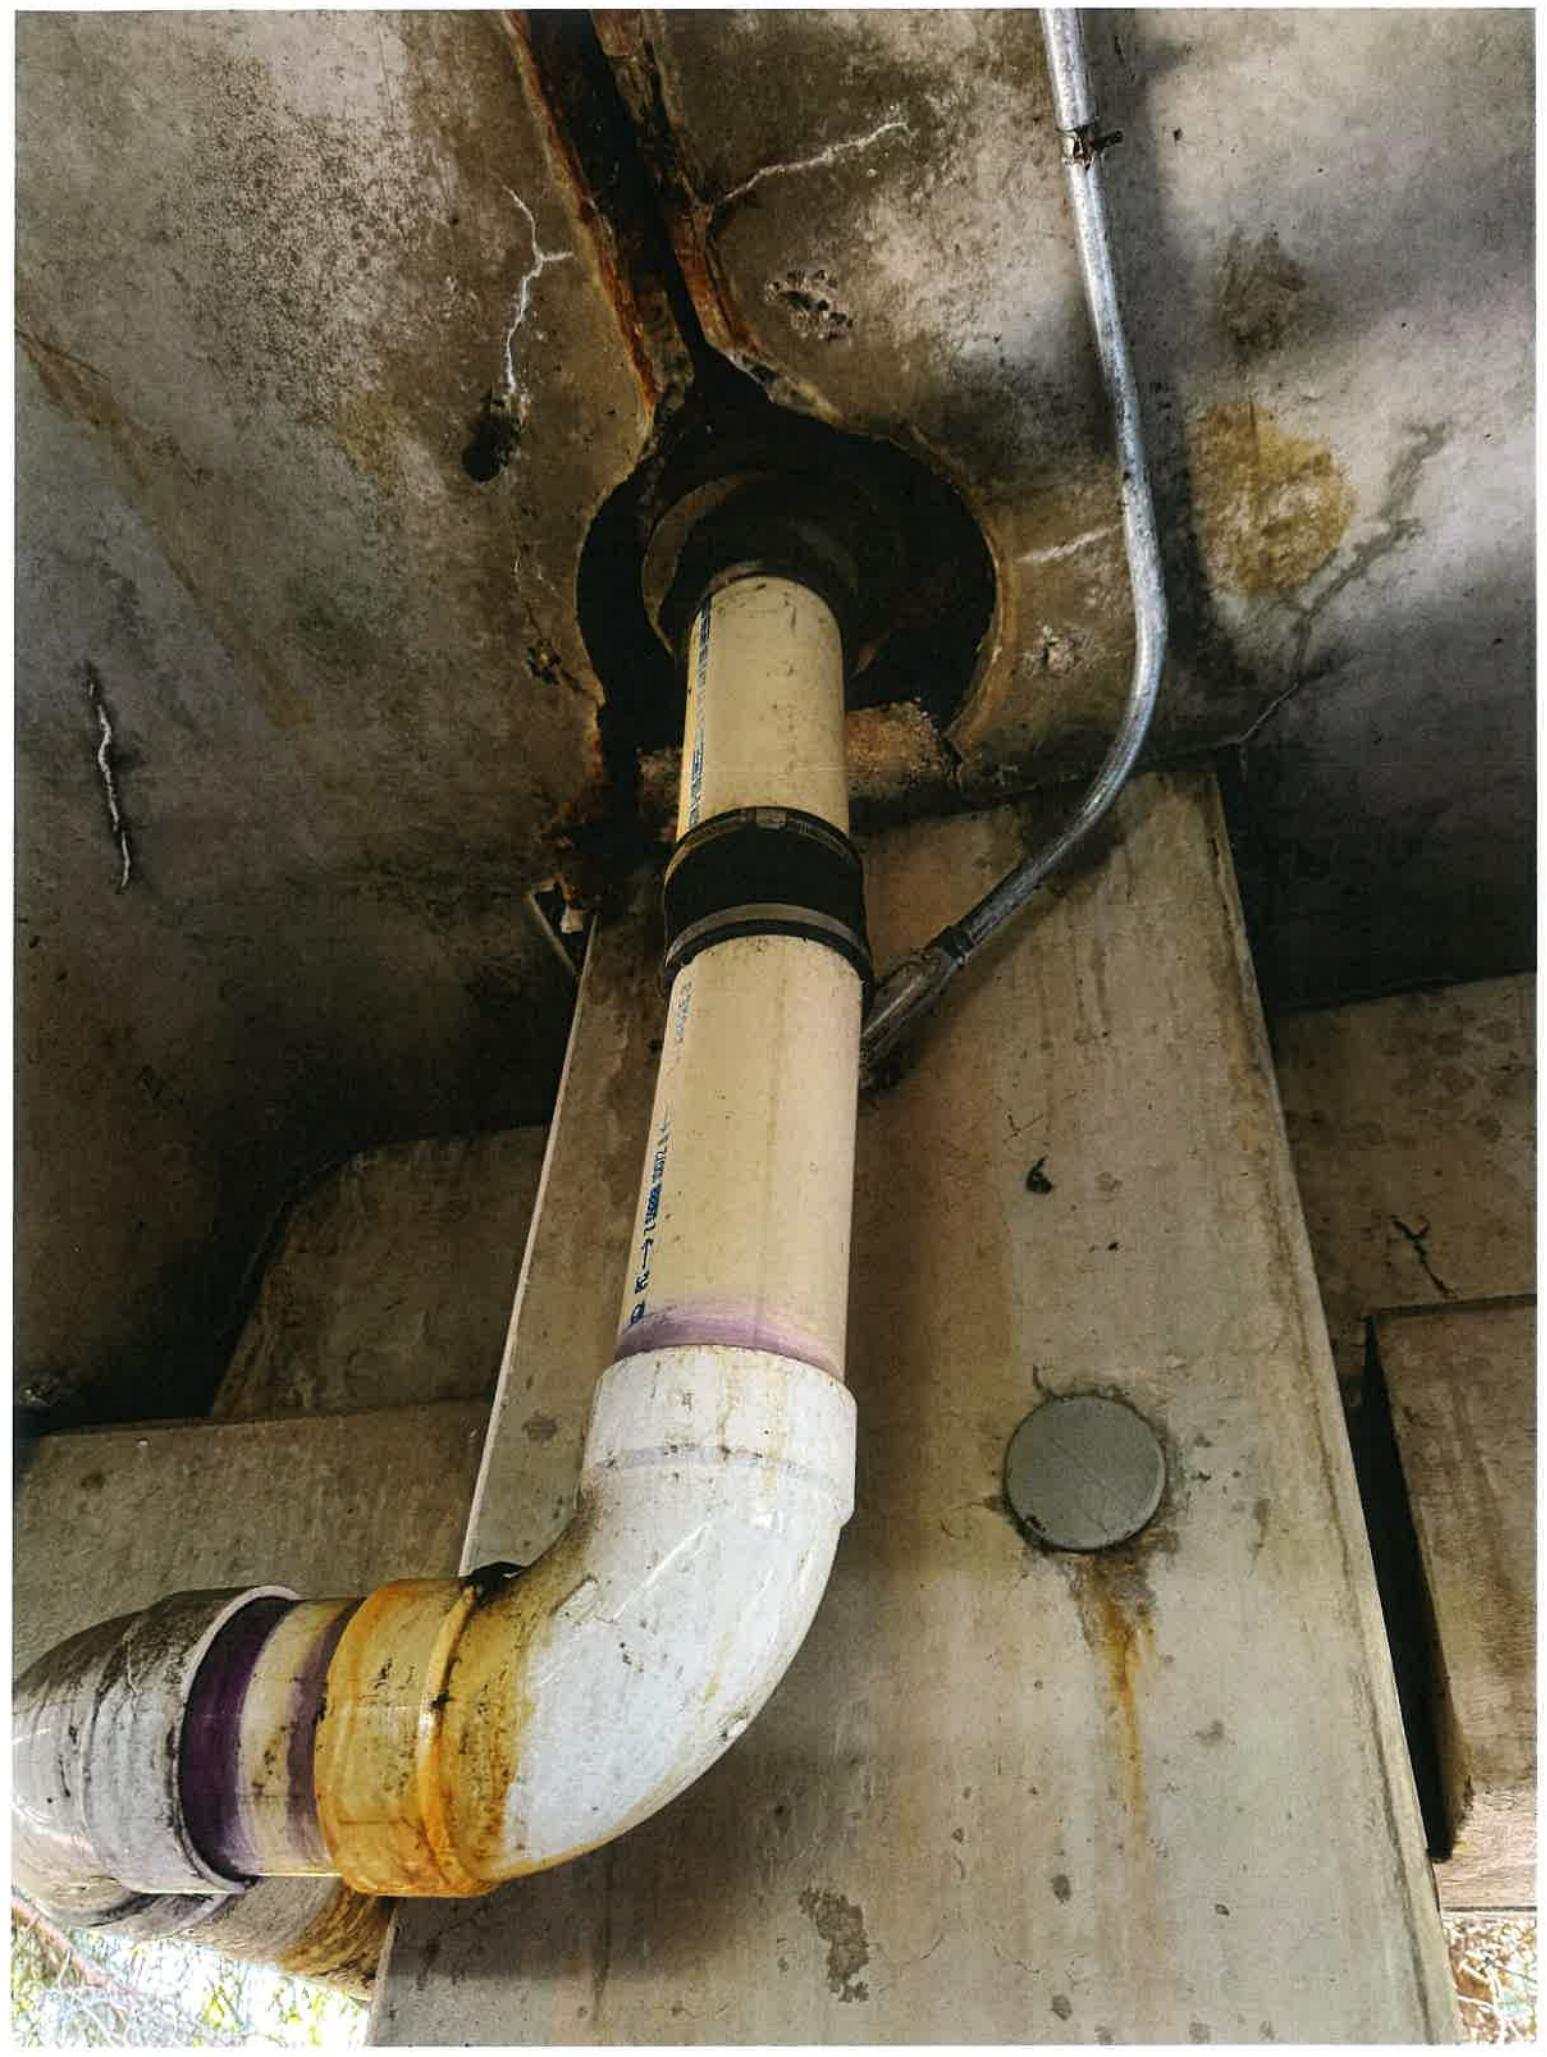
3" CONCRETE PIECE FELL OFF
UNDERNEATH DRAIN + LEFT
STEEL FLATS EXPOSED

20' NEAR EXPANSION JOINT
~~50~~ SF. X $2\frac{1}{2}$ ' EXPANSION JOINT

EACH = 8' x 6' \Rightarrow 384 S.F. TOTAL

- REMOVE EXISTING THROUGH SHEATHING
- REPLACE WITH NEW SHEATHING (ASSUMES SUPPORT BELOW IS STRUCTURALLY SOUND)
