Re: 20 Forest Street, Montclair, N.J.

Thank you for the opportunity to be of service. Please accept the following as our proposal for work at the above referenced project.

Scope of Work: All four elevations of building foundation where existing brownstone & stone veneer is presently. No work on brick masonry areas at front & rear steps/deck.

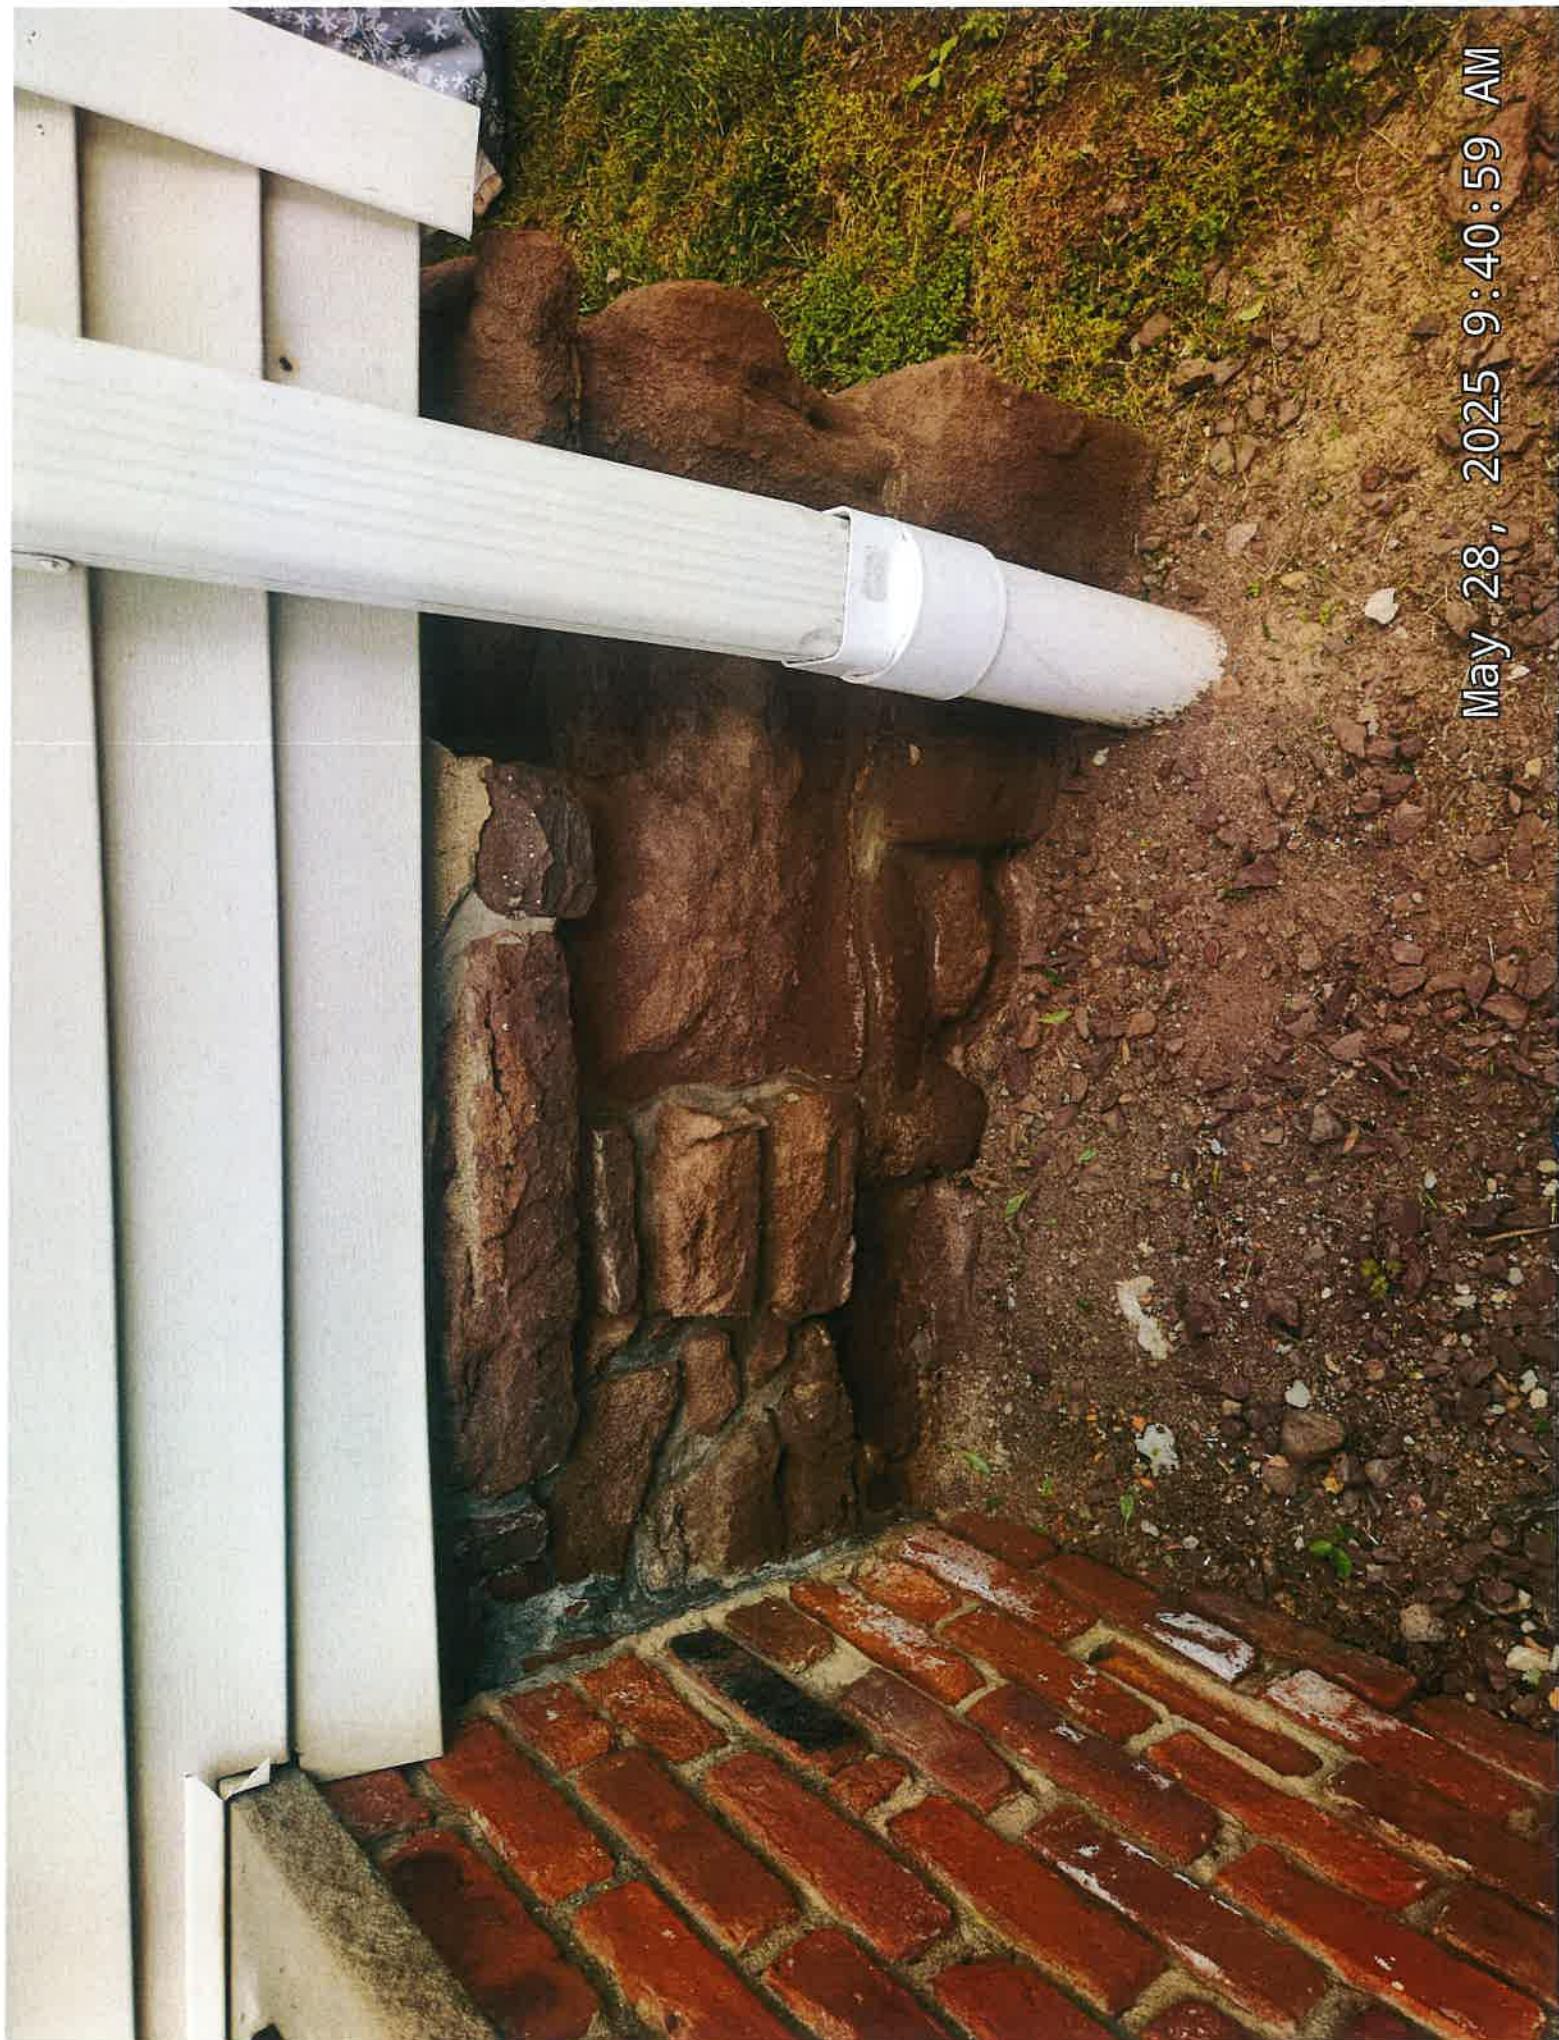
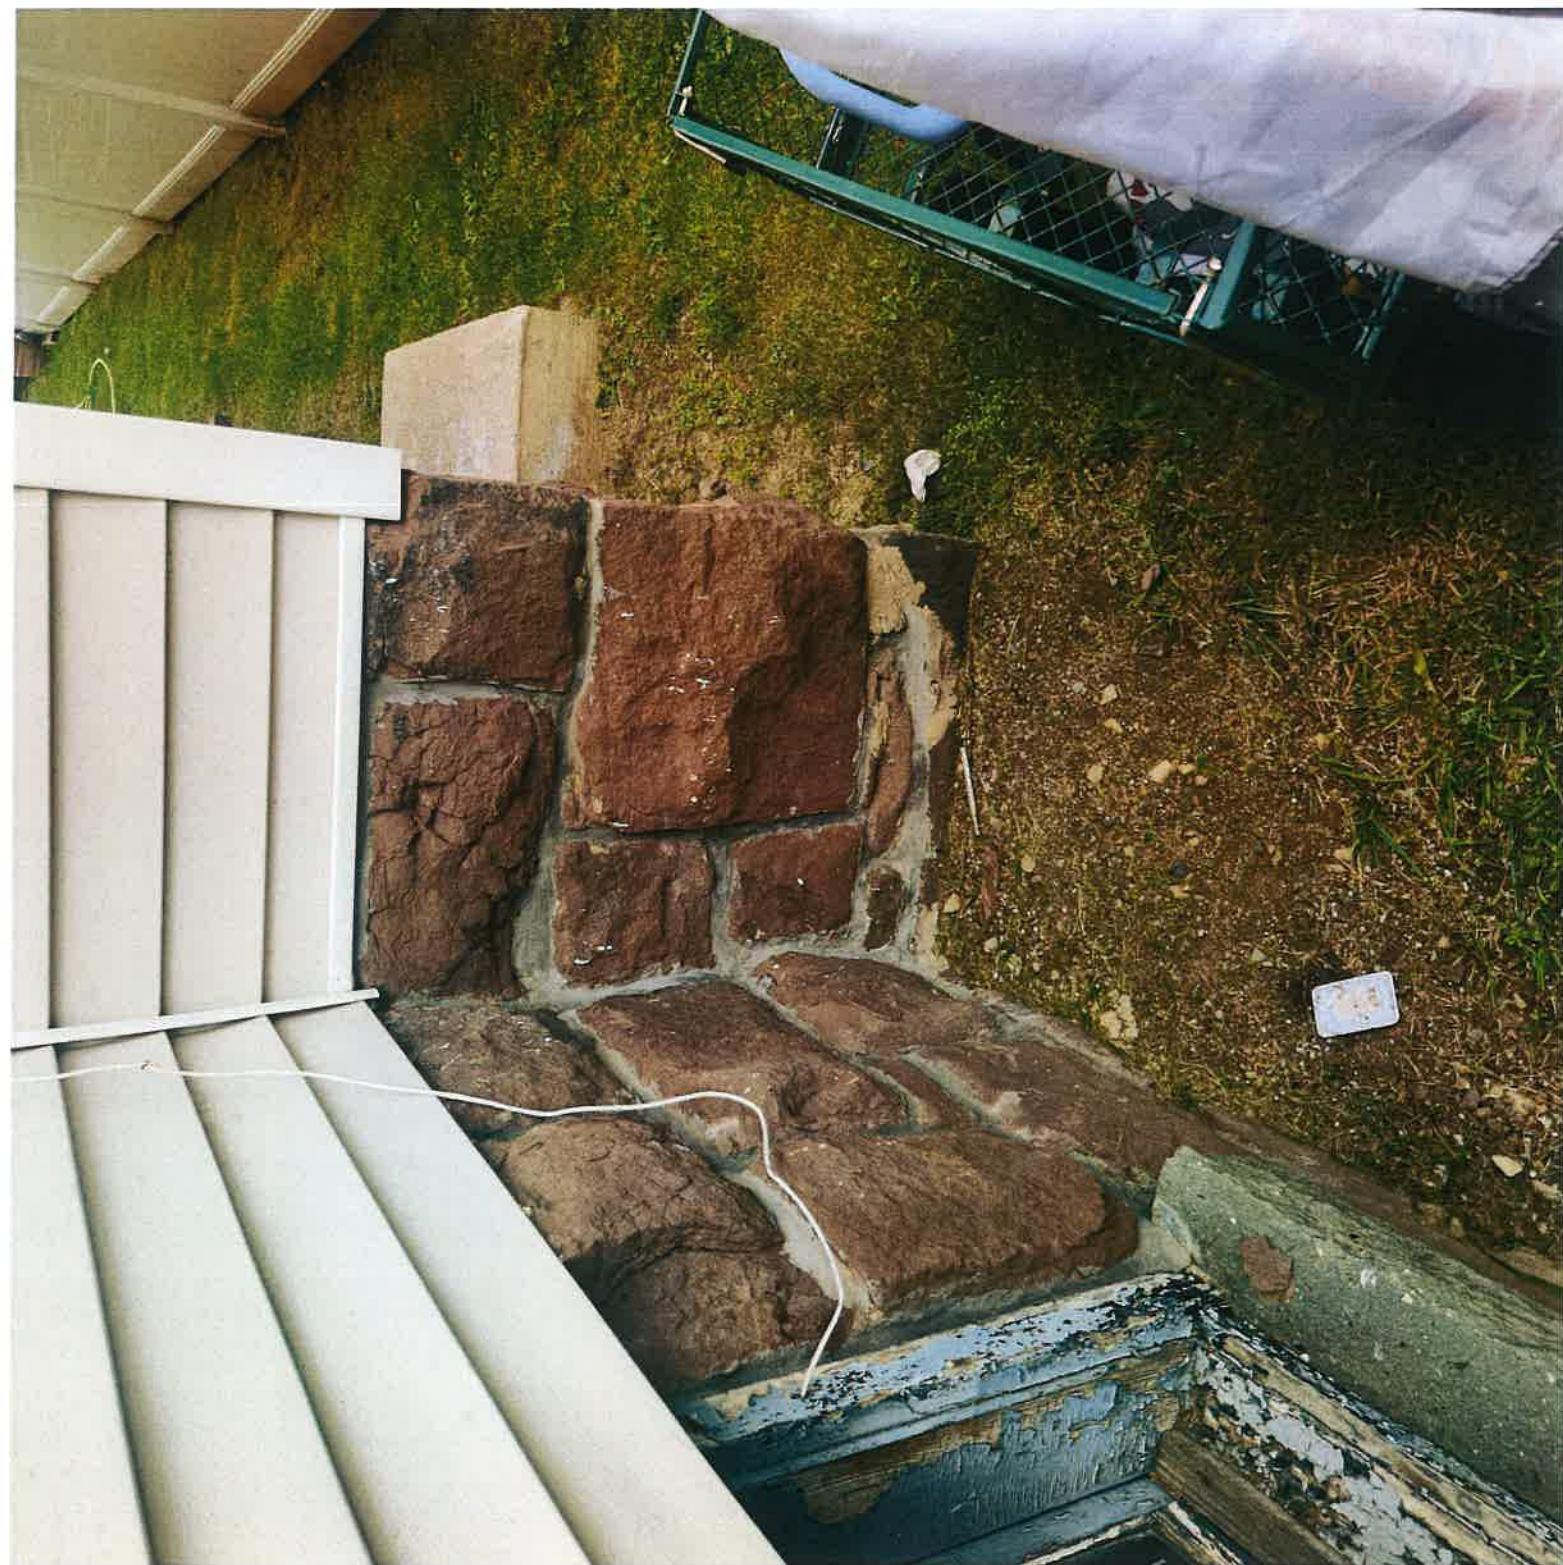
May 28, 2025 9:40:59 AM

Please see the photos in the link below for the sandstone/brownstone foundation that is in need of repair. The stones are disintegrating due to water penetration and freeze/thaw. The association has asked for the repair of the foundation on the right side of the home (fence side). Please provide a proposal for the right side repair and a separate proposal for a full perimeter repair. You will see the damaged areas clearly.

The previous contractor used a type of concrete that was not compatible — it crumbled and cracked the sandstone foundation. (Prior Management Company had this done in 2022). This is on the side of the house that faces 22 Forest street house / white fence. At the end of the driveway, there is a sidewalk needs to be repaired.

- Remove & discard the existing high areas of the existing stone to flatten out the walls as well as possible to install a new stoneface described below.
- Mechanically fasten galvanized steel lath & accessories to the substrate.
- Apply a leveling scratch coat & fill in with additional scratch coat to provide a level surface.
- Apply a mortar color coat & a stoneface color coat in colors to match the original brownstone, or different colors selected by the customer from the color box provided & cut to simulate square cut brownstone.
- Tone the individual stone created to meet the customers desired look.
