CONSTRUCTION COST TO COMPLETE

Summer Meadows

433 Hebron Road
Durham, North Carolina 27704

March 25, 2024

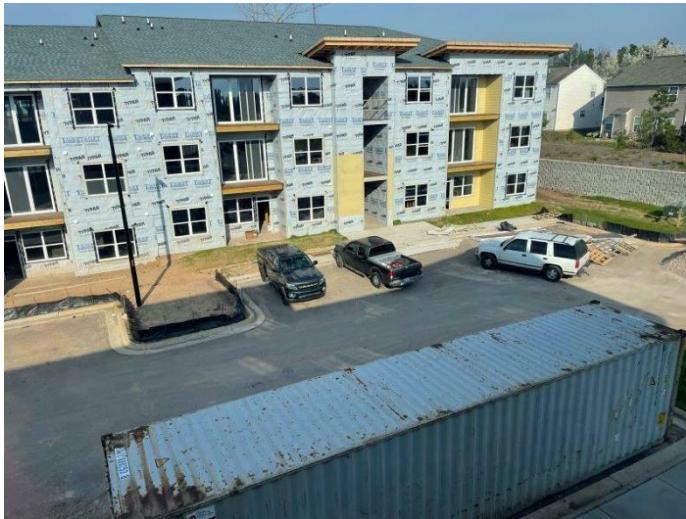
1. Building #1 - East side and northwest corner with siding partially installed over moisture/vapor layer and shingle roof installed.

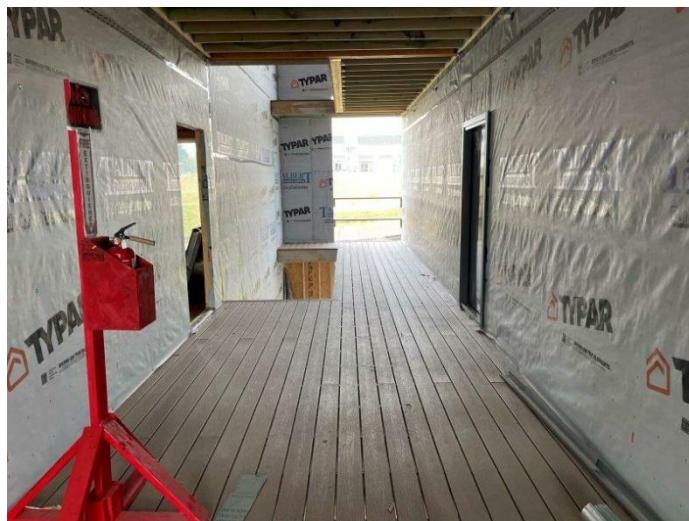
3. Building #1 - Second floor breezeway with siding as yet to be installed in addition to unit access doors and stairs from first to second floor.

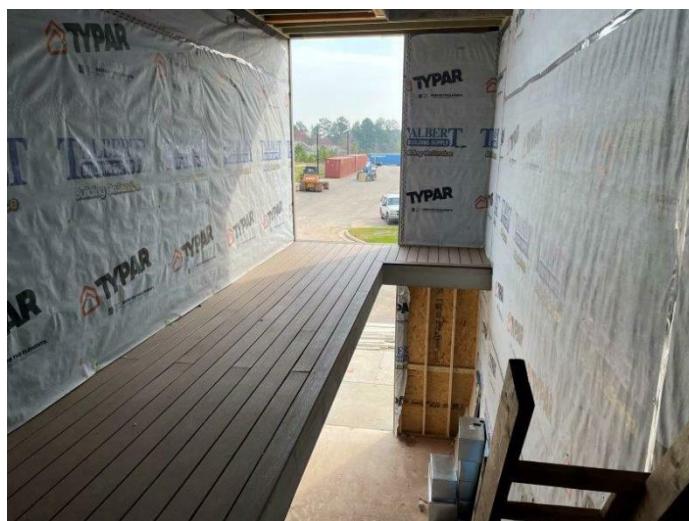
5. Building #1 - Second floor breezeway in northern one-third of structure with moisture/vapor layer and view of north parking lot with no stairs.

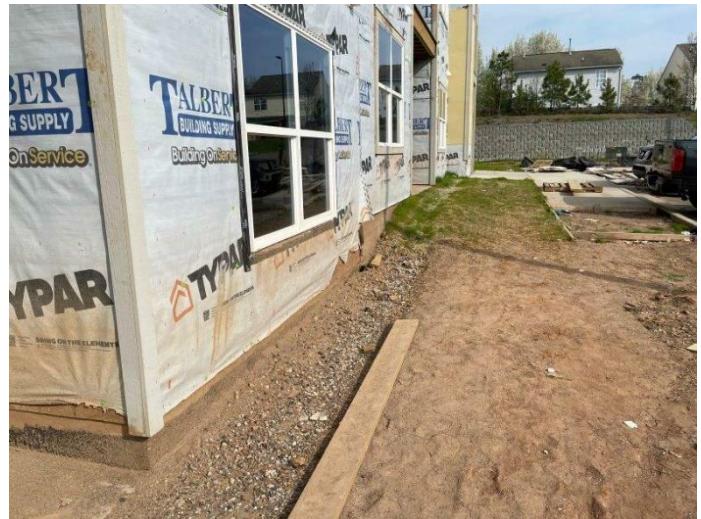
2. Building #1 - West side with windows and corner trim installed and with portion of sidewalk between building and parking lot awaiting installation.

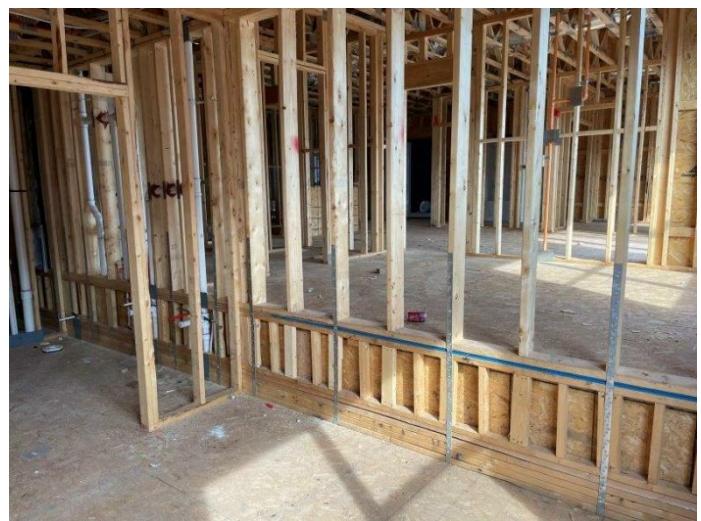
4. Building #1 - Second floor with raised level in background at north end of building and some plumbing, fire suppression and HVAC lines.

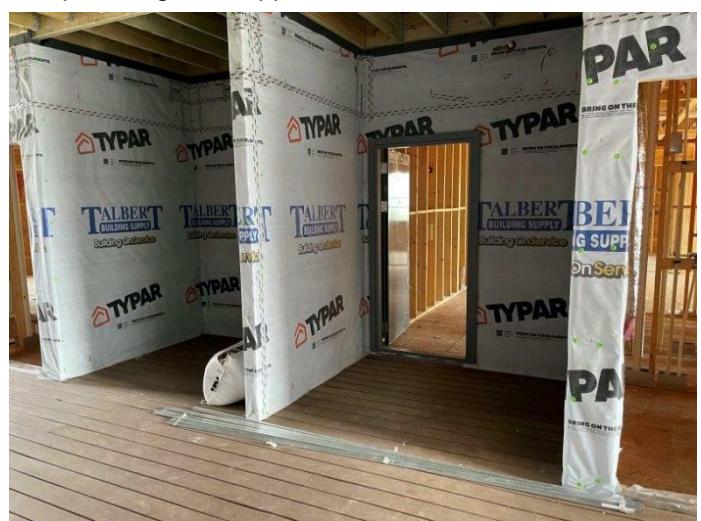
6. Building #1 - Residential unit entry with door frame and unfinished frontage of future storage closet off of second floor breezeway.

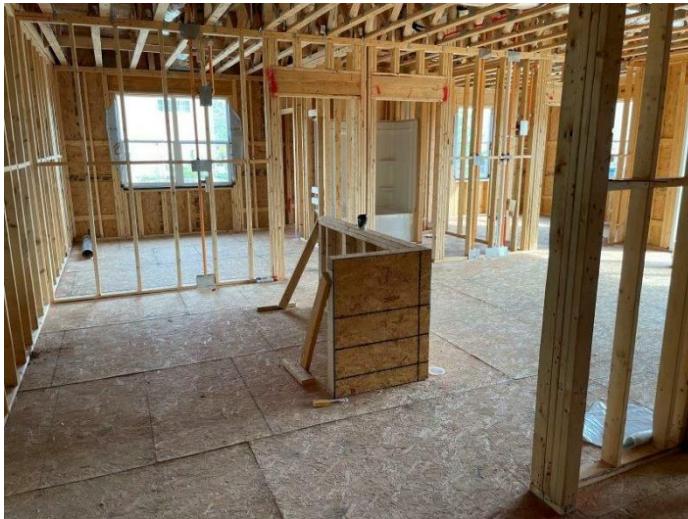
7. Building #1 - Second floor unit with framing installed along with fire suppression system lines, shower/tub insert and some overhead HVAC duct.

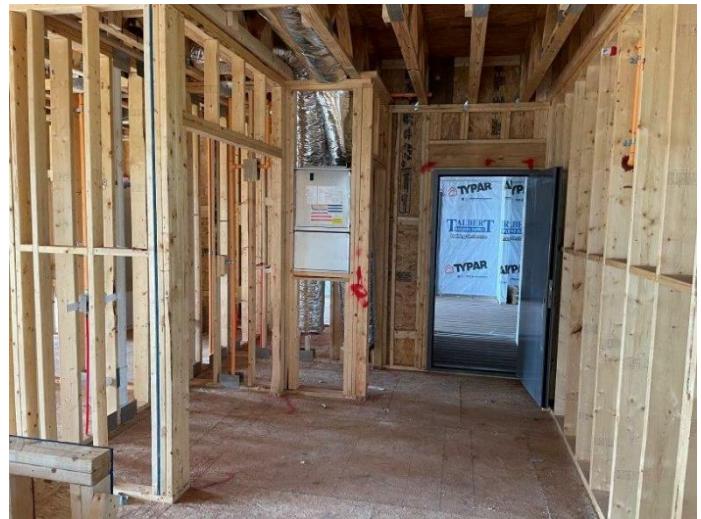
8. Building #1 - Second floor entry with installed interior air handling unit along with HVAC duct, fire suppression lines and some water lines.

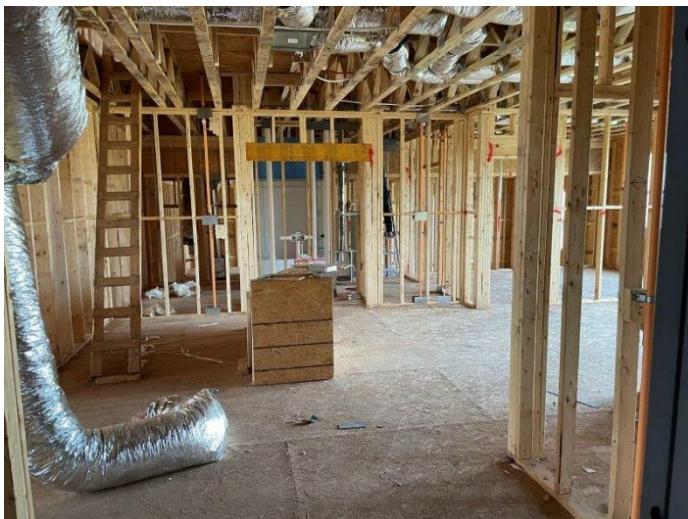
9. Building #1 - Second floor unit with duct in process of installation and installed shower/tub insert and plumbing/water/fire suppression lines.

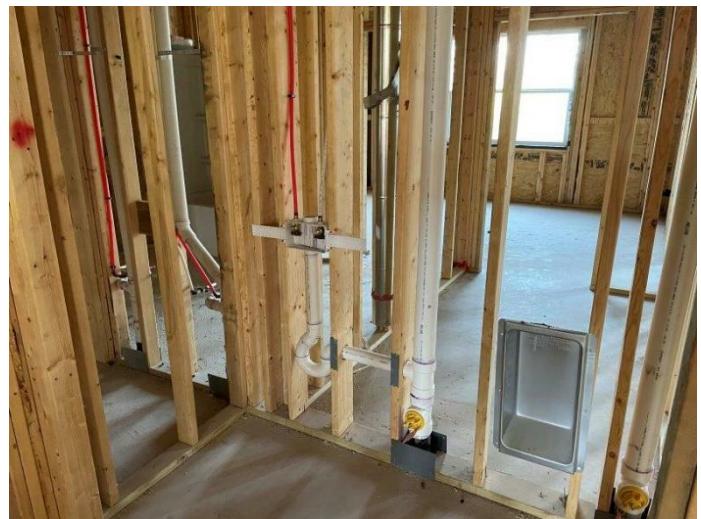
10. Building #1 - First floor unit with installed plumbing lines/water hook-ups for laundry facilities and start of dryer ventilation system install.

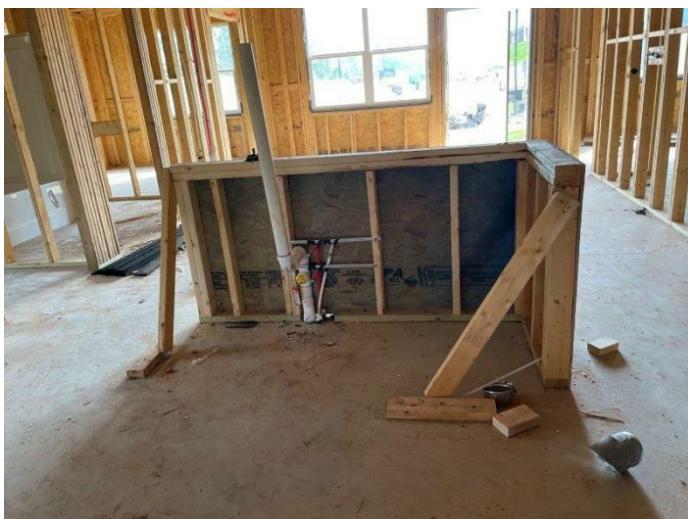
11. Building #1 - Future kitchen counter area of first floor unit with drain lines and water lines initially installed in "island" framing.

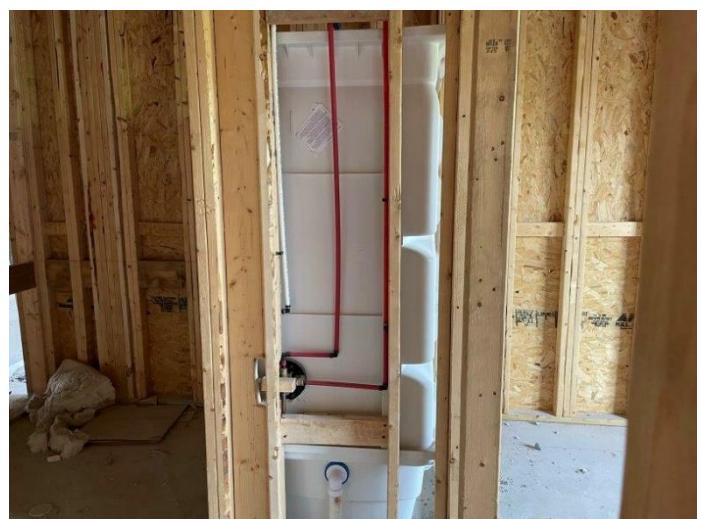
12. Building #1 - Back side view of shower/tub insert in future bathroom area of first floor unit with water and drain lines connected.

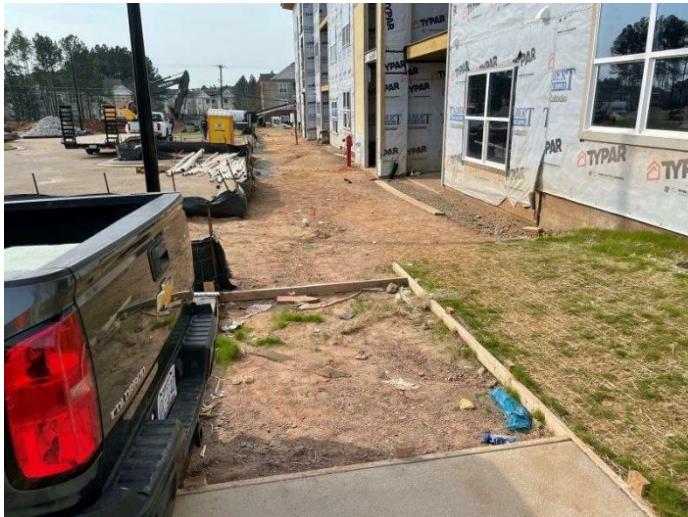
13. Building #1 - East side of building adjacent to parking lot with concrete sidewalk and walkway accessing building yet to be installed.

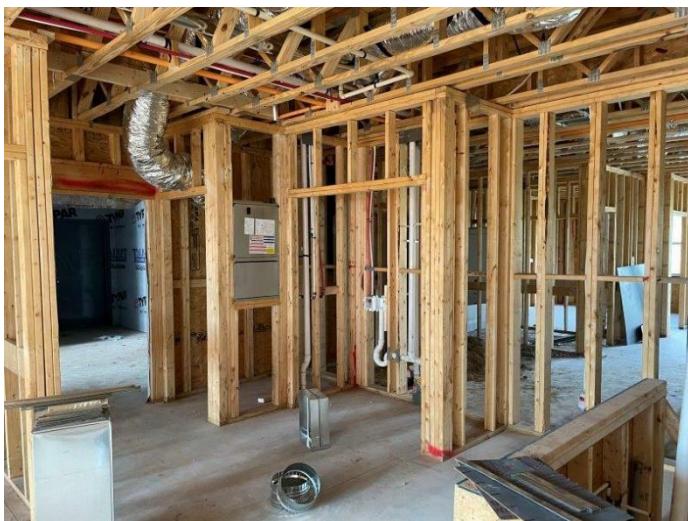
15. Building #1 - First floor unit with installed interior air handling unit along with HVAC duct, fire suppression/ drain lines and some water lines.

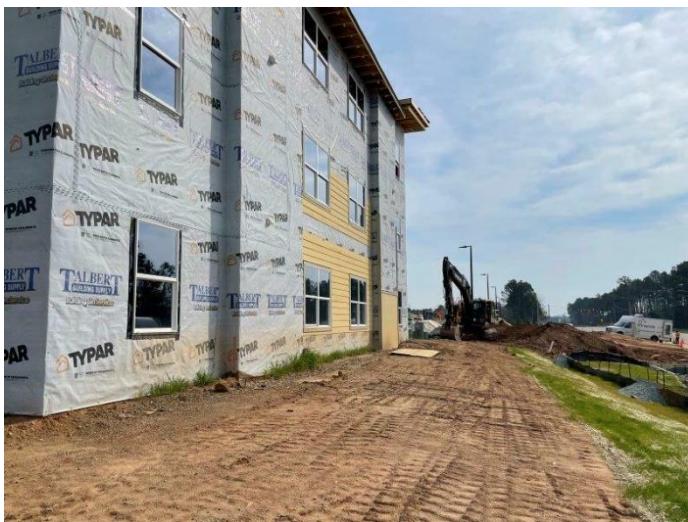
17. Building #1 - South exterior view as seen from southwest corner while facing east with some installed siding and empty meter panel.

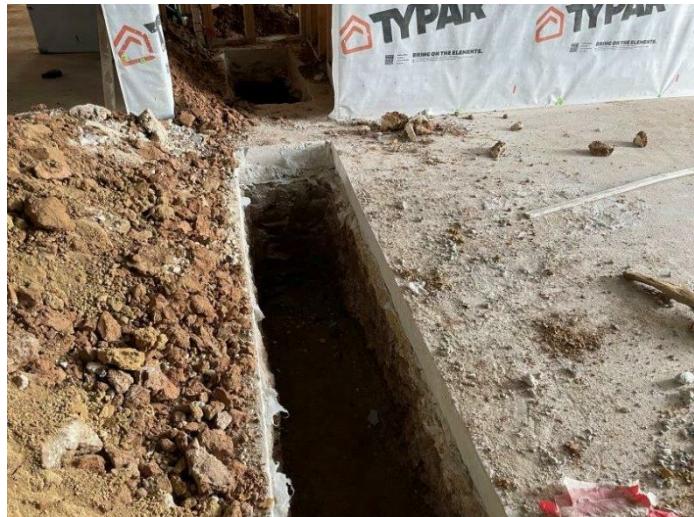
14. Building #1 - Excavation work within section of first floor breezeway/chase where foundational concrete has been removed for utility line.

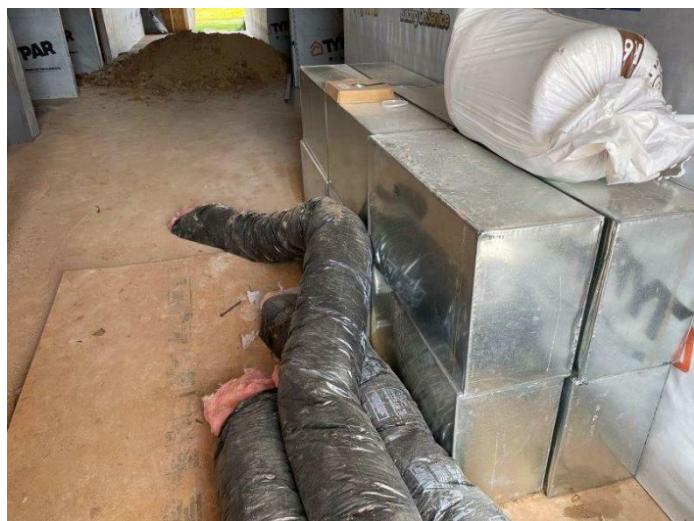
16. Building #1 - HVAC equipment and duct worked staged for unit installation at the entry to a first-floor breezeway of structure.

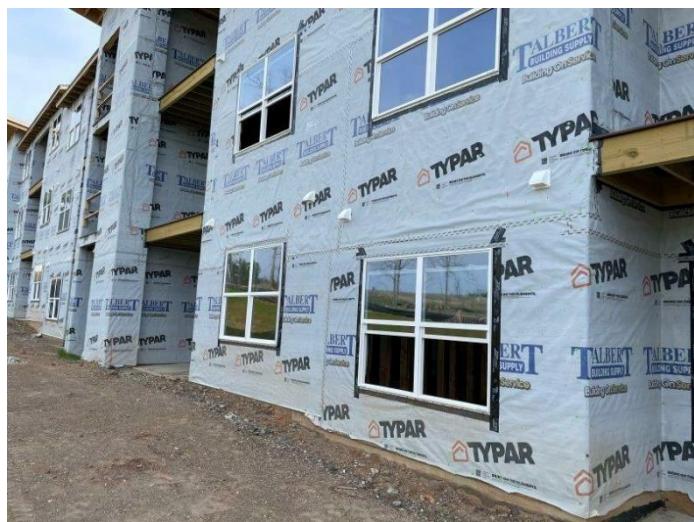
18. Building #1 - West elevation with unit windows, patio/ breezeway and roof framing installed and exterior facade with moisture/vapor barrier wrap.

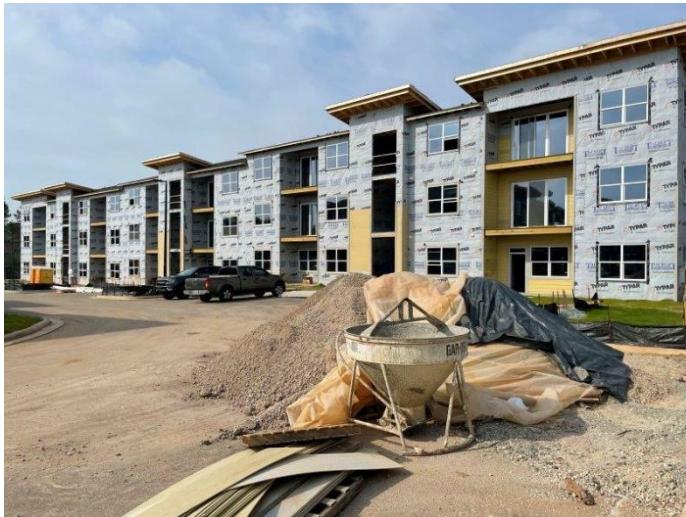
19. Building #1 - East facing side of structures as seen from parking lot to the east-northeast with curb & gutter and concrete mixing materials.

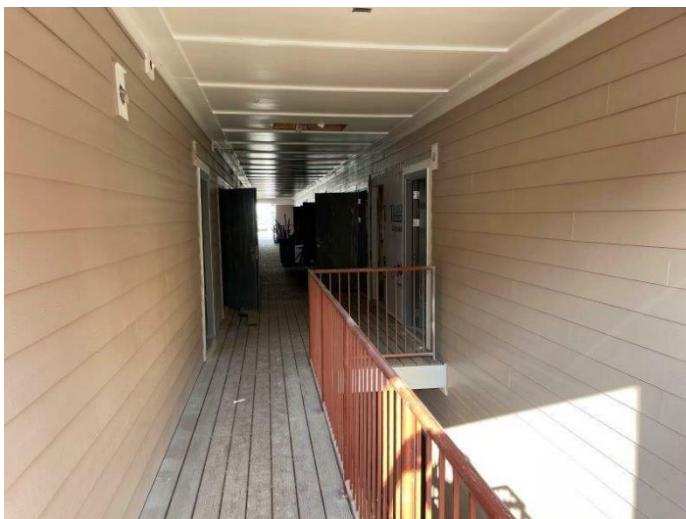
21. Building #2 - Third floor breezeway seen from east facing west with installed railings, unit/storage closet doors and siding.

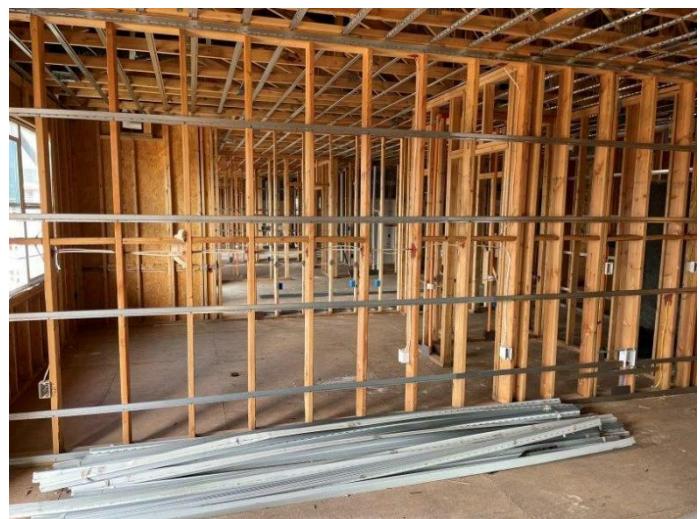
22. Building #2 - Third floor unit with electrical wiring in framing and installed/stored furring strips along wall and overhead for install of drywall.

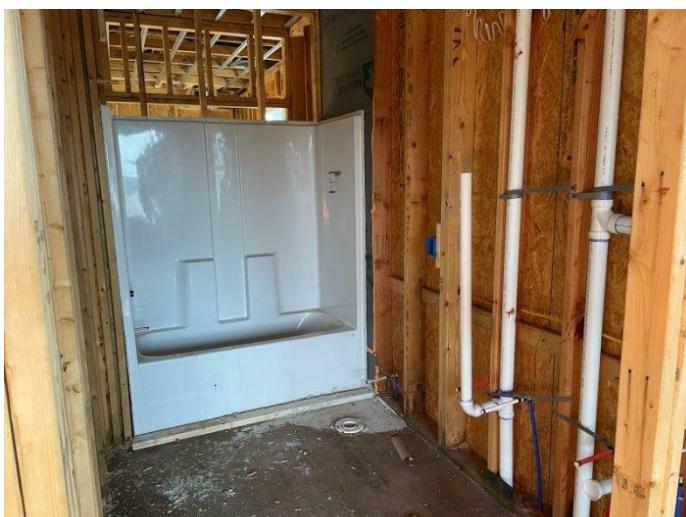
23. Building #2 - Future bathroom area of third floor unit with installed shower/tub insert and plumbing/drain lines for toilet and sink fixtures.

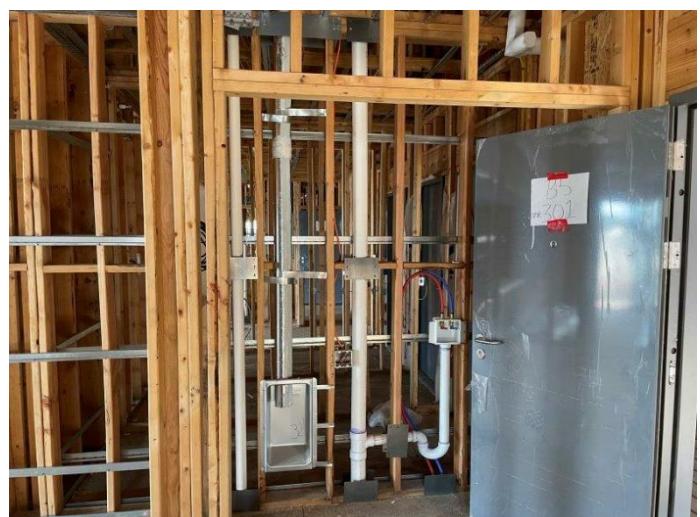
24. Building #2 - Third floor washer/dryer area with installed plumbing water/drain lines for washer as well as ventilation ductwork/hook-up for dryer.

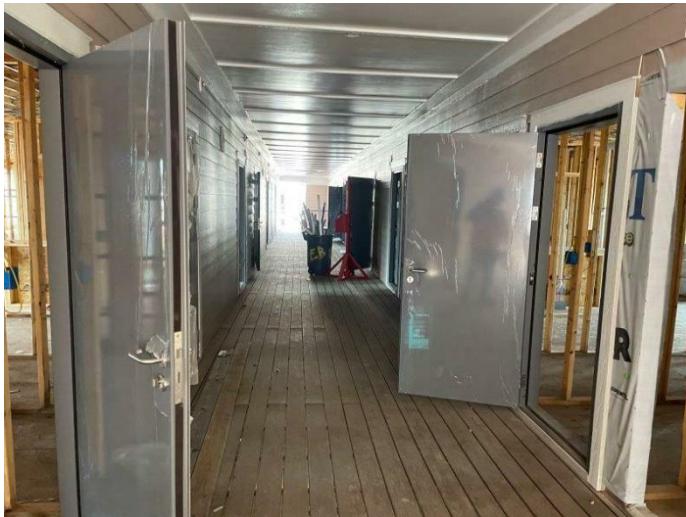
25. Building #2 - Breezeway with metal residential unit access doors and framing in addition to storage closet doors adjacent to entries.

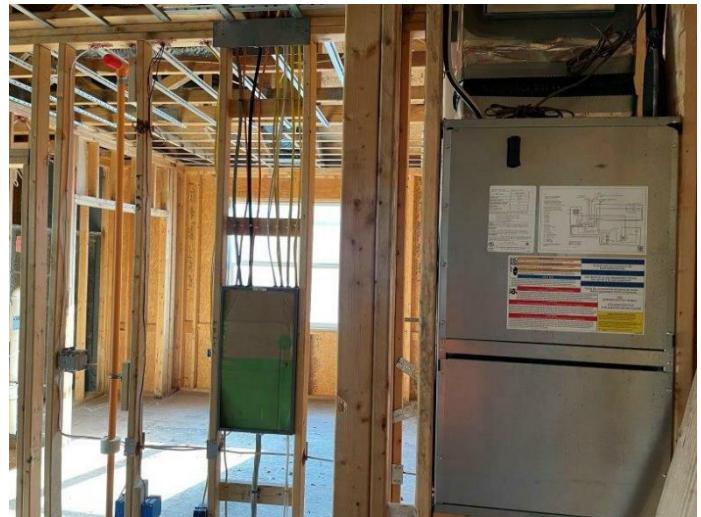
26. Building #2 - Third floor interior installed air handling unit and adjacent electrical breaker panel with connected wiring and fire suppression line.

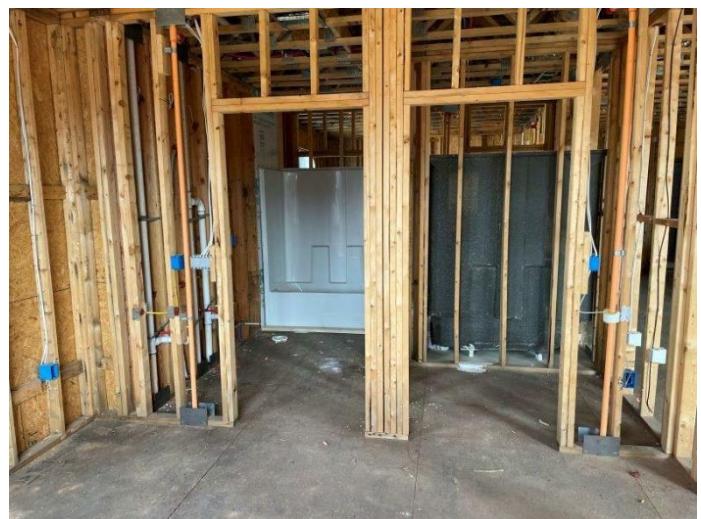
28. Building #2 - Front/back of shower/tub inserts in adjoining unit bathrooms along with installed plumbing, fire suppression and electrical lines.

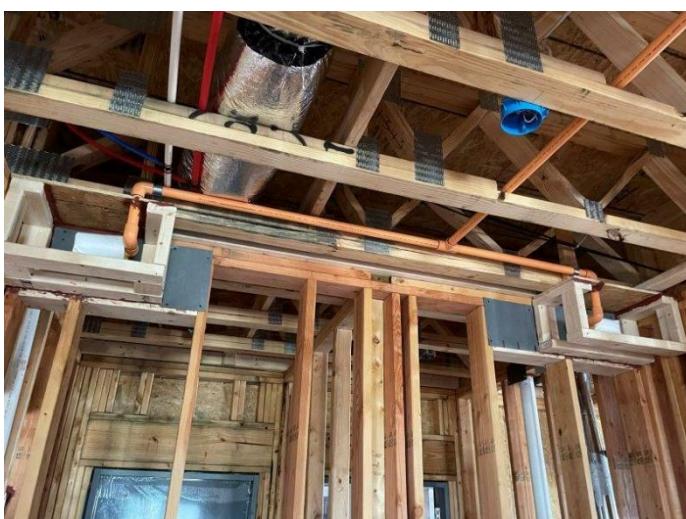
29. Building #2 - Second floor unit framing with installed overhead HVAC duct work, fire suppression/water lines and lighting fixture.

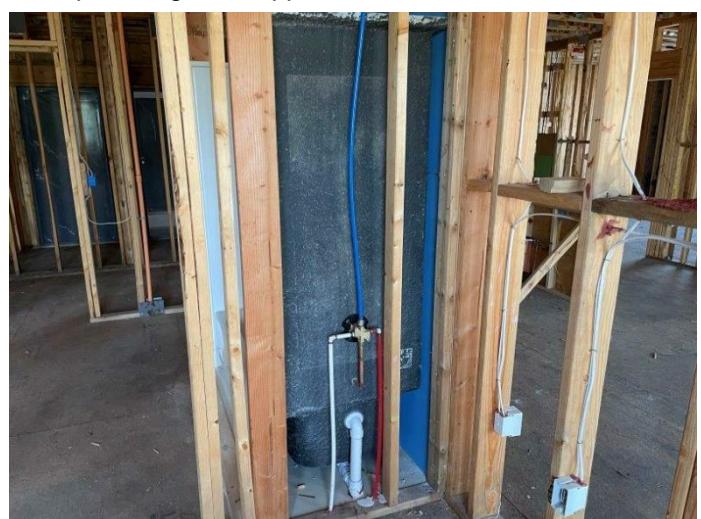
30. Building #2 - Back side view of shower/tub insert in future bathroom area of second floor unit with water and drain lines connected.

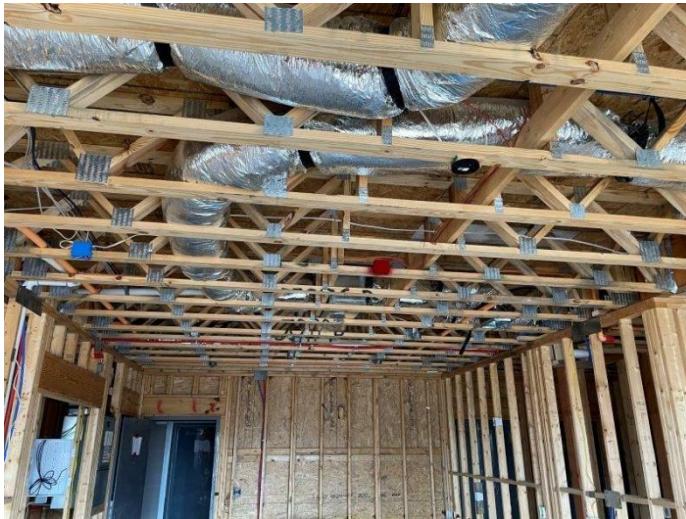
31. Building #2 - HVAC duct work above ceiling with plumbing and electrical lines and interior air handler installed adjacent to entry door.

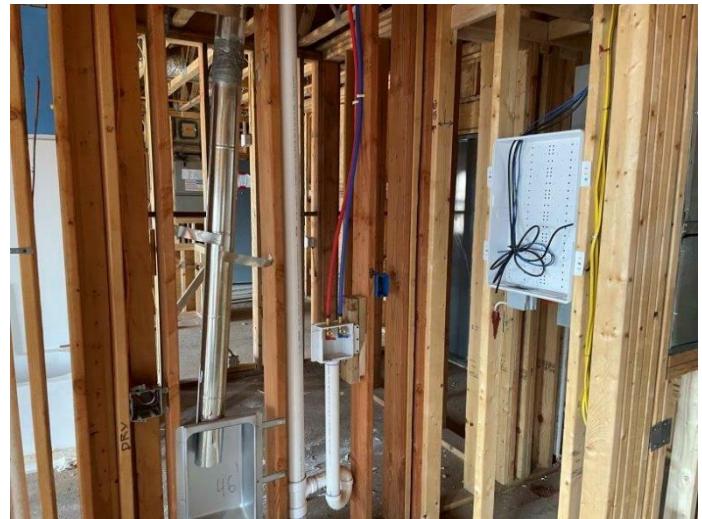
32. Building #2 - Second floor washer/dryer area with installed plumbing water/drain lines for washer as well as ventilation ductwork/hook-up for dryer.

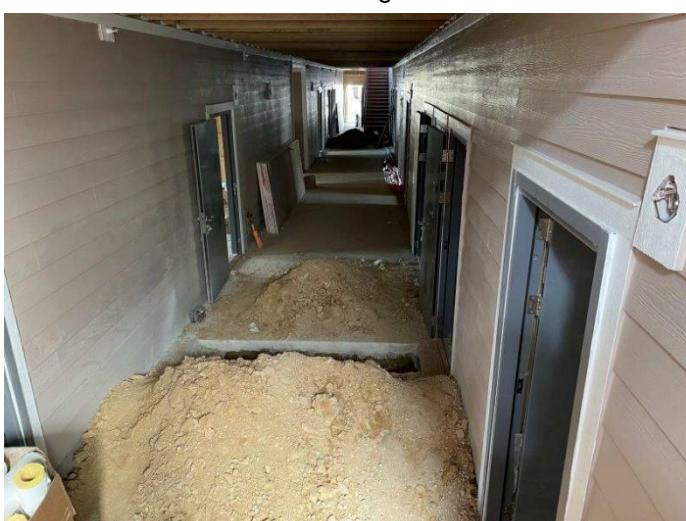
35. Building #1 - First floor breezeway seen from east stairway facing west with foundational concrete removed for excavation in two areas.

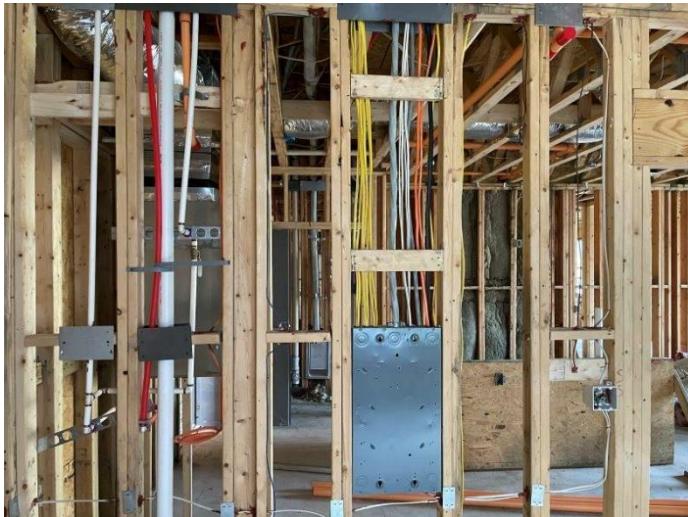
37. Building #2 - Installed/wired electrical panel within first floor unit with adjacent plumbing and fire suppression lines and HVAC duct above.

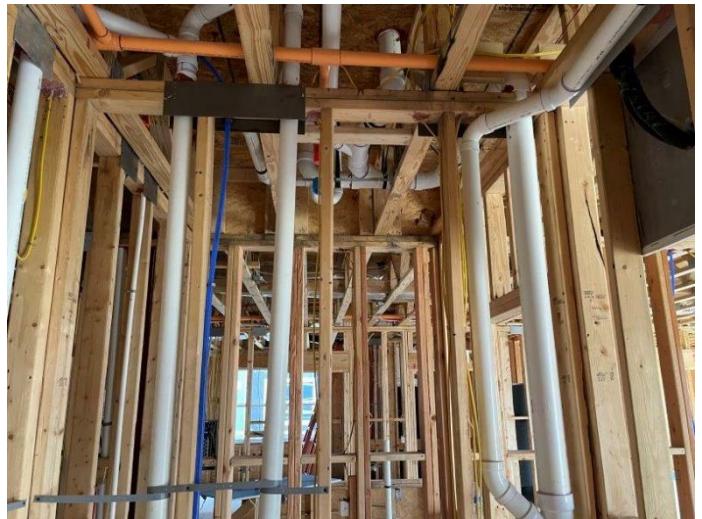
38. Building #2 - Connected plumbing drain lines below second floor as seen installed in ceiling space above first floor unit near office.

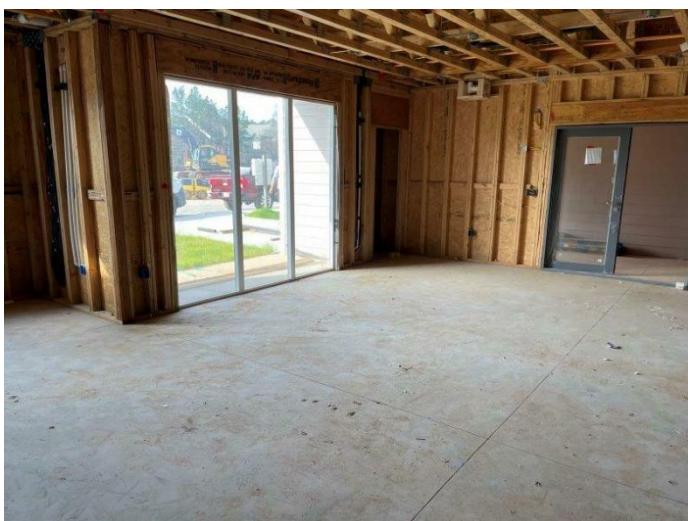
39. Building #2 - Community/common area with installed patio door facing south side parking lot and double-door entry from interior hallway.

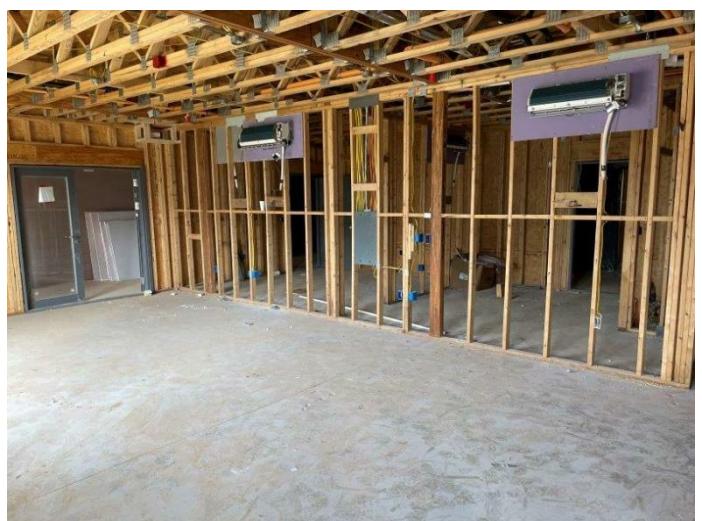
40. Building #2 - The community/common area will be mainly heated/cooled via a set of PTAC units installed along the interior wall of the space.

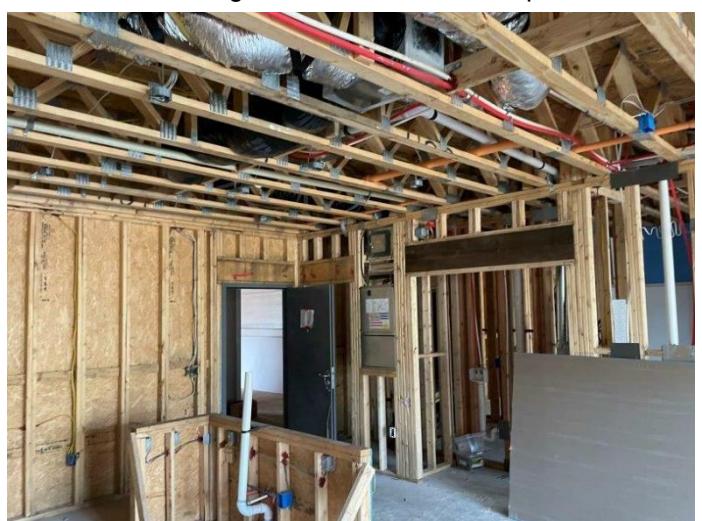
42. Building #2 - First floor unit entry/laundry area with installed interior air handler along with HVAC duct, fire suppression lines and water lines.

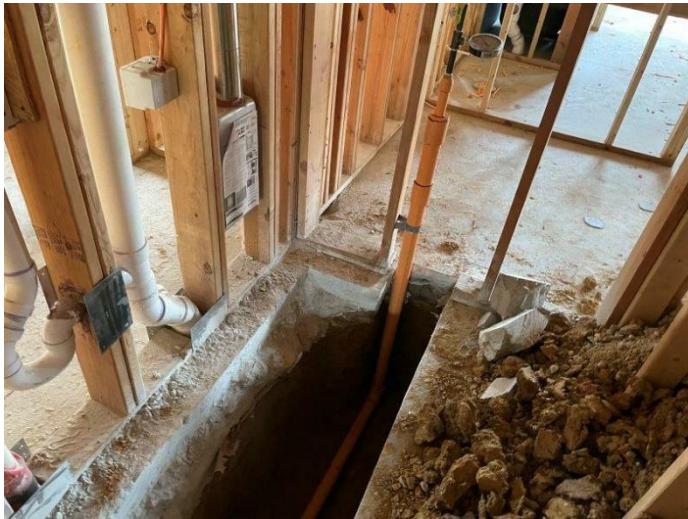
43. Building #2 - Cut concrete and sub-slab excavation observed on ground level suggests a fire suppression system issue.

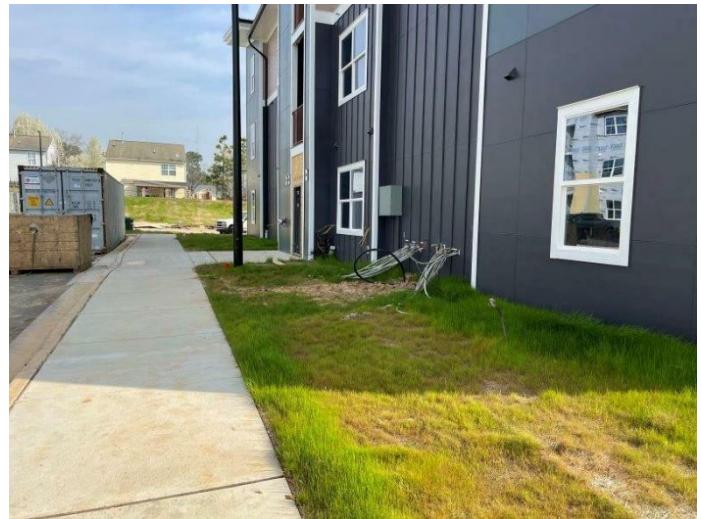
44. Building #2 - Southwest corner as seen facing north with west side electrical wiring from the individual units awaiting meter center connection.

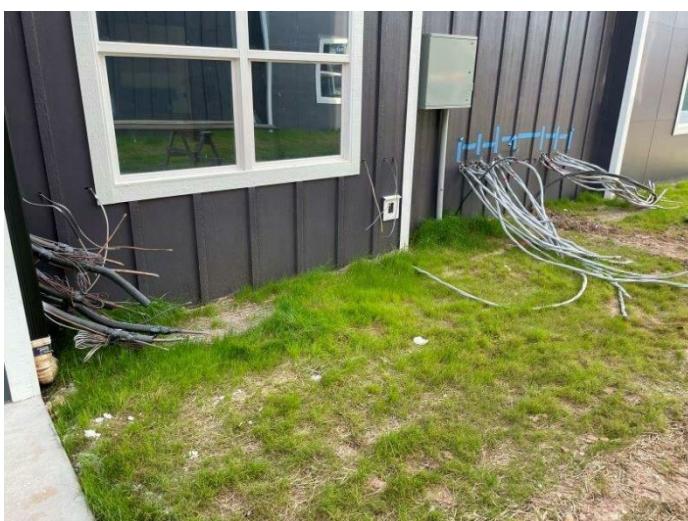
45. Building #3 - West side with electrical wiring from individual units awaiting meter center connection seen from sidewalk between Buildings #3/#2.

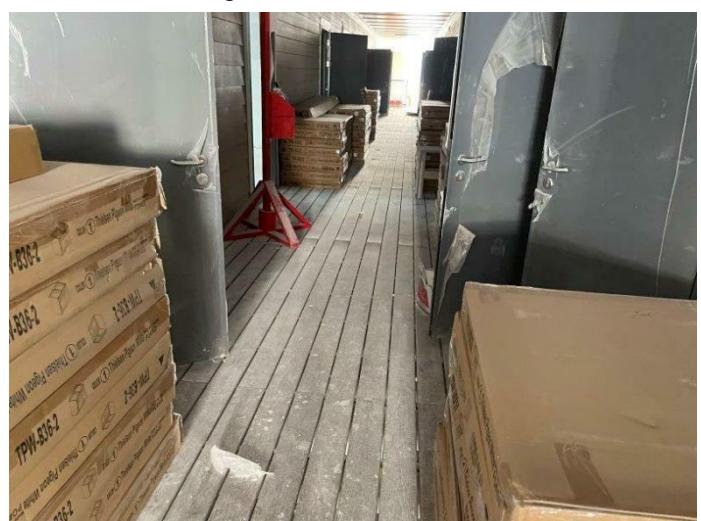
46. Building #3 - Third floor breezeway with unit/storage closet doors/trim and siding and kitchen area cabinets staged for installation.

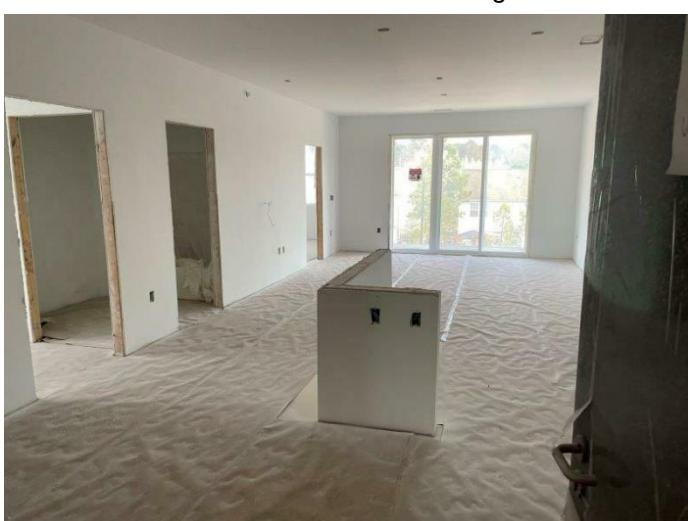
47. Building #3 - East third floor unit interior with installed and primed drywall for walls/ceilings and covered gypcrete floor awaiting tile install.

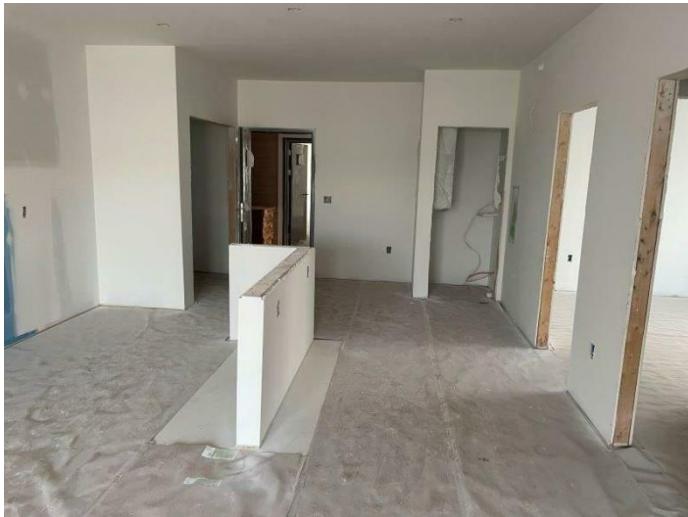
49. Building #3 - Kitchen area of third floor unit with central counter/island with washer/dryer utility area adjacent to entry.

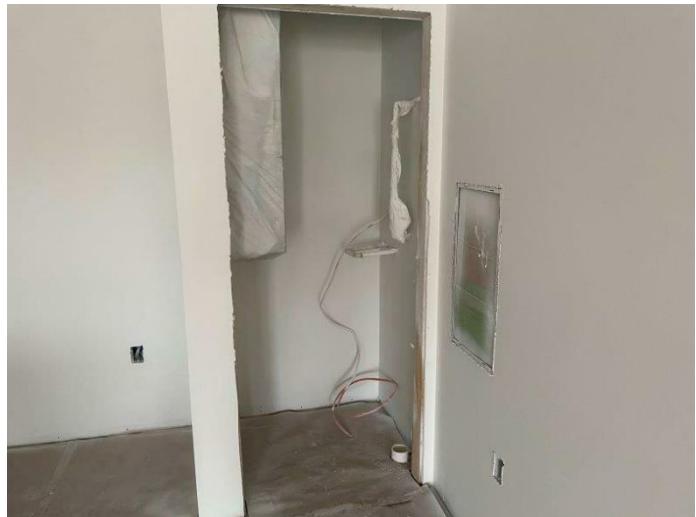
50. Building #3 - Installed interior air handler and location of future water heater in third floor unit closet with adjacent electrical breaker panel.

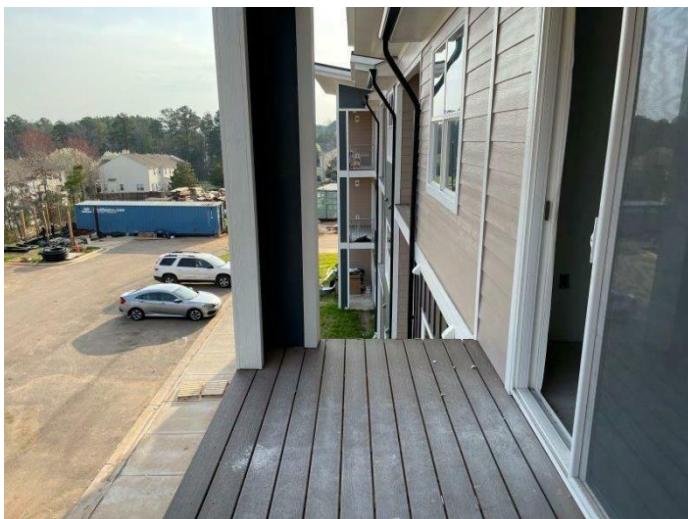
51. Building #3 - Third floor porch with installed decking without railings but with installed building gutters and downspouts and painted trim.

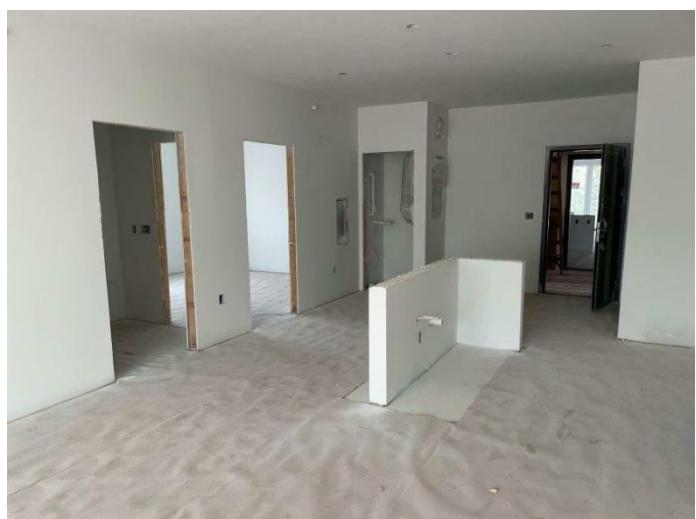
52. Building #3 - West third floor unit interior with installed and primed drywall for walls/ceilings and covered gypcrete floor awaiting tile install.

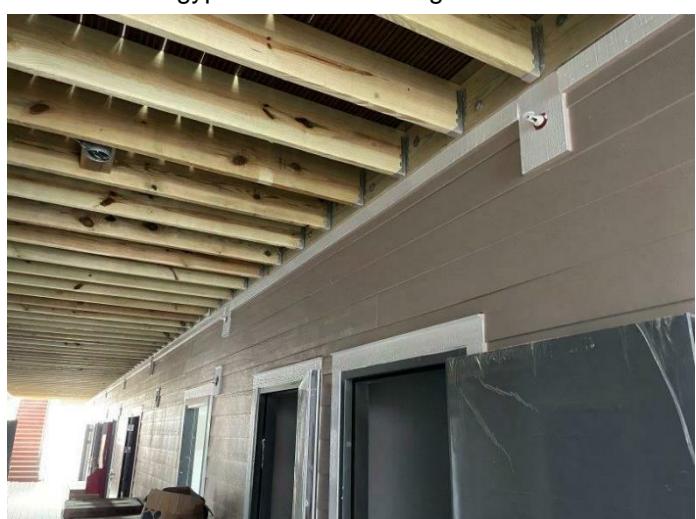
54. Building #3 - Second floor breezeway with installed metal entry/storage unit doors and trim as well as sprinkler heads and corridor lighting wiring.

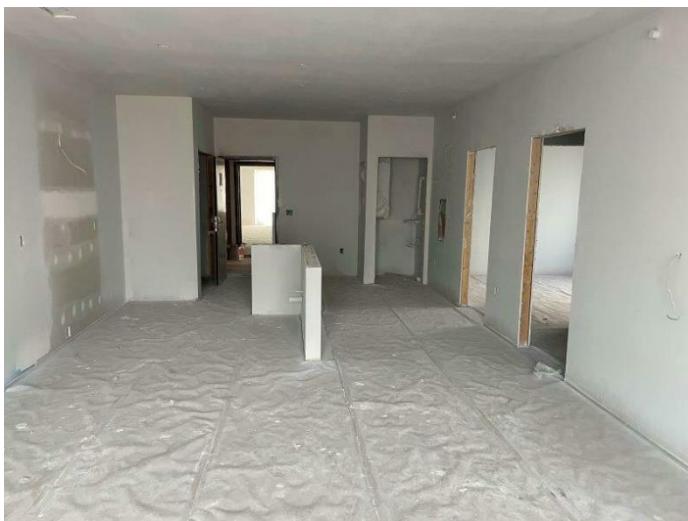
55. Building #3 - West second floor unit interior with installed and primed drywall for walls/ceilings and covered gypcrete floor awaiting tile install.

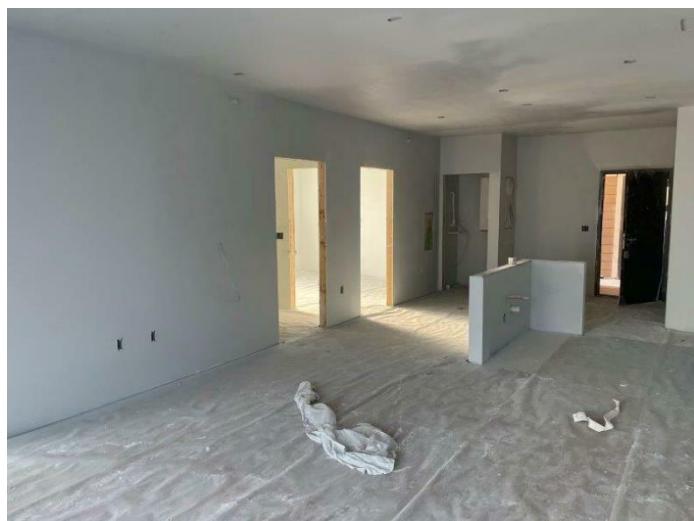
56. Building #3 - East second floor unit interior with installed and primed drywall for walls/ceilings and covered gypcrete floor awaiting tile install.

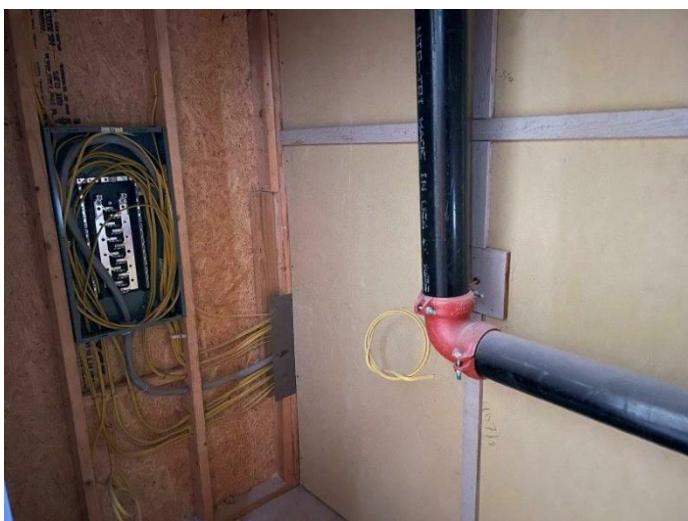
57. Building #3 - Fire suppression system utility room with piping and breaker panel at eastern end of building beneath the eastern stairway.

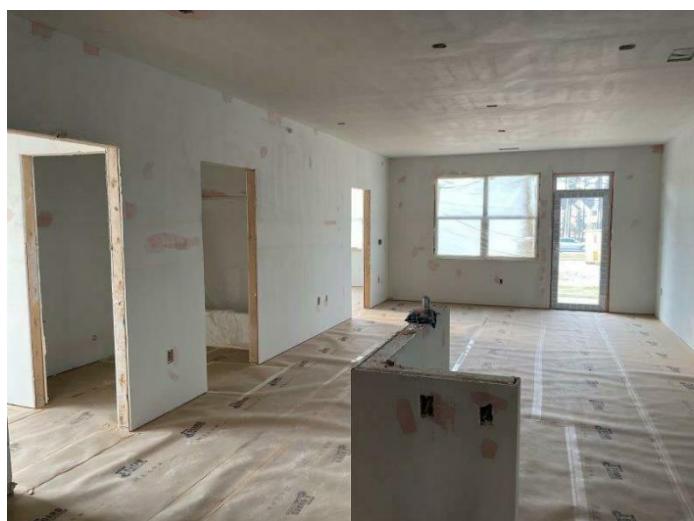
58. Building #3 - East first floor unit interior with installed and primed drywall for walls/ceilings and covered concrete floor awaiting tile install.

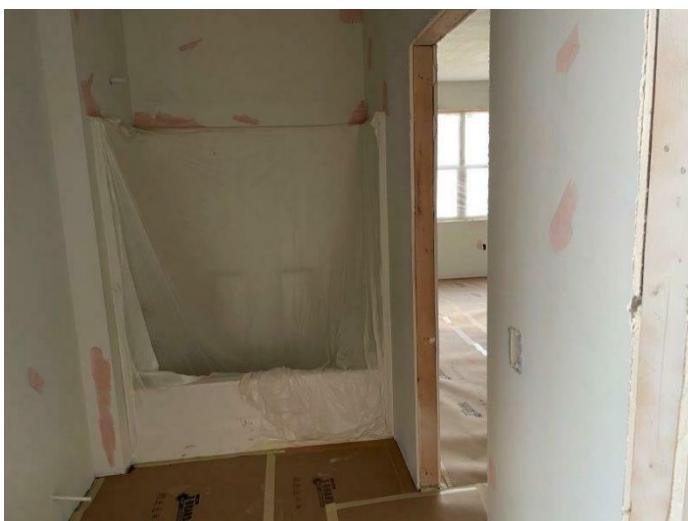
59. Building #3 - Bathroom area within first floor unit with trim out and fixture install remaining as well as floor tile and trim installation.

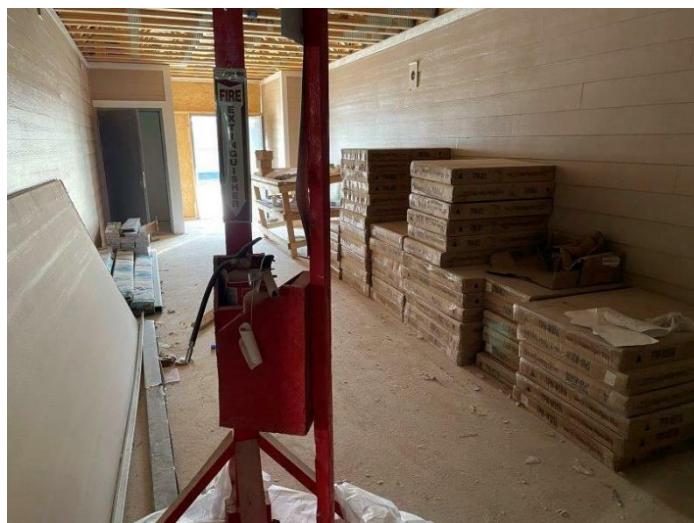
62. Building #3 - Interior hallway extending from main corridor toward south parking lot with stored cabinets, vinyl flooring and drywall panels.

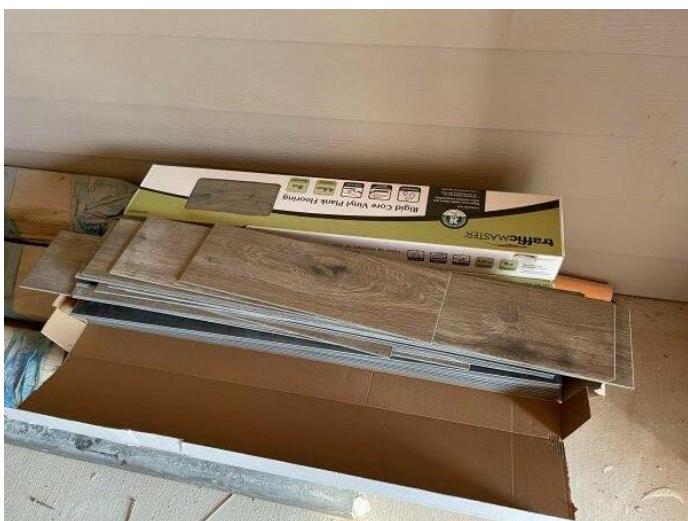
63. Building #3 - Vinyl floor tile was observed in the process of being staged for install on concrete first floor and on gypcrete second/third floors.

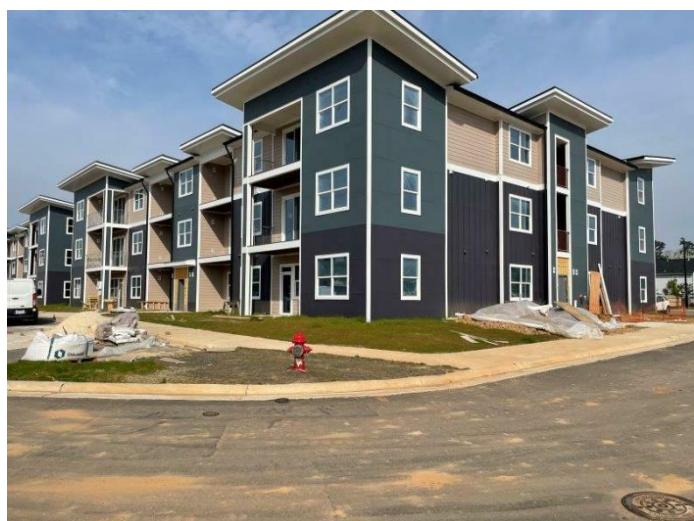
64. Building #3 - Southeast corner as seen facing west-northwest with installed siding and painted exterior with concrete sidewalks and entries.

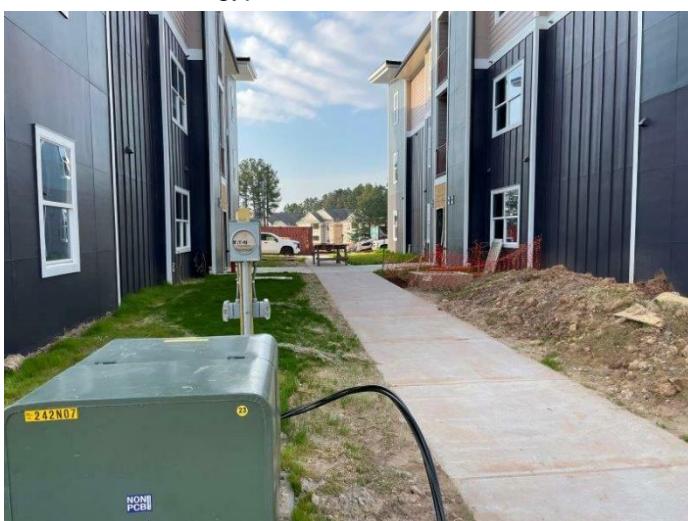
65. Pad-mounted transformer and meter base installed directly adjacent to the northwest corner of Building #1 with adjacent sidewalk.

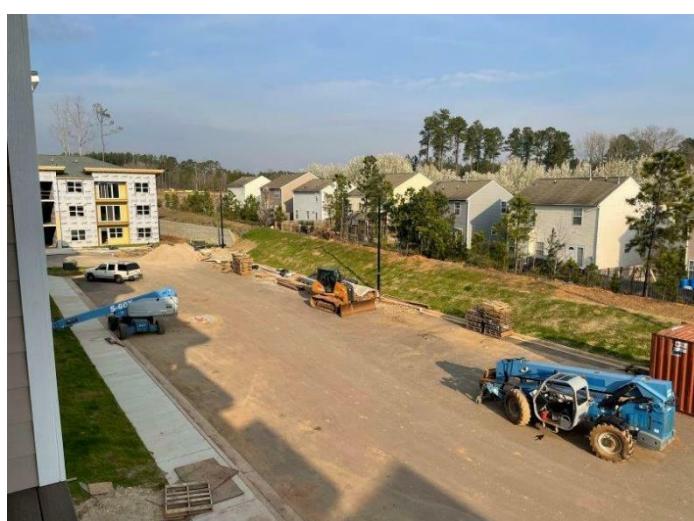
66. Parking lot north of Building #2 with curb & gutter and sidewalk installed as well as initial asphalt paving of lot and boundary landscaping.

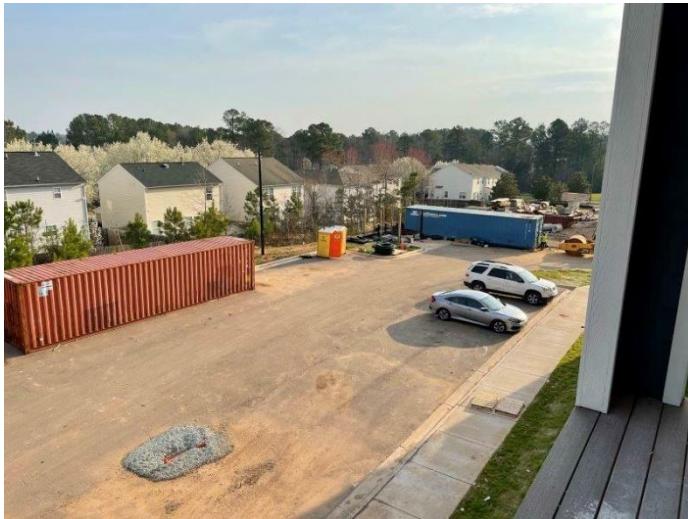
67. Northeast corner of north lot with storage trailers and posts surrounding concrete pad near far trailer for install of trash containment unit.
