CONSTRUCTION COST TO COMPLETE

Summer Meadows

433 Hebron Road
Durham, North Carolina 27704

March 25, 2024

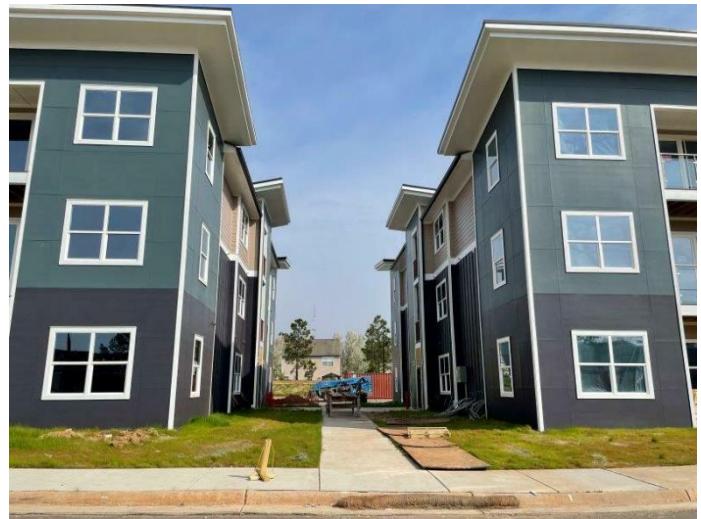
68. Sidewalk installed between Building #3 (on right) and Building #2 (on left) as seen from south lot facing north with exterior trim.

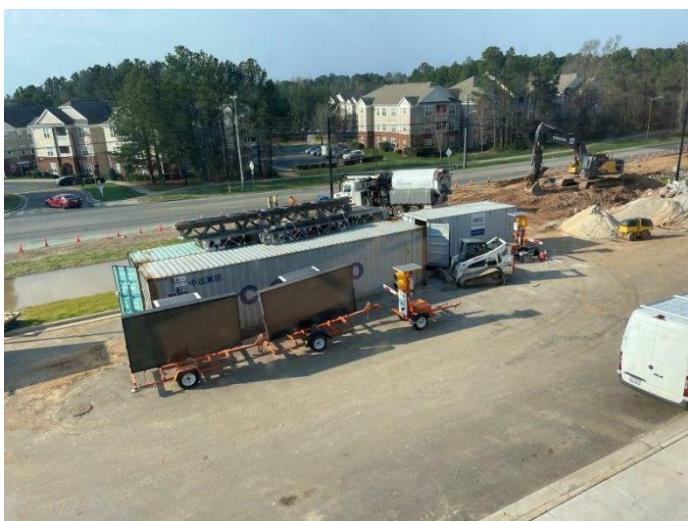
69. South parking lot with storage trailers and Hebron Road, which extends along south boundary and is reportedly being widened.

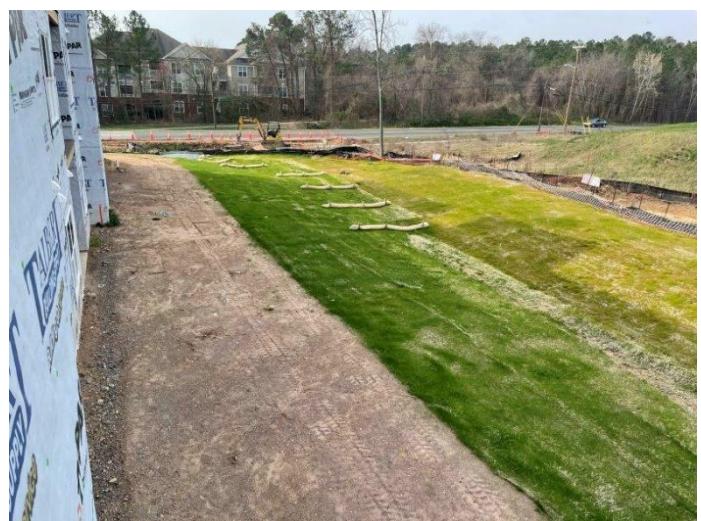
70. Western side of site with installed swale and landscaping to channel runoff from land west-northwest to drainage structures to the south.

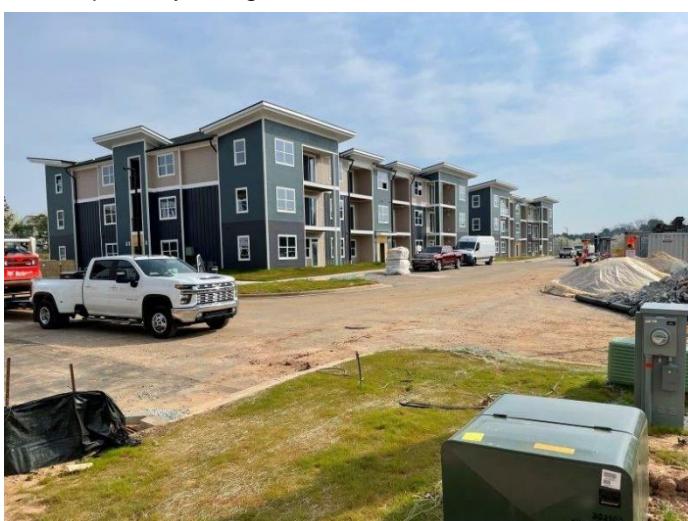
71. Buildings #2 and #3 as seen from the southwest of Building #2 facing east with meter and pad-mounted transformer in foreground across lot.

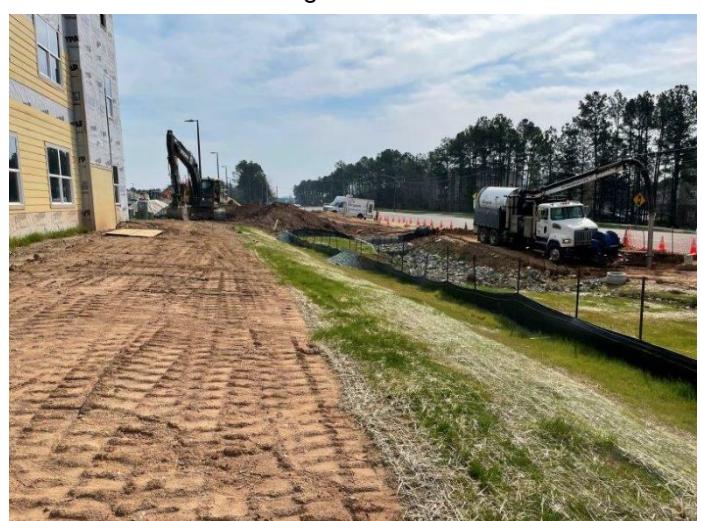
72. Southwest corner of site facing east and area directly south of Building #1 with utility contractor working adjacent to Hebron Road.

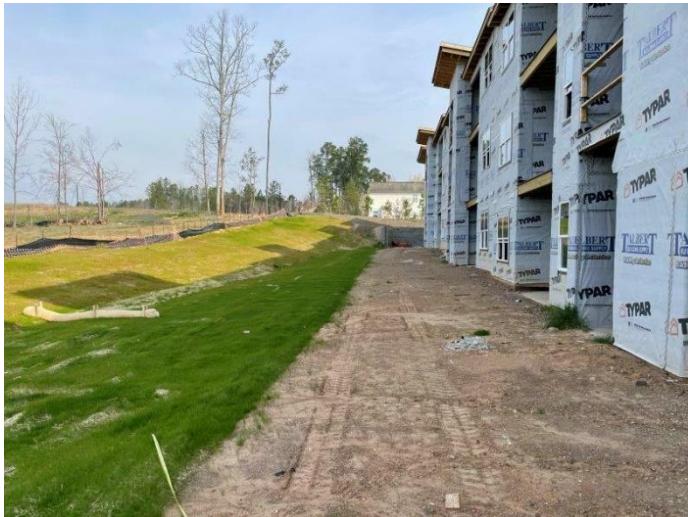
73. West side of site with western facade of Building #1 and downward slope of adjoining land to the north-northwest of site visible in distance to left.

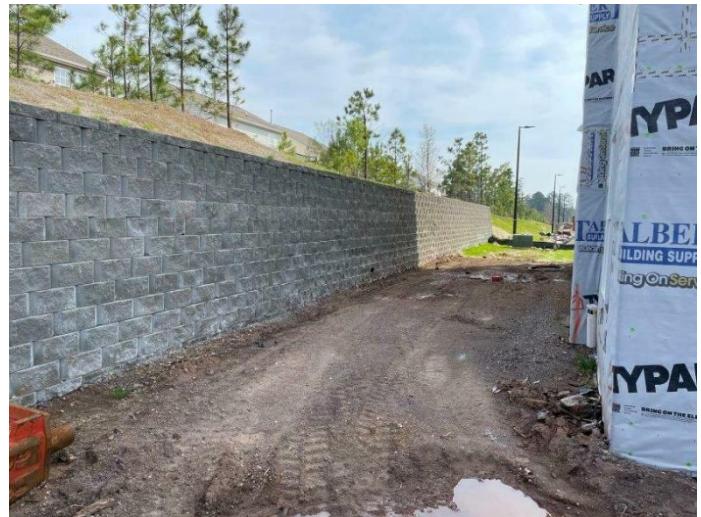
74. CMU block retaining wall installed directly adjacent to the north-northwest of Building #1 to address the rise in elevation to the north-northwest.

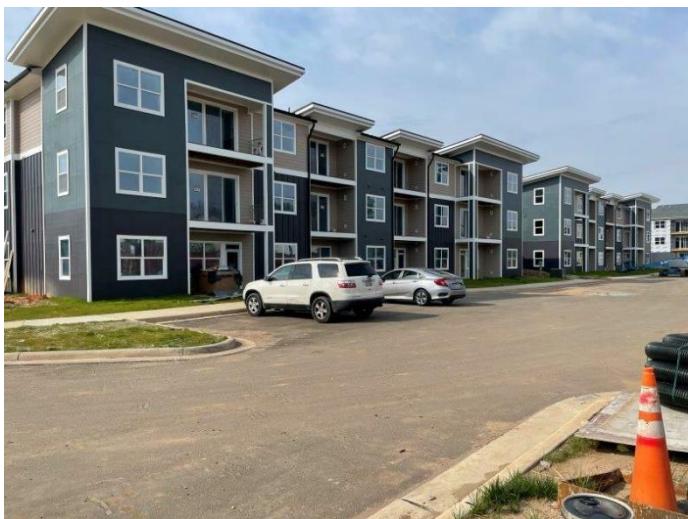
75. Northeast corner of Building #3 (on left) and parking lot north of Buildings #3 and #2 (on right) seen facing southwest from future containment area.

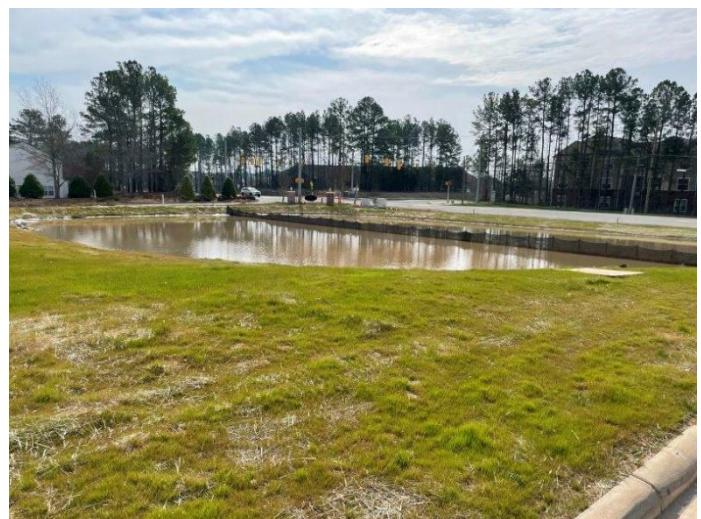
76. Stormwater retention pond installed at southeast corner of site adjacent north of Hebron Road and south of entrance to site from Danube Lane.
