# Errata Sheet MB86295 Coral P

## History

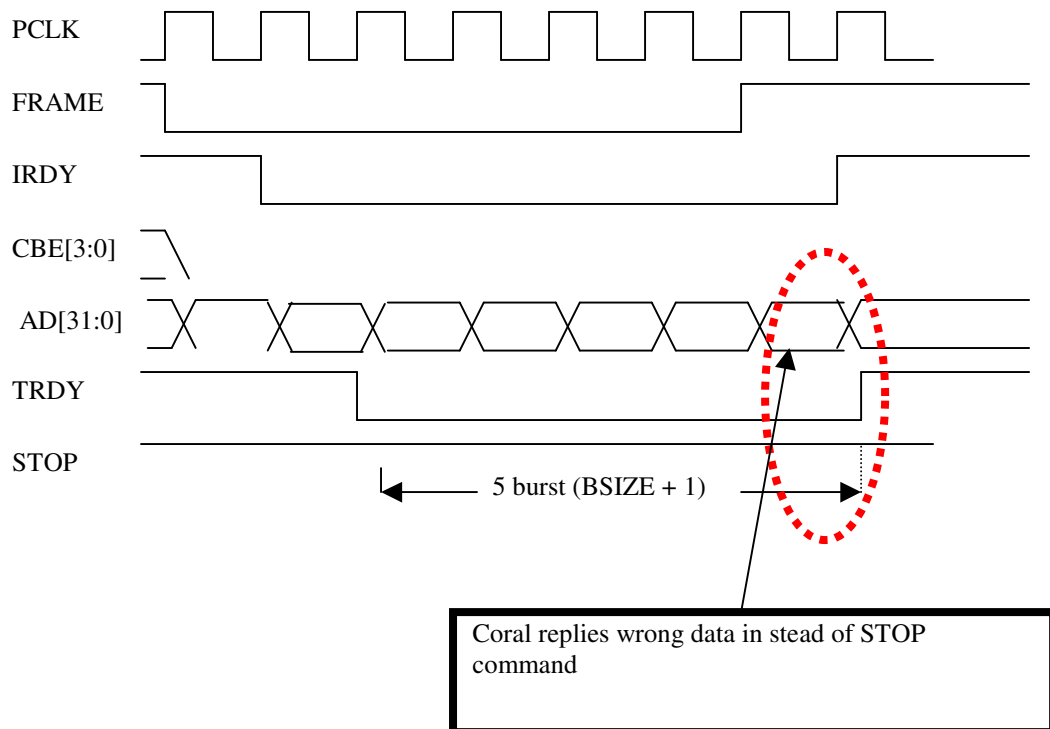
Coral reply the wrong data, if the read burst size comes more than the setting of SRBS.

Coral replies the retry until storing the SRBS size data to Coral's PCI internal buffer.

After stored the data, Coral begins to reply the data by TRDY. But if the burst read comes more than the size of SBRS, Coral replies the wrong data instead of issuing the STOP.

Ex. BSIZE of BCR = 4, Master issues the **burst read** more than "BSIZE+1" from Coral.
