# Errata Sheet MB86296 Coral PA

**Errata List:****August 05<sup>th</sup>, 2004**

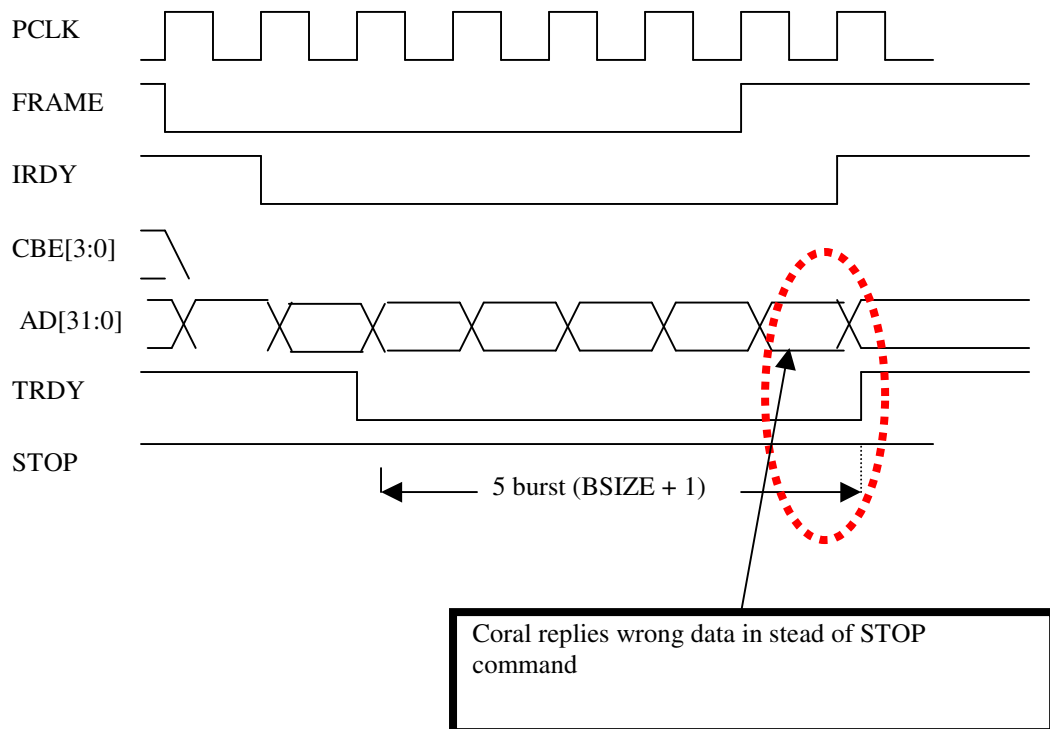
Coral reply the wrong data, if the read burst size comes more than the setting of SRBS.

Coral replies the retry until storing the SRBS size data to Coral's PCI internal buffer.

After stored the data, Coral begins to reply the data by TRDY. But if the burst read comes more than the size of SBRS, Coral replies the wrong data instead of issuing the STOP.

Ex. BSIZE of BCR = 4, Master issues the **burst read** more than "BSIZE+1" from Coral.
