# INSPECTION REPORT

5505 SHADY DRIVE  
FORT WORTH, TX 76135

# PROPERTY INSPECTION REPORT

**Concerning:** 5505 Shady Dr, Fort Worth, TX 76135  
(Address or Other Identification of Inspected Property)

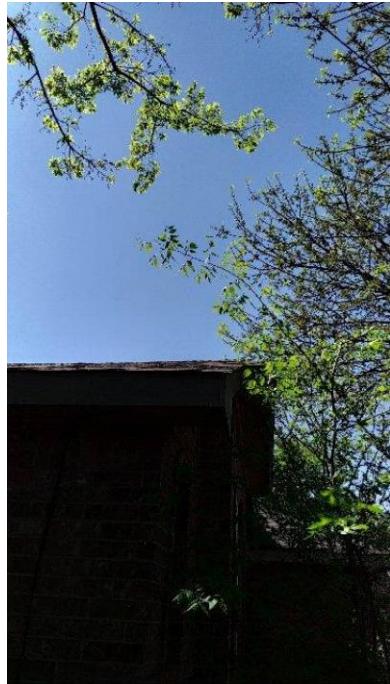
A tree on the North side was in contact with or very close to the dwelling. Trees too close to a structure can cause significant damage during high winds or as the tree grows. We recommend removal or significant trimming of the tree, which may help to prevent future damage to the residence.

**Trim trees**

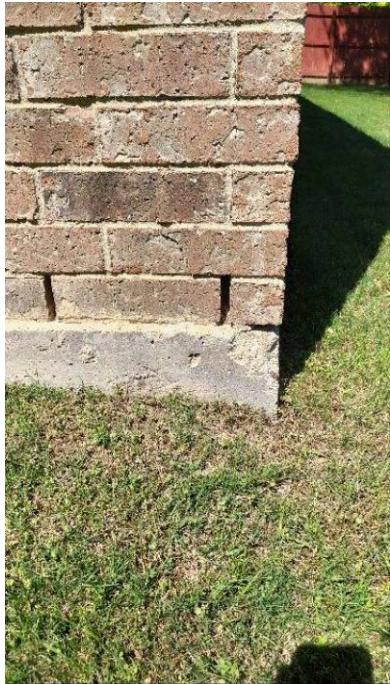
Wedge cracks or corner pops were noted at some of the foundation corners. The large majority of slab-on-ground foundations will eventually develop "corner pops" or wedge cracks. The name comes from the fact that these cracks develop at or very close to the outside corners of the foundation and frequently form a wedge at the corner. These cracks develop as a result of the expansion of the brick veneer as it is warmed by the sun. These cracks do not indicate anything unusual about the foundation. If the cracking at a corner becomes extreme, the concrete wedge may become loose and can eventually fall off. In the most extreme case, the wedge will no longer support the brick; if this were to occur, the corner should be repaired.

**Corner pop**

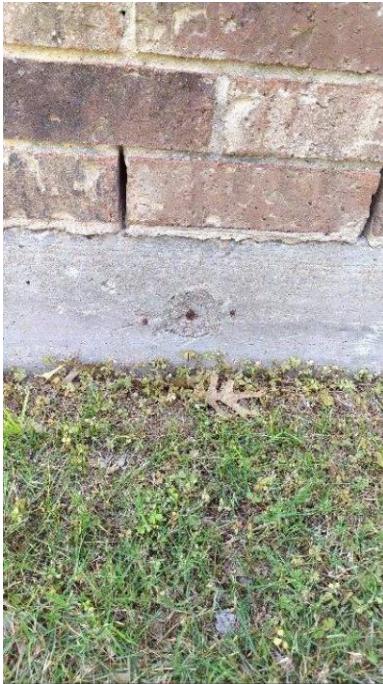
Open cable tensioning ports were noted at the East side(s). We recommend proper cleaning and sealing of any open ports to protect the cable ends from moisture and corrosion.

**Open cable port**

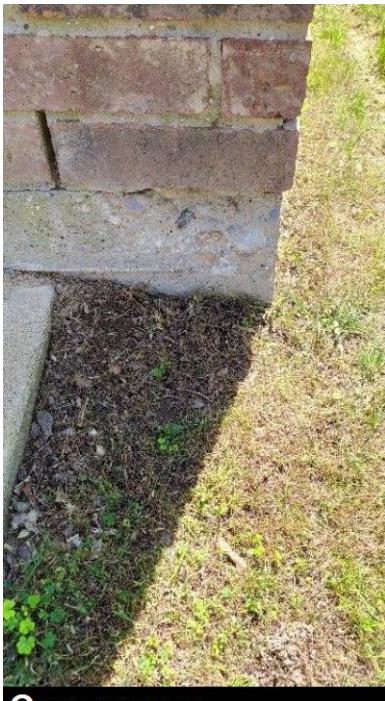
Corner pop

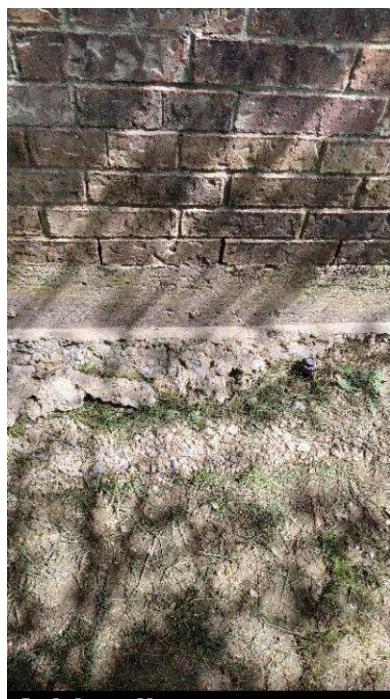
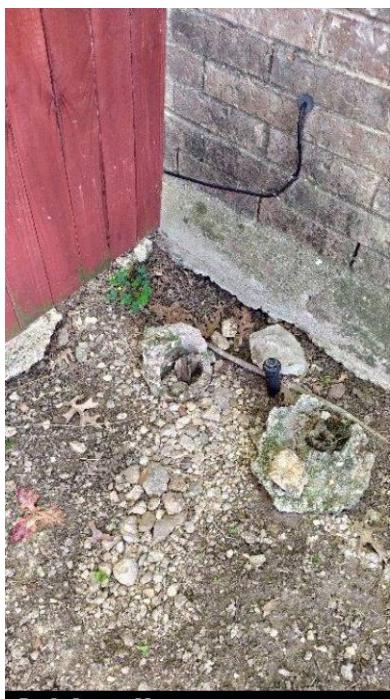
Low soil and/or soil erosion was noted near the foundation on the East and West side(s) of the structure. We recommend adding soil to these low lying areas to minimize any potential water ponding.

Add soil

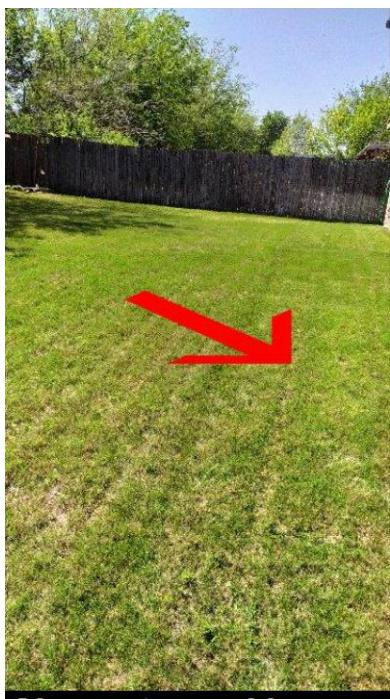
**We observed a negative grading slope at the South side(s) of the structure. This will likely cause water to drain toward the foundation. Reshaping of the area around the foundation to move water away from the structure may be required. If further review is desired, evaluation by drainage specialist is recommended.**

Slopes toward house

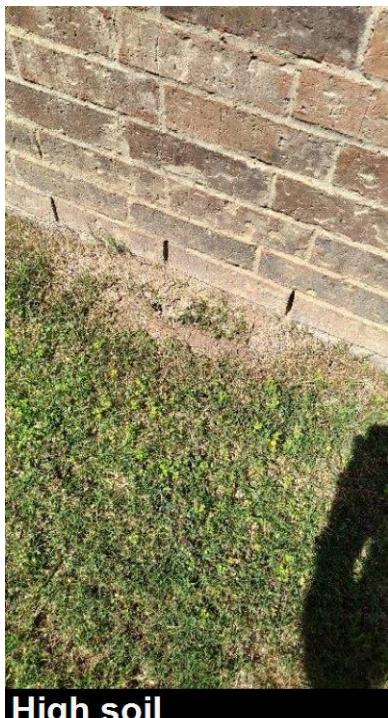
**The soil line was too high at the South side(s) of the residence. With slab foundations, we advise that approximately 2-4 inches of slab show between the brick or siding and the soil. High soil lines can cause moisture retention in exterior walls, and can be conducive for a potential WDI (termite) infestation.**

High soil

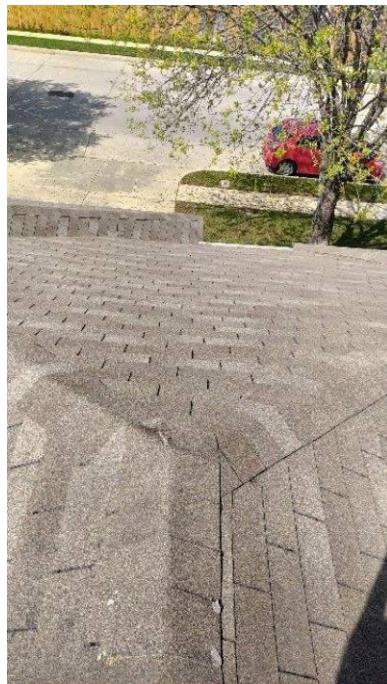
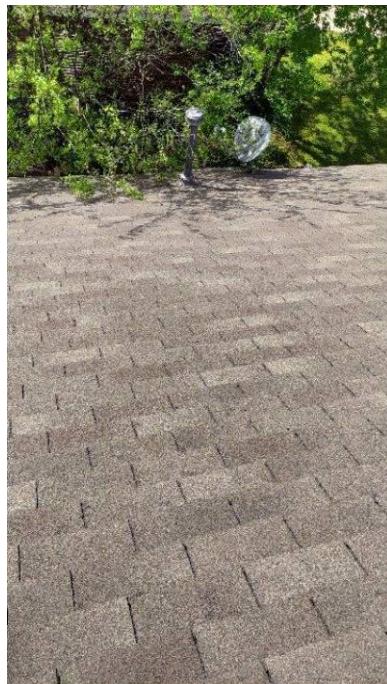
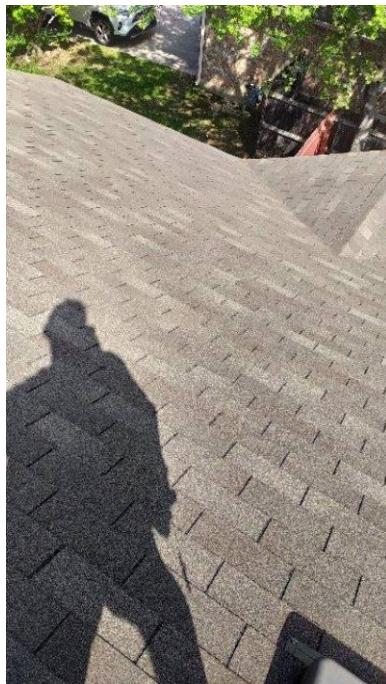
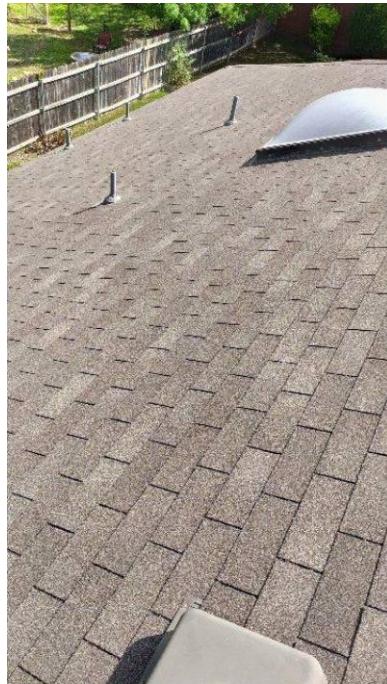
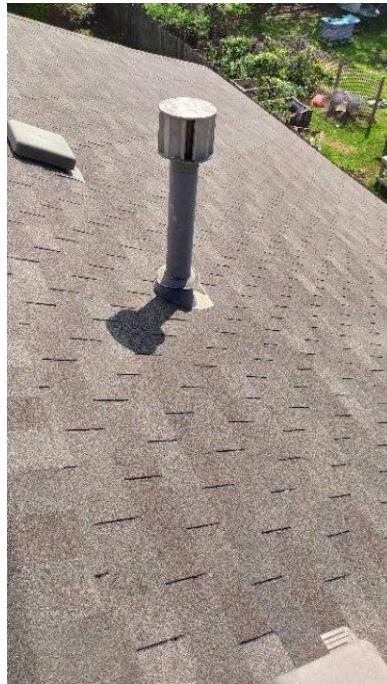
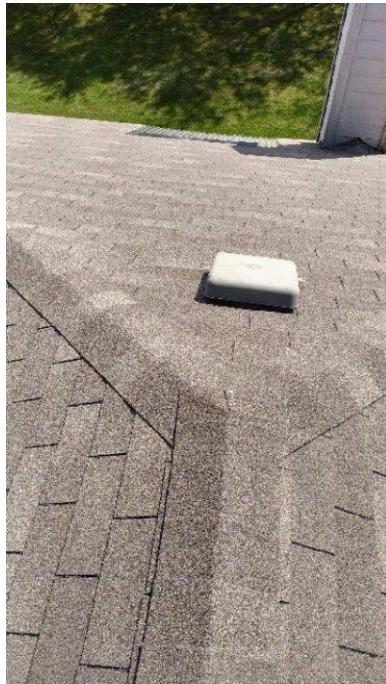
Roof view

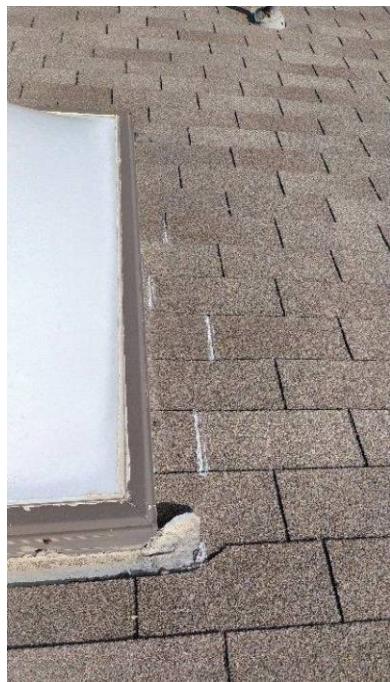
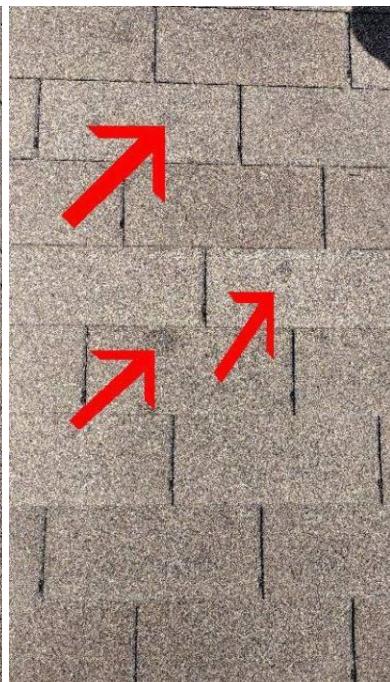
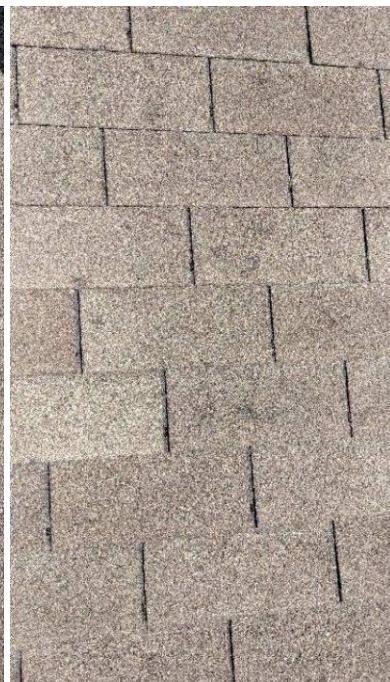
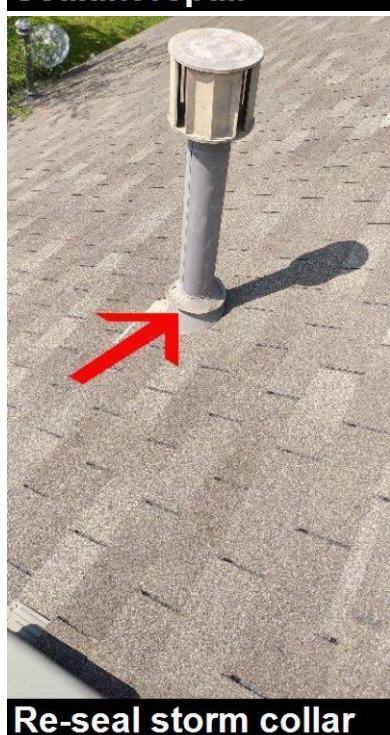
**Damaged/Missing shingles were noted at the West surface(s) of the roof. Recommend repair by a qualified roofing professional.**

**Apparent hail damage was noted on the West surface(s). We recommend an evaluation by your insurance carrier and a qualified roofing contractor to insure the roof is serviceable and insurable.**

Composition roof covering showed signs of wear due to exposure. Some of these signs were: Damaged or missing shingles and heavy aggregate loss.

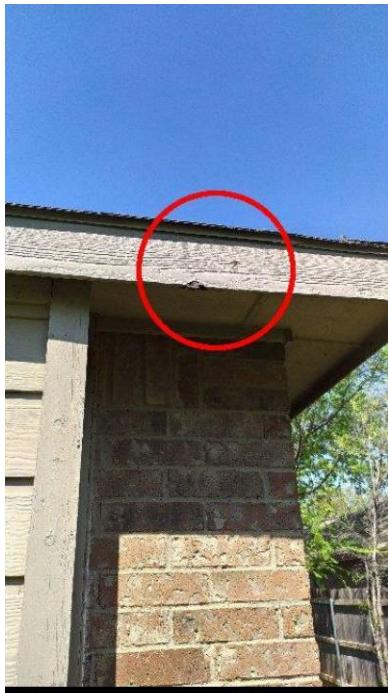
Areas of damaged fascia and/or soffit were evident. Recommend evaluation and/or repair by a qualified contractor.

Damaged soffit

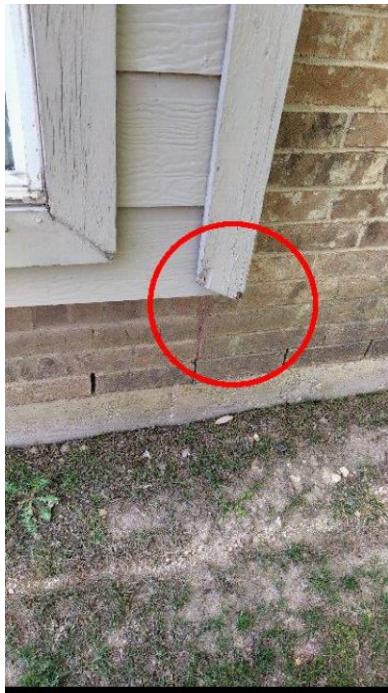
The exterior trim paint was cracked/peeling in some area(s). The regions should be scraped and painted to protect the trim from decay and deterioration. If the structure was built before 1978, lead-based paint use was fairly common. If children are going to visit/reside in the structure or you have any health concerns, you might want to consider having the paint inspected/tested by a lead paint specialist.

Trim needs paint

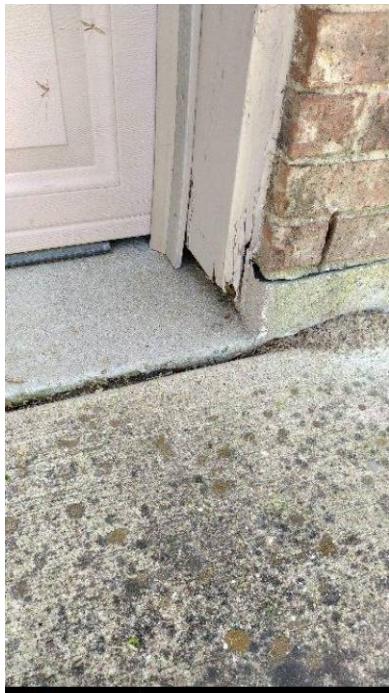
Some wood deterioration/moisture damage was noted at various locations. We recommend repairs/replacement as required, to help prevent additional damage.

Trim rot

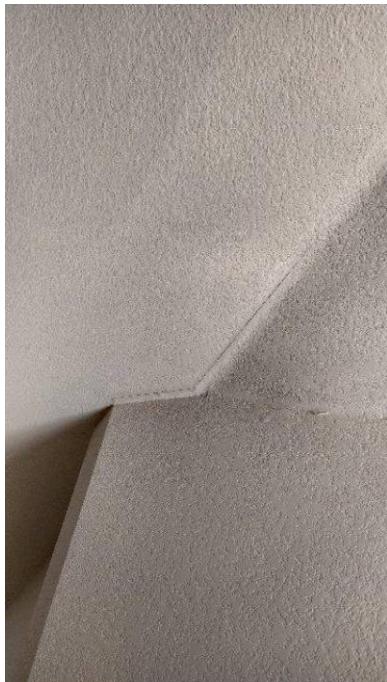
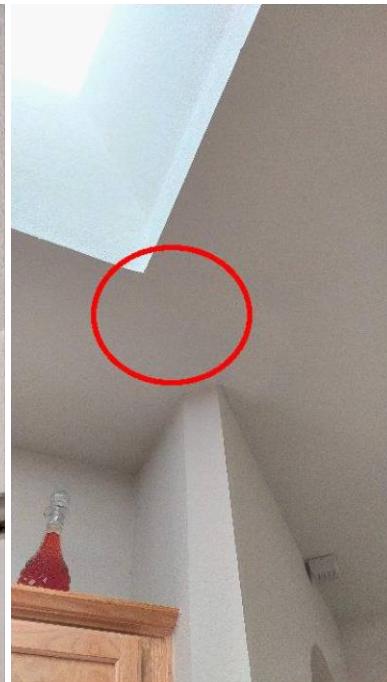
There were common cracked tape joints on the interior ceilings at multiple locations. This can be caused by expansion and contraction of construction materials and/or structural movement. Recommend repair as required.

**Common cracking**

**Common cracking*****Floors:***

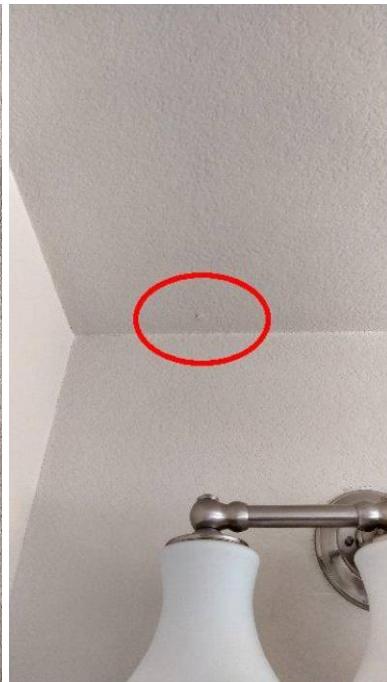
Nail pops were noted in the ceilings. They result from a variety of causes, including: normal settlement, poor ventilation or the shrinkage of the wood framing behind the drywall. Repair is usually relatively simple and inexpensive.

**Nail pop**

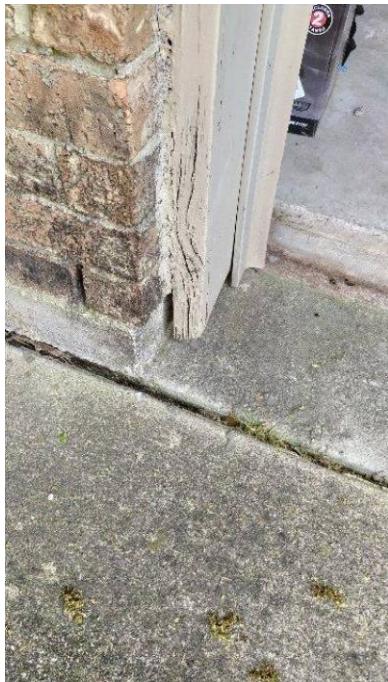
Trim rot

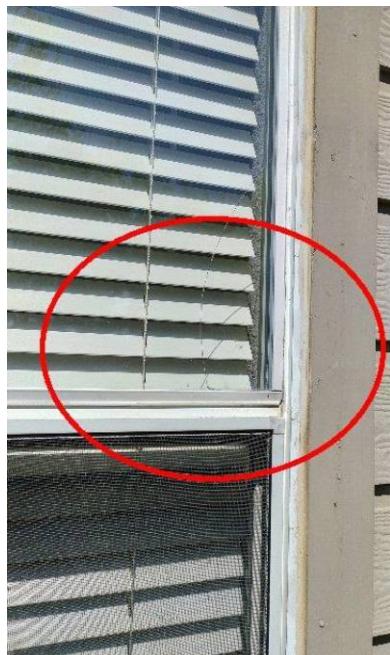
The master bedroom window was cracked.

Cracked window

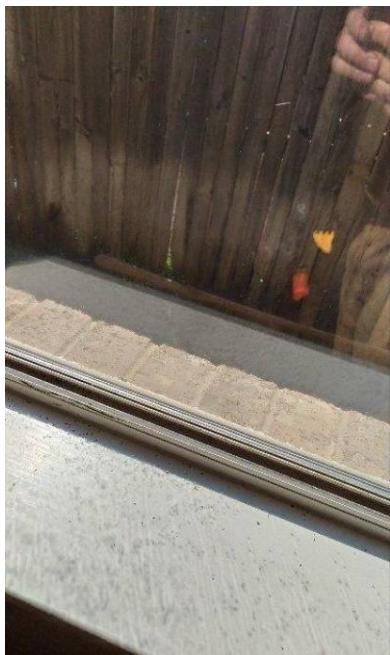
Failed seal

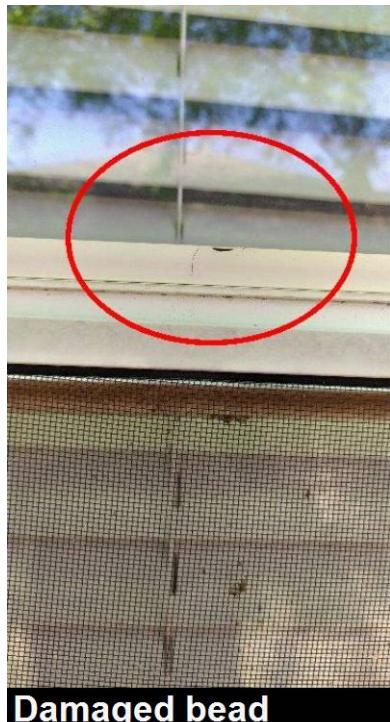
Damaged bead

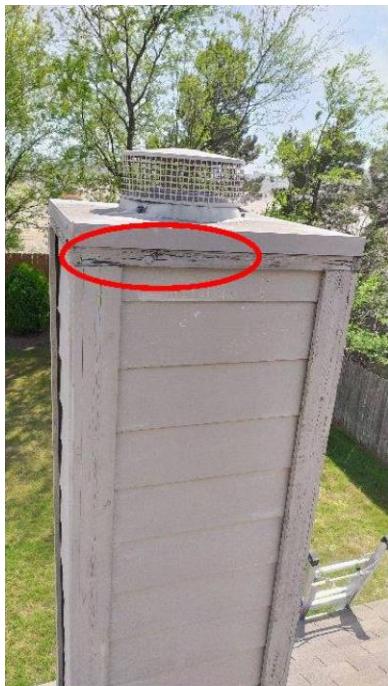
Wood deterioration damage was noted at the chimney siding and/or trim; we recommend repair and/or replacement to help prevent further damage.

**Chimney trim rot**

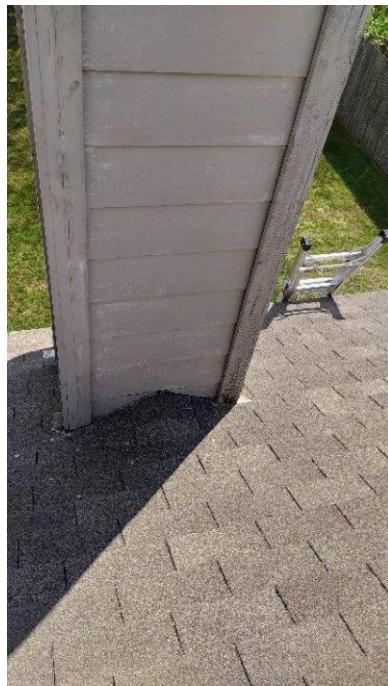
Peeling paint was observed on the chimney surface; we suggest scraping, priming and painting to protect the chimney from premature weathering.

**Needs paint**

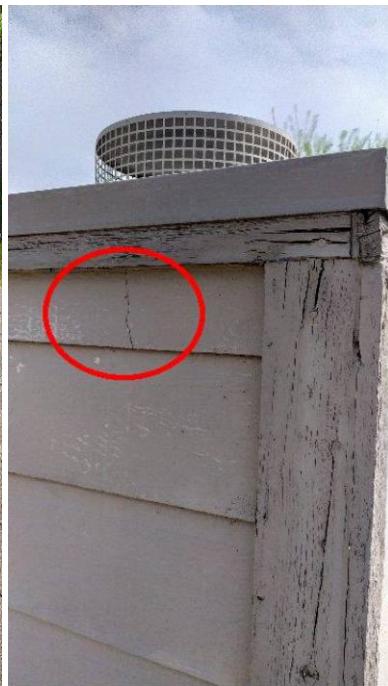
**Trim rot/small crack**

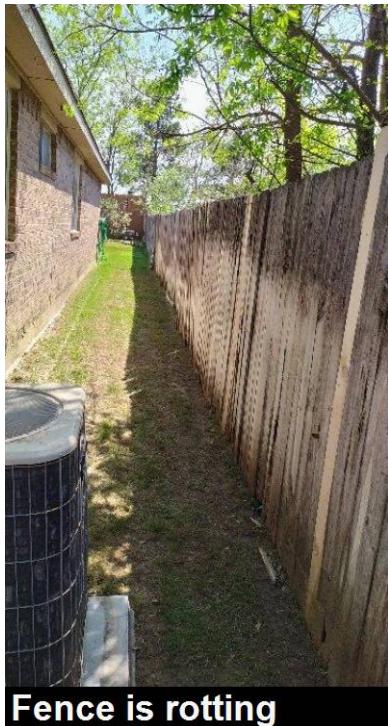
Fence is rotting

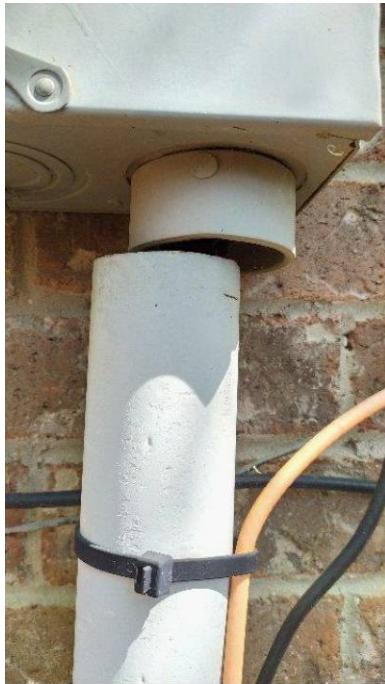
Damaged conduit

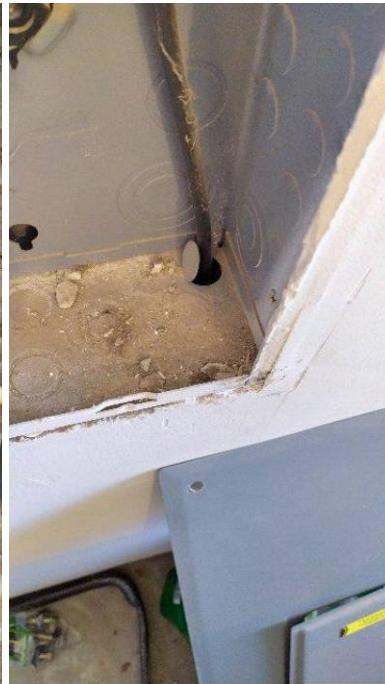
Need cable clamp

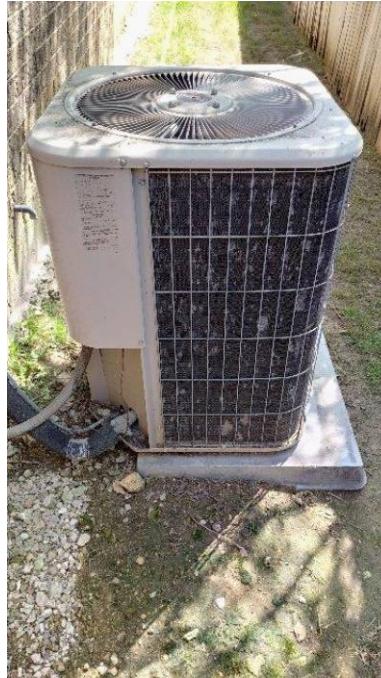
Damaged fins

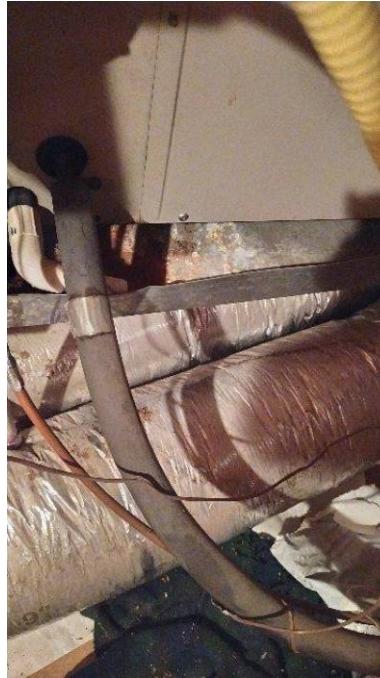
Rust in pan

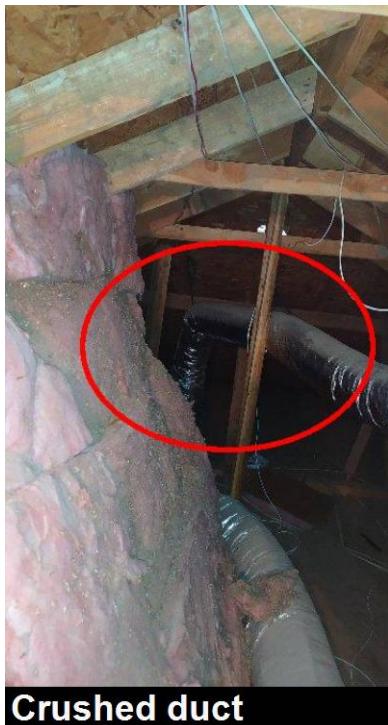
**One or more area(s) of duct works were crushed or air flow appeared to be restricted; we recommend repairs or rerouting of the duct as required to help ensure satisfactory operation.**

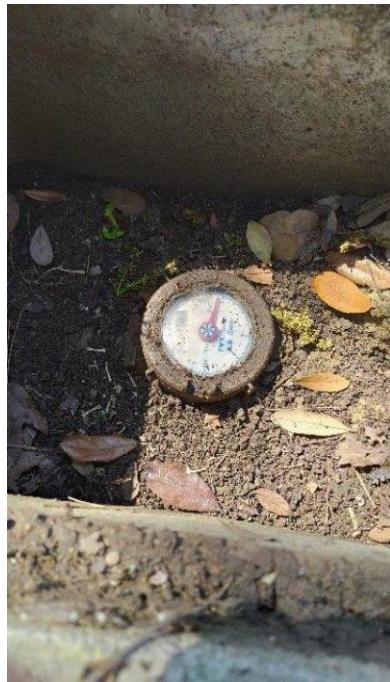
**No leak**

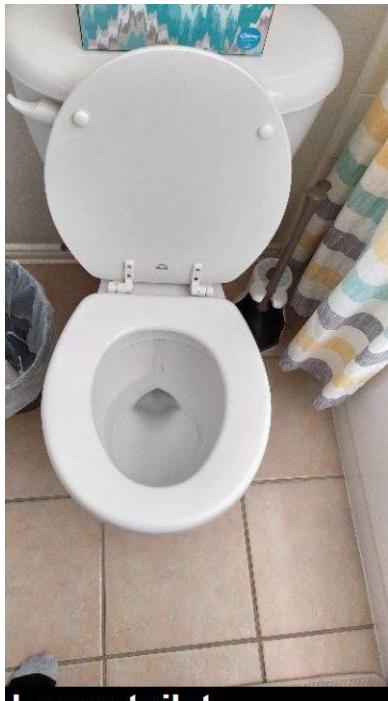
**Loose toilet**

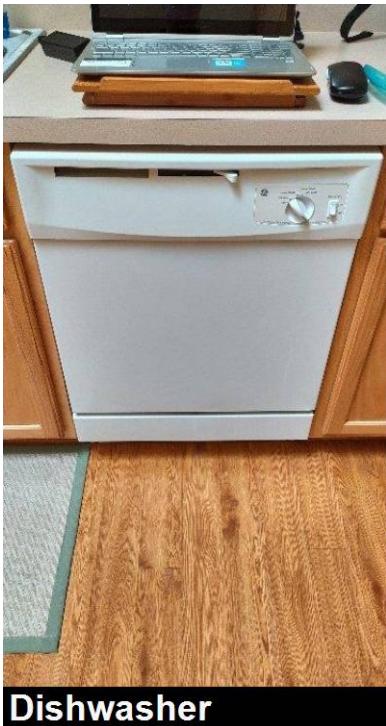
Rust was observed on the racks of the dishwasher.

There was no drip loop installed on the dishwasher drain line. A drip loop is when the dishwasher drain hose is looped up and (preferably) securely fastened to the underside of the counter. It is installed to help prevent backflow of wastewater from the sink into the dishwasher. We recommend evaluation and/or repair by a qualified plumber or handyman.

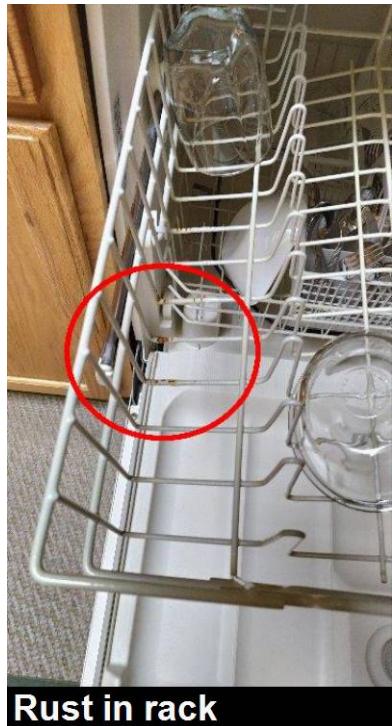
Rust in rack

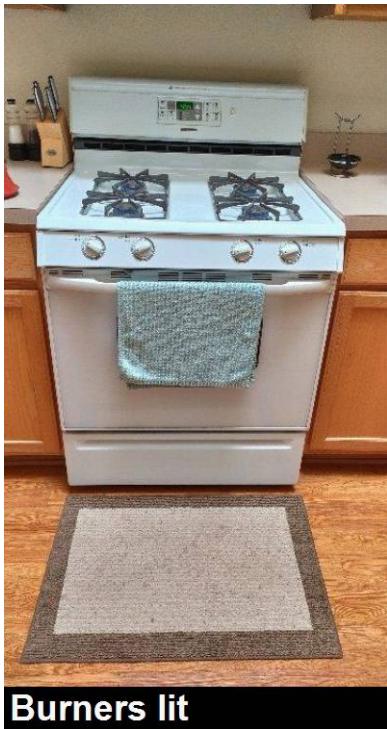
Burners lit

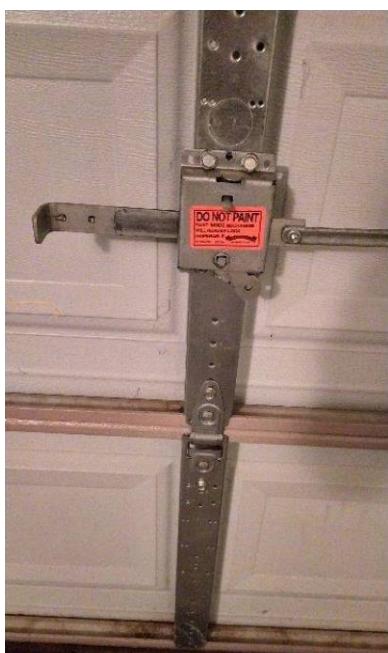
The garage door lock(s) are not disabled. When a garage door opener is installed, the mechanical door lock should be disabled to help prevent damage to the door, should the opener be activated when the garage door lock is engaged.

**Lock not disabled**

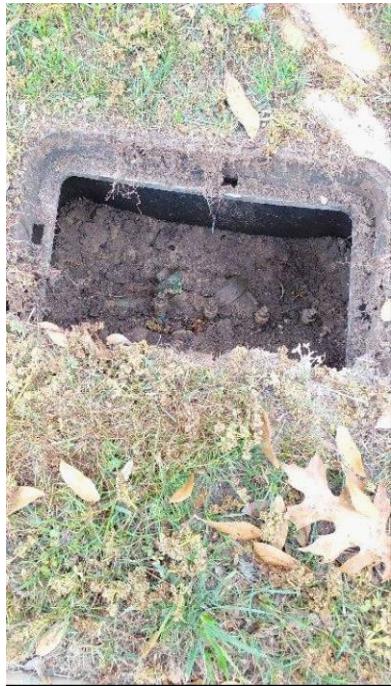
Backflow buried
