Monitoring Series No. ME-09-MSTY-0797-1

THREE-YEAR COMPREHENSIVE MONITORING REPORT

**CAMERON PRAIRIE REFUGE PROTECTION
ME-09**

**First Priority List Shoreline Protection Project
of the Coastal Wetlands Planning, Protection, and Restoration Act
(Public Law 101-646)**

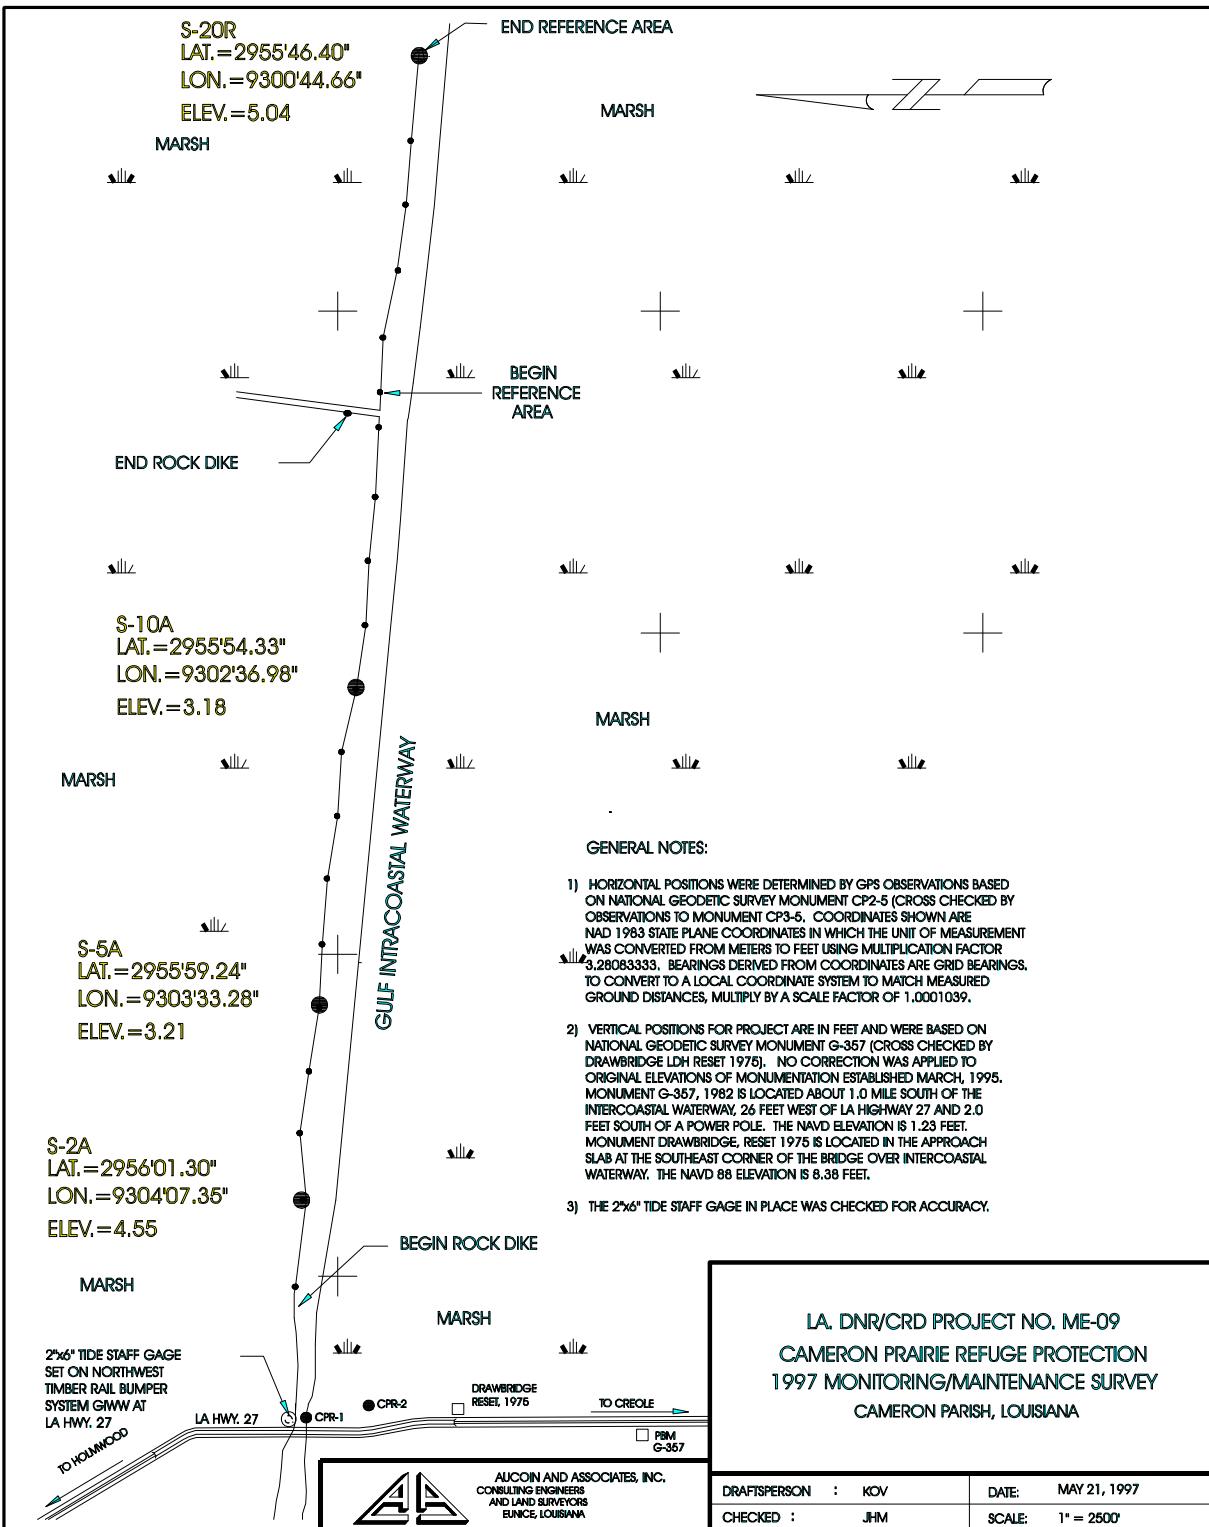
Cross-sectional surveys of the breakwater were completed in March 1995 and May 1997 (figure 2). The surveys delineated the vegetation edge, which will serve as our measure of shoreline position, and channel profile. This survey consisted of 20 cross-sections: 15 in the project area and 5 in the reference area. In the project area, the original brass hubs were all recovered in good condition. Due to erosion of the GIWW canal bank, the reference area brass hubs had to be reset on the proper azimuth away from the existing canal bank.

Figure 2. Cameron Prairie Refuge Protection (ME-09) plan view conducted by Aucoin and Associates, Inc. in 1997 showing each station in the project and reference area.

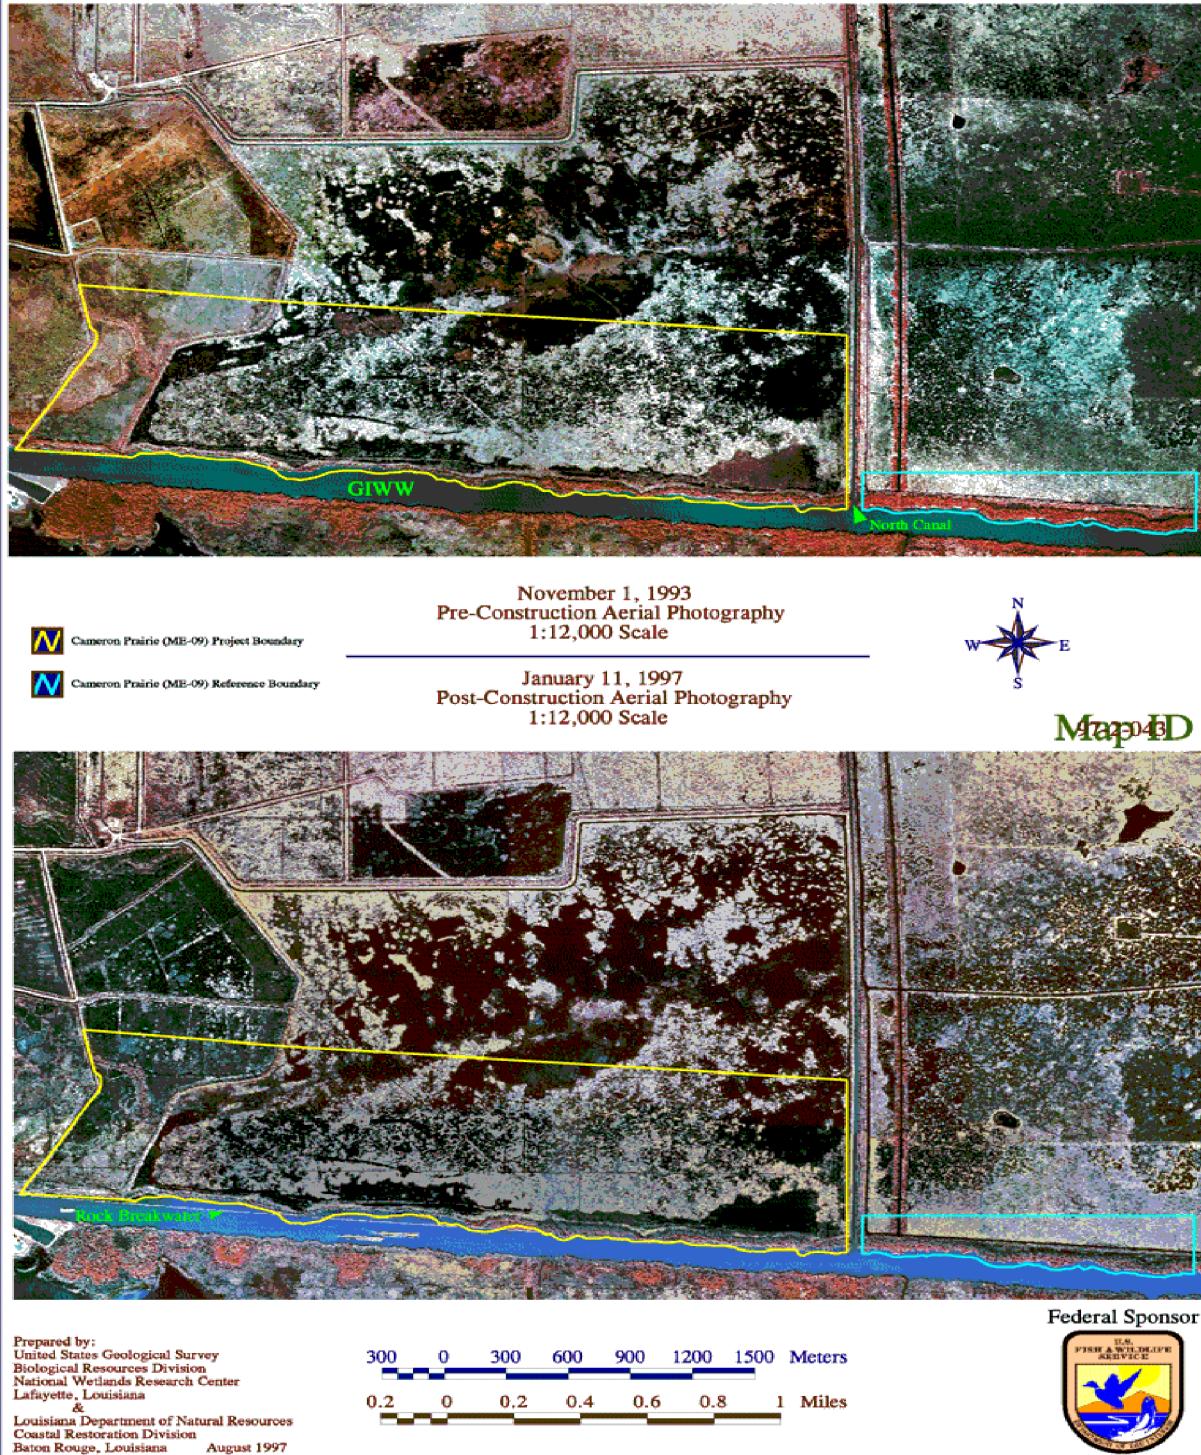
The GIS analysis revealed noticeable new vegetation present in the central portion of the project area, between the rock breakwater and the shoreline (figure 3). Overall, however, the 778 ac (315 ha) project area showed a 9.91% increase in water; by comparison, the 106 ac (43 ha) reference area experienced a 1.58% increase in water (table 1).

Figure 3. Cameron Prairie Refuge Protection (ME-09) pre- and post-construction aerial photography.

GIS land/water analysis comparing pre-construction and post-construction photography revealed only small changes in the reference area; whereas, the project area showed a marked increase in the ratio of water to land. However, four principal difficulties were associated with the interpretation of this photography. First, the western expansion section of the project area was eliminated from analysis due to standing water conditions and submersion of vegetation. Similar conditions may have contributed to the apparent increase in water in the analyzed portion of the project area as well. Second, the preconstruction photography, flown in November, showed trees and extremely high vegetation along the GIWW shoreline. This vegetation casts shadows which visually appear as open water on the photography. Third, the pre-construction photography showed large sections of floating vegetation throughout the project area and in canals in the reference area. On the photography, floating vegetation visually appears to be land. Finally, because the post-construction flight was conducted in January 1997, due to unsatisfactory weather conditions in November 1996, apparent differences in preconstruction and post-construction vegetation may be a reflection of time of year rather than project effects.

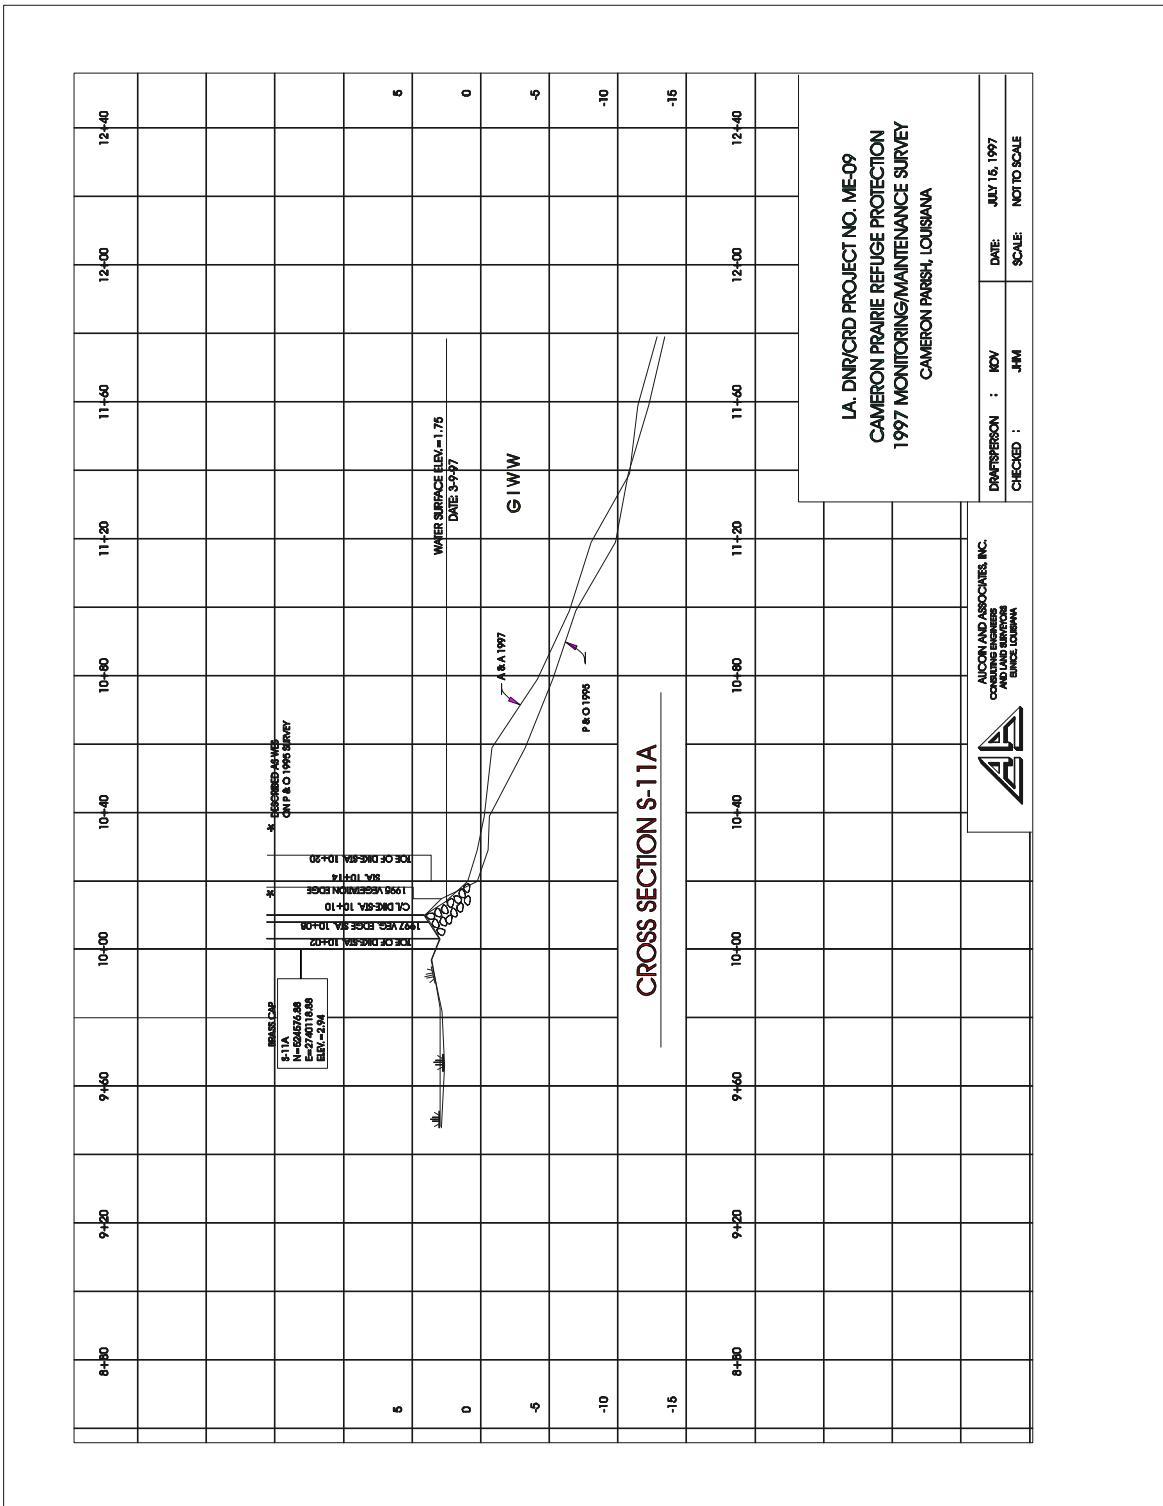
Erosion was indicated at only one station in the project area at station S-11A (figure 14). Apparently, the 1995 surveyors interpreted the vegetated edge to be on the GIWW side of the rock dike while the 1997 surveyors interpreted the vegetated edge to be on the marsh side of the rock dike. At this station the dike meets the existing spoil bank and vegetation is coming up through the dike. The 1995 and 1997 surveys show the vegetated edge on the rock dike itself.

Figure 14. Cameron Prairie Refuge Protection (ME-09) cross section S-11A in the project area showing the survey lines, vegetation edge, and channel profile.
