1. Vehicle Details

The vehicle in question is a white car with an undetectable license plate. No addition al vehicle data was found.

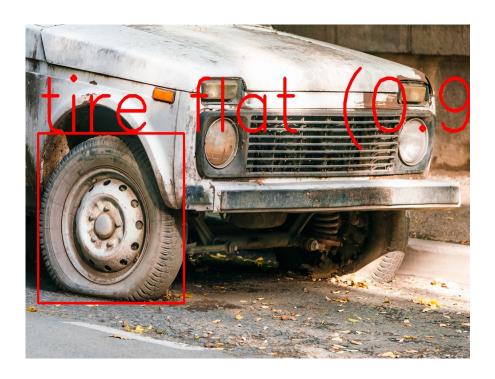
- The vehicle is currently inoperable due to a flat tire on the left side.

- 1. Flat tire on the left side:
 - Damage description: tire flat, likely due to low tire pressure or puncture
 - Damage extent: minor to moderate
 - Confidence level: 0.93

- Severity level: 2 (Moderate)

- Repair the flat tire
- Check tire pressure to prevent future flats

- The vehicle requires towing to a repair facility for tire repair.
- Estimated towing distance: approximately 5 miles
- Towing method: flatbed tow truck
- Estimated towing time: 30 minutes

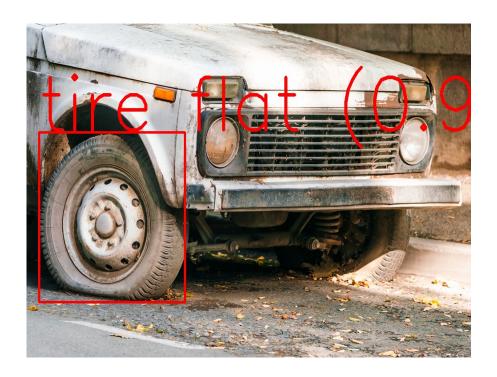
- The vehicle is currently inoperable due to a flat tire on the left side.

- 1. Flat tire on the left side:
 - Damage description: tire flat, likely due to low tire pressure or puncture
 - Damage extent: minor to moderate
 - Confidence level: 0.93

- Severity level: 2 (Moderate)

- Repair the flat tire
- Check tire pressure to prevent future flats

- The vehicle requires towing to a repair facility for tire repair.
- Estimated towing
