# Property Inspection Photos

**Job No:** BAA 242022

**Property Address:** 10 Riddle Street Bentleigh VIC 3204

**Date:** 24 July 202

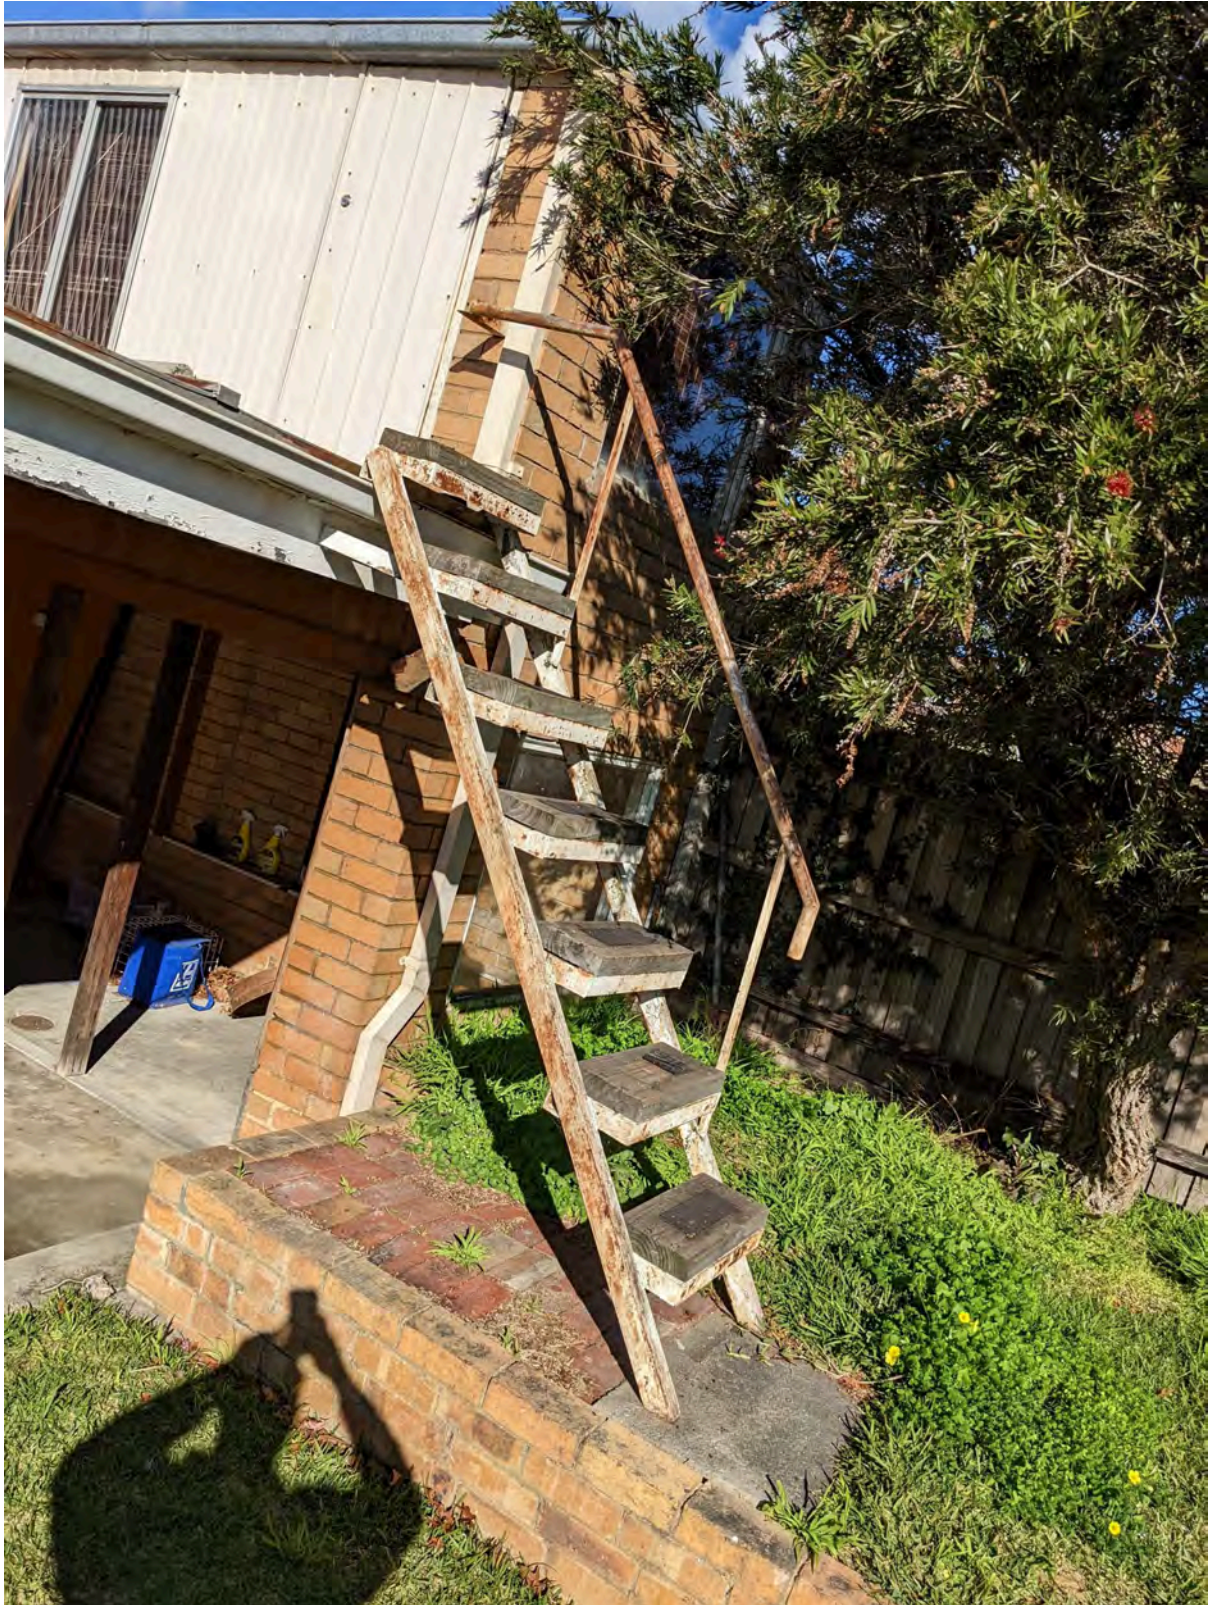
**Unsafe Stairs to Loft (1)**

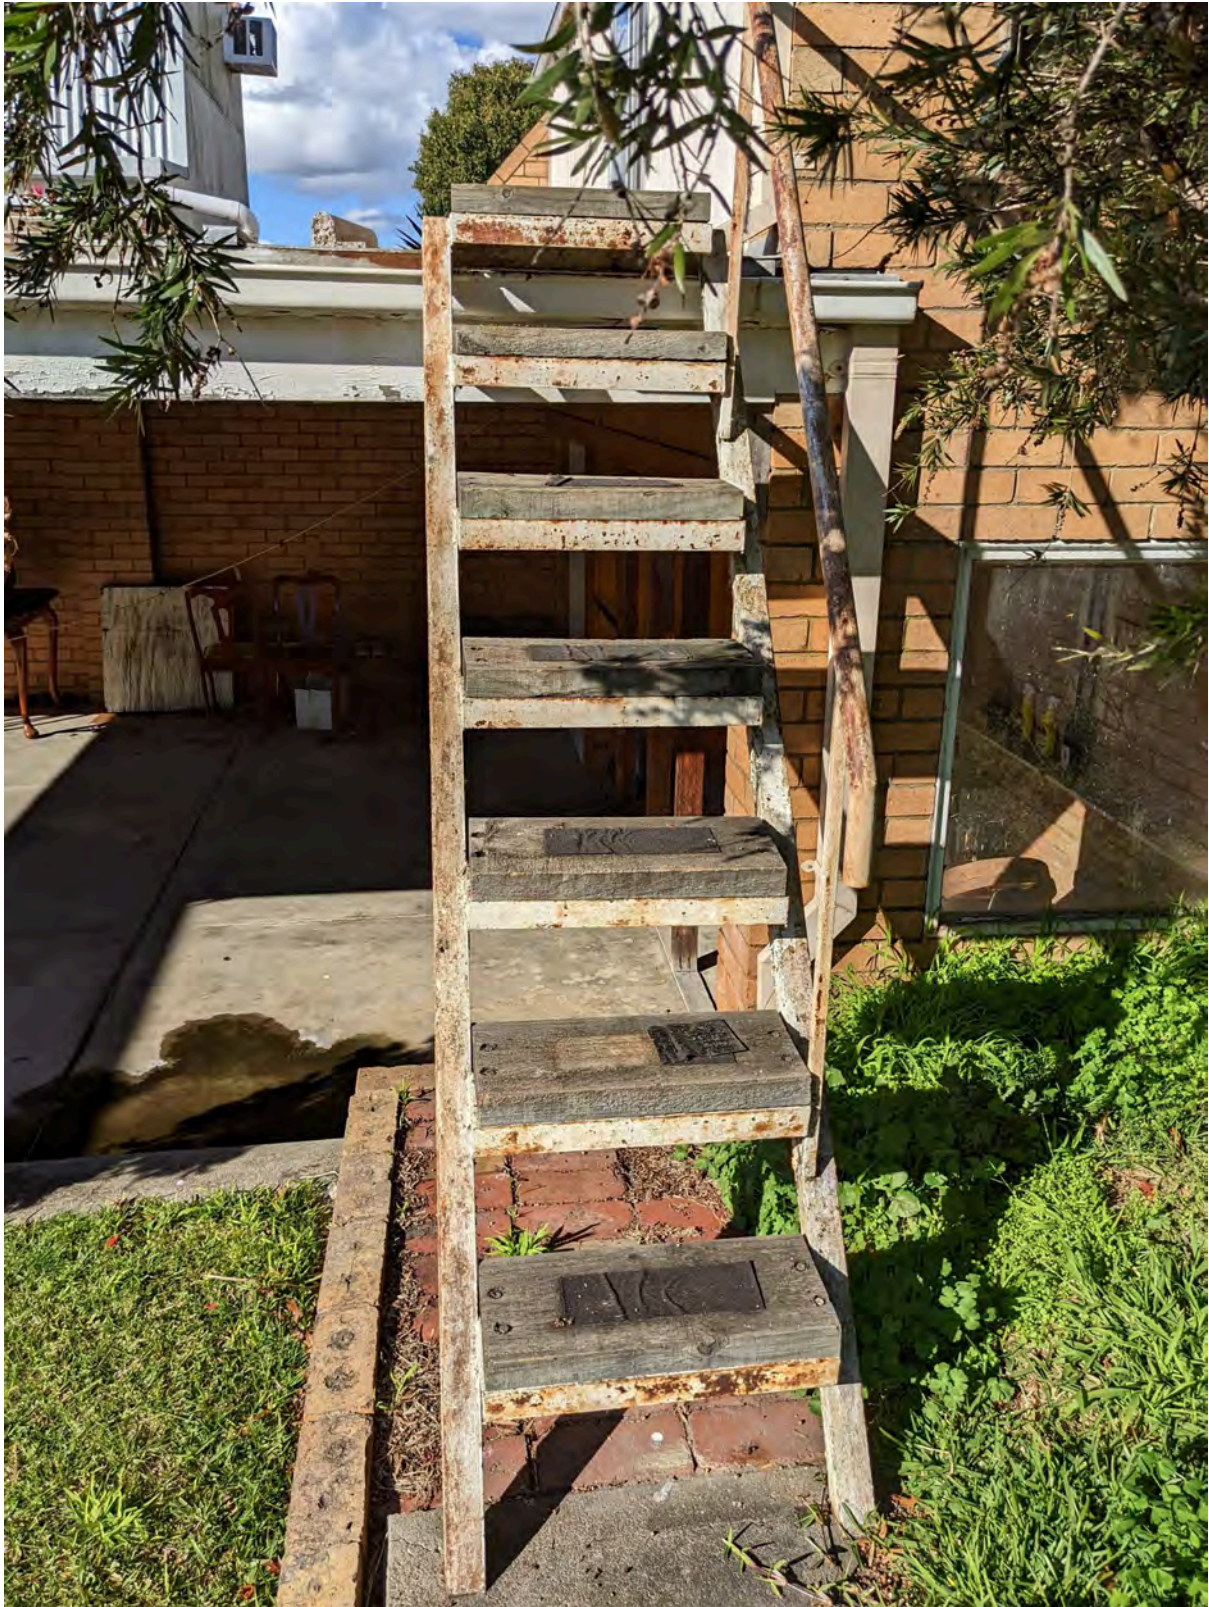
**Unsafe Stairs to Loft (2)**

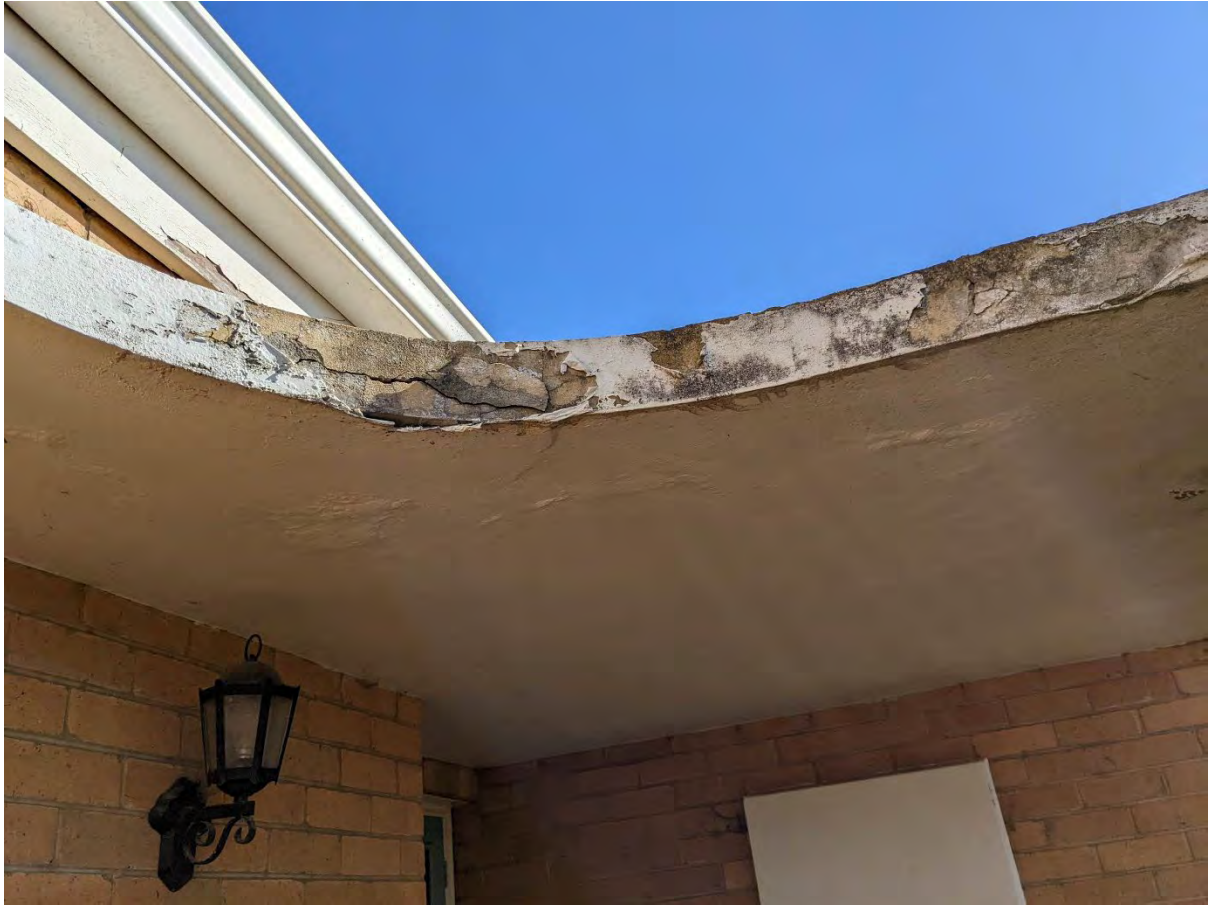
**Entry Roof Deteriorating Concrete**

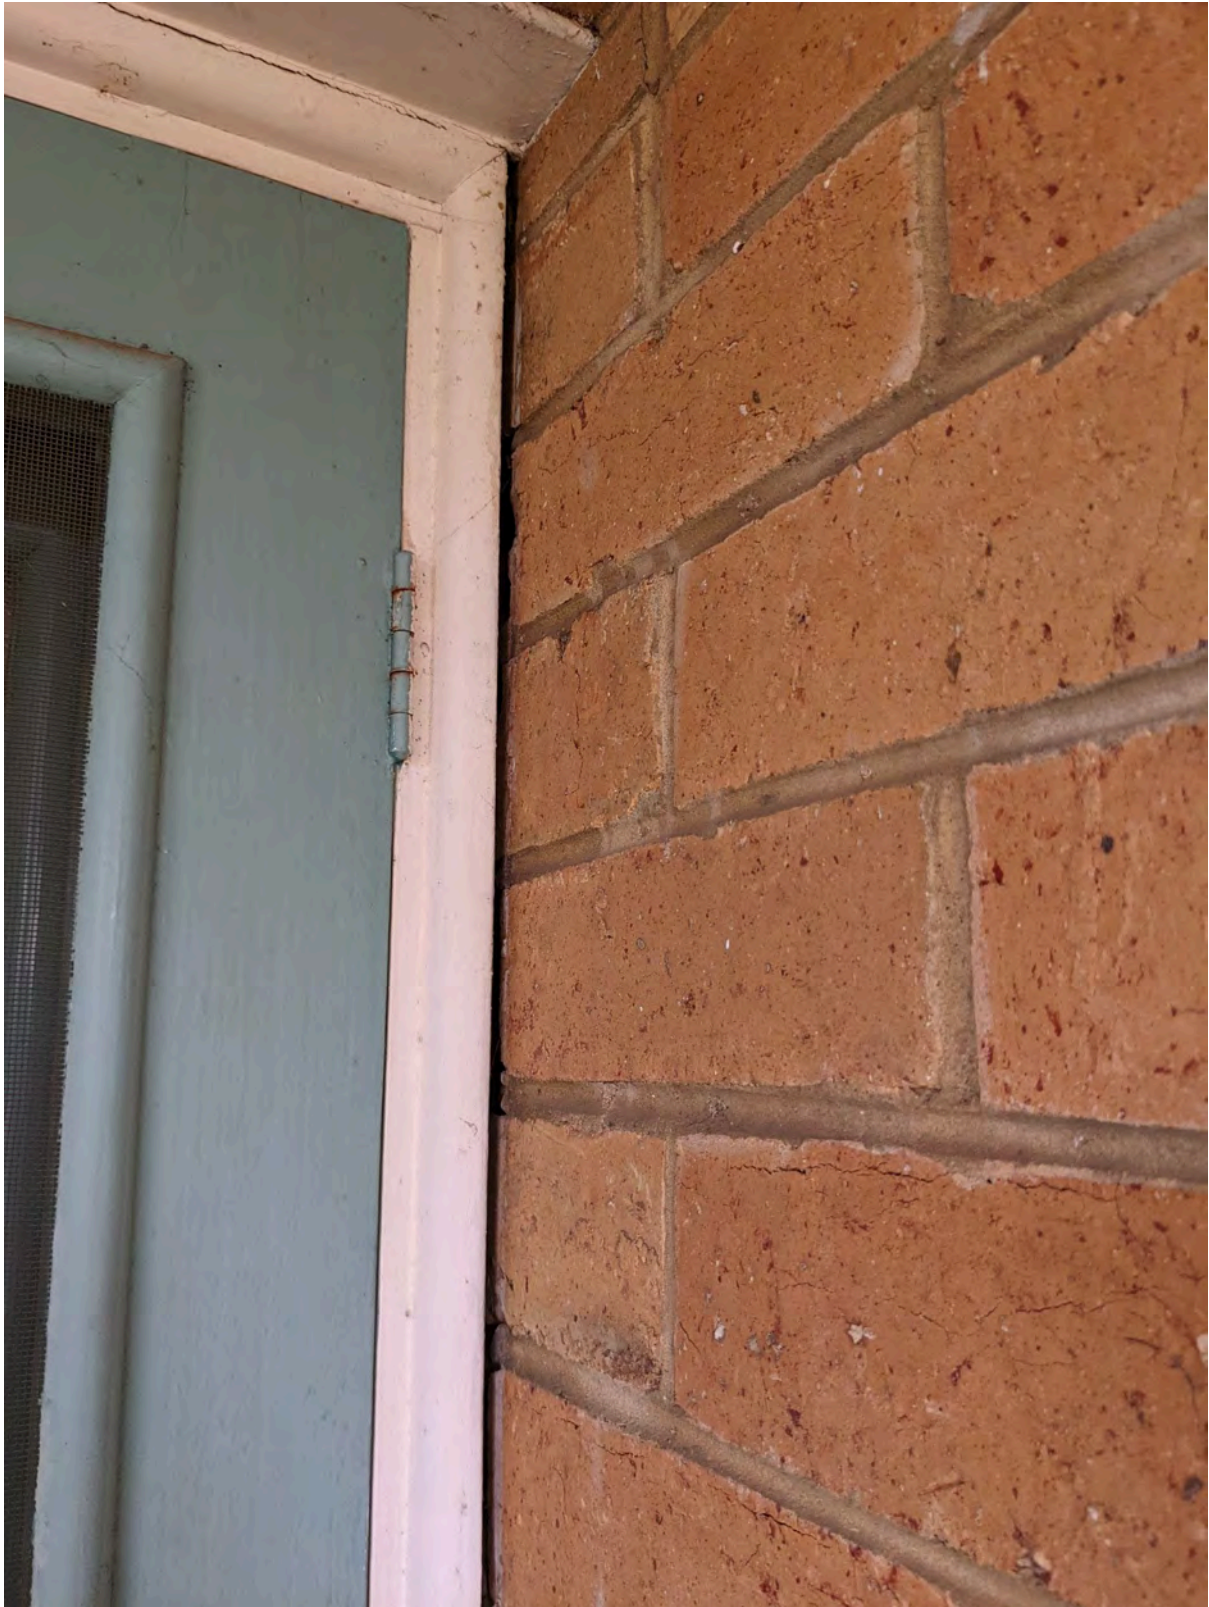
**Entry Door Gaps - No Seals**

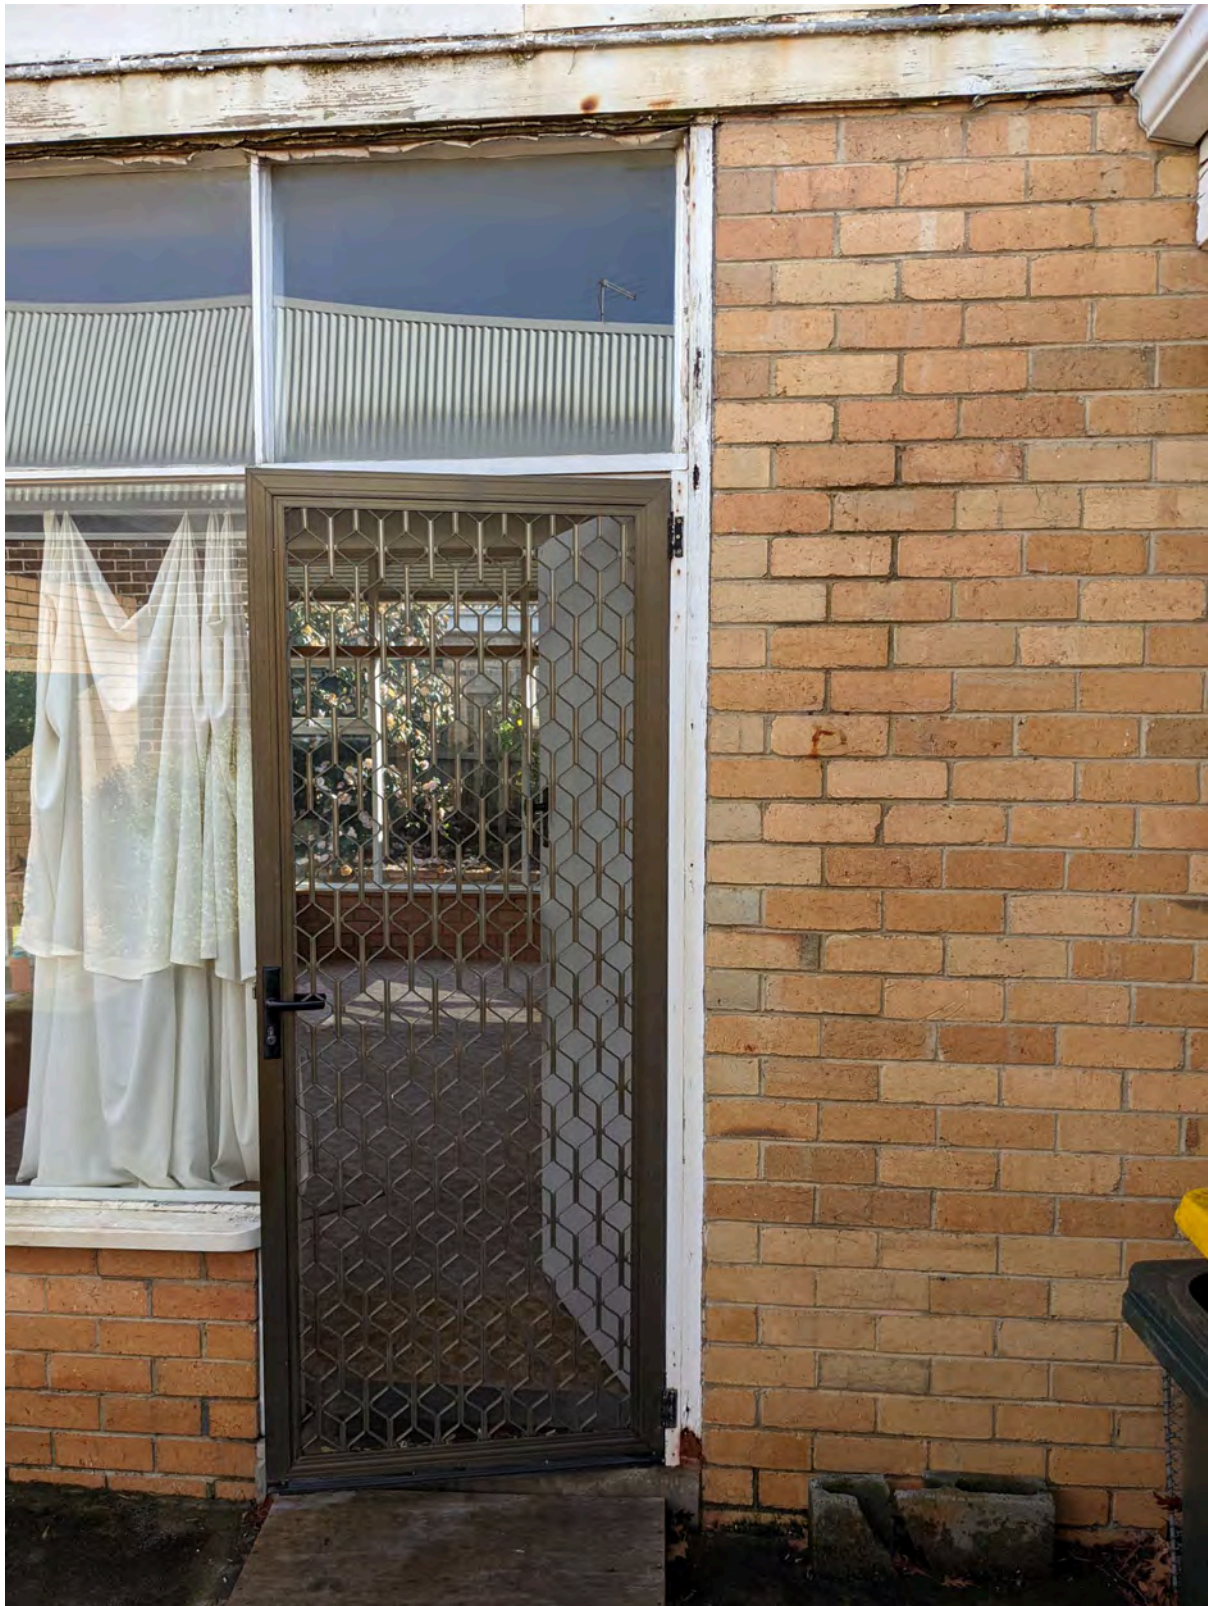
**Backdoor Frame and Ceiling Rot**

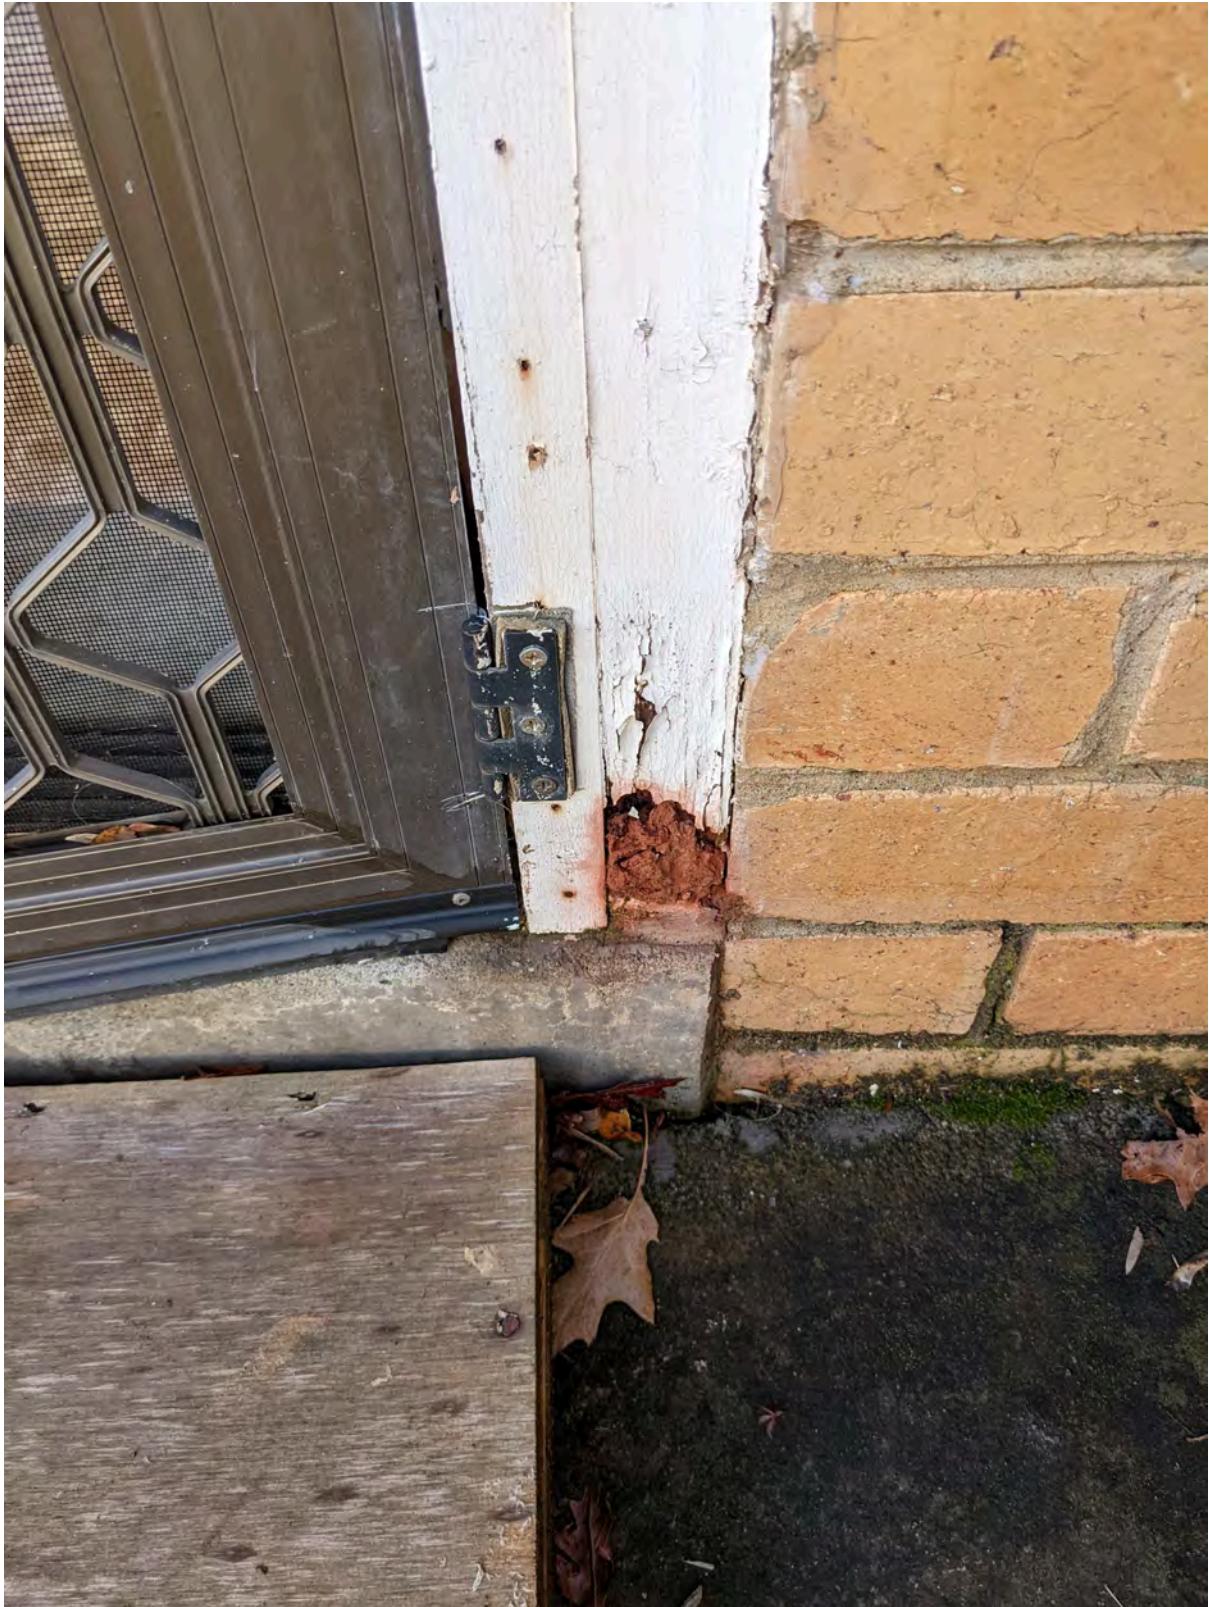
**Backdoor Frame Rot**

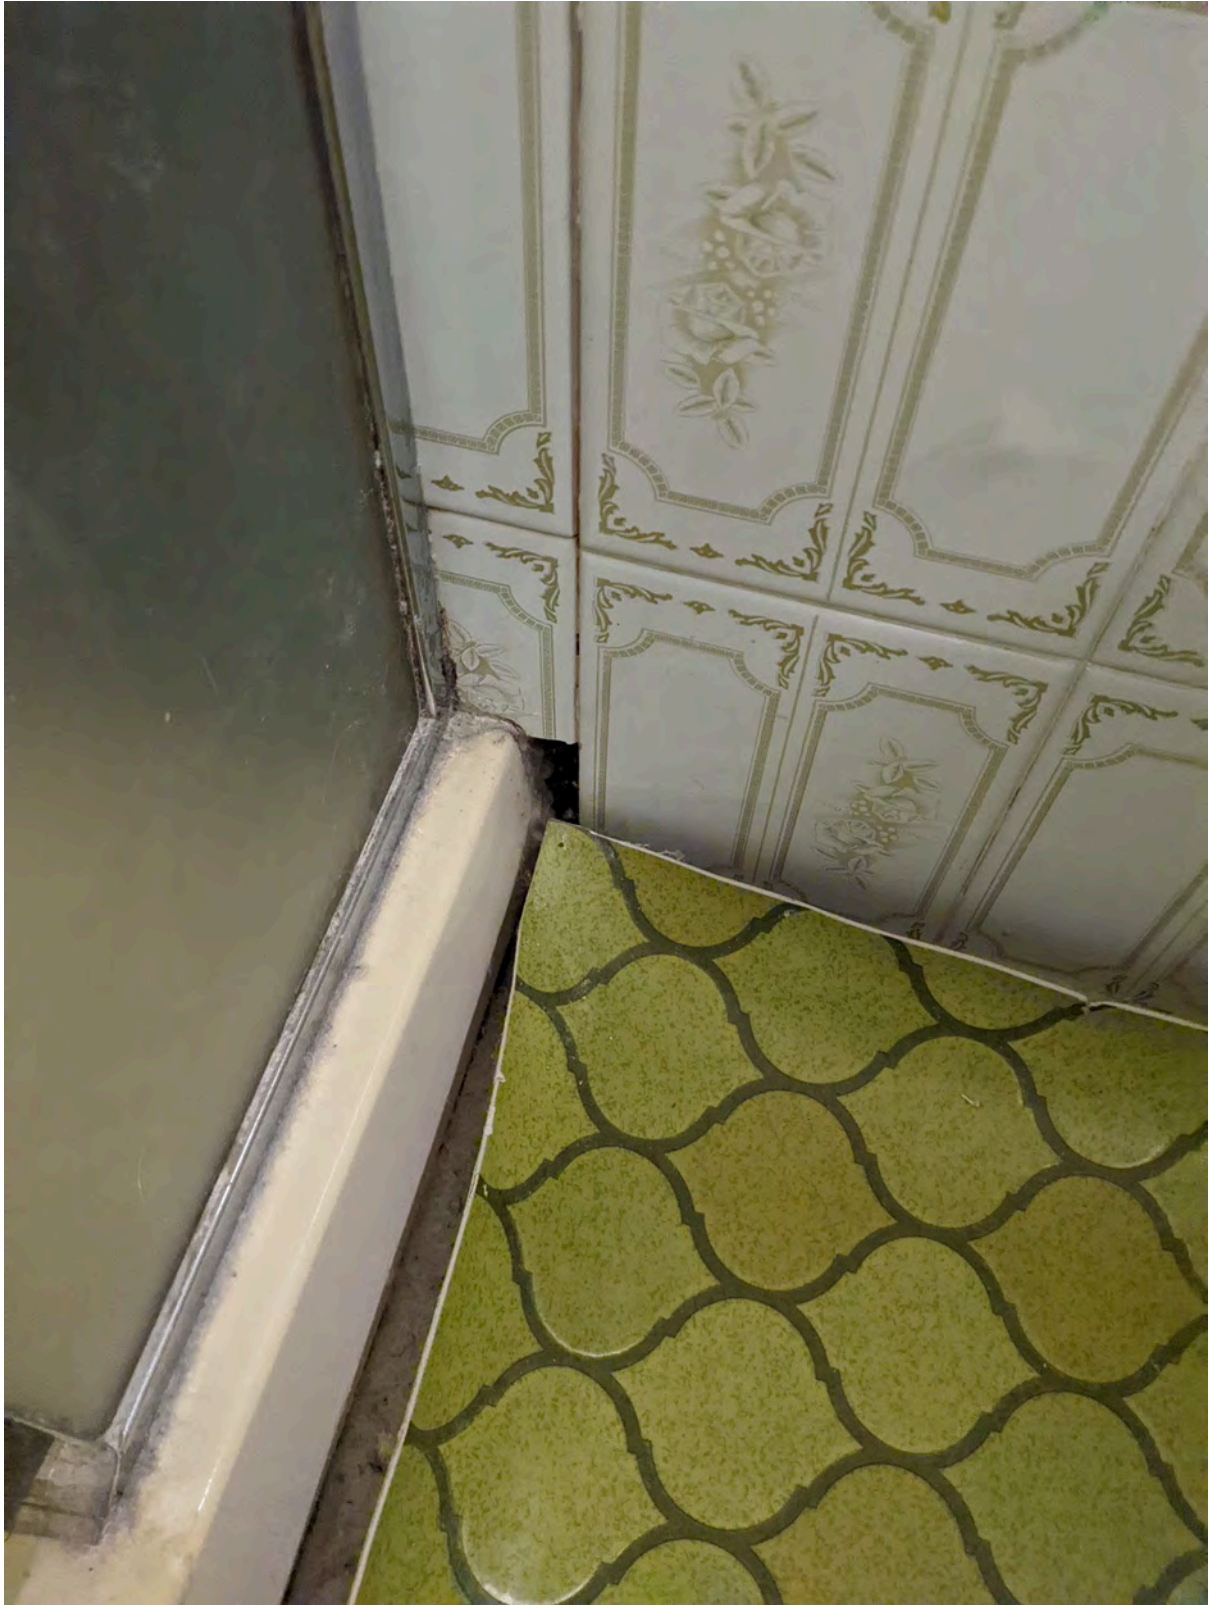
**Bathroom Gap in Tilework**

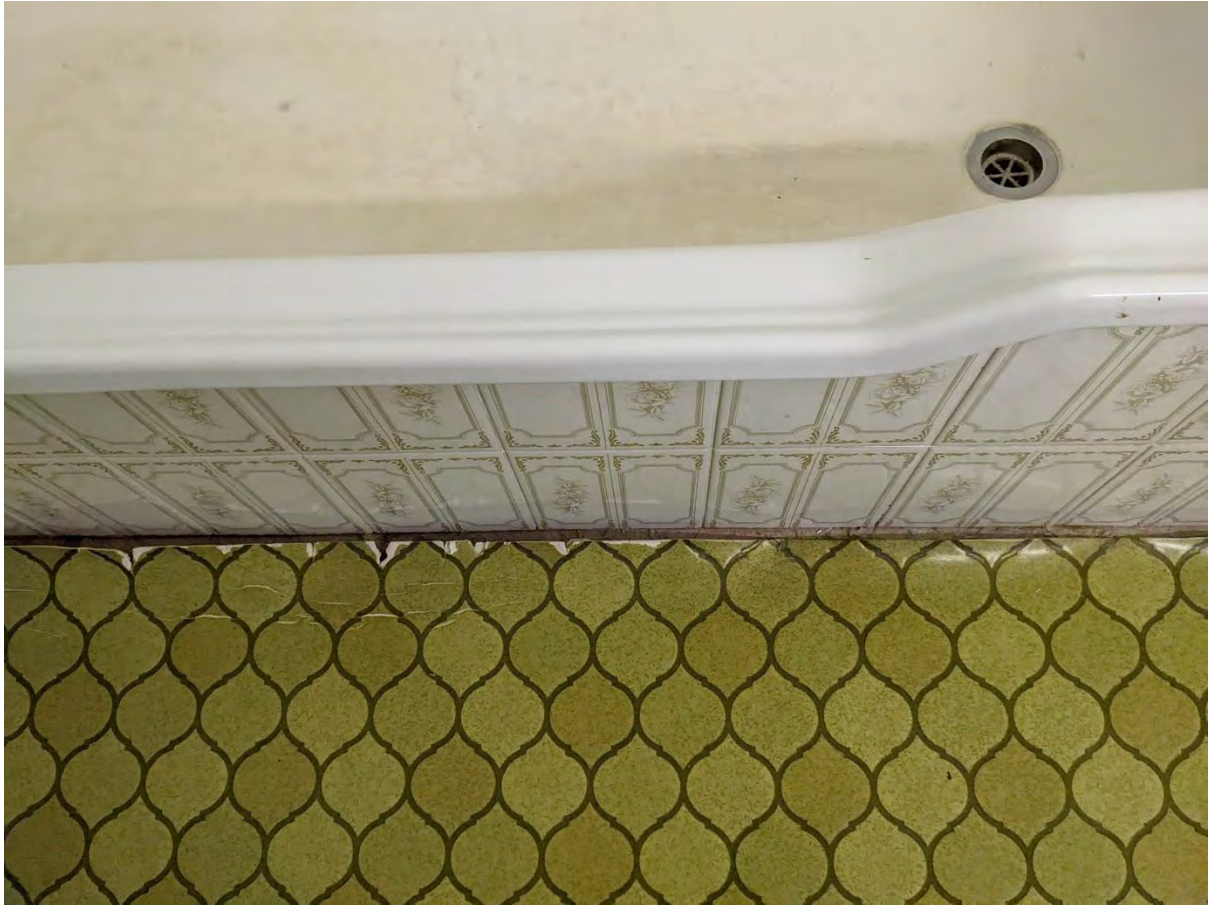
**Bathroom Lino Lifting**

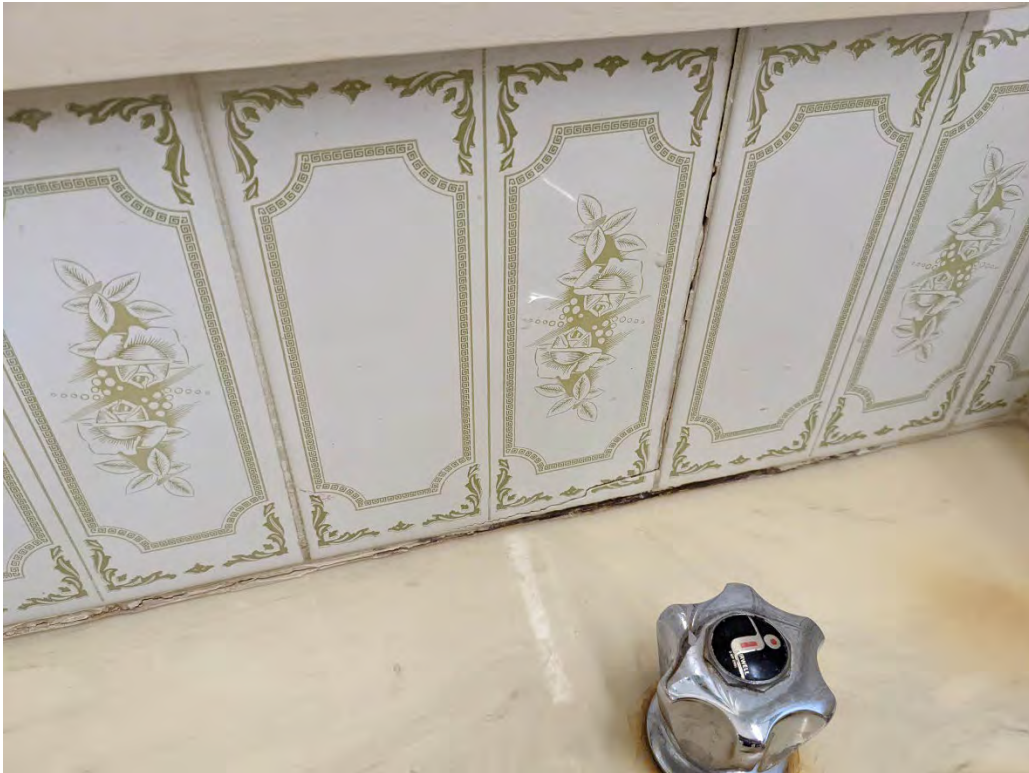
**Bathroom Sink Cracked Tiles and No Sealant**

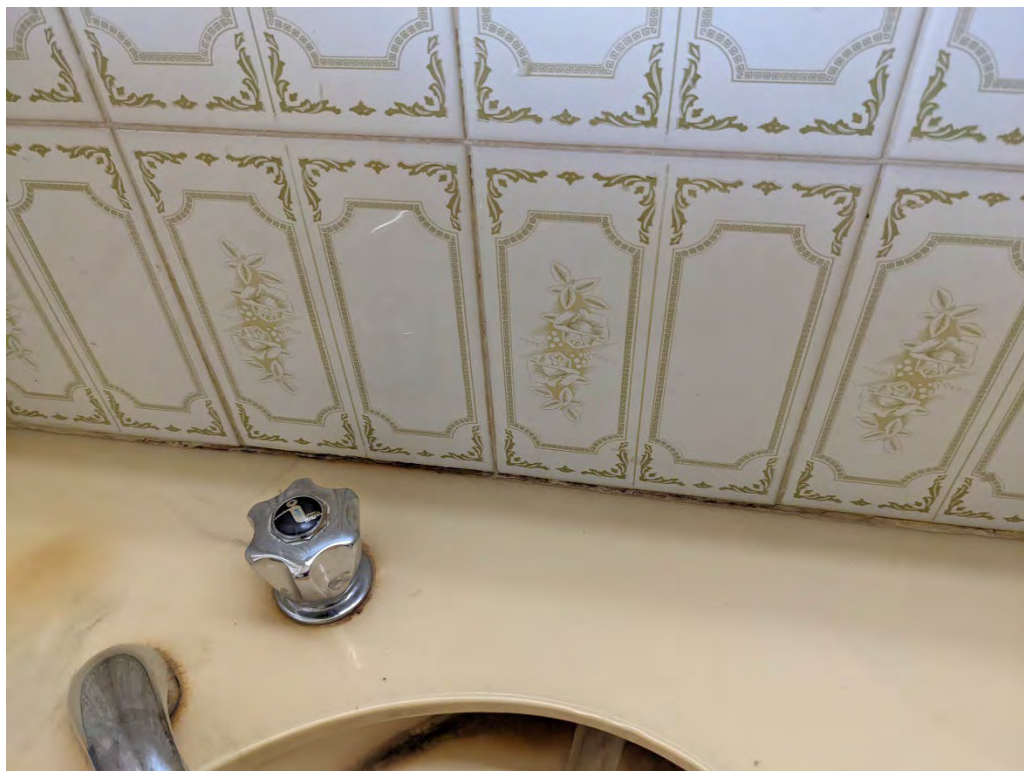
**Bathroom Sink Tiles No Sealant**

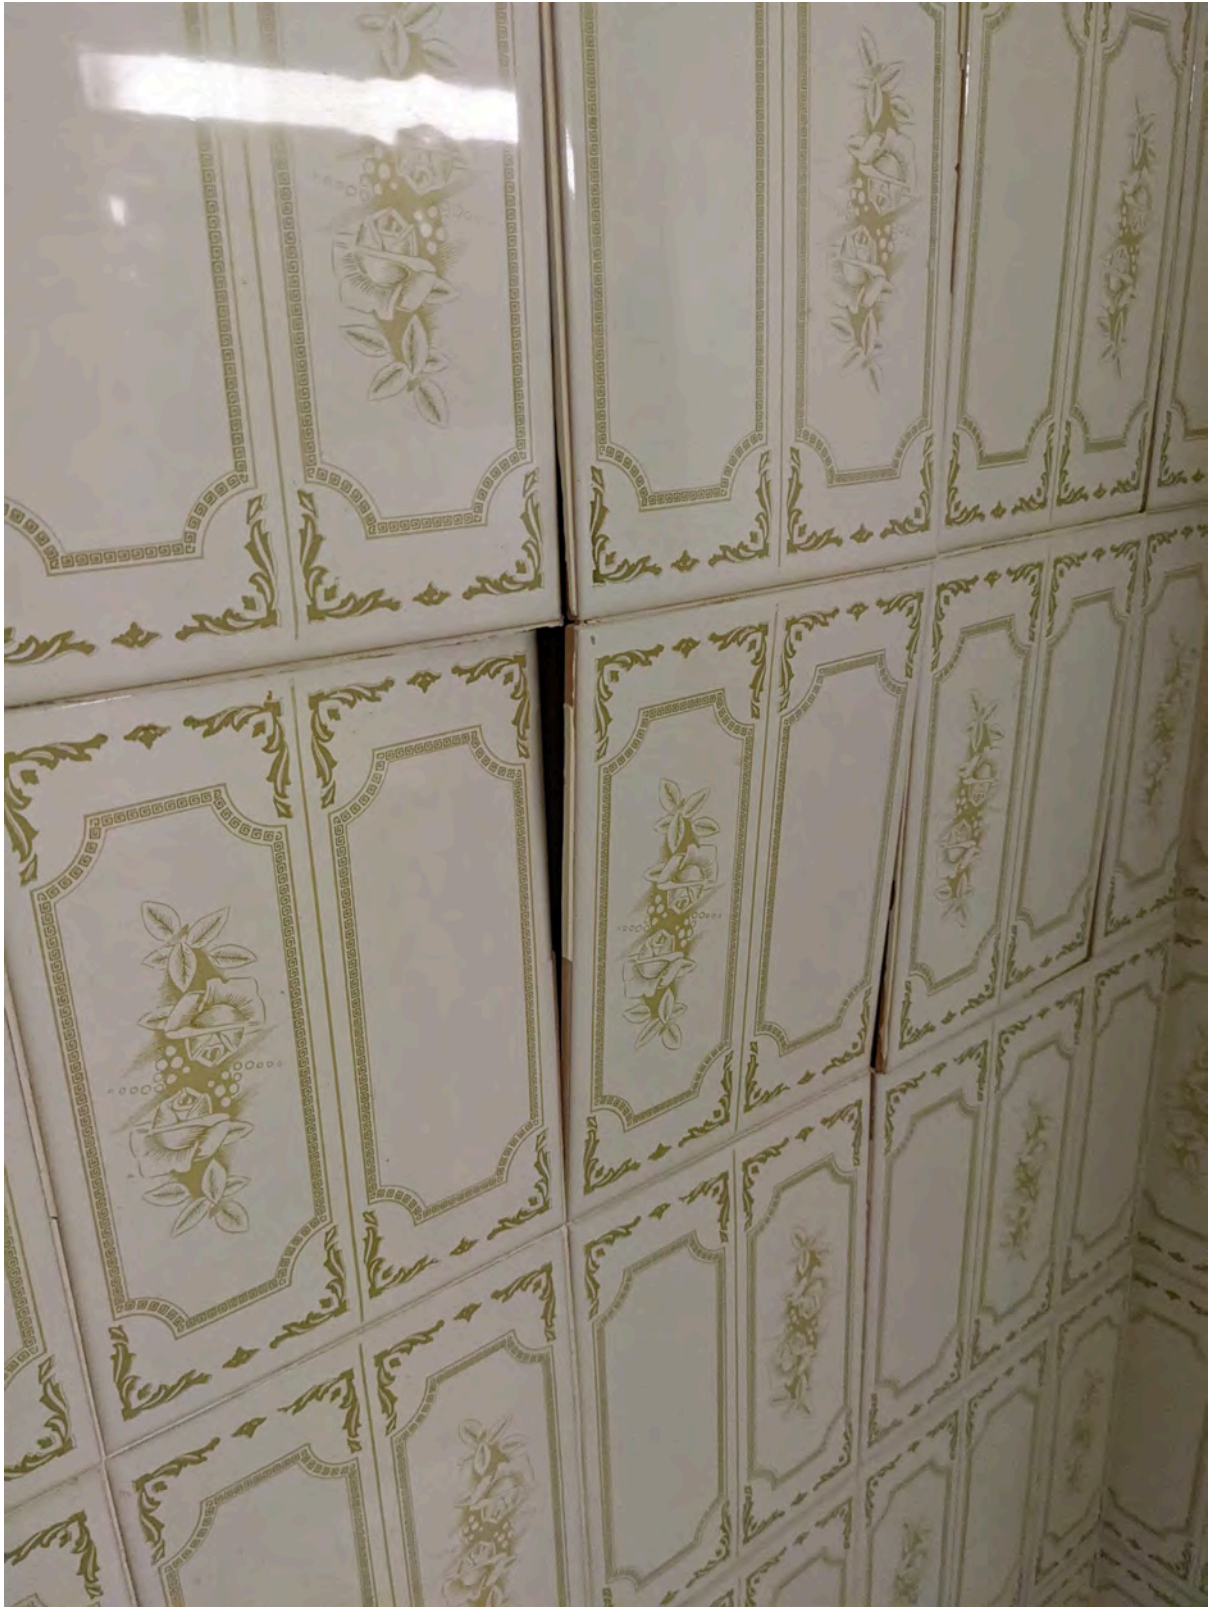
**Bathroom Tiles Falling Off (1)**

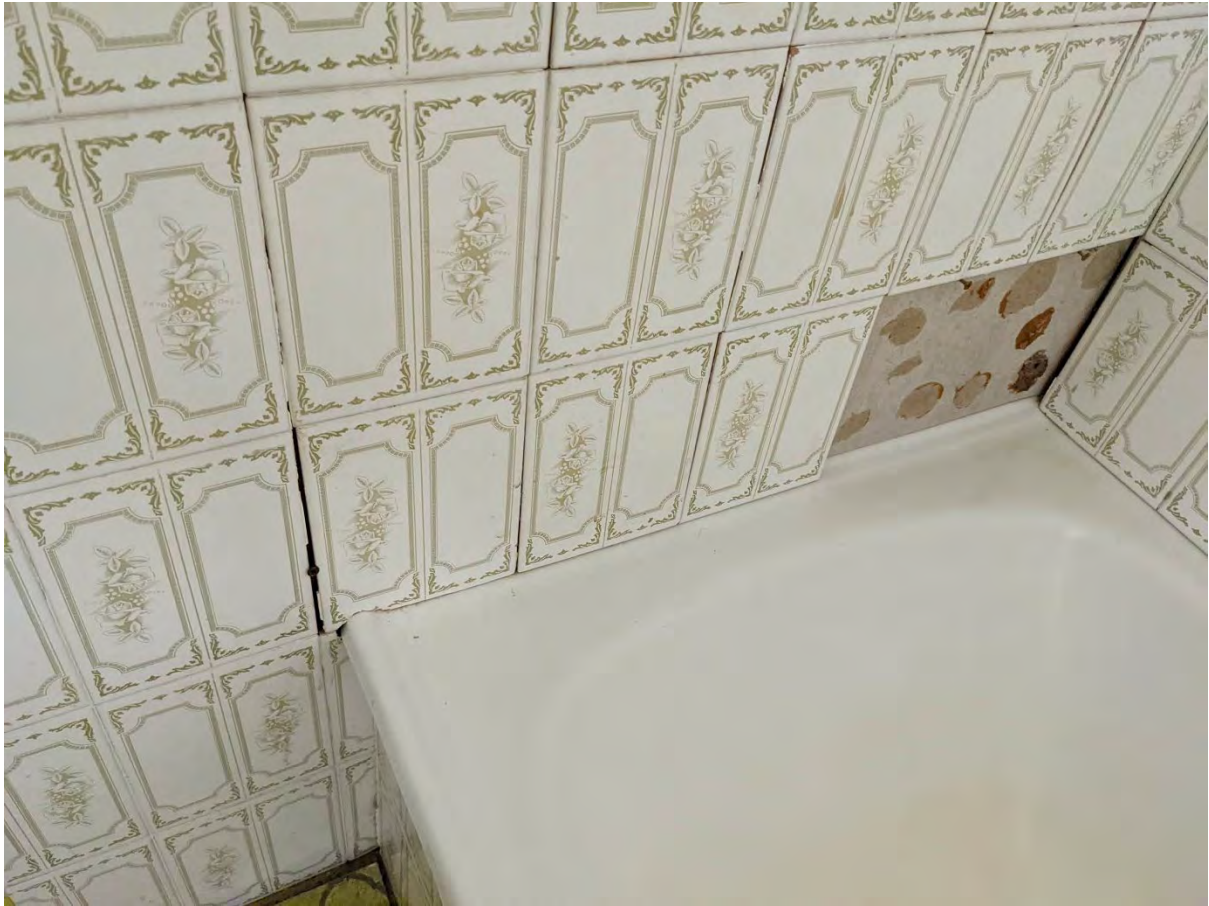
**Bathroom Tiles Falling Off (2)**

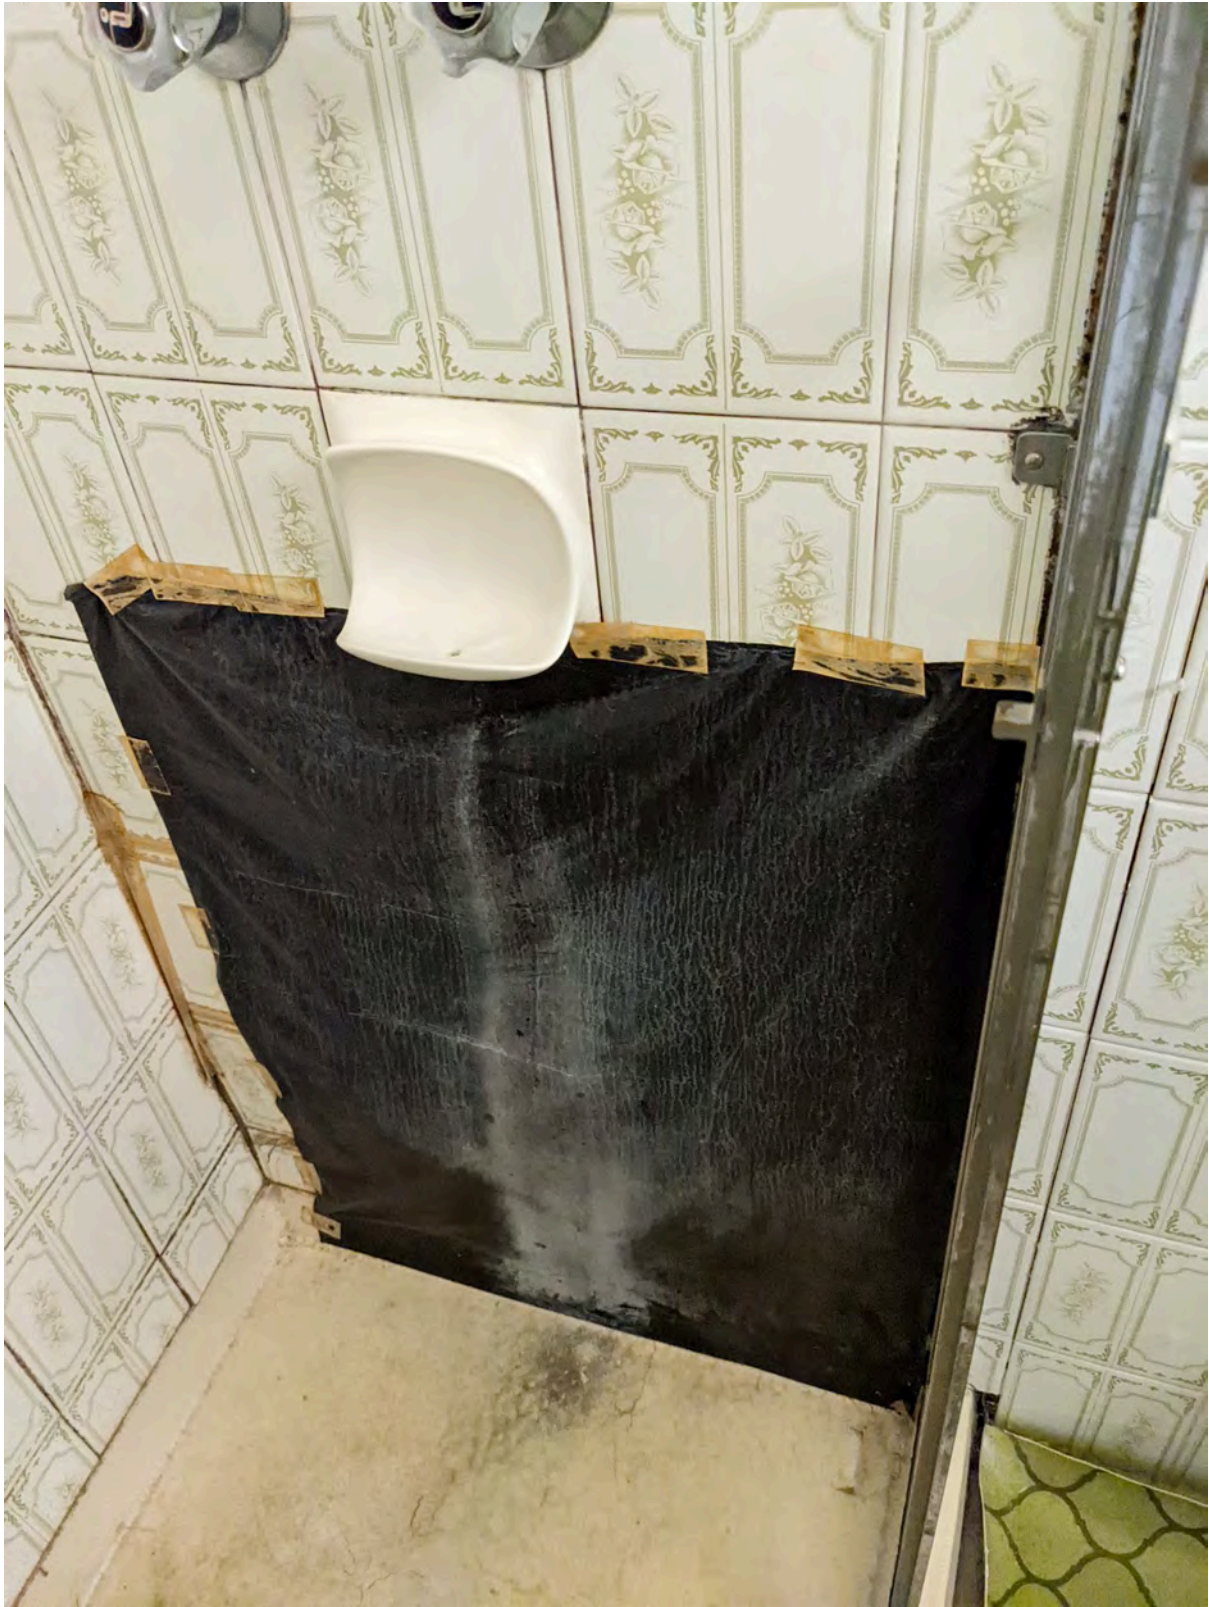
**Plastic Sheet Used to Cover Shower Wall Where Tiles Have Fallen Off**

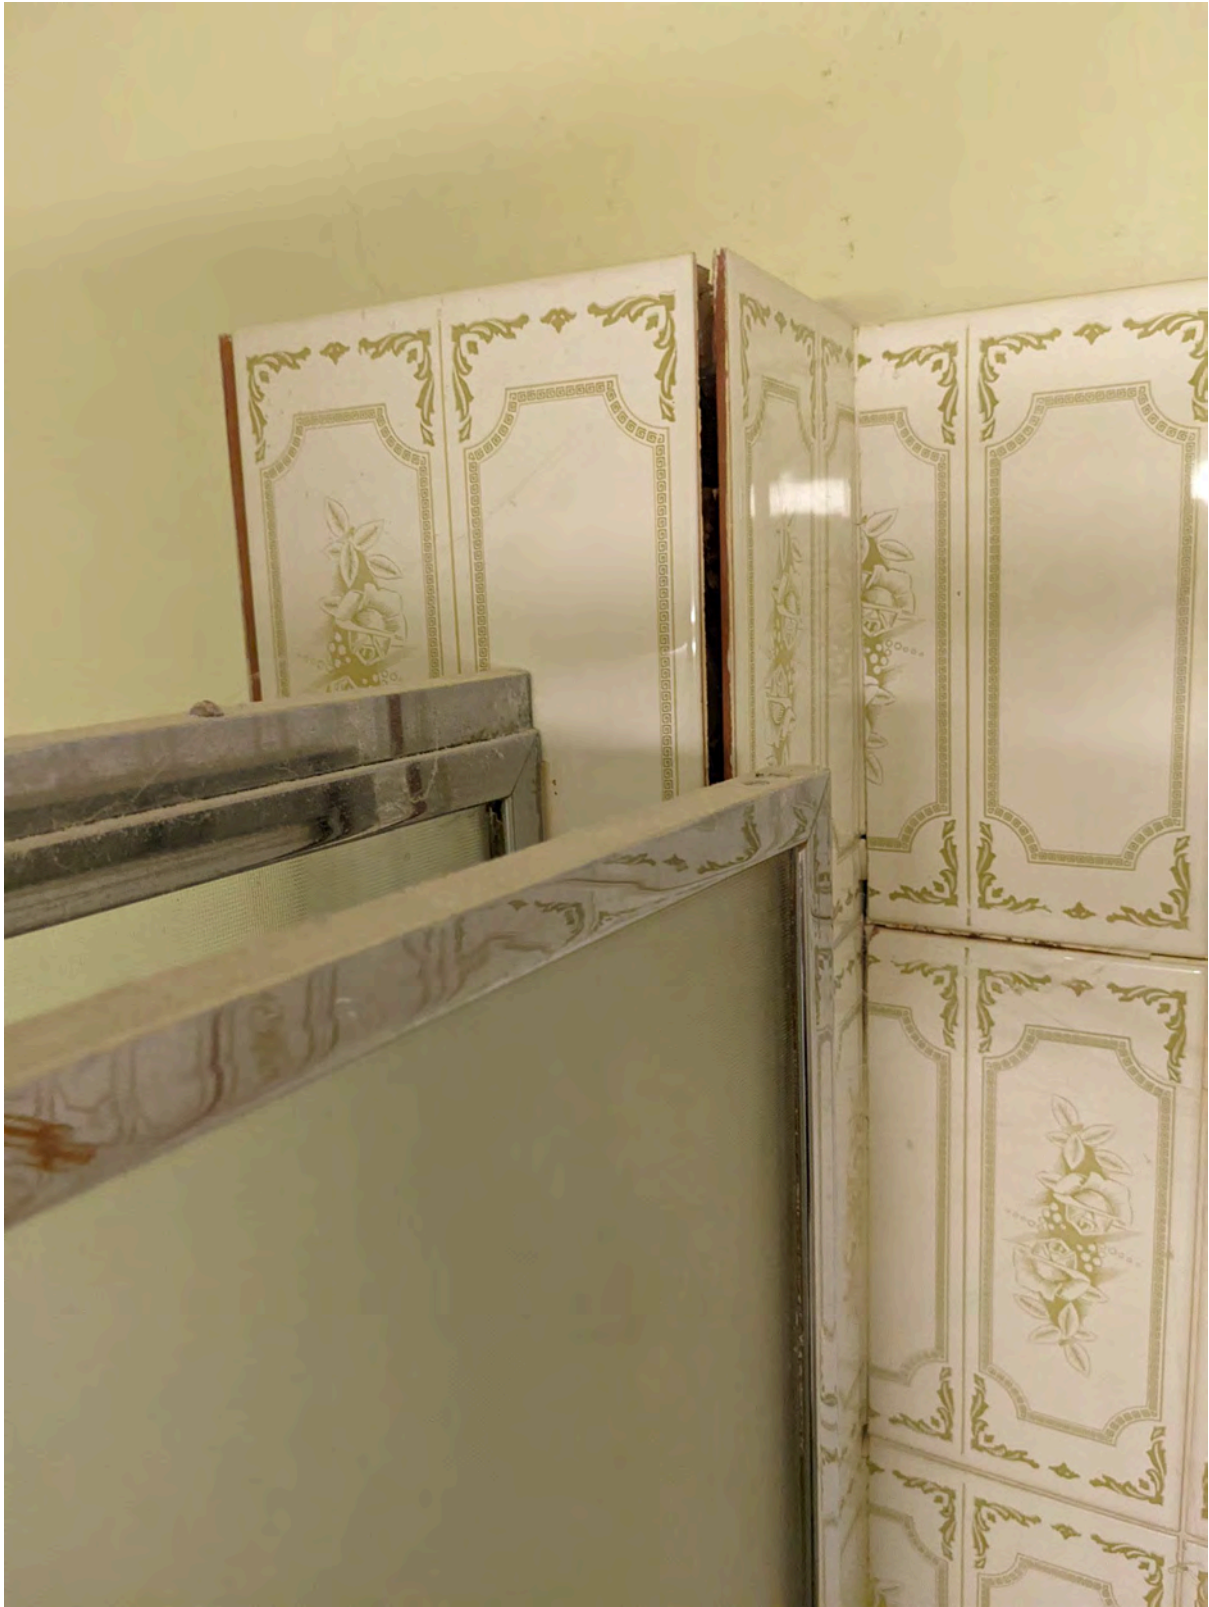
**Shower Frame Tiles Falling Off**
