# Property Inspection Photos

**Job No:** BAA 242022

**Property Address:** 10 Riddle Street Bentleigh VIC 3204

**Date:** 24 July 202

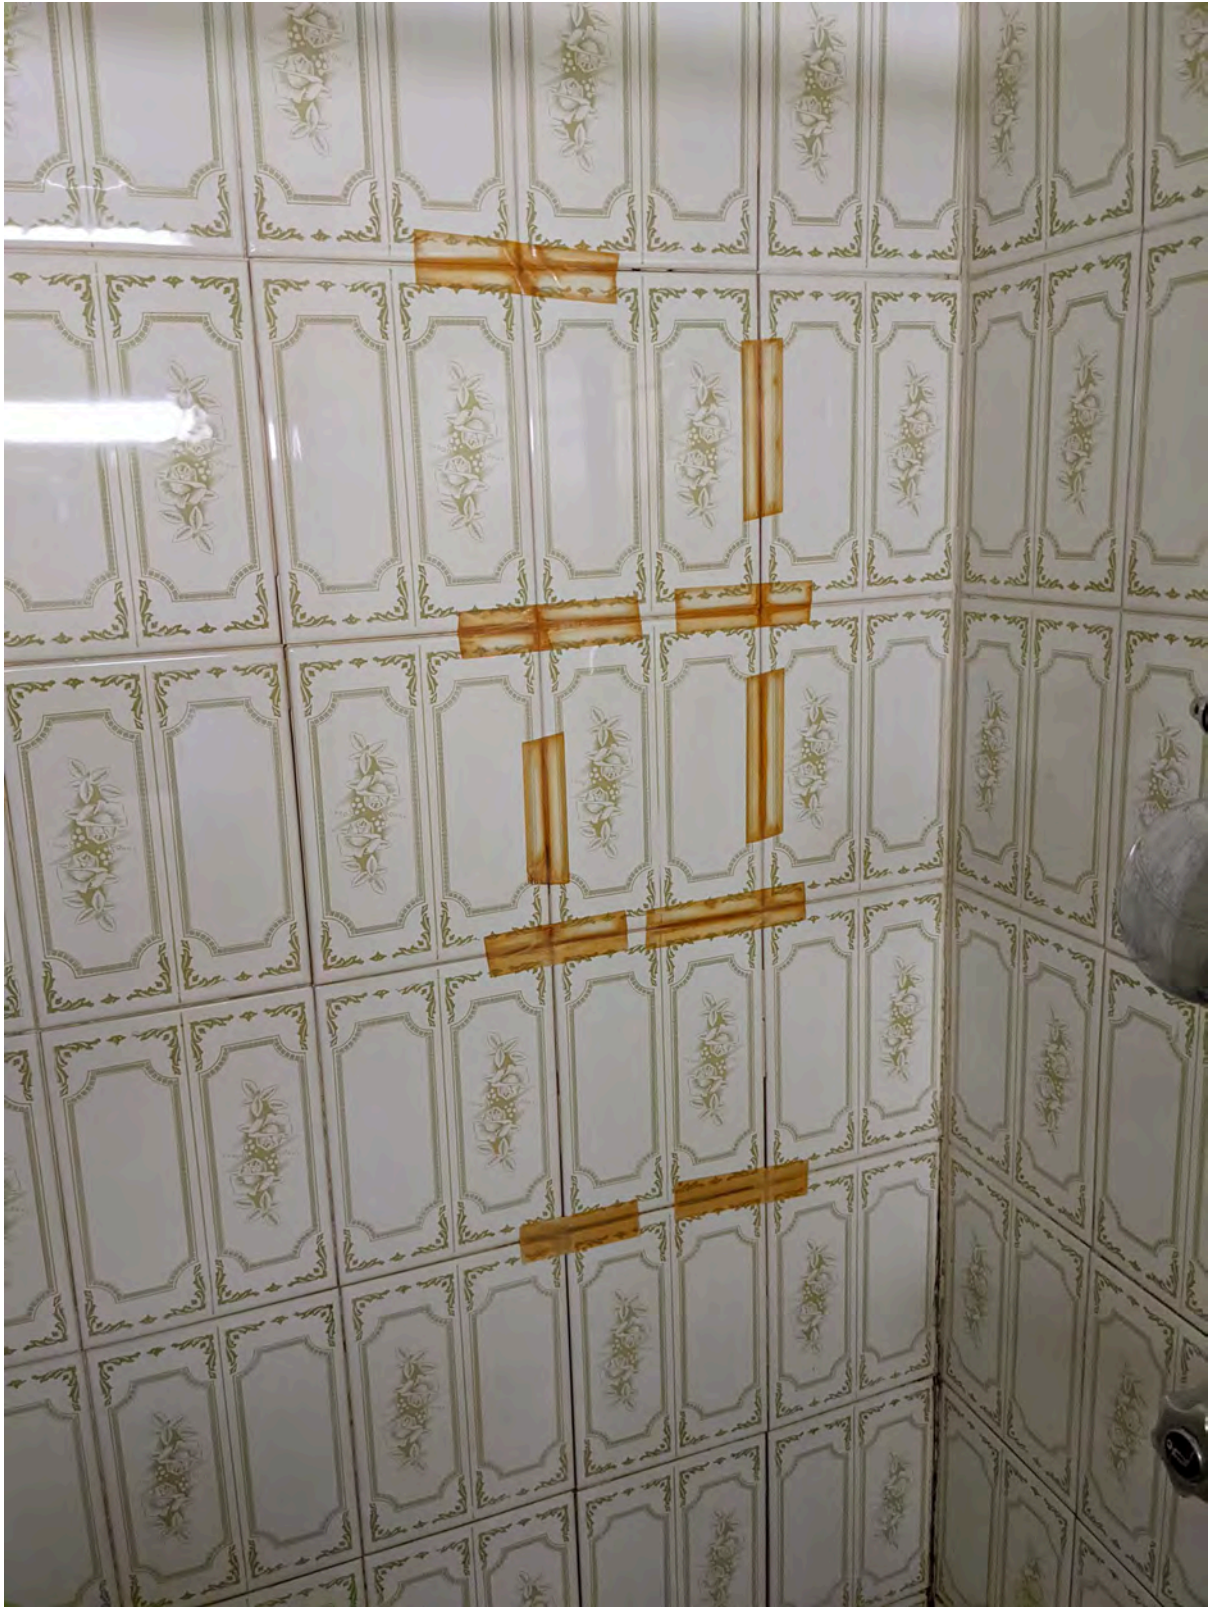
**Shower Tiles Taped to Wall**

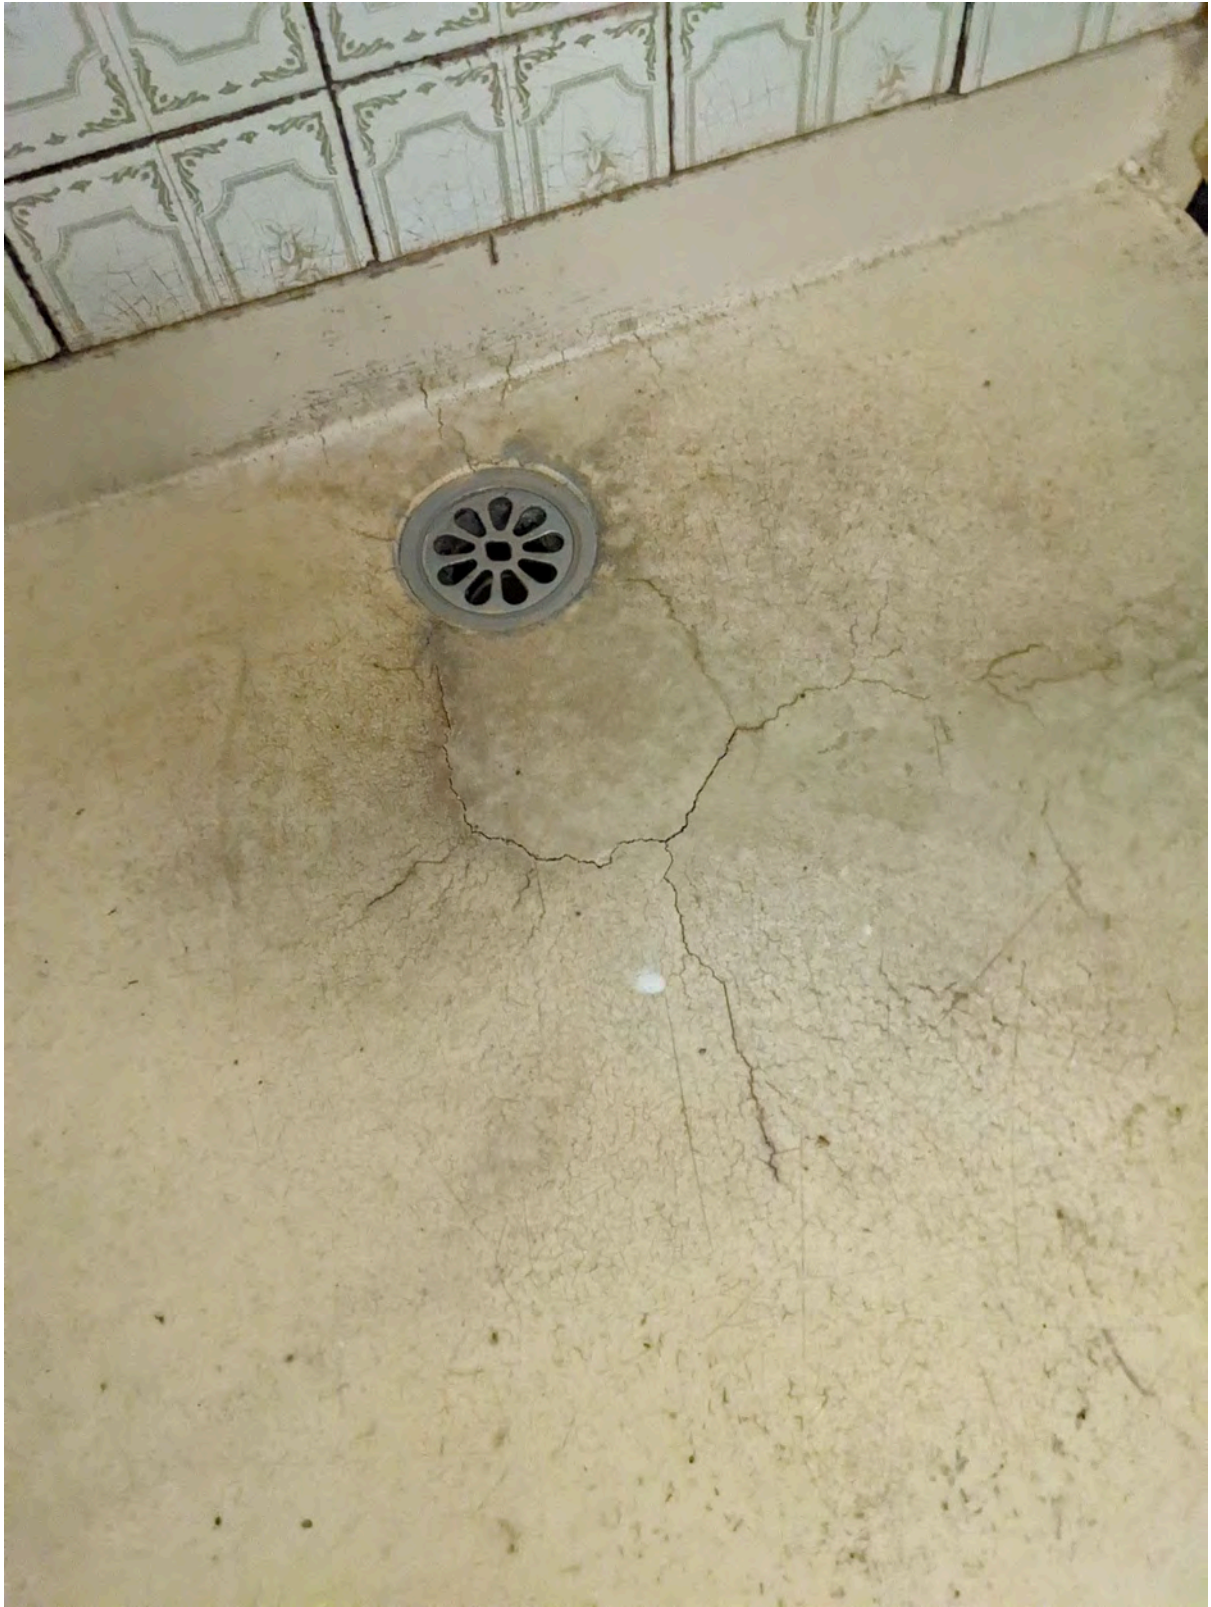
**Cracked Shower Base**

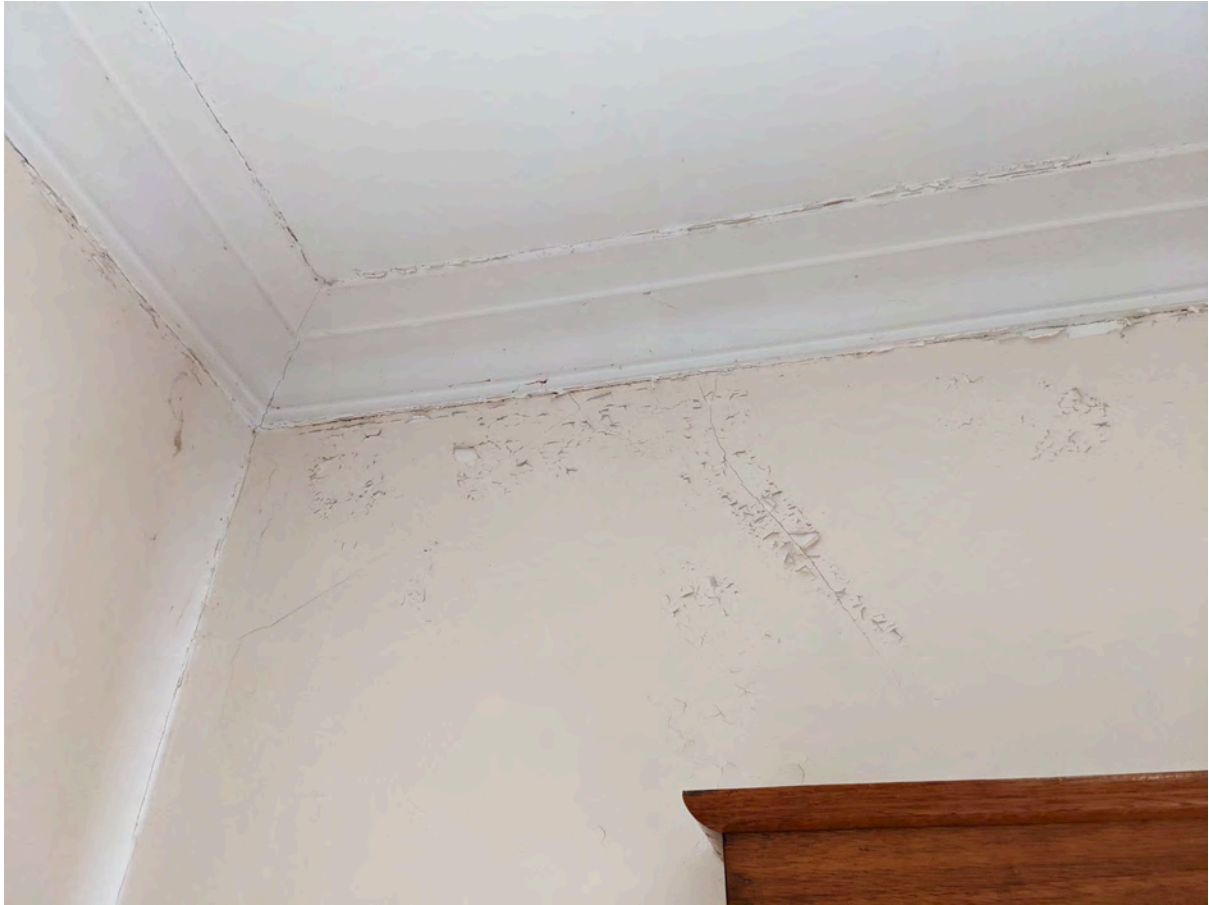
**Bedroom Ceiling Water Damage**

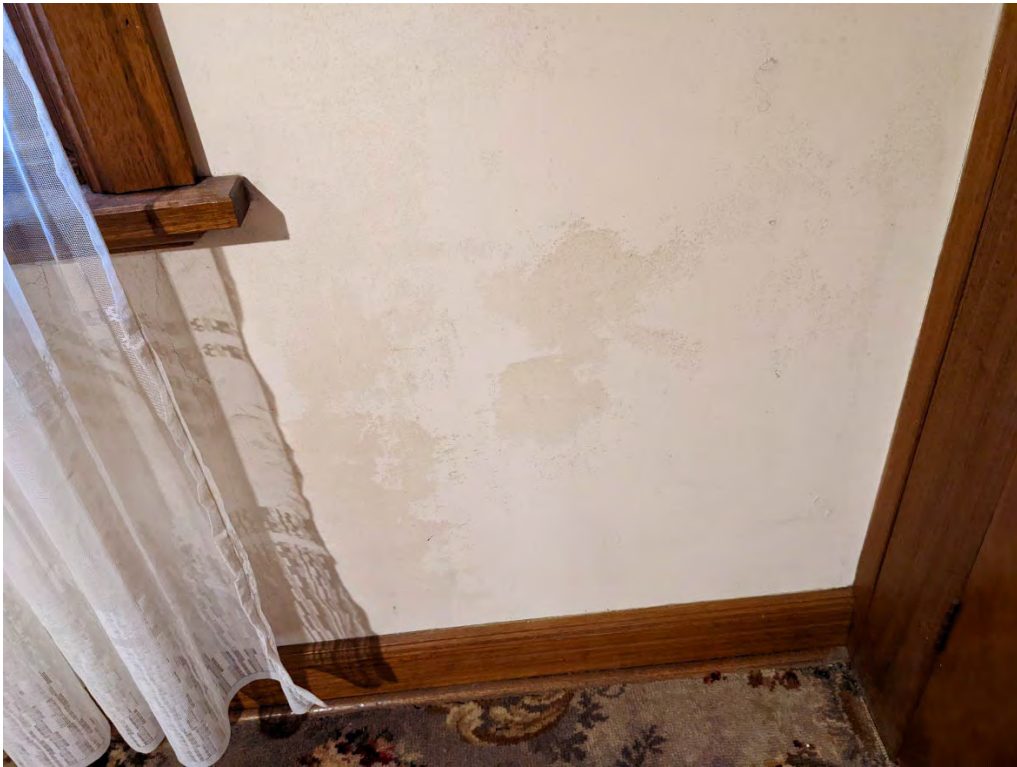
**Bedroom Damp (1)**

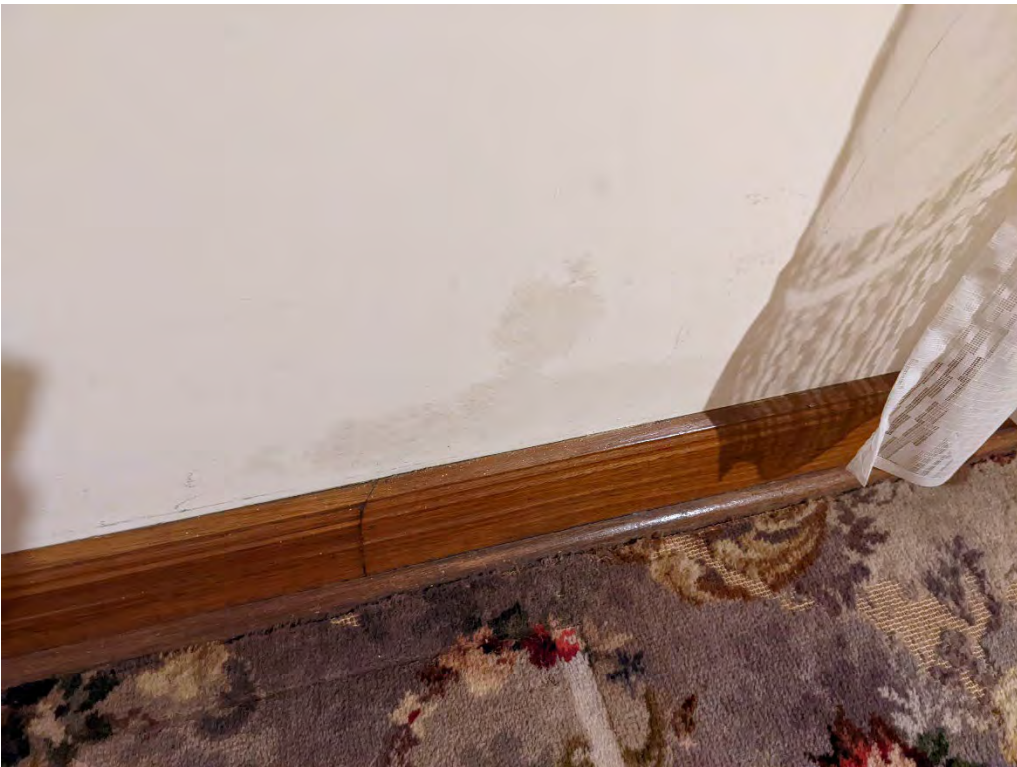
**Bedroom Damp (2)**

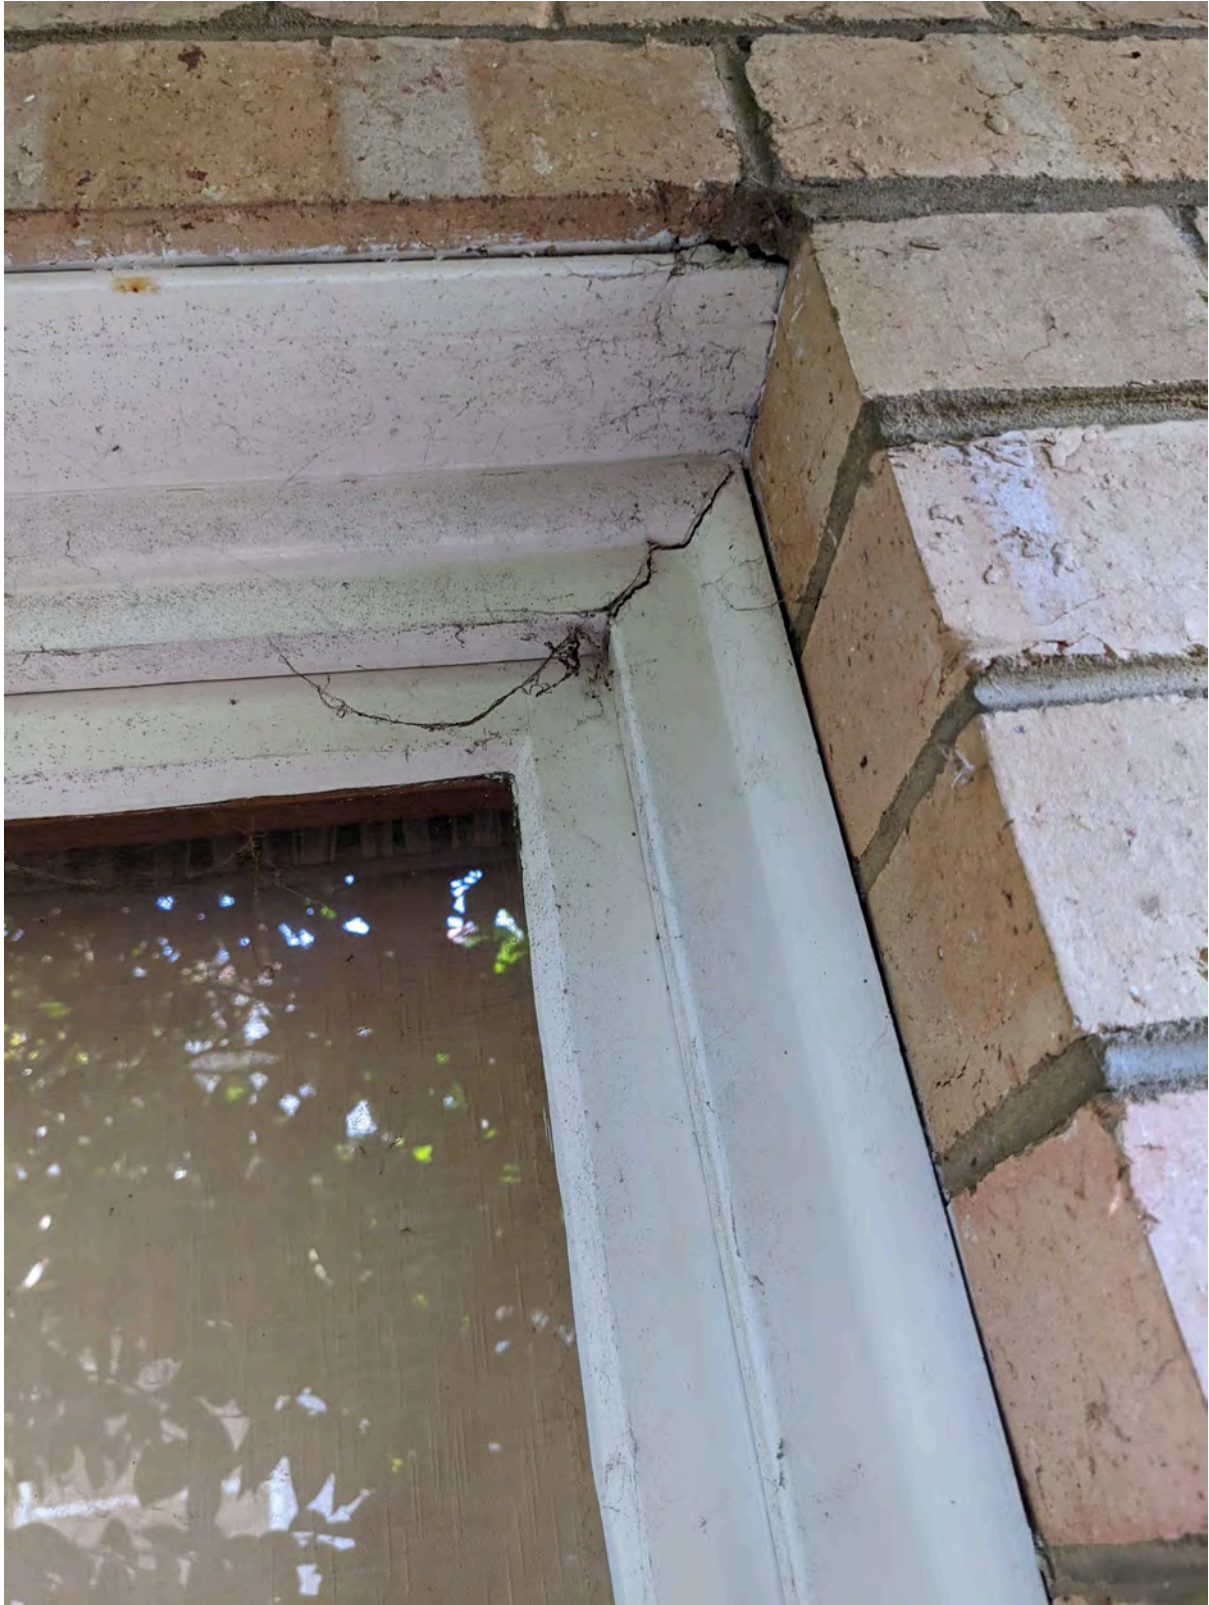
**External Bedroom Window Frame Gaps - No Seal**

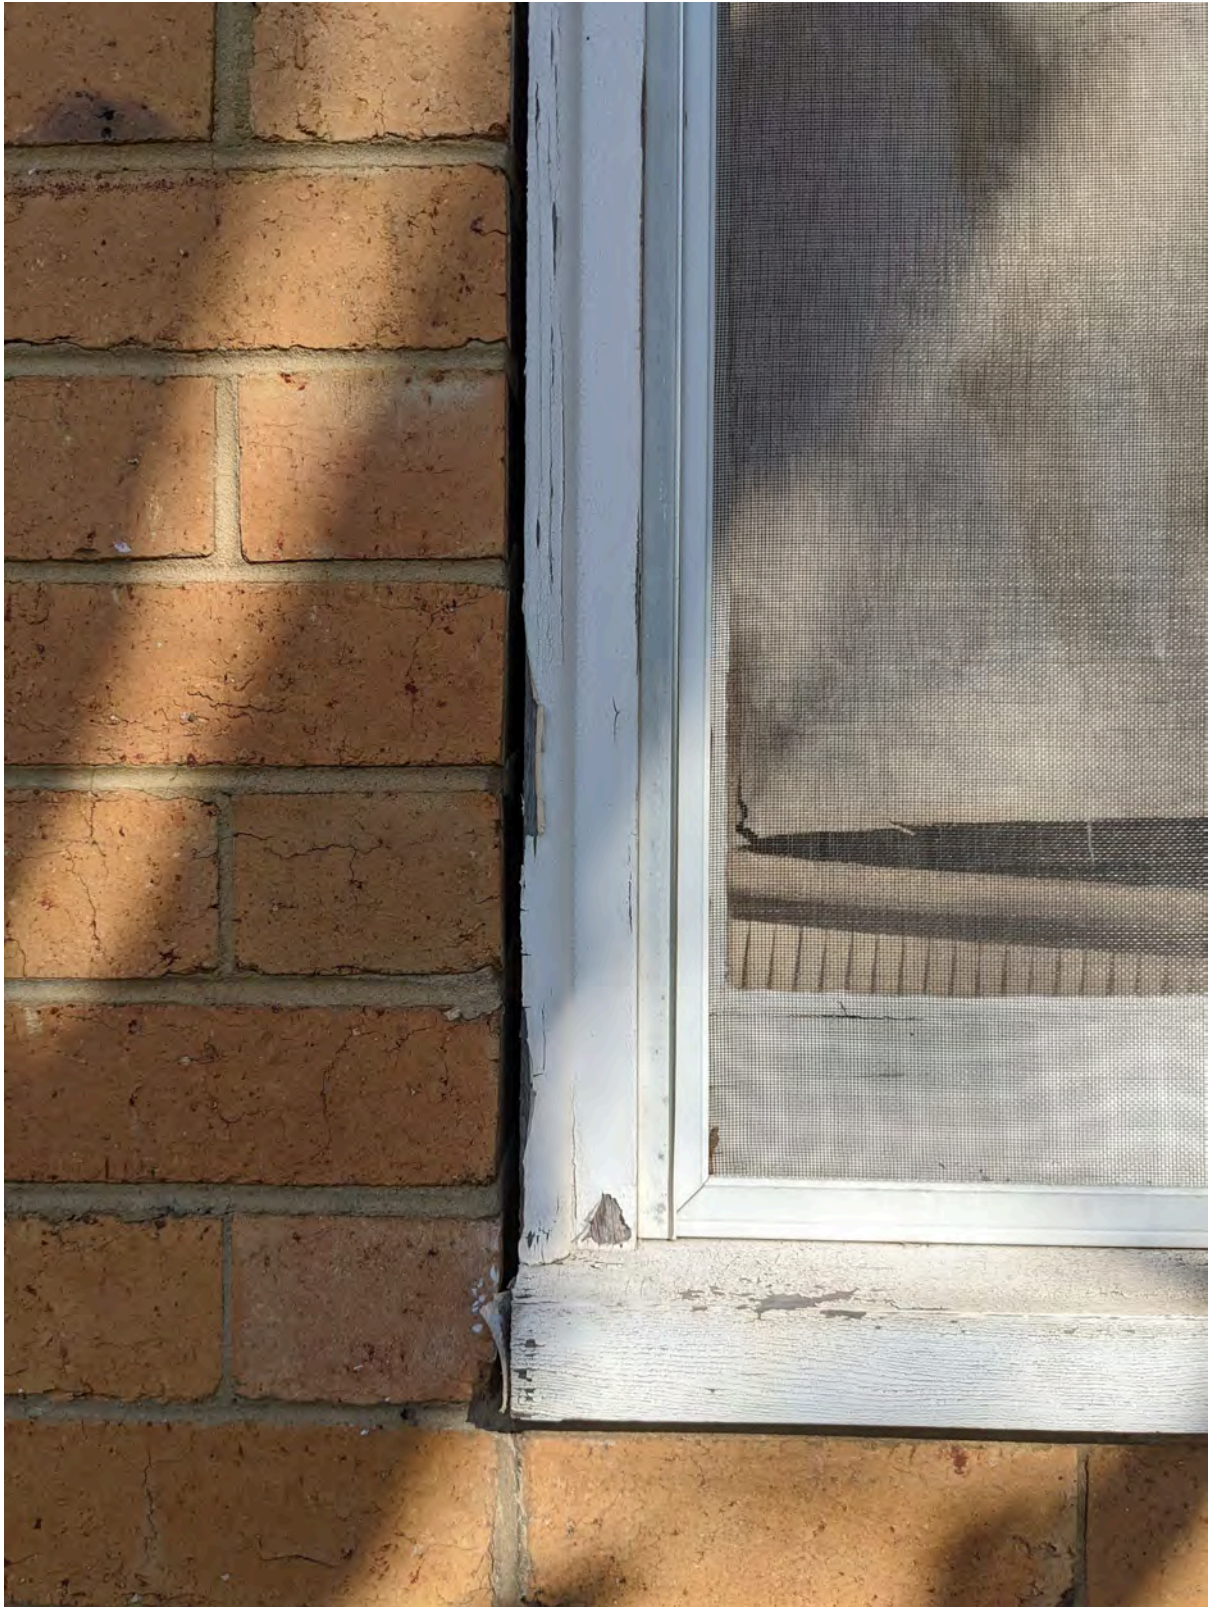
**External Bedroom Window Gap - No Seals**

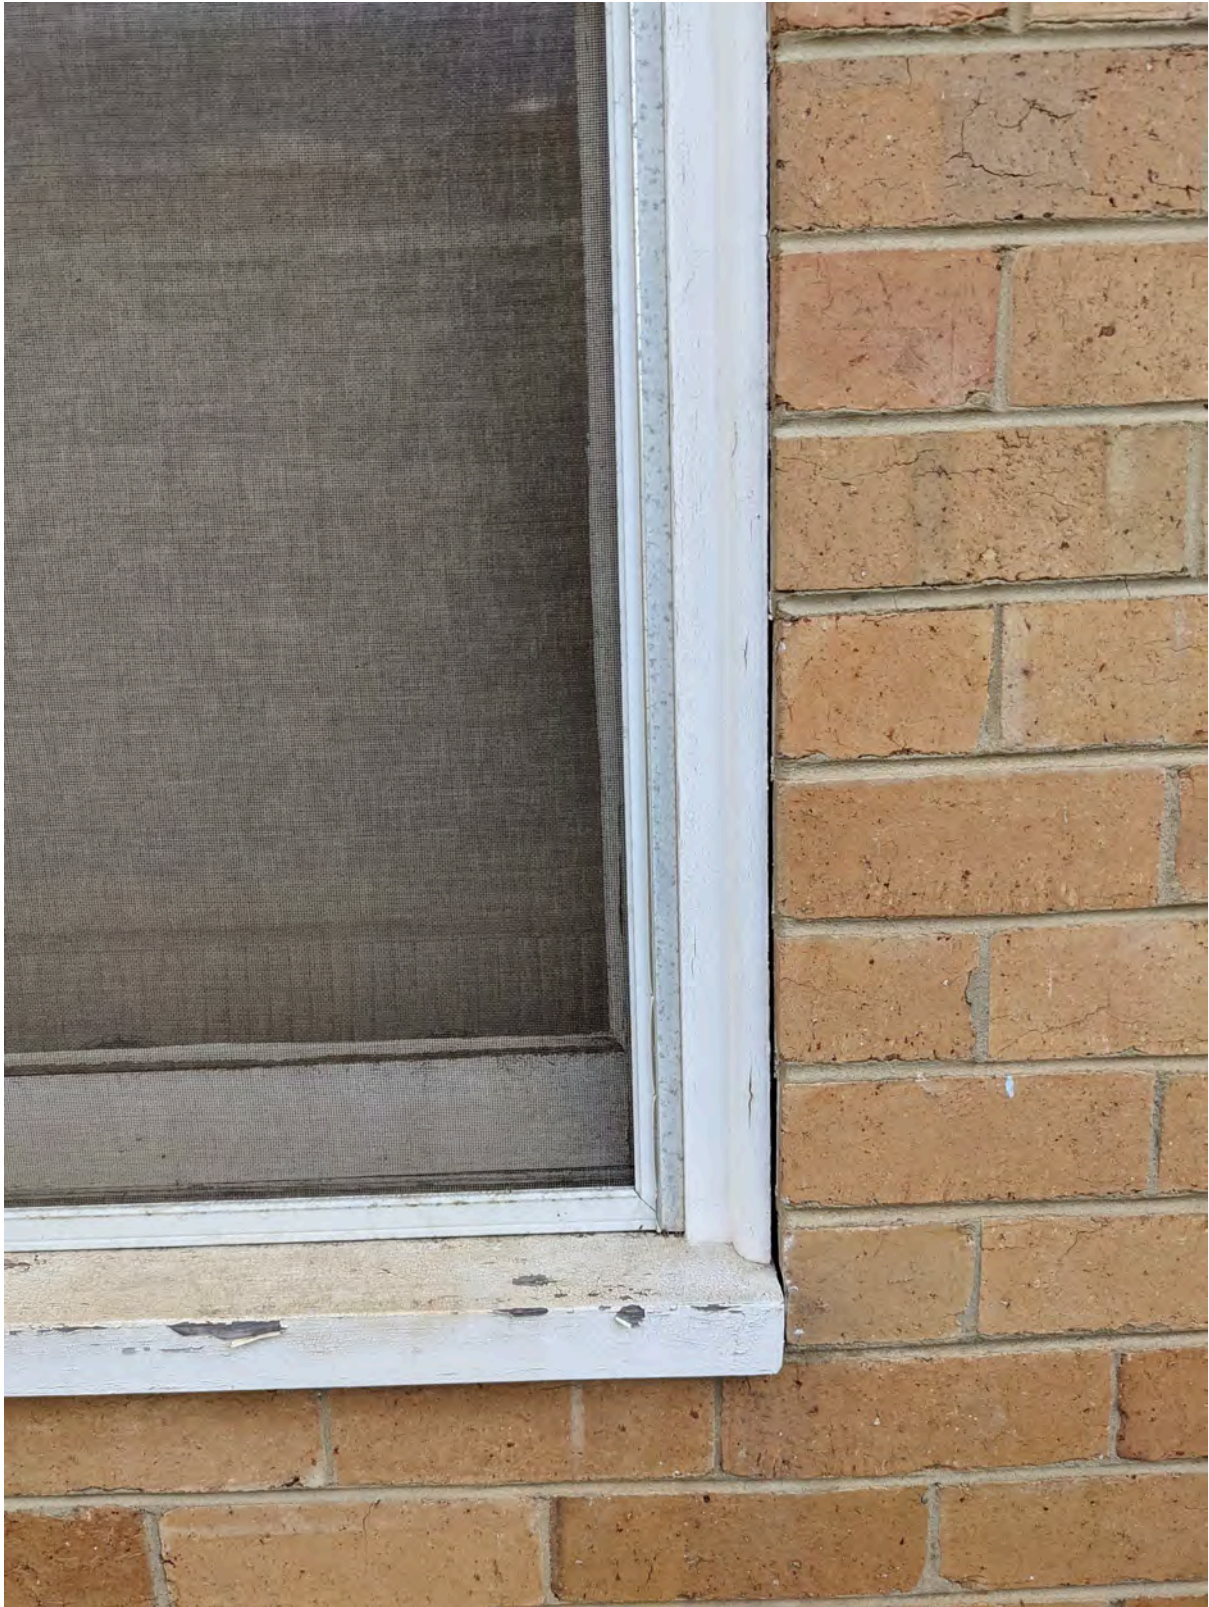
**External Dining Room Window Gap - No Seal**

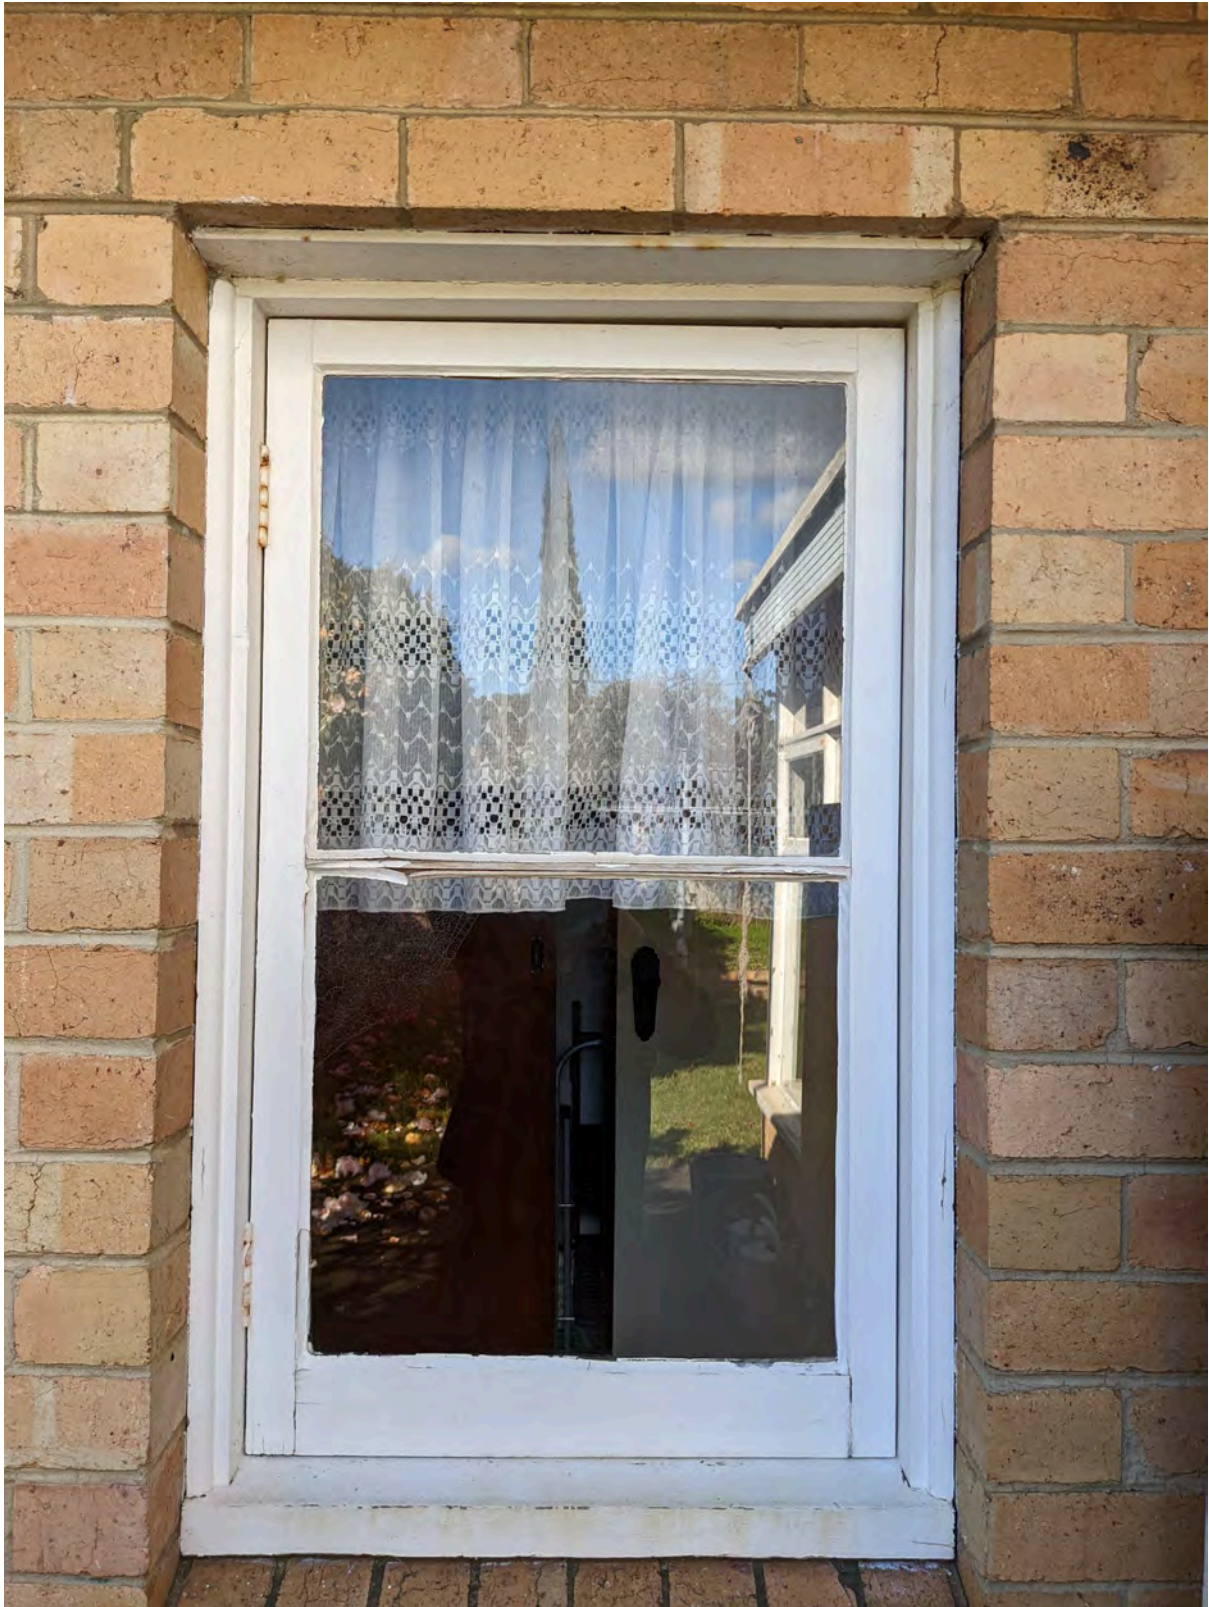
**External Laundry Window Rot & Gaps - No Seal**

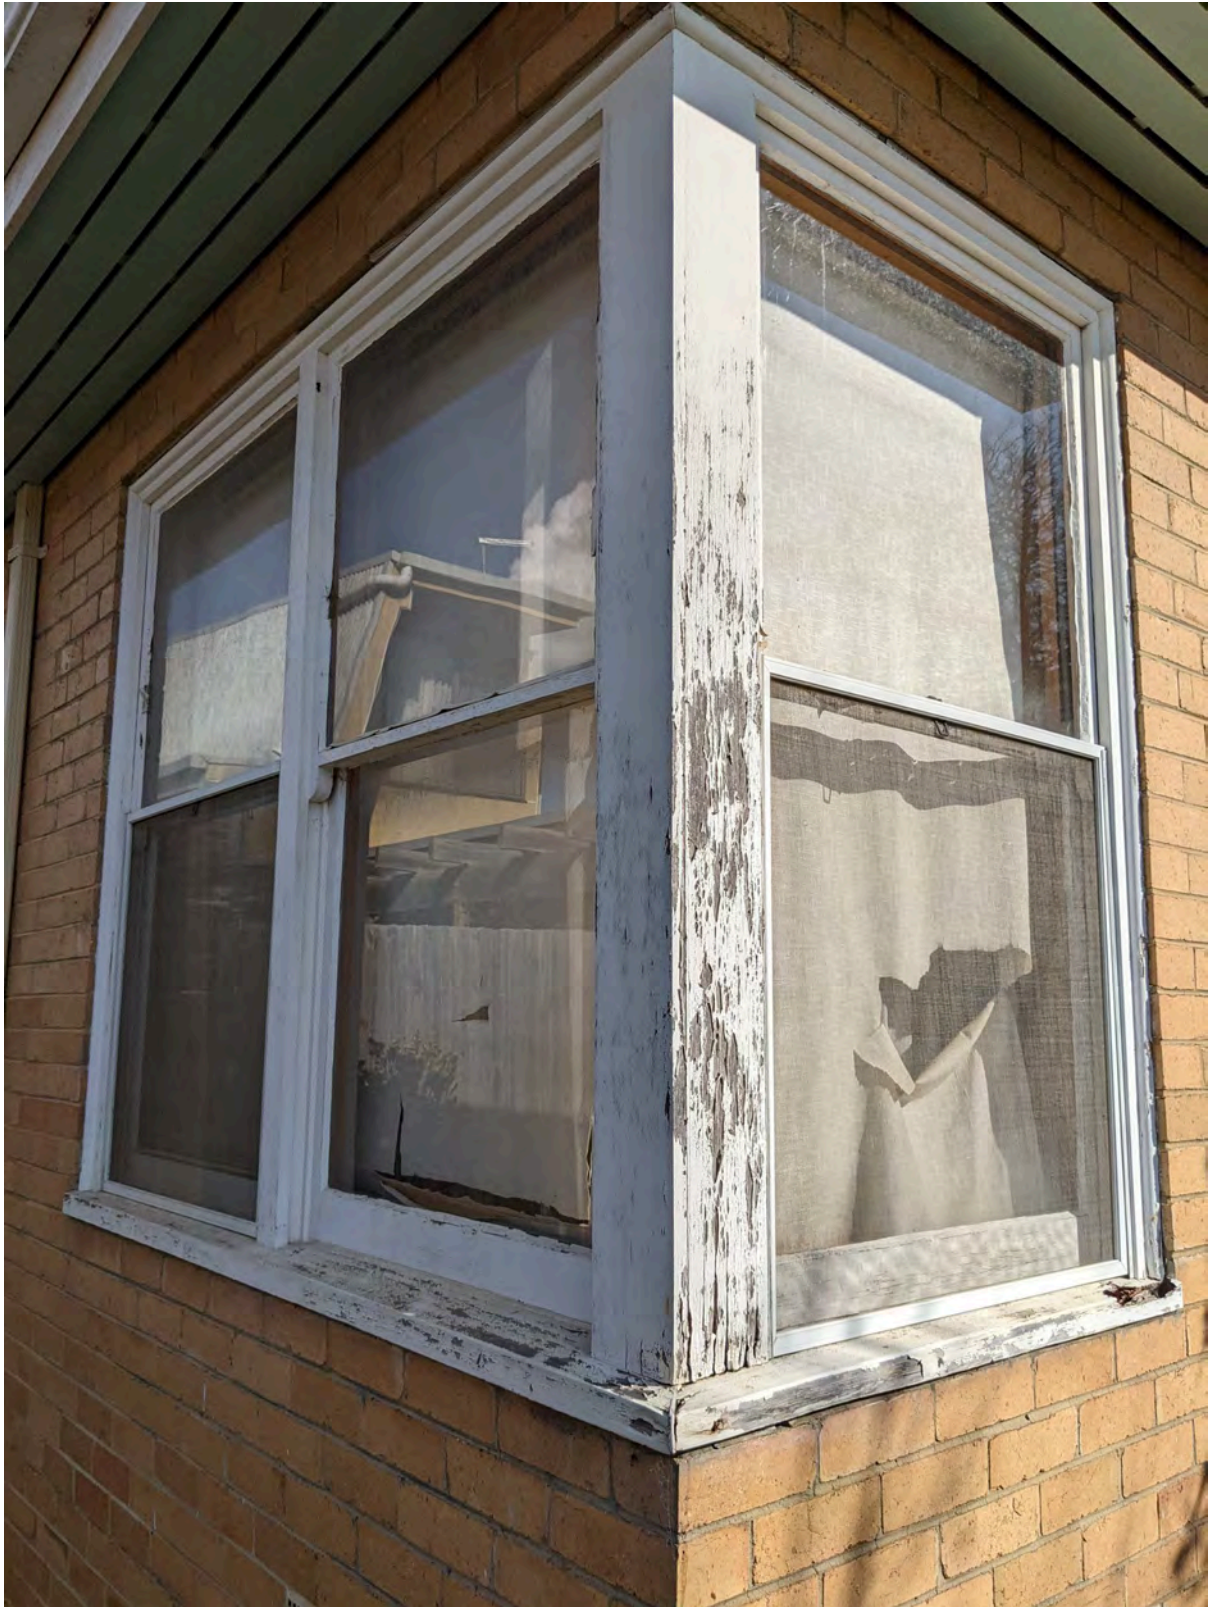
**External Loungeroom Window Rot (1)**

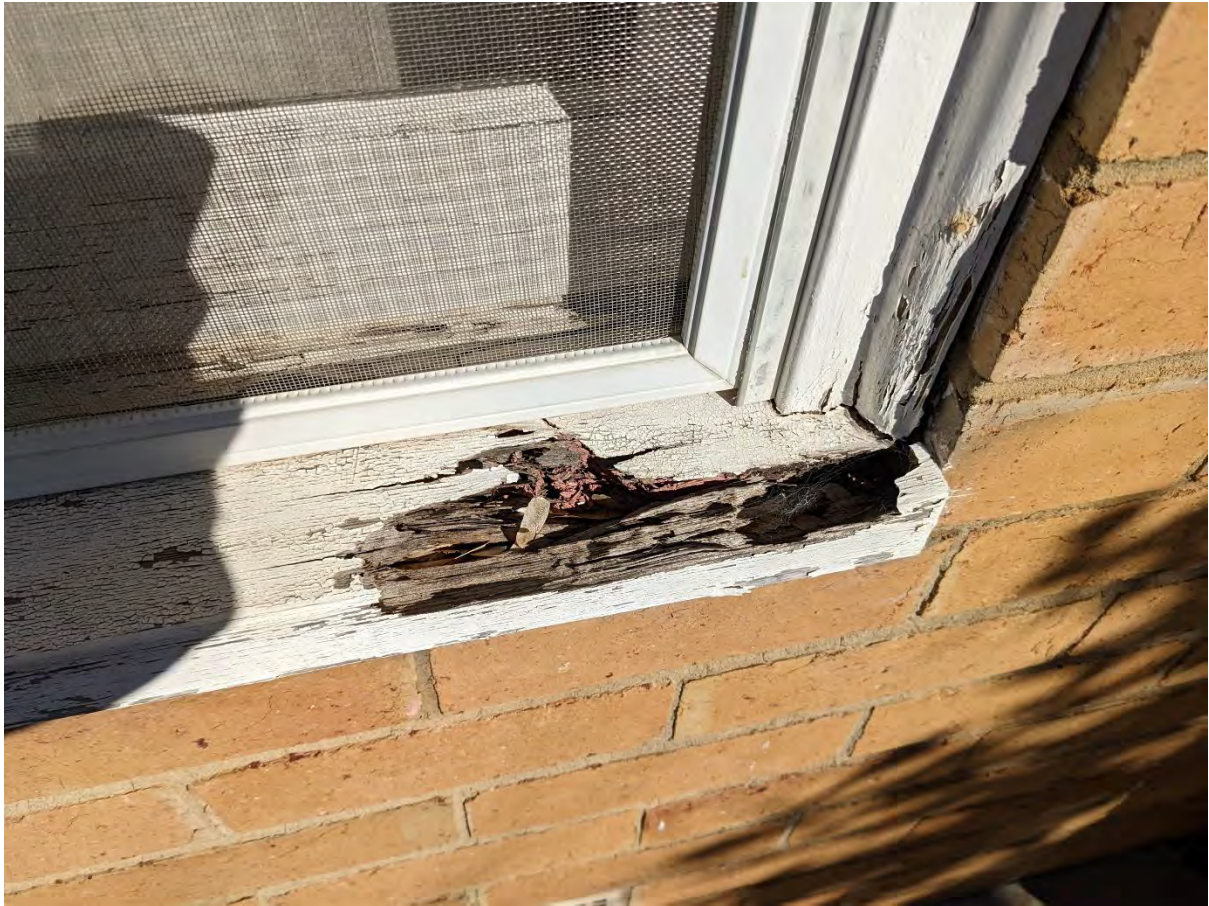
**External Loungeroom Window Rot (2)**

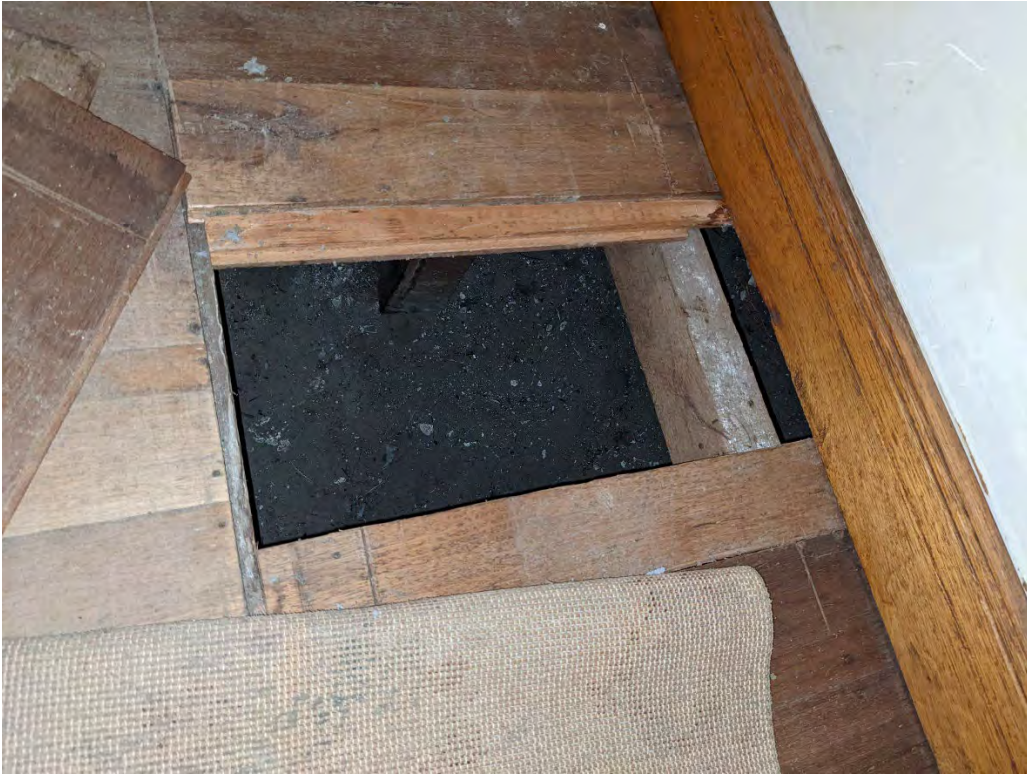
**Hallway Cupboard Missing Floorboards**

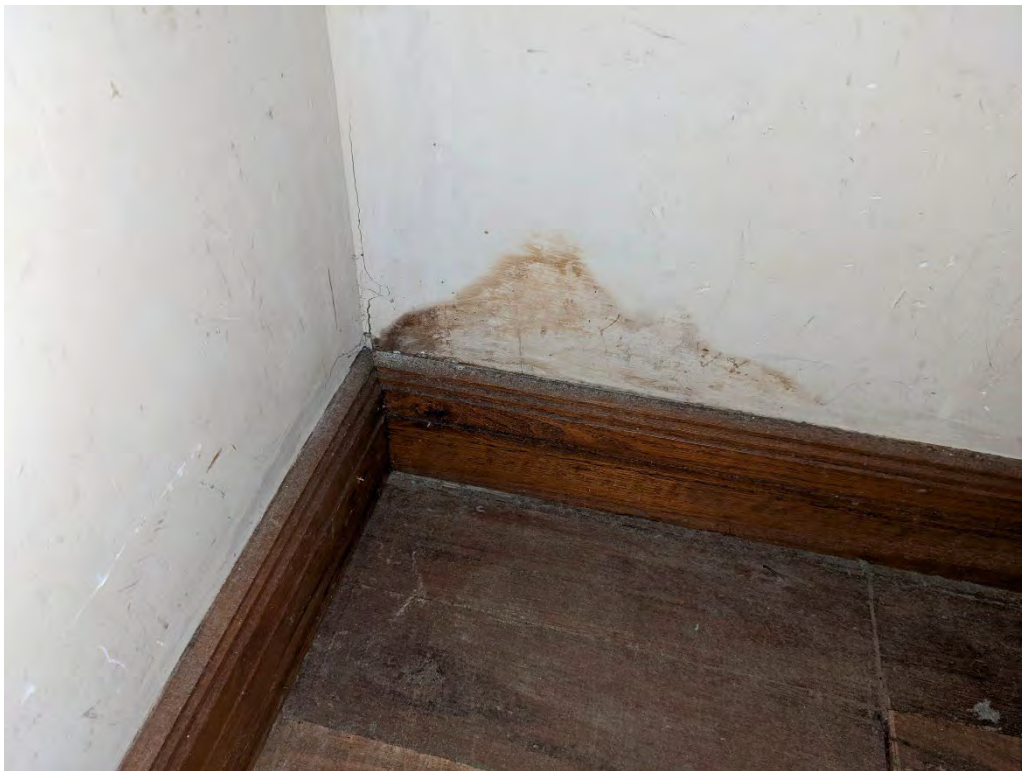
**Hallway Cupboard Water Damage**

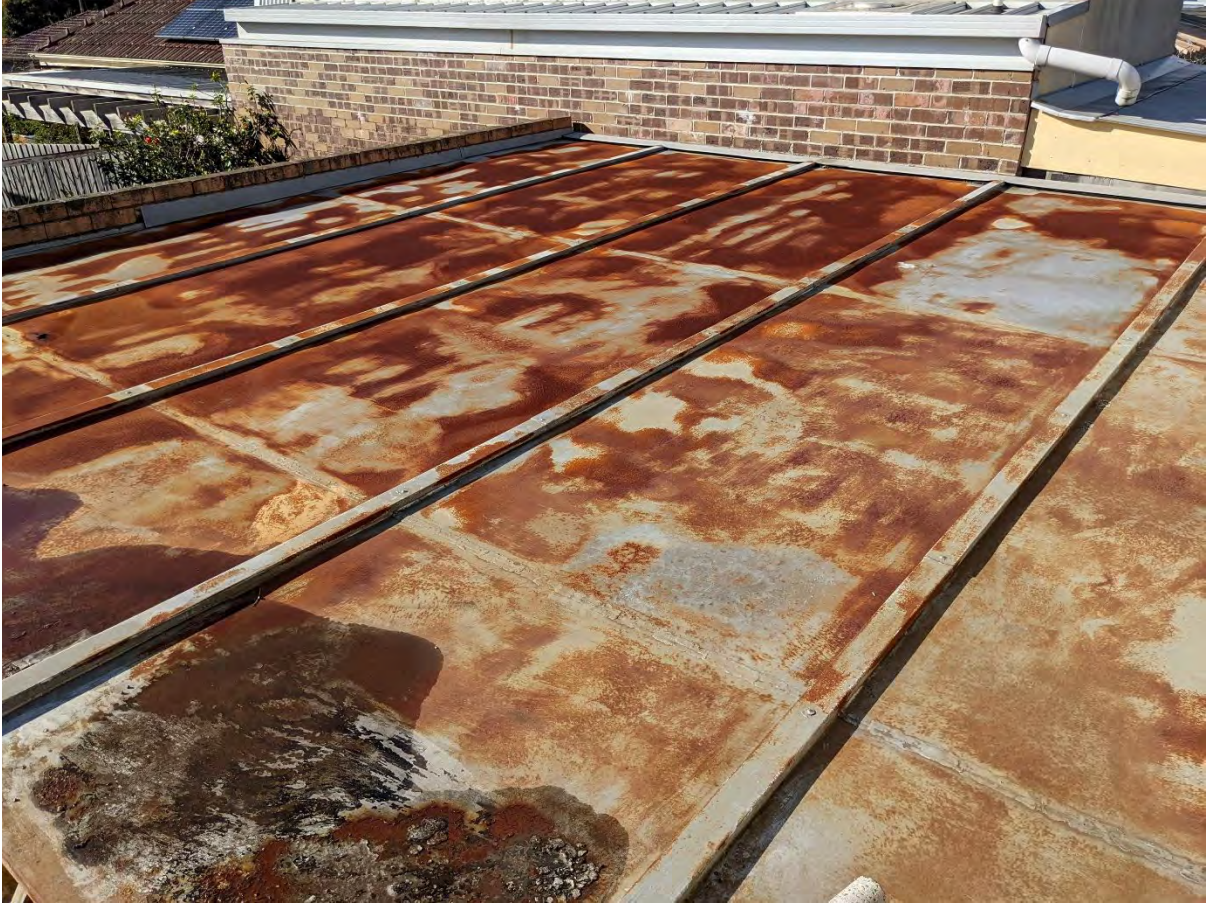
**Corroded Carport Roof**

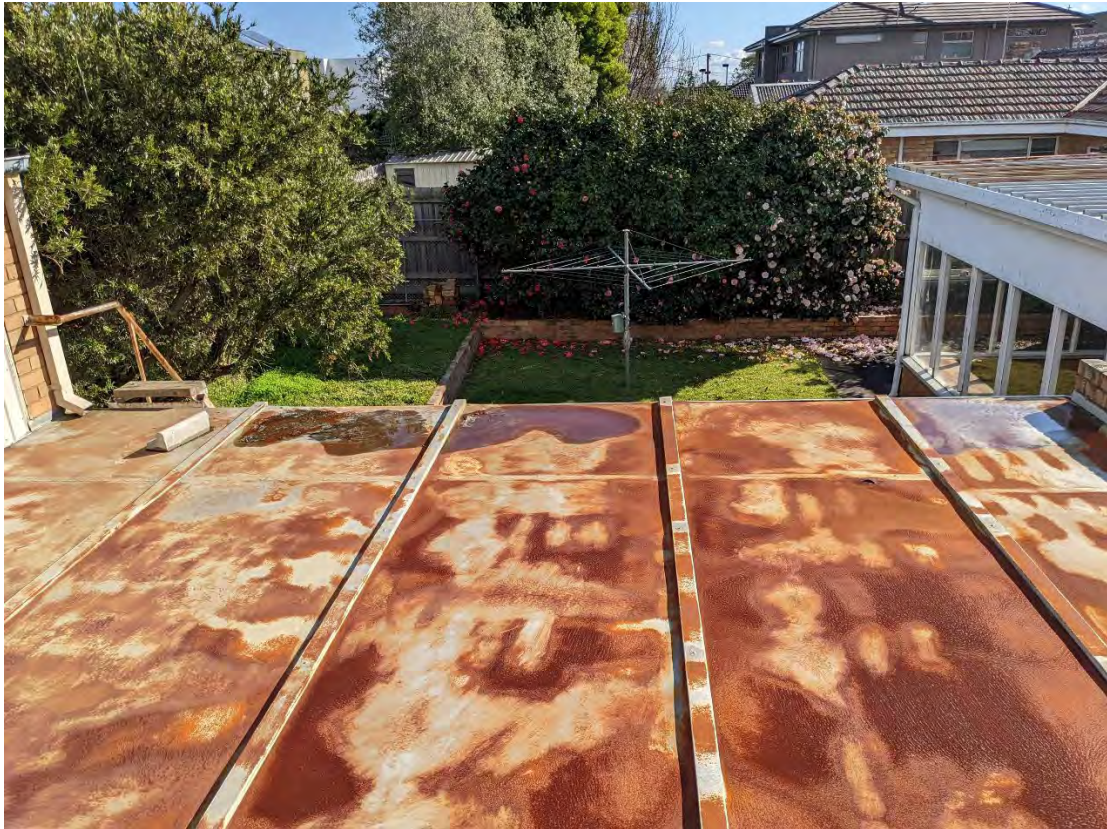
**Carport Roof - No Fall Barrier (1)**

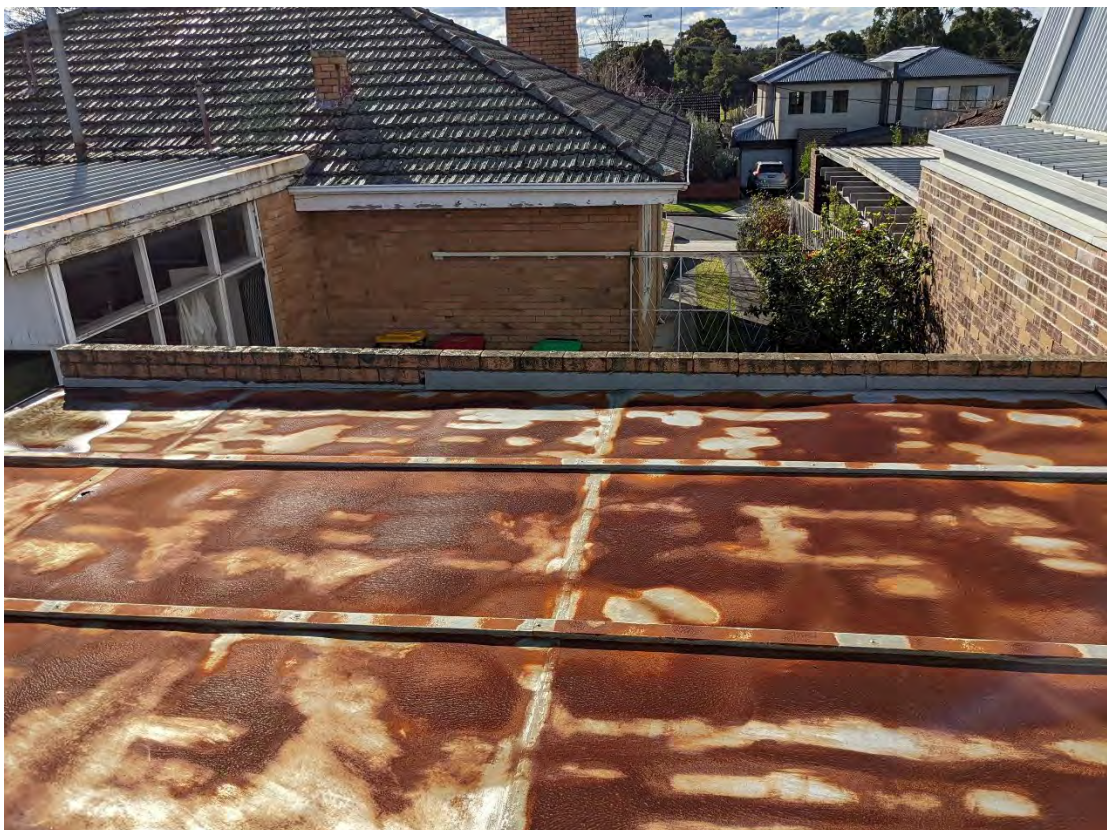
**Carport Roof - No Fall Barrier (2)**
