# Property Inspection Photos

**Job No:** BAA 242022

**Property Address:** 10 Riddle Street Bentleigh VIC 3204

**Date:** 24 July 202

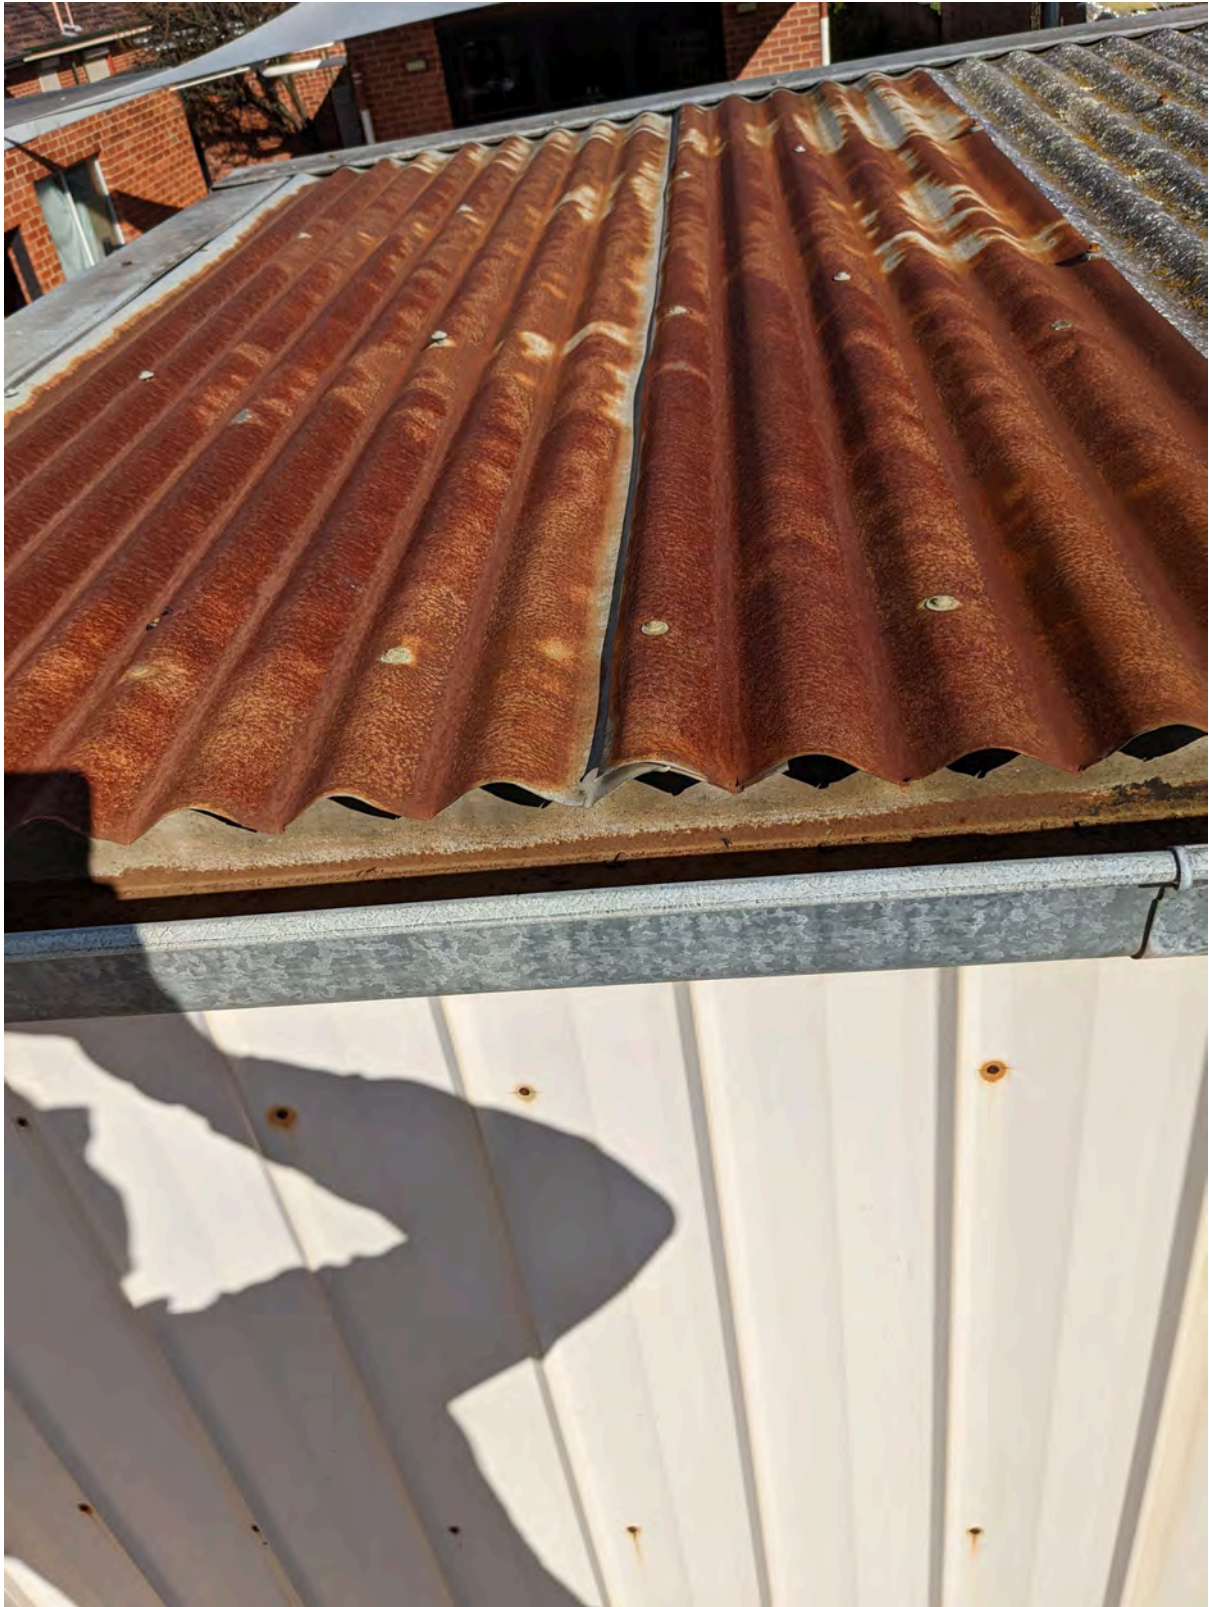
**Corroded Loft Roof Sheets**

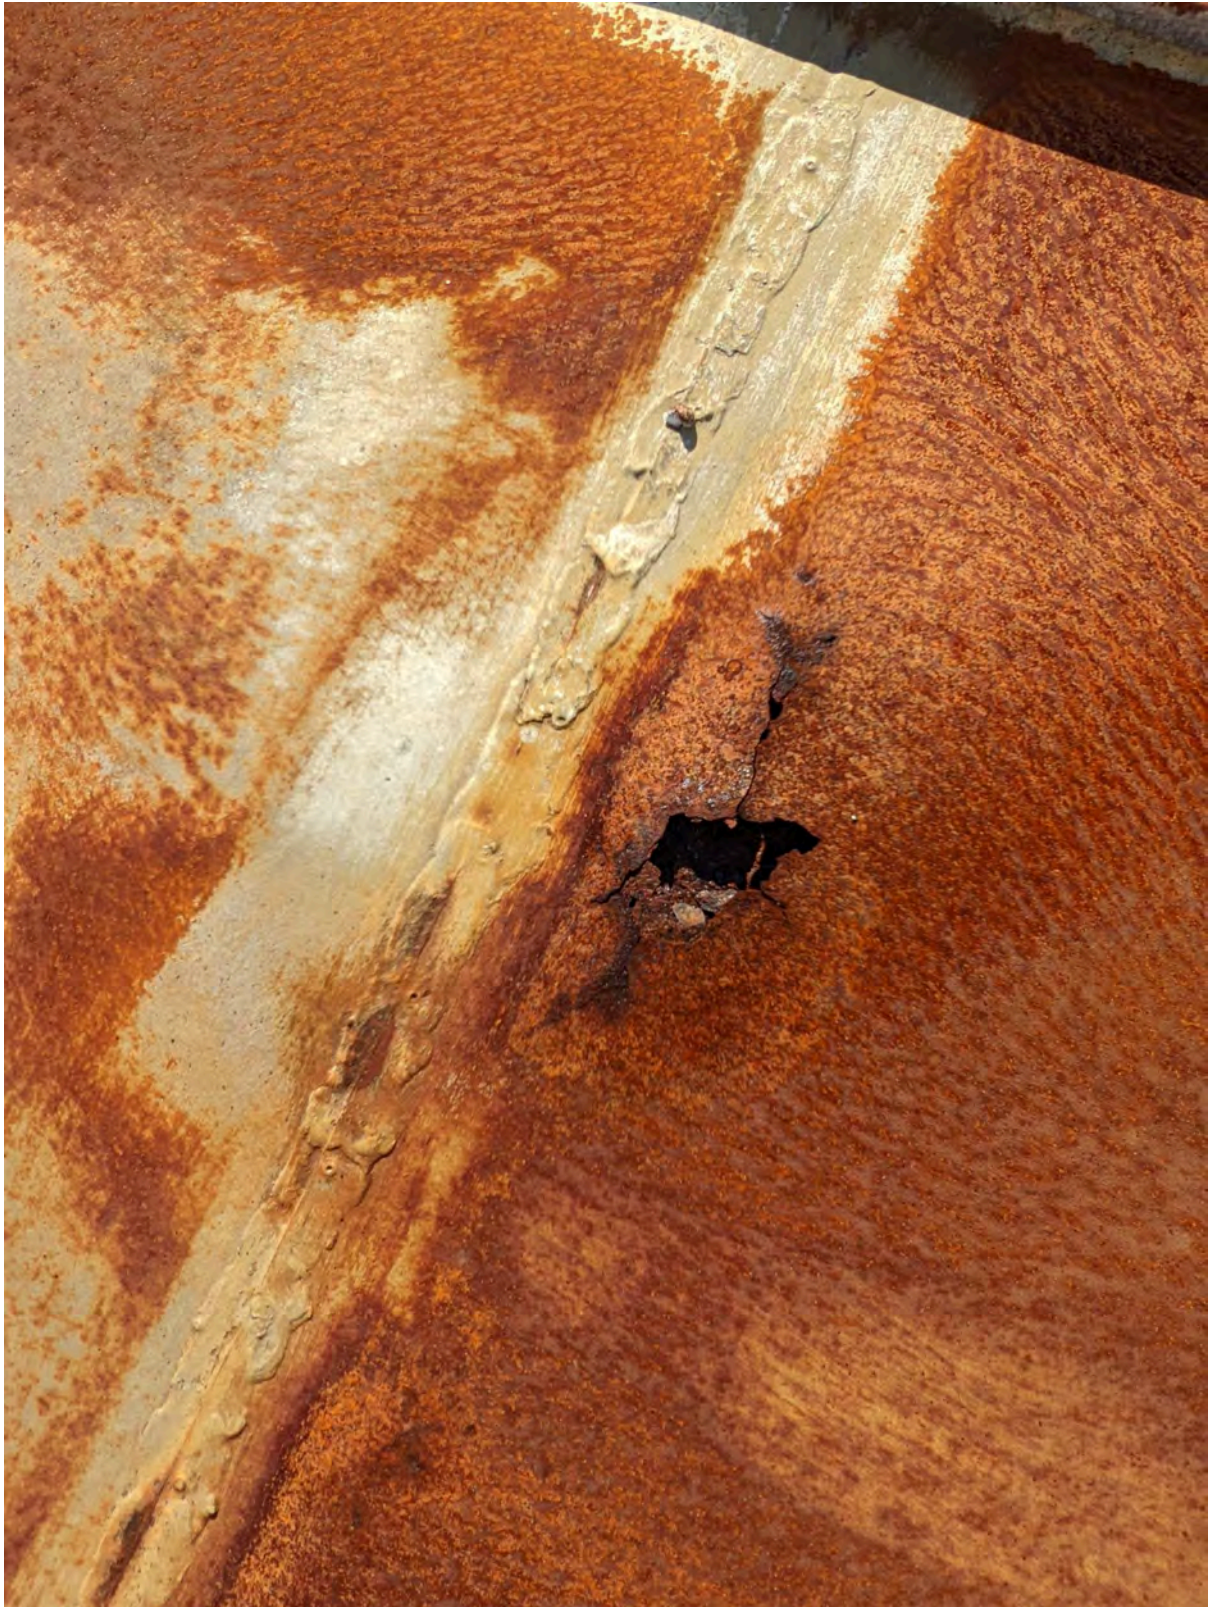
**Hole In Corroded Carport Roof**

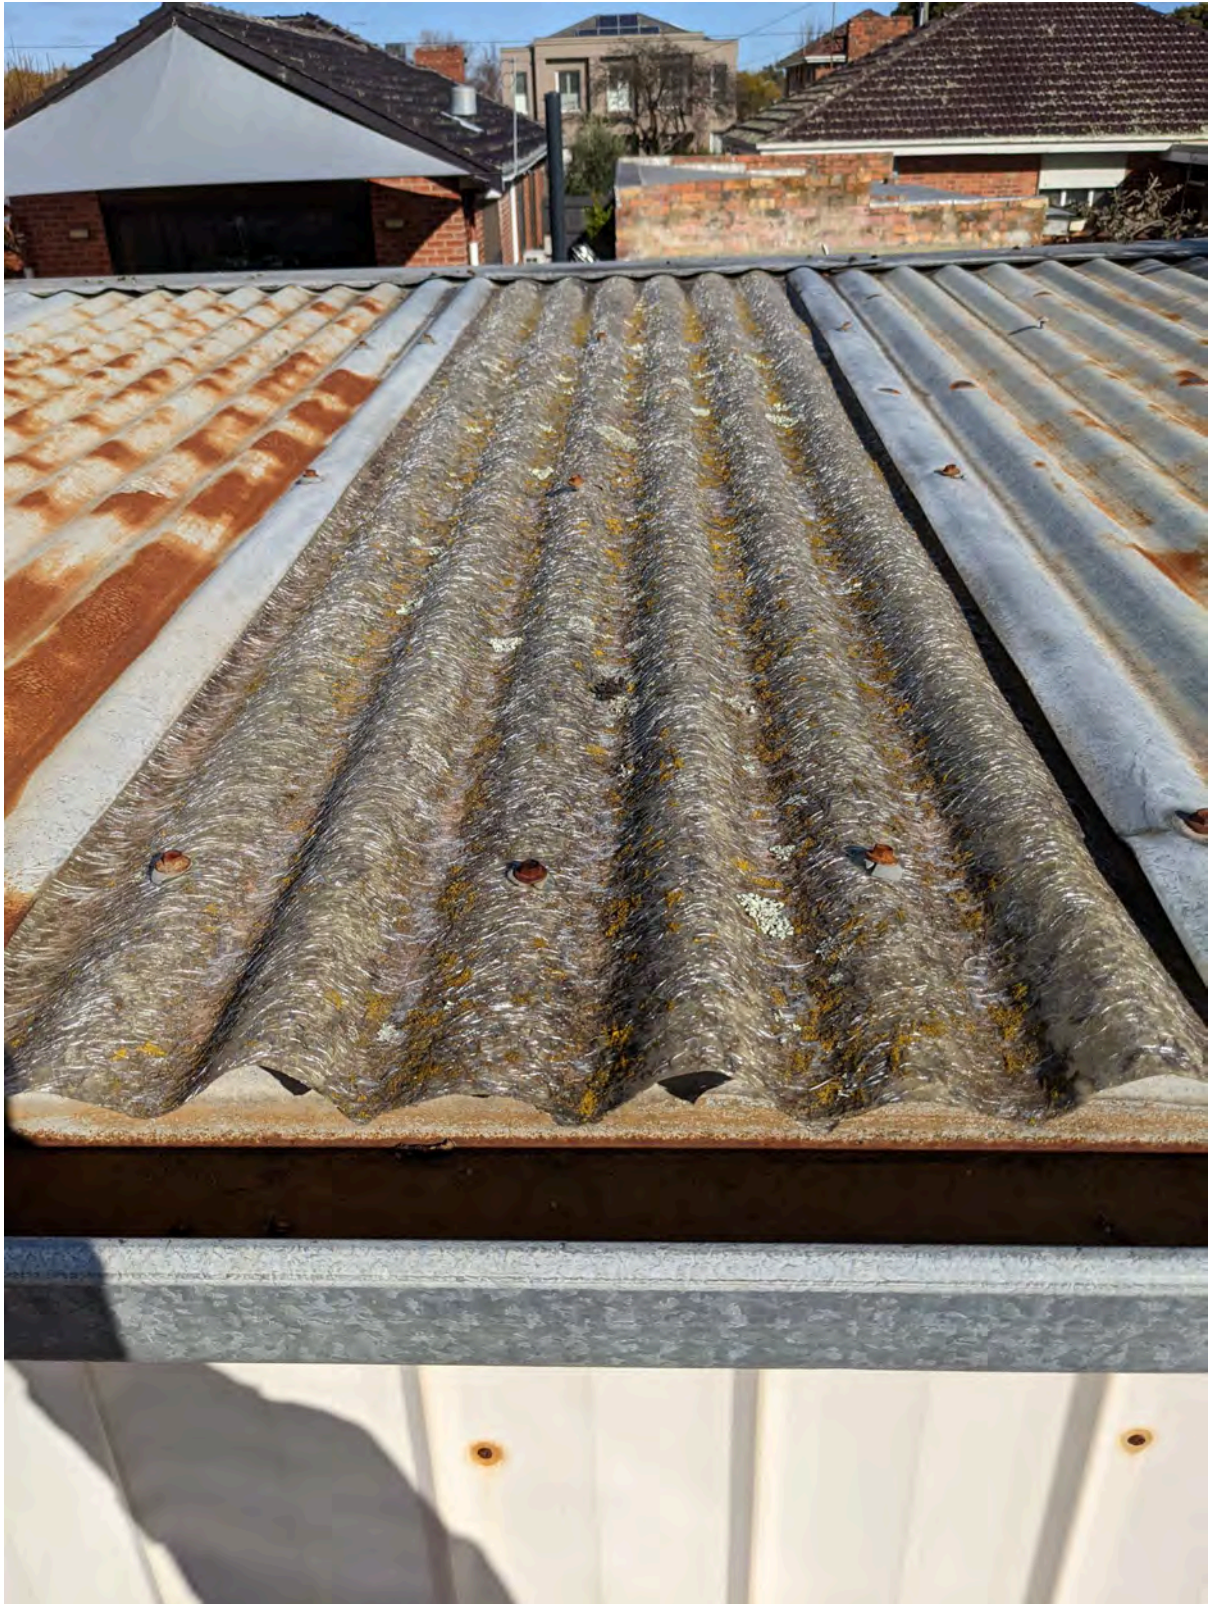
**Asbestos Roof Sheet – Loft 1**

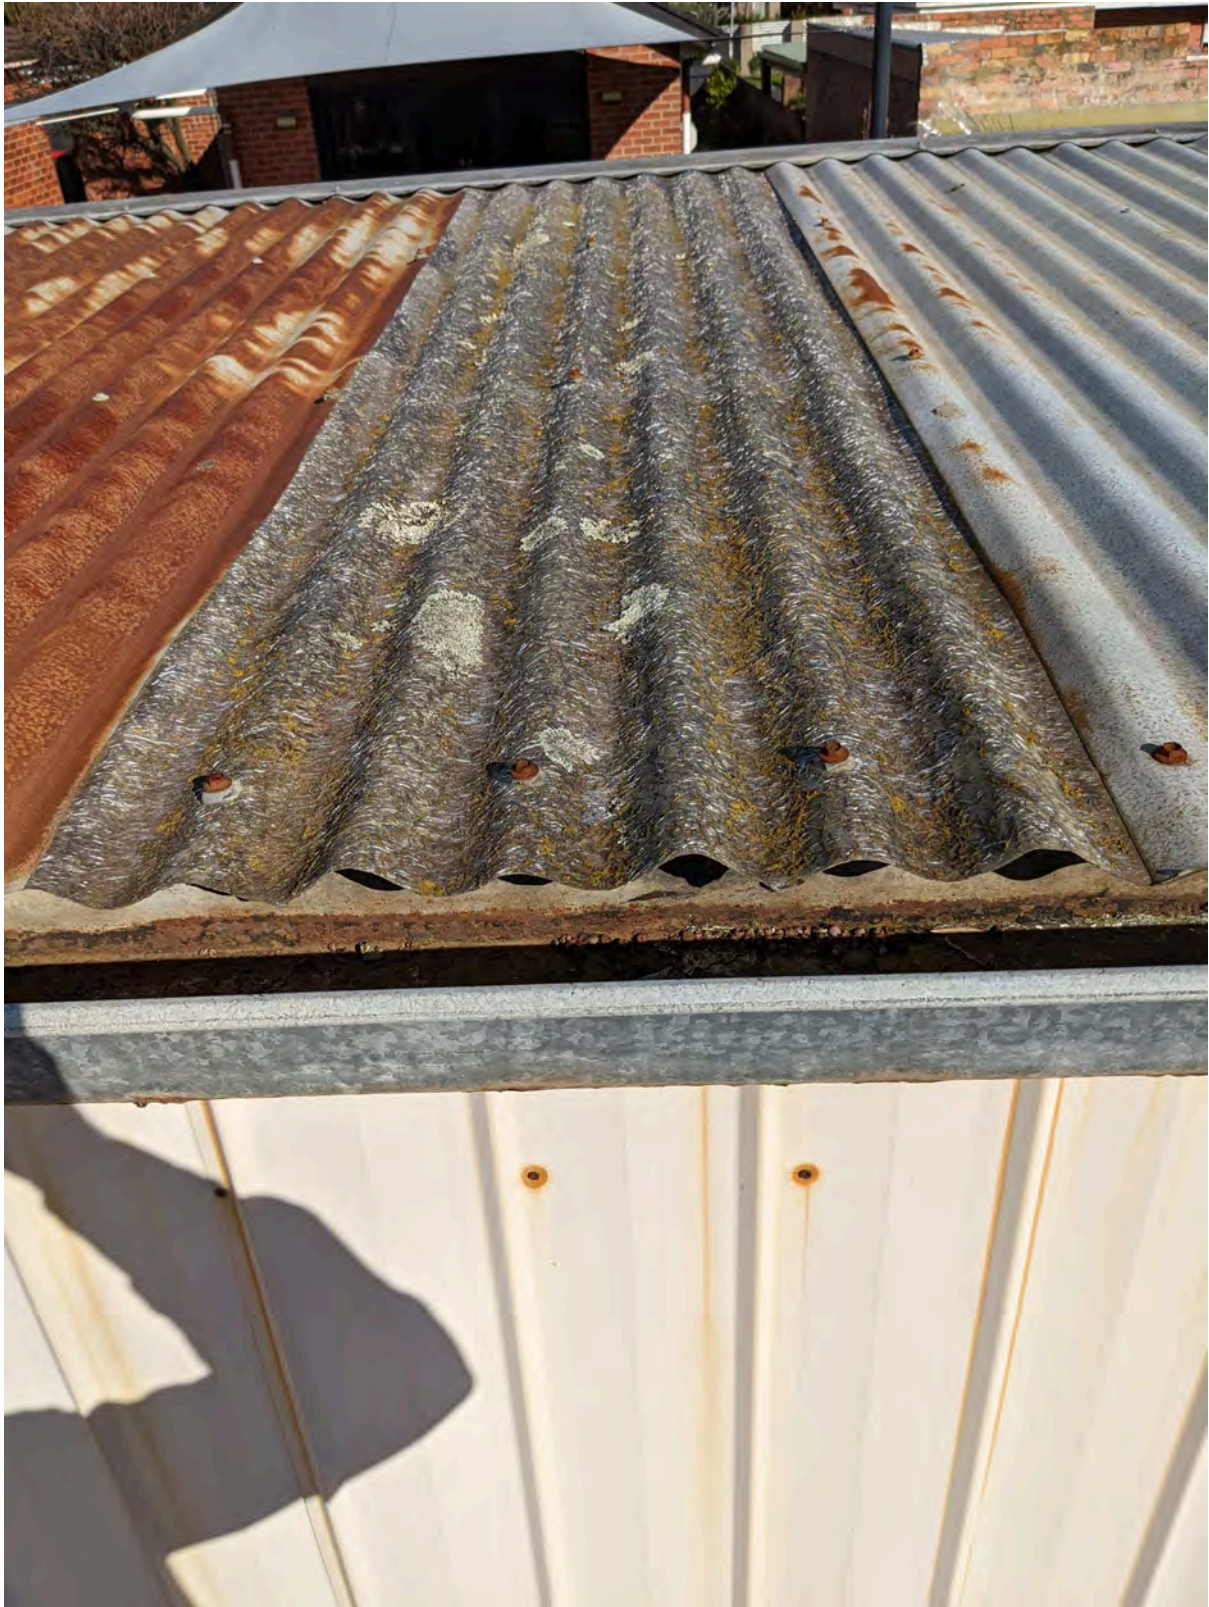
**Asbestos Roof Sheet - Loft 2**

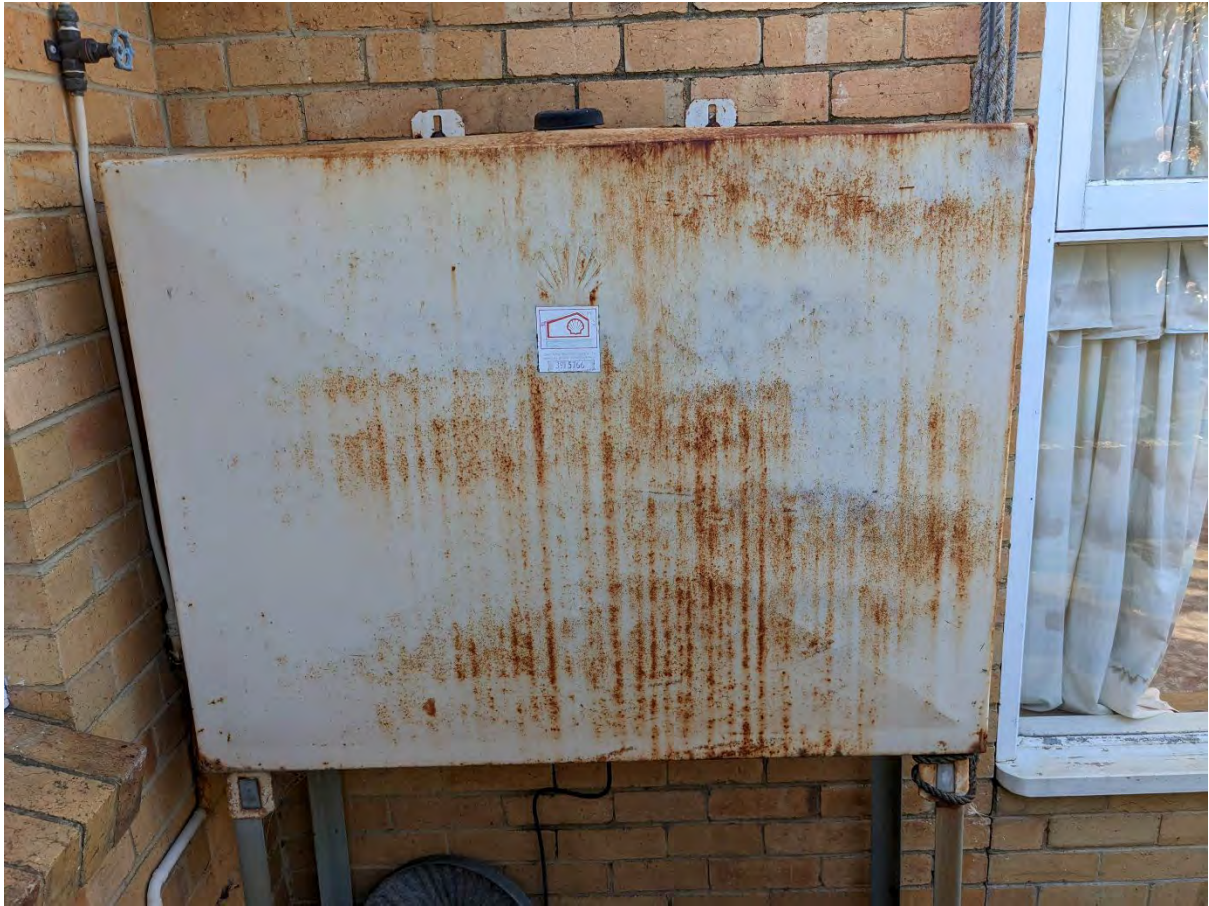
**Corroded Oil Heater Storage Tank**

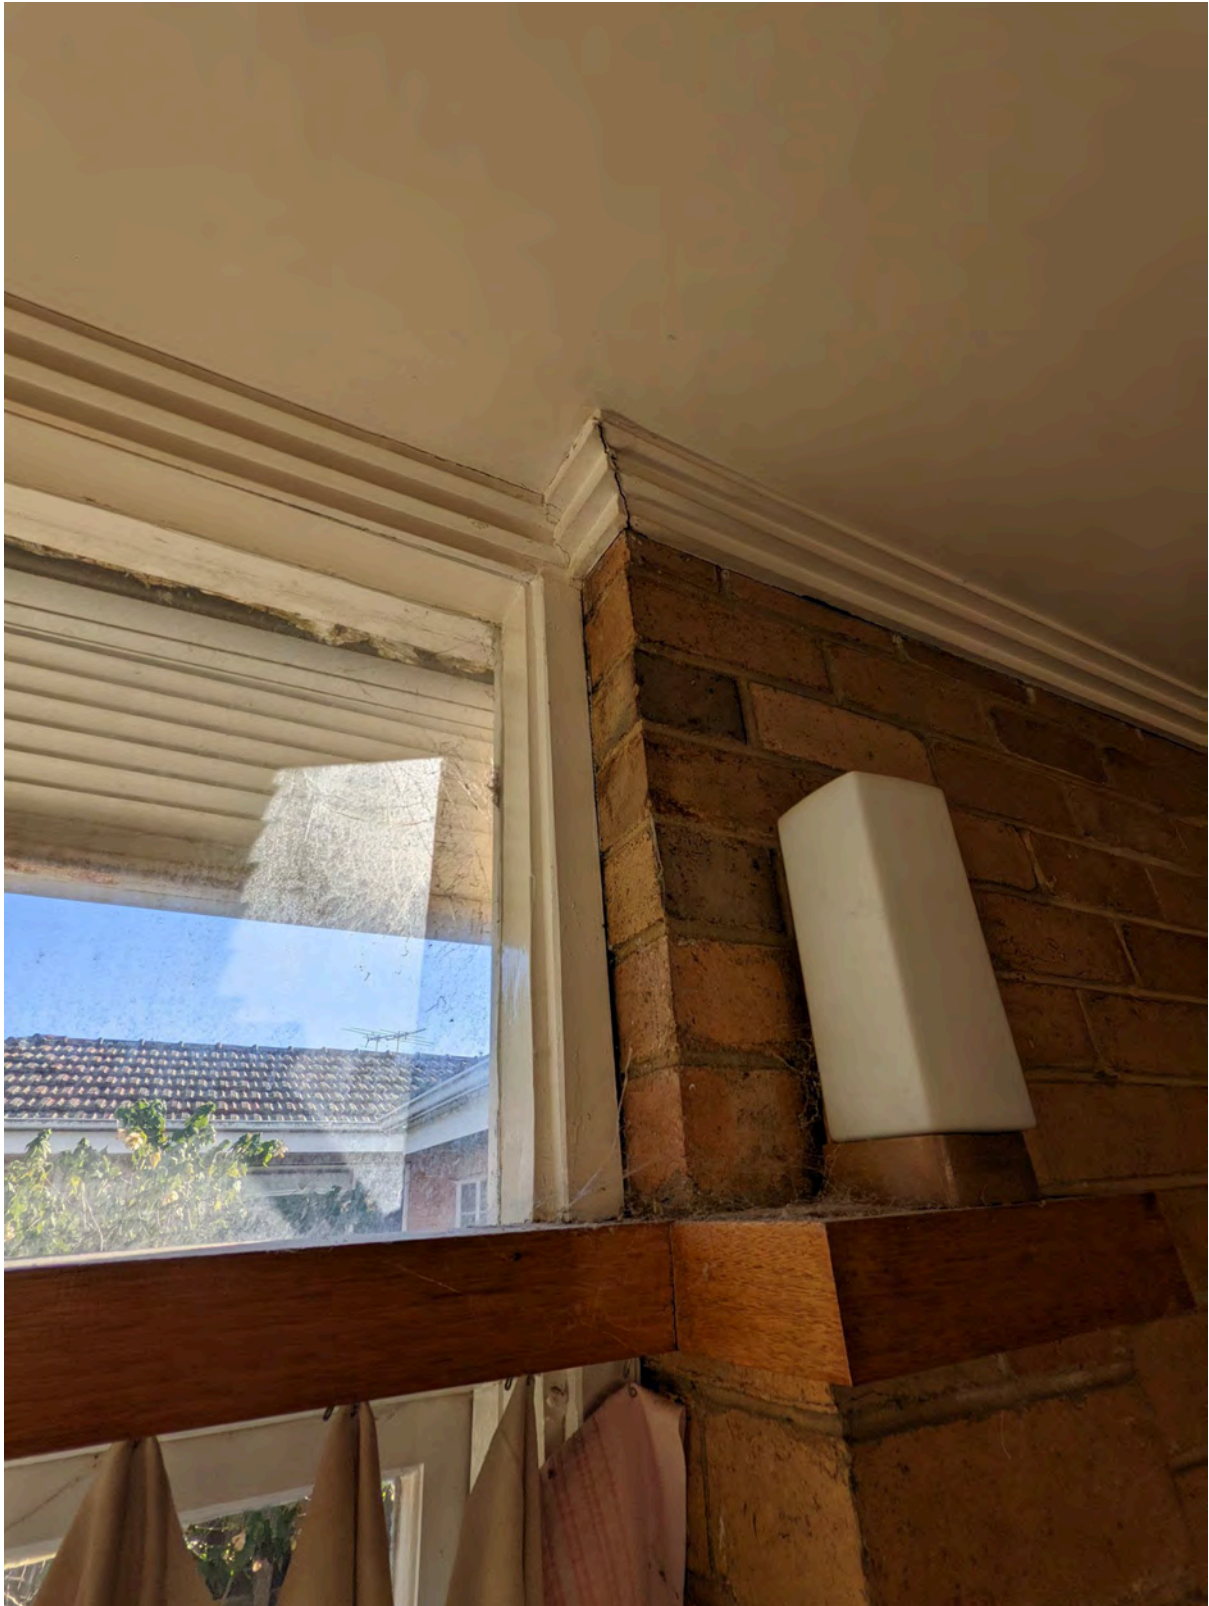
**Sunroom Roof Water Damage (1)**

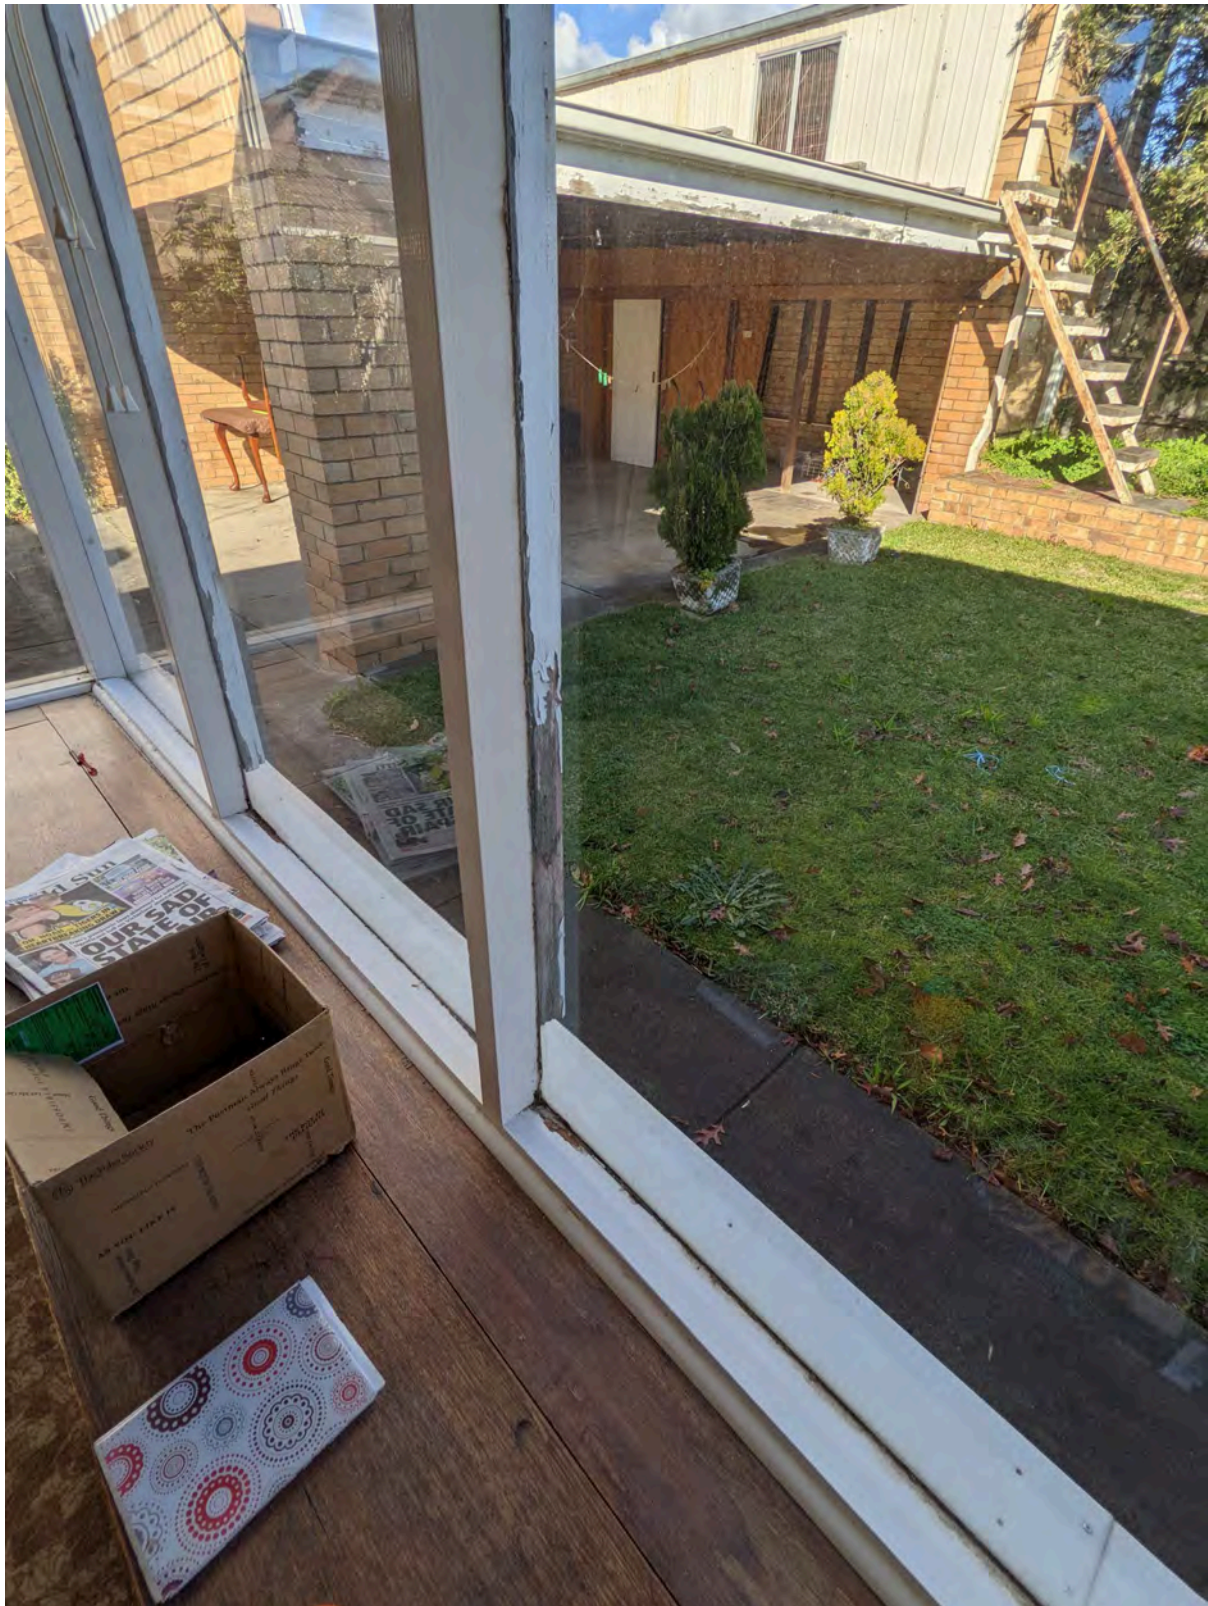
**Sunroom Rotten Window Frames**

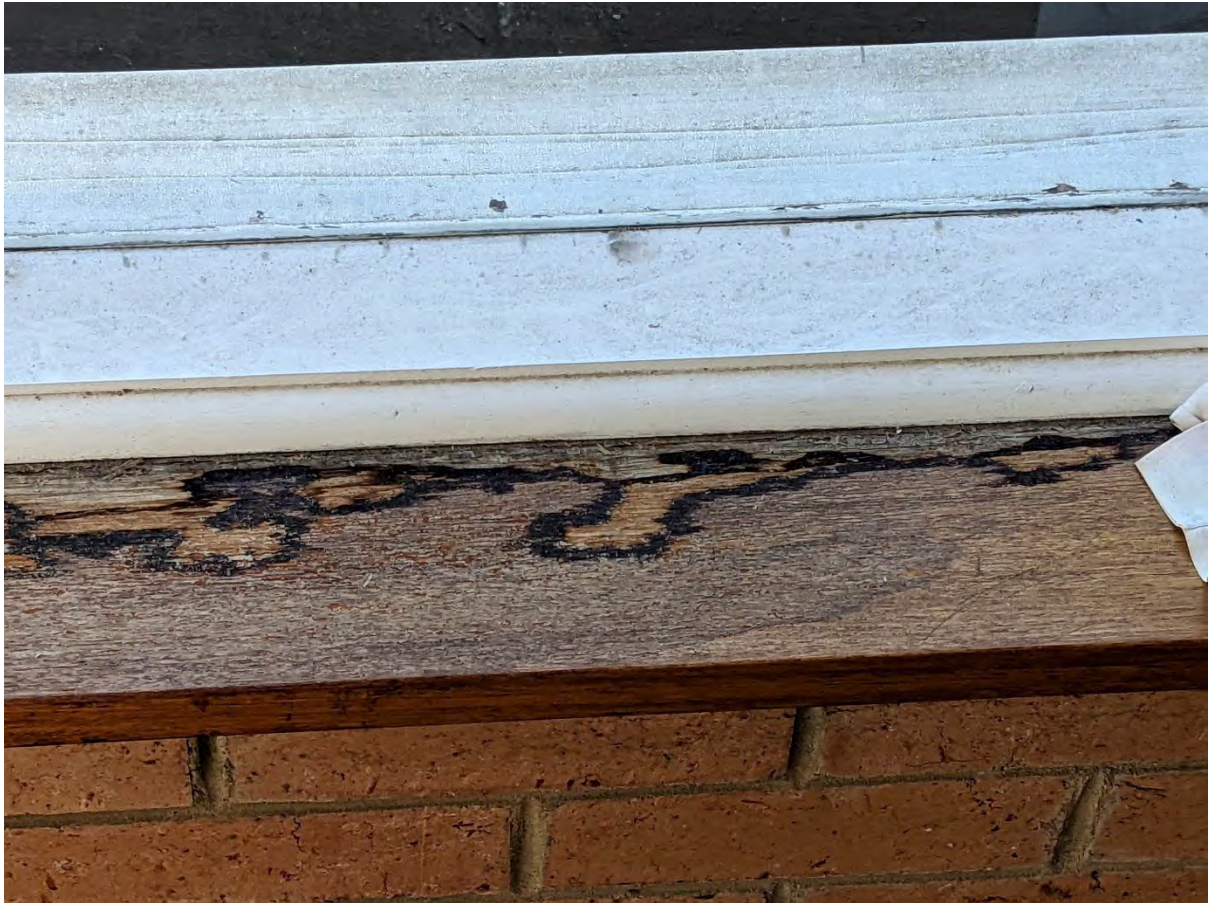
**Sunroom Water Damage**

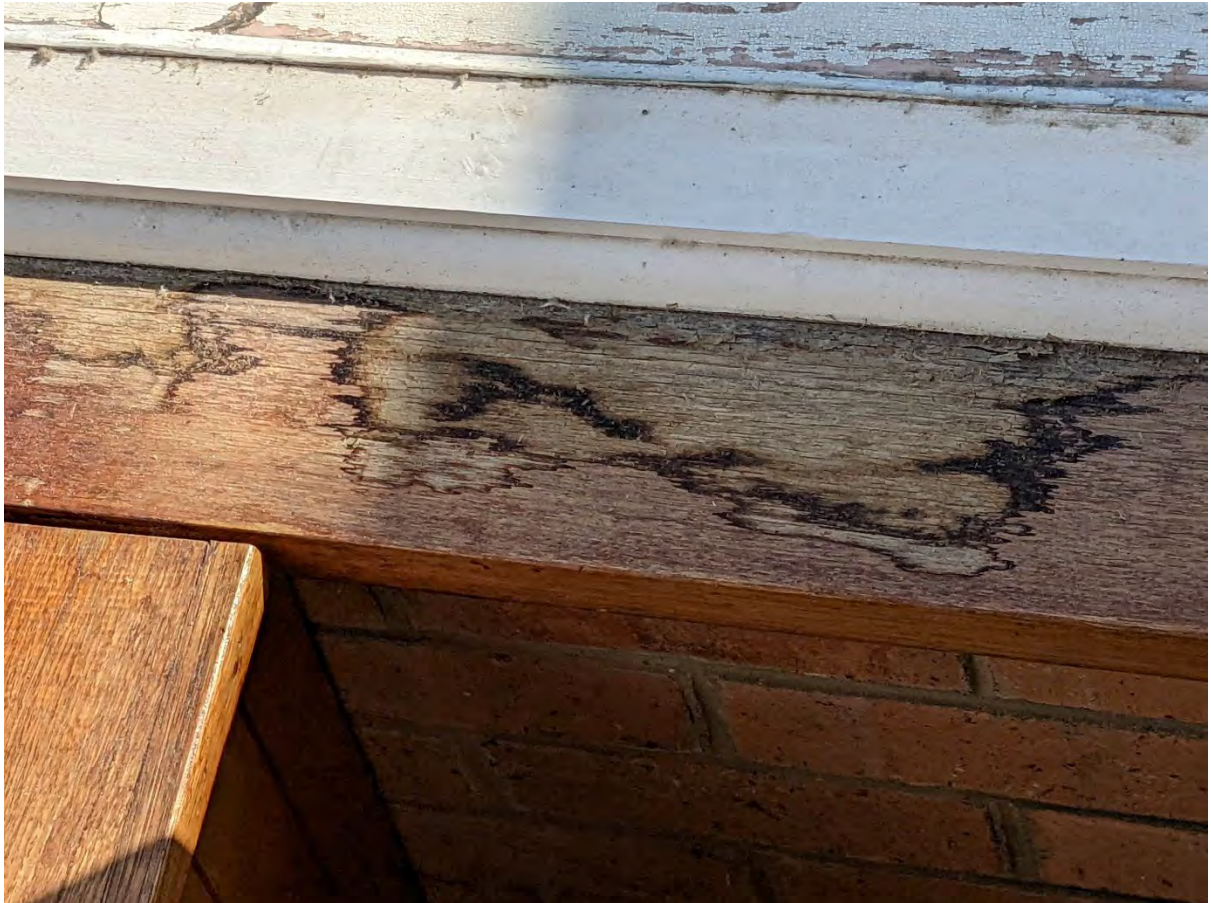
**Sunroom Water Damage (2)**

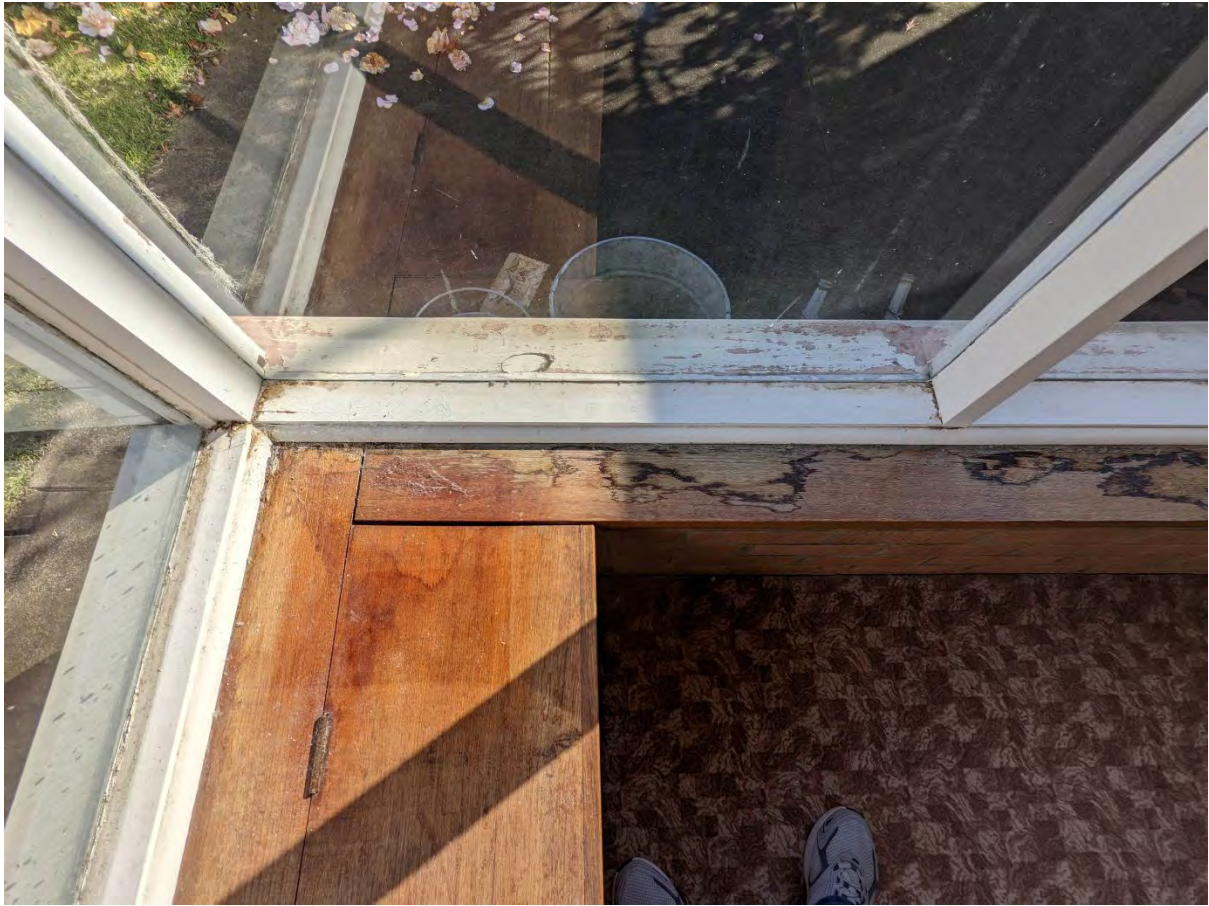
**Sunroom Water Damage (3)**

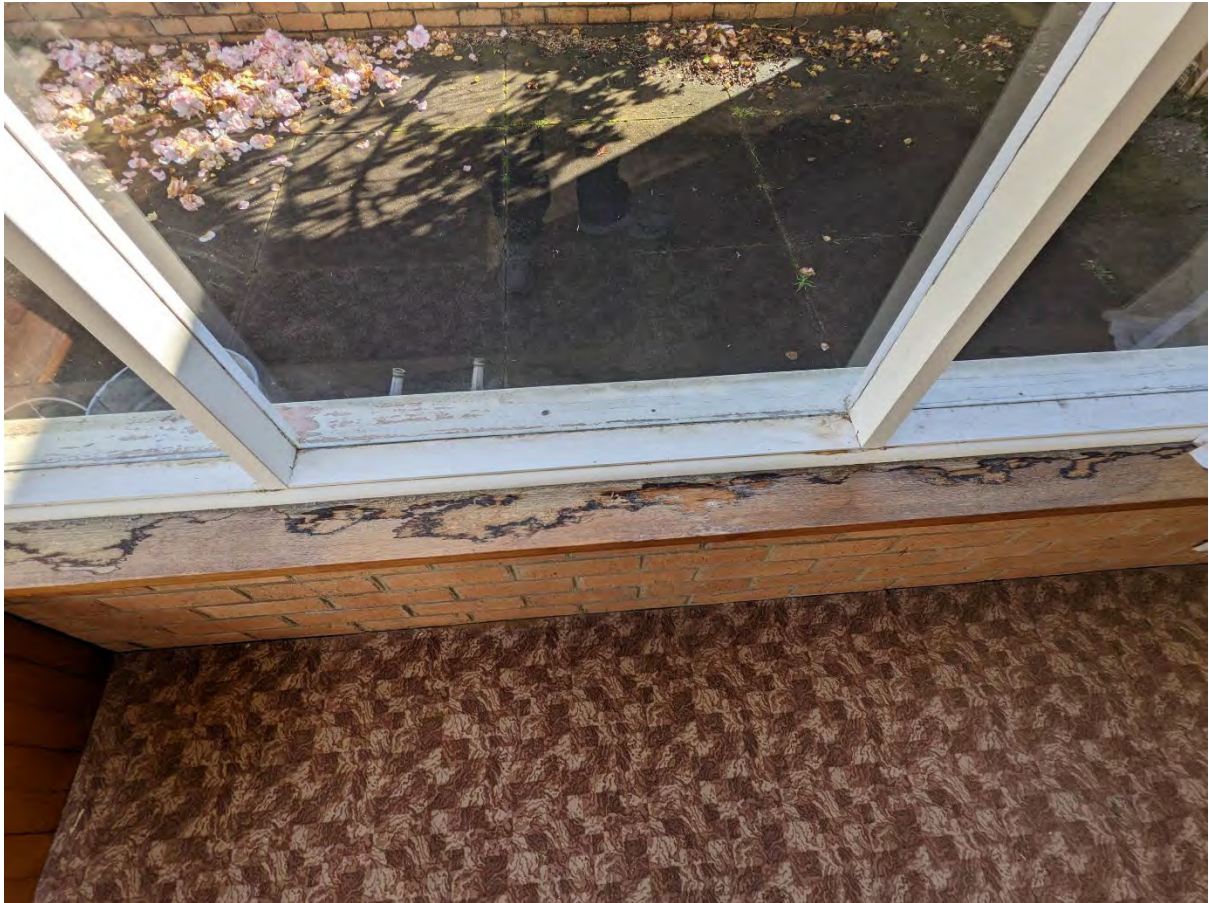
**Sunroom Water Damage (4)**

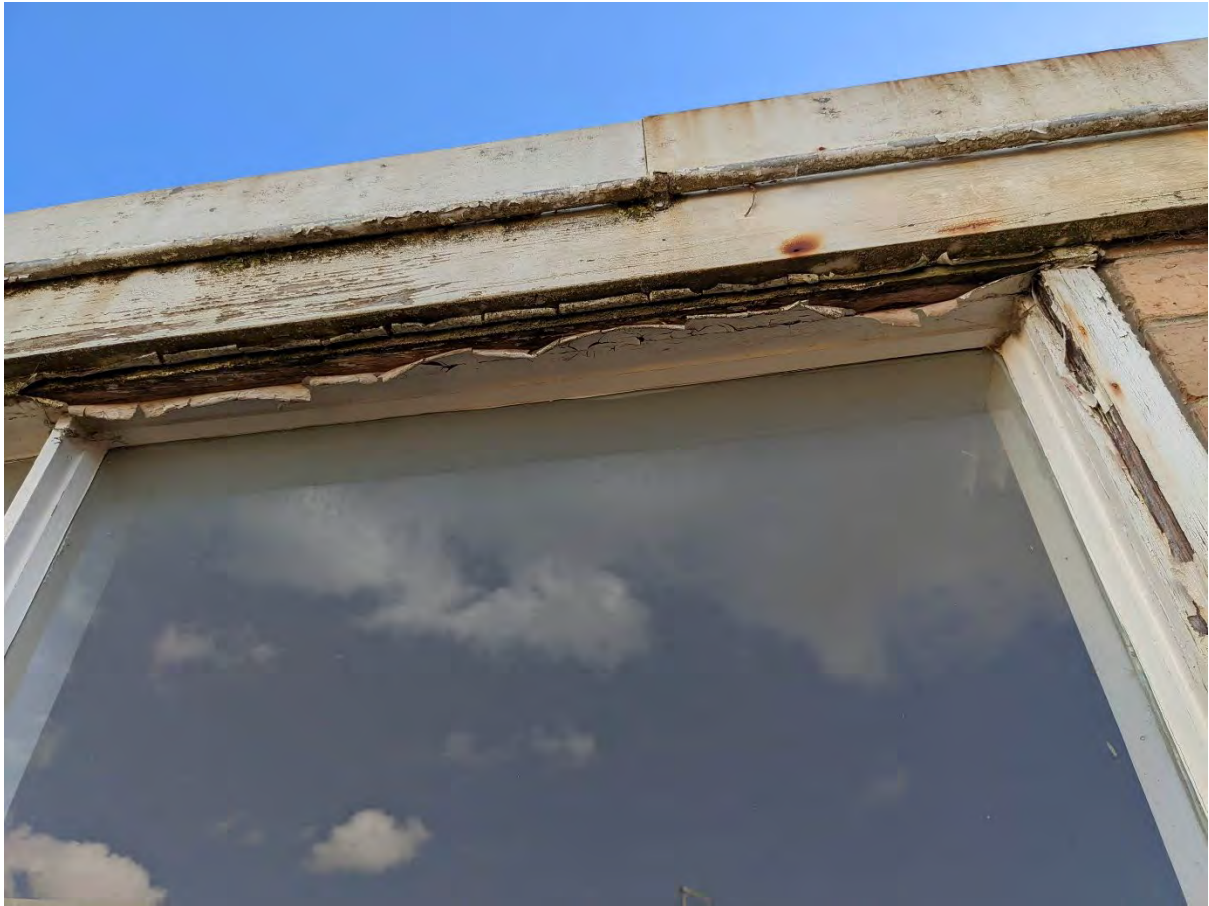
**External Sunroom Framing Rot**

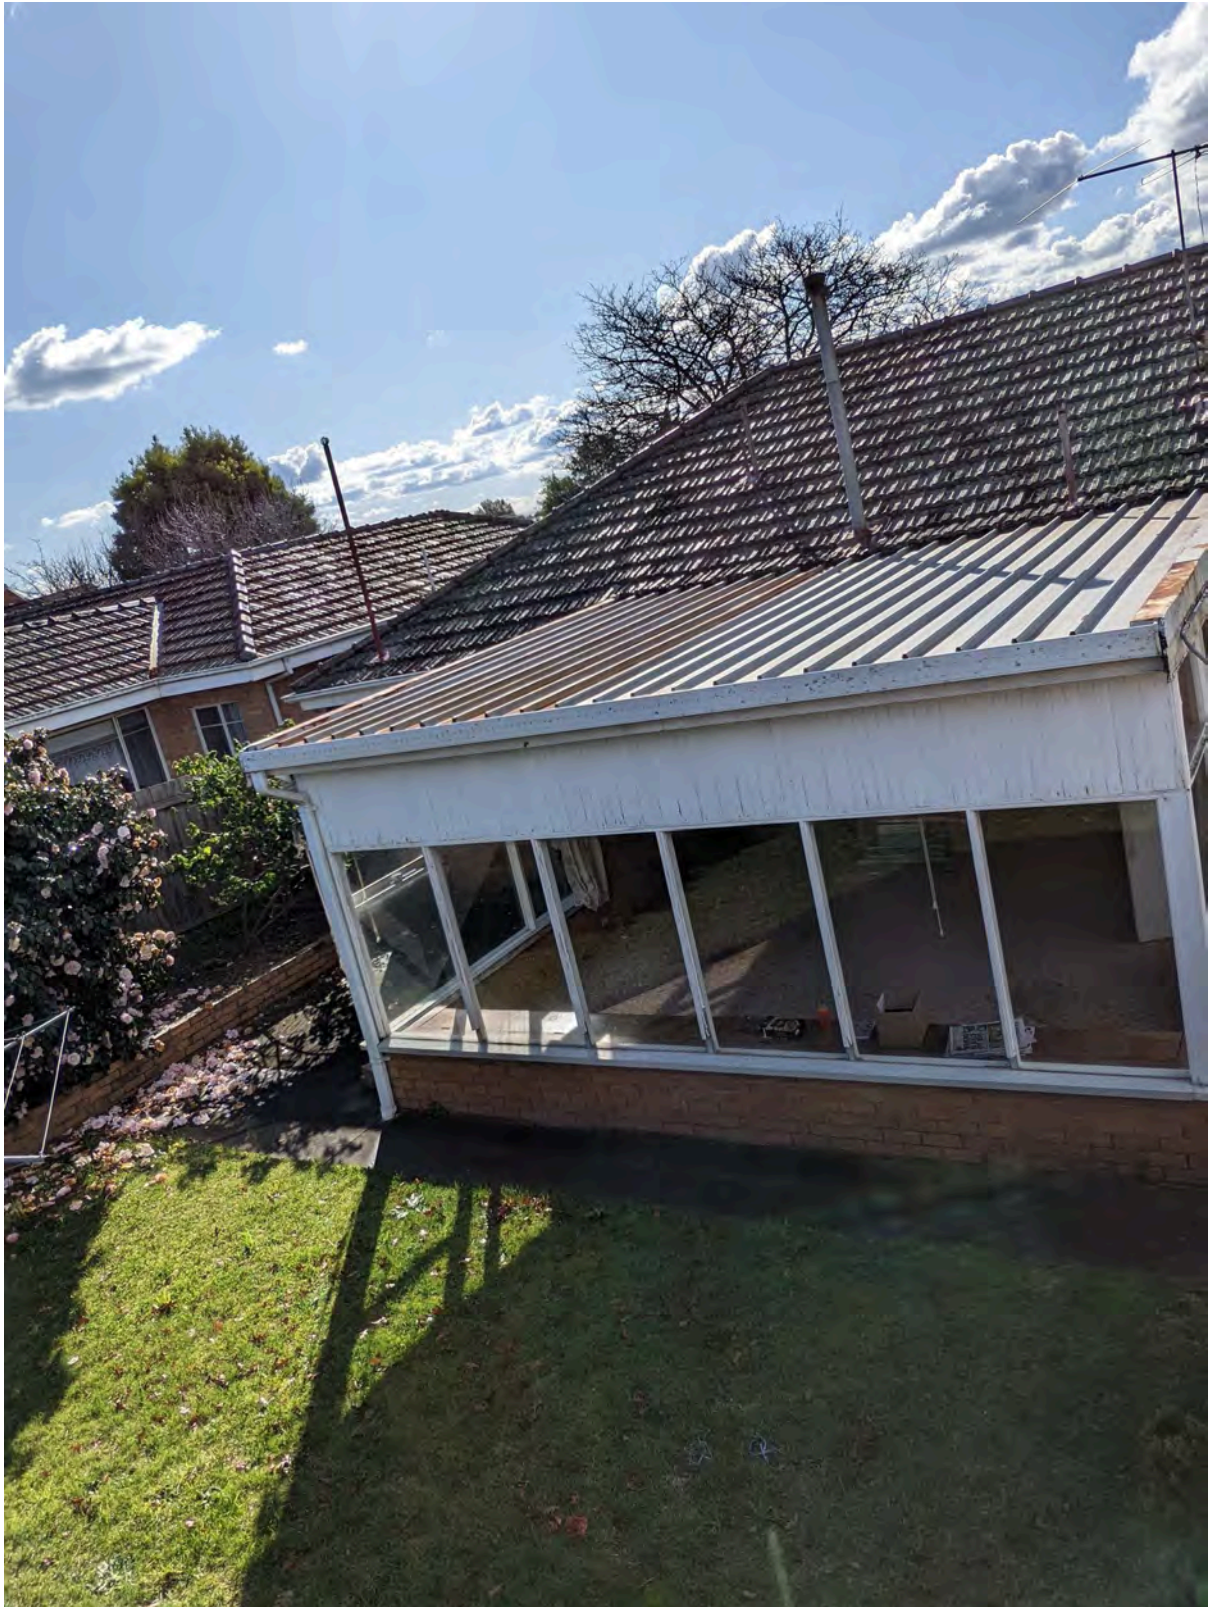
**Corroded Sunroom Roof & Rotten Frame**

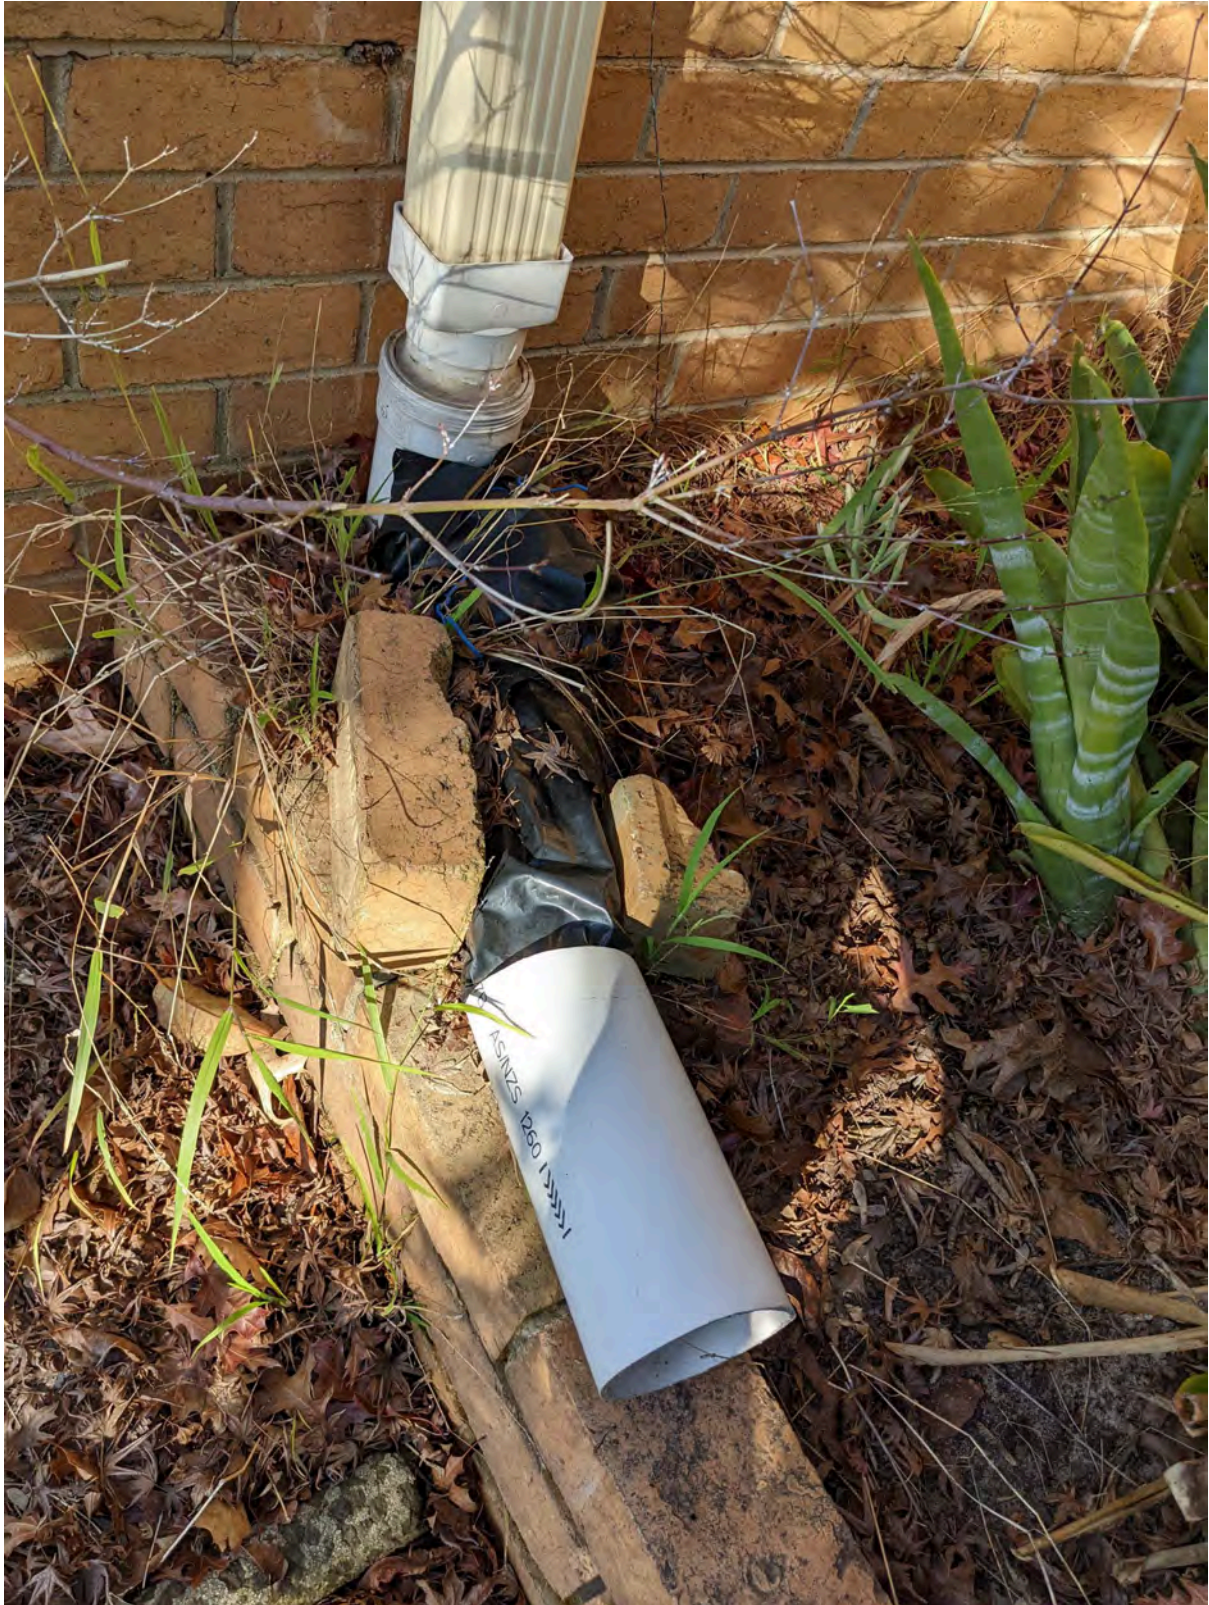
**Downpipe - DIY Diversion to Garden**
