# Property Inspection Photos

**Job No:** BAA 242022

**Property Address:** 10 Riddle Street Bentleigh VIC 3204

**Date:** 24 July 202

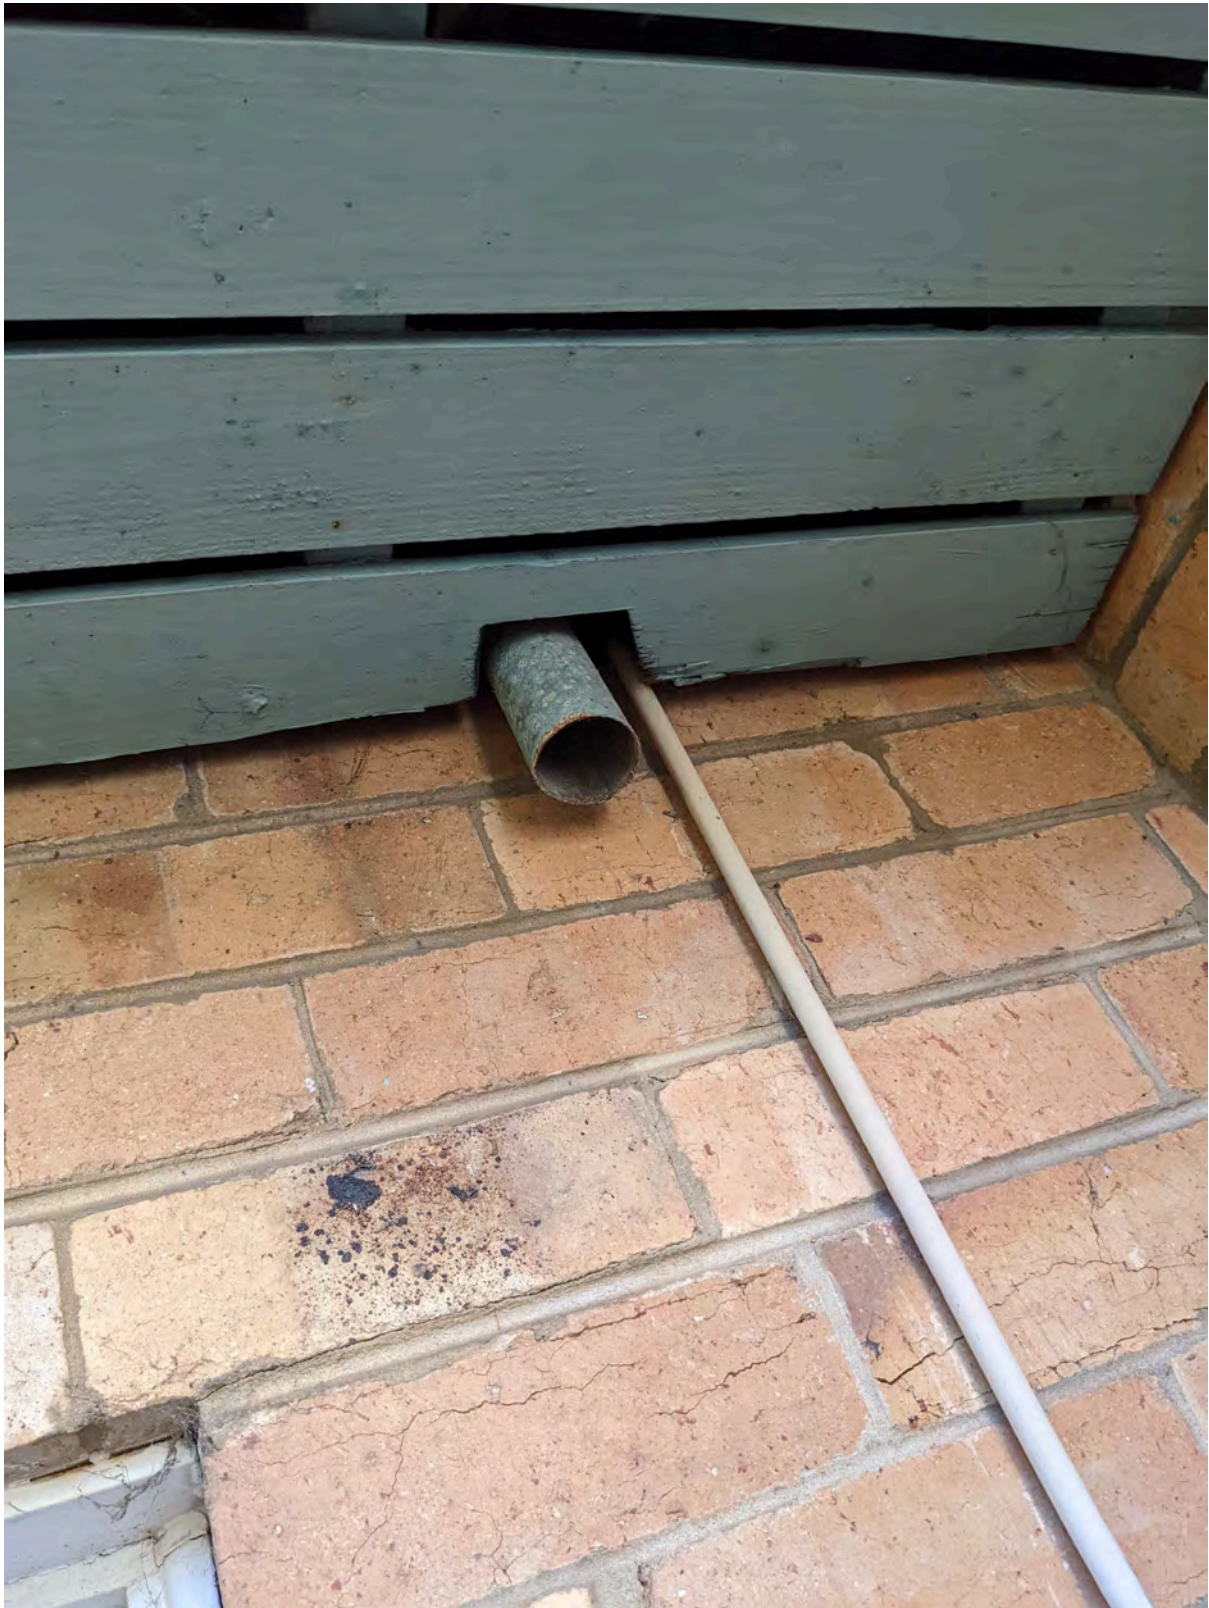
**Downpipe Not Connected**

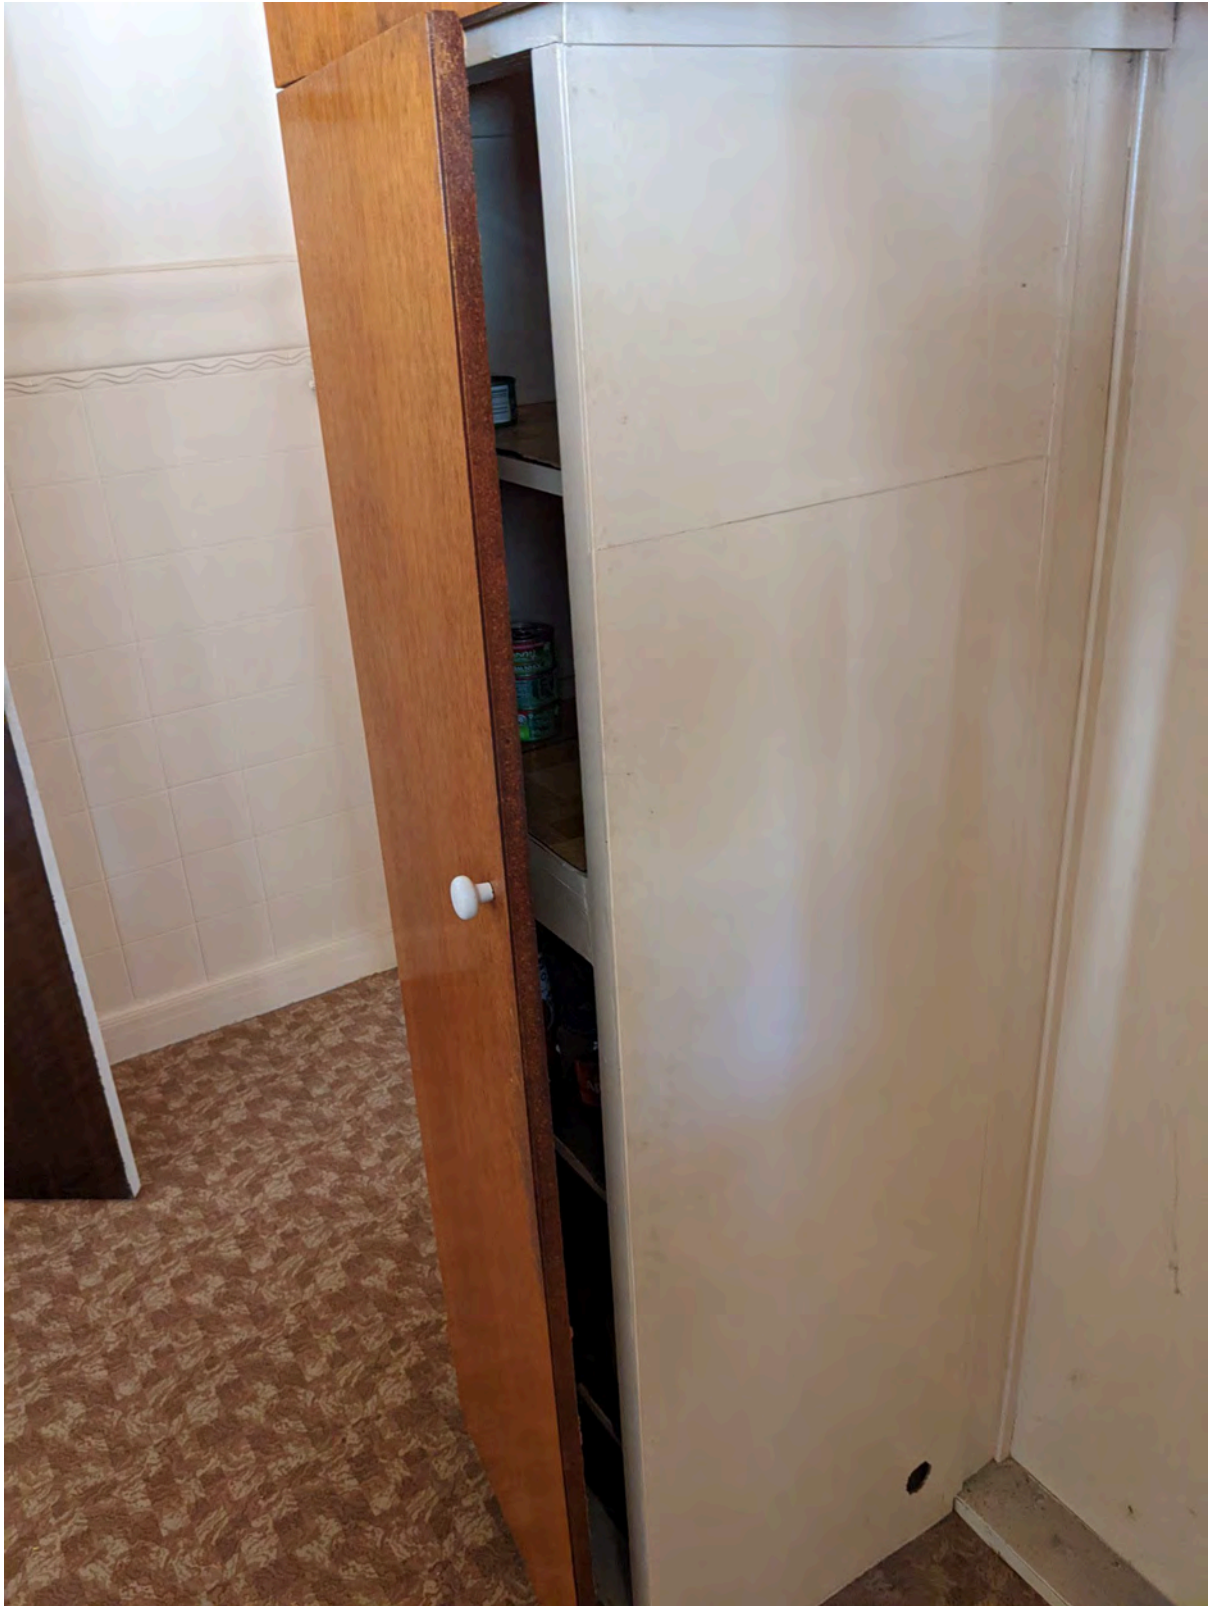
**Kitchen Cupboard - Warped and Will Not Close (1)**

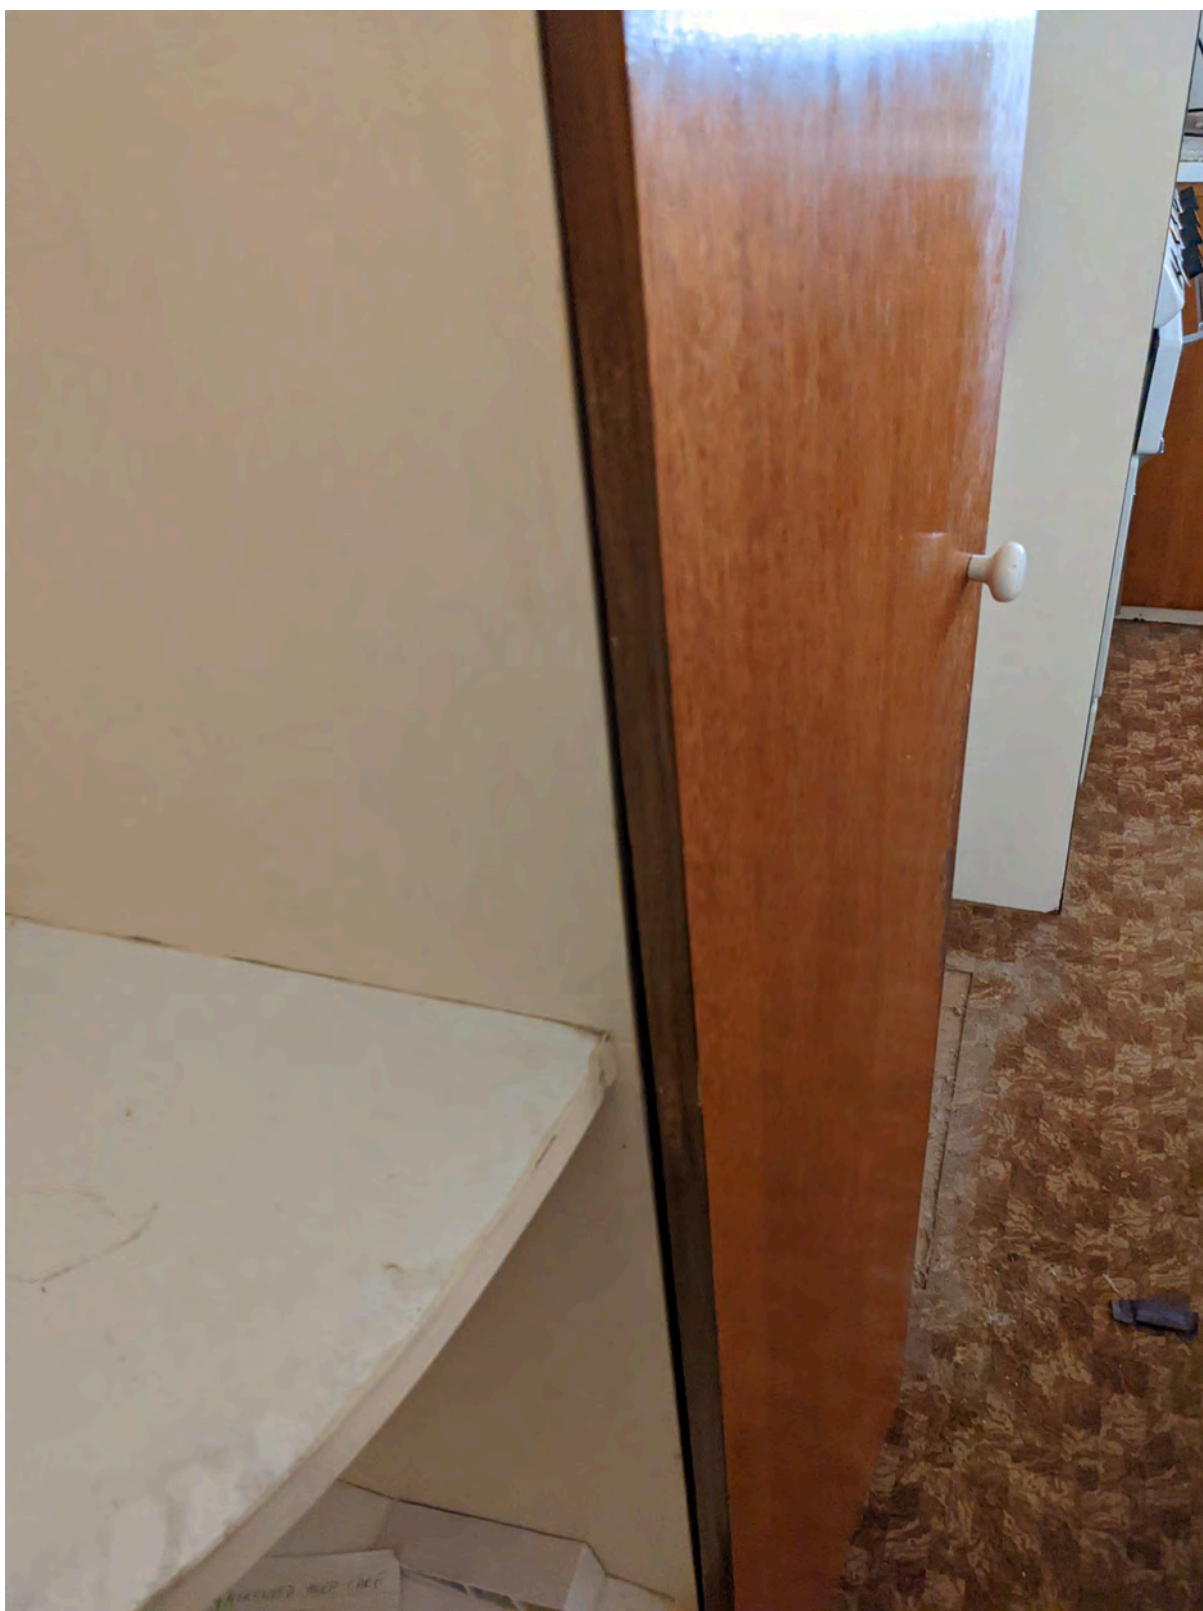
**Kitchen Cupboard - Warped and Will Not Close (2)**

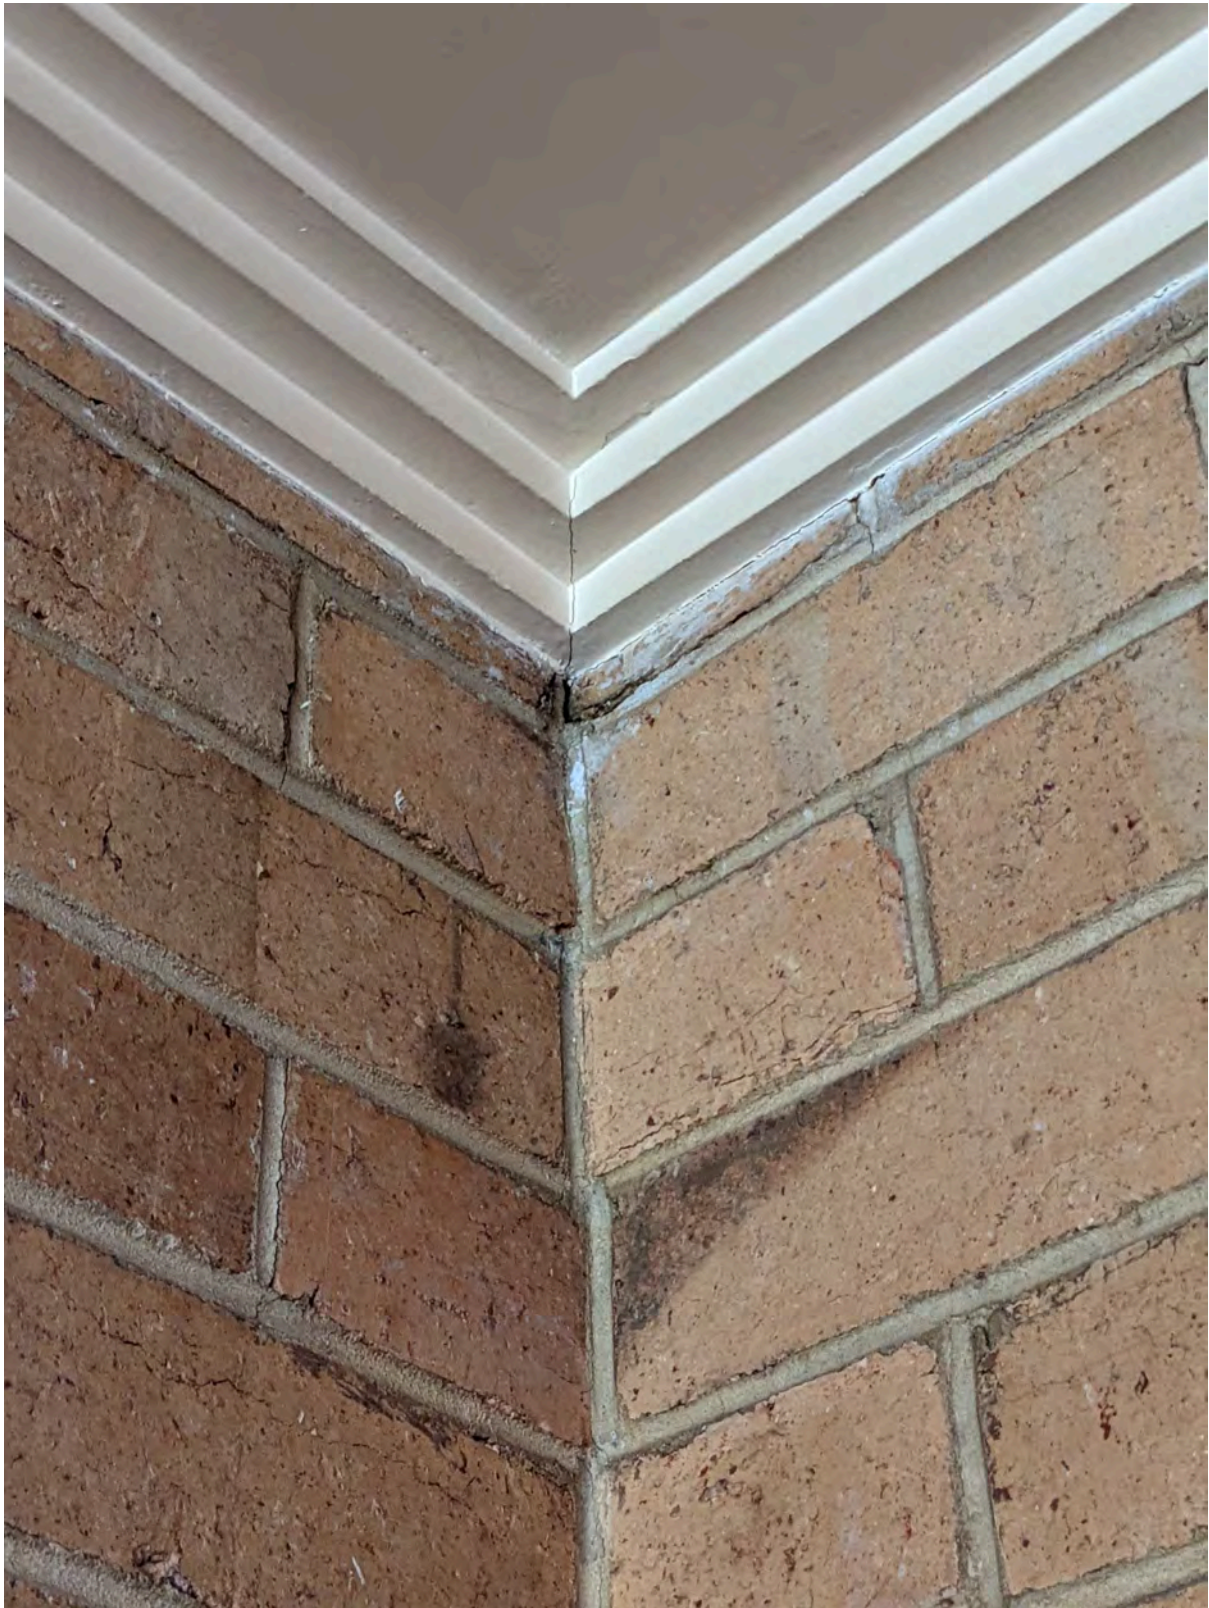
**Kitchen Internal Brickwork Damage**

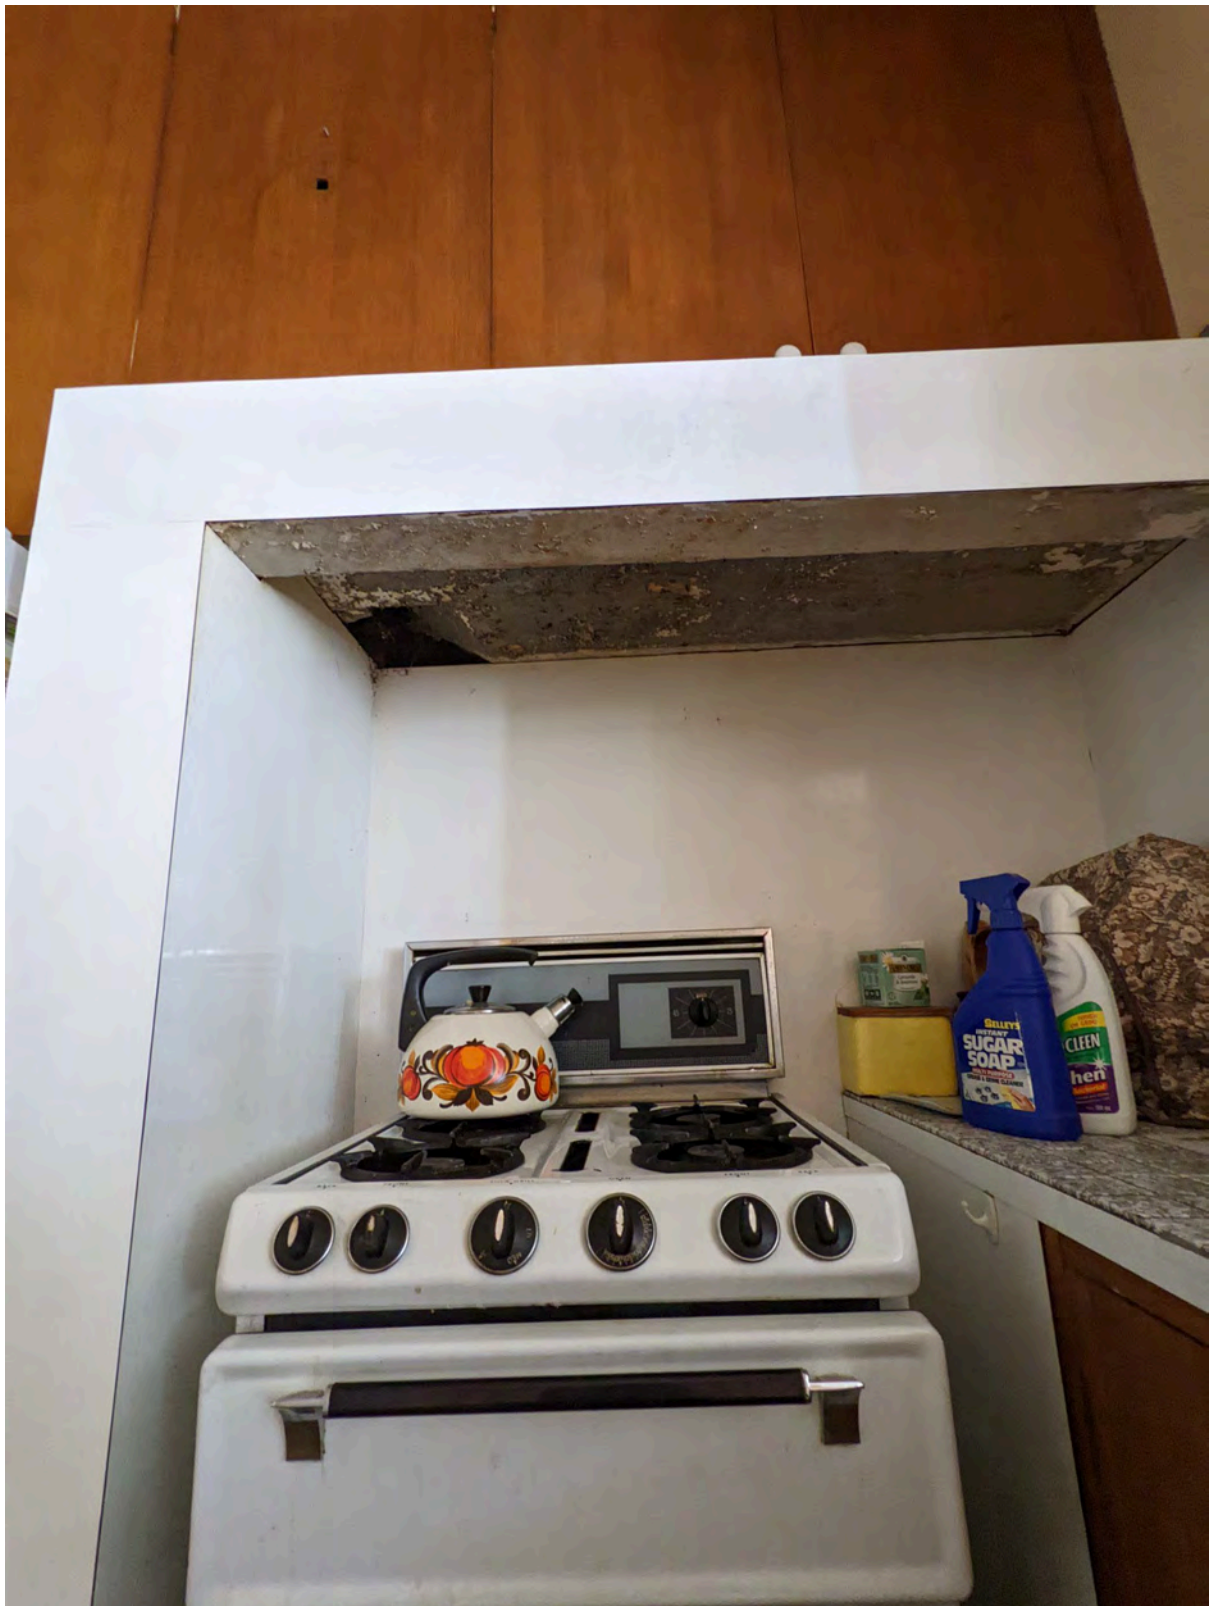
**Kitchen No Rangehood**

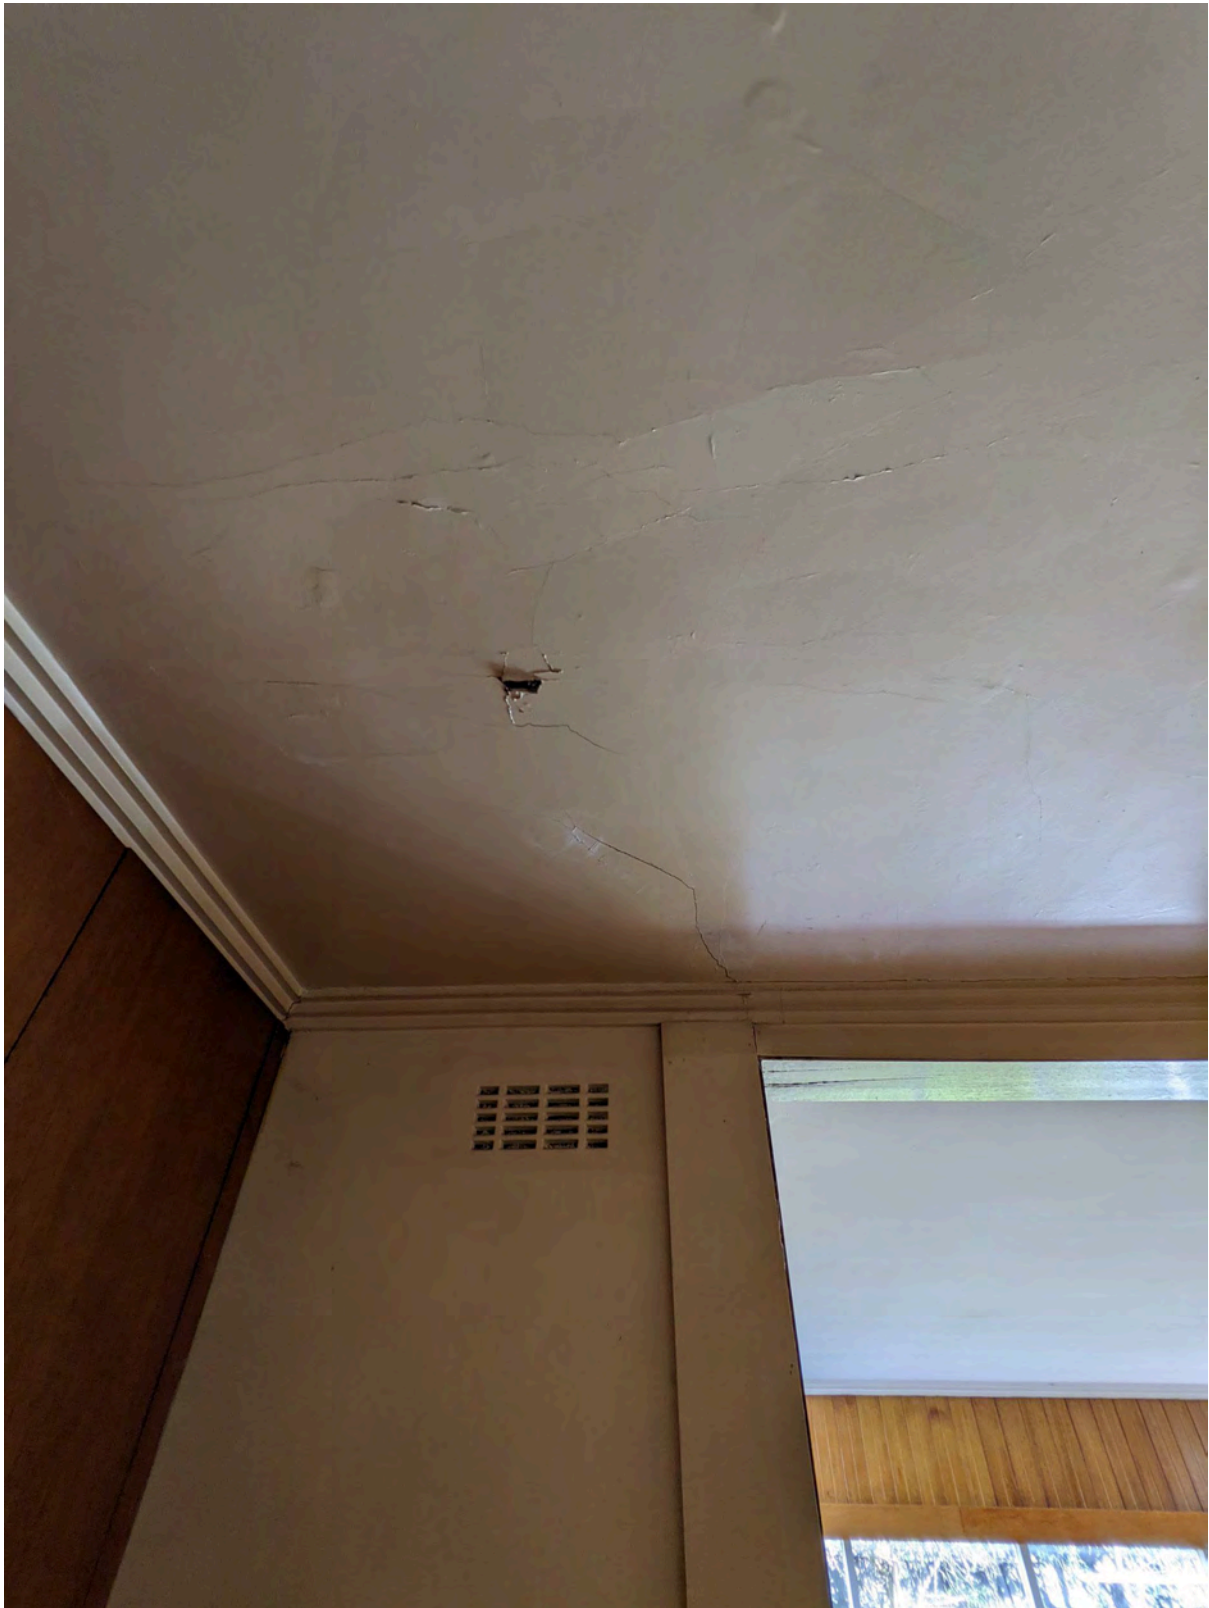
**Kitchen Roof Water Damage**

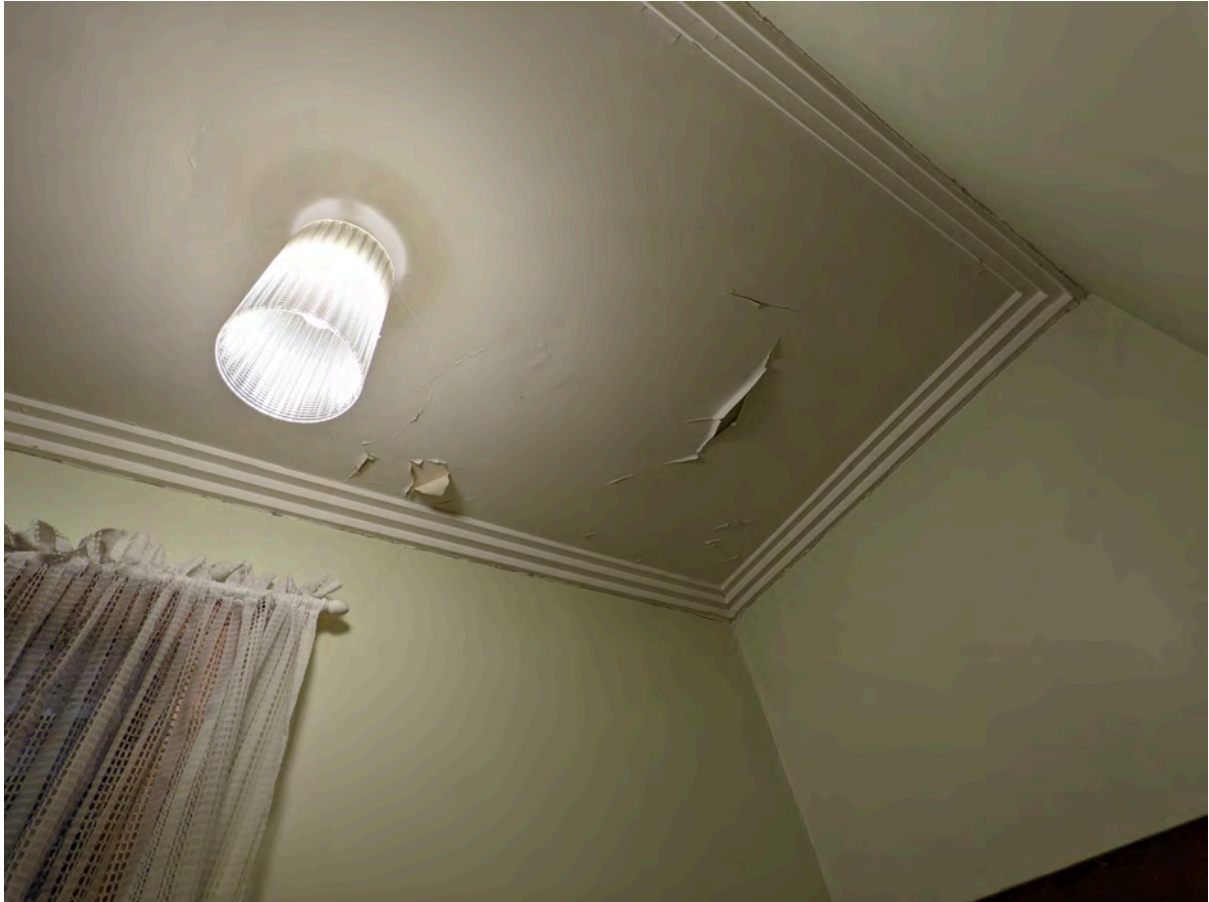
**Laundry Roof Damage**

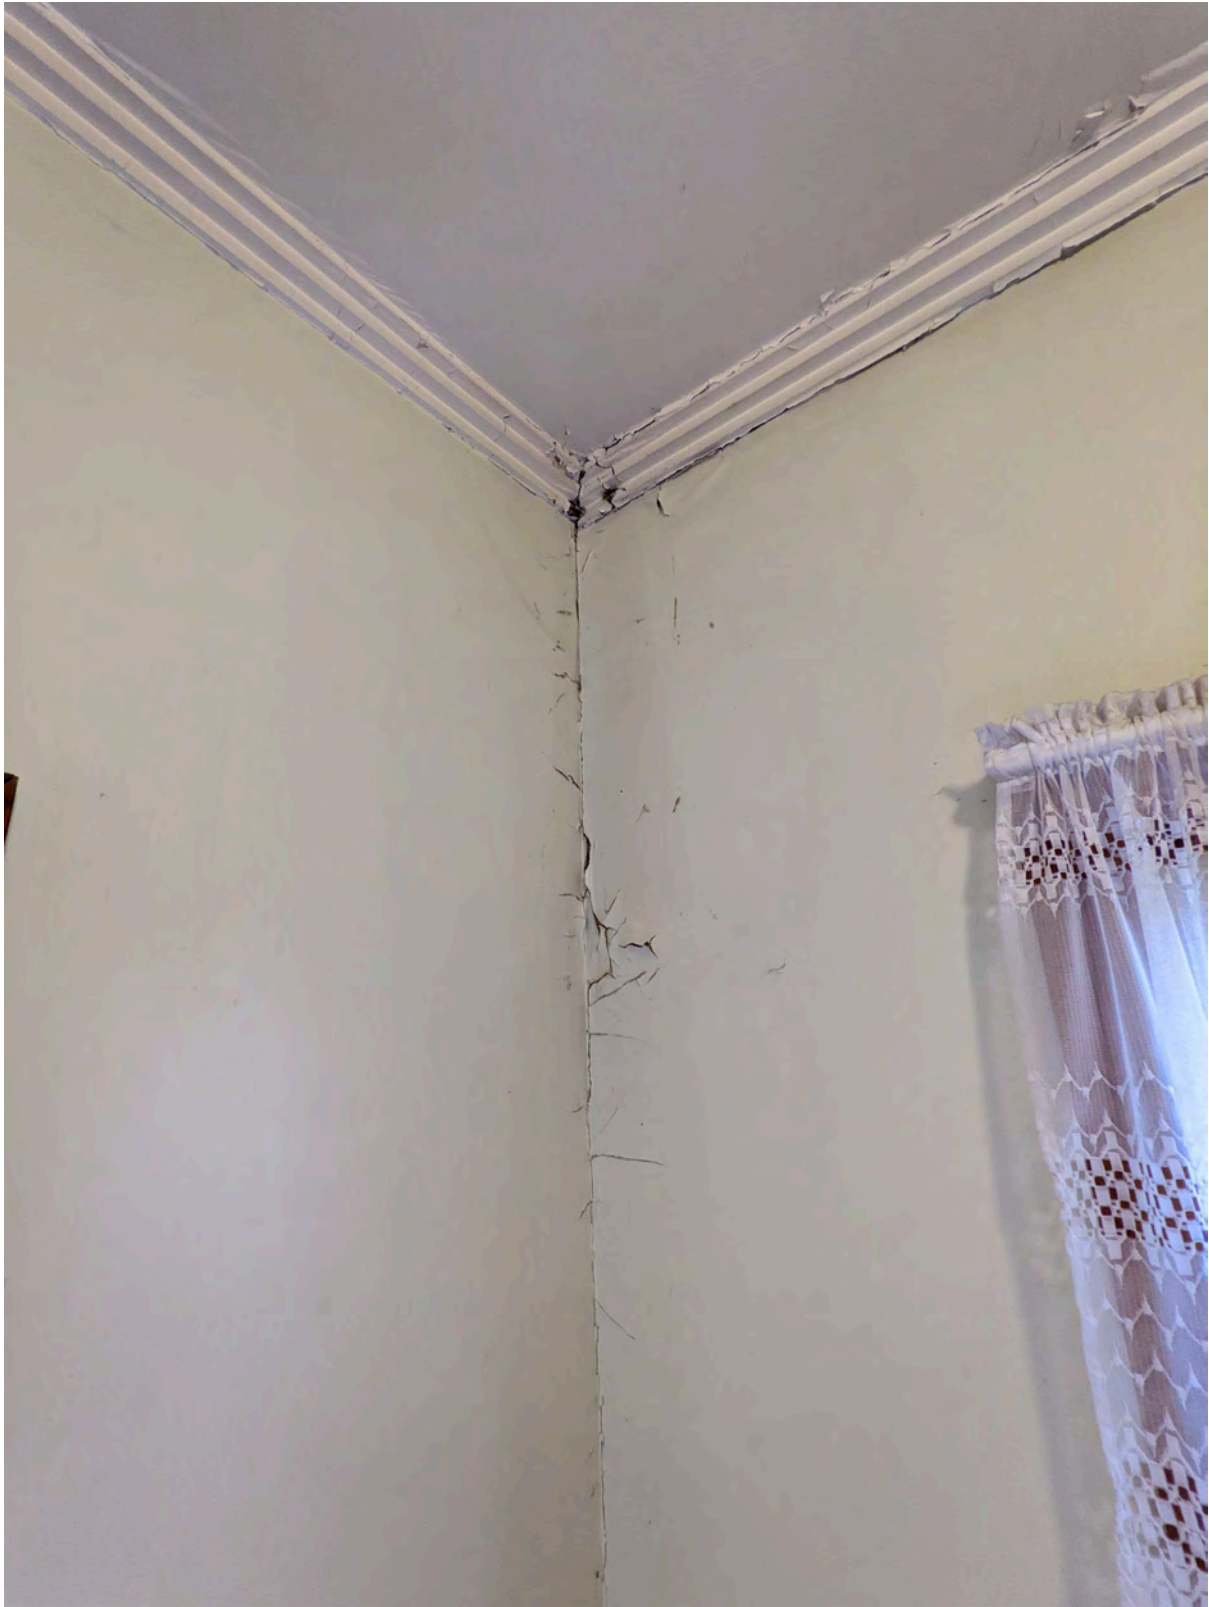
**Laundry Wall and Roof Damage**

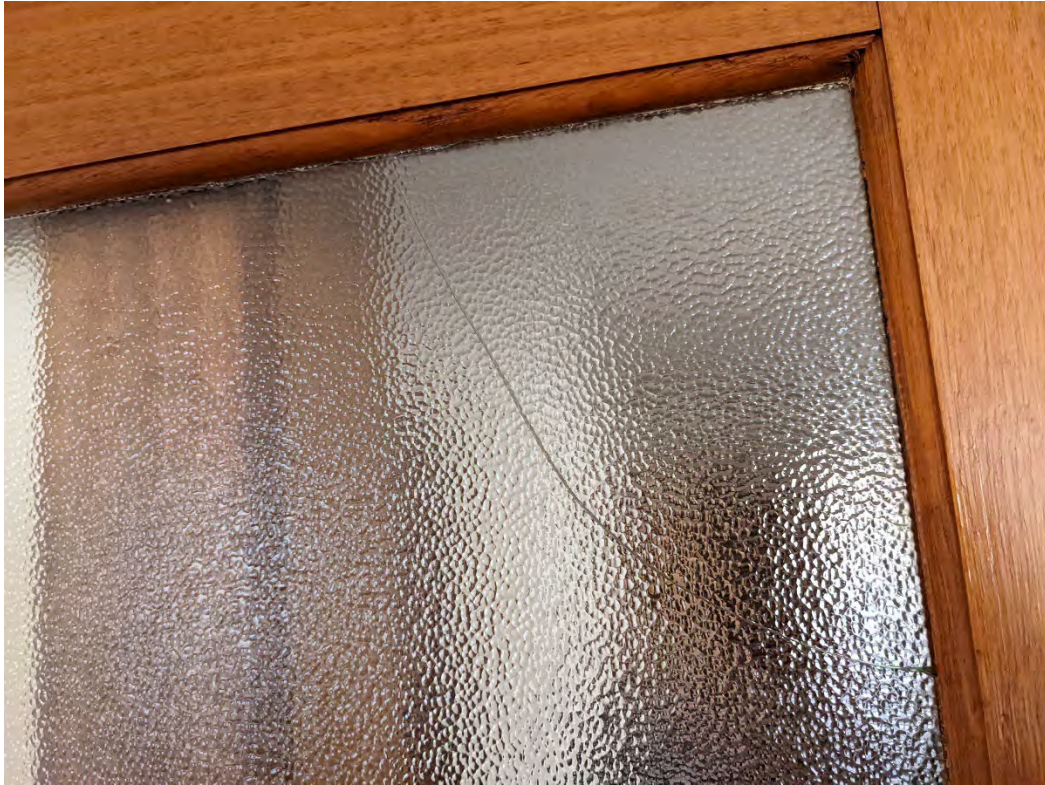
**Loungeroom Door Cracked Glass**

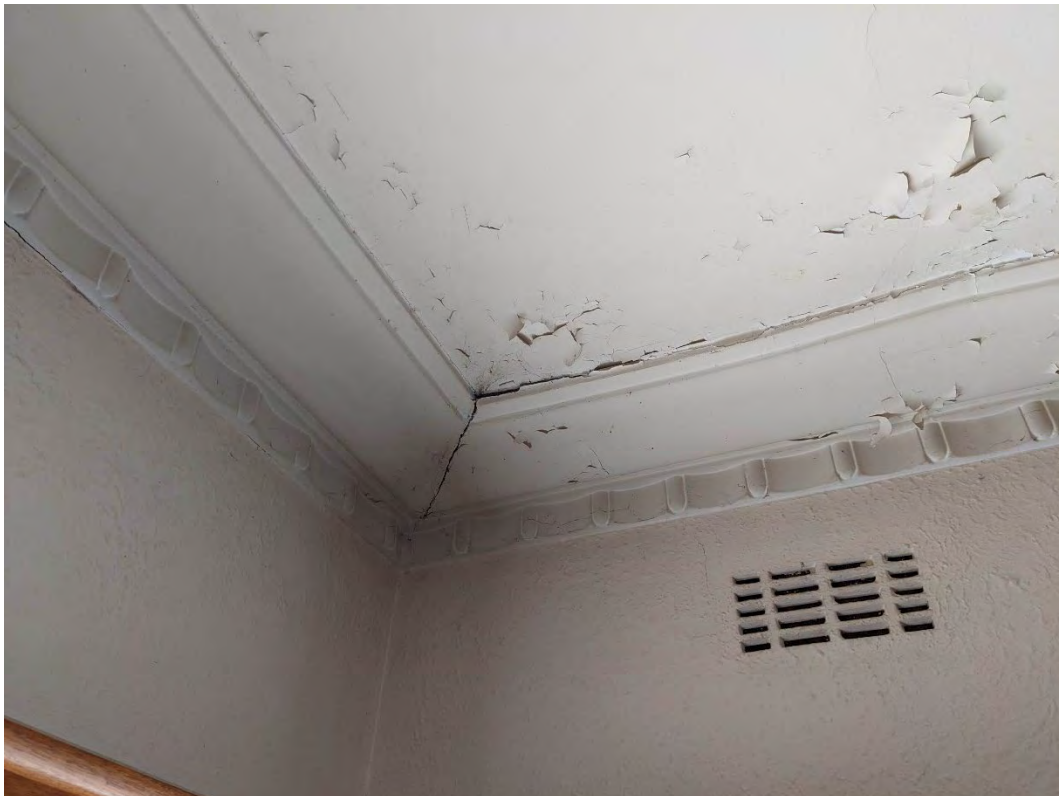
**Loungeroom Roof Water Damage**

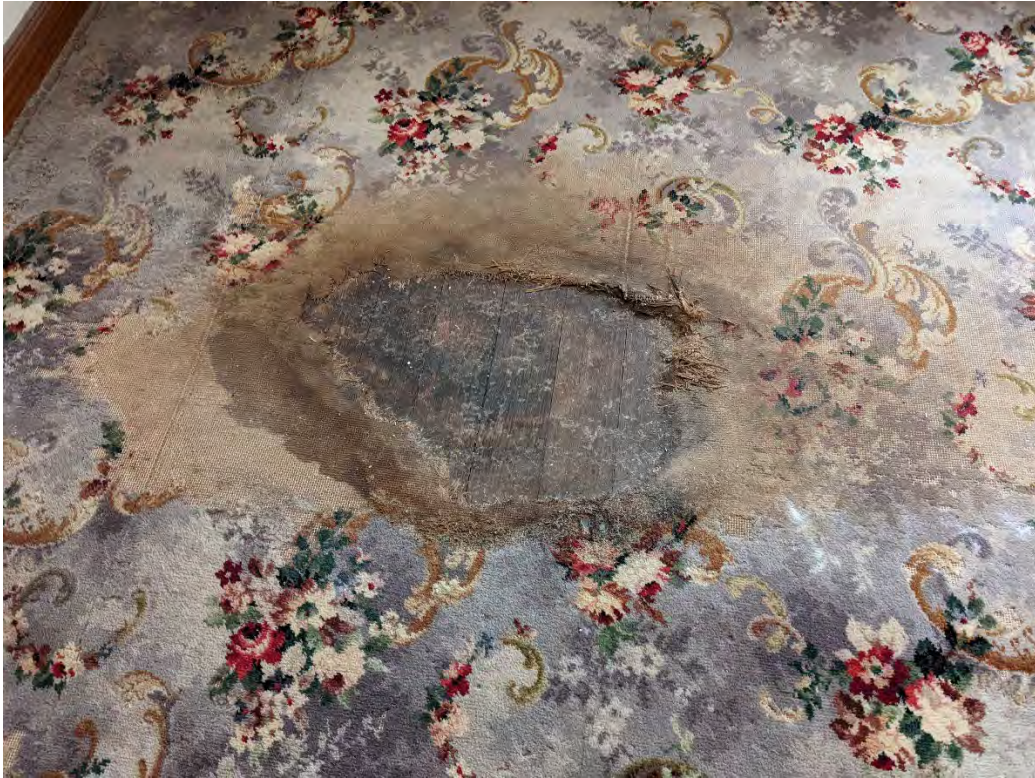
**Master Bedroom Carpet Rot**

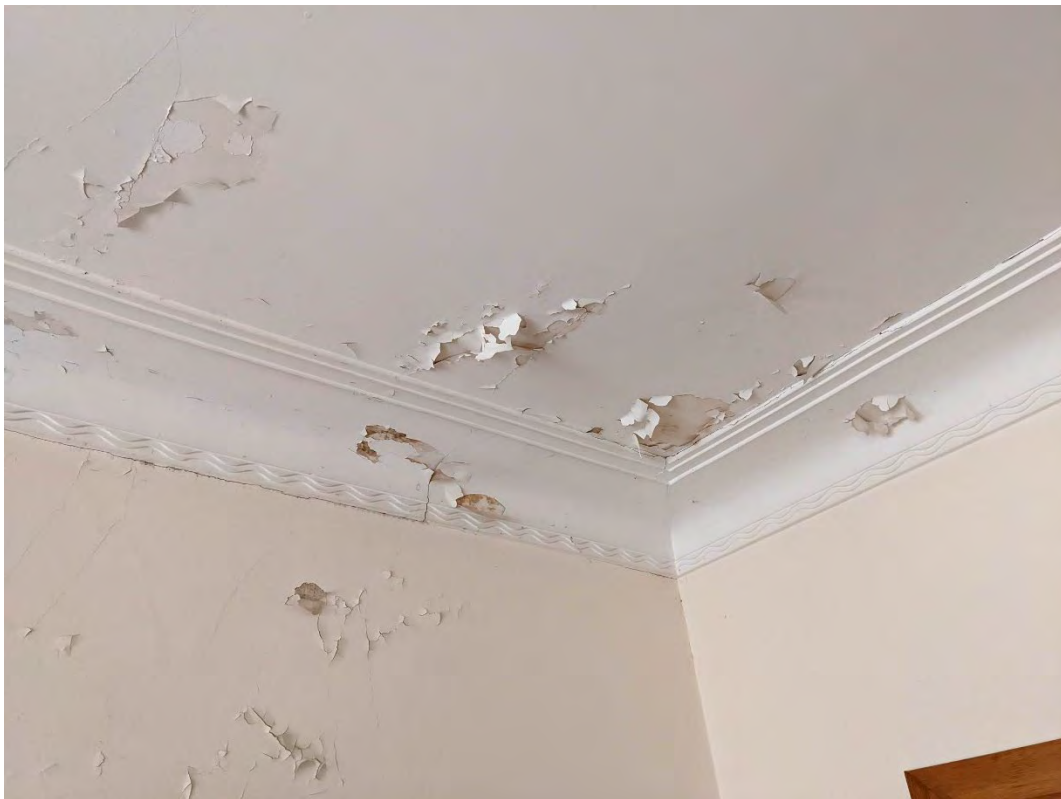
**Master Bedroom Ceiling Water Damage**

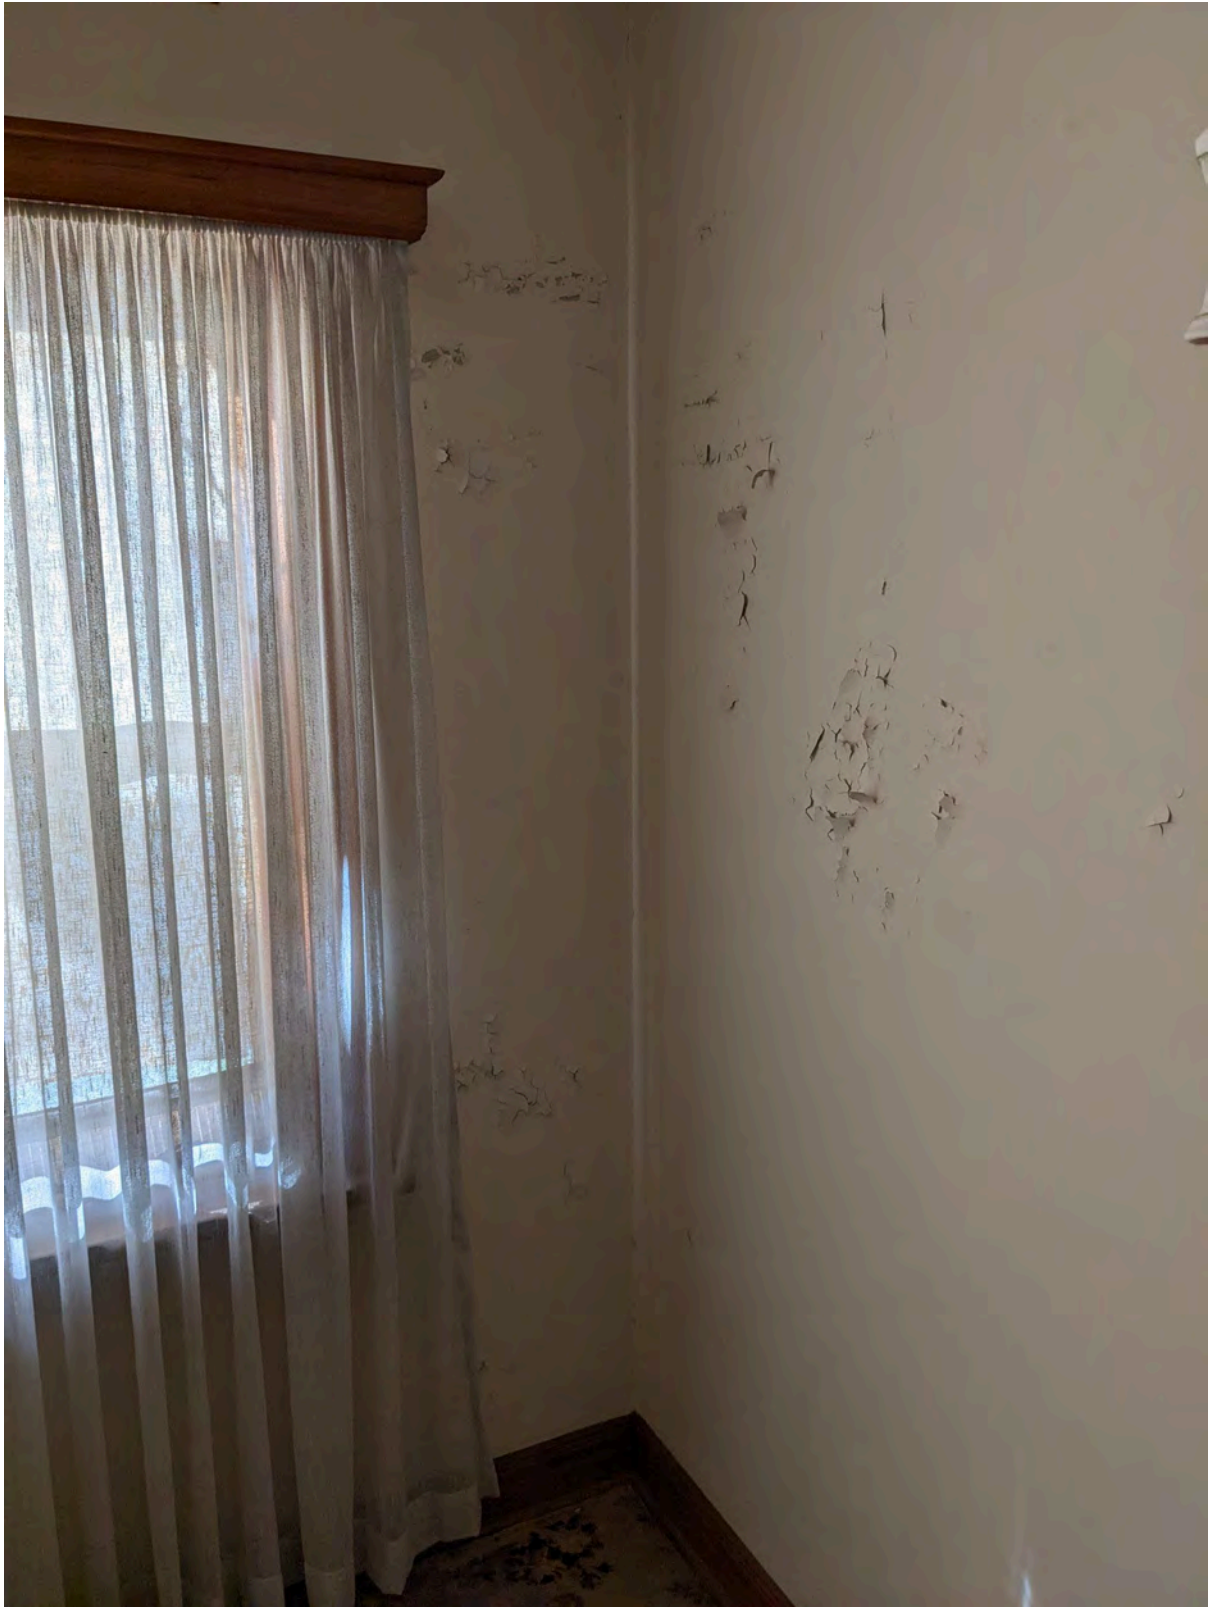
**Master Bedroom Wall Damage**

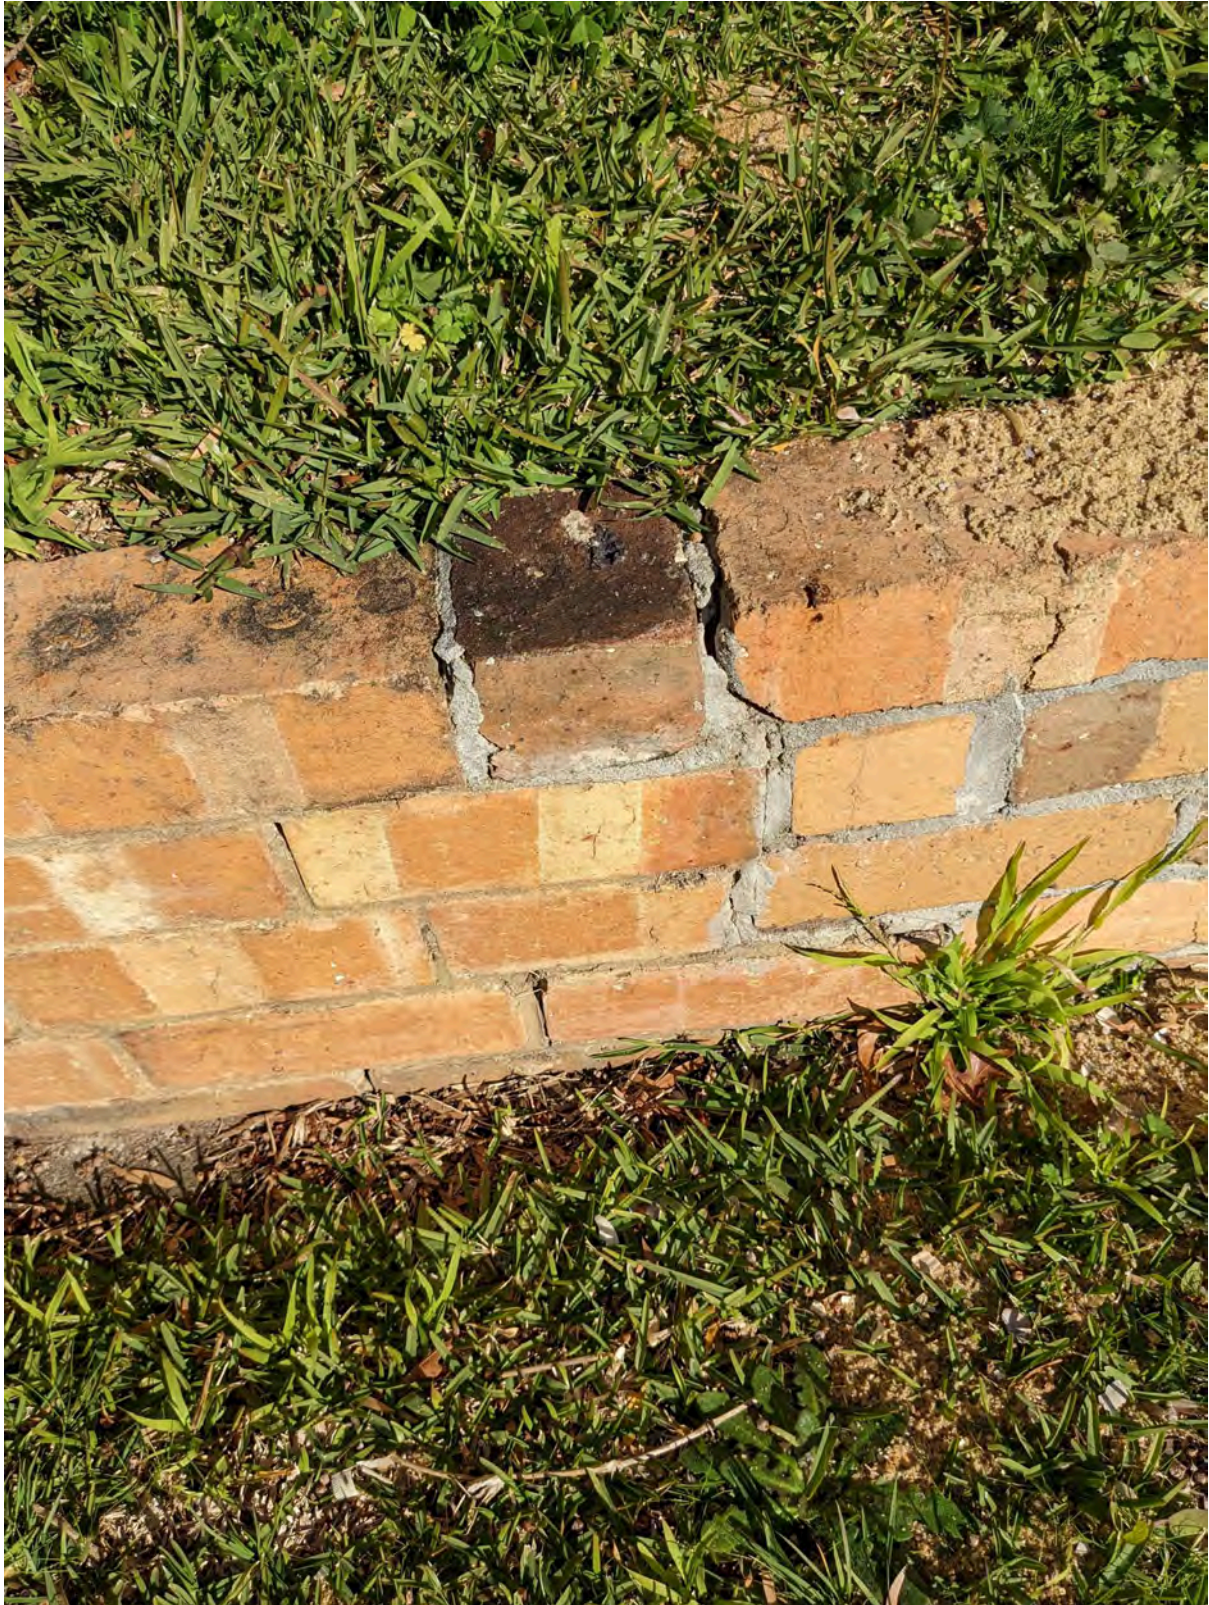
**Rear Retaining Wall Crack**
