# Property Inspection Photos

**Job No:** BAA 242022

**Property Address:** 10 Riddle Street Bentleigh VIC 3204

**Date:** 24 July 202

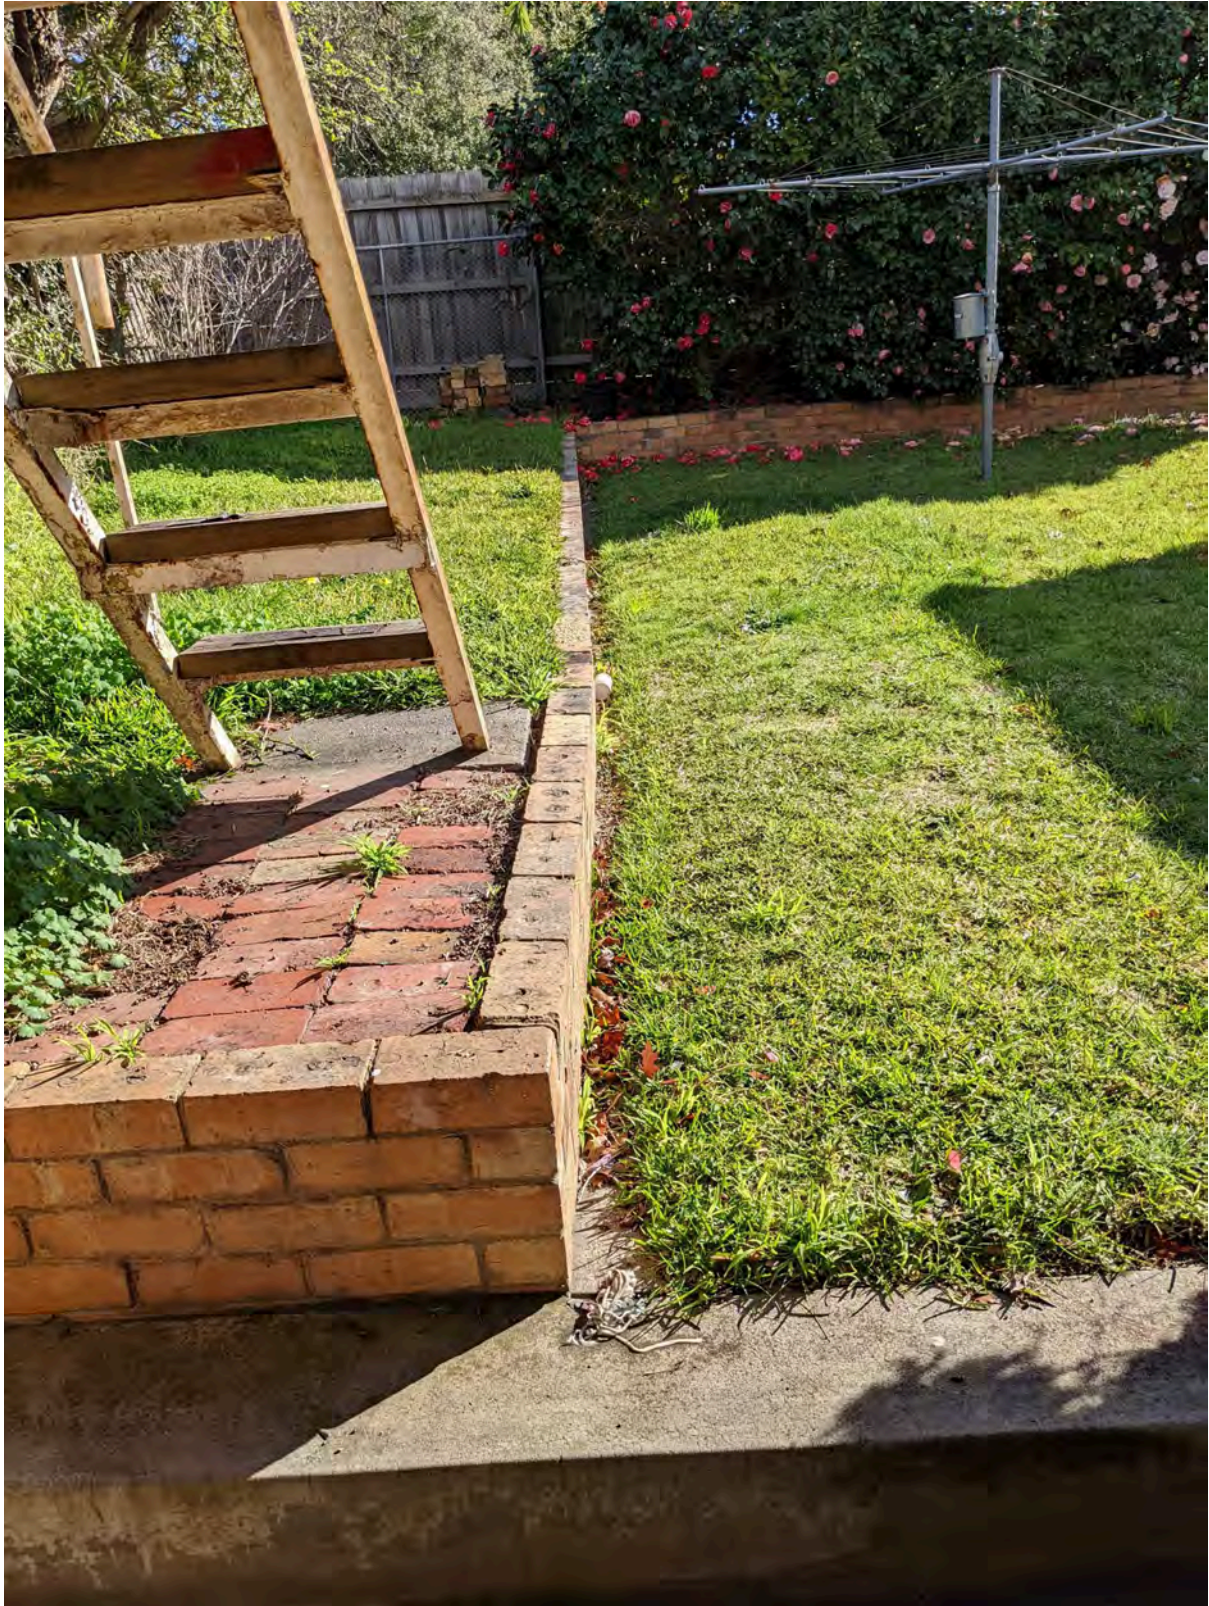
**Rear Retaining Wall Leaning and Not Straight**

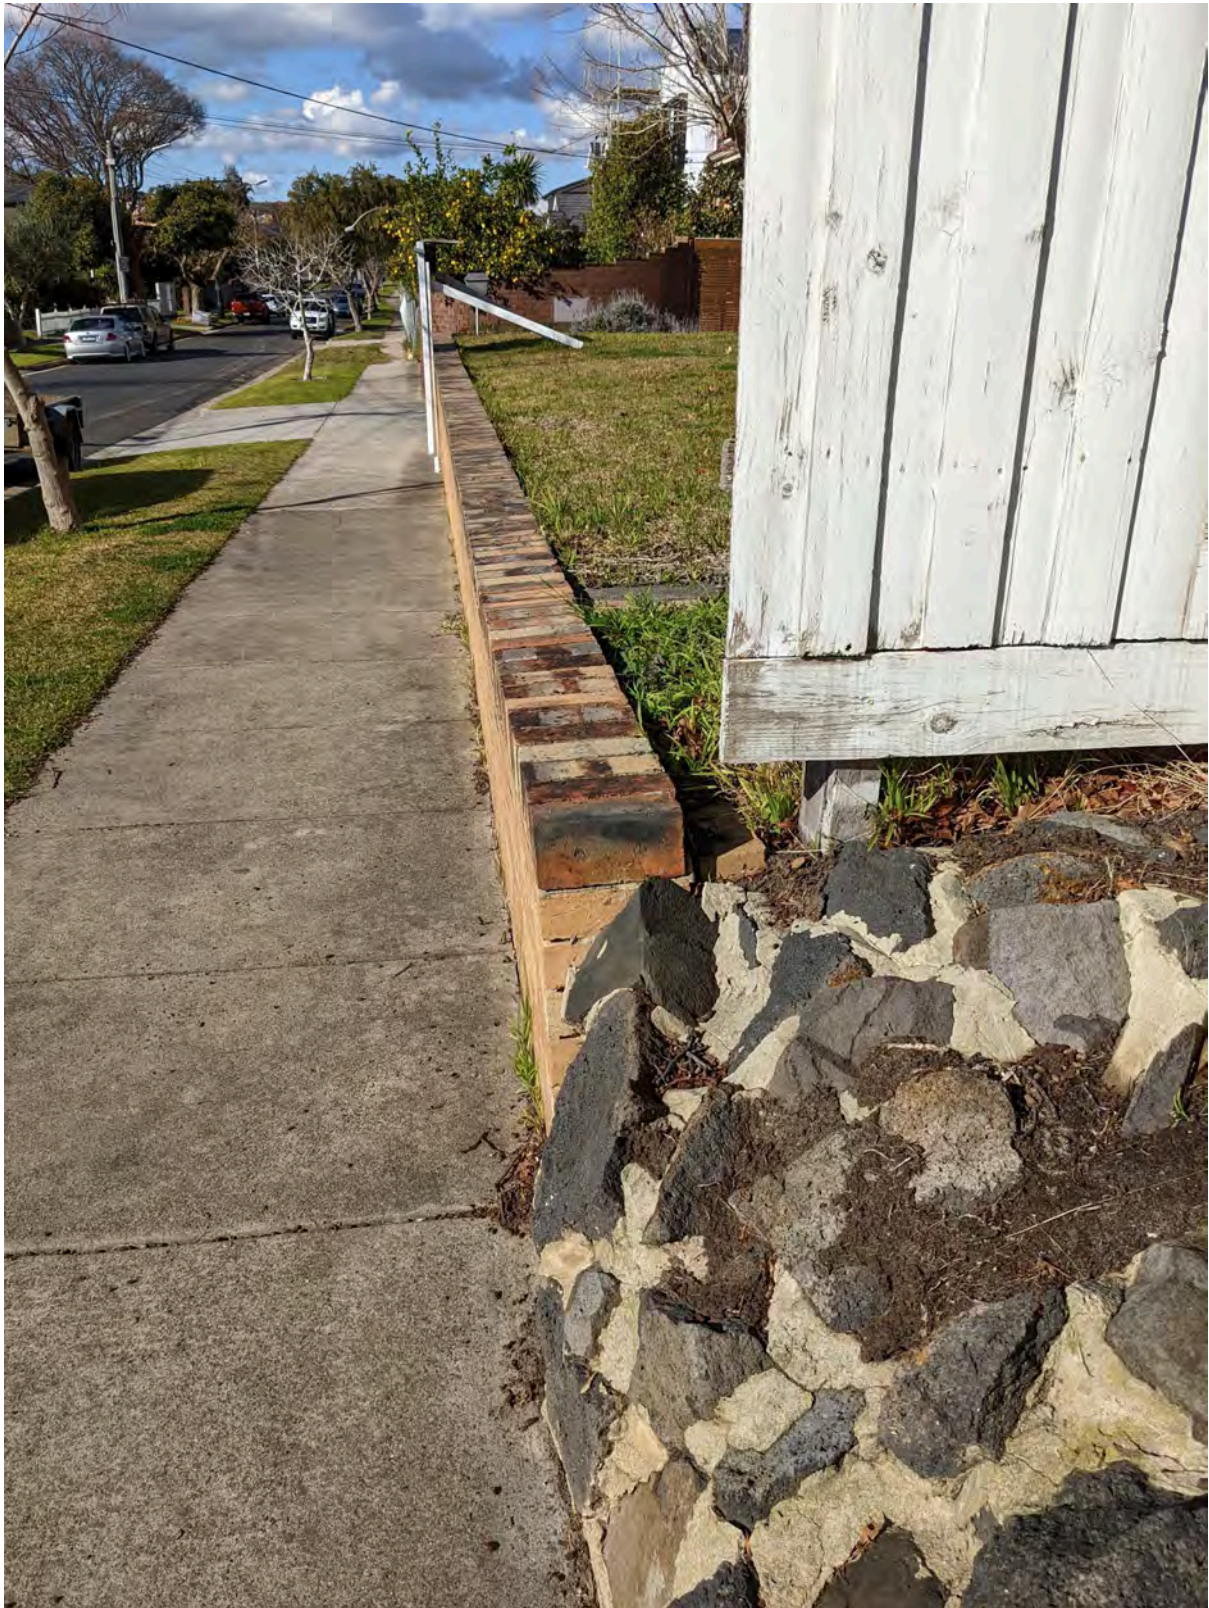
**Retaining Wall - Lean towards street**

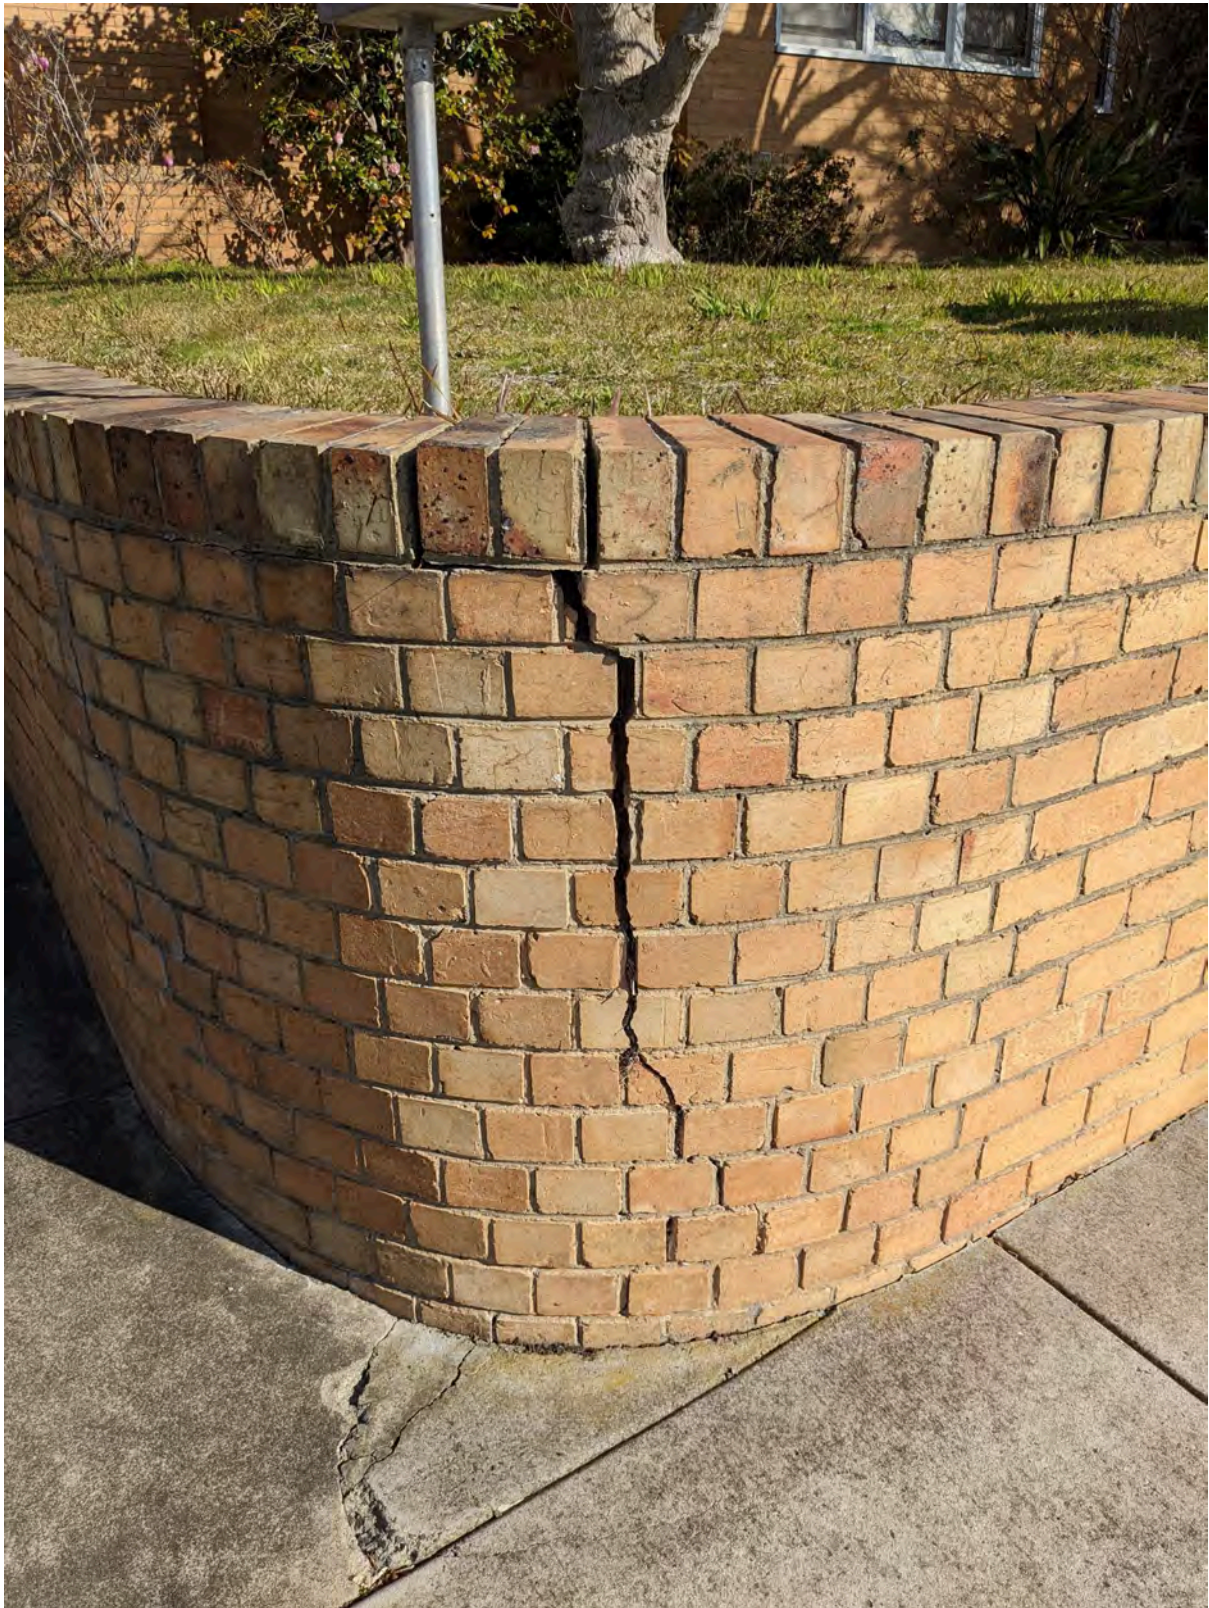
**Retaining Wall Large Crack**

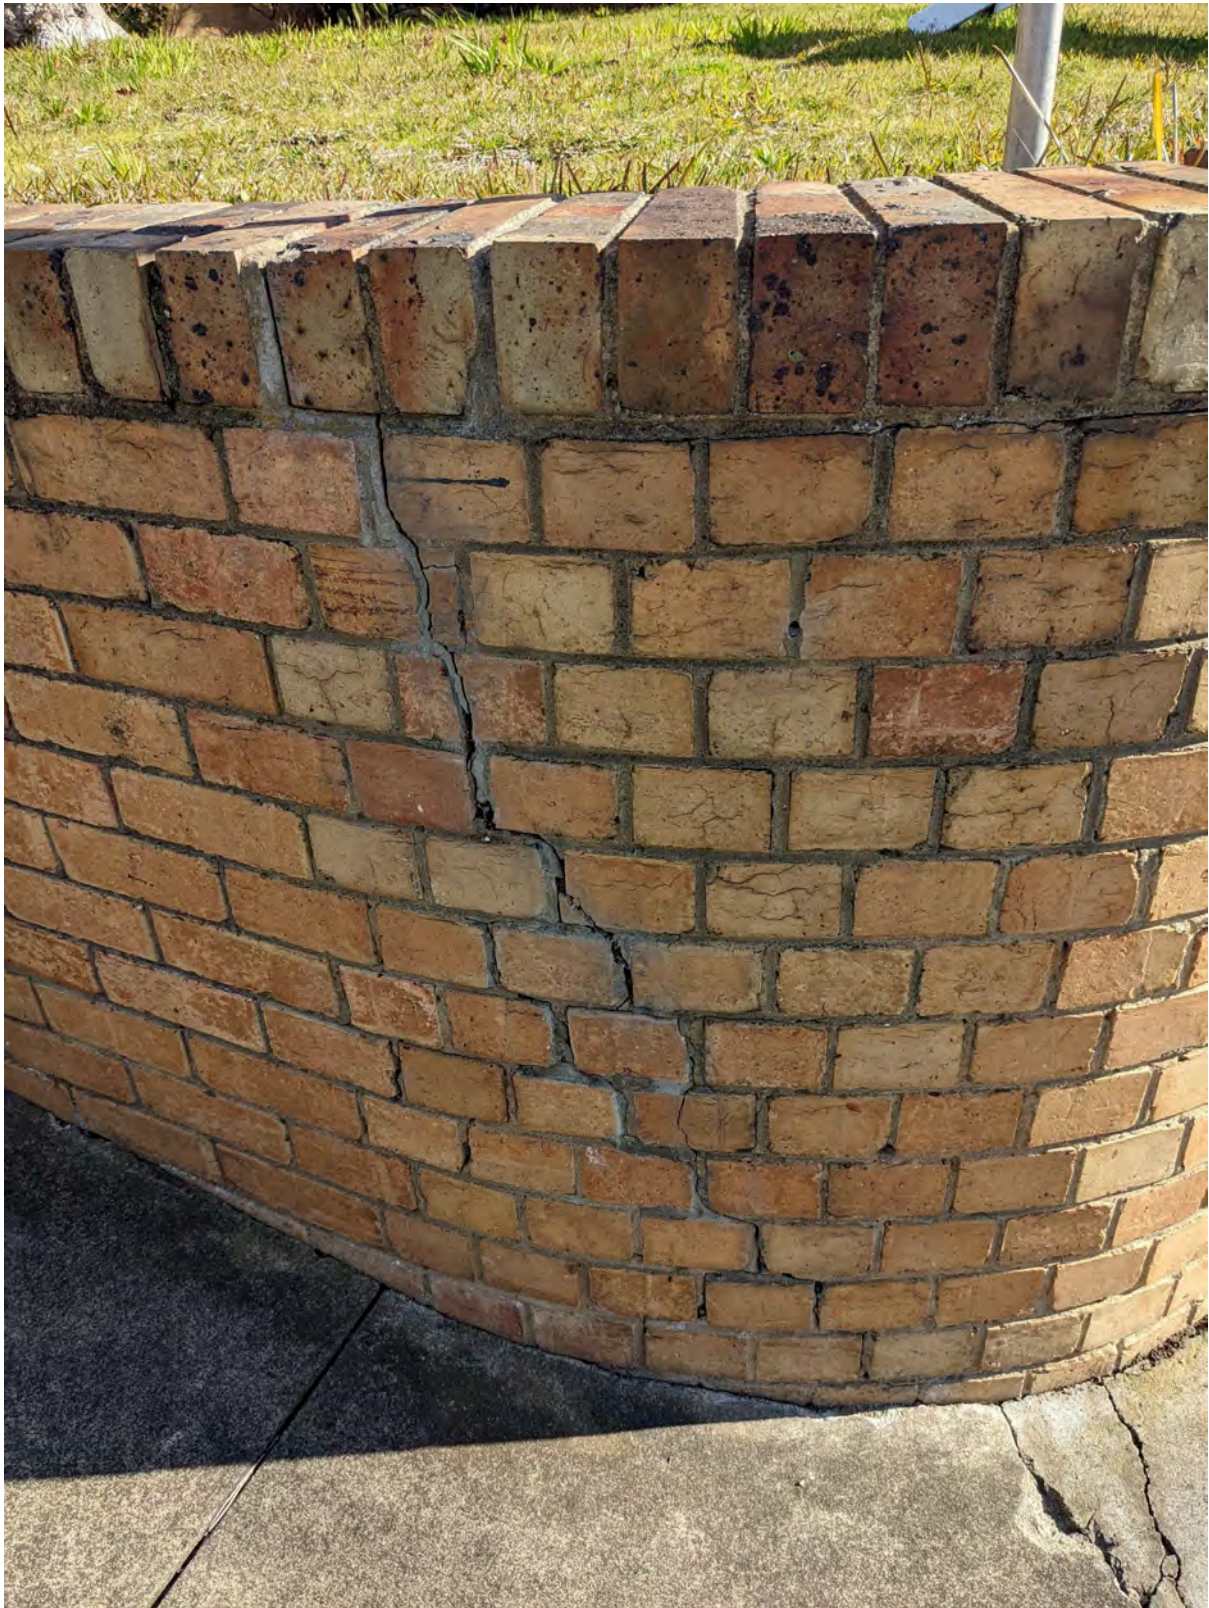
**Retaining Wall Small Crack**

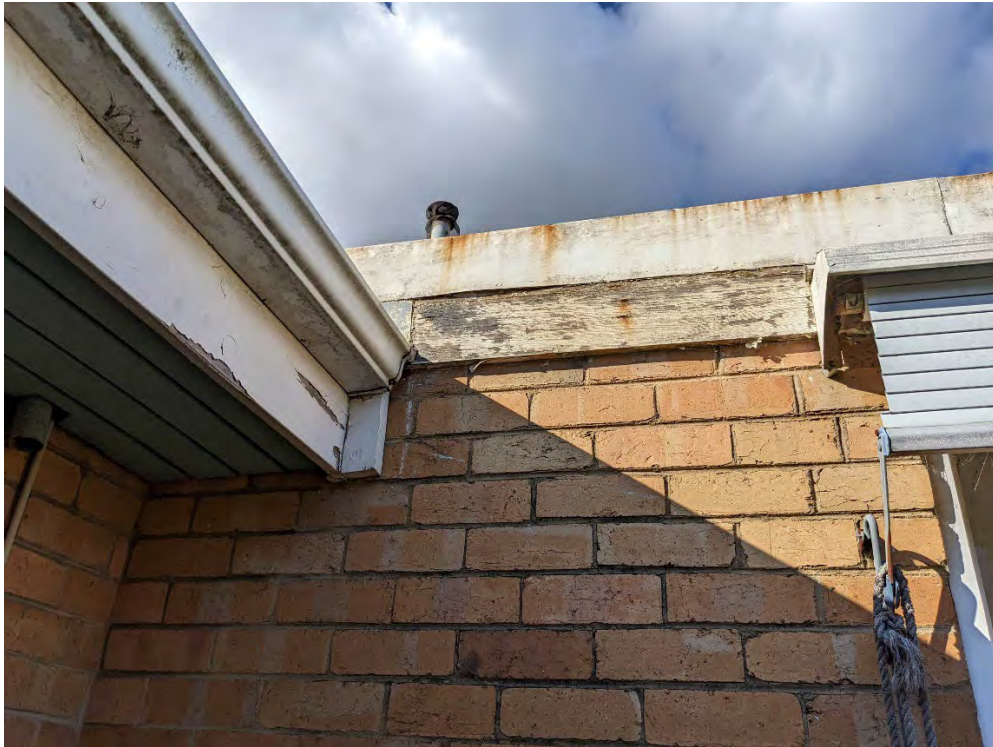
**Rusted Flashing and Rotten Timber**

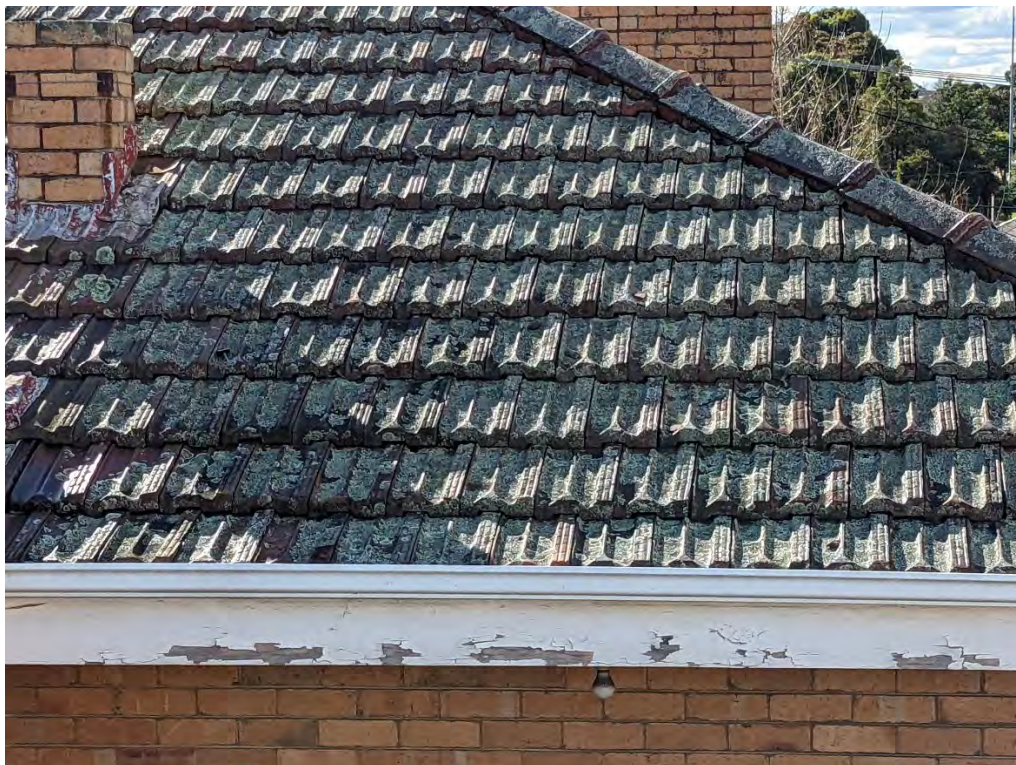
**Damaged Tiles, Flashing and Chimney Brickwork**
