## Identifying failure with Current Signature Analysis of point motors

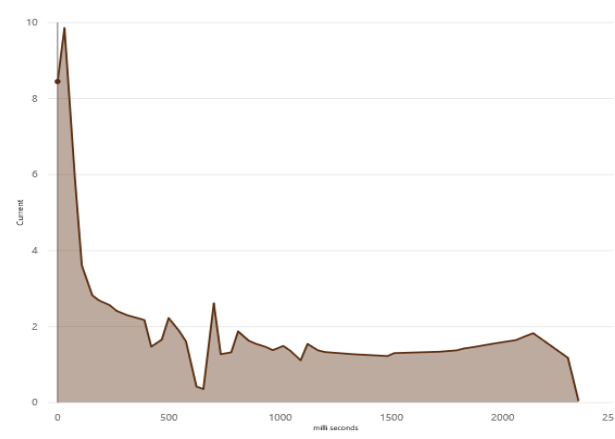
Carbon brush worn out

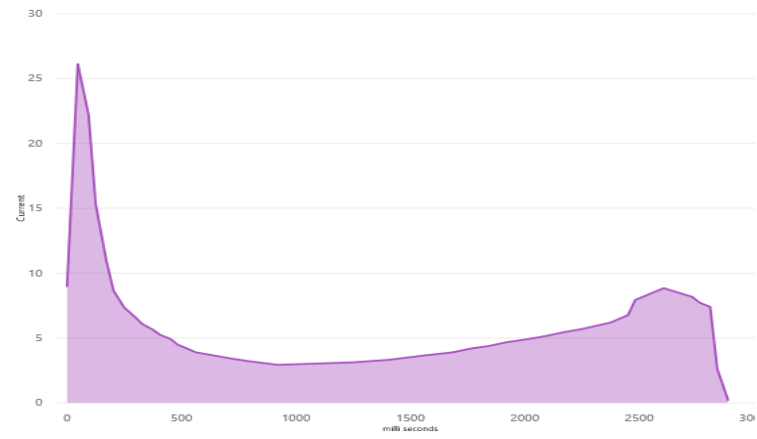
More current at locking time due to spring

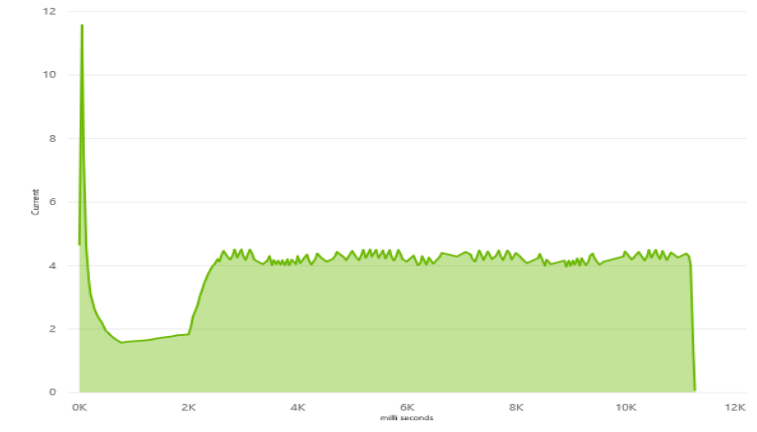
Obstruction in Point Motor

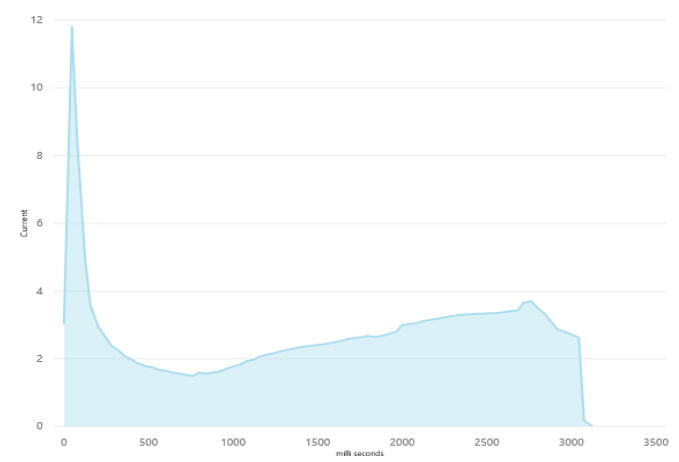
More friction due to lubrication problem

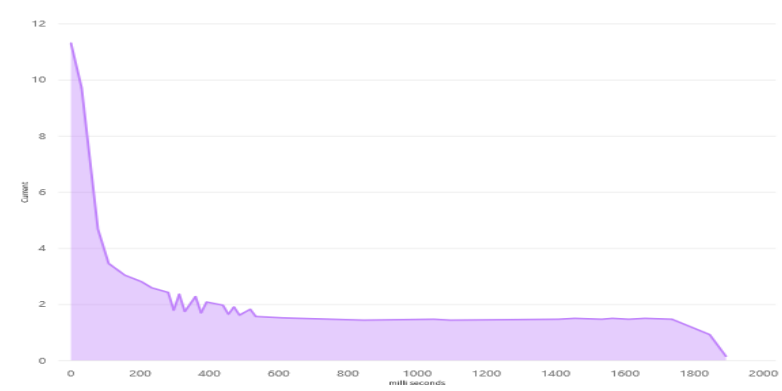
Problem in Unlocking

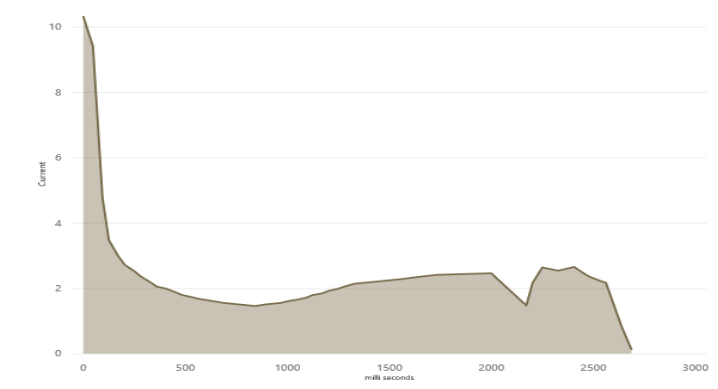
Problem in locking position
