## CONDITION REPORT

### GERFALCON

Dated 2<sup>nd</sup> January 2021

Client: Mr S Hurrell

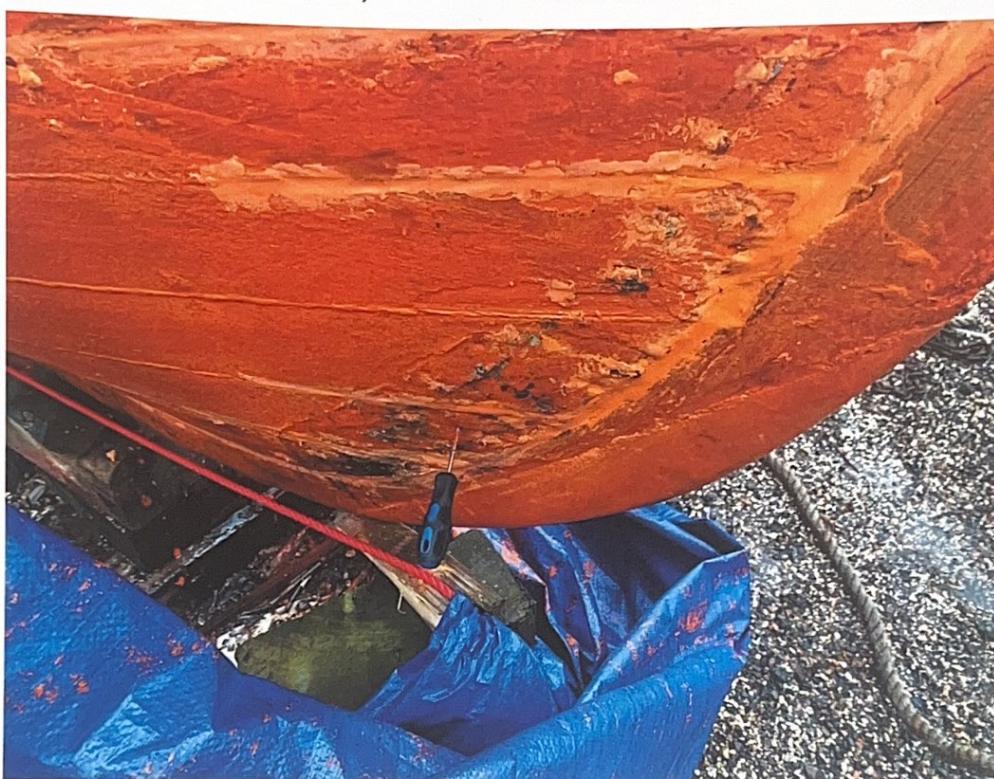
There was some soft rot noted in way of the hooded ends and deadwood.

We would recommend that any rot below the waterline be dealt with at this time and that the rot above water be dealt with at the owner's convenience.

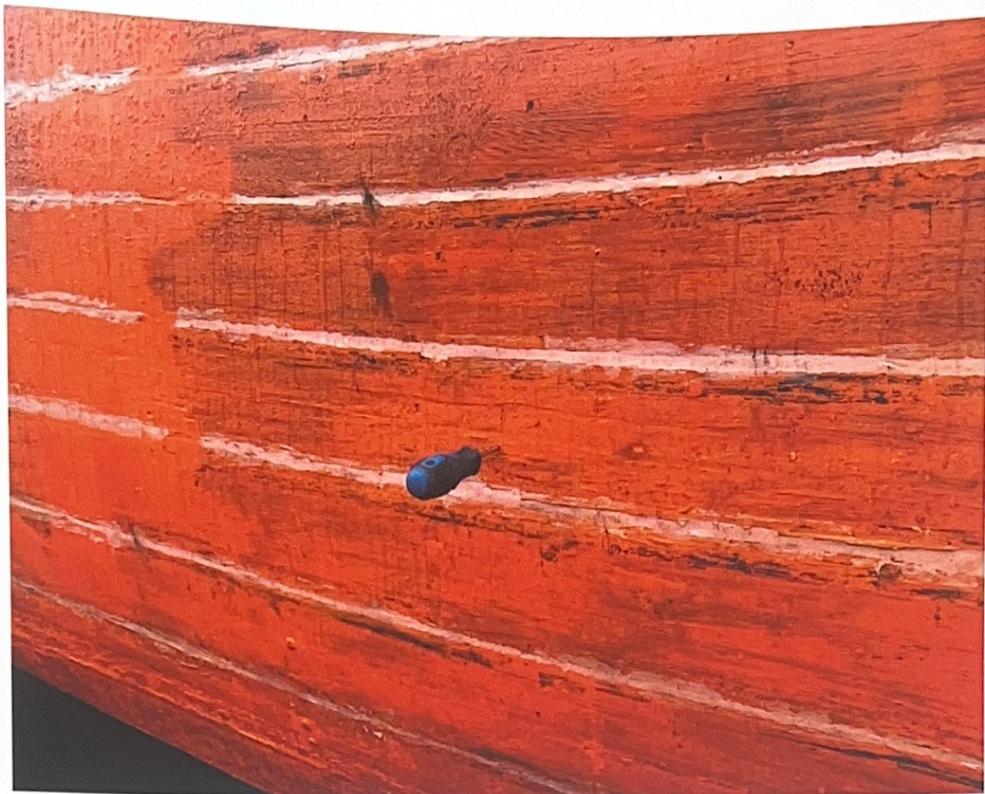
There was a small area of soft rot noted on the port side above the waterline.
