# Color Laserjet 2600 Series Cartridge Dismantling and Recycling

# Cartridge Dismantling

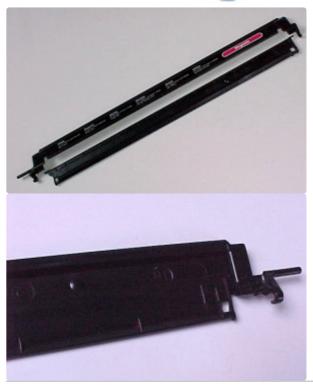
Toner Hopper

The bulk of the bottom half of the cartridge is made up of the toner hopper. The roller in the front (normally covered in toner) is the developer. The developer roller itself should have a thin but continual cover of toner. The surrounds should not really be quite as messy as some photos here suggest - (but I wouldn't have dismantled the cartridge if it had been working well).
