## Report

- **Reference:** 31420
- **Name:** Essa Yakoub
- **Emirate:** Dubai
- **Inspected on:** 2025-09-23

- **Title:** Nissan PATROL
- **Model year:** 2021
- **Manufacturing year:** 2021
- **Chassis number:** JN8BY2NY4M9345338
- **Odometer:** 115,224km
- **Condition:** Used
- **Gearbox:** Automatic
- **Fuel type:** Gasoline
- **Cylinders:** 6
- **Engine size:** 4.0 L

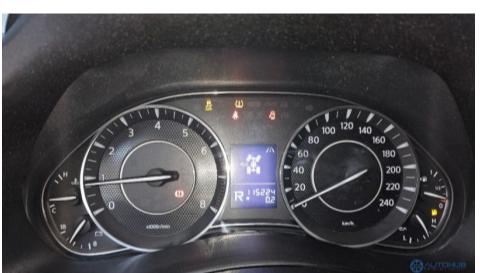
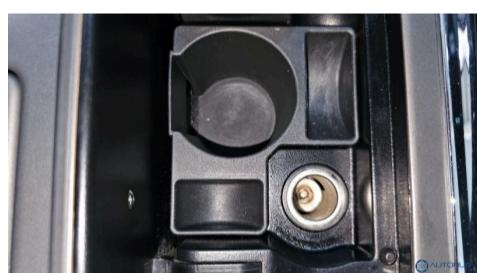
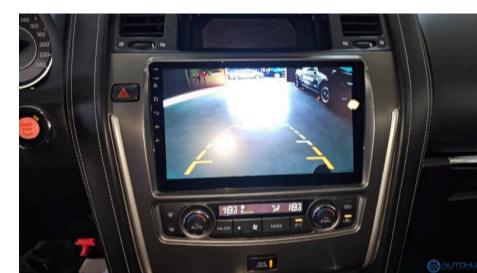
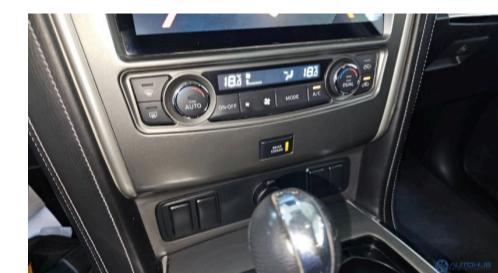
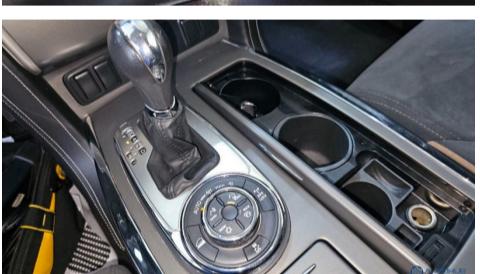
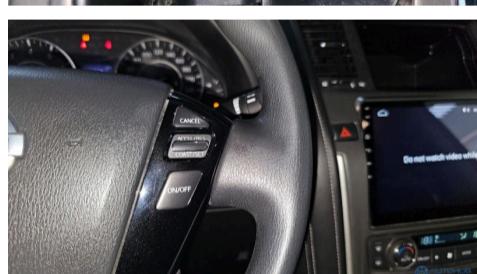
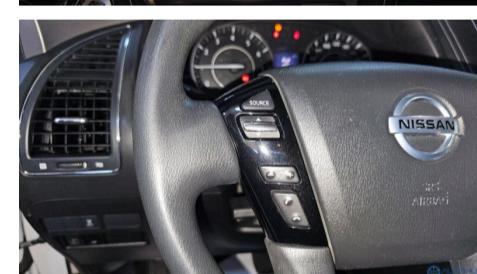
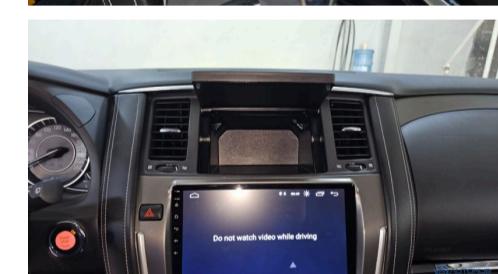
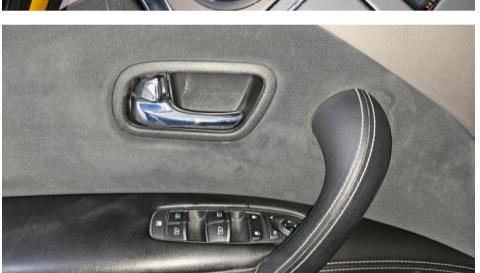
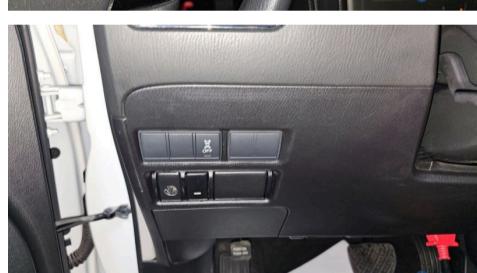
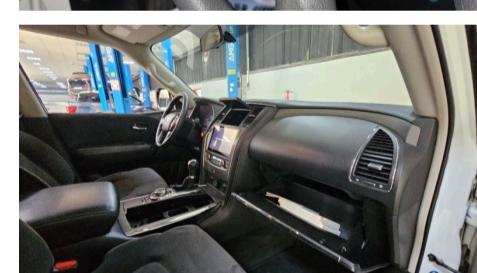
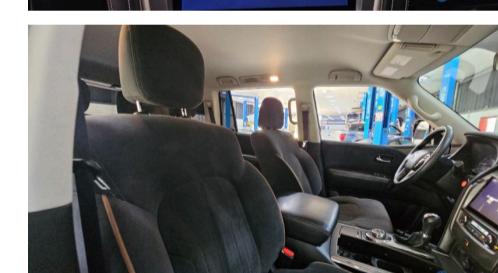
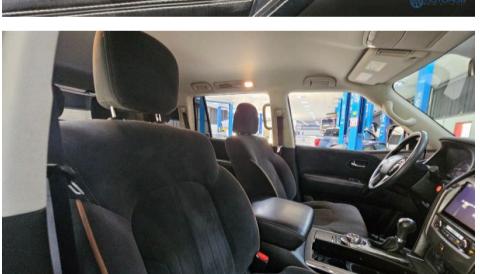
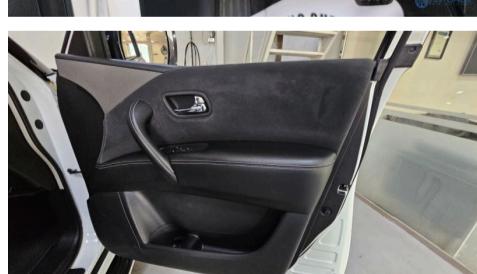
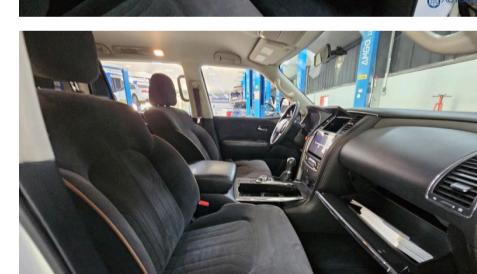
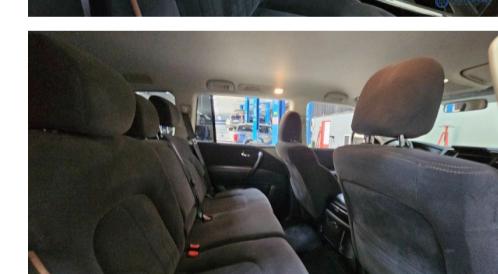
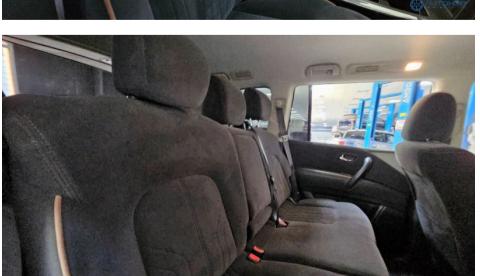
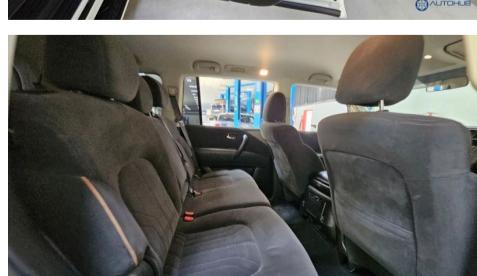
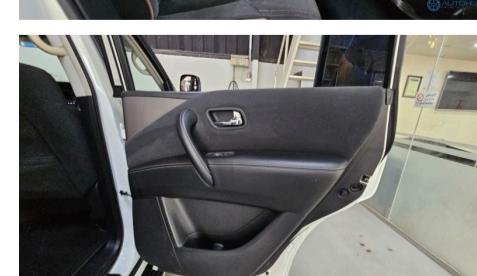
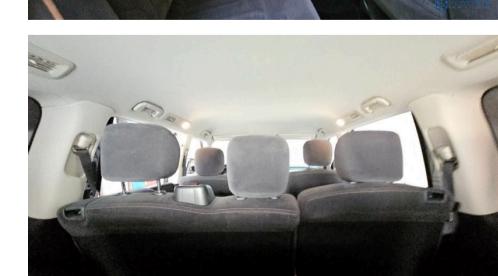
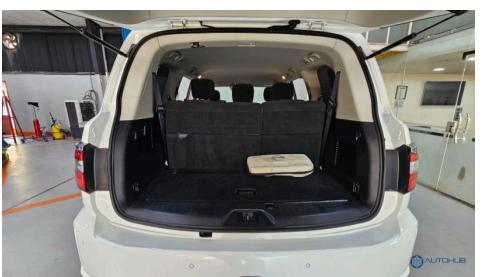
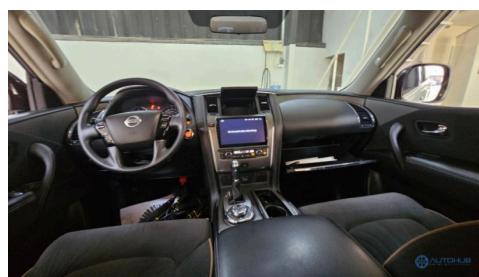
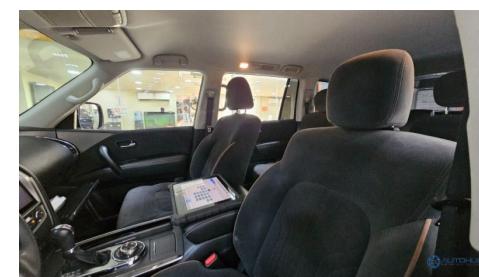
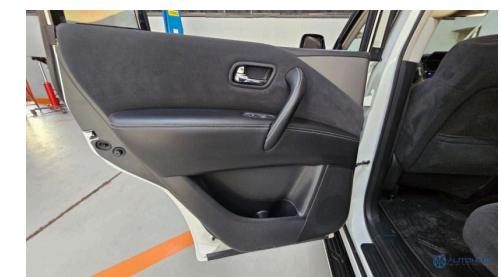
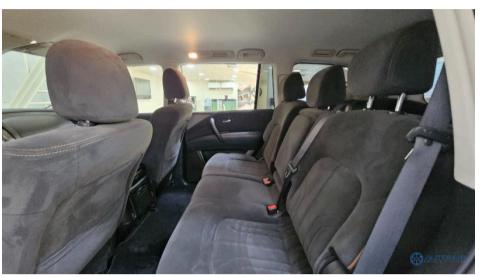
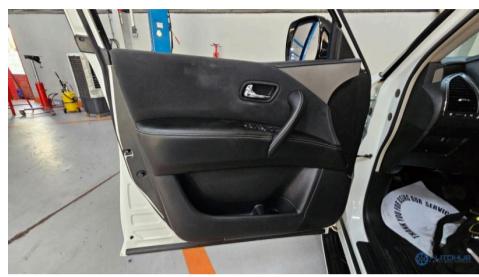
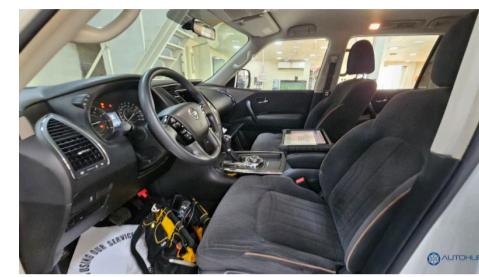
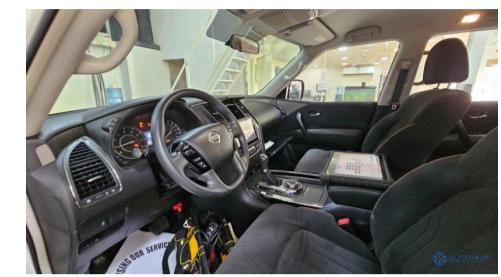
## Interior

- Normal wear and tear, underseats rusty
- Left side folding mirror not working

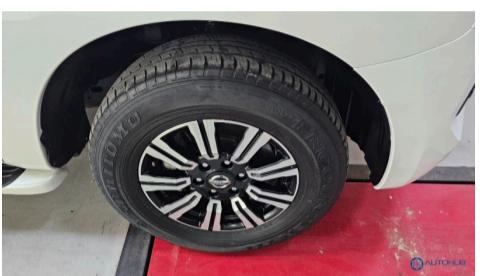
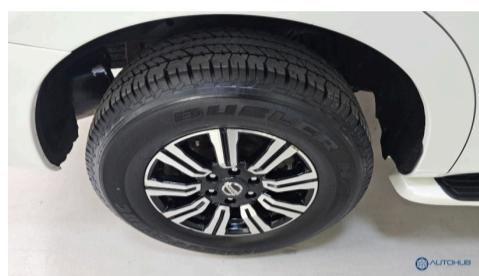
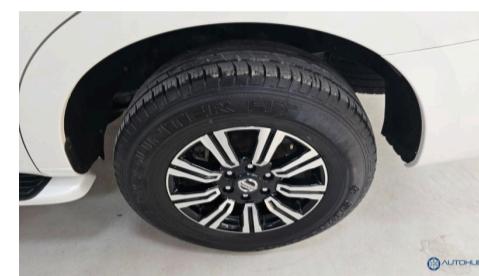
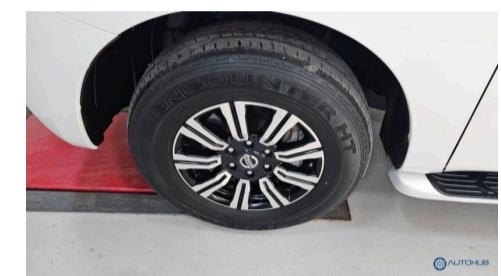
## Tires

- ✗ Front right tyre                                  Uneven wear
- ✗ Front left tyre                                  Uneven wear
- ✗ Back right tyre                                  Uneven wear
- ✗ Back left tyre                                  Uneven wear

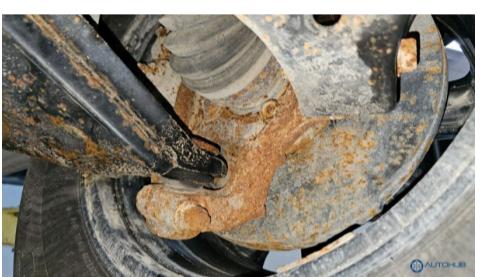
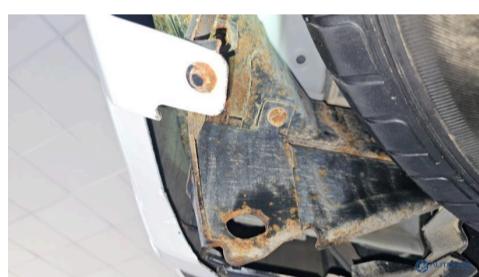
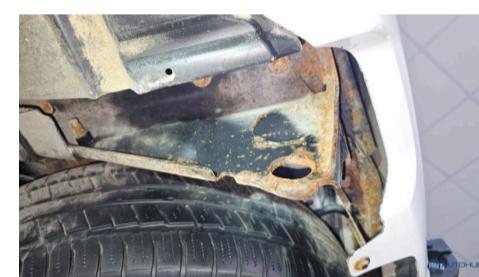
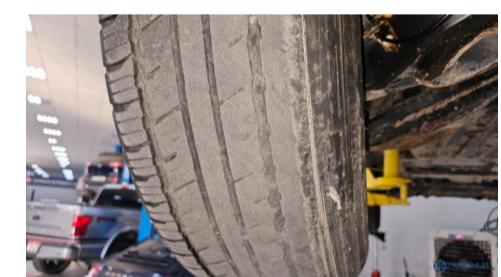
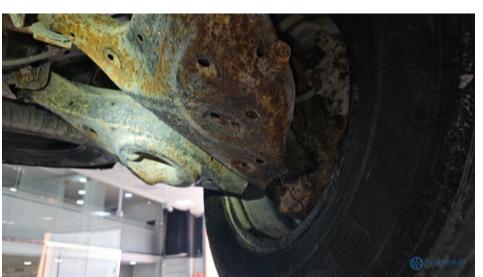
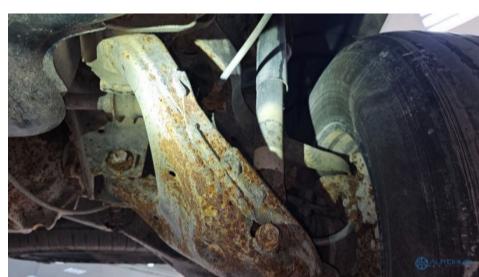
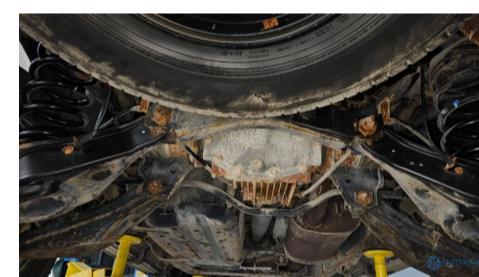
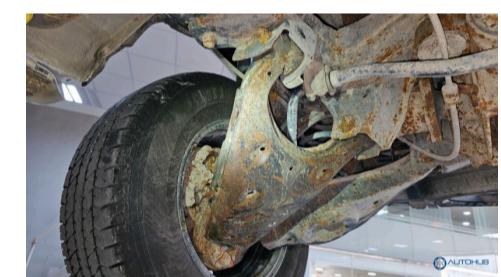
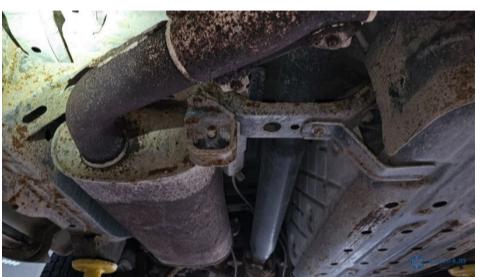
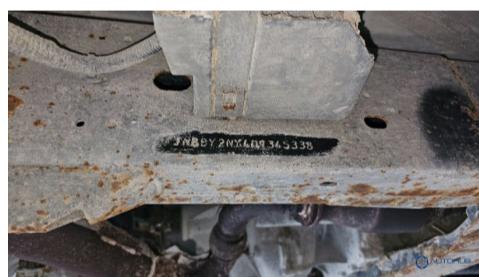
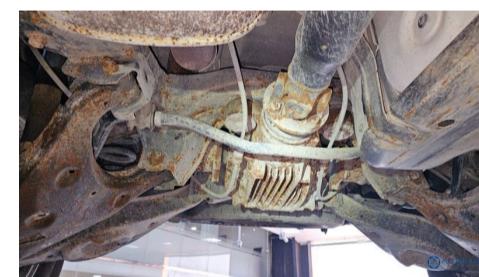
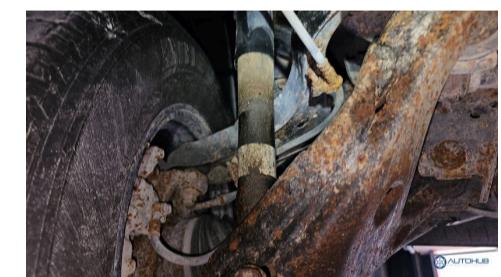
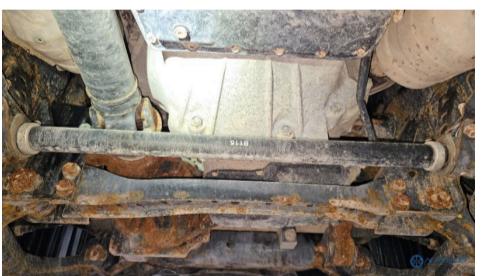
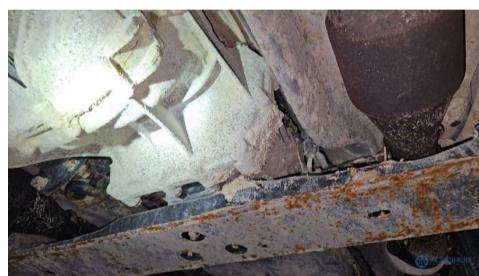
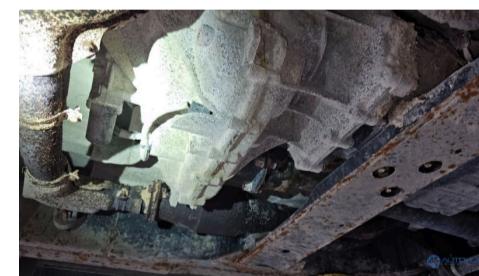
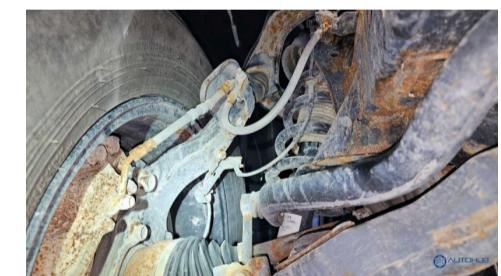
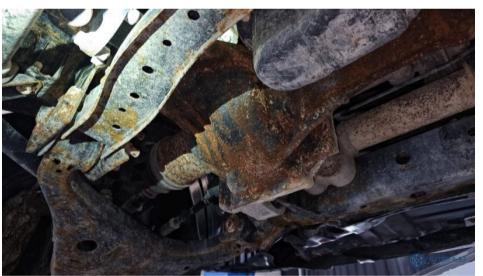
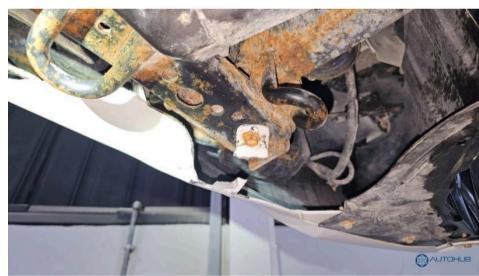
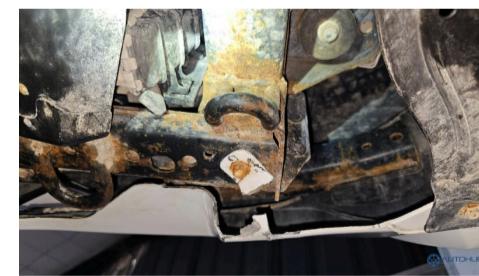
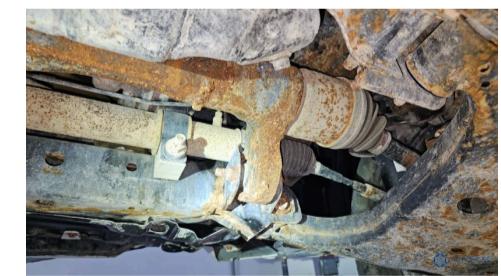
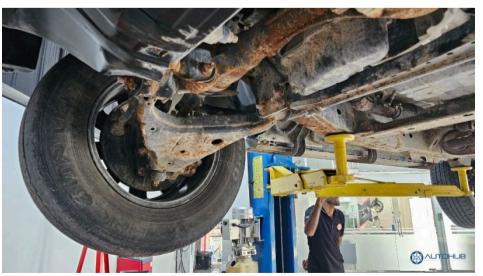
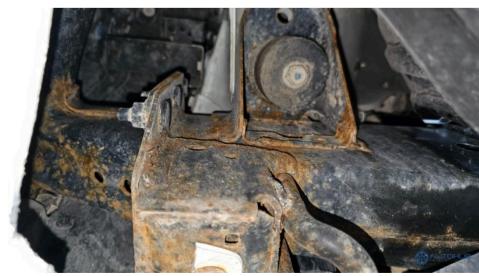
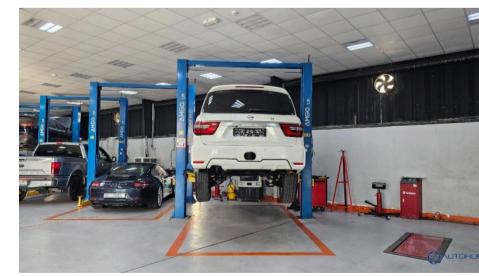
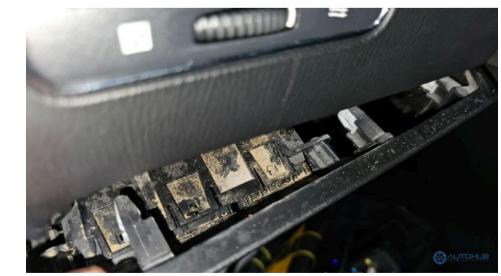
## Mechanical

- Front brake pads remaining percentage 60%, Rear brake pads remaining percentage 70%
- Recommended to do major service including spark plugs, gear oil and filter gasket, All filters includes Air, AC, Fuel filter, change front and rear differential and transfer case oil.
- Severe rust and mud underneath see photo attached.
- Change all tyres and perform wheel alignment and wheel balancing
- Need to do steam washing and apply underneath rust removal and treatment.

Disc and pads      Rusty

✗ Dampers and bushes                          Worn out

✗ Sub frames and mountings                          Severe rust

✗ Evidence of floor / chassis corrosion                          Severe rust

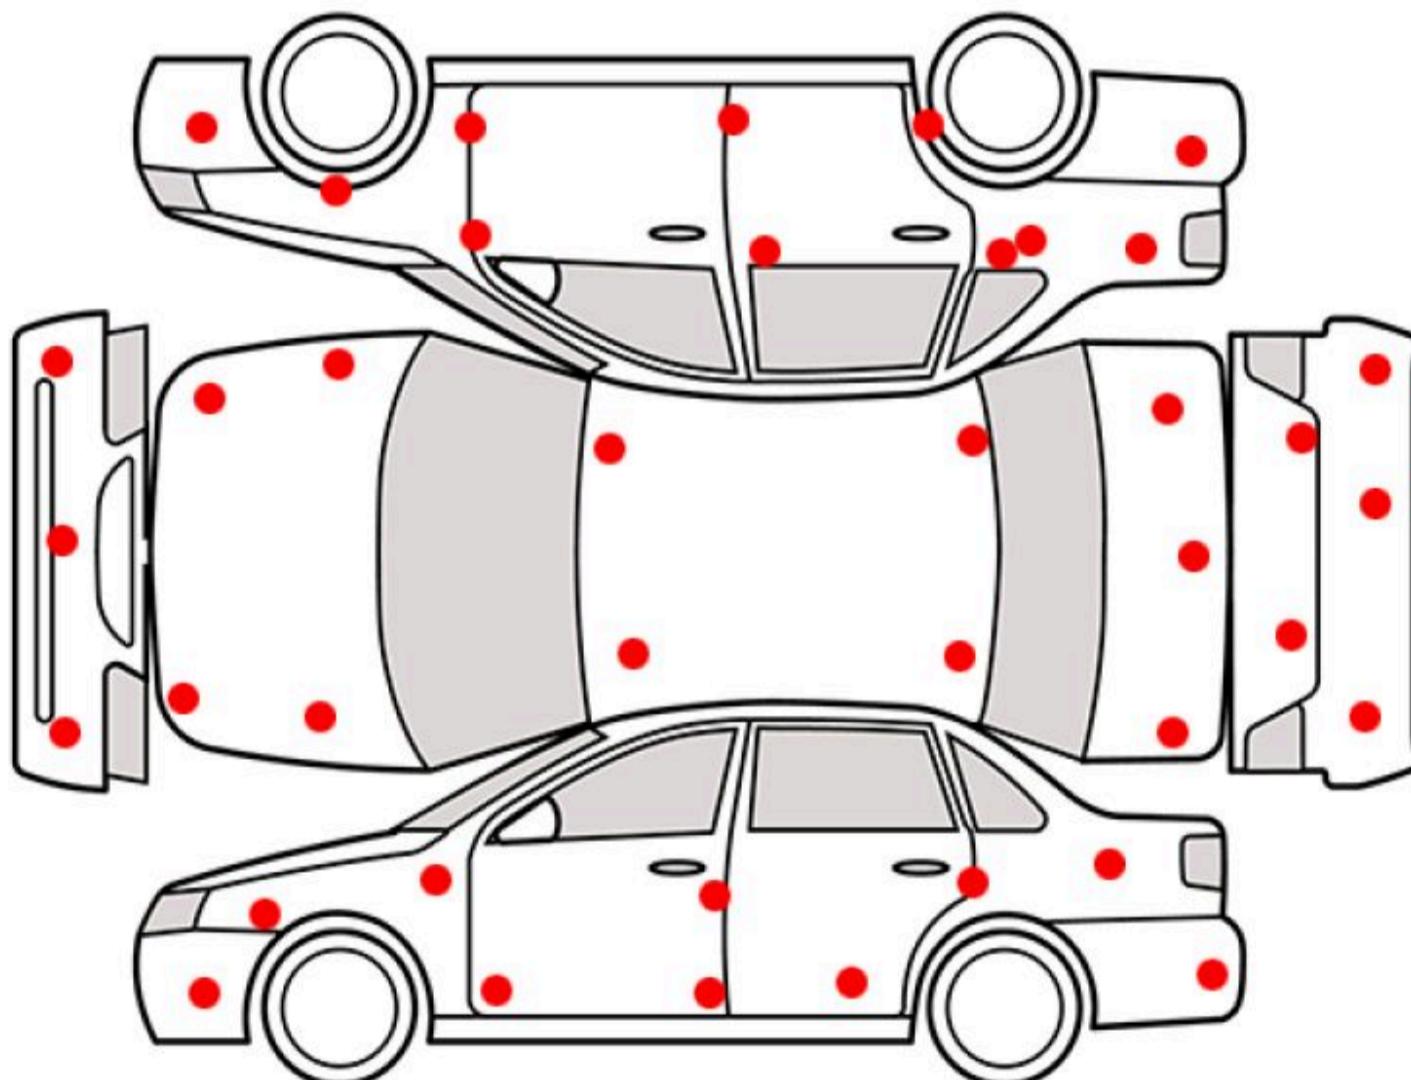
## Damage points

- 3 Accident reported, full body painted, flooded vehicle.
- Front and rear bumper required repair and repainted

- Body dents and scratches.
- Both side door moulding chrome have dents.
