## Report

- **Reference:** XXXXX
- **Name:** XXXX YYYY
- **Emirate:** Dubai
- **Inspected on:** 2025-09-23

- **Title:** XXXXXXXX XXXXXX
- **Model year:** 2021
- **Manufacturing year:** 2021
- **Chassis number:** JN8BY2NY4M9345338
- **Odometer:** 115,224km
- **Condition:** Used
- **Gearbox:** Automatic
- **Fuel type:** Gasoline
- **Cylinders:** 6
- **Engine size:** 4.0 L

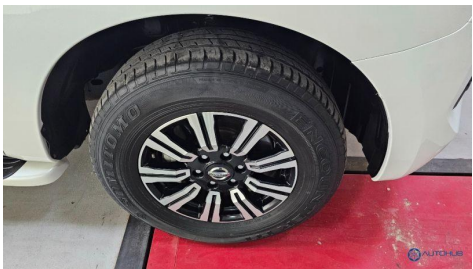
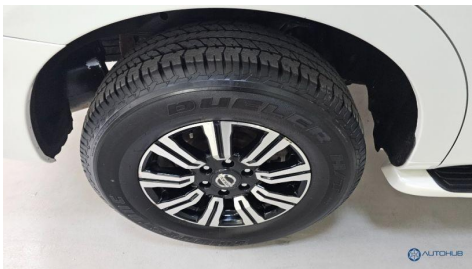
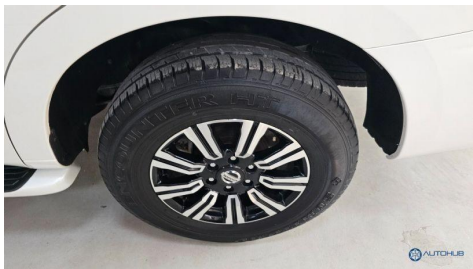
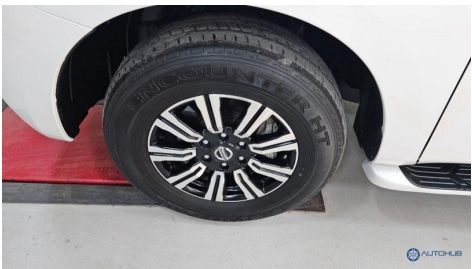
## Tires

| ✗ | Front right tyre | Uneven wear |
| ✗ | Front left tyre | Uneven wear |
| ✗ | Back right tyre | Uneven wear |
| ✗ | Back left tyre | Uneven wear |

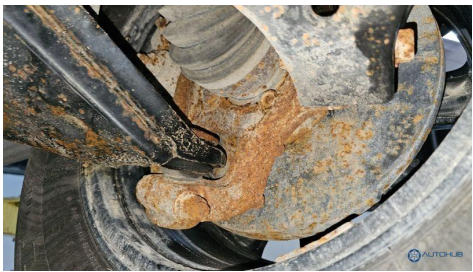
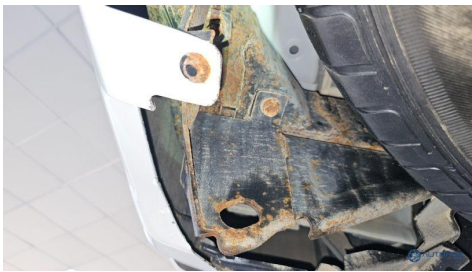
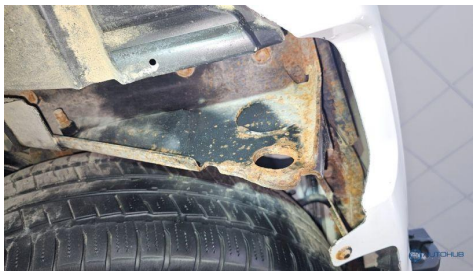
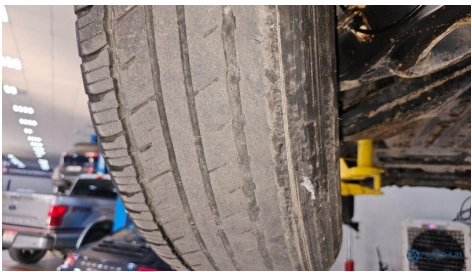
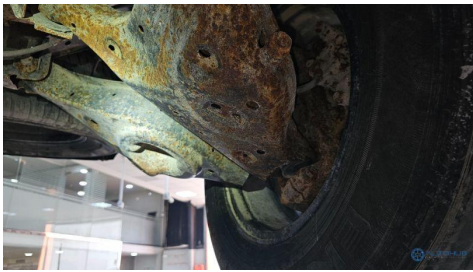
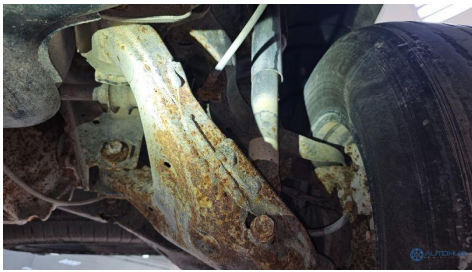
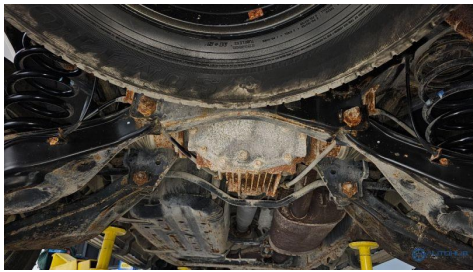
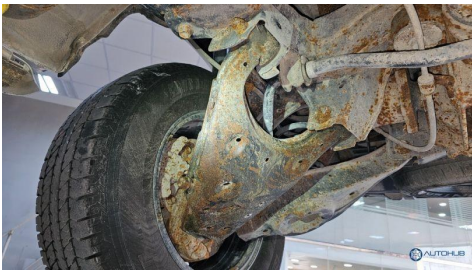
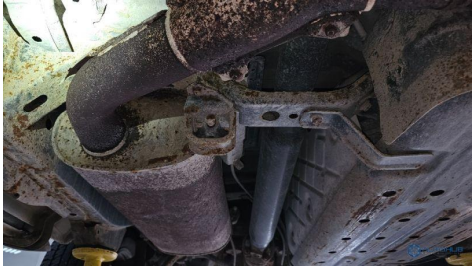
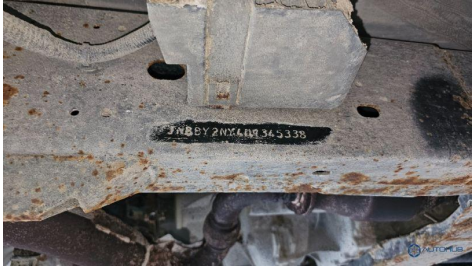
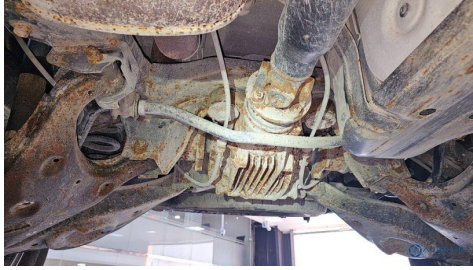
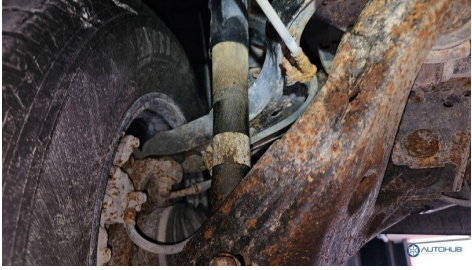
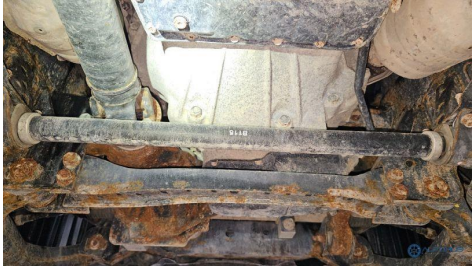
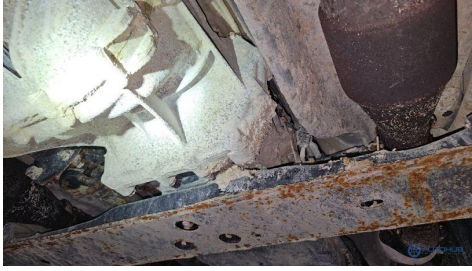
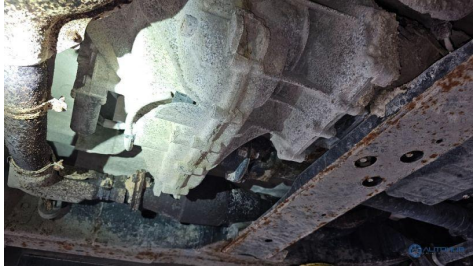
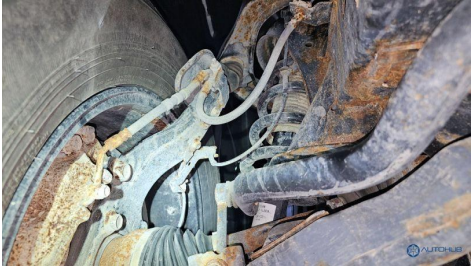
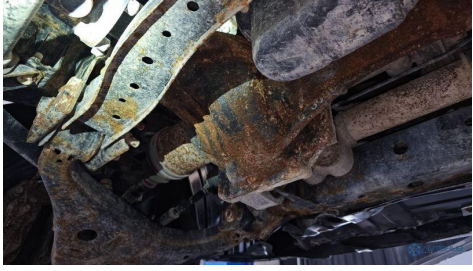
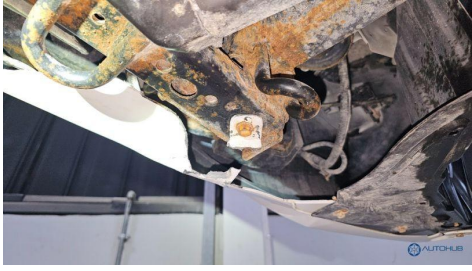
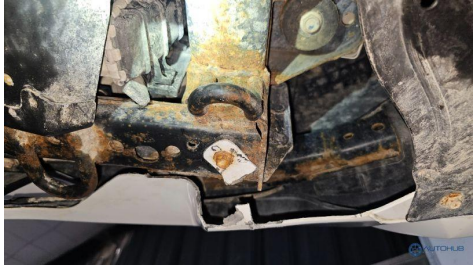
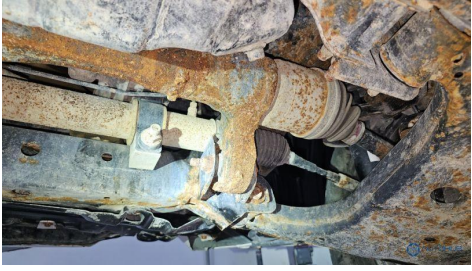
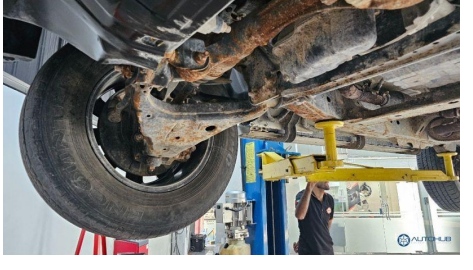
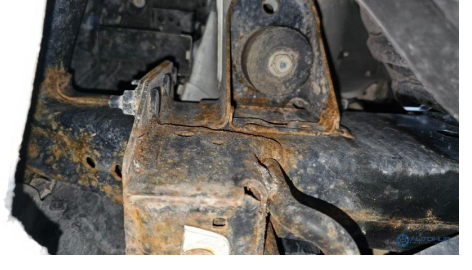
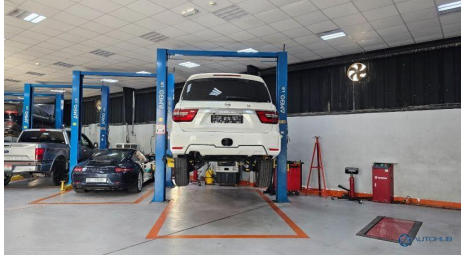
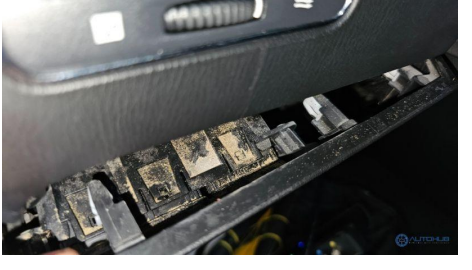
## Mechanical

| ✗ | Disc and pads | Rusty |

| ✗ | Suspension noise | Worn out |

| ✗ | Dampers and bushes | Worn out |
| ✗ | Sub frames and mountings | Severe rust |
| ✗ | Evidence of floor / chassis corrosion | Severe rust |
| ✗ | Transmission | Need servicing |

- Front brake pads remaining percentage 60%, Rear brake pads remaining percentage 70%
- Recommended to do major service including spark plugs, gear oil and filter gasket, All filters includes Air, AC, Fuel filter, change front and rear differential and transfer case oil.
- Severe rust and mud underneath see photo attached.
- Change all tyres and perform wheel alignment and wheel balancing
- Need to do steam washing and apply underneath rust removal and treatment.

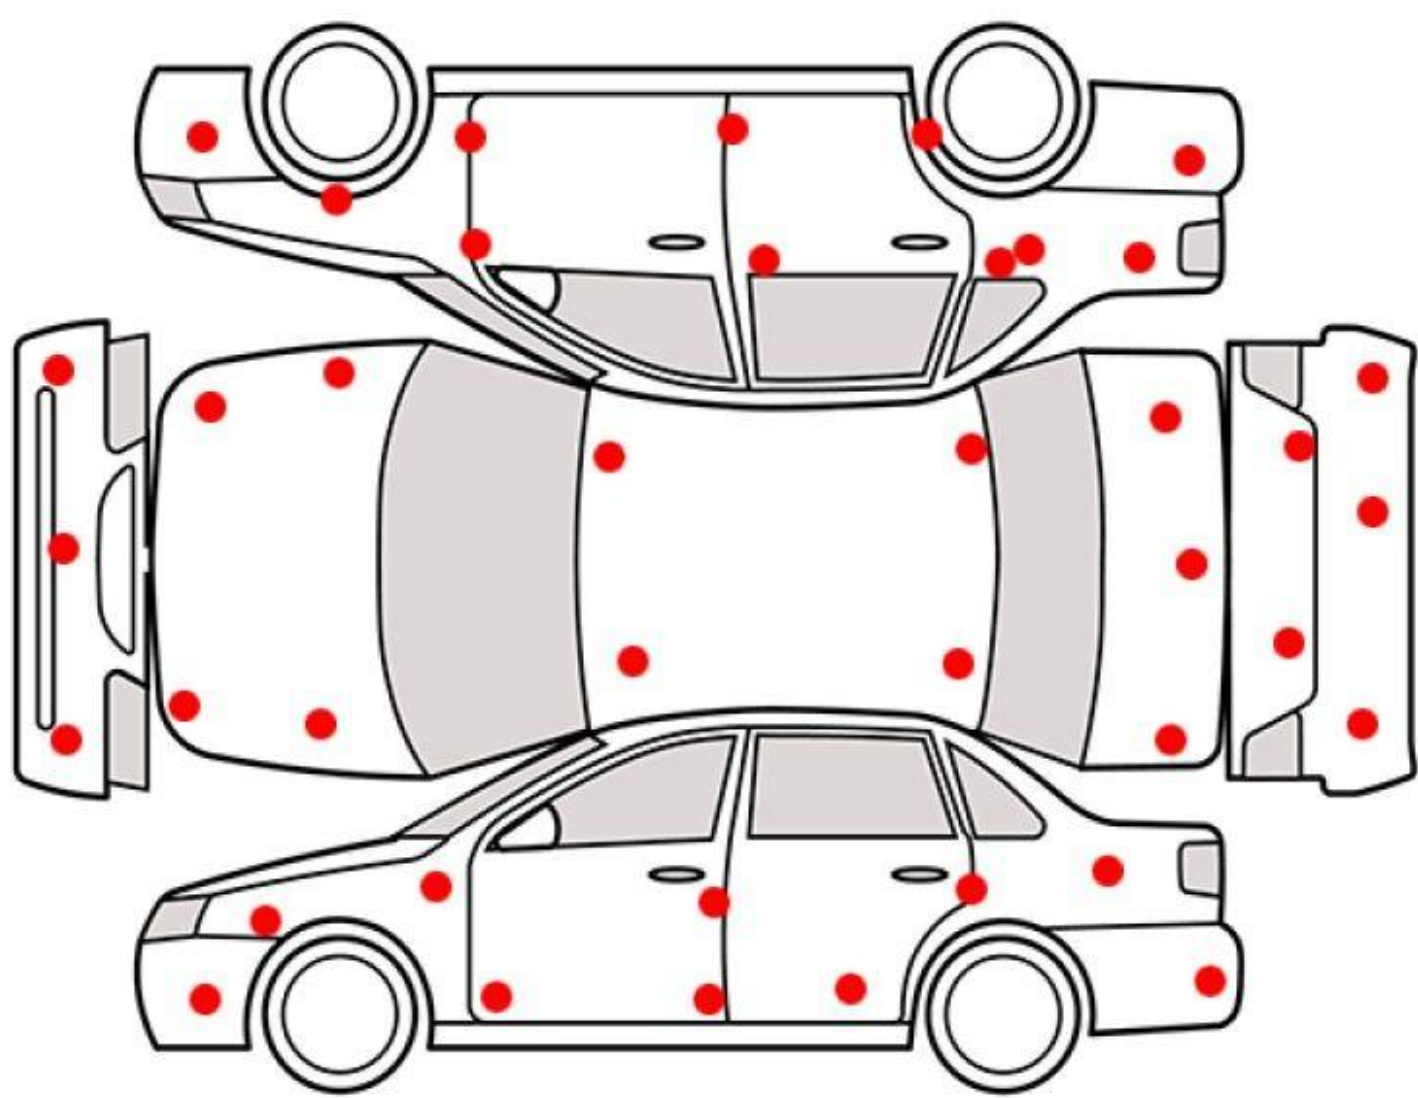
Damage points

- 3 Accident reported, full body painted, flooded vehicle.
- Front and rear bumper required repair and repainted

- Body dents and scratches.
- Both side door moulding chrome have dents.
