Delft University of Technology INSPECTION REPORT FOR DEVICES TO BE USED IN CONNECTION WITH HUMAN SUBJECT RESEARCH

Device identification (name, location): Bicycle Mock up, Automotive area (next to the bike lab)

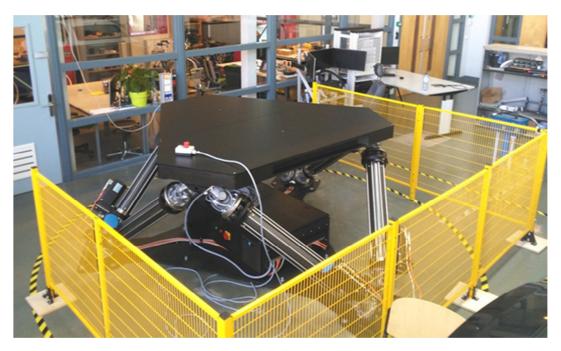
Fig.2 Hexapod platform

The Hexapod platform will be responsible for generating 3D motion perturbations in a frequency range of 0.5- 10 Hz. Amplitude and oscillation frequency are selected based on rider comfort. It should be mentioned that the operator can shut down the moving platform at any time with a safety switch.

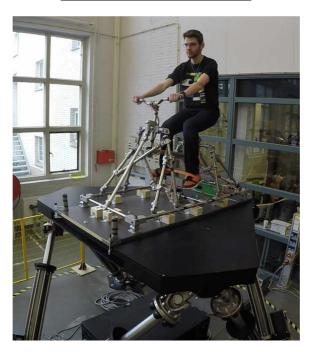
Fig.3 Bicycle mock up mounted on the top of the hexapod

As a final step the bicycle mock up fig1 is mounted on the top aluminum plate of the hexapod platform fig.2. This is achieved with 5 screws M12 6.6 distributed on the corners and middle section of the metal plate. Two clamps are also placed on the front as a second safety measure.
