**Italian guidelines for the risk classification and management of
existing bridges: a case study implementation and evaluation**

Letizia Palamara

October, 2021

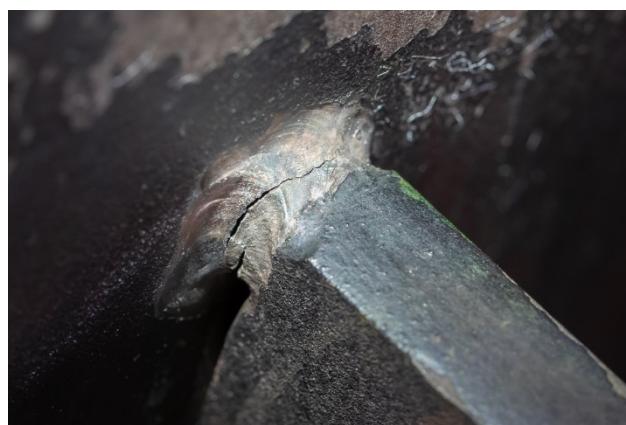
Welding defects are located along the weld length. They are particularly dangerous as they reduce the strength and toughness of the welded joint and over time, they can cause the weld fracture. The origin of these phenomena can be traced back to errors or problems arising during the welding process itself, such as the choice of unsuitable materials and/or techniques, unfavourable welding conditions, and poor welding skills. For this reason, this defect is assigned a G value of 4. An example is provided in Figure 11.

Figure 11 - Welding defect

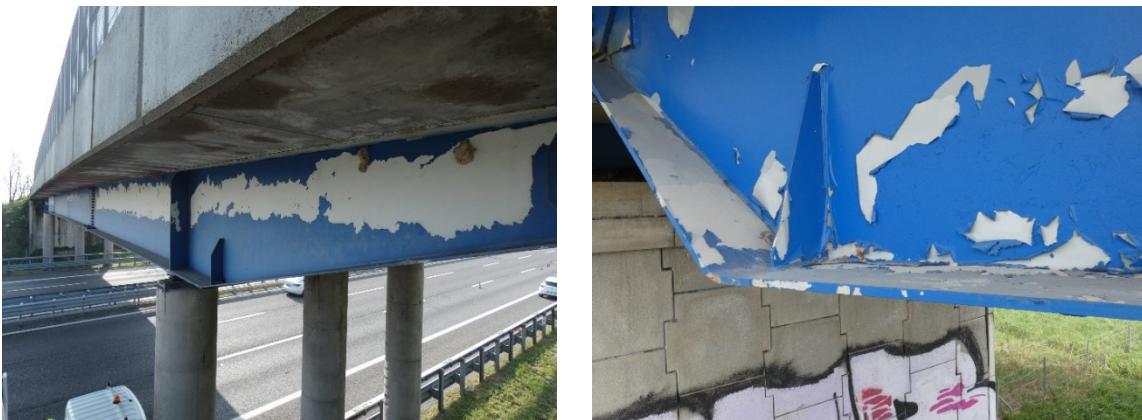
The occurrence of this phenomenon is favoured in presence of humidity and aggressive agents, such as those found in marine or industrial environments. If not promptly and properly repaired, it can lead to corrosion and oxidation of structural elements. This defect is assigned a G value of 2. An example is provided in Figure 12.

Figure 12 - Peeling paint

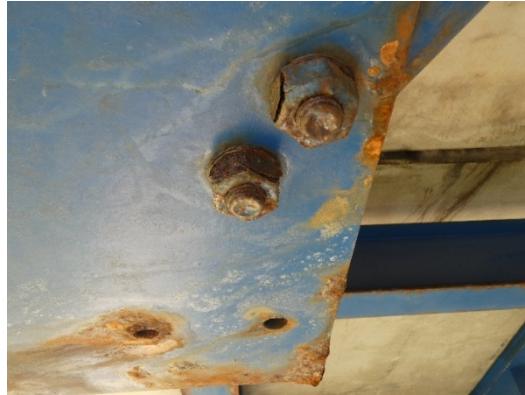
are associated to web/flange deformation of the connected elements. An example is provided in Figure 13.

Figure 13 - Bolting defect

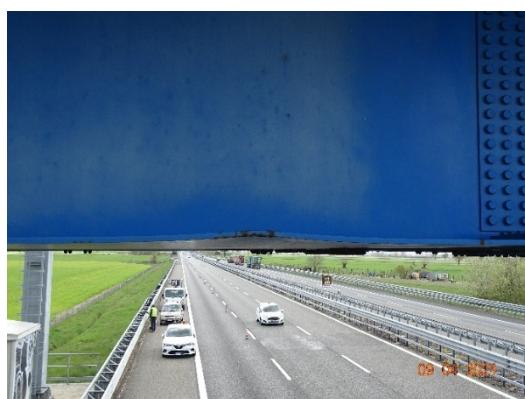
The G value assigned to this defect is 3. An example is provided in Figure 14.

Figure 14 - Flange deformation

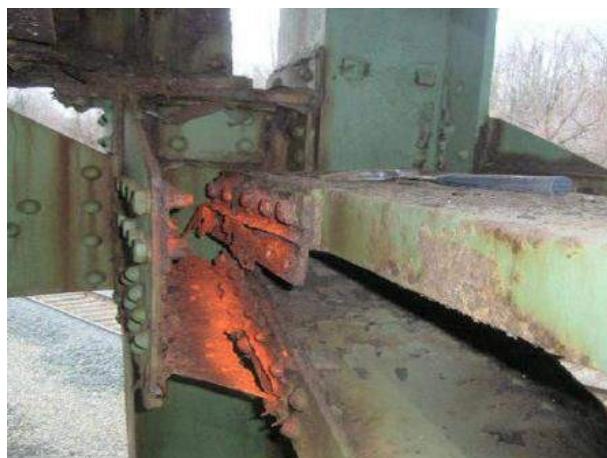
It is particularly dangerous for the stability of the structure, and it is assigned a G value of 5. An example is provided in Figure 15.

Figure 15 - Joint damage (Adopted from Annex C of the Italian guidelines)

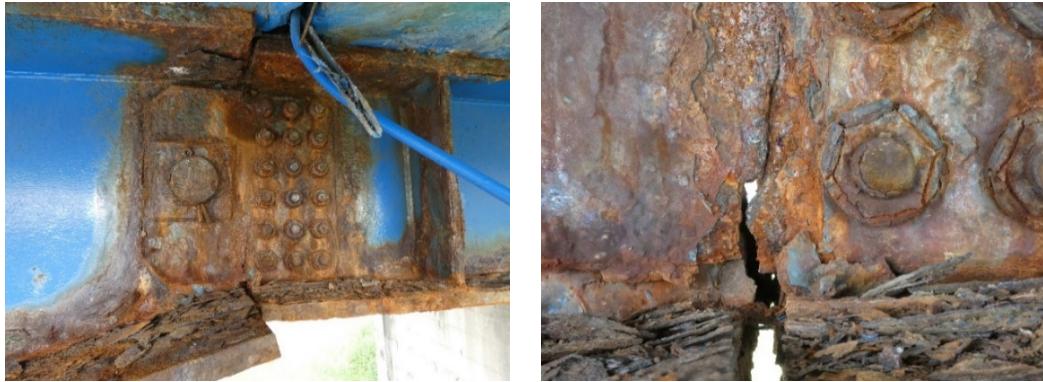
As the process evolves, the section progressively reduces until the metal is perforated. It is assigned a G value of 4. An example is provided in Figure 16.

Figure 16 – Corrosion

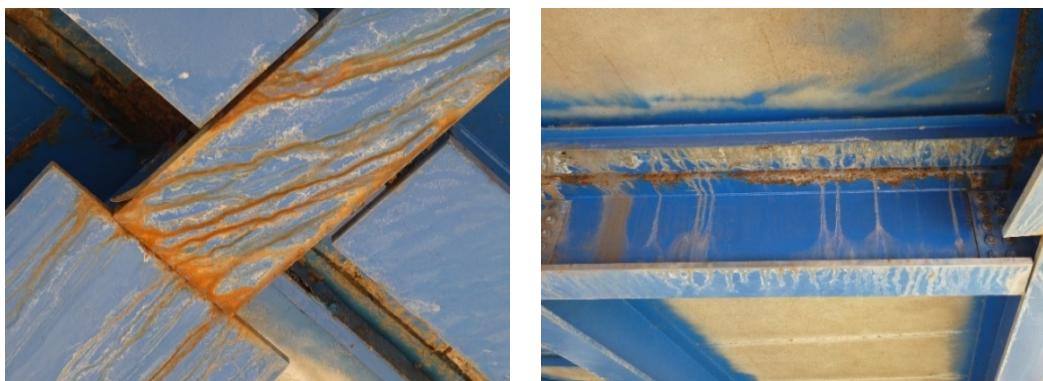
The causes of this phenomenon are the same illustrated in the previous defect. It is assigned a G value of 2. An example is provided in Figure 17.

Figure 17 – Oxidation

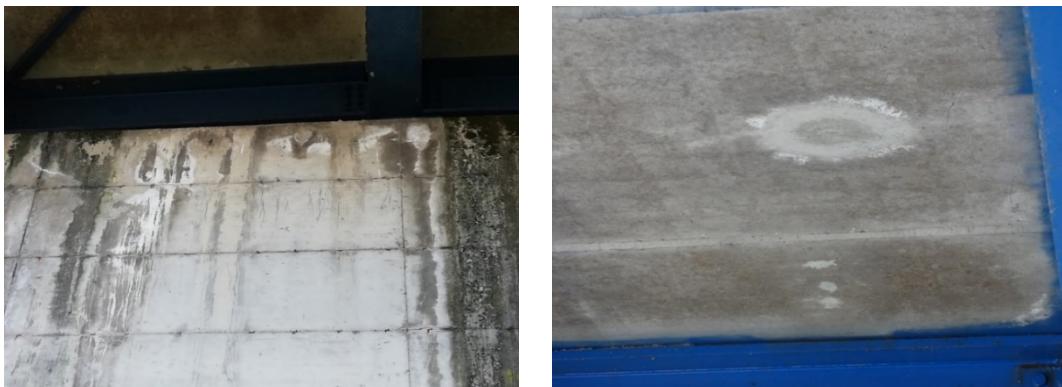
The progression of this phenomenon could lead to the initiation of concrete deterioration phenomena. The stains are typically whitish in color and the defect is assigned a G value of 1. An example is provided in Figure 18.

Figure 18 - Passive moisture stains

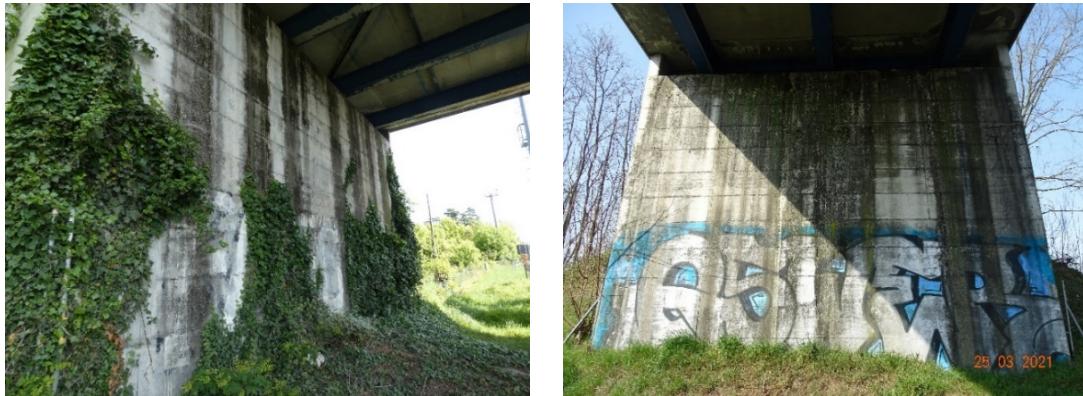
progression of the phenomenon can lead also to concrete spalling. The defect is assigned a G value of 3. An example is provided in Figure 19.

Figure 19 - Active moisture stains

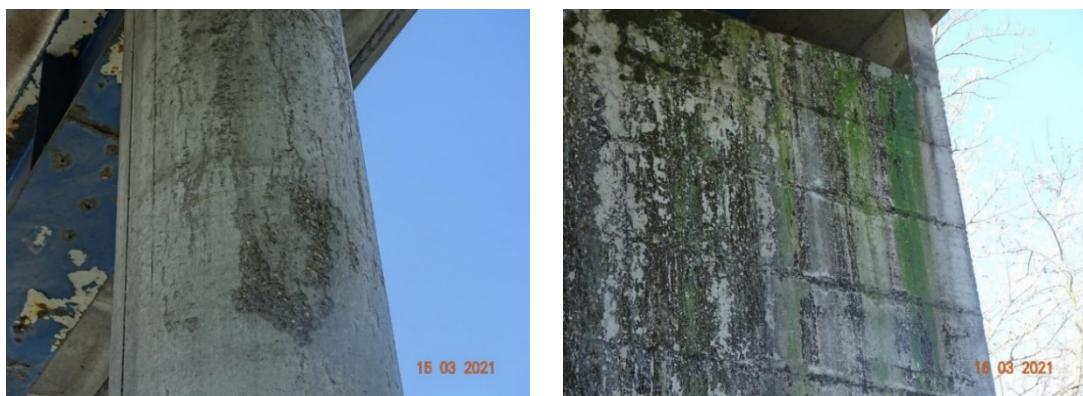
Deterioration of concrete is due to percolation of surface water and occurs mainly on the vertical or inclined surfaces of the elements. The defect refers both to erosion of the surface layer of material due to the frequent passage of water, and to swelling of the concrete surface, spalling, loss of cohesion, etc. Deteriorated concrete represents the evolution of other defects such as moisture stains (both passive and active) and drainage marks (which will be discussed in the section “General defects”) and, as it progresses, it can cause a reduction of the concrete resisting section. This defect is assigned a G value of 3. An example is provided in Figure 20.

Figure 20 - Deteriorated concrete

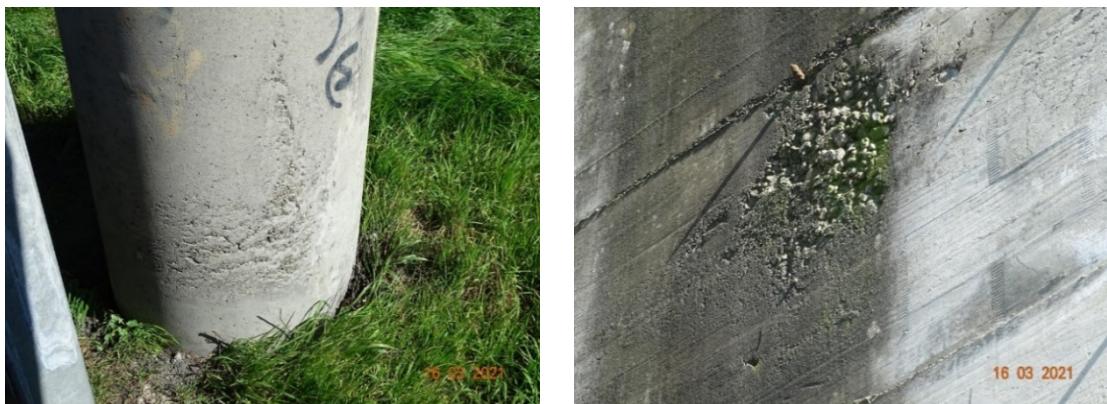
This defect compromises the surface continuity of concrete resulting in non-homogeneous areas due to the exposure of concrete aggregates. It may affect extensive areas of the structural elements or be localised. Generally, the causes of this phenomenon can be traced back to problems during construction: gravel nests are frequent in the case of poorly made concretes, with inadequate grain size and/or mix, in the case of poorly made casts, with insufficient vibratory, or poorly sealed formworks. In the vicinity of gravel nests a considerable increase in the permeability of the concrete is registered due to the presence of voids between aggregates, which facilitates the penetration of aggressive agents. They are, therefore, often associated with other degradation phenomena, such as oxidation and/or corrosion of the longitudinal and transversal reinforcement. The G value assigned to the defect is 2. An example is provided in Figure 21.

Figure 21 - Gravel nests

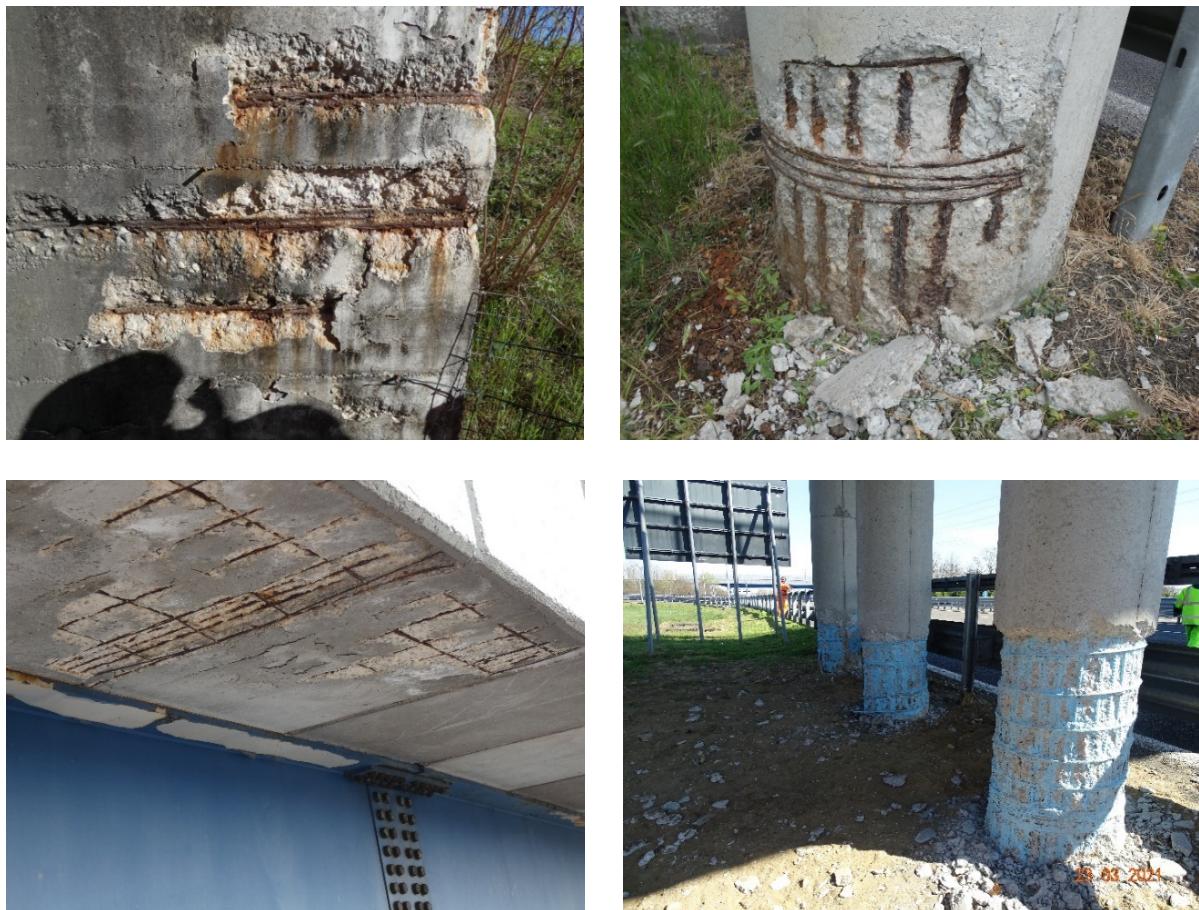
This defect refers to the absence of portions of the concrete covering layer of the longitudinal and transverse reinforcements of the elements, with consequent exposure of the latter to oxidising and corrosive agents. Concrete spalling is due to chemical and physical phenomena, such as the deterioration of the concrete caused by the action of water and humidity, and carbonation, favoured by the presence of porous concretes in aggressive environments, but also to errors during execution, such as very limited thicknesses of concrete, or accidental causes, such as vehicles impacts. Generally, this phenomenon occurs where concrete appears deteriorated or at gravel nest's location. It is assigned a G value of 2. An example is provided in Figure 22.

Figure 22 - Concrete spalling

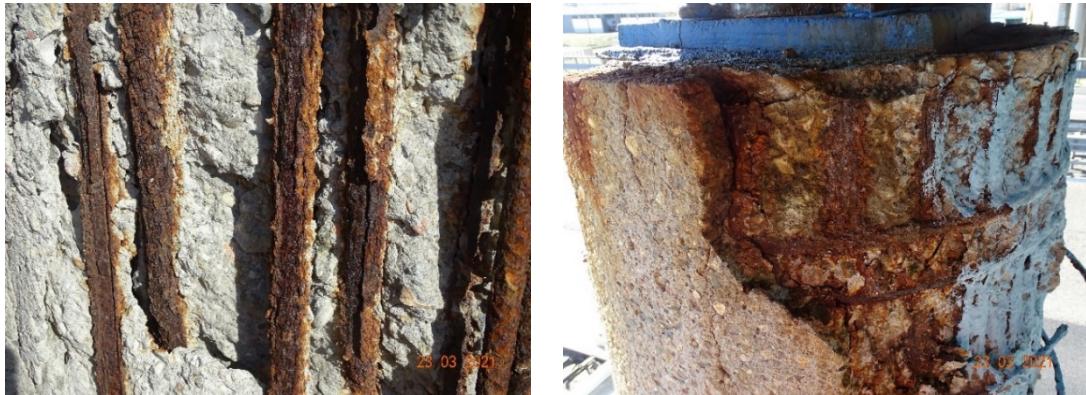
Reinforcement steel rusts and/or corrodes mainly due to the absence or deficiency of a suitable concrete cover. The absence of the cover layer allows external aggressive agents to come into contact with steel. If the concrete is carbonated and the concrete cover intact, this phenomenon is not visible but develops below the concrete cover. Carbonation means calcium carbonate formation with the consequent reduction in the PH of concrete and the formation of an iron oxide layer around reinforcement bars, which facilitates their oxidation. The latter causes an increase in the steel volume and subsequent cracking, first, and then expulsion of concrete cover. The defect is assigned a G value of 5 because in the worst cases, it can cause a reduction in the reinforcement cross-section. An example is provided in Figure 23.

Figure 23 - Corroded reinforcement

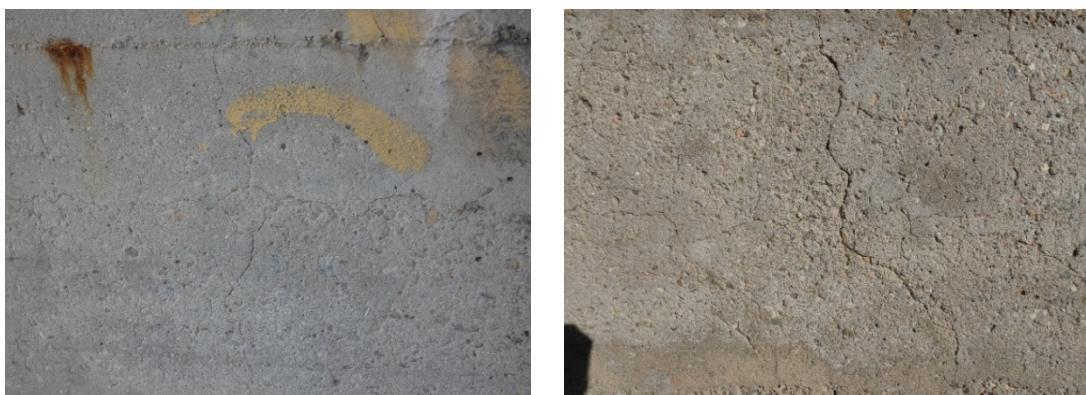
The defect refers to the presence of small cracks irregularly distributed on the surface of the elements and clearly visible in areas particularly subjected to the effects of humidity. In general, the causes of this phenomenon are linked to shrinkage in the case of inadequately mixed concrete and, in particular, when an excessive amount of water is used in the mix. Moreover, minor cracks can also occur in the case of inadequately cured casts or when the superficial reinforcement is insufficient. It is assigned a G value of 1. An example is provided in Figure 24.

Figure 24 - Minor cracks

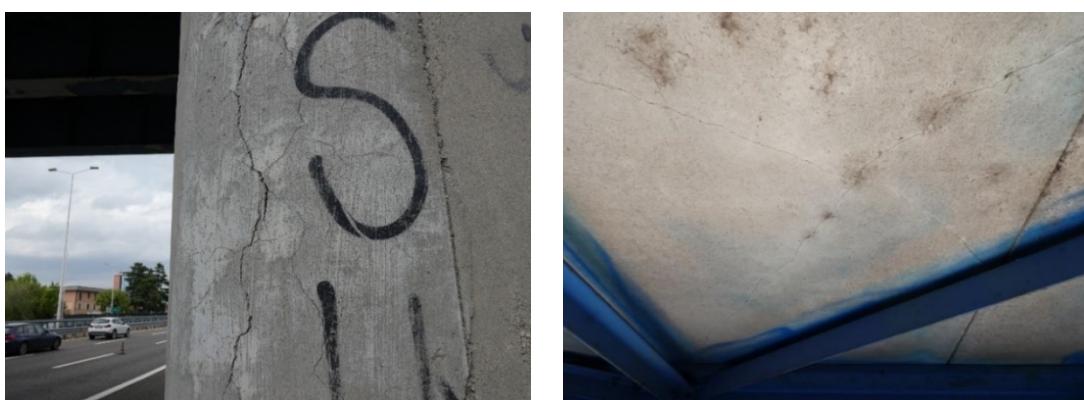
Vertical, horizontal, and longitudinal cracks are assigned a G value of 2, whereas diagonal and transversal cracks are assigned a G value of 5. An example is provided in Figure 25.

Figure 25 – Cracks

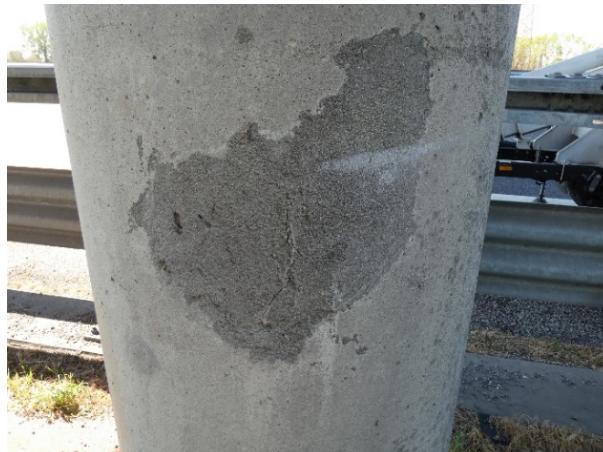
This defect comprises concrete localized interventions such as void filling, concrete cover reconstruction, and gravel nests reparation. Deteriorated reparations include several defects: cracks, moisture phenomena and detachment of new elements from the old material. This phenomenon can be caused by several factors, including unsuitable repair materials, incorrect design or execution of retrofit intervention, presence of aggressive external agents (e.g., freeze/thaw cycles, carbonation, etc.), and failure in preventing deterioration phenomena to affect the structure. The defect is assigned a G value of 1. An example is provided in Figure 26.

Figure 26 - Deteriorated reparations

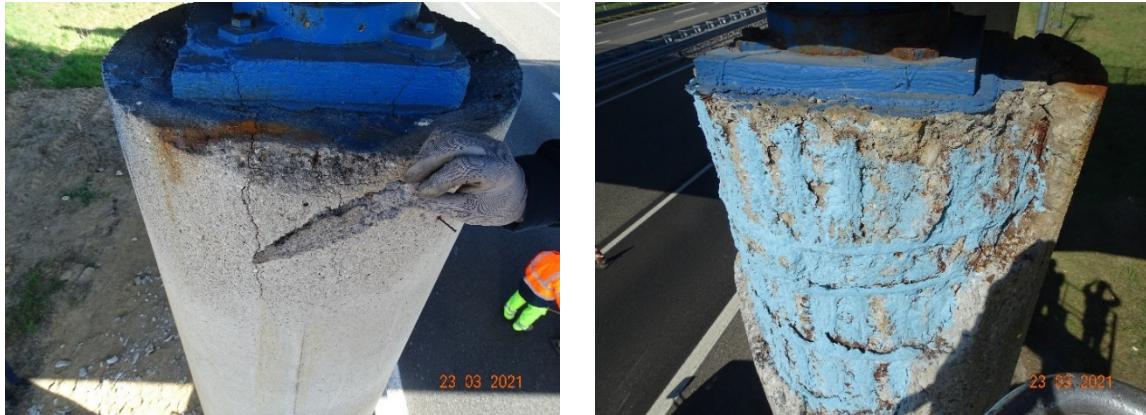
The term “crush lesions” refers to cracks generally located at the supports position, typically inclined by 45°. They are caused by excessive compression and the phenomenon is often associated with the detachment of wedges of material. Excessive compression may result from design errors (e.g., incorrect element sizing) or construction errors (e.g., poor materials, lack of reinforcement). The presence of cracks facilitates the infiltration of water and aggressive agents through the material, which may lead to moisture stains, deteriorated concrete, and reinforcement oxidation/corrosion. The defect is assigned a G value of 4. An example is provided in Figure 27.

Figure 27 - Crush lesions

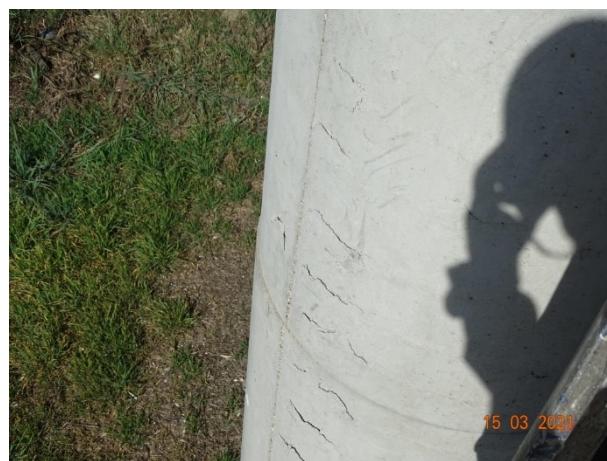
The defect is characterised by regularly distributed cracks reproducing the stirrups arrangement in structural elements. The presence of cracks at the stirrups position is due to oxidation of the reinforcement surface layer, the increase in volume of which causes concrete cover to crack. This phenomenon is favoured in the case of small thickness of the concrete cover and very porous concrete in aggressive environments, where air and moisture penetrate more easily. A further cause could be the effects of concrete shrinkage. It The development of the phenomenon could cause the complete detachment of the concrete cover and the consequent exposure of the transverse reinforcement which, exposed to atmospheric agents, could be subject to rusting and/or corrosion. The defect is assigned a G value of 2. An example is provided in Figure 28.

Figure 28 - Cracks at the stirrup position

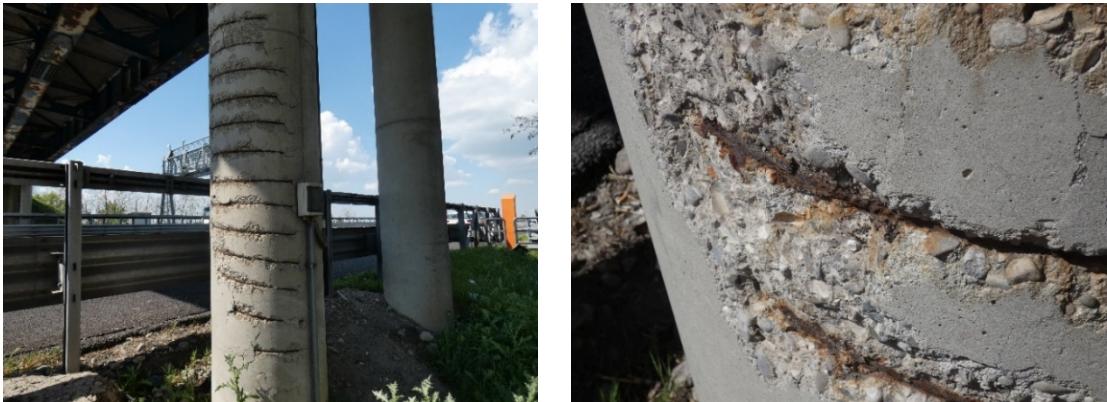
This defect refers to the exposure of the transverse reinforcements to air and water in the external environment and their consequent rusting/corrosion. The causes of the defect are concrete spalling and cracks at the stirrup position, which allows external agents to come into contact with steel. It is assigned a G value of 3. An example is provided in Figure 29.

Figure 29 - Rusted and/or corroded stirrups

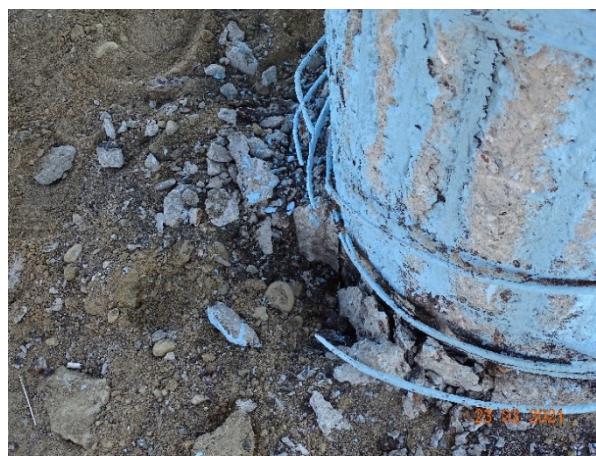
The defect refers to the complete failure of the transverse reinforcement of the structural elements. Continuous exposure of stirrups to external agents following concrete spalling can lead to rusting and, in the most serious cases, to a reduction in the bars' cross-section up to complete failure. The defect is assigned a G value of 4. An example is provided in Figure 30.

Figure 30 - Broken stirrups

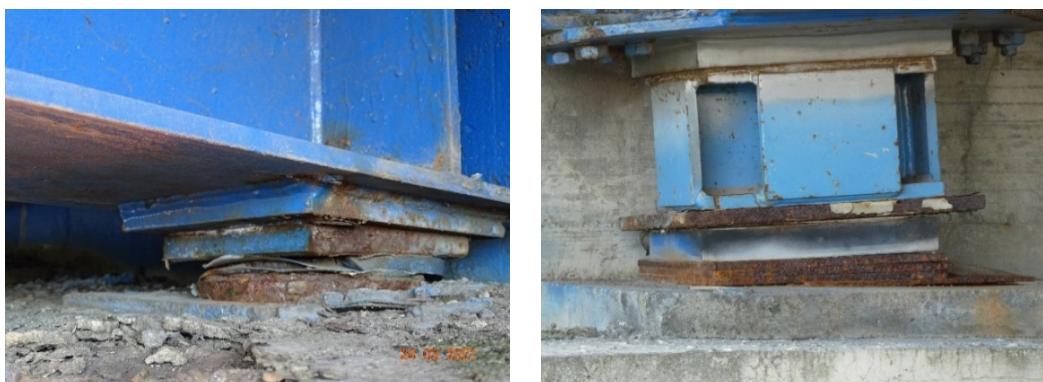
The defect relates to the loss of shape and flatness of the steel baseplate of the supports. The origin of the defect can be traced back to the assembly process, if the defect is due to surface irregularities or incorrect positioning of the equipment, or during service life, if it is due to abnormal or unexpected movements and in the case of severe deterioration of the plate itself. It is assigned a G value of 2. An example is provided in Figure 31.

Figure 31 - Deformed baseplate

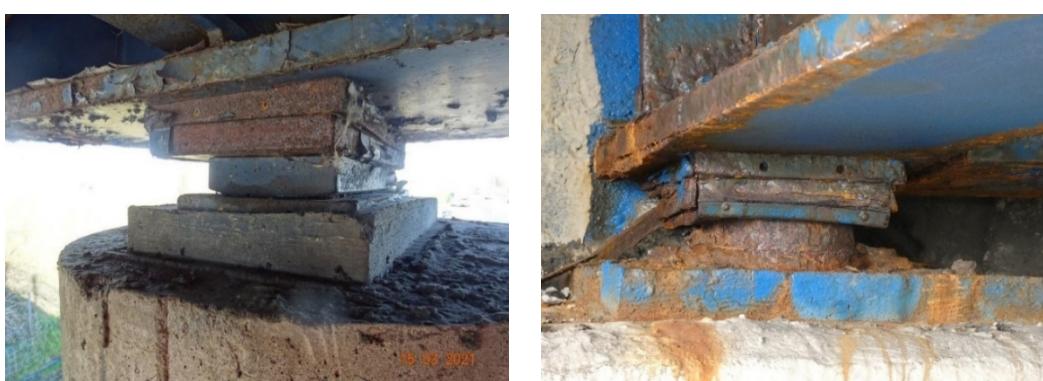
The defect consists in the rusting of the steel components of the support. Depending on the progress of the phenomenon, it can manifest in various forms, ranging from the mere perforation of the surface coating layer to the reduction of the element's section. Rusting is triggered if the steel parts of the devices are not adequately protected (e.g., lack of paint, paint deterioration). The phenomenon is intensified in a humid environment. Other causes include stray currents or aggressive chlorides from de-icing salts, marine environment, etc. It is assigned a G value of 2. An example is provided in Figure 32.

Figure 32 - Bearing device rusting

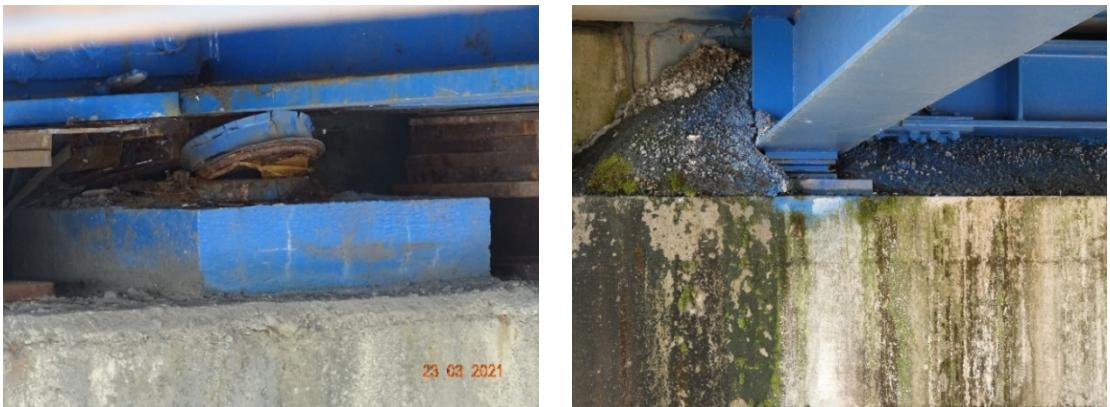
The defect refers to incorrect, or other than intended, functioning of the supports. The occurrence of this phenomenon is related to the preservation characteristics of the devices. It is more likely in the case of deteriorated or aged materials or if the devices are poorly positioned. Other possible causes are the presence of debris, which blocks the movement and foundation movements. It is assigned a G value of 4. An example is provided in Figure 33.

Figure 33 - Locking

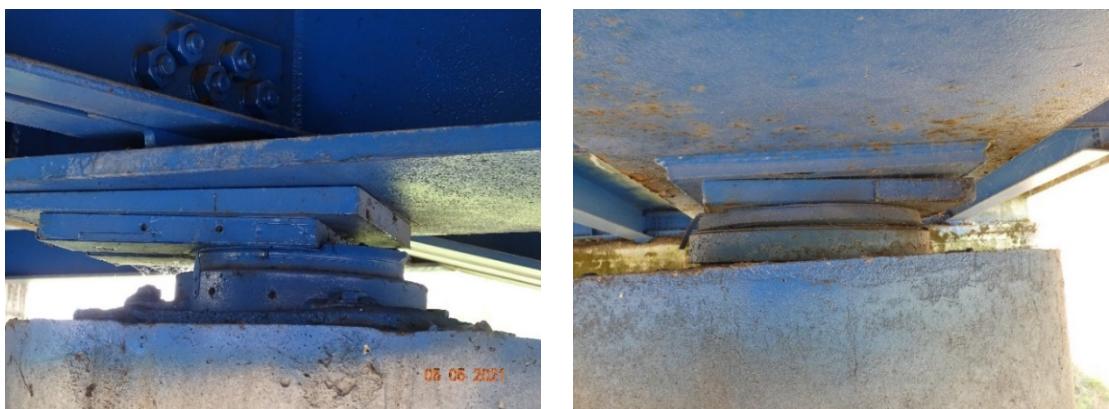
The defect refers to incorrect, or other than intended, functioning of the supports due to incorrect presetting. The origin of the defect is to be found in the installation phase, as it is due either to incorrect original positioning or to positioning without taking into account the long-term phenomena that may affect their operation (e.g., temperature variations, concrete viscosity, etc.). It is assigned a G value of 4. An example is provided in Figure 34.

Figure 34 - Incorrect presetting

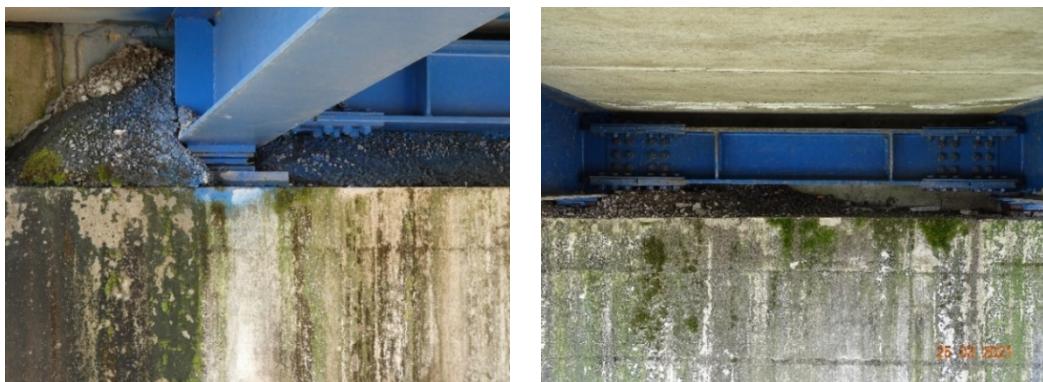
This defect refers to the presence of material deposits (e.g., earth, mud, wooden planks, bitumen, etc.) in the vicinity of the supports that affects its normal functioning. Debris generally results from unremoved manufacturing residues or weathered materials deposited on the horizontal surfaces of abutments and pier caps. It is assigned a G value of 2. An example is provided in Figure 35.

Figure 35 - Presence of debris

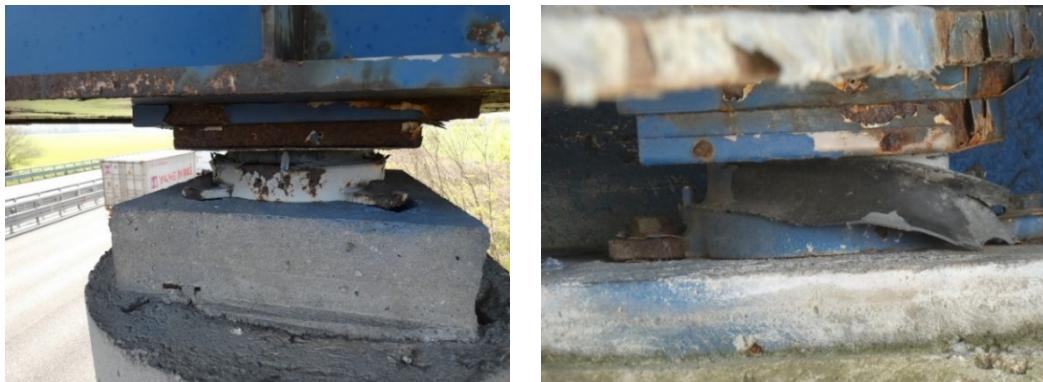
caused by dust intrusion, unintended loads, poorly executed assembly or the use of materials with unsuitable characteristics and qualities. The defect is assigned a G value of 3. An example is provided in Figure 36.

Figure 36 - Neoprene/Teflon deterioration

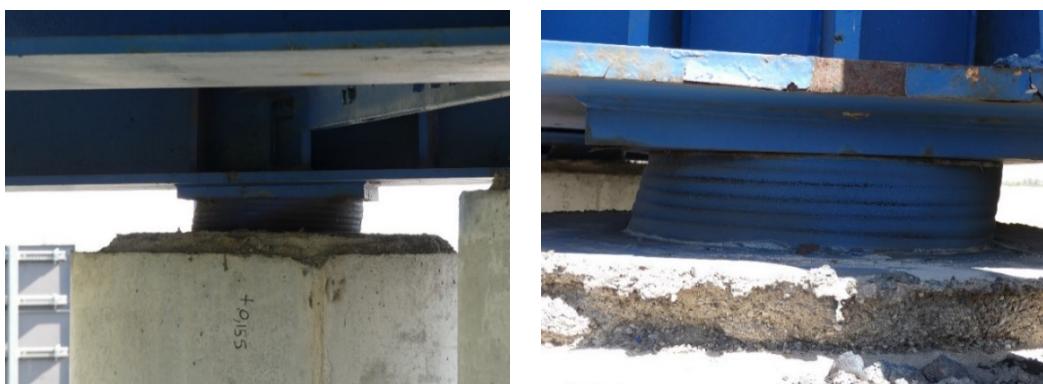
The defect is favoured in the case of ageing and consequent loss of elasticity of the material. It is assigned a G value of 4. An example is provided in Figure 37.

Figure 37 - Excessive lateral deformation of neoprene

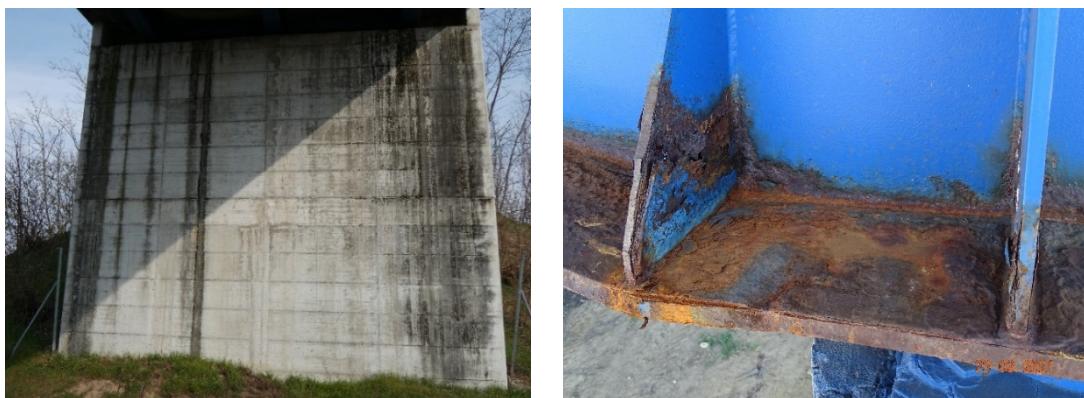
The defect occurs when a significant quantity of water accumulates in specific areas of structural elements. This phenomenon can induce degradation phenomena and corrosion of the elements. Water stagnation occurs where there are irregularities on the surfaces and in the case of poor maintenance of the water drainage system and lack or insufficient waterproofing of the slab. The phenomenon is accentuated in the presence of particularly porous and permeable concrete. Annex C distinguishes the case in which water stagnation verifies inside box sections. If the latter is not the case, the defect is assigned a G value of 2, otherwise it is assigned a G value of 4. An example is provided in Figure 38, on the right.

Figure 38 – Left: Drainage marks; Right: Water stagnation.

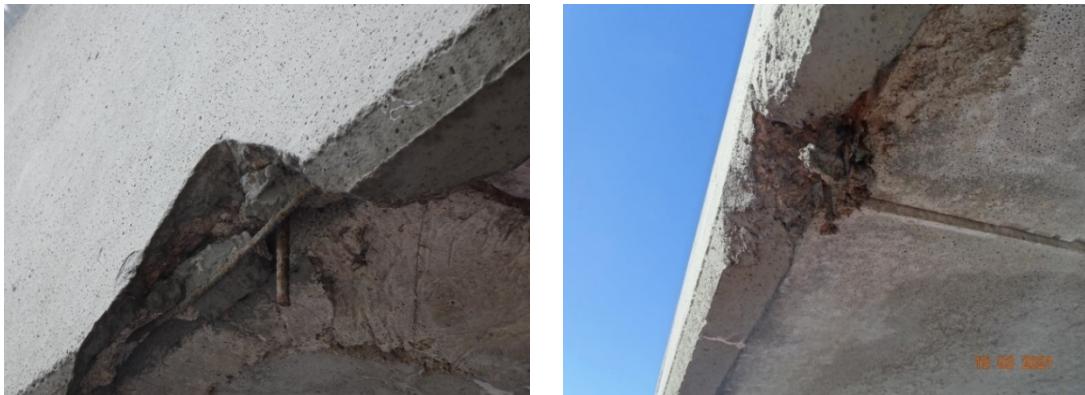
Such damages comprise breaking of the edges, detachment of the concrete cover, and reinforcement cut or deformation. The impact of elements of various kinds with the structure can be caused by the passage of vehicles that do not comply with the clearance height under the bridge, or by traffic accidents. The defect is assigned a G value of 4. An example is provided in Figure 39.

Figure 39 - Impact damage

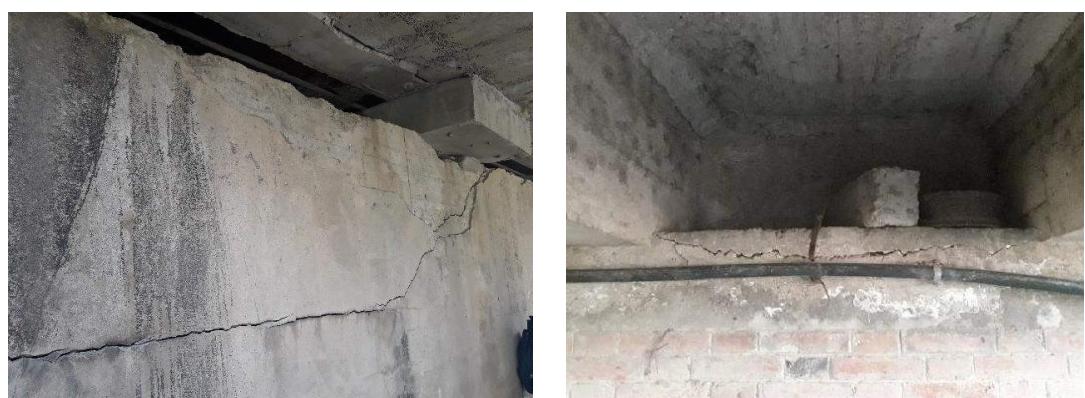
The defect refers to crack formation at the support location due to the bearing device functioning. Cracks can occur on both the supporting element and the supporting device. Cracks form as a result of tensile stresses arising from the failure in sliding of the device, which in turn can be caused by material deterioration, blockage or incorrect dimensioning. The defect is assigned a G value of 3. An example is provided in Figure 40.

Figure 40 - Characteristic cracks at the support location (Adopted from Annex C of the Italian guidelines)

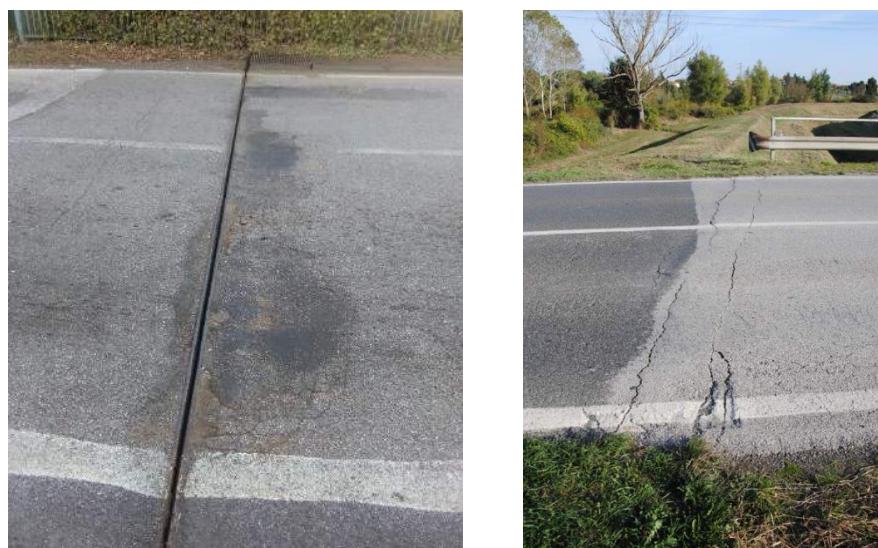
Figure 41 – Left: Pavement-expansion joint gap; Right: Gap plug detachment (Adopted from Annex C of the Italian guidelines)

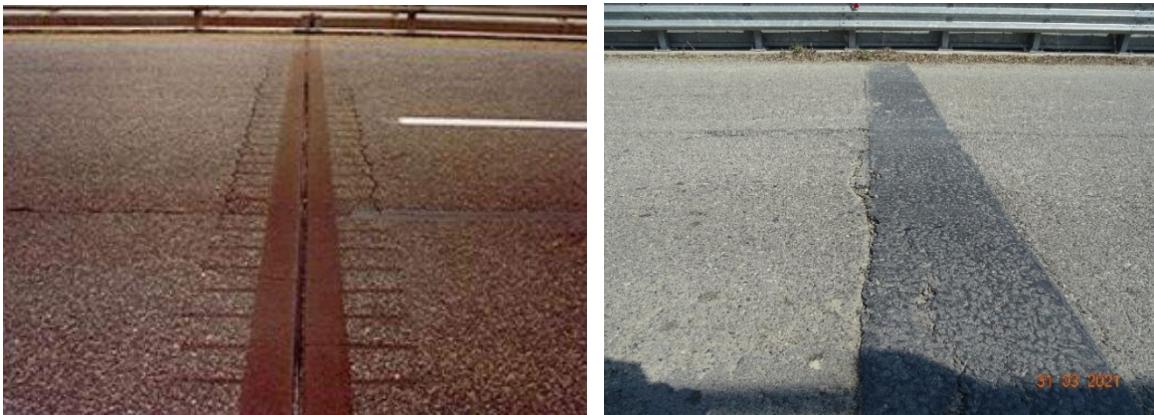
Figure 42 – Left: damaged screeds; Right: gap plug deformation (Adopted from Annex C of the Italian guidelines)

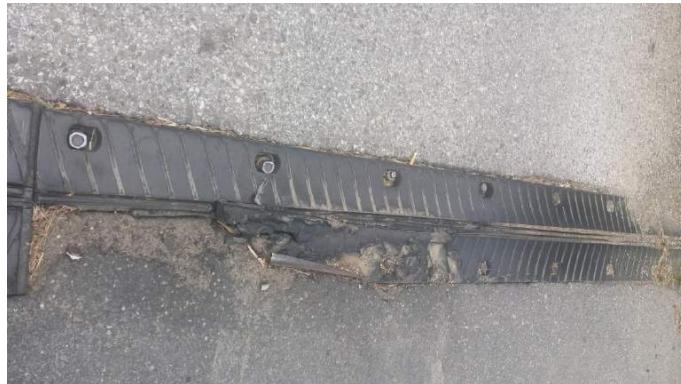
Figure 43 - Deformation/breakage of continuity elements (Adopted from Annex C of the Italian guidelines)

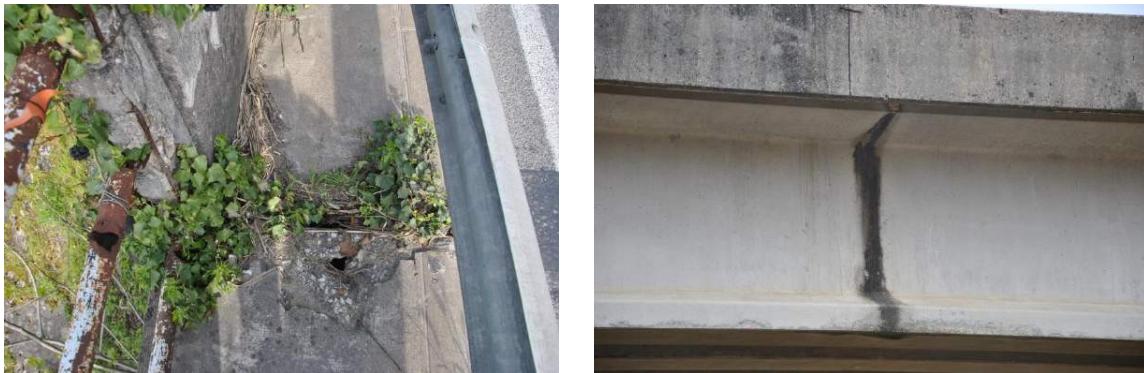
Figure 44 - Permeable or absent flashing (Adopted from Annex C of the Italian guidelines)
