Hardware Diagnostics: POST Failure Isolation using Bottom-Up Methodology

Abstract

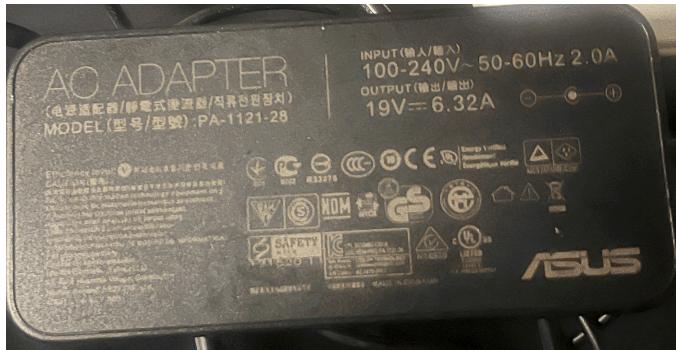
As expected from such an old computer, the charger AC adapter has worn out. The plug is bent and worn out. My next step is to substitute the charger to see if the issue is due to the external PSU. For this, the output voltage needs to be the same and the amperage needs to be equal or greater. I used a Powseed 19V Replacement AC Adapter Power Cord Charger found on amazon. From observation, the external PSU is ruled out as the computer still does not power on with this new charger. Therefore, the fault is internal.

a new, properly rated 19V/6.32A AC adapter, as the original was a likely contributing factor to the failure. Secondly, leaning the fan and replacing the thermal paste on the CPU and GPU needs to be done to ensure thermal integrity. Finally, backing up any data stored in the HGST drive needs to be done depending on my brother's needs.

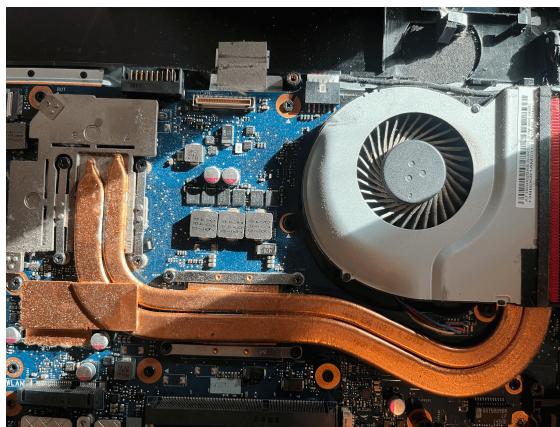
Cooling System

- **Cooling System:** The copper heat pipes and mounting hardware appeared structurally sound. The CPU and GPU were correctly positioned beneath the heatsink assembly.

- **Thermal Condition:** Minor dust was noted on the cooling fan blades, but not a heavy enough collection to cause catastrophic overheating. The system's passive cooling elements appeared functional.

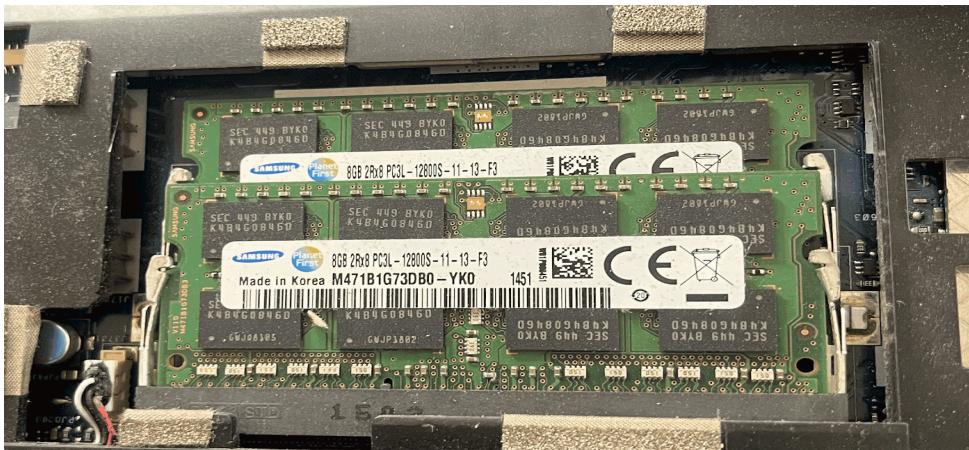
The laptop runs at 8GB of RAM and uses PC3L so the system uses DDR3 RAM. It operates at 1.35V because of the 'L'. The 12800S indicates a 1600 mHz effective clock speed, common for midrange DDR3. The 'S' means its for small outlined DIMM which can be confirmed as it is a laptop. 2Rx8 confirms the memory stick is not a specialized ECC server stick.
