# Failure Analysis of a Titan PowrTwin 8900 Pump Cylinder

ME-3033 Properties of Materials

May 01, 2026

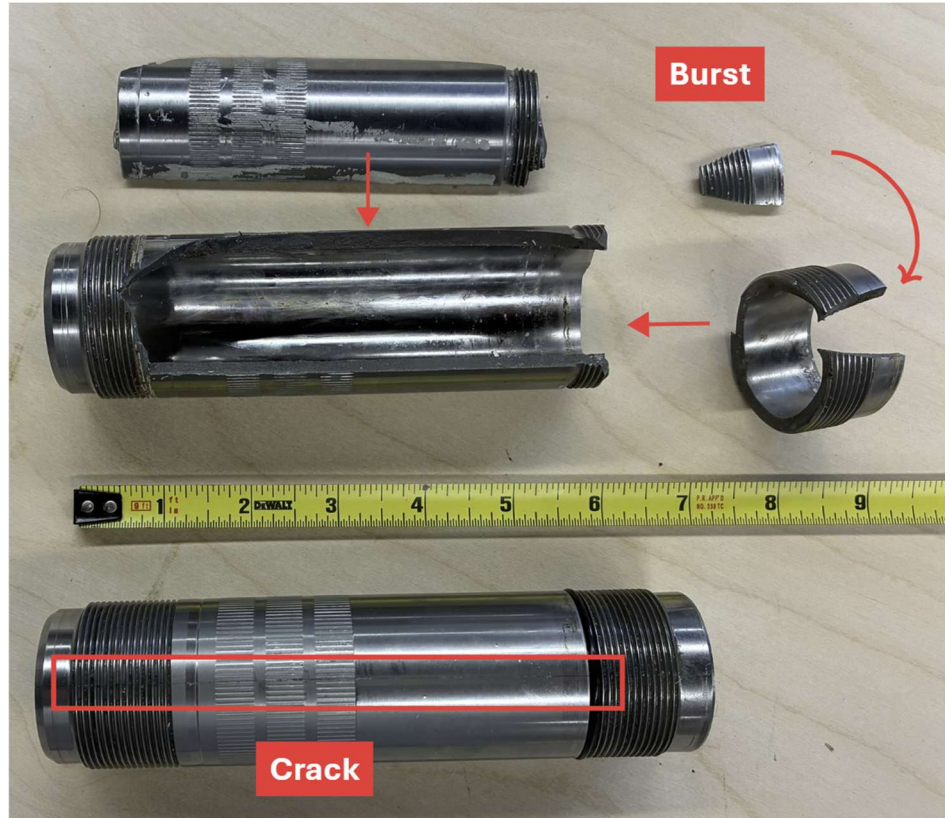
An initial visual examination of the failed pump cylinders shows very small amounts of wear on the inside surface and no evidence of corrosion. Pump cylinders failed both by cracking and leaking or by bursting, as seen in Figure 5. Besides the failure lines, no other cracks were found on the failed pump cylinders.

Figure 5: Two Different Failed Cylinders

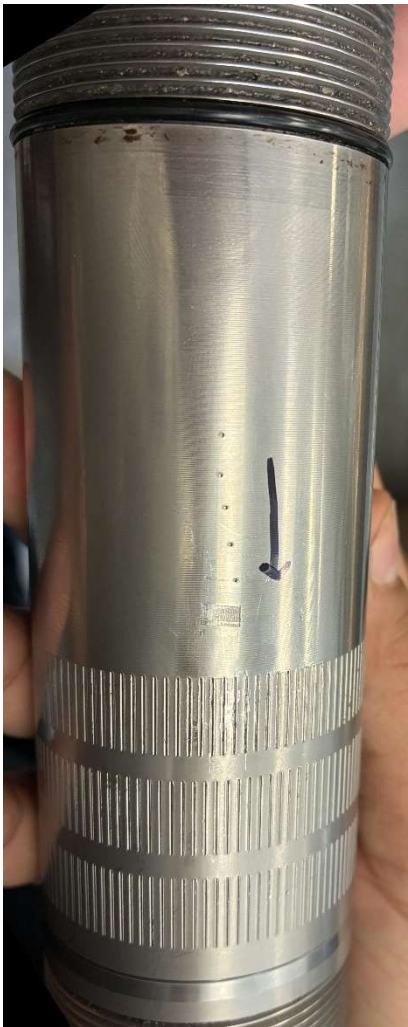
Figure 6 (Left):  
The Hardness Test  
Locations

A Rockwell C Hardness test was conducted on the cracked cylinder shown in Figure 5, yielding an average hardness of  $58.7 \pm 0.5$  HRC. Figure 6 below shows the testing locations, while Table 1 shows the data gathered in step with the arrow direction noted on Figure 6.

The Rockwell Hardness results suggested that the pump cylinders were made out of a high-grade martensitic stainless steel; this was confirmed in a call to the Titan Tool Technical Service line, where they stated that the pump cylinder was made from 440C stainless steel.

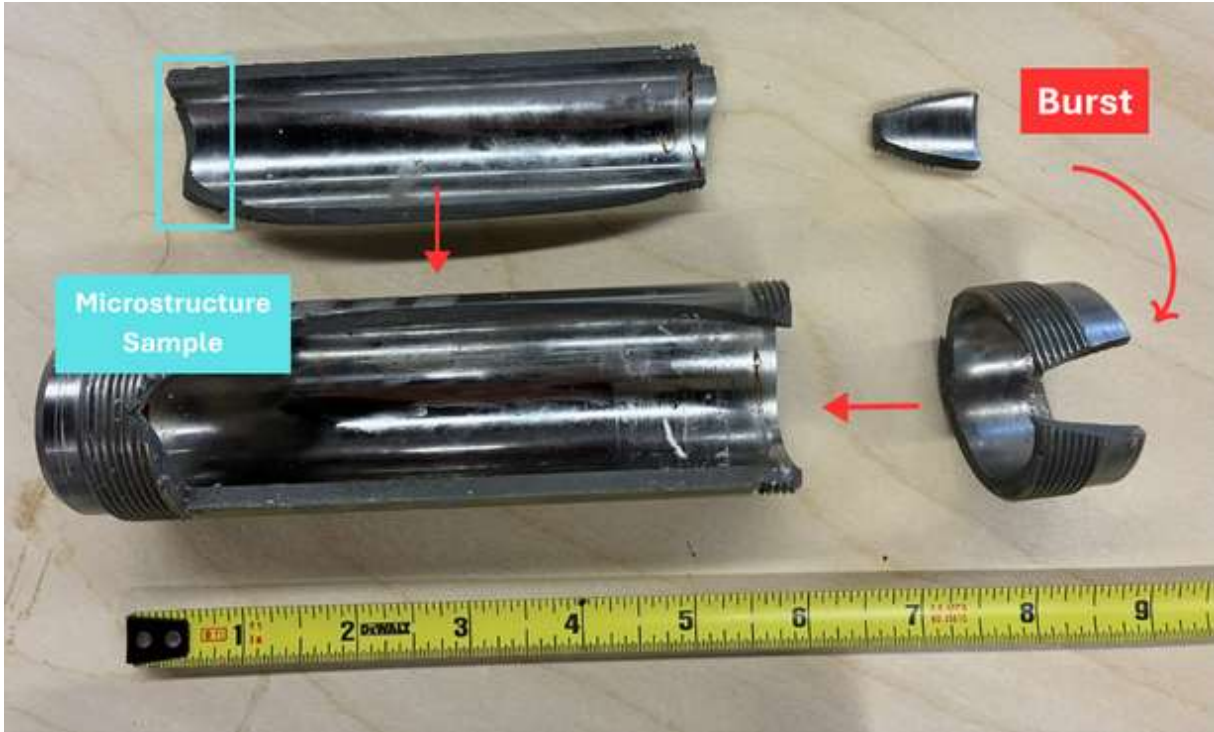
Figure 7: Microstructure Sample Piece from Burst Cylinder

The microstructure sample was taken from the side piece of pipe that came from the burst pipe (see Figure 7 above). The sample was encased in epoxy, and the surface was wet ground to 600 grit and polished to a mirror finish. The first look through the microscope did not see any microstructure, so the sample was then etched with Villela's reagent to reveal the grain structure. In the microstructure pictures in Figure 8, the lighter areas are complex carbides, and the darker background areas either retained austenite or more likely tempered martensite.

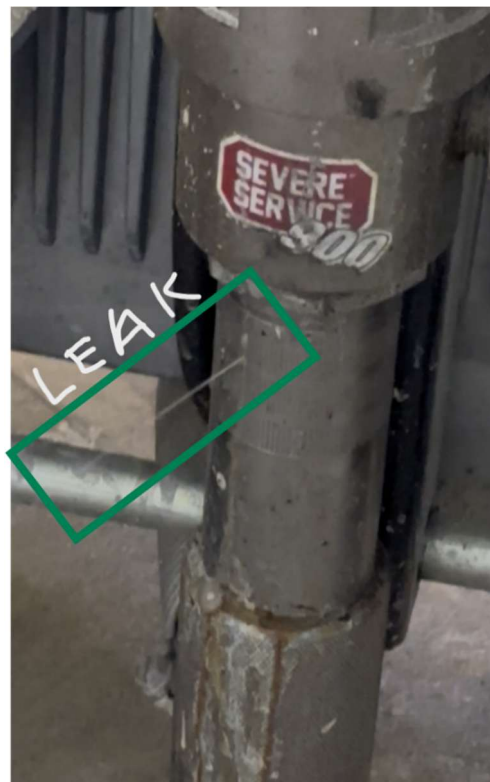
to cracking under extreme stress conditions. No obvious material defects were observed that would be indicators of a manufacturing flaw. According to Sherwin-Williams, a paint-supply store that also fixes inoperable paint machines, fractures in this specific component are common during the winter when the temperature reaches below the freezing point of water. Mr. Rios has ten of these PowrTwins out of use due to this same failure. Many have a minute crack, invisible until the sprayer is turned on and the cylinder leaks; a few have fully burst with pieces broken and falling apart. Although it is difficult to see in the image, a small leak is visible and highlighted for clarity in Figure 12.

Figure 12: Leaking Pipe – Only Visible While Running

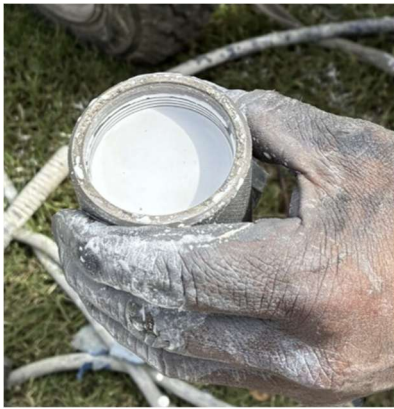
Figure A4: Non-modified inlet elbow full of water

This is the non-modified inlet elbow of the Titan 8900 PowrTwin we used to test our valve-actuating pin solution. The trapped water is easily visible when the elbow is removed. This water causes the connected pump cylinder to rupture in freezing conditions. Taken April 30<sup>th</sup>, 2026, in testing the valve-actuating pin on a working machine.
