ADA Curb Ramp New Construction Inspection Form (Perpendicular)

| | - Carch | | | | | | | |
|---|--|---|---|---|---|---|---|---|
| N | lw Jackson school rd | 24952.54 | | | | West | unio | n rd |

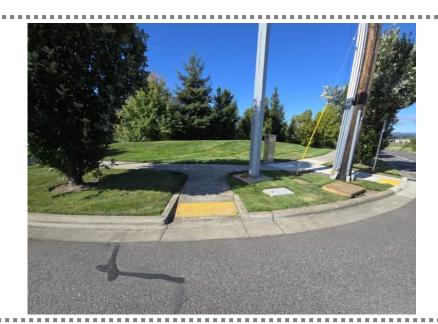
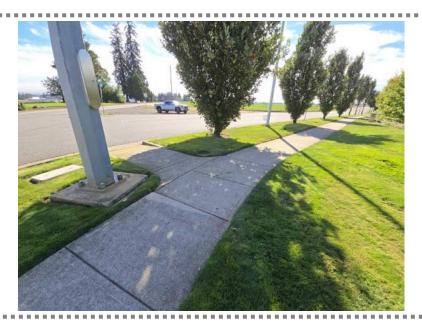
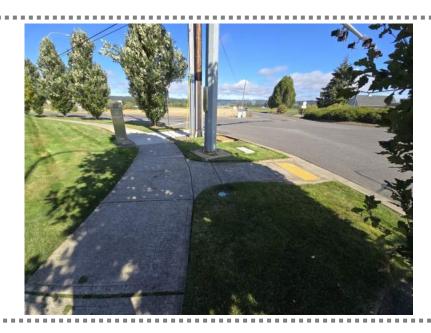
ADA Curb Ramp Images

| | - Carch | | | | | | | |
|---|--|---|---|---|---|---|---|---|
| | | Back of Ramp Obstruction (Y/N) | | ≥ 5.0' * 1 | | < 5.0'*1 | | IITD tool joint in turn space ICRR |
