## **ADA Curb Ramp New Construction Inspection Form (Perpendicular)**

## **ADA Curb Ramp Images**

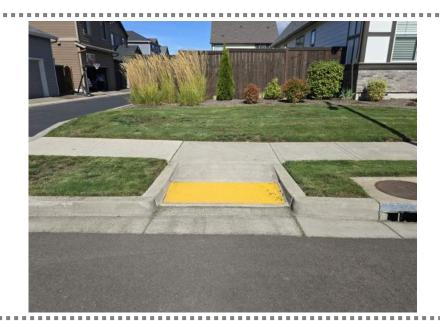
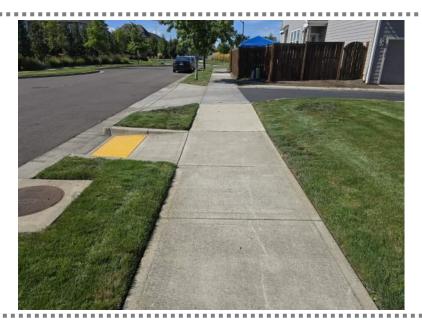
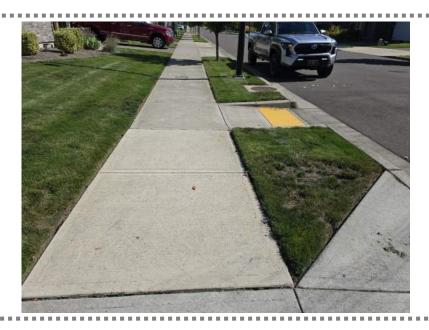
Run 1/2 2 2 2	Width X	6.1	≥ 4.0'		< 4.0'			
Counter slope Gutjer Flow slope	Length Y	5.0	≥ 4.0'*¹		< 4.0'*1		Comments:	
	Back of Ramp Obstruction (Y/N)		≥ 5.0' <b>*</b> ¹		< 5.0'*1			
PERPENDICULAR RAMP (PR)  Pedestrian Access Route (to measure Clear Width)	Slope X		≤2.0%		>2.0%			
manning Baratala Wardan Cartan	Slope Y	2.6	≤2.0%		>2.0%			_
□ Detectable warning Surface     □ Cross Slope (2.0% max.)	MISCELLANEOUS Traversa	able		Pass		Fail		_
Running Slope (8.3% max.)	Flare Slope 1		≤ 10%		< 10%	川	Inspector's Signature Date	.e (n
Counter Slope (5.0% max.)	Flare Slope 2		≤ 10%		<10%		Darrell Wyant 52	26
Turning Space (X & Y) (2.0% max. / 4' x 4' min.)*  * If constrained at back of walk, min. Y length is 5'.	Clear Width (feet)		≥ 4.0'		< 4.0'	Ш	Print name clearly Certif	
Gutter Flow Slope (as directed)	Intersection Control Type	MB	Slope of	Road	0.2		3J Consulting	_
	Horizontal Gaps		≤1/2"		> 1/2"		Company/Agency	_
