ADA Curb Ramp New Construction Inspection Form (Perpendicular)

| | 20142.6 | | | | | | | | | |
|--|--|---|---|---|---|---|---|---|---|--|
| N | IW 309th Ave | 24952.54 | | NW Yorks | | | orks | shire St | | |

ADA Curb Ramp Images

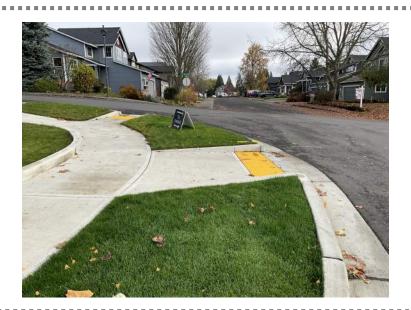
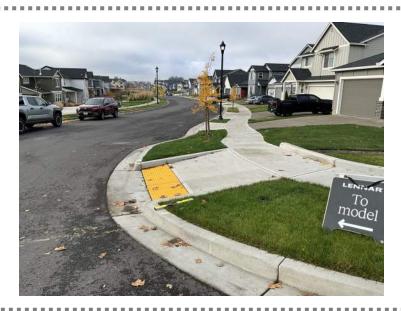
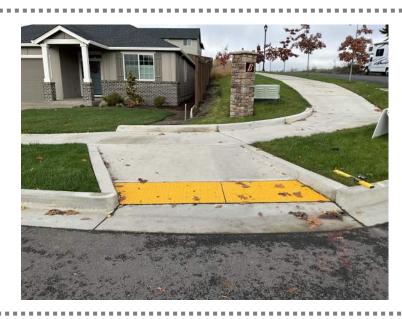
| | 20142.6 | | | | | | | | | |
|--|--|---|---|---|---|---|---|---|---|--|
| | | Cross Slope 1 | 2.3 | ≤ 2.0% | | >2.0% | | 1 | 3 | |
