## EWR D&I ANNOTATION

FAN-000001L103001DP618-4585

DI11-005. SEQ ID 618. 2010 Q3. WE RECEIVED A CALL LOG AND CRASH DATA FOR A 2007 SATURN ION. THE DRIVER WAS TRAVELLING ON A ROADWAY ABOUT 60MPH WHEN A VEHICLE ON THE RIGHT SIDE SHOULDER CAME INTO HIS LANE AND CUT HIM OFF. HE REAR ENDED THEM. THE DRIVER AND PASSENGER WERE WEARING THEIR SEATBELTS AND ARE WONDERING WHY THE BELTS DID NOT LOCK. THEY ALSO ALLEGE A NON-DEPLOYMENT OF THE AIRBAGS. THE FRONT END OF THE CAR WAS CRUSHED AND THE TWO OCCUPANTS SUFFERED MINOR INJURIES. THE MAXIMUM VELOCITY CHANGE DURING THE IMPACT WAS 8MPH. GM HAS DENIED ANY DEFECT. \*RM

**DI11-005**  
**618 316870364 – 697440**  
**2007 SATURN ION**

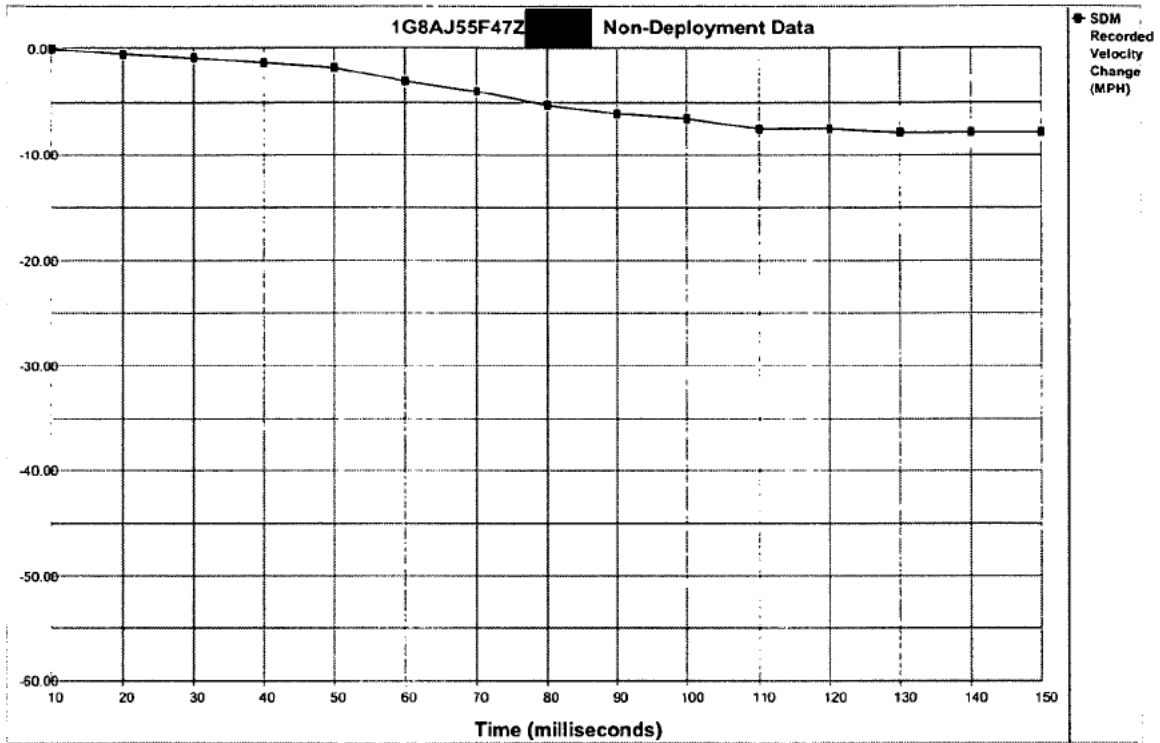
| Time (milliseconds) | 10 | 20 | 30 | 40 | 50 | 60 | 70 | 80 | 90 | 100 | 110 | 120 | 130 | 140 | 150 |
| SDM Recorded Velocity Change | 0.00 | -0.44 | -0.88 | -1.32 | -1.76 | -3.07 | -3.95 | -5.27 | -6.14 | -6.58 | -7.46 | -7.46 | -7.90 | -7.90 | -7.90 |
