DIO5-142 NC  
POSTED

## EWR D&amp;I ANNOTATION

MAR - 1 2006

**PRODUCT ALLEGATION RESOLUTION  
PRELIMINARY INSPECTION  
FIELD PHOTOGRAPHIC NOTES**

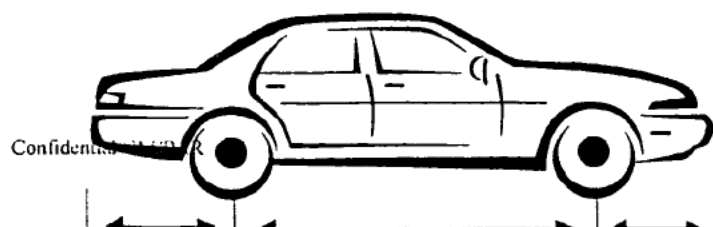
**STRUCTURAL DEFORMATION - CRUSH AREAS**

Additional comments concerning any seat damage (front or rear): **Passenger front seat position has been Twisted and compromised by a right B-pillar crush depth of 18".**
