**EWR D&I ANNOTATION**

FAN-000001L064001DP88-1444

IN-06-033  
SCI • ~~CAOS-049~~

NVS-217ph  
DI07-044

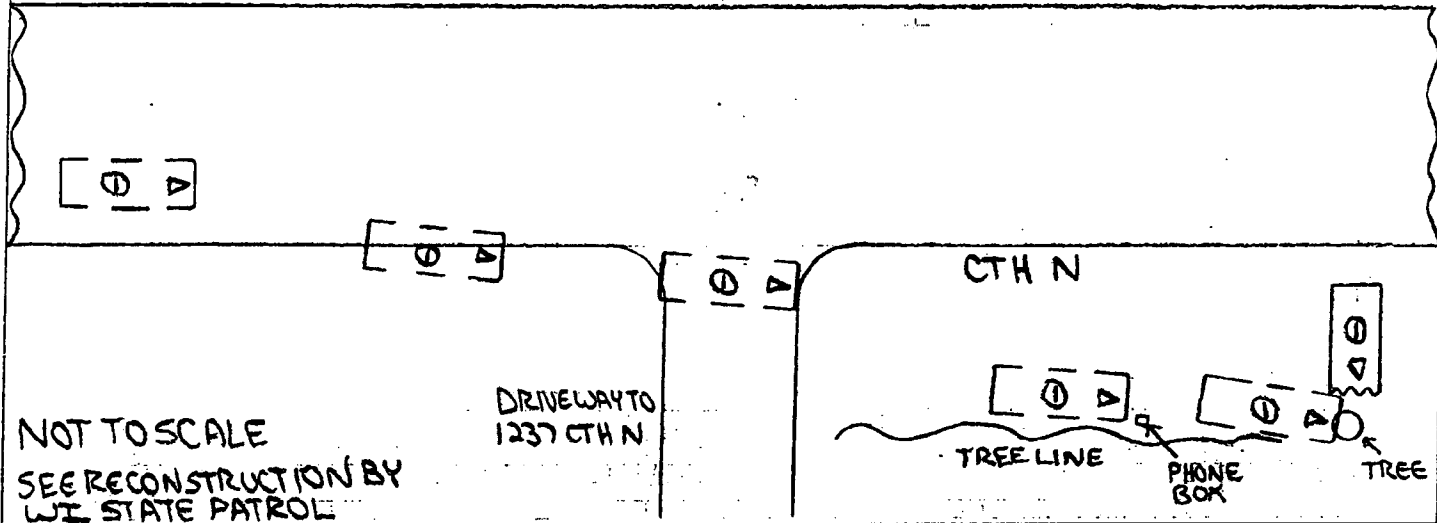
Unit one was eastbound on CTH N.  
Unit one entered the south ditch and struck a tree.  
The driver was transported by ground ambulance to Regions Hospital.  
The position 4 passenger was air lifted to Regions hospital from the scene.  
The position 3 passenger was transported by ground ambulance to the Hudson Medical center and air lifted from there to Regions Hospital. On 10-24-06 at 2318 the position 3 passenger was pronounced dead at Regions hospital.

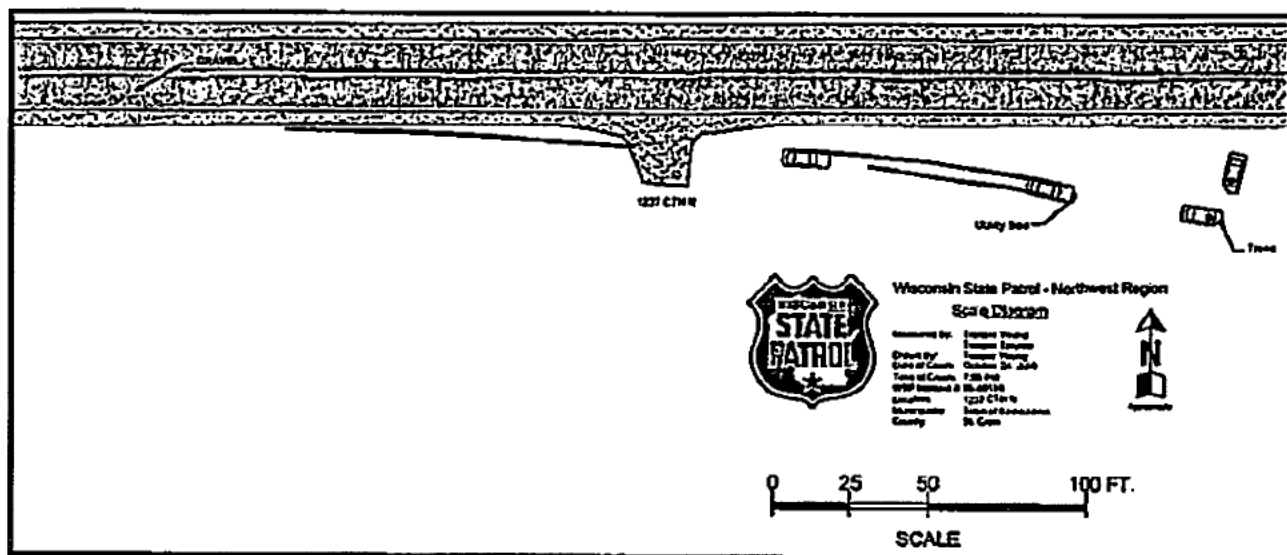
As the [REDACTED] vehicle traveled down a slight grade her vehicle went onto the south shoulder and into the south ditch. When the vehicle approached the driveway at house number 1237 it launched off of the west edge of the driveway and was airborne for approximately 59 feet. The vehicle landed and traveled approximately 82 feet before striking a telephone junction box and knocking it down. The vehicle then traveled another 46 feet through some brush before striking two larger trees. The vehicle then rotated clockwise approximately 94 degrees while traveling another 14 feet before coming to rest.

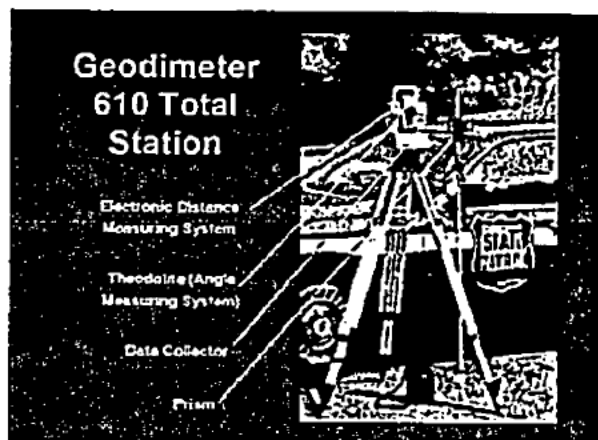
On October 24, 2006, with the assistance of Trooper William Traynor the crash scene was mapped with the State Patrol's Geodimeter 610 Total Station. Detailed measurements of the scene were taken locating roadway and lane edges, tire marks, a utility box and tree as well as the final rest position of the vehicle involved in the crash. The measurements obtained using the total station were then used in *Crash Zone*, a *Computer Aided Drawing (CAD)* program to produce a forensic map of the crash scene.

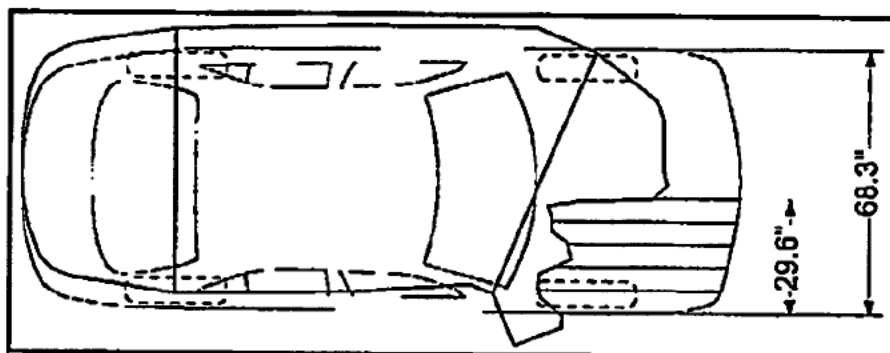
On November 6, 2006, Trooper Traynor and myself went to the St. Croix County Impound Lot to measure the damage profile of the [REDACTED] vehicle. Using the State Patrol's Geodimeter 610 Total Station, measurements of the [REDACTED] vehicle were taken to determine the amount of deformation that was caused by the collision with the trees.

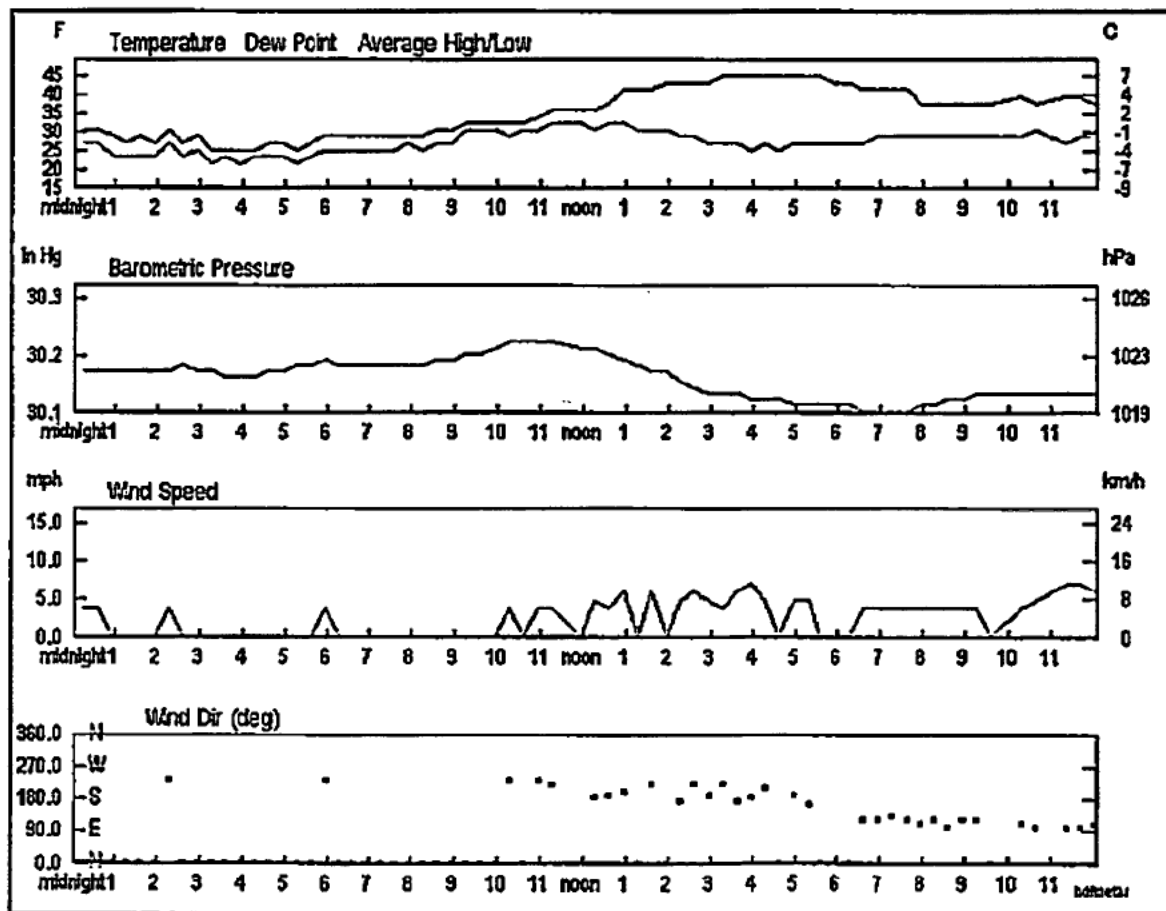
The weather conditions were reported by the Weather Underground for New Richmond, Wisconsin (*the nearest reporting station*) on October 24, 2006, at 7:55 pm as mostly cloudy skies, visibility was 10 miles, the wind was out of the east south east at 3.5 mph and the temperature was 37.8 degrees. The weather does not appear to have been a factor in the crash.

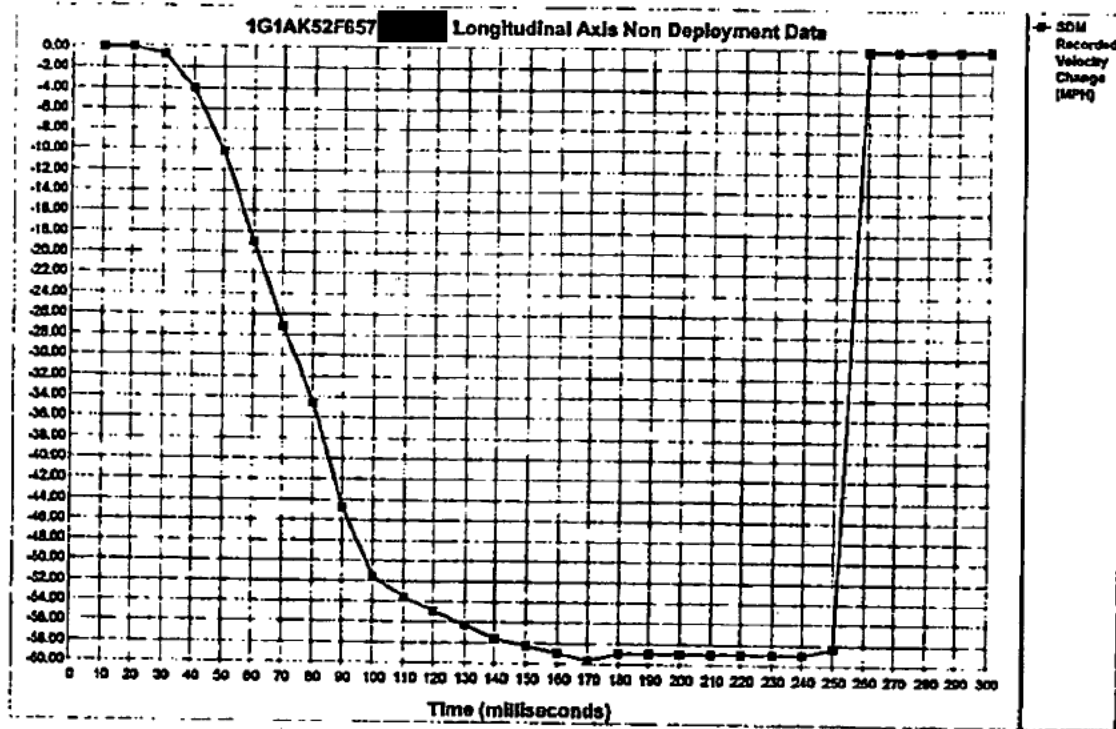
| Longitudinal Axis Recorded Velocity | 0.00 | 0.00 | -0.68 | -4.07 | -10.17 | -18.98 | -27.11 | -34.57 | -44.74 | -51.52 | -53.55 | -54.90 | -56.28 | -57.82 | -58.29 |
| Longitudinal Axis Recorded Velocity | -58.97 | -58.65 | -58.97 | -58.97 | -58.97 | -58.97 | -58.97 | -58.97 | -58.97 | -58.29 | 0.00 | 0.00 | 0.00 | 0.00 | 0.00 |

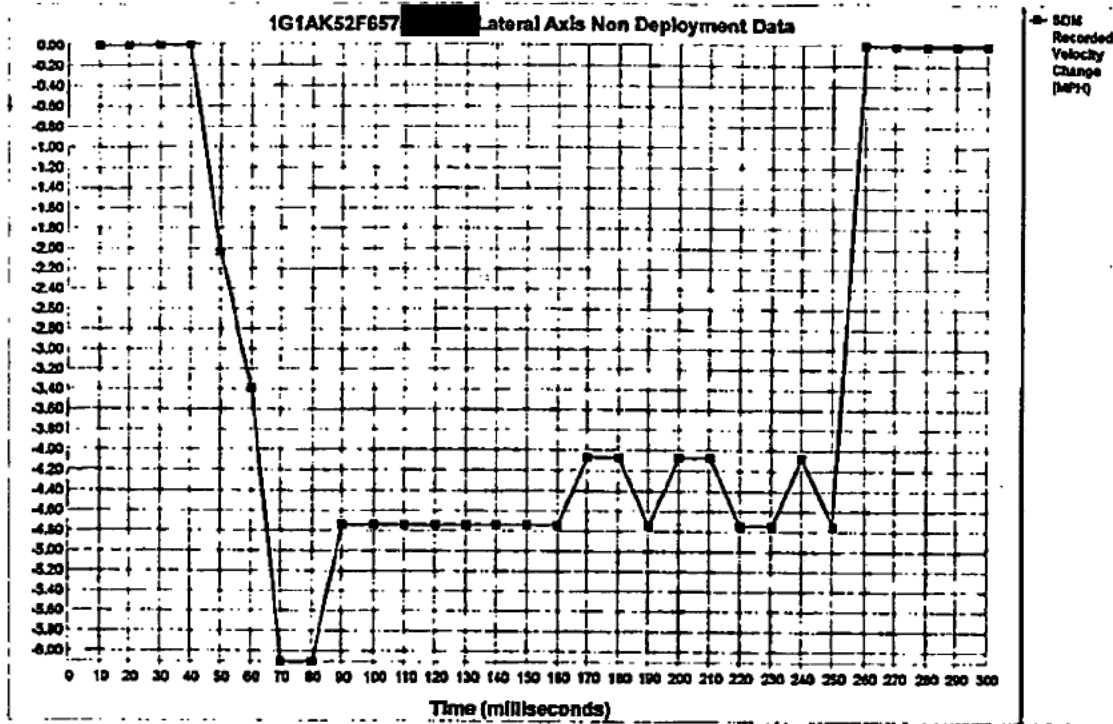
| Lateral Axis Recorded Velocity Change (MPH) | 0.00 | 0.00 | 0.00 | 0.00 | -2.03 | -3.39 | -4.10 | -4.10 | -4.74 | -4.74 | -4.74 | -4.74 | -4.74 | -4.74 | -4.74 |
