**EWR D&I ANNOTATION**

DI11-072 SEQUENCE ID 121: A SERVICE REQUEST DETAIL LOG FOR GENERAL MOTORS LLC MAKES THE ALLEGATION THAT A 2007 CHEVROLET COBALT IS POTENTIALLY DANGEROUS DUE TO AN AIR BAG NONDEPLOYMENT. THE LOG STATES THAT THE COBALT WAS INVOLVED IN AN ACCIDENT WHEREBY ANOTHER VEHICLE SWERVED INTO ITS LANE THUS CAUSING THE DRIVER TO APPLY THE BRAKES. THE COBALT WAS UNABLE TO STOP IN TIME AND STRUCK THE VEHICLE IN FRONT AND ALSO WAS STRUCK FROM BEHIND BY ANOTHER VEHICLE. THE SPEED THE VEHICLE'S WERE TRAVELING AND/OR SPEED OF IMPACT WAS NOT PROVIDED. THE LOG CLAIMS THAT THE INCIDENT OCCURED ON LOCAL HIGHWAY. NO INJURIES WERE CLAIMED. FRONT AND REAR DAMAGE TO THE COBALT WERE MENTIONED. NO POLICE REPORTS WERE INCLUDED WITH THE SEQUENCE DOCUMENTATION. FROM A SEARCH NO RECALLS OR PURSUITS WERE FOUND RELATING THIS VEHICLE TO THE ALLEGED SAFETY DEFECT. FROM A VOQ SEARCH, 11 REPORTS WERE FOUND CLAIMING AIR BAG NON DEPLOYMENT OF VARYING SPEEDS AND INCIDENT SPECIFICS. FROM A SEARCH, 21 FIELD REPORTS WERE FOUND WHICH STATED 'NONDEPLOYMENT' IN THE SUMMARY OF THE REPORT. 7 TSBS WERE FOUND FOR THE AIRBAG COMPONENT WHICH ALL MENTION SIR/PASSENGER PRESENCE LIGHTS BEING ILLUMINATED. \*NO

NVS

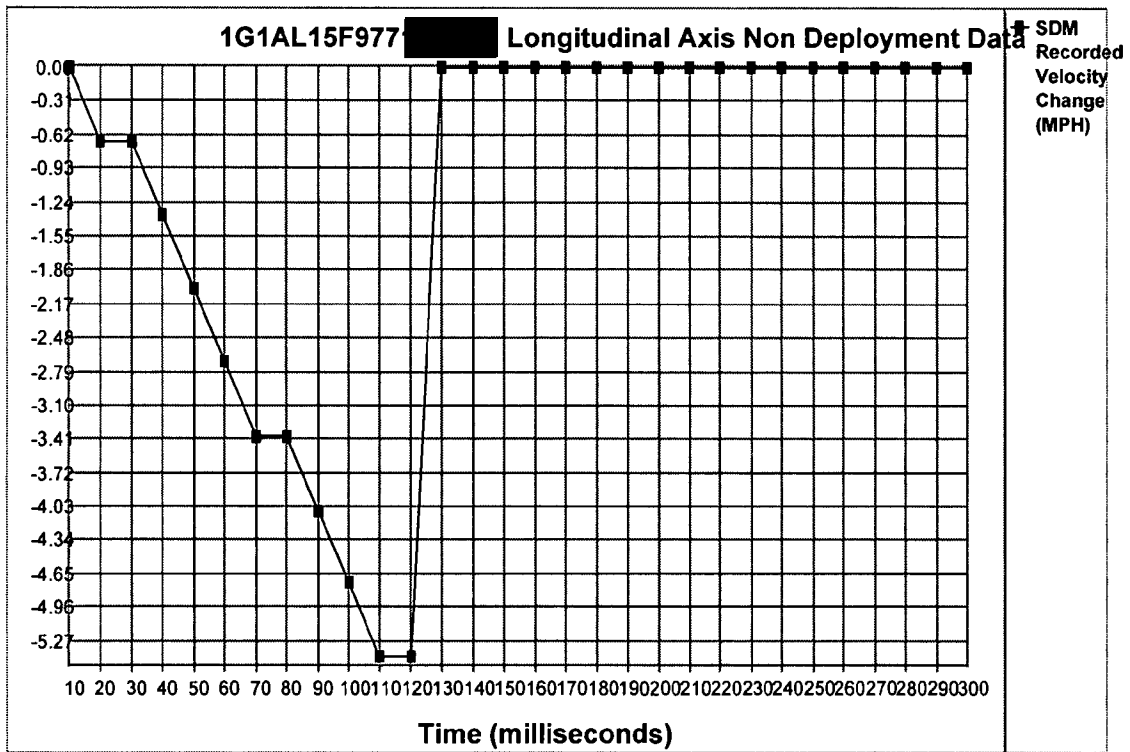
| Time (milliseconds) | 10 | 20 | 30 | 40 | 50 | 60 | 70 | 80 | 90 | 100 | 110 | 120 | 130 | 140 | 150 |
|---|---|---|---|---|---|---|---|---|---|---|---|---|---|---|---|
| SDM Longitudinal Axis Recorded Velocity Change (MPH) | 0.00 | -0.68 | -0.68 | -1.36 | -2.03 | -2.71 | -3.39 | -3.39 | -4.07 | -4.74 | -5.42 | -5.42 | 0.00 | 0.00 | 0.00 |

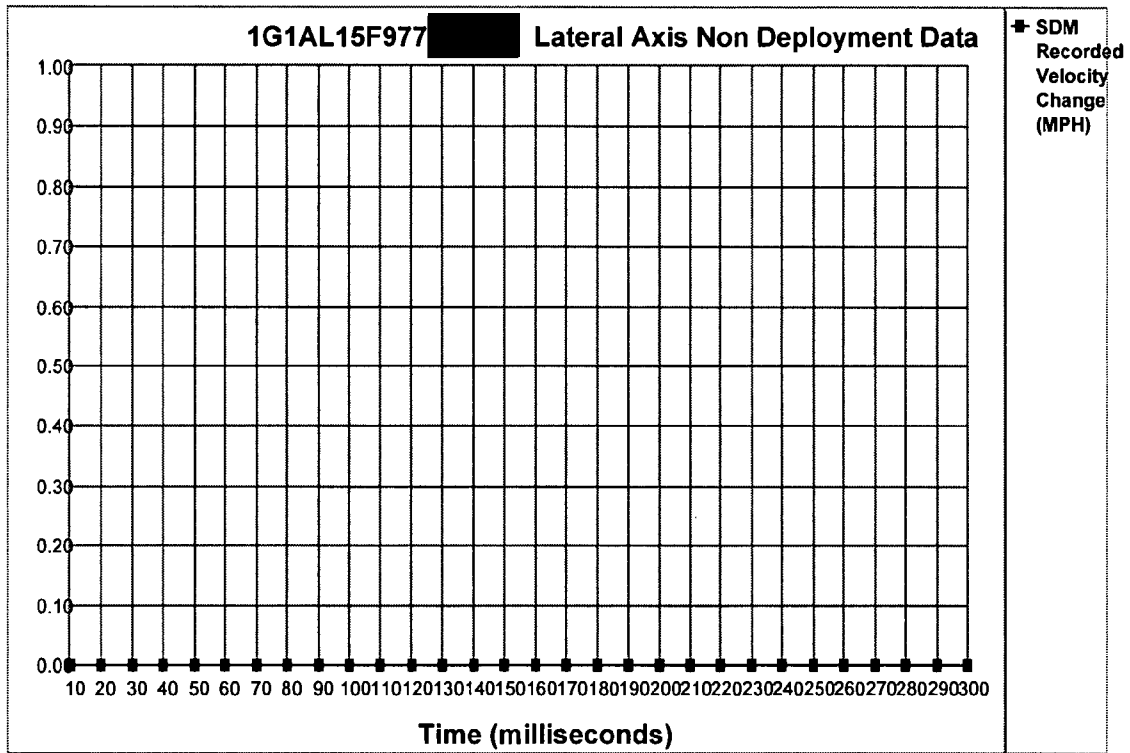
| SDM Lateral Axis Recorded Velocity Change (MPH) | 0.00 | 0.00 | 0.00 | 0.00 | 0.00 | 0.00 | 0.00 | 0.00 | 0.00 | 0.00 | 0.00 | 0.00 | 0.00 | 0.00 | 0.00 |
