Task Force SAFE

Inspection-Report_TFSafe_F797V_Camp-Echo-Ground-Floor-Office-RLB_113_24-1**2-25_1-2**

Base Location	Erbil (Iraq)	Date:	2025-12-24
Base Code	F797V	Team #:	113
Building #	Camp-Echo-Ground-Floor-Office-RLB	System Voltage	230/400
Building Type	Administrative	Inspection Phase	Initial Inspection
Previous Report #:	N/A	Work Order:	TFS-F797V-2025-00046

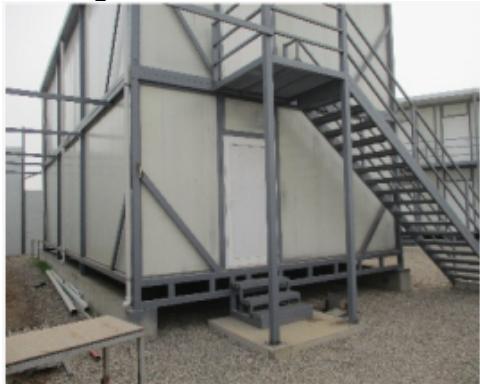
Overall Building Electrical System: Poor**Building Picture:**

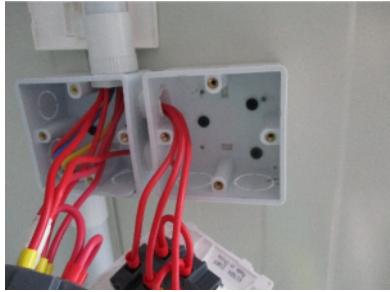
Deficiency #1	RAC 2	Occurrences: 1
----------------------	--------------	-----------------------

Description: There is no ground cable to light switches.

Location:	By back exit door
Category:	Grounding and Bonding
Equipment:	WLT
Imminent:	No
Action:	N/A
Code:	BritishStandard 542: Earthing arrangements
Status:	Open

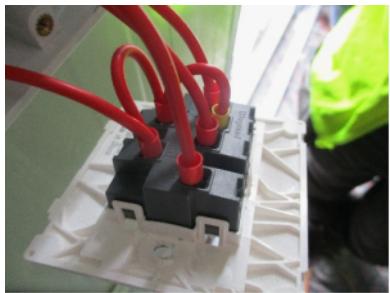
Deficiency #2	RAC 3	Occurrences: 1
----------------------	--------------	-----------------------

Description: The emergency exit light is wired through a normal light switch.

Location:	By back exit door
Category:	Poor Workmanship
Equipment:	WLT
Imminent:	No
Action:	N/A
Code:	BritishStandard 510: Common rules
Status:	Open
