## **SAFETY INVESTIGATION REPORT**

**Malaysia Airlines Boeing B777-200ER (9M-MRO)  
08 March 2014**

**The Malaysian ICAO Annex 13 Safety Investigation Team for MH370**

Issued on 02 July 2018  
MH370/01/2018

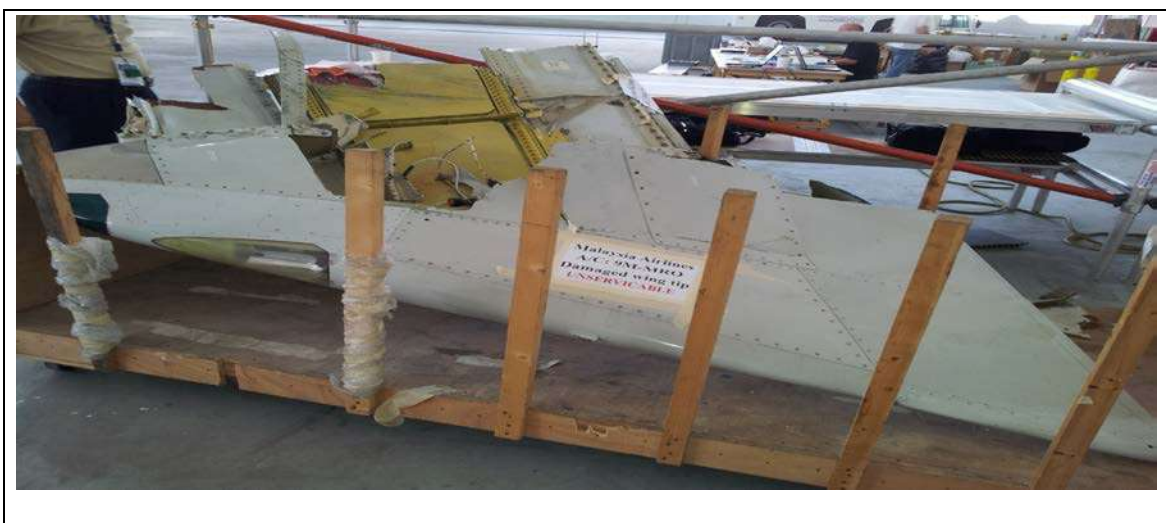
*Figure 1.6B - Damaged Wing Tip*

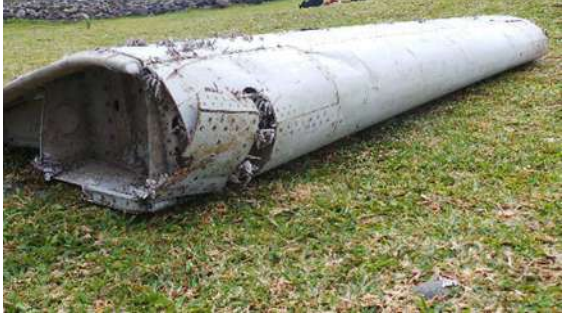
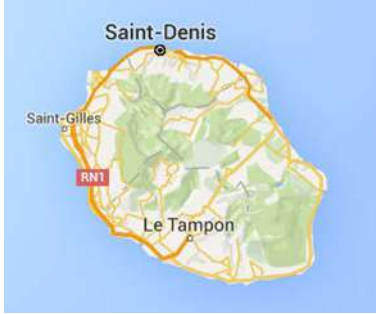
| Ref. | Date Found | Debris | Location | Remarks |
|---|---|---|---|---|
| Item 1 | 29 July 2015 | <p>Right Flaperon</p> | <p>Saint-Denis, Réunion Island</p> | <ul style="list-style-type: none"> <li>• <i>Confirmed</i> by French Judicial Authority belonging to MH370 on 03 September 2015</li> <li>• Refer to <i>Appendix 1.12A-1</i> and <i>Appendix 1.12A-2</i></li> </ul> |

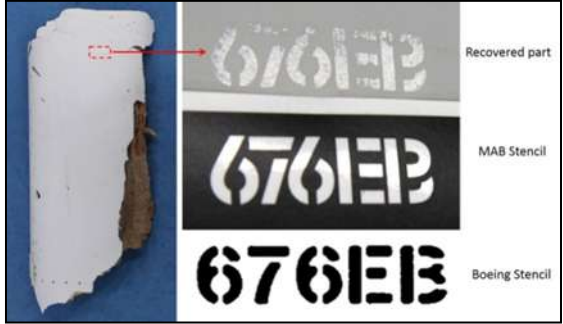
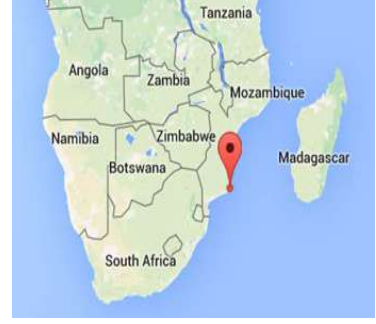
| Ref. | Date Found | Debris | Location | Remarks |
|---|---|---|---|---|
| Item 2 | 27 December 2015 | <p>Right Wing No. 7 Flap Support Fairing</p> | <p>Daghatane Beach, Mozambique</p> | <ul style="list-style-type: none"> <li>• Examination showed that part is <i>almost certain</i> from MH370</li> <li>• Refer to <i>Appendix 1.12B</i></li> </ul> |

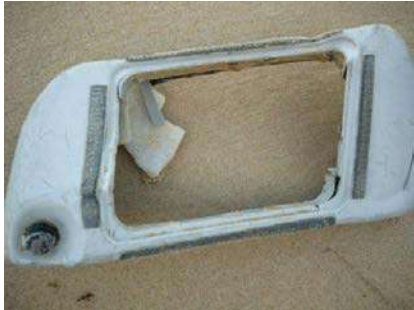
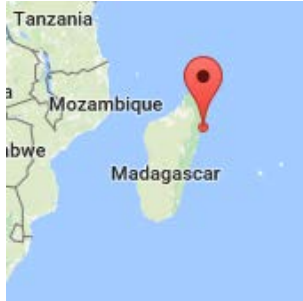
| Ref. | Date Found | Debris | Location | Remarks |
|---|---|---|---|---|
| Item 11 | 06 June 2016 | <p>Seat Back Trim Panel<br/>encasing IFE Monitor</p> | <p>Riake beach, Nosy<br/>Boraha Island,<br/>Madagascar</p> | <ul style="list-style-type: none"> <li>• Examination showed that part is <i>highly likely</i> from MH370</li> <li>• Refer to <i>Appendix 1.12I</i></li> </ul> |

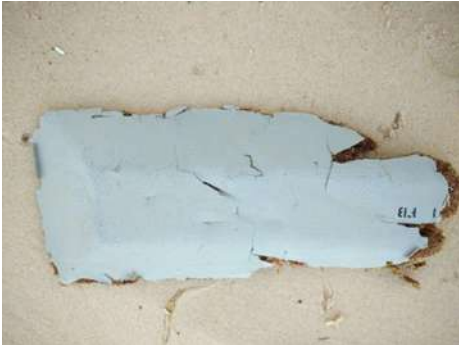
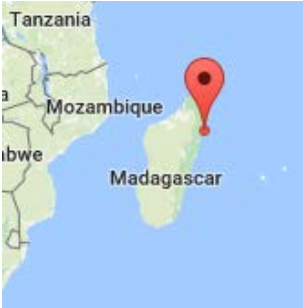
| Ref. | Date Found | Debris | Location | Remarks |
|---|---|---|---|---|
| Item 12 | 06 June 2016 | <p>Bottom panel on the Wing or<br/>Horizontal Stabilizer</p> | <p>Riake beach, Nosy<br/>Boraha Island,<br/>Madagascar</p> | <ul style="list-style-type: none"> <li>• Examination showed that part is <i>likely</i> from MH370</li> <li>• Refer to <i>Appendix 1.12J</i></li> </ul> |

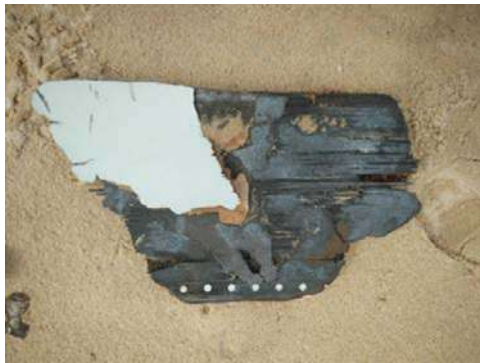
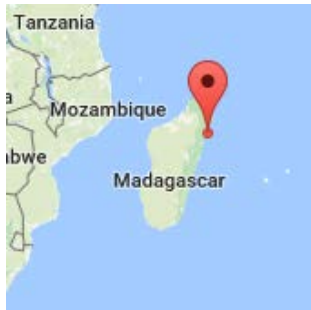
| Ref. | Date Found | Debris | Location | Remarks |
|---|---|---|---|---|
| Item 13 | 12 June 2016 | <p>Unidentified part</p> | <p>Riake beach, Nosy<br/>Boraha Island,<br/>Madagascar</p> | <ul style="list-style-type: none"> <li>• Not identifiable</li> <li>• Refer to <i>Appendix 1.12K</i></li> </ul> |

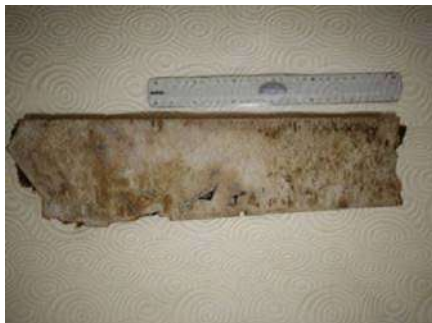
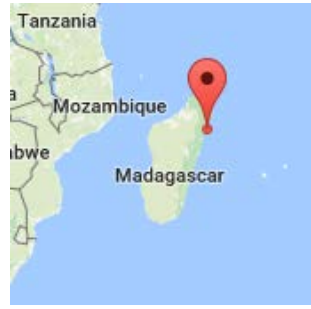
| Ref. | Date Found | Debris | Location | Remarks |
|---|---|---|---|---|
| Item 14 | 12 June 2016 | <p>Unidentified part</p> | <p>Riake beach, Nosy<br/>Boraha Island,<br/>Madagascar</p> | <ul style="list-style-type: none"> <li>• Not identifiable</li> <li>• Refer to <i>Appendix 1.12L</i></li> </ul> |

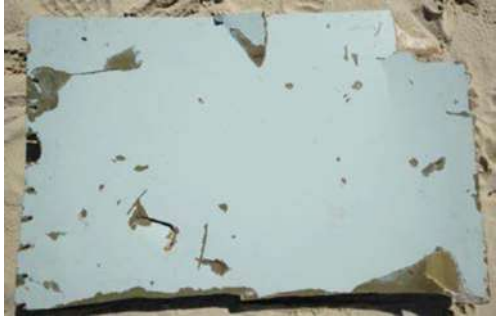
| Ref. | Date Found | Debris | Location | Remarks |
|---|---|---|---|---|
| Item 15 | 06 June 2016 | <p>Right Wing Trailing Edge Panel</p> | <p>Riake beach, Nosy Boraha Island, Madagascar</p> | <ul style="list-style-type: none"> <li>• Examination showed that part is <i>highly likely</i> from MH370</li> <li>• Refer to <i>Appendix 1.12G</i></li> </ul> |

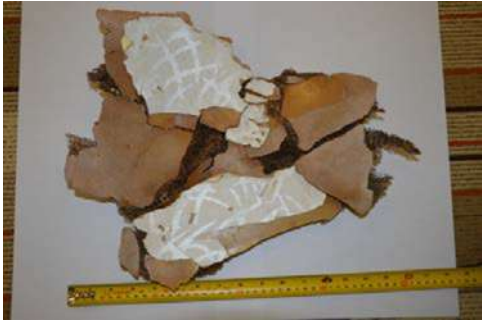
| Ref. | Date Found | Debris | Location | Remarks |
|---|---|---|---|---|
| Item 16 | 12 June 2016 | <p>Cabin Interior Panel</p> | <p>Antsiraka beach, Madagascar</p> | <ul style="list-style-type: none"> <li>• Examination showed that part is <i>almost certain</i> from MH370</li> <li>• Refer to <i>Appendix 1.12M</i></li> </ul> |

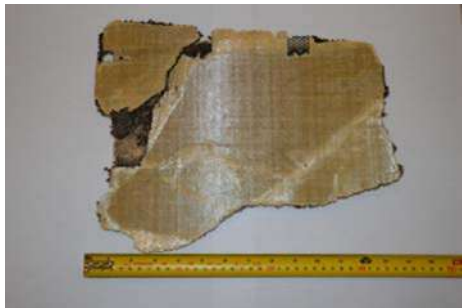
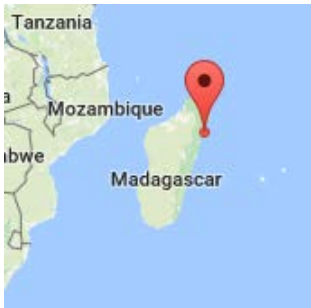
| Ref. | Date Found | Debris | Location | Remarks |
|---|---|---|---|---|
| Item 17 | 12 June 2016 | <p>Unidentified part</p> | <p>Antsiraka beach,<br/>Madagascar</p> | <ul style="list-style-type: none"> <li>• Not identifiable</li> <li>• Refer to <i>Appendix 1.12M</i></li> </ul> |

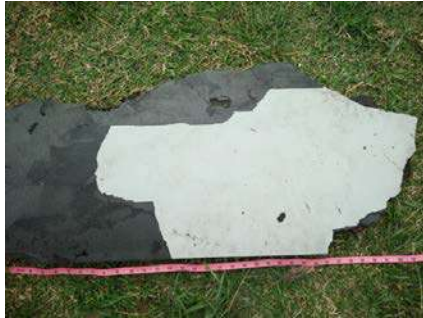
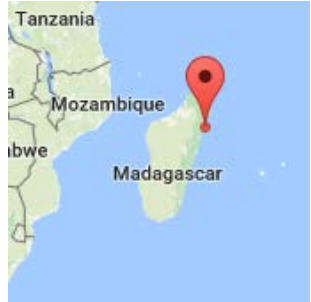
| Ref. | Date Found | Debris | Location | Remarks |
|---|---|---|---|---|
| Item 18 | 12 June 2016 | <p>Right Forward Nose Landing Gear Door</p> | <p>Antsiraka beach,<br/>Madagascar</p> | <ul style="list-style-type: none"> <li>• Examination showed that part is <i>highly likely</i> from MH370</li> <li>• Refer to <i>Appendix 1.12N</i></li> </ul> |

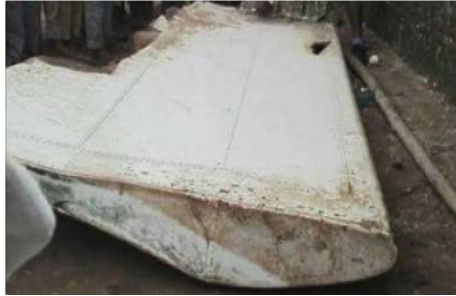
| Ref. | Date Found | Debris | Location | Remarks |
|---|---|---|---|---|
| Item 19 | 20 June 2016 | <p>Right Outboard Flap</p> | <p>Pemba Island,<br/>East of Tanzania</p> | <ul style="list-style-type: none"> <li>• The part is <i>confirmed</i> from MH370</li> <li>• Refer to <i>Appendix 1.12O</i></li> </ul> |

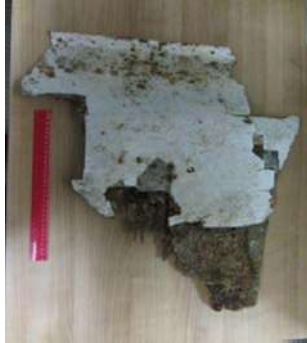
| Ref. | Date Found | Debris | Location | Remarks |
|---|---|---|---|---|
| Item 21 | 18 July 2016 | <p>Unidentified Part</p> | <p>Northern Kwa Zulu Natal,<br/>South Africa</p> | <ul style="list-style-type: none"> <li>• Not identifiable</li> <li>• Refer to <i>Appendix 1.12Q</i></li> </ul> |

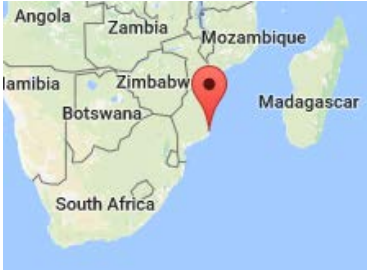
| Ref. | Date Found | Debris | Location | Remarks |
|---|---|---|---|---|
| Item 22 | 26 August 2016 | <p>Right Vertical Stabilizer Panel</p> | <p>Linga Linga beach<br/>Mozambique</p> | <ul style="list-style-type: none"> <li>• Examination showed that part is <i>almost certain</i> from MH370</li> <li>• Refer to <i>Appendix 1.12R</i></li> </ul> |

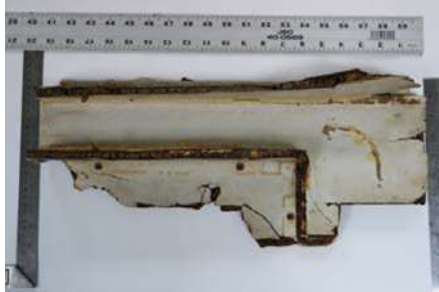
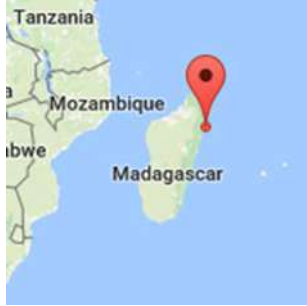
| Ref. | Date Found | Debris | Location | Remarks |
|---|---|---|---|---|
| Item 23 | October 2016 | <p>Unidentified Part</p> | <p>Riake beach, Nosy Boraha Island, Madagascar</p> | <ul style="list-style-type: none"> <li>• Not identifiable</li> <li>• Refer to <i>Appendix 1.12S</i></li> </ul> |

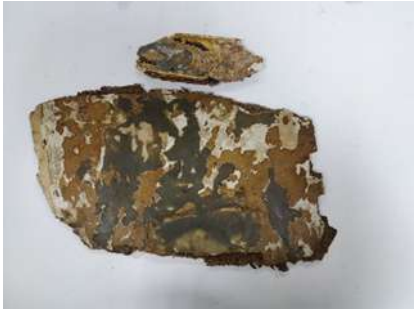
| Ref. | Date Found | Debris | Location | Remarks |
|---|---|---|---|---|
| Item 24 | February 2016 | <p>Unidentified Part</p> | <p>Saint Luce, Madagascar</p> | <ul style="list-style-type: none"> <li>• Not Identifiable</li> <li>• Refer to <i>Appendix 1.12T</i></li> </ul> |

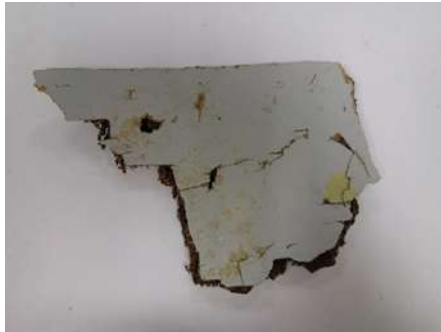
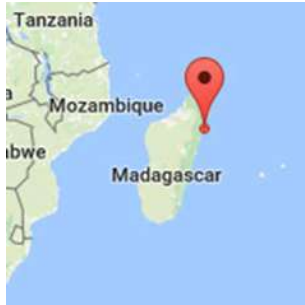
| Ref. | Date Found | Debris | Location | Remarks |
|---|---|---|---|---|
| Item 25 | July 2016 | <p>Unidentified Part</p> | <p>Riake beach, Nosy<br/>Boraha Island,<br/>Madagascar</p> | <ul style="list-style-type: none"> <li>• Not identifiable</li> <li>• Refer to <i>Appendix 1.12U</i></li> </ul> |

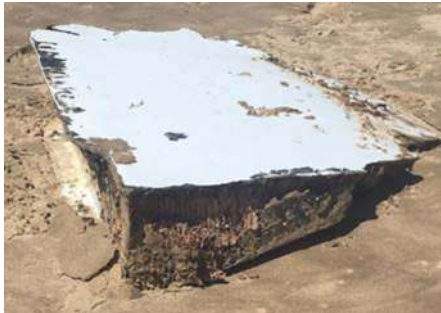
| Ref. | Date Found | Debris | Location | Remarks |
|---|---|---|---|---|
| Item 26 | 23 December 2016 | <p>Right Aileron</p> | <p>Nautilus Bay,<br/>South Africa</p> | <ul style="list-style-type: none"> <li>• Examination showed that part is <i>highly likely</i> from MH370</li> <li>• Refer to <i>Appendix 1.12V</i></li> </ul> |

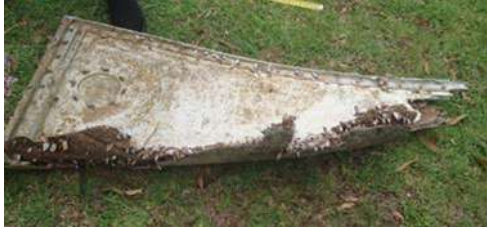
| Ref. | Date Found | Debris | Location | Remarks |
|---|---|---|---|---|
| Item 27 | 27 January 2017 | <br>Right Wing No. 7 Flap Support Fairing | <br>Mpame Beach,<br>South Africa | <ul style="list-style-type: none"> <li>• Examination showed that part is <i>highly likely</i> from MH370</li> <li>• Refer to <i>Appendix 1.12W</i></li> </ul> |

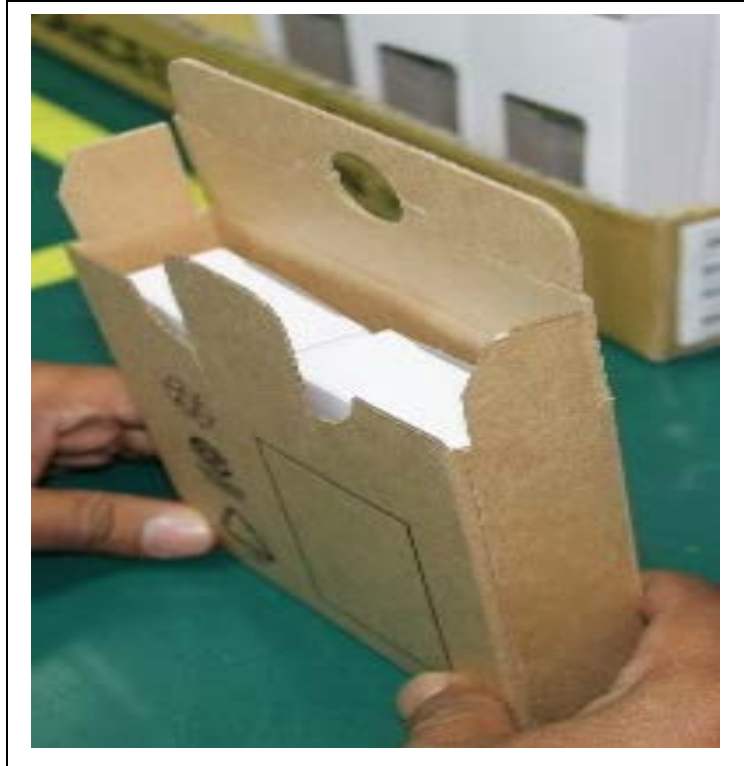
*Figure 2.8A - 2 Batteries in window white box and placed in a brown box*

The tests were carried out with batteries (window white box in brown box (*Figure 2.8A*, [below]) dropped at a height of 120.92 cm (48 inches) on to a wooden platform. It was found that the batteries had no observable physical damage and functioned normally.

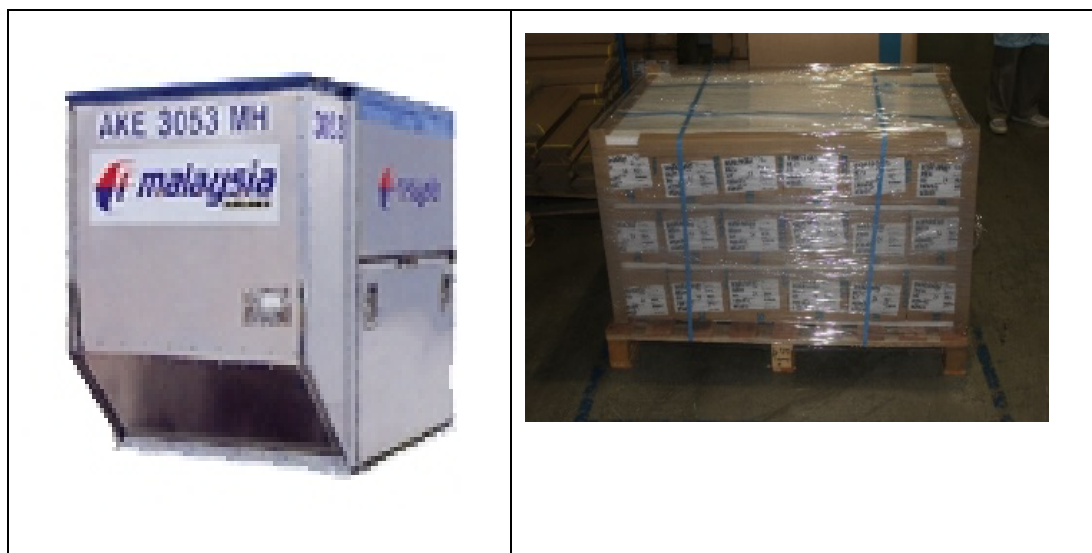
*Figure 2.8B - Sample ULD and Batteries placed next to each other*

In one of the cargo compartments on MH370 the Motorola Solutions batteries and mangosteens were placed next to each other (No. 1 and 'A'). Even though they were placed next to each other in the aircraft (*Figure 2.8B* [below]), the mangosteens were packed in plastic crates and placed in Unit Load Device (ULD) containers. The consignment was also wrapped in a plastic sheet to make it water-proof to a certain extent.
