# DEFECT INSPECTION REPORT

| <b>Building Type</b> | 2 Store Terrace House |
| <b>Inspected By</b> | <b>Muhammad Fikri bin Ab Rahman – Building Surveyor, Registered under Royal Institution of Surveyors Malaysia (RISM)</b> |

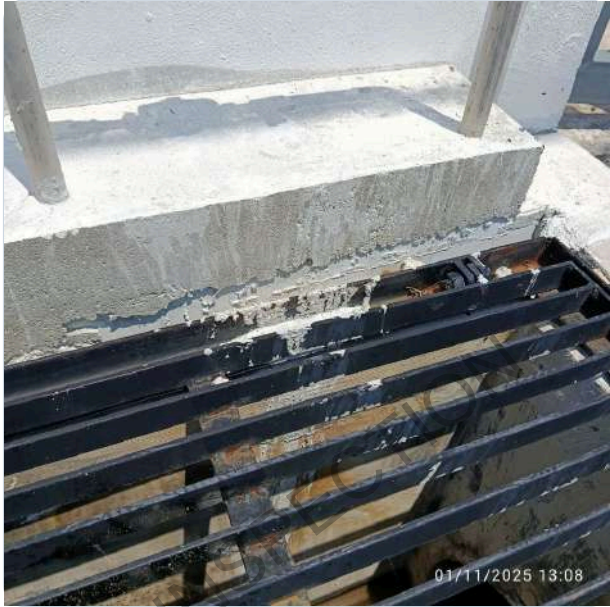
| Location | Tag | Defect & Description | Pictures |
|---|---|---|---|
| Car Porch<br>Floor | <b>3</b> | <b>Finishing issues</b><br>Concrete stains | |

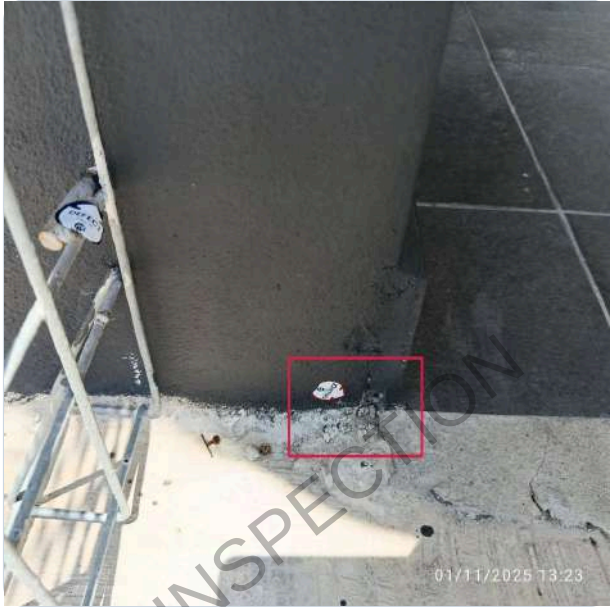
| Location | Tag | Defect & Description | Pictures |
|---|---|---|---|
| Car Porch<br>Floor | 6 | <b>Jointing Issue</b><br>Visible gaps | |

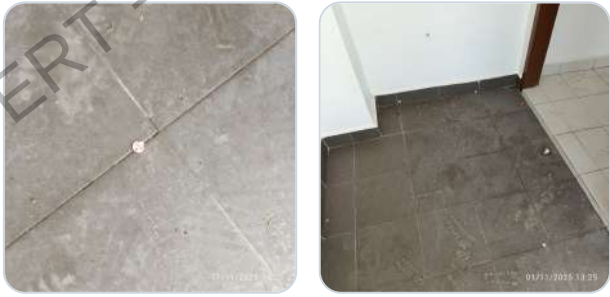
| Location | Tag | Defect & Description | Pictures |
|---|---|---|---|
| Car Porch<br>Floor | 7 | <b>Jointing Issue</b><br>Visible gaps at floor tile grouting | |

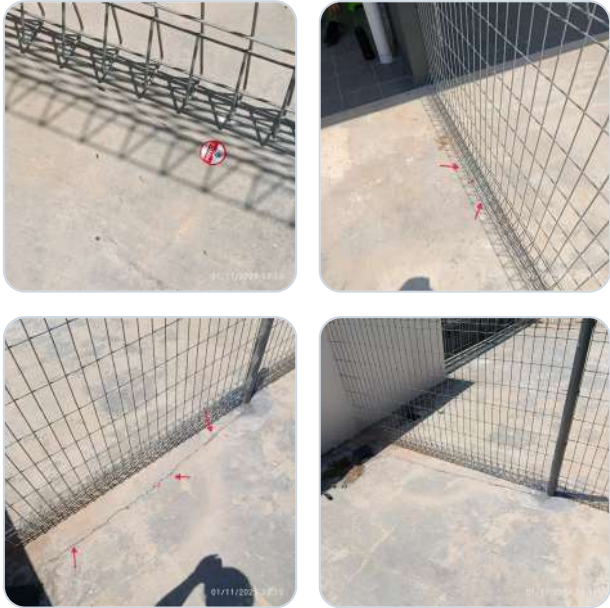
| Location | Tag | Defect & Description | Pictures |
|---|---|---|---|
| Car Porch<br>Floor | 8 | <b>Major defects</b><br>Crack on floor slab | |

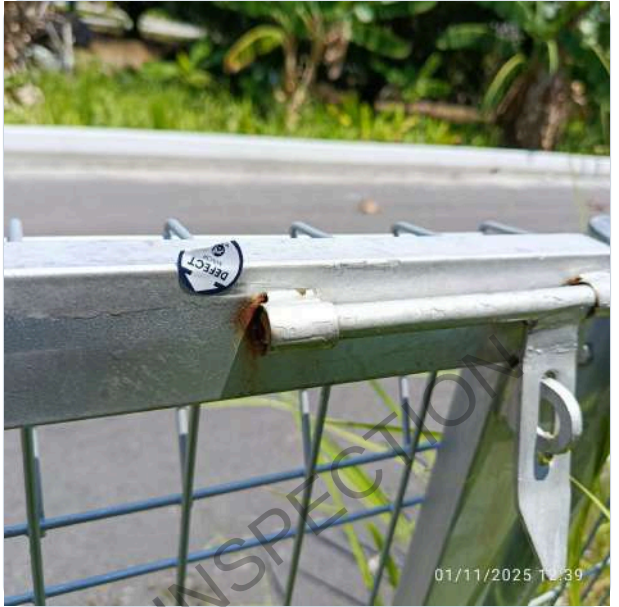
| Location | Tag | Defect & Description | Pictures |
|---|---|---|---|
| Backyard Gate | 154 | <b>Minor defects</b><br>Rusty on gate | |

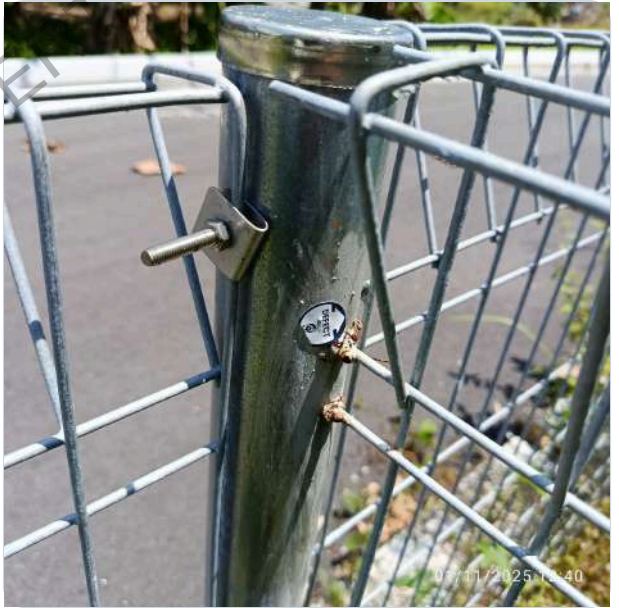
| Location | Tag | Defect & Description | Pictures |
|---|---|---|---|
| Backyard Fence | 155 | <b>Minor defects</b><br>Rusty on fence | |

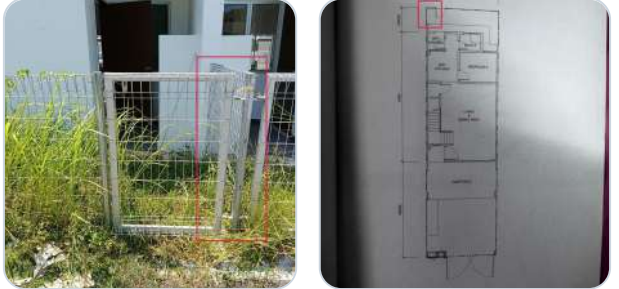
| Location | Tag | Defect & Description | Pictures |
|---|---|---|---|
| Backyard Gate | 156 | <b>S&amp;P Review</b><br>Refer to floor plan, gate should have space between gate and boarder fence | |

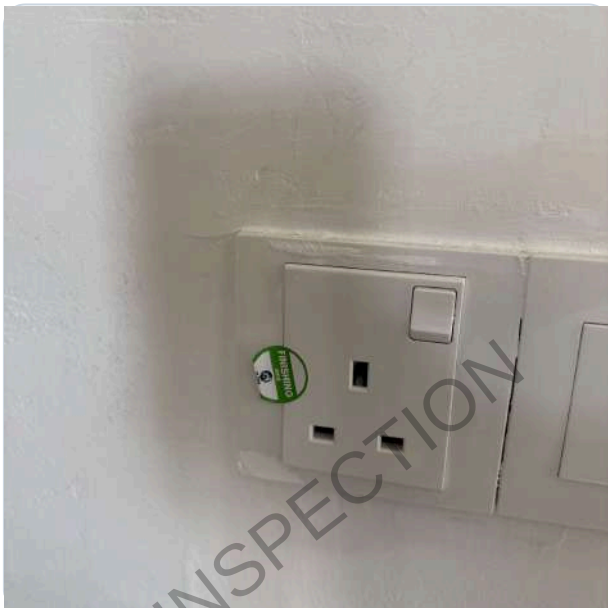
| Location | Tag | Defect & Description | Pictures |
|---|---|---|---|
| Family Area<br>M&E | 175 | <b>Finishing issues</b><br>Stains on socket | |

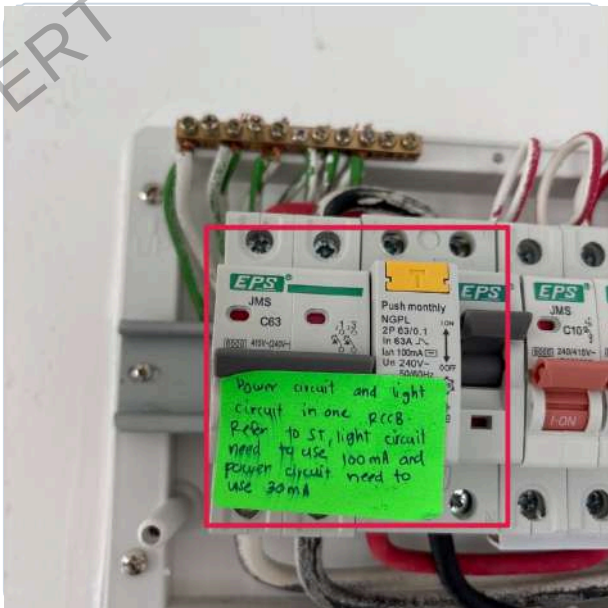
| Location | Tag | Defect & Description | Pictures |
|---|---|---|---|
| Family Area<br>M&E | 176 | <b>Standard &amp; Regulation</b><br>Power circuit and light circuit in one RCCB.<br>Refer to ST, Light circuit need to use 100mA and Power circuit need to use 30mA | |

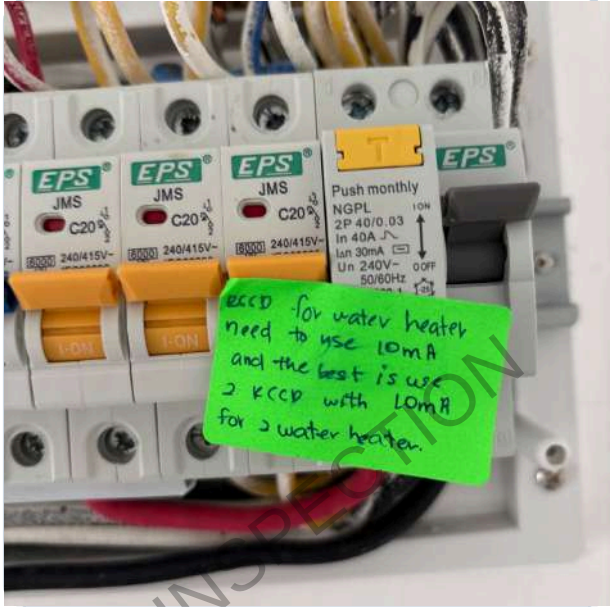
| Location | Tag | Defect & Description | Pictures |
|---|---|---|---|
| Family Area<br>M&E | 177 | <b>Standard &amp; Regulation</b><br>RCCD for water heater need to use 10mA and the best is use 2 RCCD with 10mA for 2 water heater | |

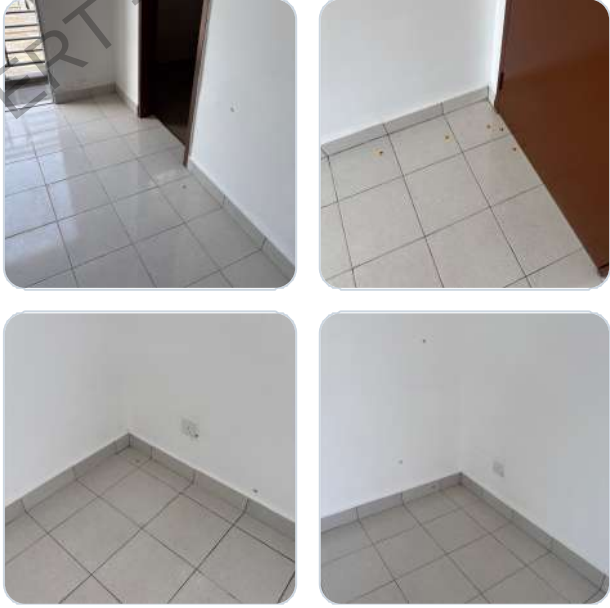
| Location | Tag | Defect & Description | Pictures |
|---|---|---|---|
| Master Bedroom<br>Floor | 178 | <b>Hollowness issues</b><br>Hollowness floor tile | |

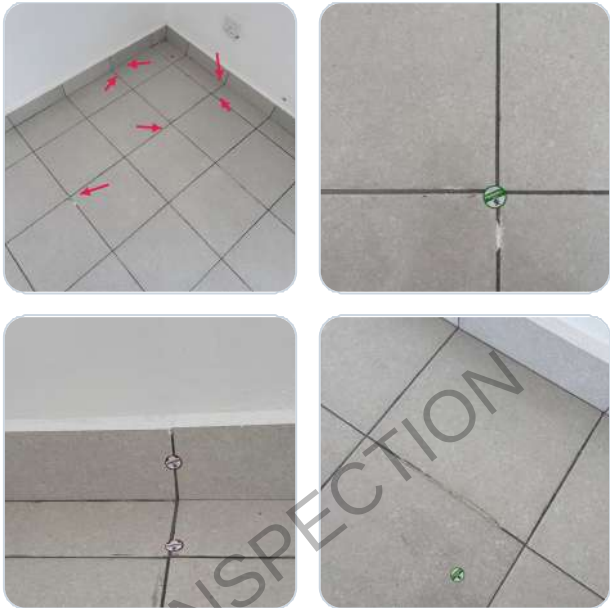
| Location | Tag | Defect & Description | Pictures | |
|---|---|---|---|--|
| Master Bedroom Floor | 179 | <b>Jointing Issue</b><br>Visible gaps at floor grouts and discolouration at floor tile grouting | | |

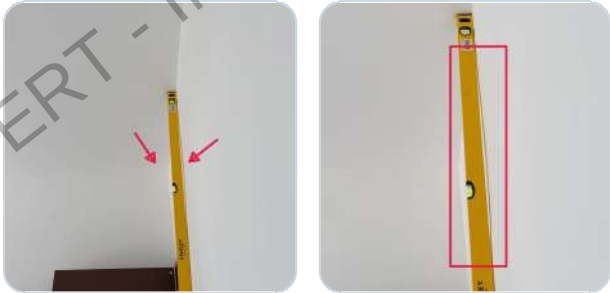
| Location | Tag | Defect & Description | Pictures | |
|---|---|---|---|--|
| Master Bedroom Wall | 180 | <b>Alignment issues</b><br>Wall misaligned | | |

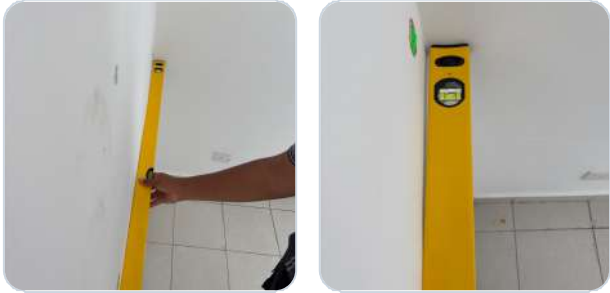
| Location | Tag | Defect & Description | Pictures | |
|---|---|---|---|--|
| Master Bedroom Wall | 181 | <b>Alignment issues</b> | | |

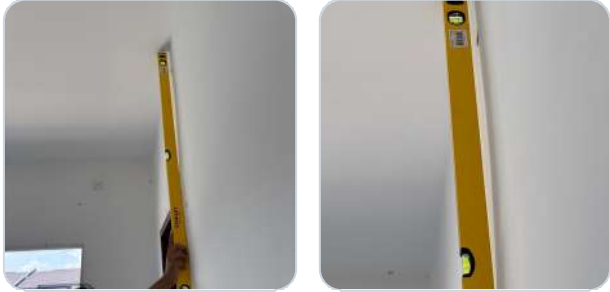
| Location | Tag | Defect & Description | Pictures | |
|---|---|---|---|--|
| Master Bedroom Wall | 182 | <b>Alignment issues</b><br>Wall misaligned | | |

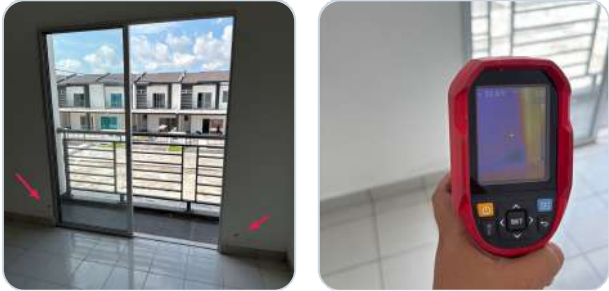
| Location | Tag | Defect & Description | Pictures |
|---|---|---|---|
| Master Bedroom<br>Wall | 185 | <b>Stains/Water Mark</b><br>Water mark and moisture on painted wall near to sliding door | |

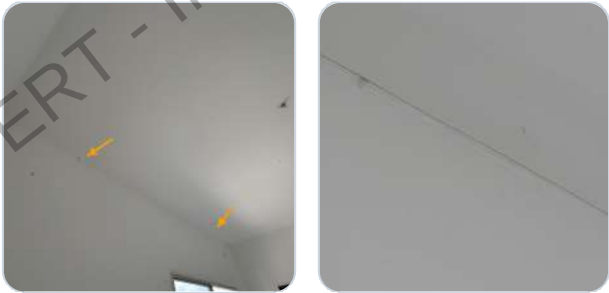
| Location | Tag | Defect & Description | Pictures |
|---|---|---|---|
| Master Bedroom<br>Ceiling | 186 | <b>Jointing Issue</b><br>visible gaps between painted wall and ceiling surface joints | |

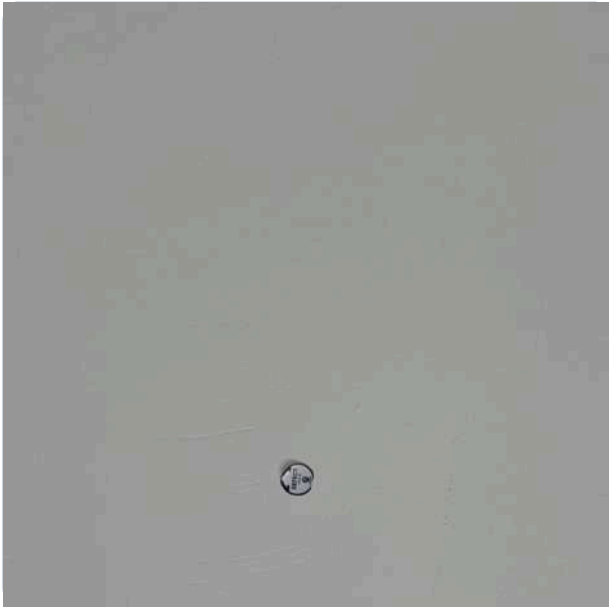
| Location | Tag | Defect & Description | Pictures |
|---|---|---|---|
| Master Bedroom<br>Ceiling | 187 | <b>Minor defects</b><br>Dented on ceiling surface | |

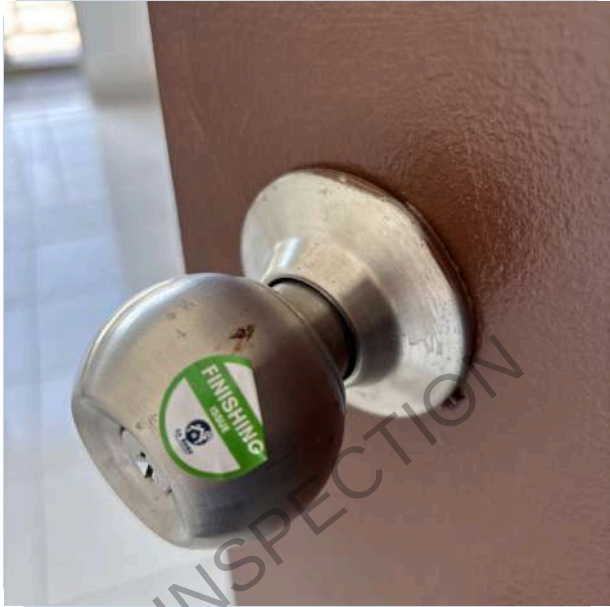
| Location | Tag | Defect & Description | Pictures |
|---|---|---|---|
| Master Bedroom<br>Door | 188 | <b>Accessories Defects</b><br>Stains on door knob | |

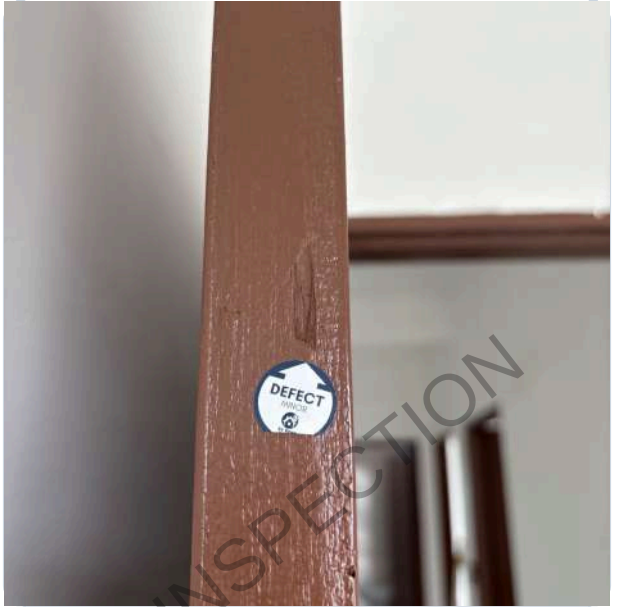
| Location | Tag | Defect & Description | Pictures |
|---|---|---|---|
| Master Bedroom<br>Door | 191 | <b>Minor defects</b><br>Damaged on door leaf | |

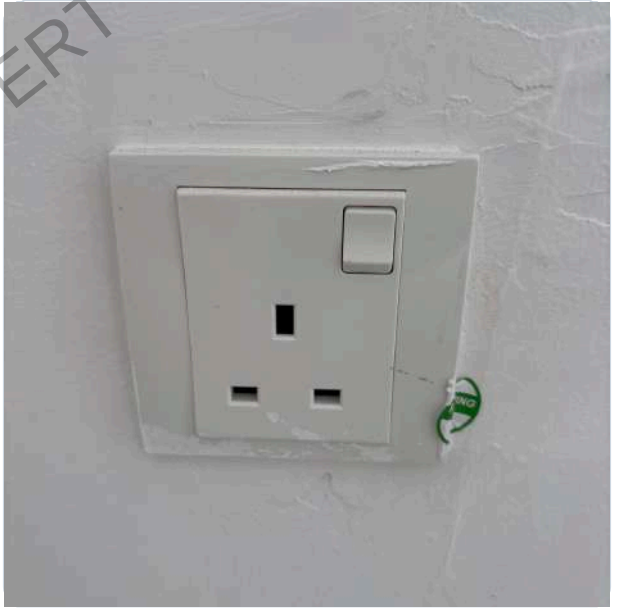
| Location | Tag | Defect & Description | Pictures |
|---|---|---|---|
| Master Bedroom<br>M&E | 192 | <b>Finishing issues</b><br>Stains at socket | |

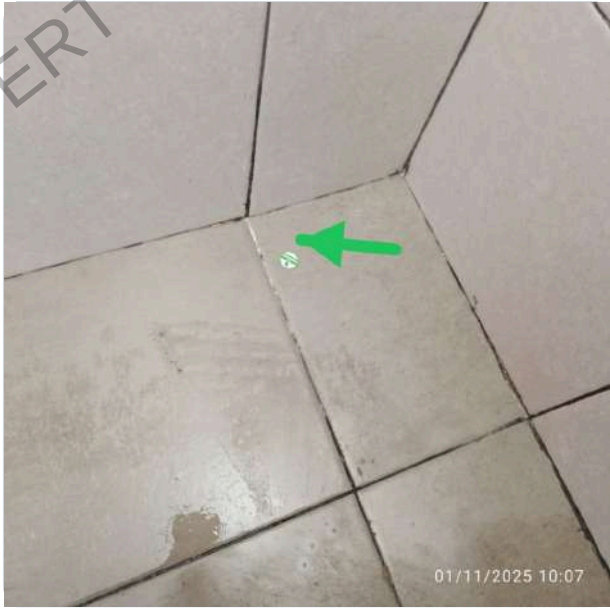
| Location | Tag | Defect & Description | Pictures |
|---|---|---|---|
| Master Bathroom<br>Floor | 194 | <b>Finishing issues</b><br>Discoloration on the floor tiles grouting | |

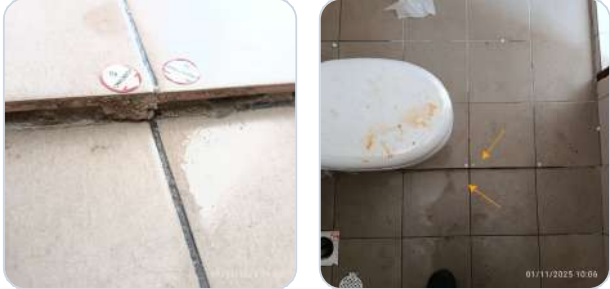
| Location | Tag | Defect & Description | Pictures |
|---|---|---|---|
| Master Bathroom<br>Floor | 195 | <b>Jointing Issue</b><br>Improper grouting work / over grouting | |

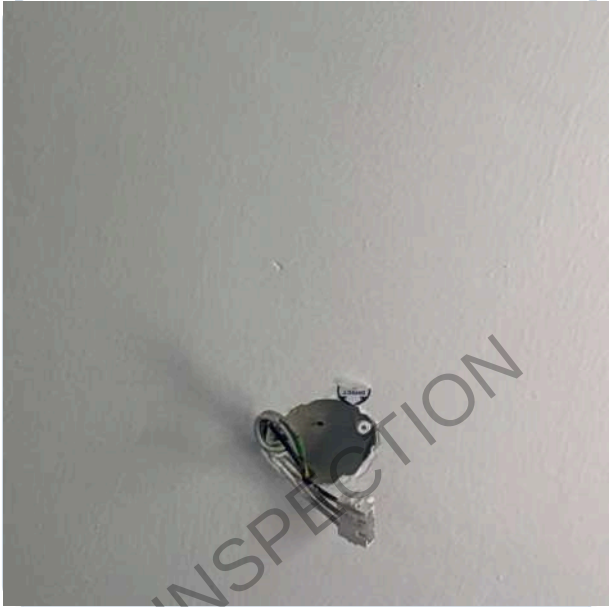
| Location | Tag | Defect & Description | Pictures |
|---|---|---|---|
| Bath 2<br>M&E | 283 | <b>Accessories Defects</b><br>Missing junction box cover | |

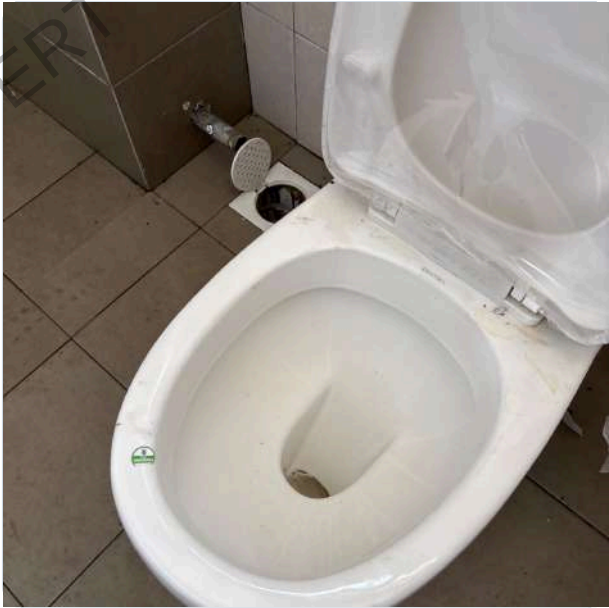
| Location | Tag | Defect & Description | Pictures |
|---|---|---|---|
| Bath 2<br>Fixtures | 284 | <b>Finishing issues</b><br>Stains at toilet bowl | |

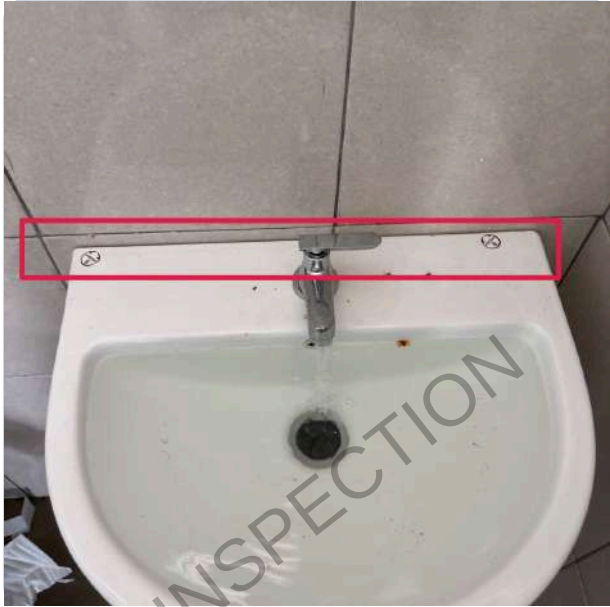
| Location | Tag | Defect & Description | Pictures |
|---|---|---|---|
| Bath 2<br>Fixtures | 285 | <b>Jointing Issue</b><br>Visible gaps between wall tile and basin | |

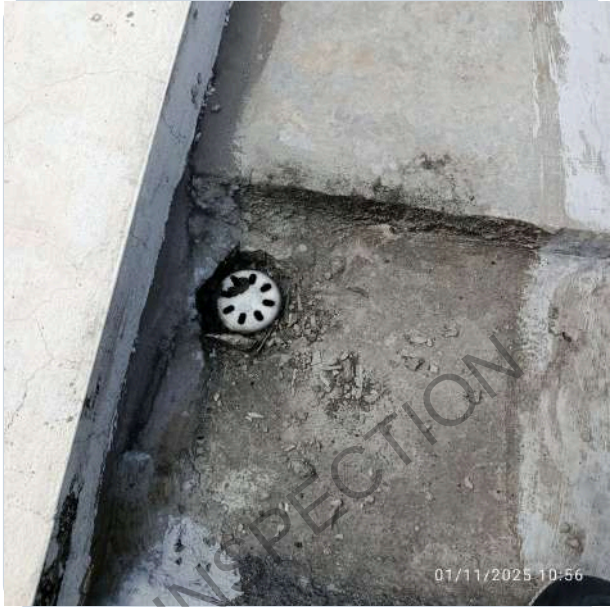
| Location | Tag | Defect & Description | Pictures |
|---|---|---|---|
| Flat Roof<br>Floor | 287 | <b>Finishing issues</b><br>Construction left over<br>on floor slab | |

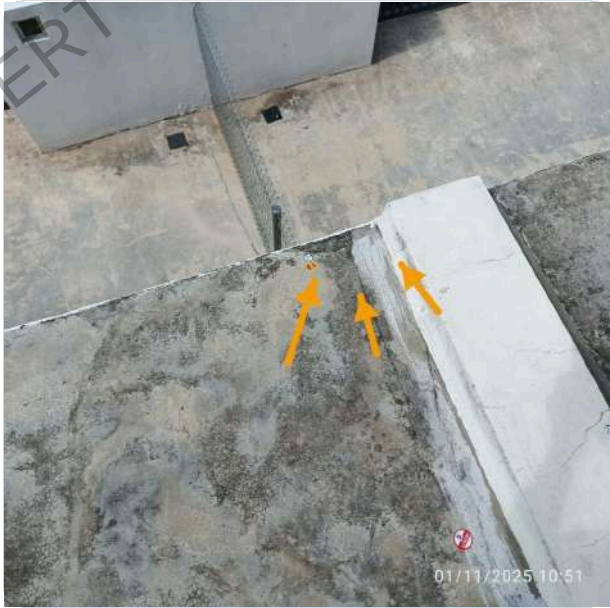
| Location | Tag | Defect & Description | Pictures |
|---|---|---|---|
| Flat Roof<br>Floor | 288 | <b>Hollowness issues</b><br>Hollow sound on floor<br>slab | |

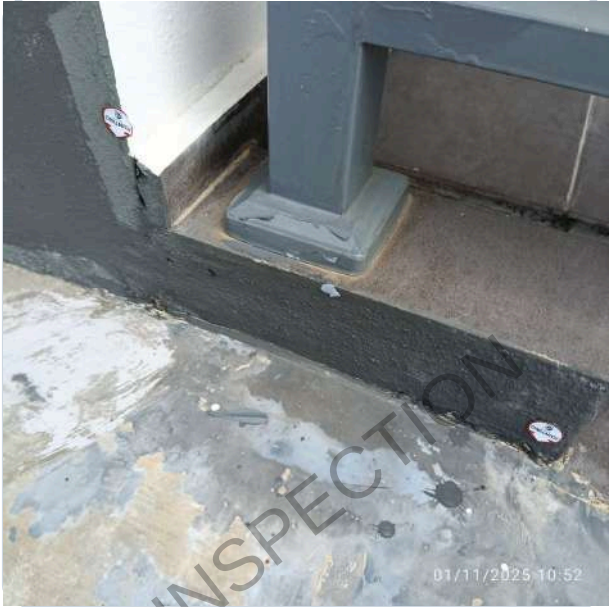
| Location | Tag | Defect & Description | Pictures |
|---|---|---|---|
| Flat Roof<br>Floor | 289 | <b>Jointing Issue</b><br>Visible gaps on floor | |

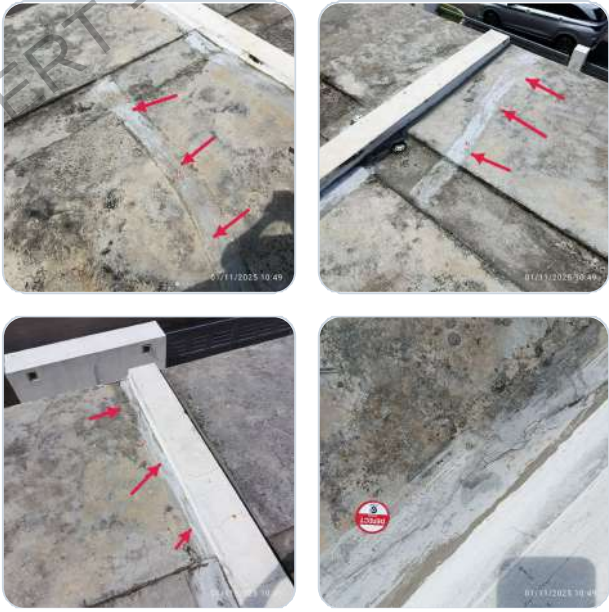
| Location | Tag | Defect & Description | Pictures |
|---|---|---|---|
| Flat Roof<br>Floor | 290 | <b>Major defects</b><br>Crack on floor slab That have possible for leaking | |

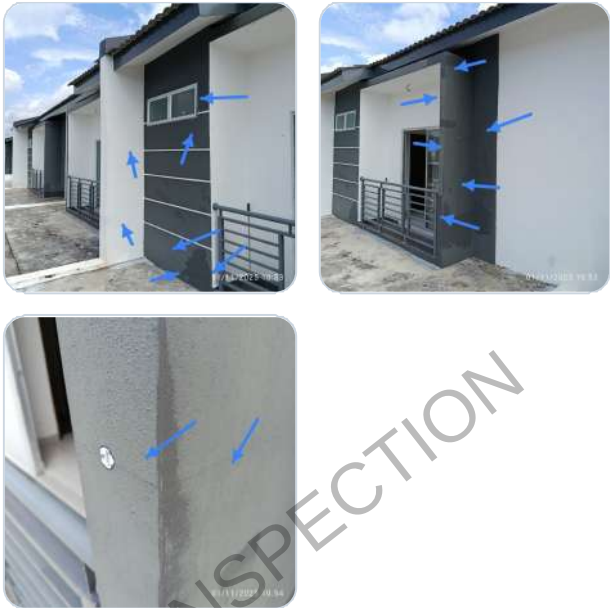
| Location | Tag | Defect & Description | Pictures |
|---|---|---|---|
| Flat Roof<br>Wall | 296 | <b>Minor defects</b><br>Crack on wall surface | |

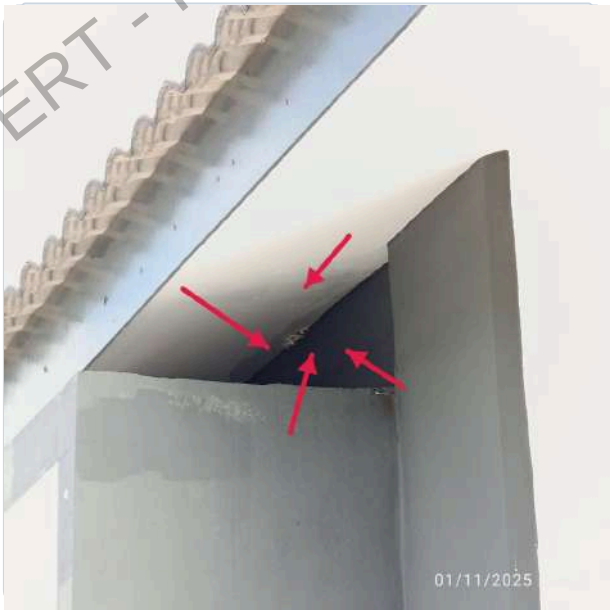
| Location | Tag | Defect & Description | Pictures |
|---|---|---|---|
| Flat Roof<br>Ceiling | 297 | <b>Major defects</b><br>Damaged on ceiling board | |

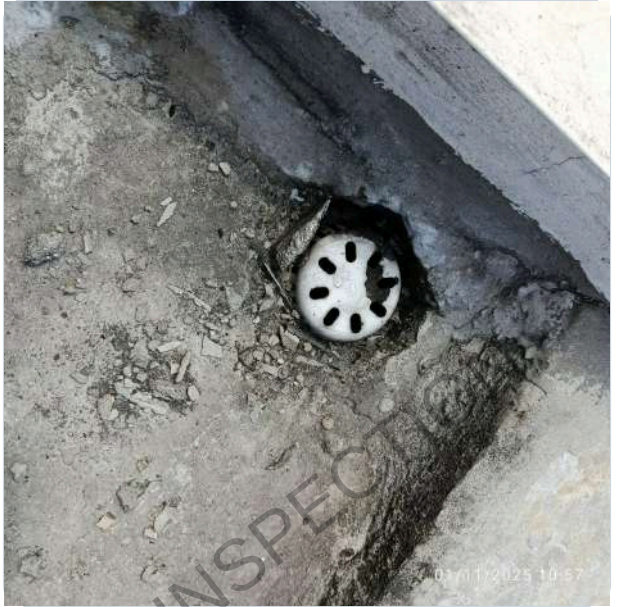
| Location | Tag | Defect & Description | Pictures |
|---|---|---|---|
| Flat Roof<br>Plumbing & Sanitary<br>Fitting | 298 | <b>Accessories Defects</b><br>Drainage filter hard to open | |

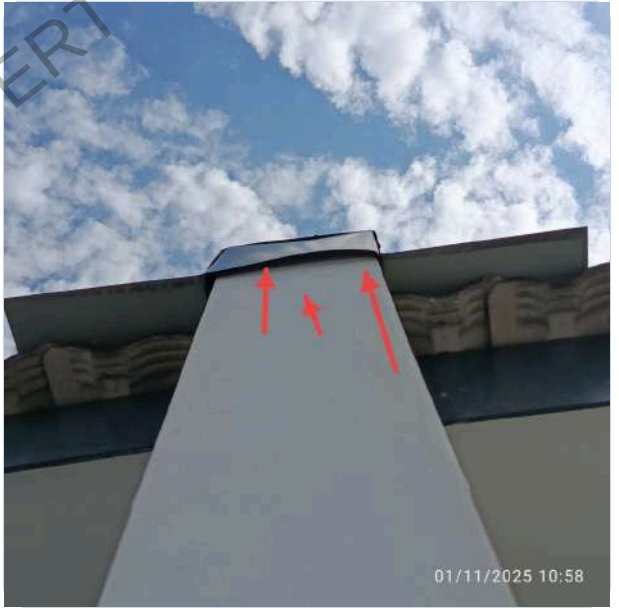
| Location | Tag | Defect & Description | Pictures |
|---|---|---|---|
| Flat Roof<br>Fixtures | 299 | <b>Jointing Issue</b><br>Visible gap on roof flushing | |

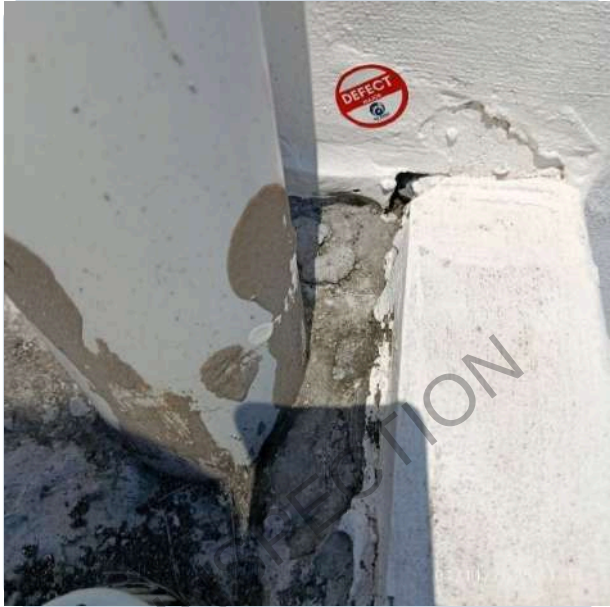
| Location | Tag | Defect & Description | Pictures |
|---|---|---|---|
| Water Tank Area<br>Floor | 303 | <b>Major defects</b><br>Improper plastering<br>work, have gaps | |

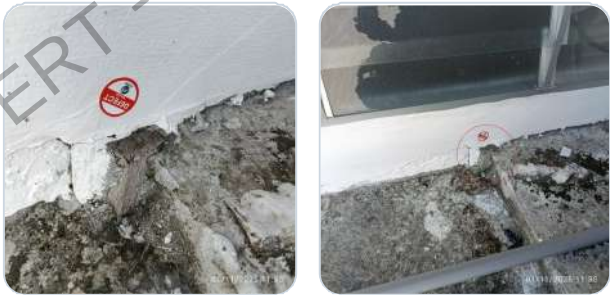
| Location | Tag | Defect & Description | Pictures |
|---|---|---|---|
| Water Tank Area<br>Floor | 304 | <b>Major defects</b><br>Expose temporary<br>timber support | |

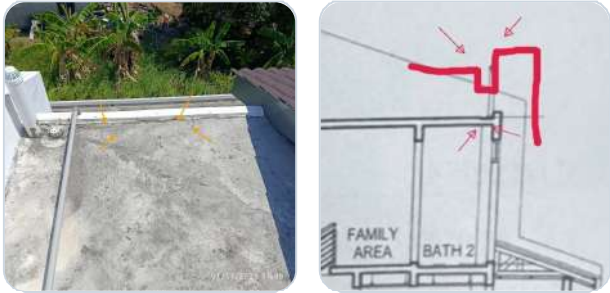
| Location | Tag | Defect & Description | Pictures |
|---|---|---|---|
| Water Tank Area<br>Floor | 305 | <b>S&amp;P Review</b><br>Refer to section<br>plan, this area should<br>have drop not slope | |

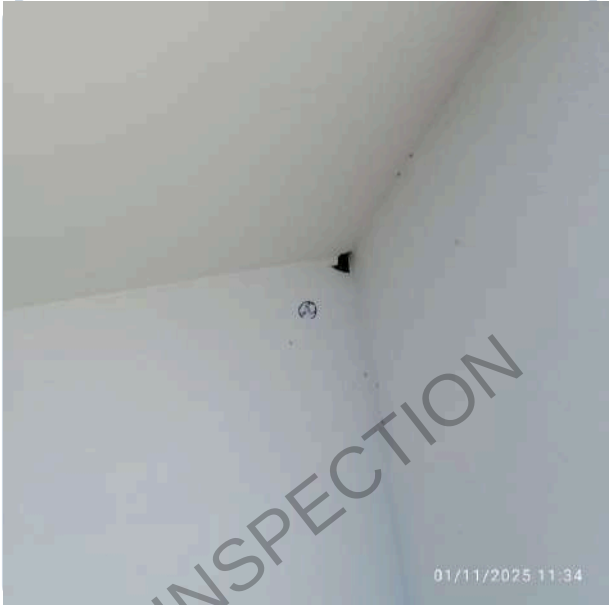
| Location | Tag | Defect & Description | Pictures |
|---|---|---|---|
| Water Tank Area<br>Wall | 306 | <b>Jointing Issue</b><br>Visible gaps at corner<br>of wall | |

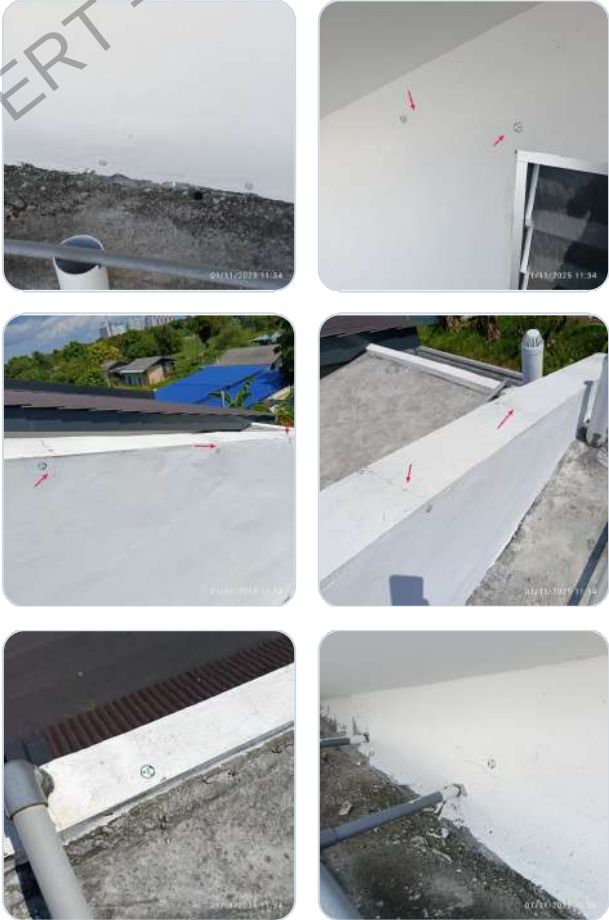
| Location | Tag | Defect & Description | Pictures |
|---|---|---|---|
| Water Tank Area<br>Wall | 307 | <b>Minor defects</b><br>Crack on painted wall | |

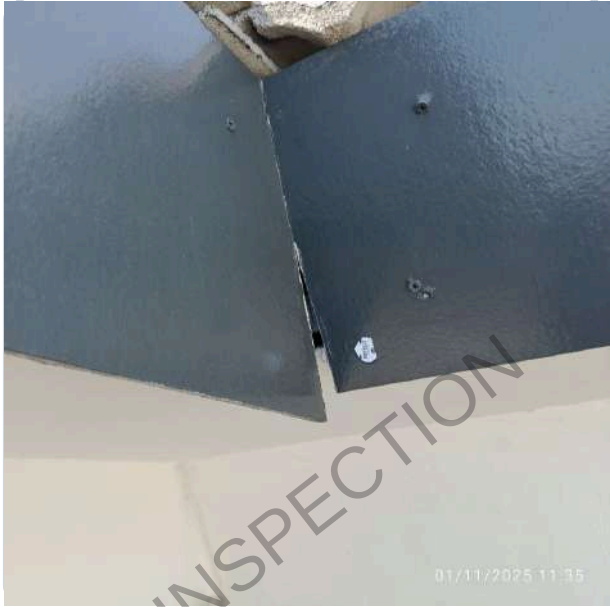
| Location | Tag | Defect & Description | Pictures |
|---|---|---|---|
| Water Tank Area<br>Ceiling | 308 | <b>Jointing Issue</b><br>Visible gaps | |

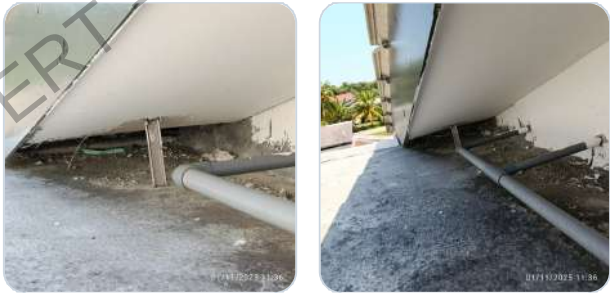
| Location | Tag | Defect & Description | Pictures |
|---|---|---|---|
| Water Tank Area<br>Ceiling | 309 | <b>Major defects</b><br>Missing ceiling board and improper support for ceiling | |

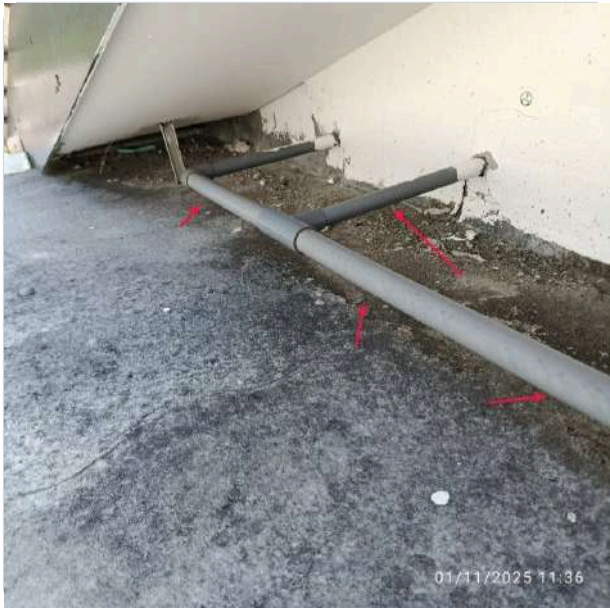
| Location | Tag | Defect & Description | Pictures |
|---|---|---|---|
| Water Tank Area<br>Plumbing & Sanitary<br>Fitting | 310 | <b>Accessories Defects</b><br>Missing support for distribution pipe | |

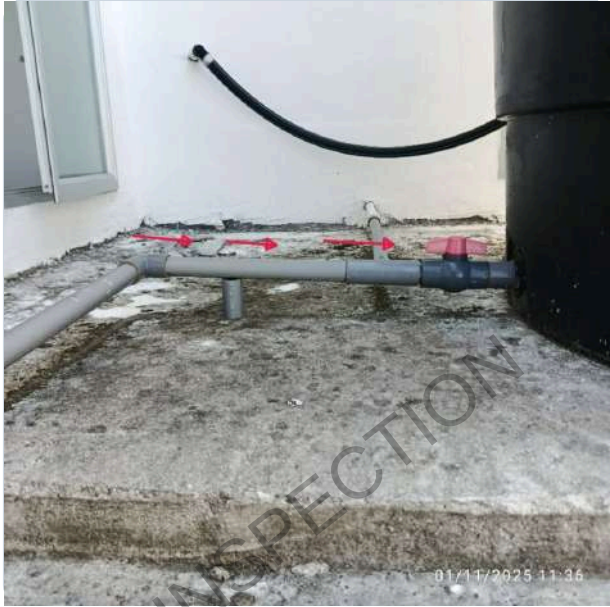
| Location | Tag | Defect & Description | Pictures |
|---|---|---|---|
| Water Tank Area<br>Plumbing & Sanitary<br>Fitting | 311 | <b>Alignment issues</b><br>Distribution pipe has alignment issues and causes of low water pressure for bathroom 2 and 3 | 01/11/2025 11:36 |

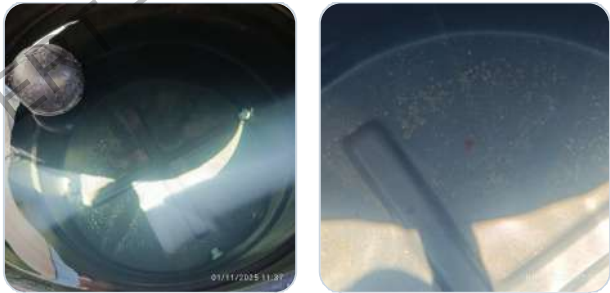
| Location | Tag | Defect & Description | Pictures |
|---|---|---|---|
| Water Tank Area<br>Fixtures | 312 | <b>Accessories Defects</b><br>Dirty inside water tank | 01/11/2025 11:37 |

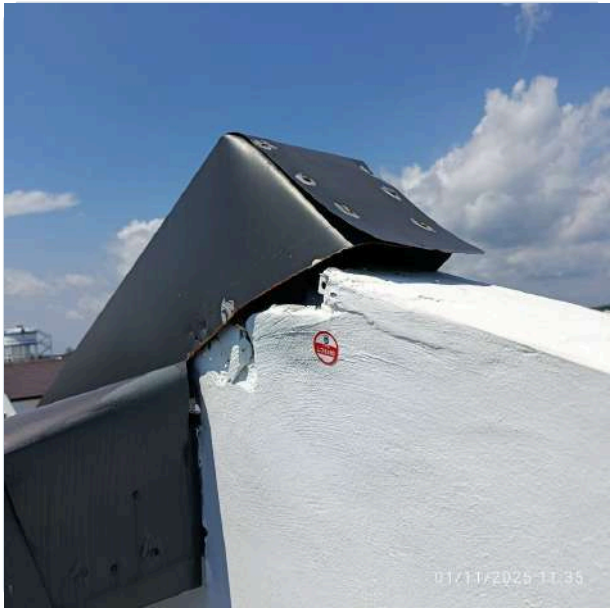
| Location | Tag | Defect & Description | Pictures |
|---|---|---|---|
| Water Tank Area<br>Fixtures | 313 | <b>Major defects</b><br>Detached roof flashing (not installed properly) | 01/11/2025 11:35 |

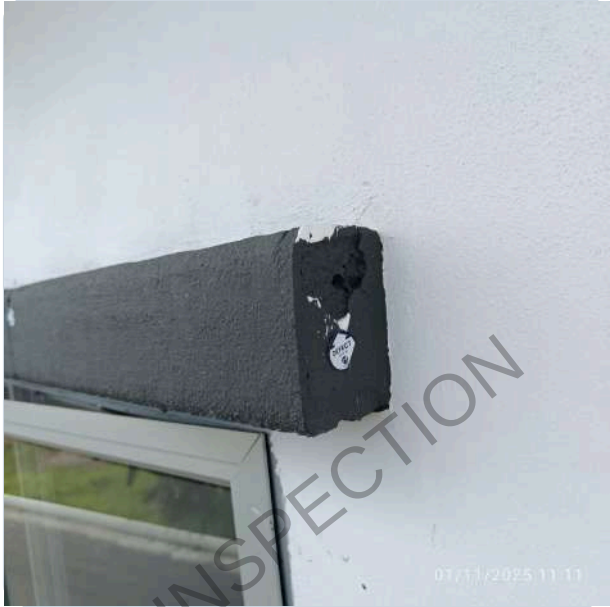
| Location | Tag | Defect & Description | Pictures |
|---|---|---|---|
| Roof First Level<br>Wall | 317 | <b>Minor defects</b><br>Damaged on window<br>copping | |

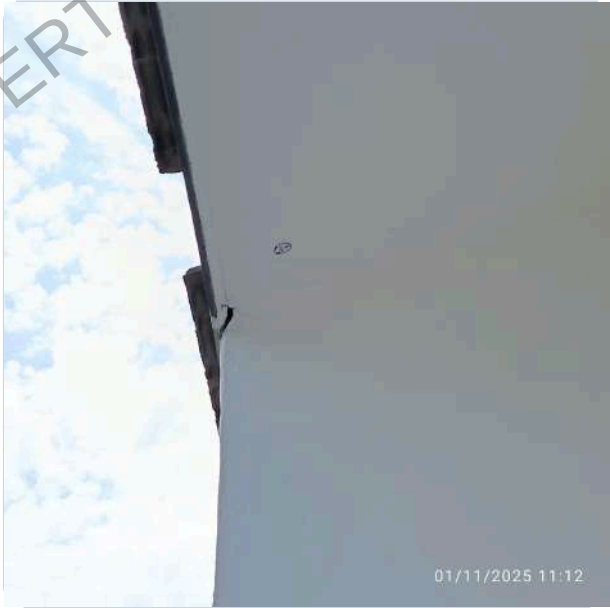
| Location | Tag | Defect & Description | Pictures |
|---|---|---|---|
| Roof First Level<br>Ceiling | 318 | <b>Jointing Issue</b><br>Visible gap on ceiling | |

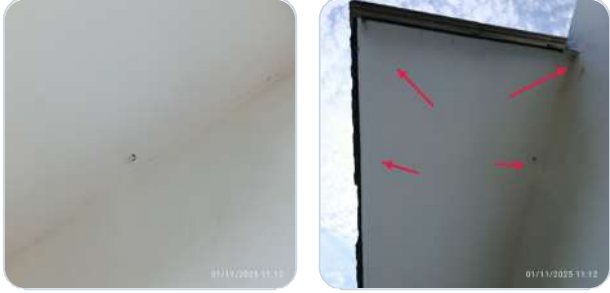
| Location | Tag | Defect & Description | Pictures |
|---|---|---|---|
| Roof First Level<br>Ceiling | 319 | <b>Minor defects</b><br>Crack on ceiling surface | |

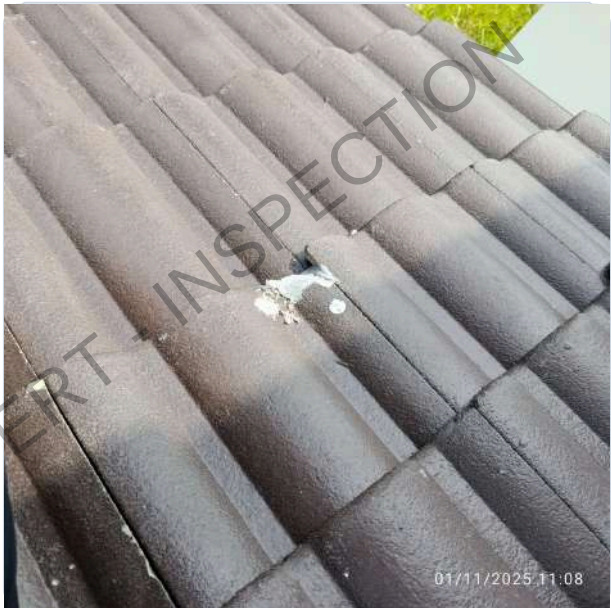
| Location | Tag | Defect & Description | Pictures |
|---|---|---|---|
| Roof First Level<br>Roof | 321 | <b>Minor defects</b><br>Chipping floor tiles and need to replace One on One. Cannot use silicon. | |

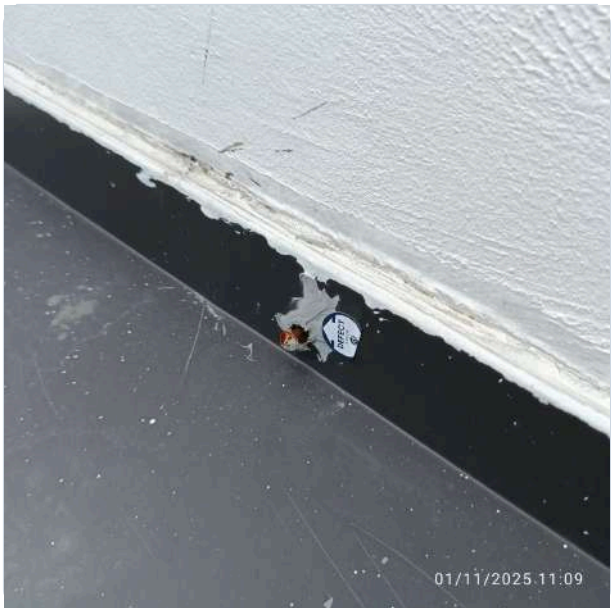
| Location | Tag | Defect & Description | Pictures |
|---|---|---|---|
| Roof First Level<br>Fixtures | 322 | <b>Accessories Defects</b><br>Rusty screw at roof flushing | |
