# CONSERVATION DEVELOPMENT STRATEGY

# HENDRON'S BUILDING

36-40 Dominick Street Upper, Broadstone, Dublin 7  
For Western Way Developments Ltd.

Prepared by Carole Pollard FRIAI November 2020

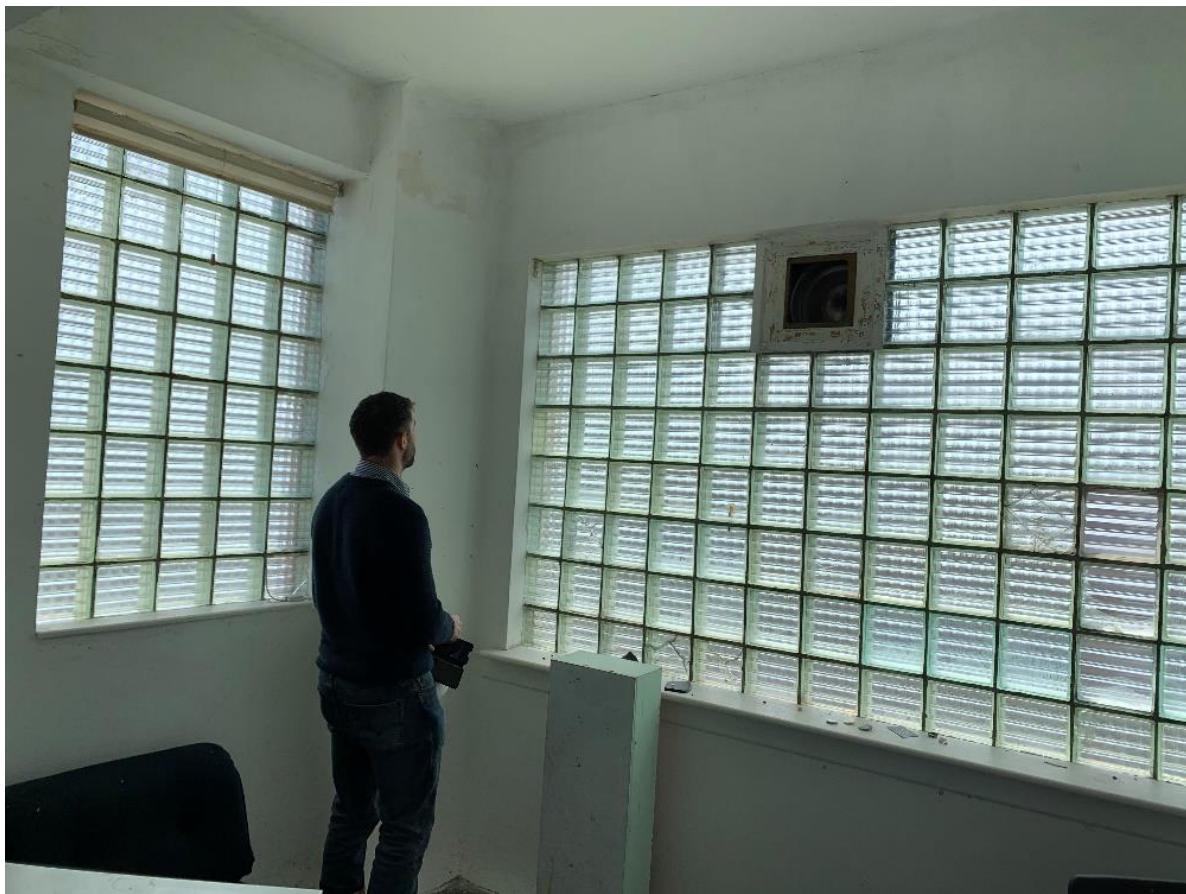
**Illustration 5: Different cill and head heights of glass block ope.**

**Also note ventilation unit in central upper portion of ope facing onto Dominick Street Upper.**

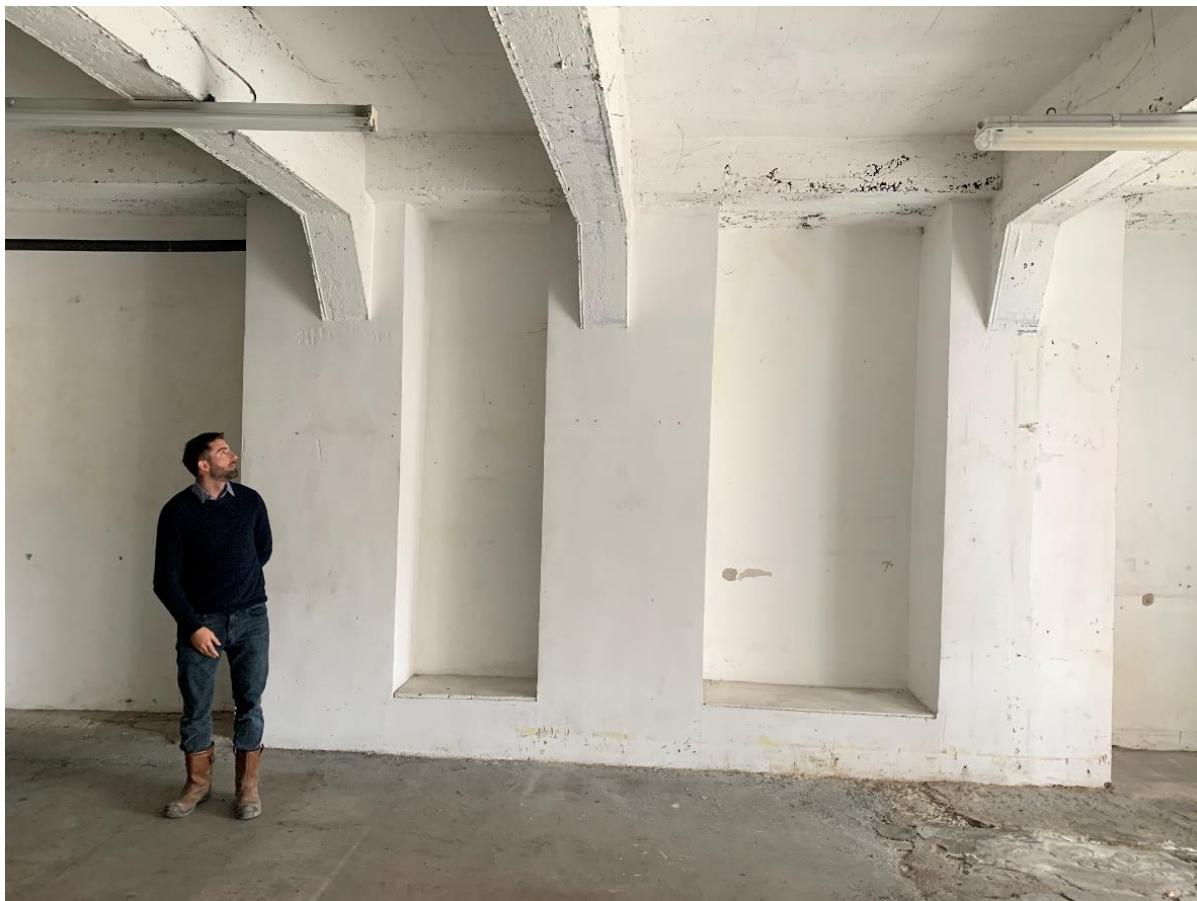
**Illustration 6: Existing concrete structure to be retained, including all columns and beams. These will be left exposed as part of the conservation and refurbishment works.**

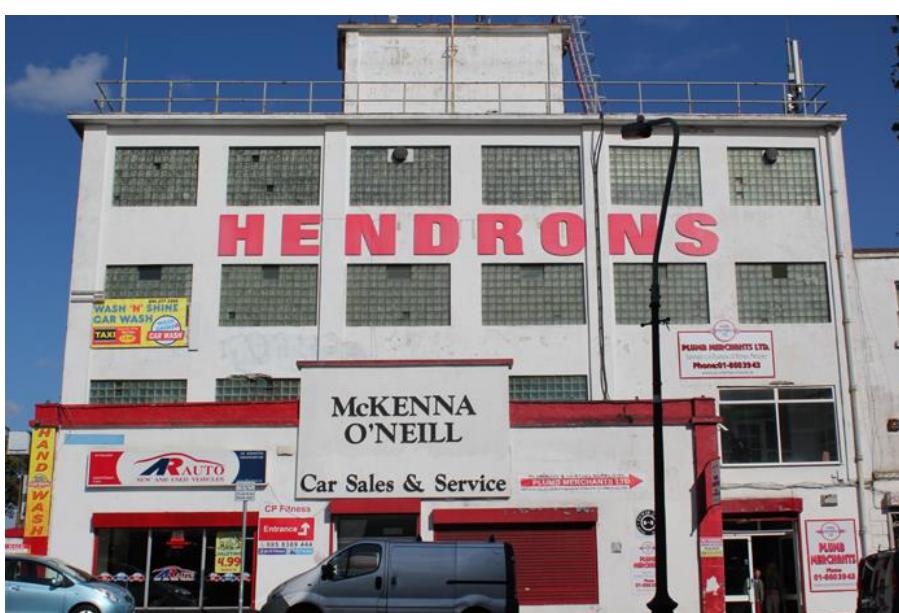
Illustration 12: current Hendrons signage 2020

Sometime after the building was completed in 1948 signage was erected on the front facade of the building (see illustration 11). This signage comprised of red letters mounted on a steel frame fixed to the horizontal band between first and second floor windows. Photographs taken later in the 1980s show some letters missing. This sign was removed and replaced with flat lettering, also in red, stuck directly to the building facade. The bold, red lettering has become a much-loved and familiar icon in the neighbourhood. It is one of the main distinguishing features of the building and an integral part of its identity. It is proposed to retain this signage, carrying out only necessary remedial repairs.

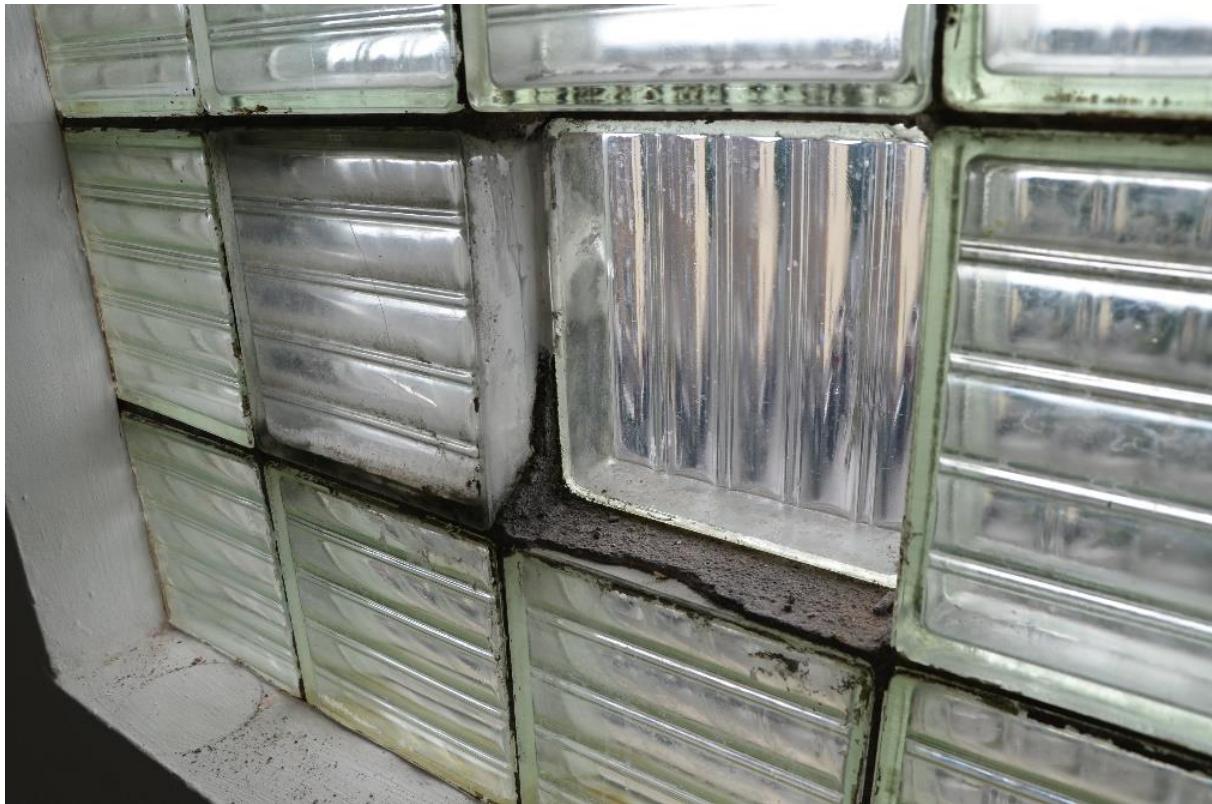
**Illustration 14: Cross-pattern ribbed hollow assembly glass blocks (blocks comprise of two separate ribbed faces reversed on opposite sides). These blocks are manufactured by Seves Glass Block in Czech Republic. Replacements will be made only where necessary and without disturbance to surrounding blocks.**

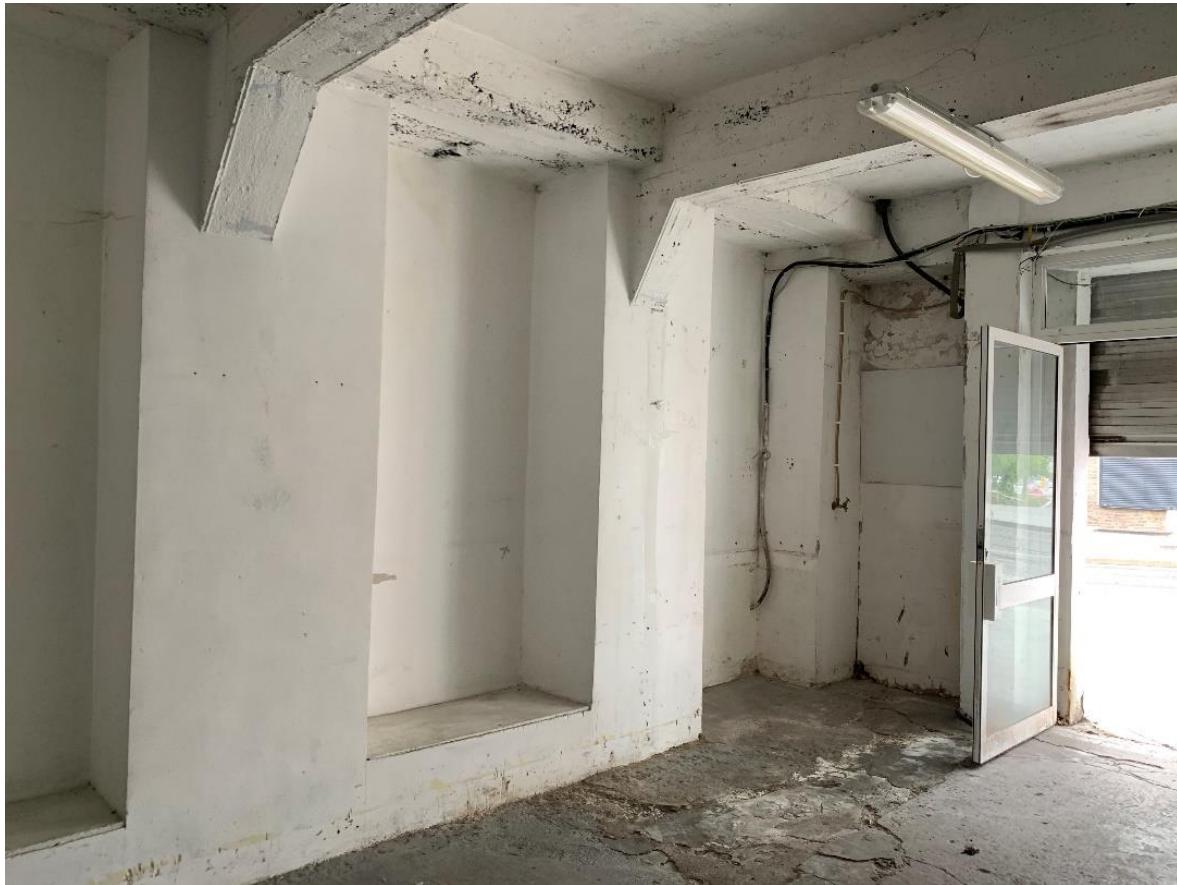
**Illustration 17:** Typical condition of concrete in ground floor areas that have not been recently painted. Concrete generally in good condition.

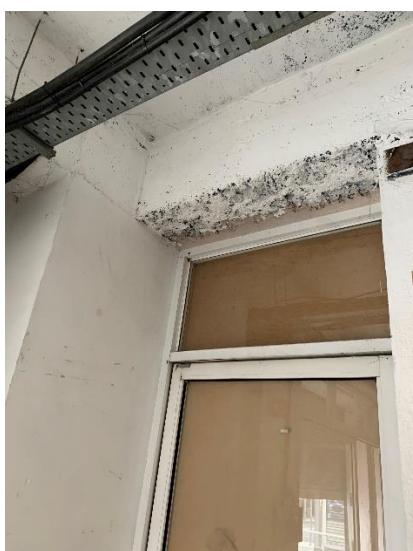
**Illustration 18 (left):** Sample of spalling over internal window – localised repair to be carried out.

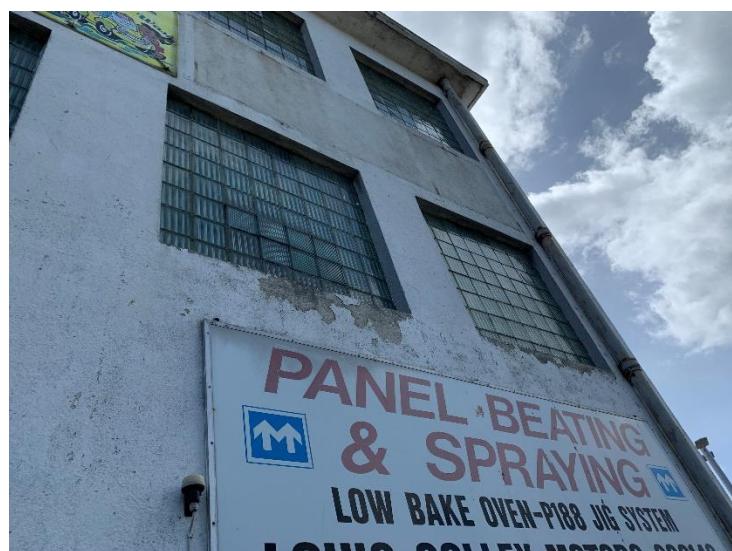
**Illustration 19 (right):** The concrete facades are in general good condition with only minimal loss of definition around opes. This will be remedied where necessary by localised repairs with painted finish on completion.

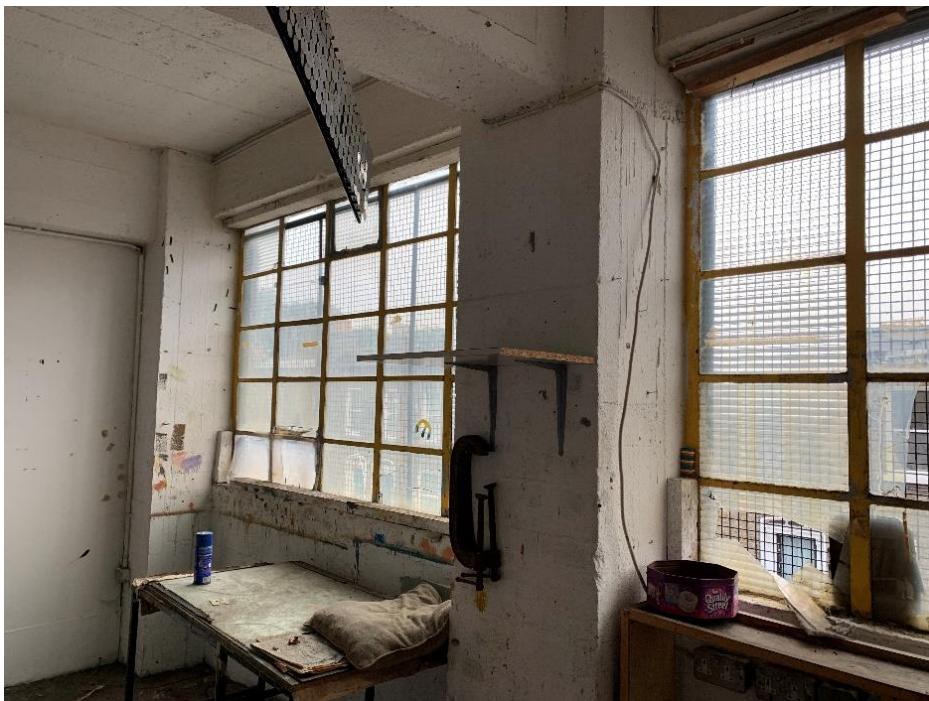
**Illustration 20:** sample of condition of internal concrete on upper floors. Removal of non-original fittings and fixtures will necessitate small localised repairs. Window reveals generally in good condition.

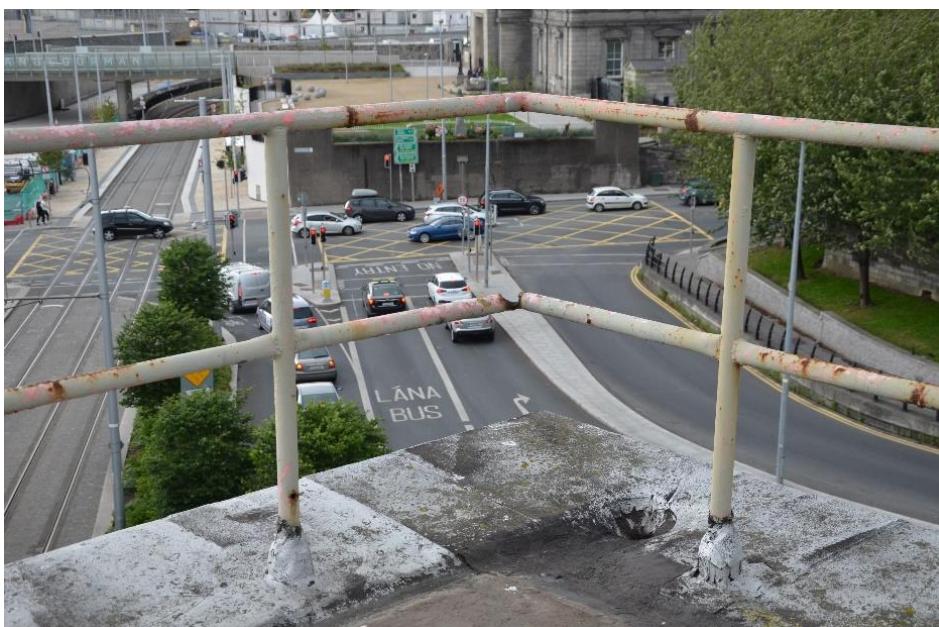
**Illustration 21:** Existing open corner detail of roof parapet rail.  
Minor damage as a result of corrosion.

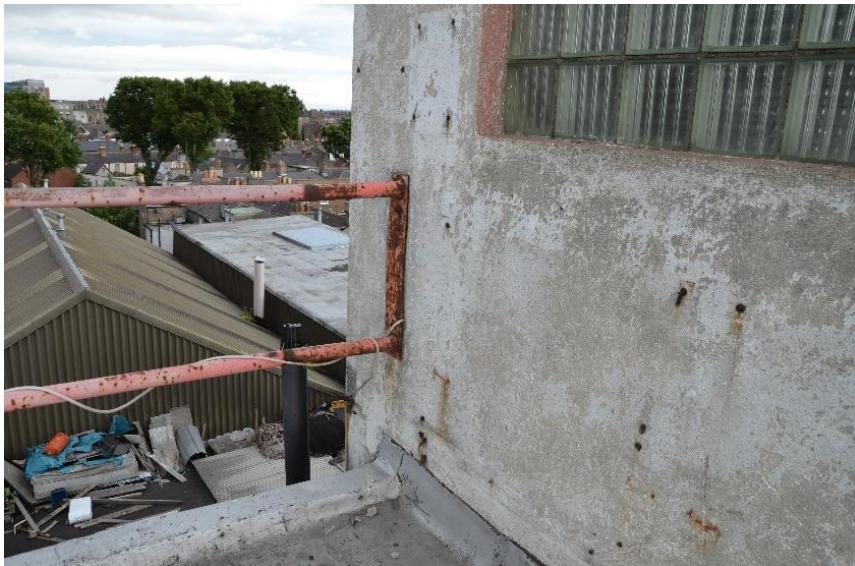
**Illustration 22:** Fixing detail for handrail at lift shaft tower. At one stage the rails were painted red, as were the window reveals.

After 1920, the use of cast iron was phased out and steel became the more common material for handrails. The simplicity of the design of the handrails at the Hendron's building is very much in the spirit of the modernist intentions of its engineer designer Vaclav Gunzl. The tubular design would have been standard issue available from local metalworkers, but the open corner detail contributes to the minimalist style of the structure. The galvanized steel has been damaged at the on-site welding junctions where some corrosion is evident. This will require localised repair and extra protective painting.

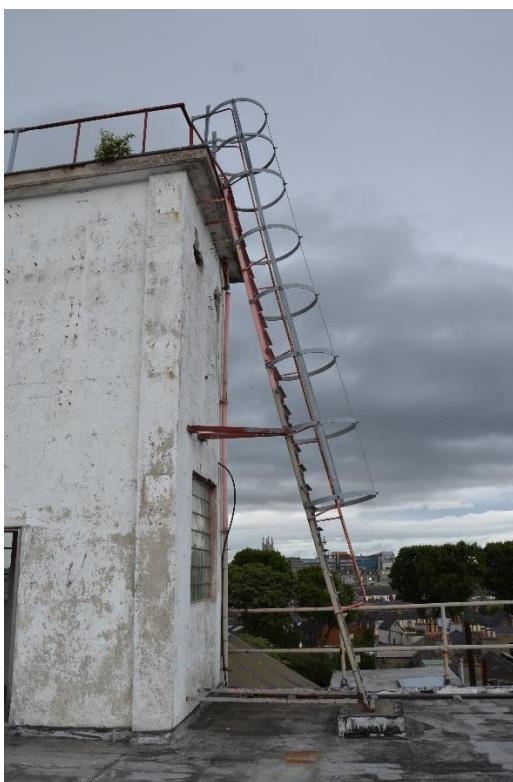
**Illustration 23:** Steel ladder stairs and single rail handrail on roof shaft.  
The circular guard is a later addition but will be retained.

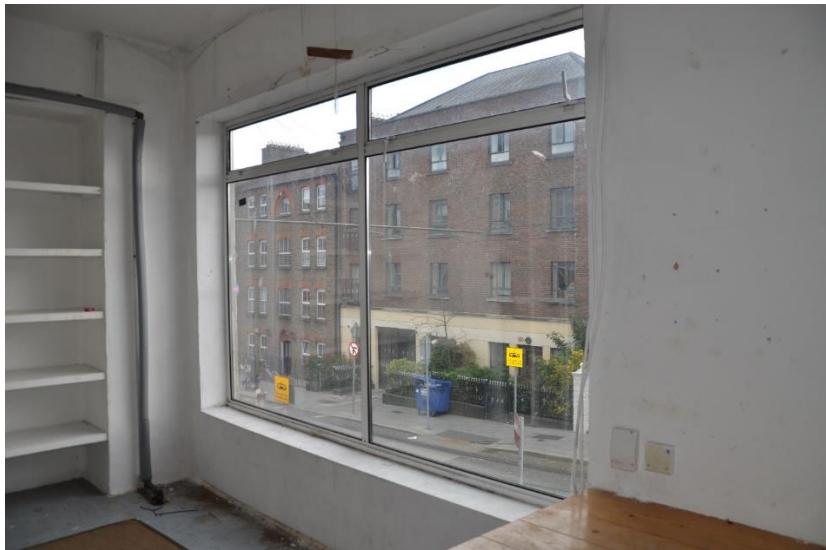
**Illustration 28: EW16, a non-original window will be replaced with new clear glazed steel framed window.**  
**(See illustration 4, taken in 1949, which shows no window in the position, and illustration 12, taken in 1987, which shows a glass block ope in this position).**

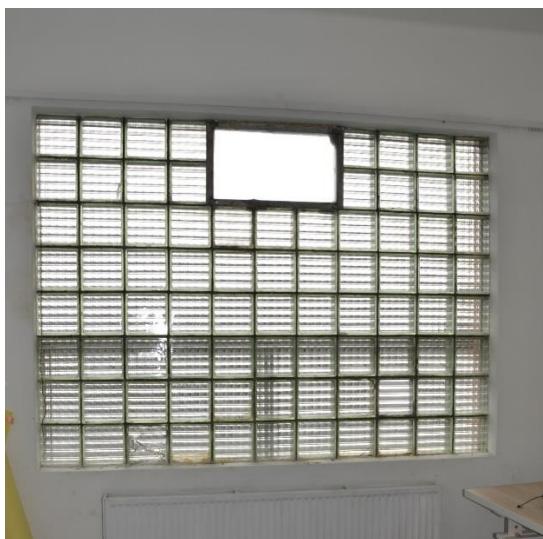
**Illustration 29: Existing window EW07 with central clear-glazed panel**

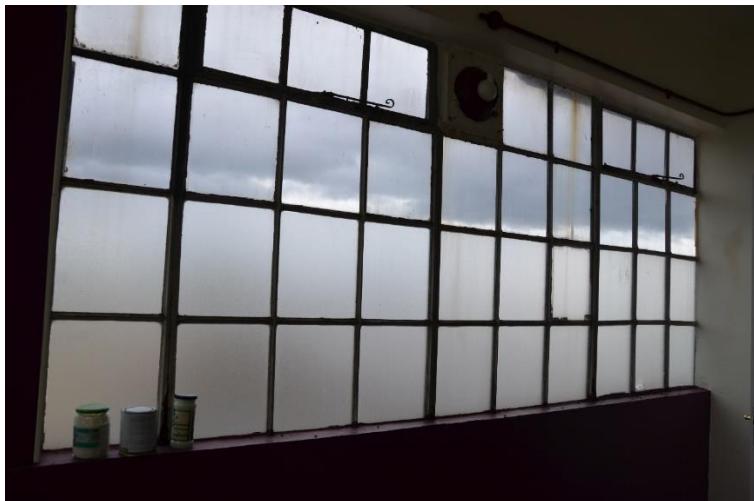
*Illustration 30: Existing steel framed window (EW27) at third floor*

- The rear elevation comprises two large steel windows, EW25 and EW27. EW will be removed to facilitate development of Block A. EW 27 (illustration 30) will be refurbished or replaced to match existing. Existing door ED07 will be removed to facilitate the refurbishment.

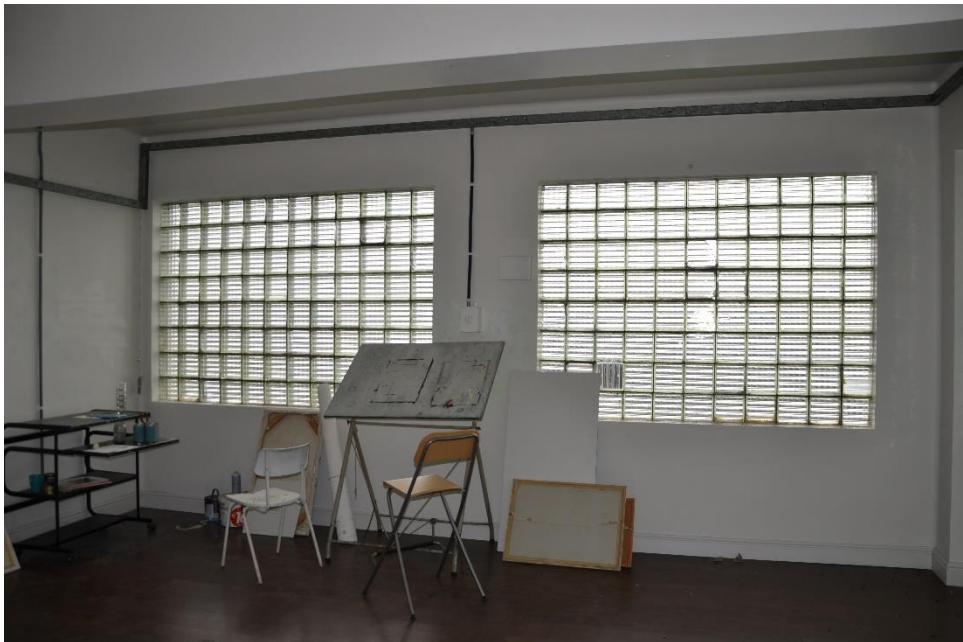
**EW01 (right) AND EW02 (left)**

These windows are in reasonably good condition and will require localised repairs only.

*Note: in all cases, where glass blocks require replacement this will be carried out, as far as possible, using blocks salvaged from window EW20, EW21, EW22 and EW23.*

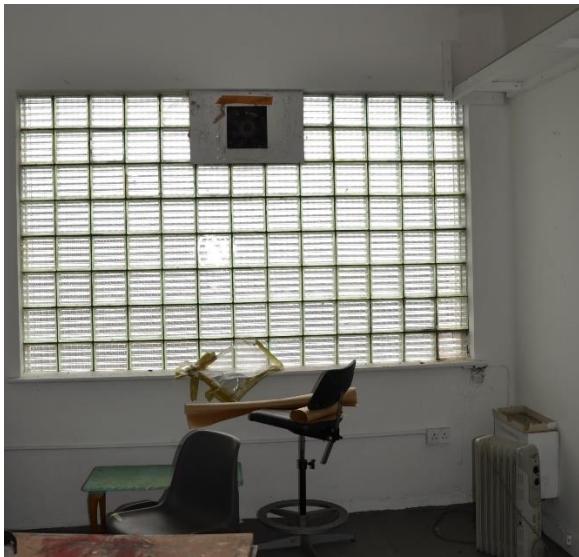
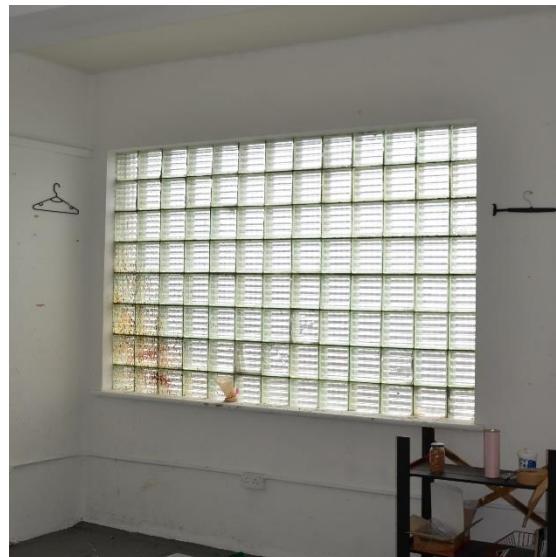
These windows are in reasonably good condition and will require localised repairs to existing glass blocks. The central panel (3 block wide x full height) will be removed and fitted with a steel pivot opening frame to allow natural light and ventilation. The frame will be filled with existing glass blocks.

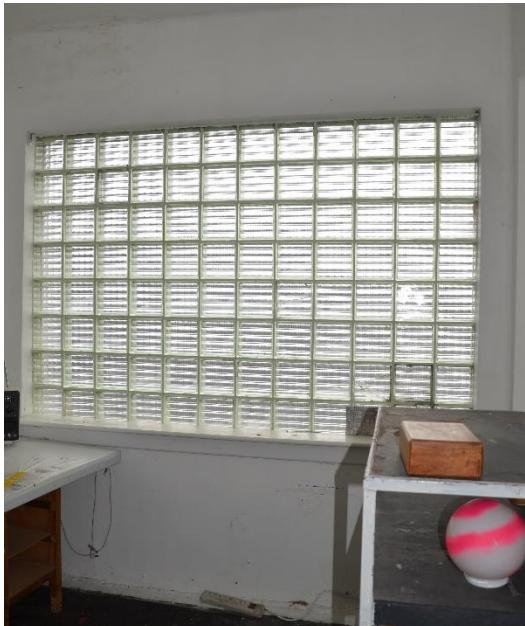
These windows are in reasonably good condition and will require localised repairs to existing glass blocks. The central panel (3 block wide x full height) will be removed and fitted with a steel pivot opening frame to allow natural light and ventilation. The frame will be filled with existing glass blocks.

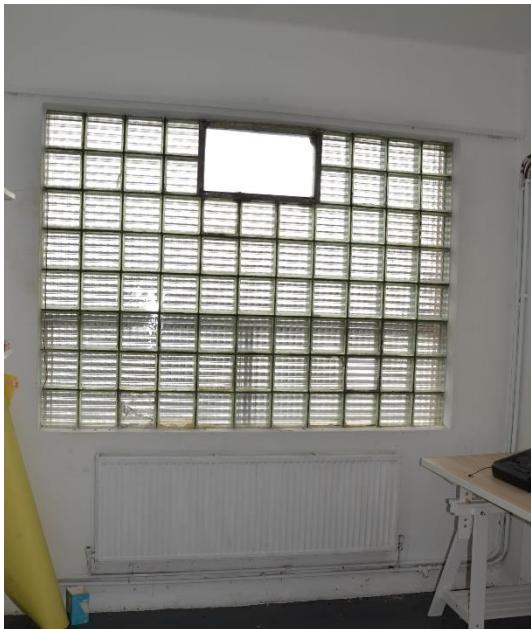
Ew07 will require localised repairs to existing glass blocks. Salvaged blocks will be used to replace missing / damaged blocks. The central panel (3 block wide x full height) will be removed and fitted with a steel pivot opening frame to allow natural light and ventilation. The frame will be filled with existing glass blocks.

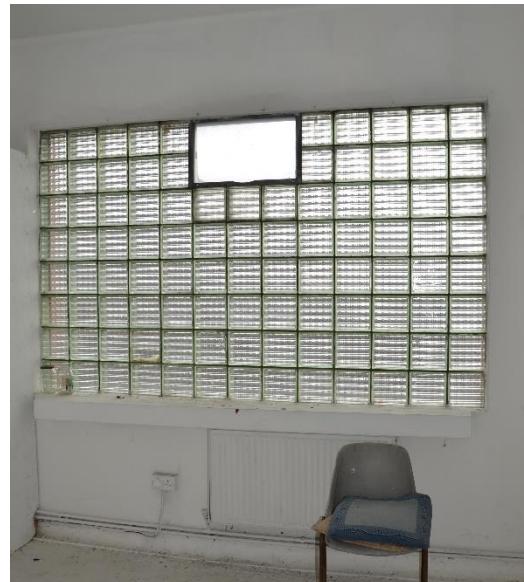
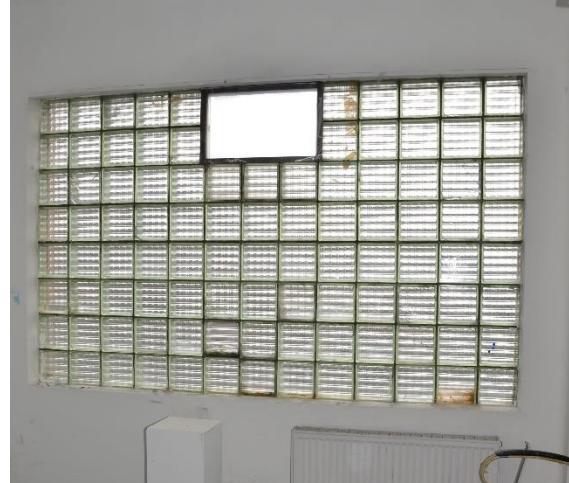
EW09 AND EW10 will require localised repairs and replacement of existing damaged glass blocks. Salvaged blocks will be used to replace missing / damaged blocks. The central panel (3 block wide x full height) will be removed and fitted with a steel pivot opening frame to allow natural light and ventilation. The frame will be filled with existing glass blocks.

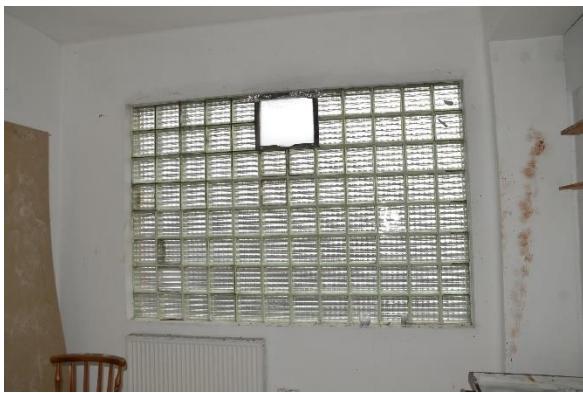
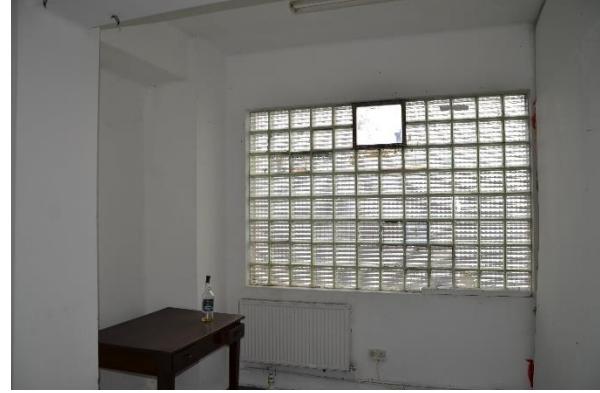
EW11 AND EW12 will require localised repairs and replacement of existing damaged glass blocks. Salvaged blocks will be used to replace missing / damaged blocks. The central panel of EW11 (3 blocks wide x full height) will be removed and fitted with a steel pivot opening frame to allow natural light and ventilation. The frame will be filled with existing glass blocks. The central panel of EW12 (2 blocks wide x full height) will be removed and fitted with a steel pivot opening frame to allow natural light and ventilation.

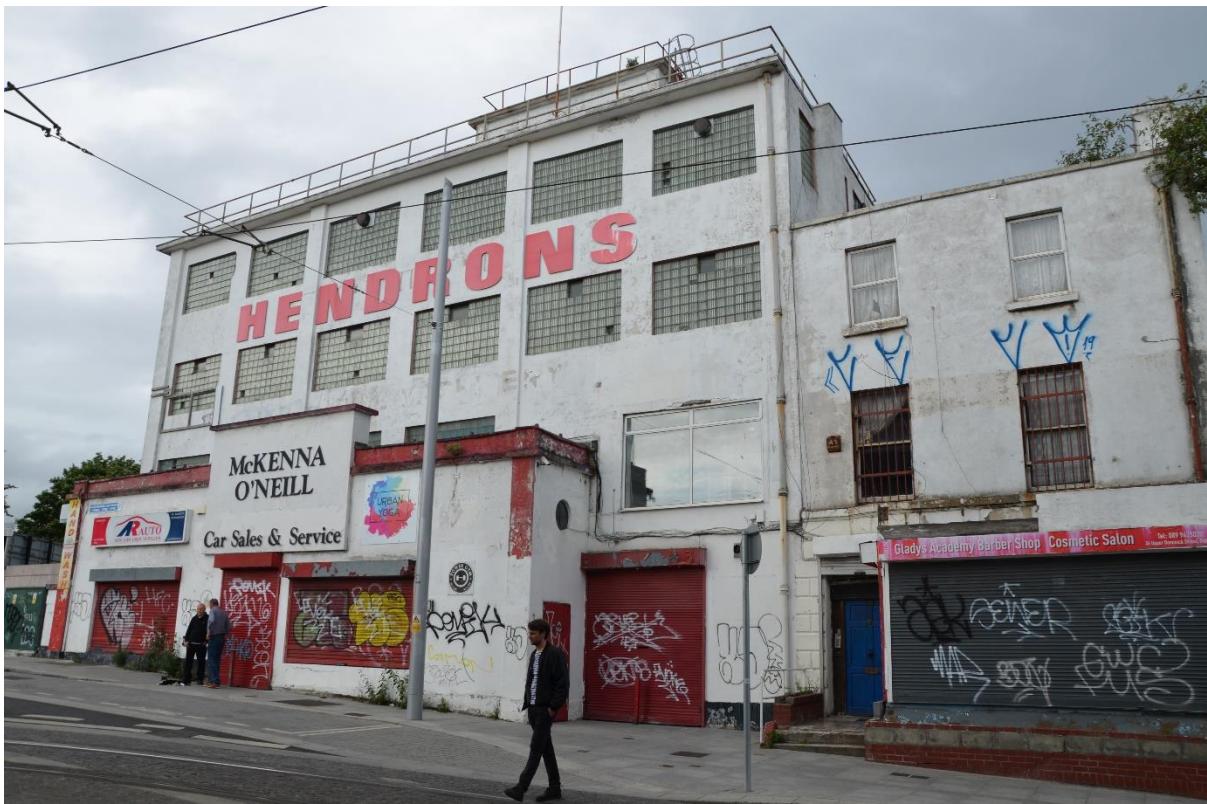
**GROUND FLOOR L-R: EW17, ED04, EW18, ED05 with ED06 on return of single storey projection.**

All of these opes will be altered and fitted with new windows and doors as per JFA drawings. The circular 'porthole' window above ED06 will be retained and repaired.

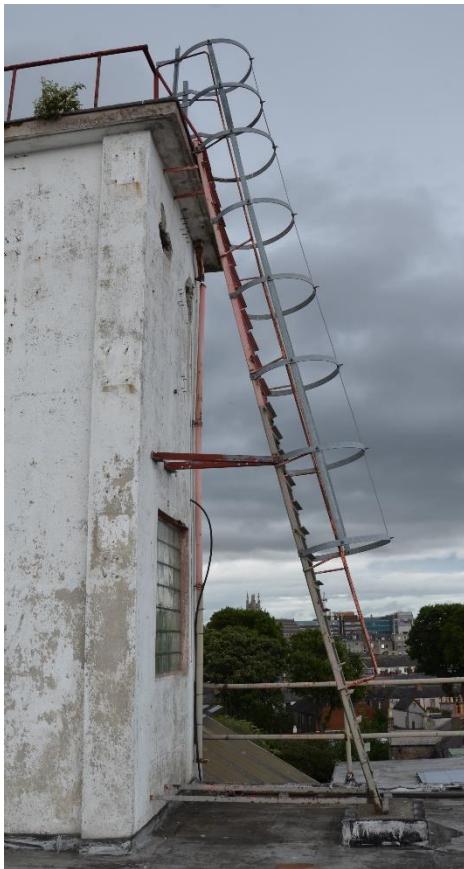
**EW19**

EW19 will require localised repairs to existing glass blocks. Salvaged blocks will be used to replace missing / damaged blocks.

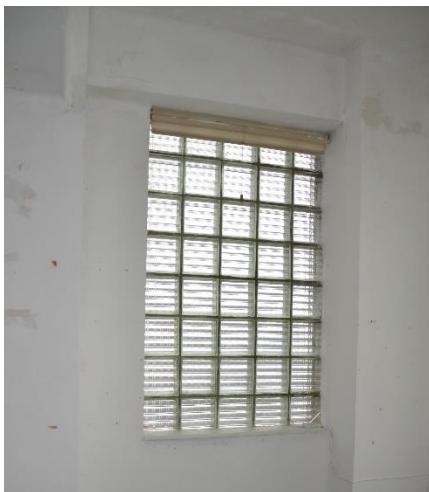
No access to photograph EW21. EW20 will be retained as a window ope but will be fitted with a clear glass opening window section to provide natural light and ventilation in compliance with current building regulations. Windows EW21, EW22 and EW23 will be removed to facilitate Block A of the new development. The glass blocks will be carefully removed, stored, and used to repair other glass block window opes.

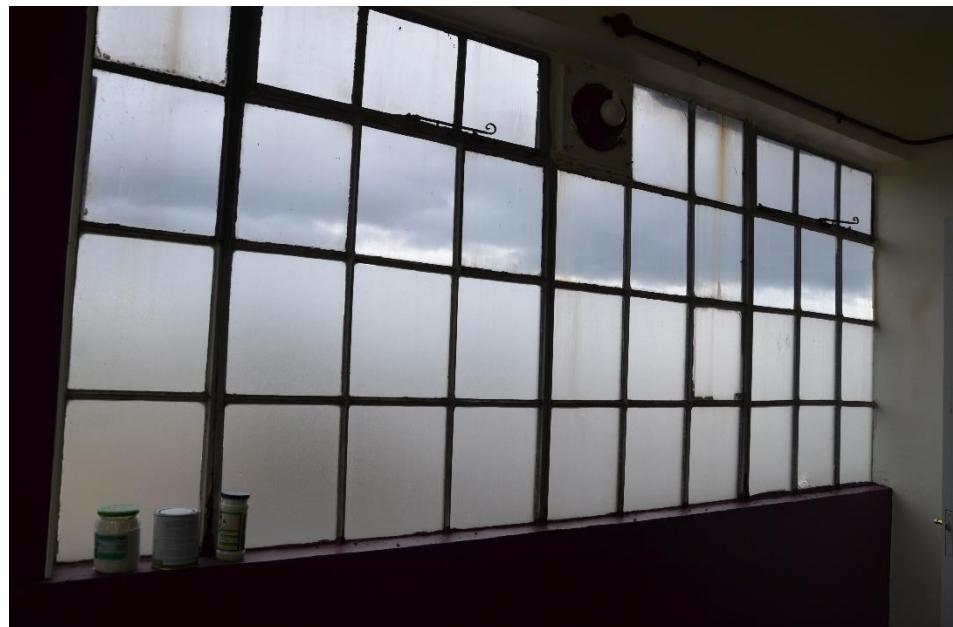
EW27 (partial)

EW27 has been altered to accommodate an internal partition and the insertion of ED07. It is proposed to remove ED07 and replace EW27 (in its former elongated format) with a steel window to the same design but with higher thermal performance.

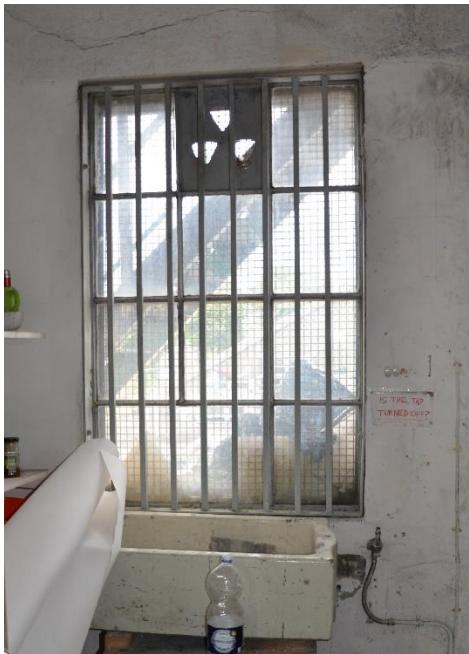
**EW 29 (no photo of EW28)**

EW28 and EW29 are steel framed windows. They will be replaced with steel windows to the same design but with higher thermal performance.

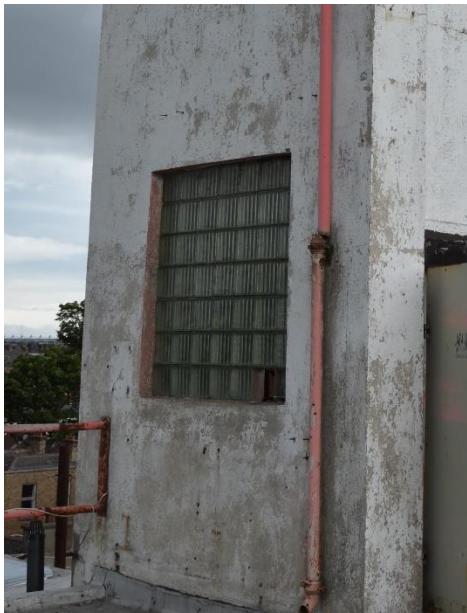
**EW30**

EW30 will require localised repairs to existing glass blocks. Salvaged blocks will be used to replace missing / damaged blocks.

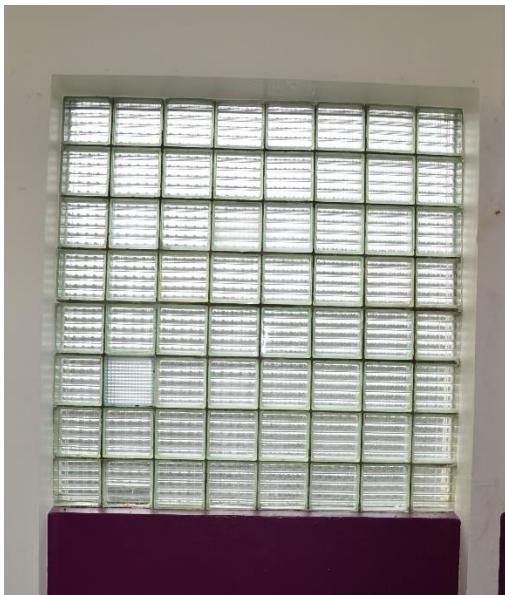
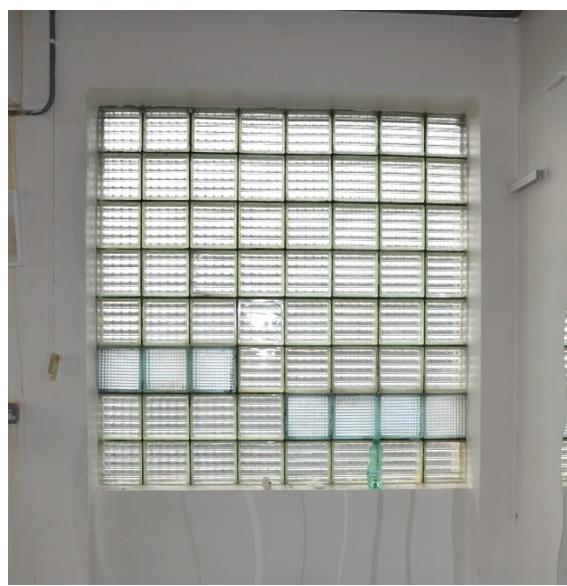
EW31 AND EW32 will require localised repairs and replacement of existing damaged / non-original glass blocks. Salvaged blocks will be used to replace missing / damaged blocks. The central panel of each window, 2 blocks wide x full height, will be removed and fitted with a steel pivot opening frame to allow natural light and ventilation. The pivot frame will be filled with existing glass blocks.

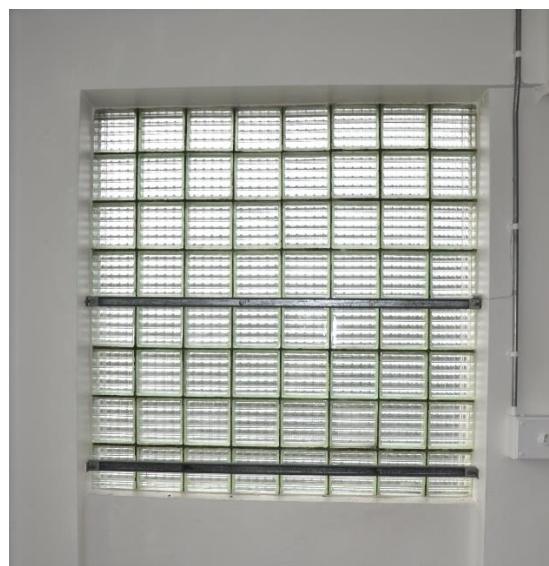
EW33 AND EW34 will require localised repairs and replacement of existing damaged / non-original glass blocks. Salvaged blocks will be used to replace missing / damaged blocks. Steel bars will be removed. The central panel of each window, 2 blocks wide x full height, will be removed and fitted with a steel pivot opening frame to allow natural light and ventilation. The pivot frame will be filled with existing glass blocks.

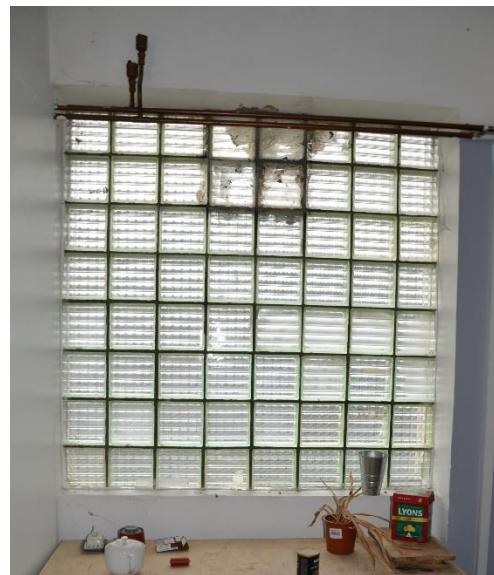
EW35 AND EW36 will require localised repairs and replacement of existing damaged / non-original glass blocks. Salvaged blocks will be used to replace missing / damaged blocks. The central panel of each window, 2 blocks wide x full height, will be removed and fitted with a steel pivot opening frame to allow natural light and ventilation. The pivot frame will be filled with existing glass blocks.
