**WESTERN WAY SHD
36-40 DOMINICK STREET UPPER
DUBLIN 7**

**ARCHITECTURAL HERITAGE
IMPACT ASSESSMENT**

4th December 2020

1085/02

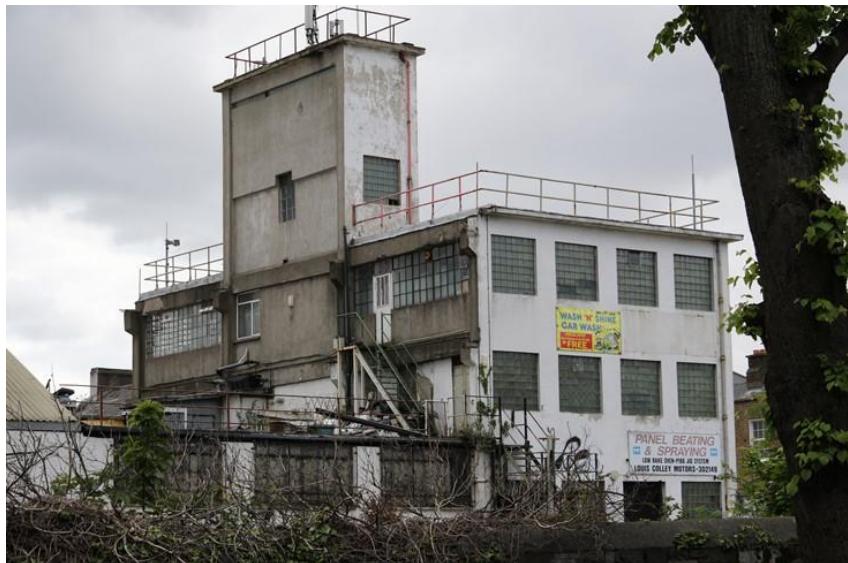
Plate 3: Rear and western side of main building

The rear of the main building rises above the structure to the rear. This side is not pained and has steel windows with a mix of opaque glass and clear glass. The reinforced concrete framing is visible on this side and nibs project from just below slab level on each floor, as if prepared for the building to be extended to the rear.

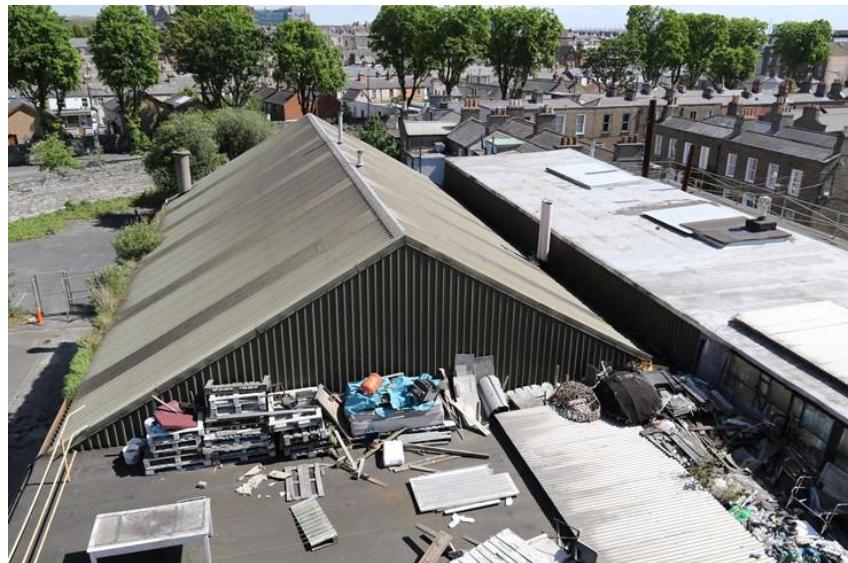
Plate 4: Western section of roof at rear

To the rear of the main building there are lower structures projecting towards the rear of the site. These are in three sections. The western section, seen in the photograph above, is flat-roofed in the part immediately to the rear of the main building, while behind that the large part of this section has an A-roof, clad in profiled steel, with panels of profiled Perspex.

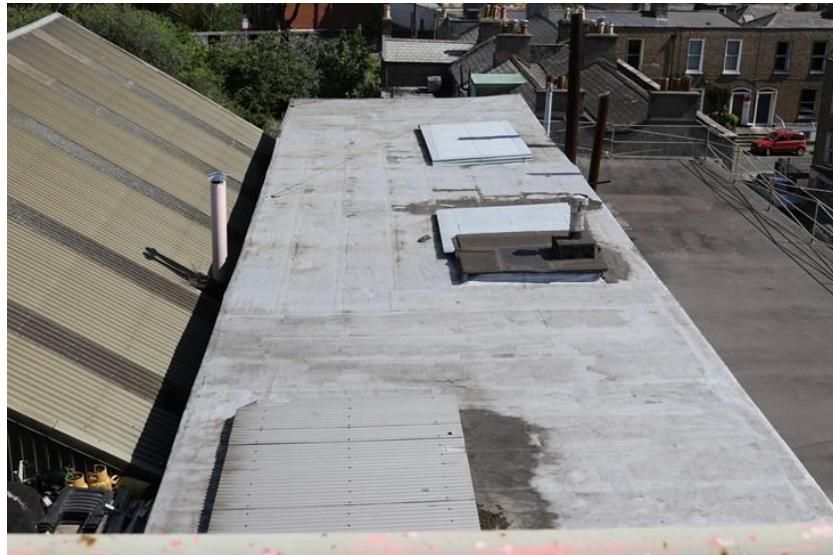
Plate 5: Central section at rear, with eastern section to the right

The central section of the structures at the rear is flat roofed, with a felt covering. In three places there are raised sections that are clad with corrugated steel and it is likely that these were roof lights originally. To the east of this is the third rear section, which runs along the western side of Palmerston Place. This is lower than the central section and is also flat roofed with a felted finish.

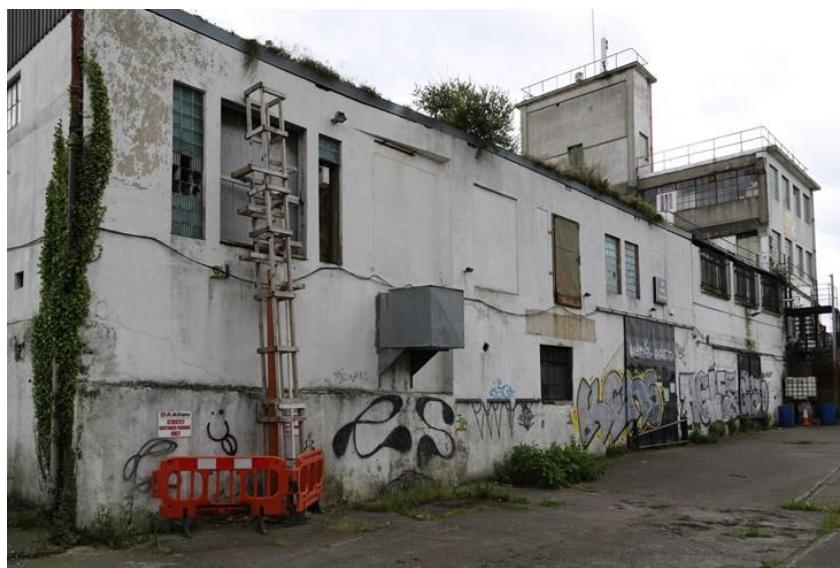
Plate 6: Western elevation of building at rear

The building to the rear is constructed with mass concrete. The western part is seen in the photograph above and has an irregular array of windows on the upper level, most of which are stopped up, while some small windows are glazed with glass block. The greater part of the building is constructed with mass concrete, rendered and painted, while part of it is built with concrete blockwork.

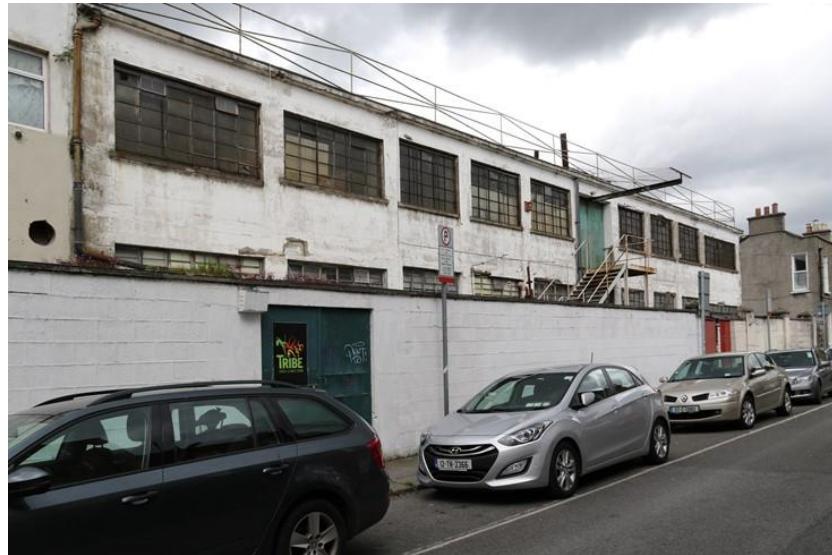
Plate 7: Eastern elevation, seen from the south

At the south-eastern corner of the site is number 36 Upper Dominick Street, which is described below. To the rear and built on what was originally the rear garden of number 36 is a two-storey, ten-bay addition to the rear of the commercial building, though the northernmost bay is wider than others. This structure is of reinforced concrete with horizontal steel windows and is set back from the street frontage to Palmerston Place, with a high concrete-block wall at the back of the footway. The roof is flat, as noted above. In the centre of the eastern façade, at first-floor level, is a doorway, outside which is a steel platform and stairway.

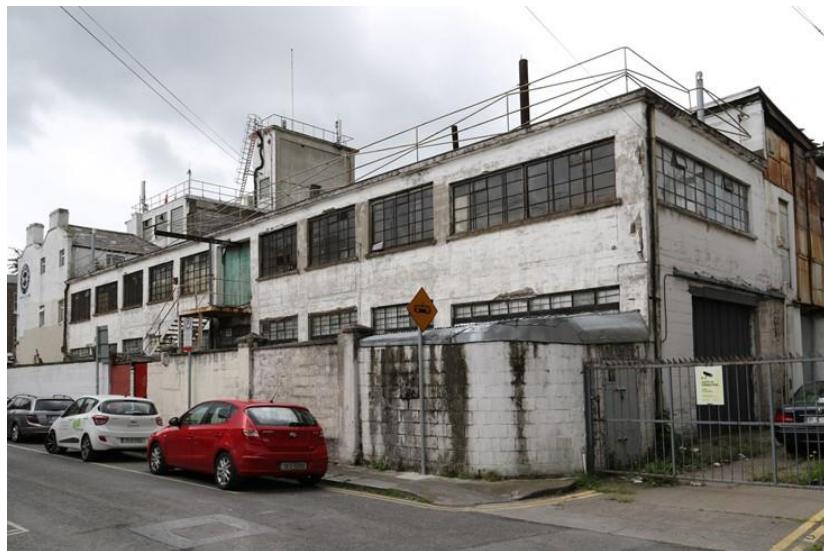
Plate 8: Eastern elevation, seen from the north

The building to the rear is in poor condition, with extensive spalling on the face of the concrete, revealing the reinforcing bars.

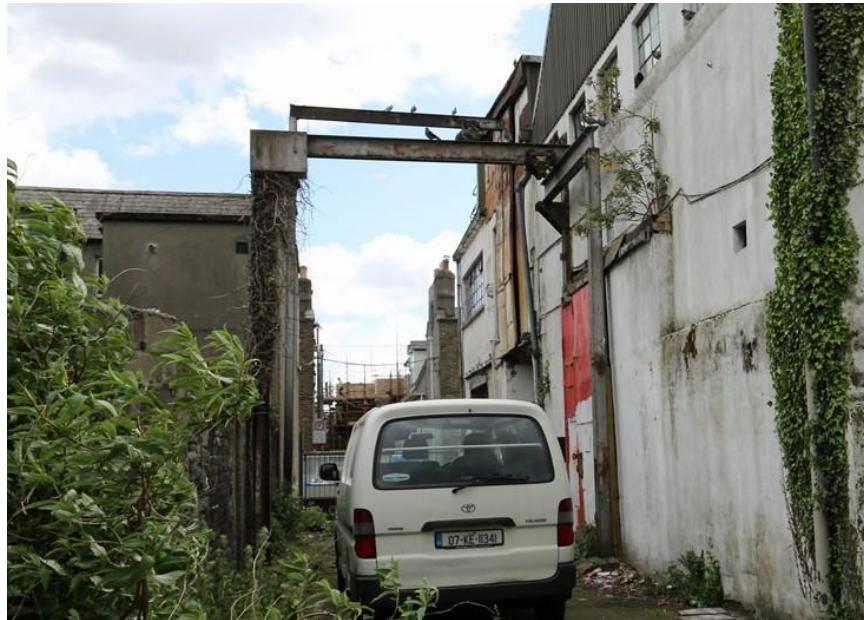
Plate 9: Gantry crossing access from Palmerston Place

Very little survives of machinery or other industrial equipment at Hendron's. The only exceptions are winding gear at the rear of the buildings at the access lane from Palmerston Place. Here there is a steel gantry comprised of steel stanchions supporting a steel beam that runs above the lane some remnants of winch gear survive at one end of the beam. Close to this another beam crosses from the building to a stanchion and also has some winch gear remaining. These elements cannot be said to have any industrial heritage or architectural heritage significance.

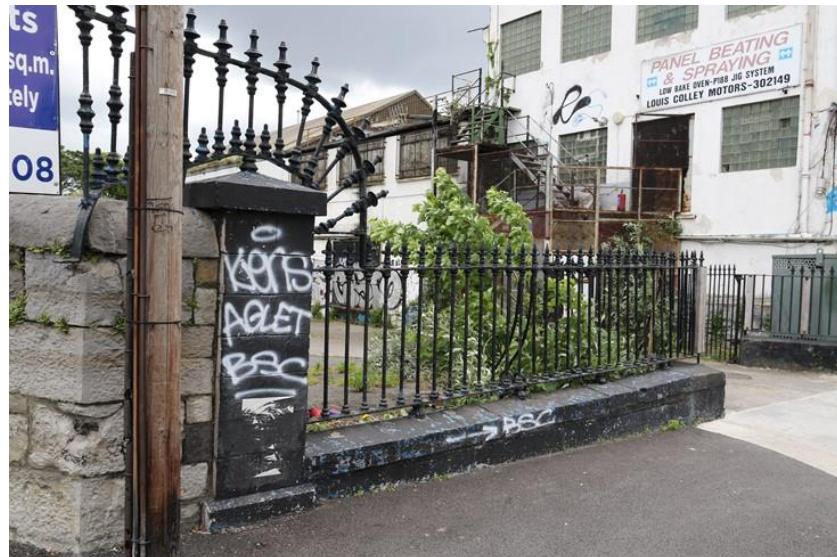
Plate 12: Eastern elevation, seen from the north

The yard adjacent to the Hendron's building on the north-western side is enclosed on the road frontage by a low plinth wall and iron railings. The entrance to the yard from Dominick Street Upper interrupts this railing and the only original stretch is the section seen in the photograph above, away from the main building and running to the corner of Western Way. Here the railings terminate at a masonry pier with a rendered finish. The railings are of wrought iron with cast-iron bosses and finials and rise from a plinth wall of dressed calp limestone with a limestone capping.

Where the later railings are removed it is proposed to provide a masonry pier to match the existing pier at the end of the railing and which is seen in plate 12 above. The preferred option is to remove the other pier, which is adjacent to the Hendron's building and relocate it to form the termination of the original railings, rather than to erect a new pier.

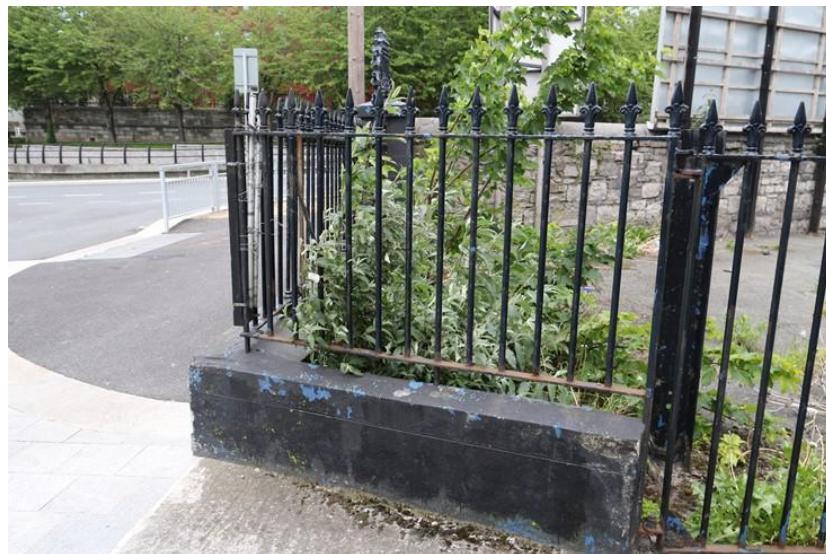
Plate 13: Twentieth-century replacement railings at gateway

The original railing terminates a little to the west of the return towards the gates and the section flanking the gateway is a twentieth-century replacement, with mild steel railings with finials and without bosses, mounted on a mass concrete plinth wall. The junction between the historic and the later railings is clear to see, where the later mass concrete plinth wall adjoins the original limestone wall.

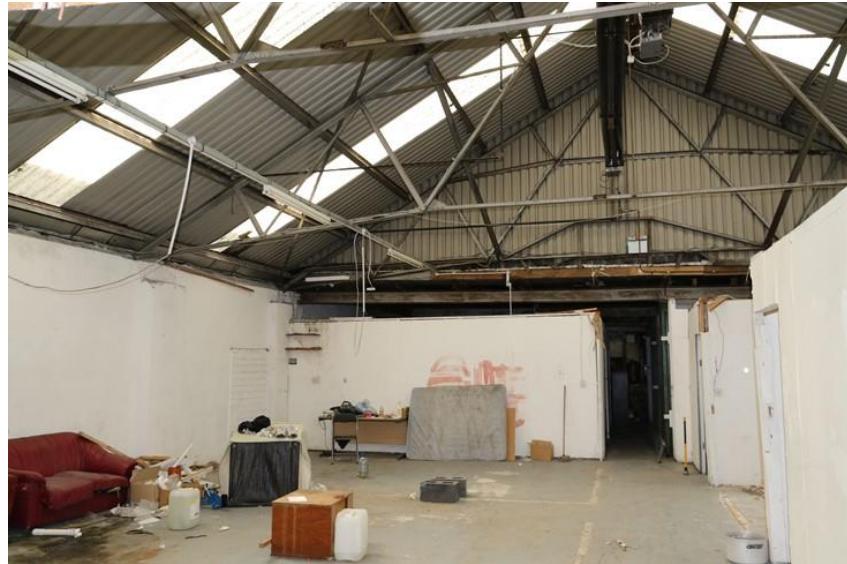
*Plate 18: Interior of western section of rear buildings*

The buildings at the rear are partly mass-concrete and partly concrete blockwork, while some of the structures have concrete roofs and one large area has a steel-truss roof with a covering of profiled steel. The floors are concrete.

In the western of the three structures to the rear there is charring on the timbers in places, arising from a fire in the building at some time in the past. There is also a significant crack through the concrete floor slab, and it appears that this crack is gradually widening.

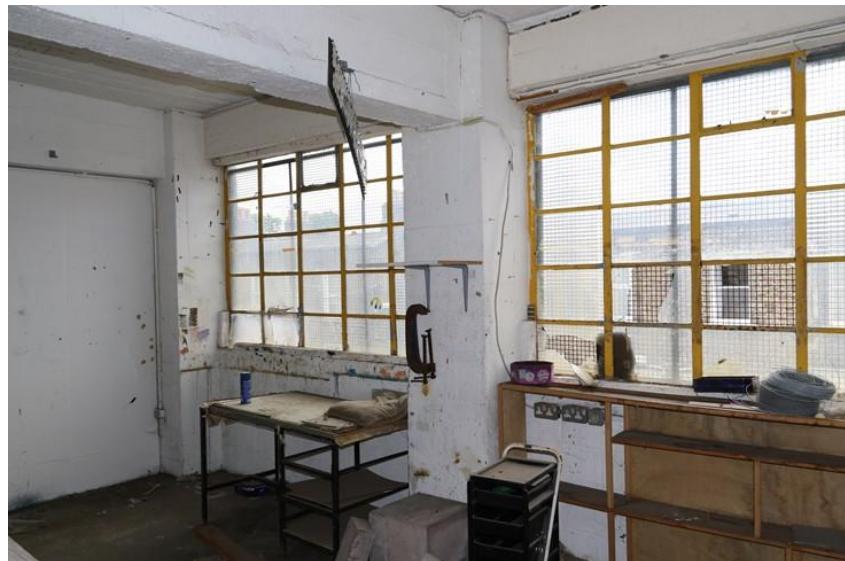
*Plate 19: Interior of eastern section of rear buildings*

The rear sections have been subdivided in places, much of it of late date. The quality of the buildings is poor, as is described in more detail in the assessment section below.

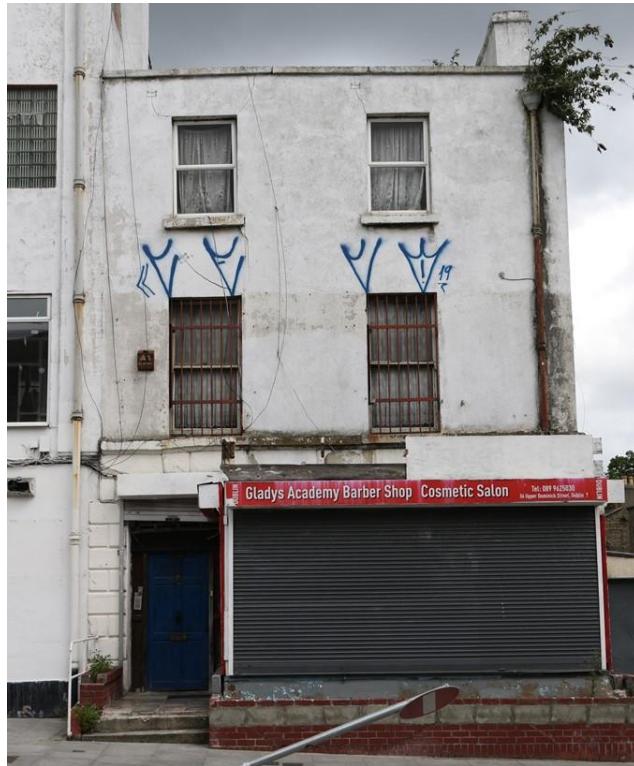
Plate 20: 36 Upper Dominick Street

Number 36 Upper Dominick Street is a three-storey, two-bay building with a rendered and painted façade topped by a parapet with stone copings. The windows on the first floor are one-over-one timber sashes with horns and are replacements, while the windows on the top floor at the front are of uPVC. A shopfront projects to the front on a concrete base. The remnants of the original ground floor are faced with render in imitation of ashlar. The panelled door has a fanlight over.

Number 36 Upper Dominick Street is also in very poor condition. There are significant signs of settlement in the front façade, including a severe degree of movement in the front doorcase, where the left-hand side of the door opening has descended by a significant amount. There is cracking in the façade, with tell-tales installed to monitor the continuing movement of the façade. The interior of the property is in poor condition and seems to have been extensively refitted inside, following which little has been done to maintain it in good order. Severe damp and water ingress have left their mark throughout the building and there have been collapses in the ceilings.

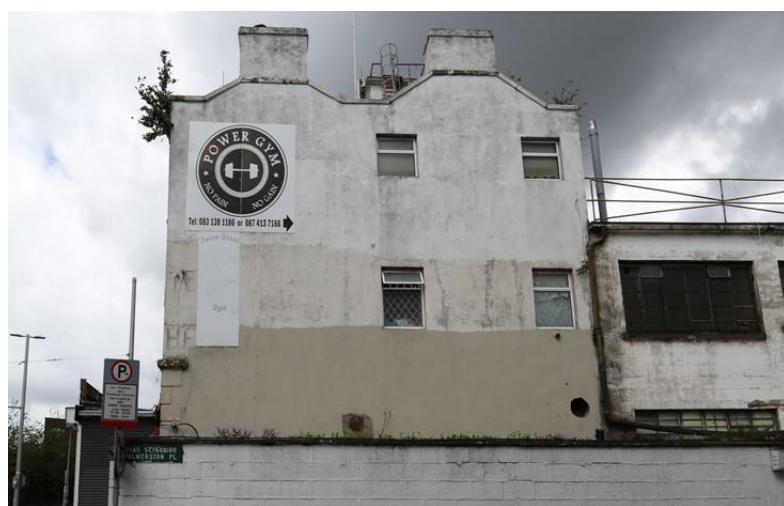
Plate 21: Side elevation

The side elevation is rendered and painted with uPVC windows.

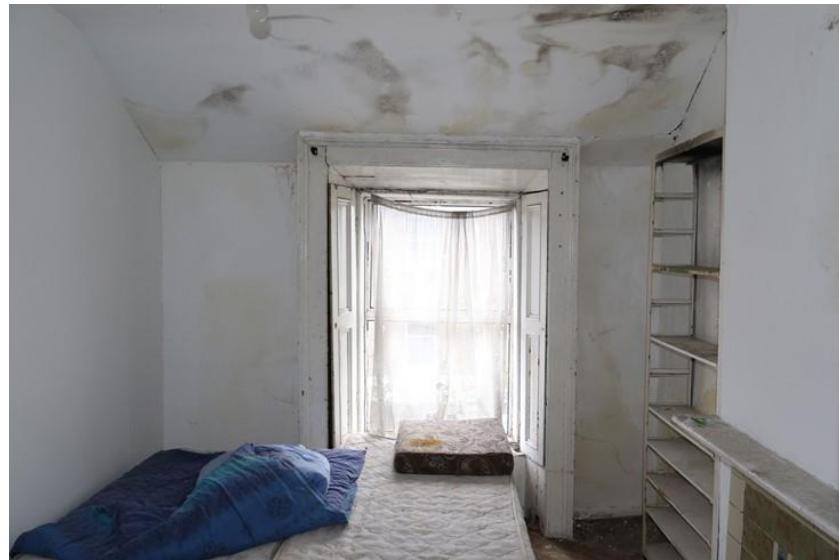
*Plate 22: Upper floor bedroom*

The interior of number 36 Upper Dominick Street is in very poor condition. Ceilings have been replaced with plasterboard and walls replastered with modern hard-wall plasters. There has been a significant amount of water penetration and ceilings have collapsed in places. Some features survive consistent with an 1840 date of construction, including shutters and architraves and some decorative cornicing in the entrance hall. The staircase has a hardwood handrail supported on turned balusters, many of which are missing.

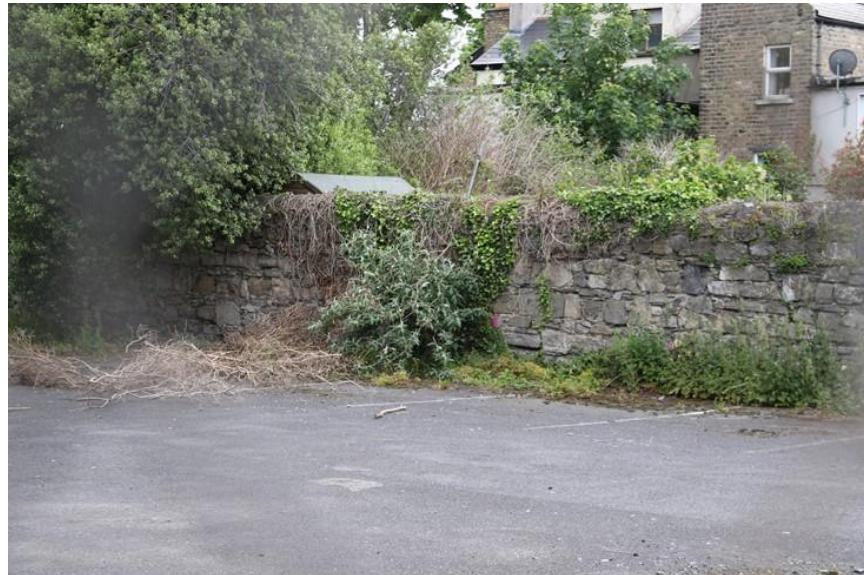
Plate 28: Rear wall at Palmerston Place

The houses at numbers 1 to 5 Palmerston Place back on to the rear of the application site and the boundary is marked by a stone wall approximately 1.5 metres in height. The wall is constructed with calp limestone rubble, brought to courses of about 300mm and it is capped with sand and cement in which is bedded broken glass. Parts of the wall have a covering of ivy and there is also buddleia and other vegetation in places. The wall that runs alongside the access to Palmerston Place has some brick in the masonry. At the rear of number 1 Palmerston Place the wall has been raised with three courses of concrete blocks, while at the corner with the access lane the wall has been repaired with areas of mass concrete.

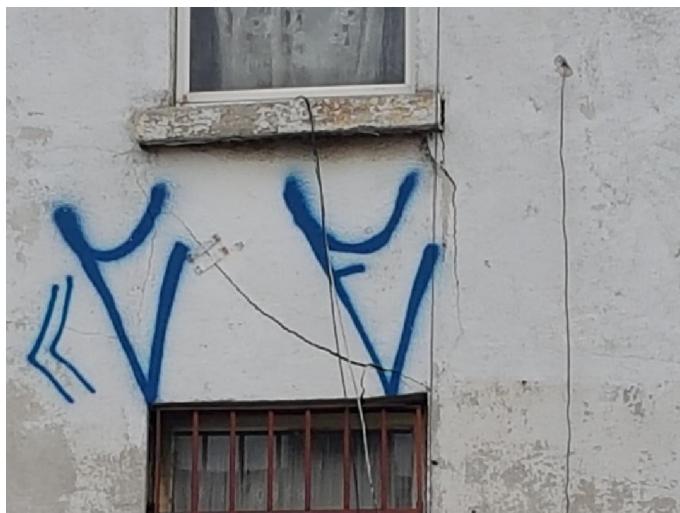
Figure 1. Lattice at cracks at front of No.36

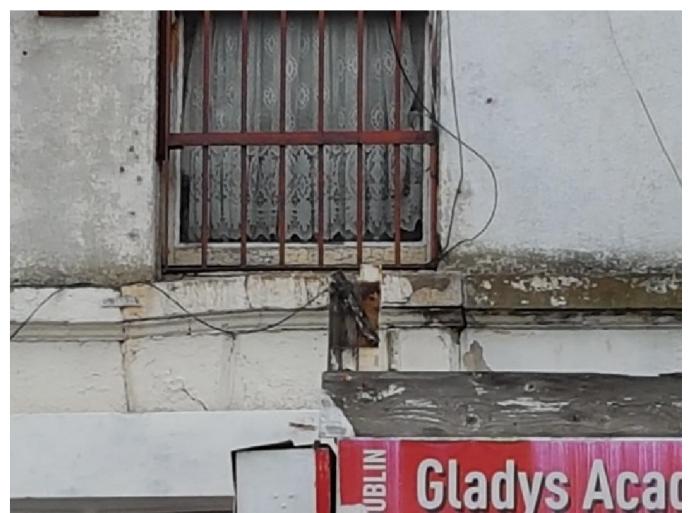
Figure 2. No.36: Window cill broken

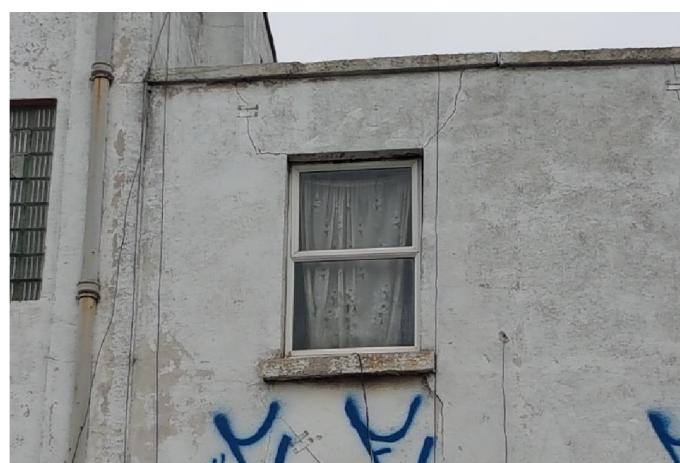
Figure 3. No.36: Parapet failure

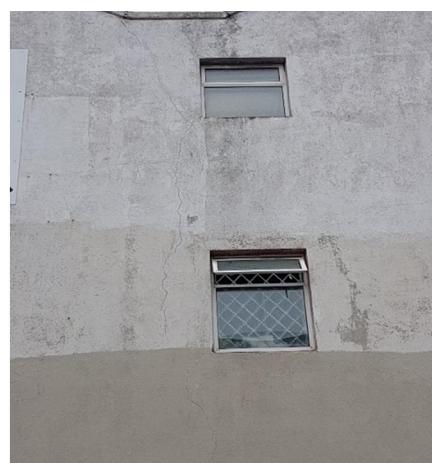
Figure 4. No.36: Structural cracks to gable

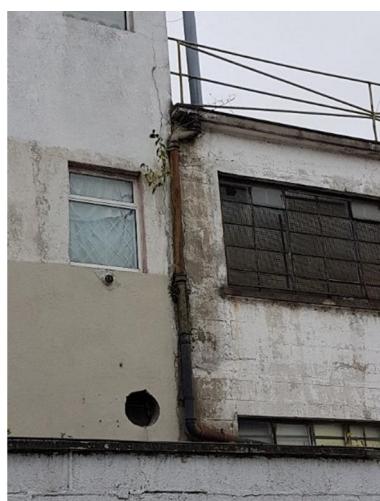
Figure 5.No.36/Sheds interface: Structural cracks

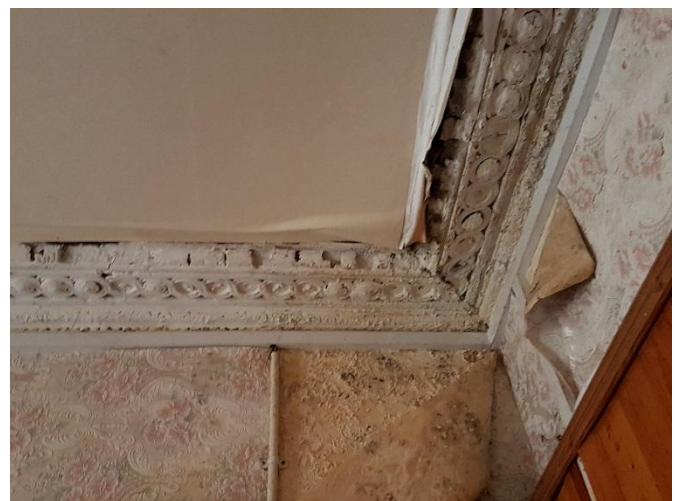
Figure 6. No.36 Internal: Water damage to features

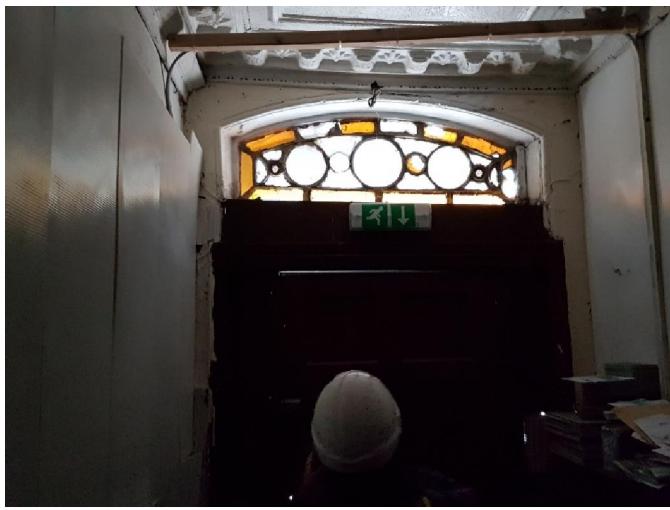
Figure 7. No. 36: Vertical movement across door frame

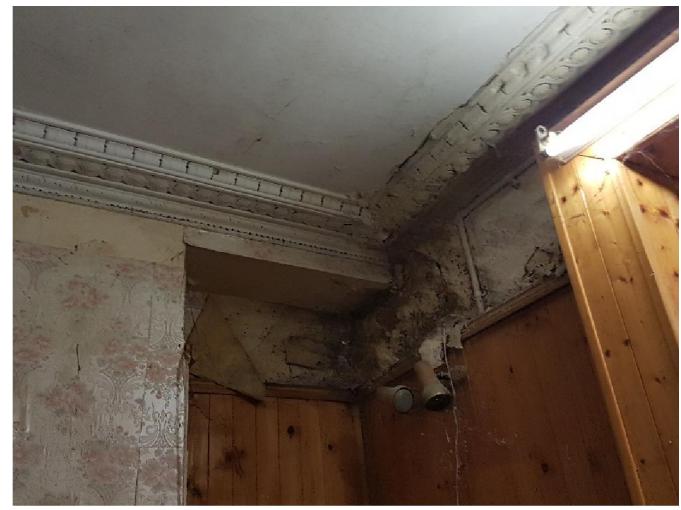
Figure 8. No. 36: Water damage to plaster features

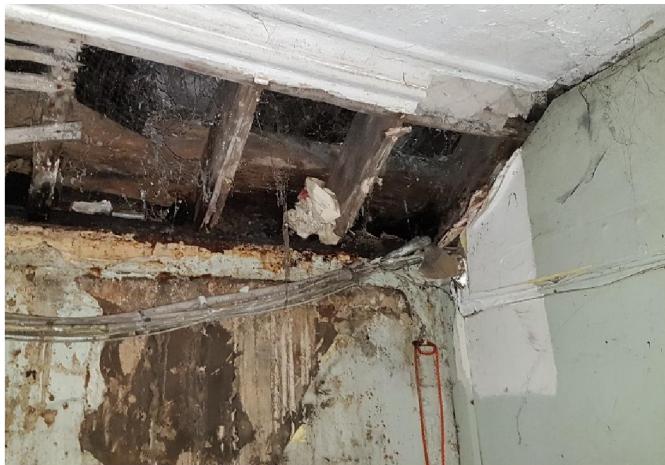
Figure 9. No. 36: Roof - Significant decay

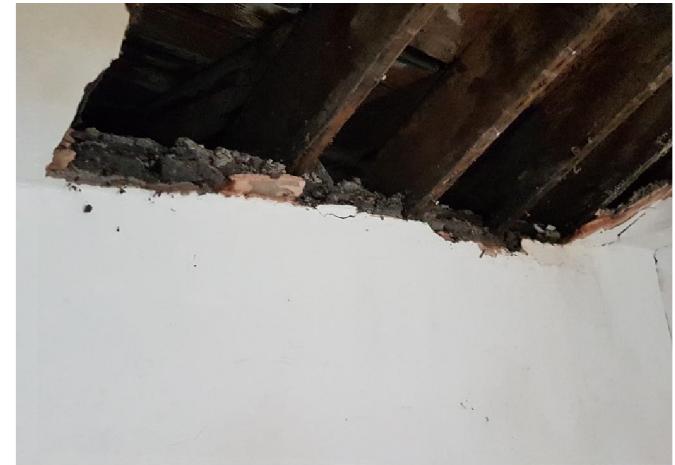
Figure 10. No. 36: Water ingress floors

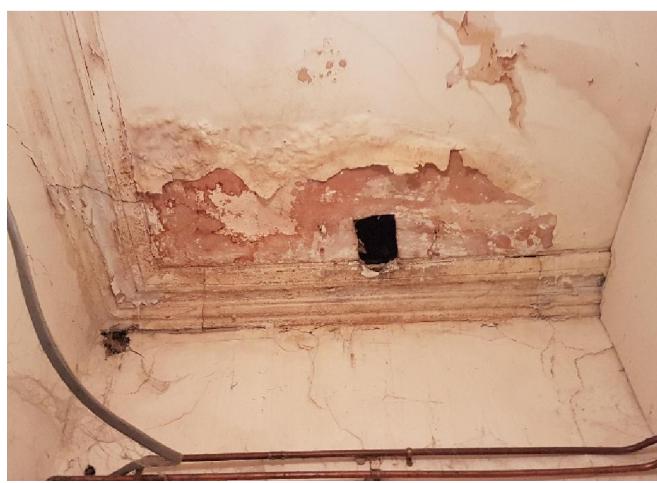
Figure 11. No.36: Water damage to ceiling

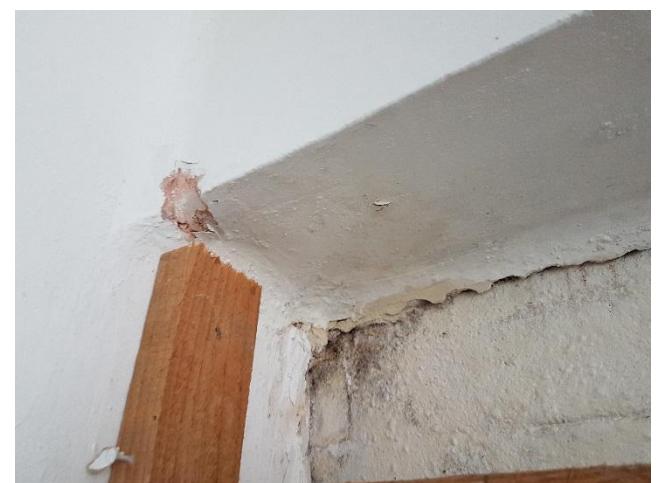
Figure 12. Hendrons: Water damage at No.36 gable

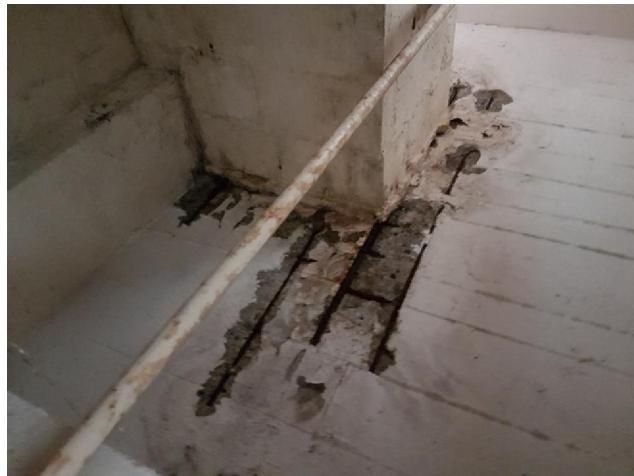
Figure 13. Workshop Building: Water ingress through slab/damage

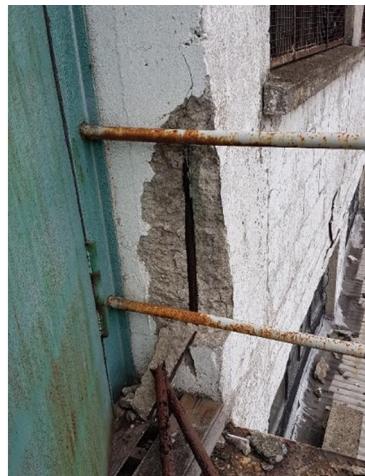
Figure 14. Workshop Building: Concrete column spalling

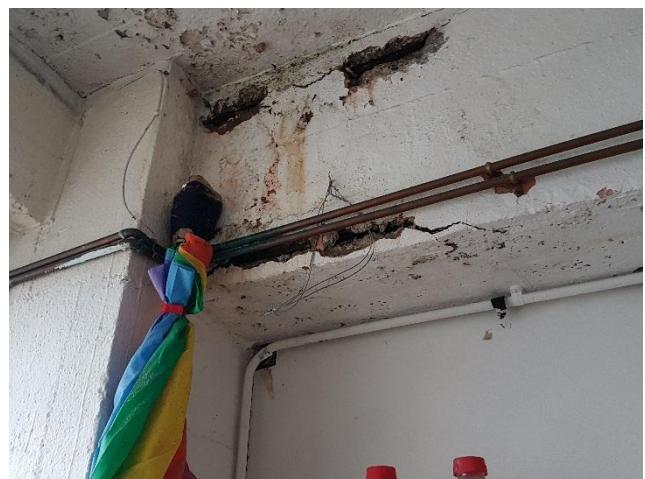
Figure 16. Workshop Building: Beam/Column joint failure

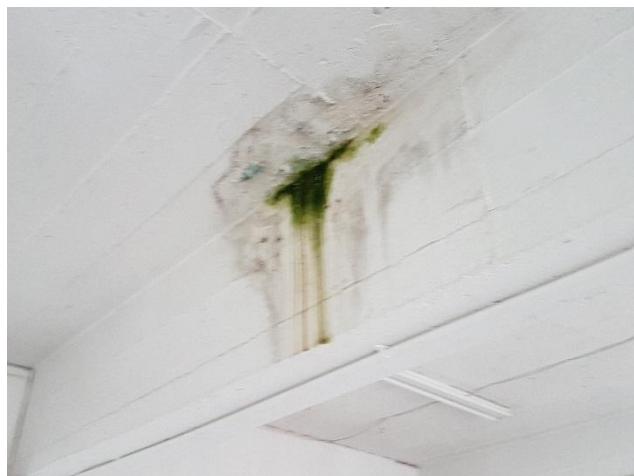
Figure 17. Workshop building: Water ingress through slab

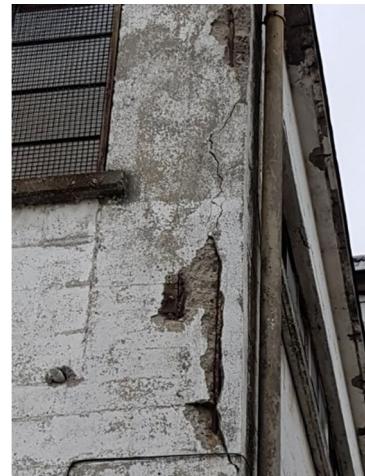
Figure 18. Workshop Building: Column steel exposed/corroded
