Aviation Investigation Preliminary Report

Location:	Moab, UT	Accident Number:	DCA26LA012
Date & Time:	October 16, 2025, 06:43 Local	Registration:	N17327
Aircraft:	Boeing 737	Injuries:	1 Minor, 111 None
Flight Conducted Under:		Part 121: Air carrier - Scheduled

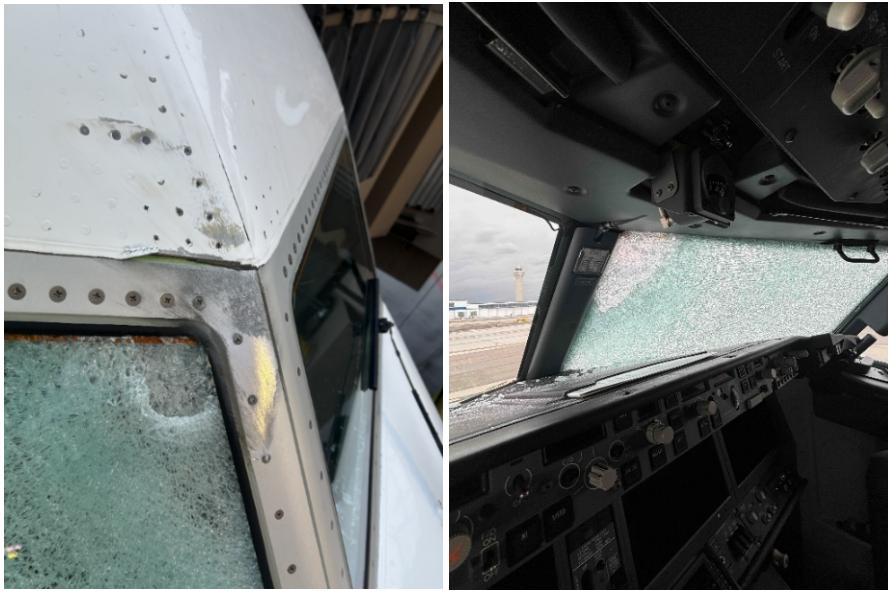
According to the captain, while established in cruise flight at flight level 360 (36,000 ft pressure altitude), he noticed an object distant on the horizon. Before he could mention the object to the first officer (FO), there was a significant impact to the FO's forward windshield along with a loud bang. The impact resulted in both pilots being showered with pieces of glass. The captain sustained multiple superficial lacerations to his right arm; the FO was uninjured.

Figure 1. Photos of the first officer's forward windshield. (Source: United Airlines)

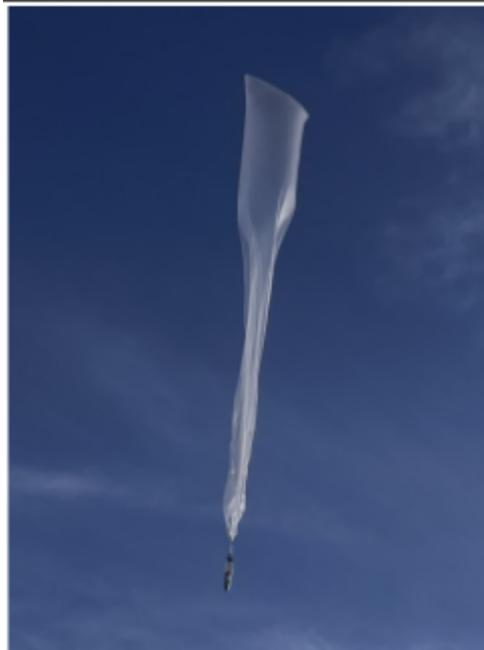
Figure 3. WindBorne GSB in flight. (Source: WindBorne)

According to WindBorne, the GSB is a lightweight, long duration high-altitude weather balloon platform operated under the provisions of Title 14 CFR Part 101.1. It is an unmanned free balloon.

The GSB system consists of a balloon envelope filled with lift gas, an avionics package for flight control, communications, and sensing, and a ballast system for altitude control. According to Windborne the GSBs are designed with the intent to minimize harm in the event of an impact during flight or landing. No large metal or high-stiffness structural elements are employed. The balloon envelope and the ballast container are a thin, low tensile strength, plastic film. The silica ballast is relatively low density and low grain-size.

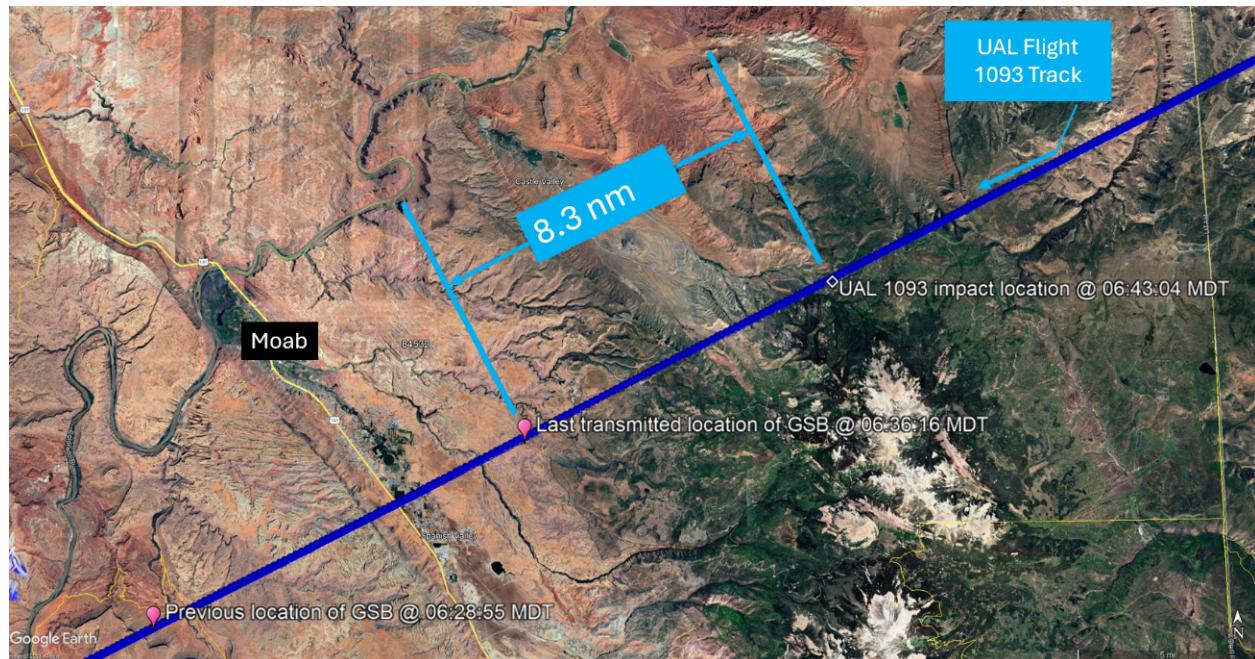
In addition, the flight data and the cockpit voice recorder were sent to the NTSB Vehicle Recorder Laboratory in Washington, DC. A preliminary review of the data from the cockpit voice and flight data recorders revealed that at the time of the collision, the airplane's track was to the southwest at 233° magnetic (nearly the reciprocal of the balloon track), at a pressure altitude of 36,002 ft, and a groundspeed of 395 knots.

Figure 5. UAL flight 1093 ground track and GSB locations.
