Investigating subsidence characteristics of Kyoto imperial garden cultural heritage shaped by historical landscape construction, through remote sensing

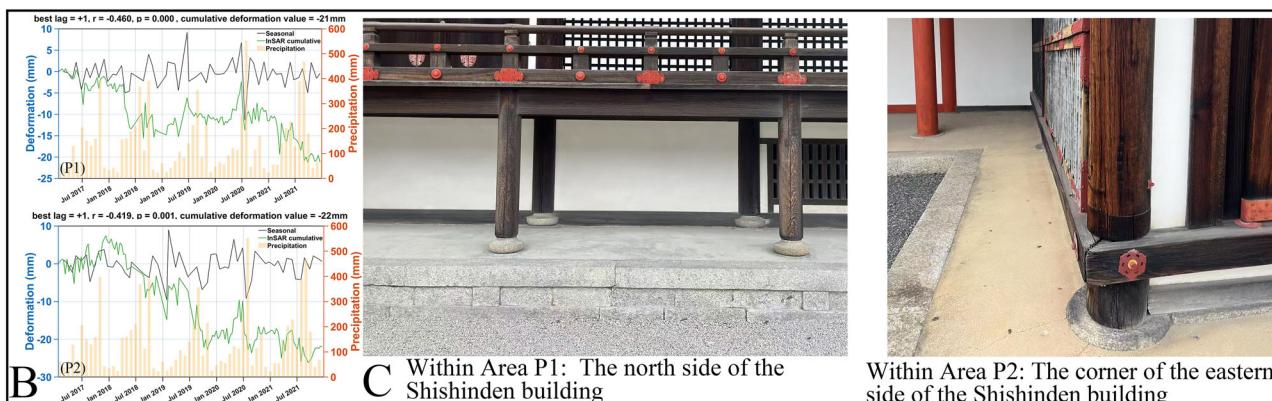
The courtyard section primarily features a surface layer ~2–3 cm thick of white sand, underlain by a leveling layer composed of either clean sand or mixed sandy soil, and a lower layer of compacted foundation or gravel bedding to ensure proper drainage and structural stability. And the foundations of the buildings and courtyards are situated within thick Holocene deposits, consisting of clay, silt, and fine sand (Fig. 7A).

To further investigate the deformation characteristics, the time series was analyzed based on Seasonal-Trend decomposition using Loess (STL). STL decomposition results show that the seasonal deformation component in the P1 and P2 areas is significantly negatively correlated with monthly rainfall, with an approximate one-month response lag (Fig. 7B). This indicates that intensive rainfall events, after recharging groundwater and increasing soil moisture content, can lead to delayed surface subsidence, a phenomenon may related to the time required for groundwater infiltration and pressure transmission^{59–61}. As rainfall infiltrates through the courtyard's white-sand pavement (originally designed to minimize surface water retention and allow rapid percolation) and the foundation cracks of building

Fig. 7 | Schematic cross-section and deformation analysis within the Kyoto Imperial Palace. A Schematic cross-section of the foundation of the Shishinden building complex. B STL decomposition^{60,81} of monthly deformation–precipitation

and time series of points for P1(the northeast corner of the Shishinden building) and P2 (north side of the Shishinden building). C Field photographs of the P1 and P2 areas.

The current conservation strategy follows the principle of “preserving existing conditions and respecting original materials.” Initial assessments are conducted through visual inspections to identify visible deterioration, such as cracks and structural collapse. Restoration is undertaken only when these issues are deemed to pose an evident threat to the building or the courtyard. During regular conditions, only minimal interventions are performed as part of routine maintenance. Consequently, bold splicing marks have appeared on some columns where no joints were originally required, or small metal nails and other materials have been added to maintain structural stability. It is recommended to inspect the structural damage and the elevation of column base stones within the affected area, and to implement preventive conservation measures in a timely manner to address limitations in current traditional restoration strategies. Furthermore, regular inspection of the drainage infrastructure surrounding the courtyards and palace buildings is advised, with particular attention given during the rainy season.
