Depreciation Report

NWS 2040 – Mountaingate

RE: Depreciation Report for Strata Plan NWS 2040
File No. NW2040DR25

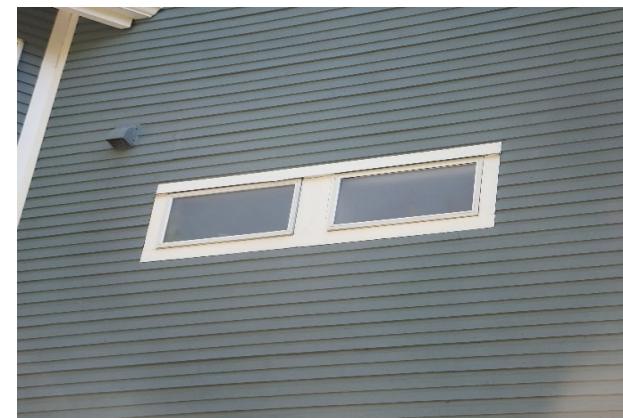
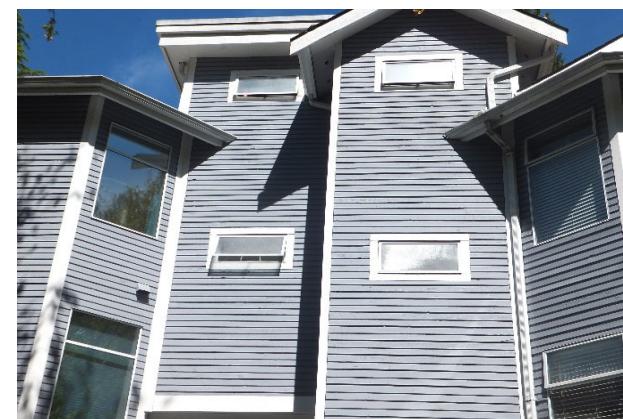
Cedar siding

Remarks An allowance has been included to replace 15% of the cedar siding with fiber cement cladding every 10 years.

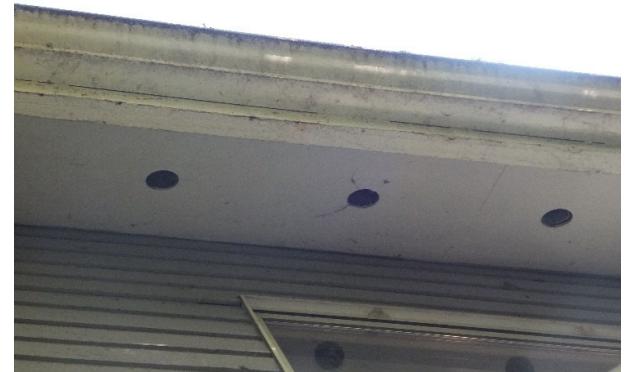
Wooden soffits

DOI	CA	EUL	EA	RUL								
	1983	42 years	40 years	36 years	4 years								
Cost Estimates	<table><thead><tr><th></th><th>Starting Year</th><th>Current Cost</th><th>Future Cost</th></tr></thead><tbody><tr><td></td><td>2029</td><td>\$222,561</td><td>\$246,626</td></tr></tbody></table>		Starting Year	Current Cost	Future Cost		2029	\$222,561	\$246,626				
	Starting Year	Current Cost	Future Cost										
	2029	\$222,561	\$246,626										
Funding Method	Budget for full replacement.												
Preventative Maintenance	Inspect and clean as needed.												
Remarks	None.

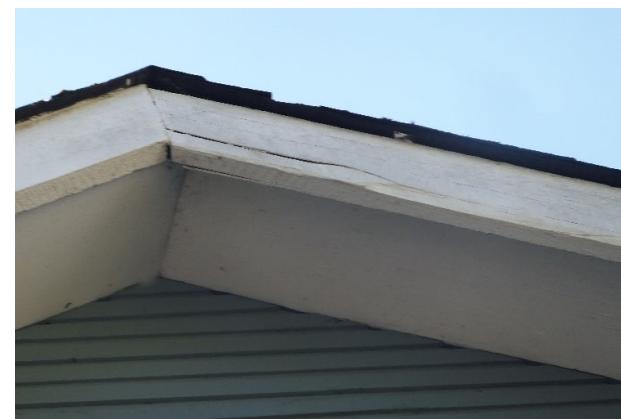
Cracks at roof fascia board

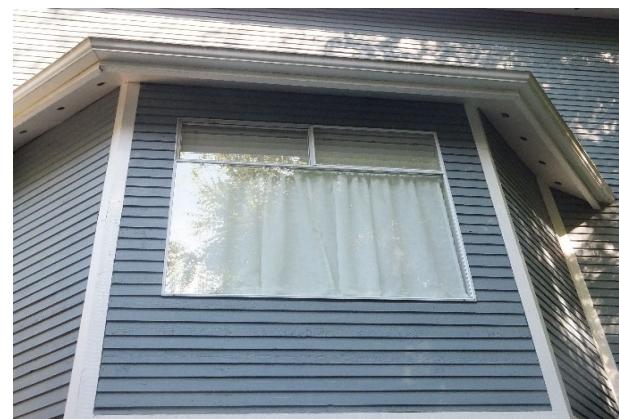
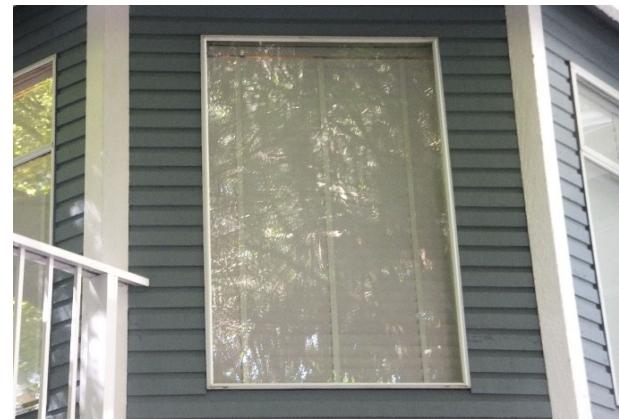
Aluminum framed window

DOI	CA	EUL	EA	RUL							
1983	42 years	45 years	42 years	3 years							
Cost Estimates	<table><thead><tr><th>Starting Year</th><th>Current Cost</th><th>Future Cost</th></tr></thead><tbody><tr><td>2028</td><td>\$728,346</td><td>\$786,647</td></tr></tbody></table>	Starting Year	Current Cost	Future Cost	2028	\$728,346	\$786,647				
Starting Year	Current Cost	Future Cost									
2028	\$728,346	\$786,647									
Funding Method	Budget for full replacement.										
Preventative Maintenance	Clean windows regularly to prevent corrosive substances from damaging the glass and the frame. Operable windows may require replacement of hardware after many operating cycles. Make sure the drain holes in the metal frame are clear of dirt and able to carry water away.										
Remarks	None.

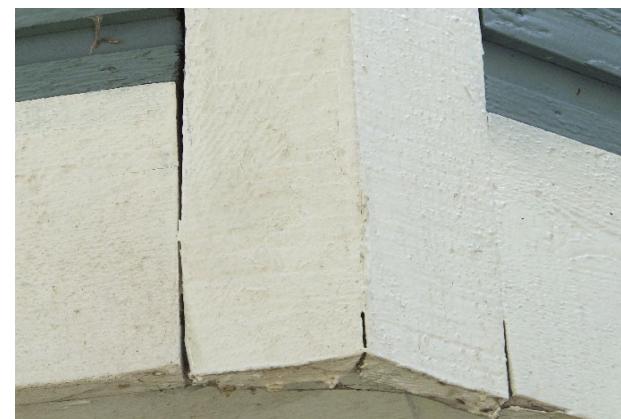
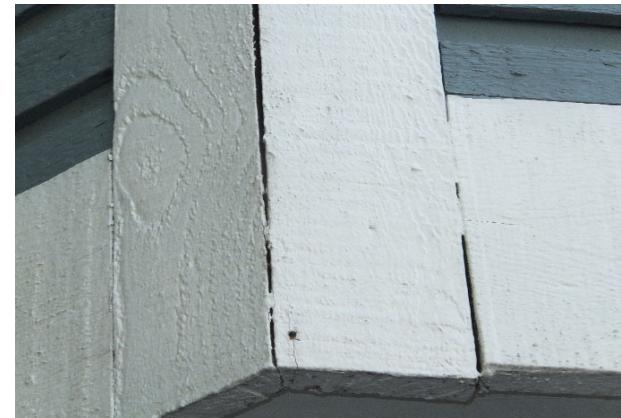
Failed caulking

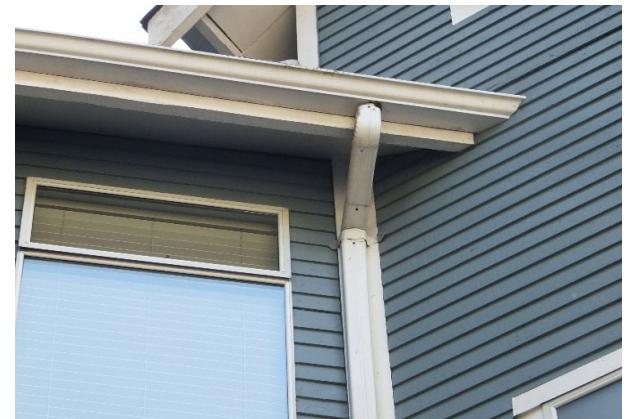
Gutters and downspouts

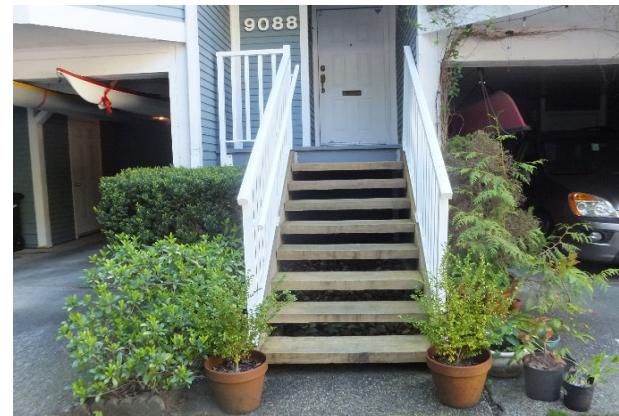
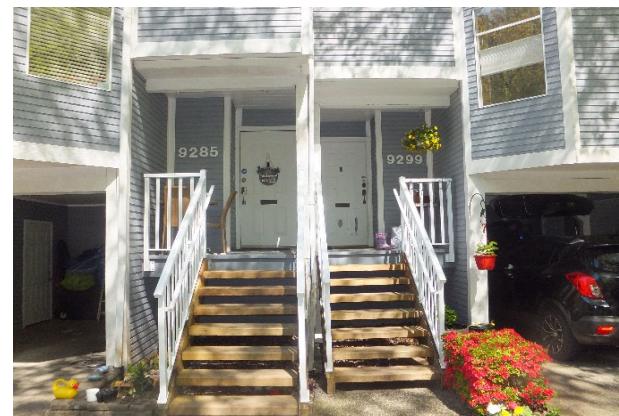
Exterior wooden stairs with metal guardrails

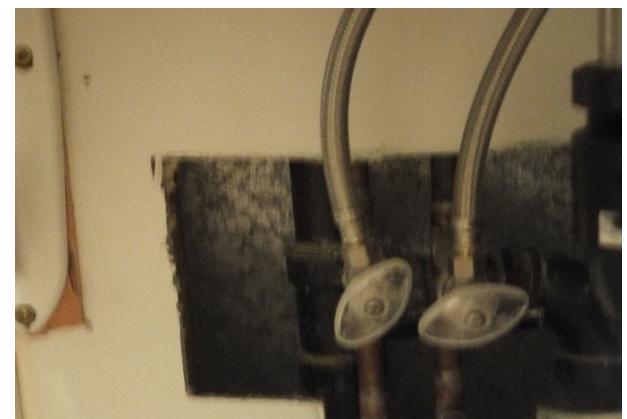
Condition Analysis **Deterioration** None observed.

Overall Condition Good.

Domestic water piping

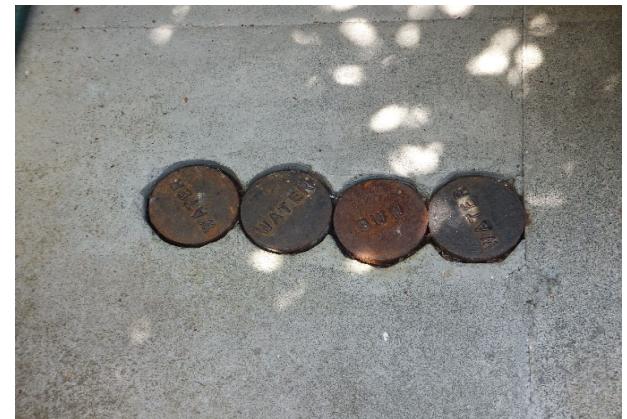
Water shut-off valves

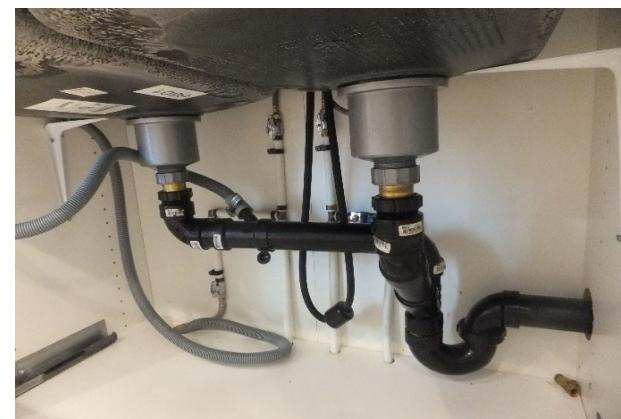
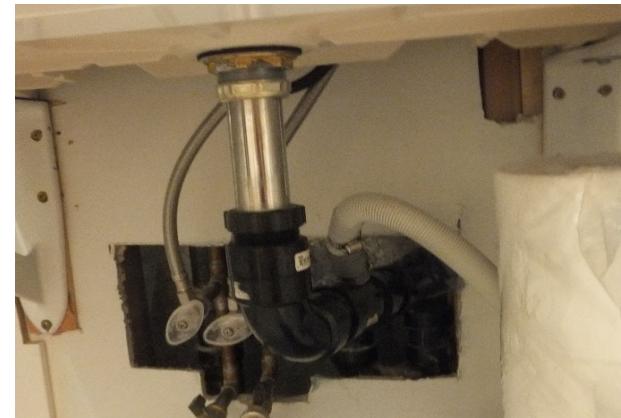
Condition Analysis **Deterioration** None observed.

Overall Condition Good.

Sanitary drainage piping

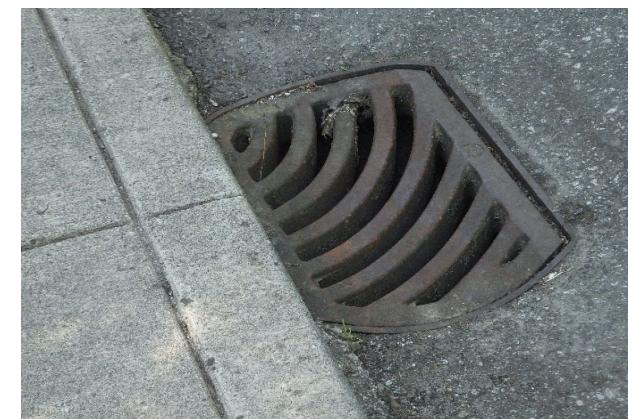
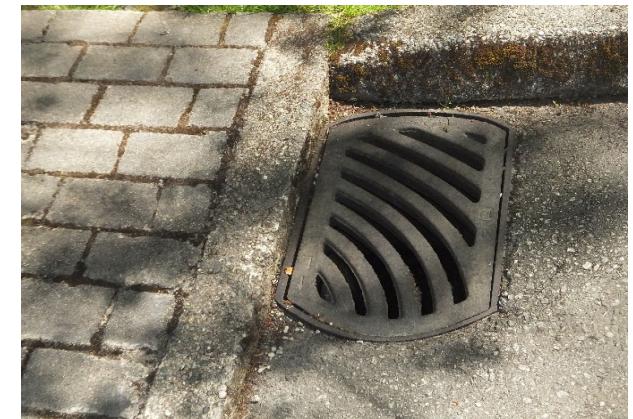
Condition Analysis **Deterioration** None observed.

Overall Condition Good.

Catch basin

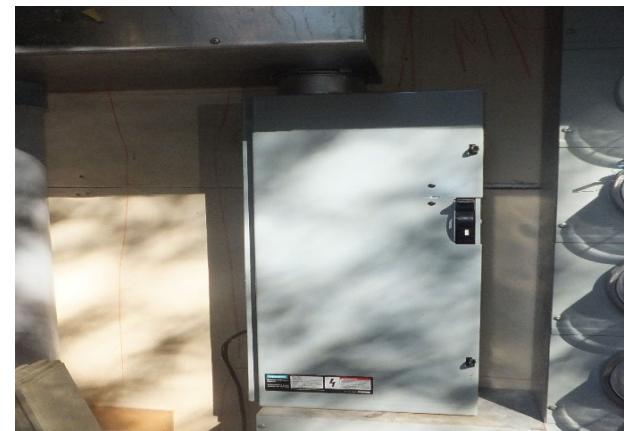
Deterioration None observed.

Overall Condition Good.

Electrical main switch

As per the council's request, one-time allowance of \$100,000 has been included in 2027 to upgrade the transformer in the complex.

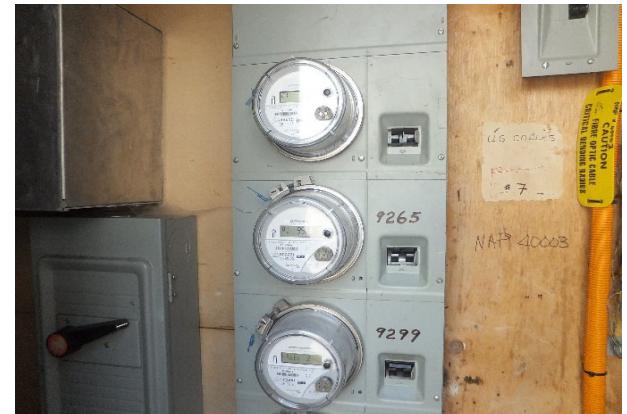
Electric meters

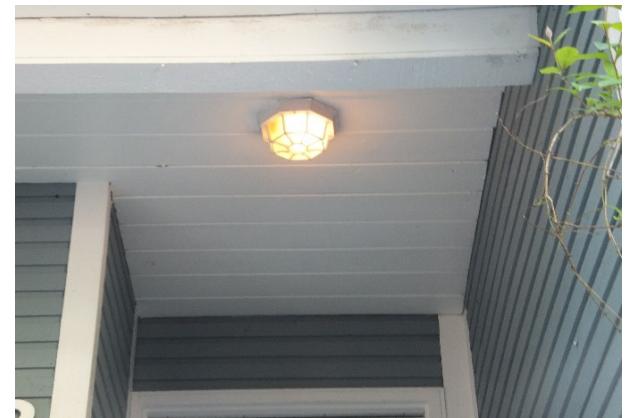
Soffit-mounted light fixture

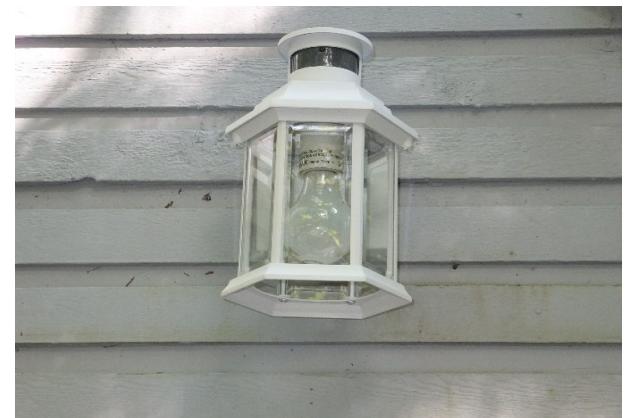
Wall-mounted light fixture

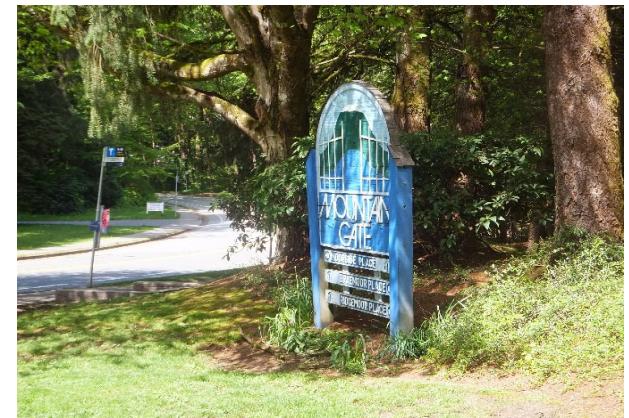
Leaning property signage

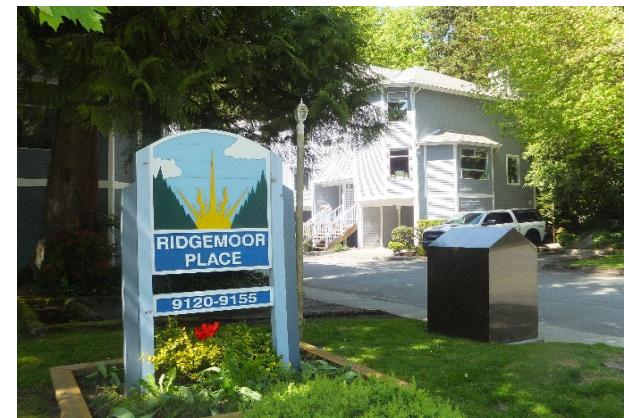
Property signage

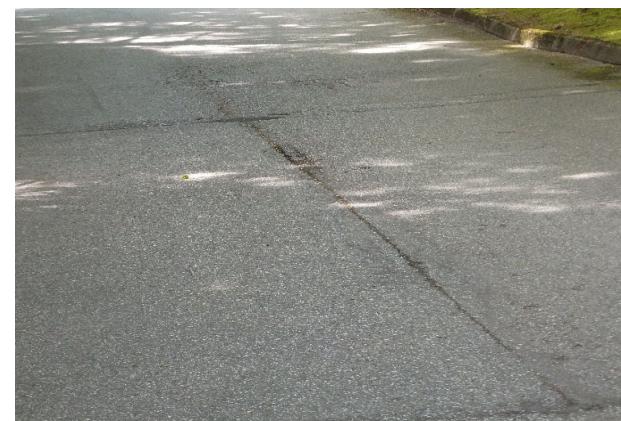
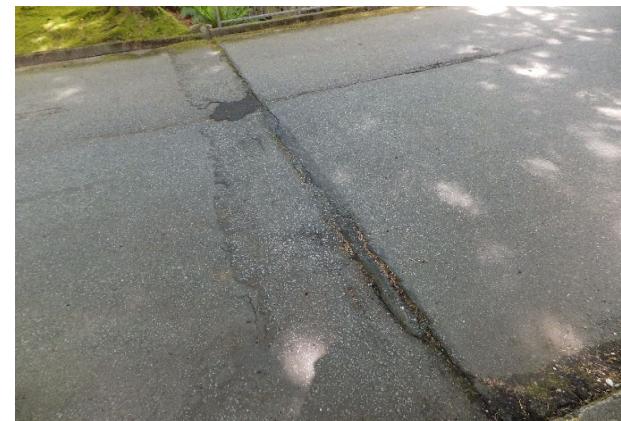
Cracks at asphalt paving

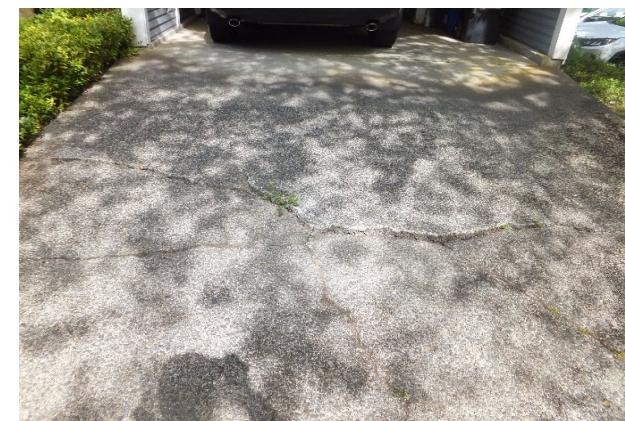
Cracks at concrete paving

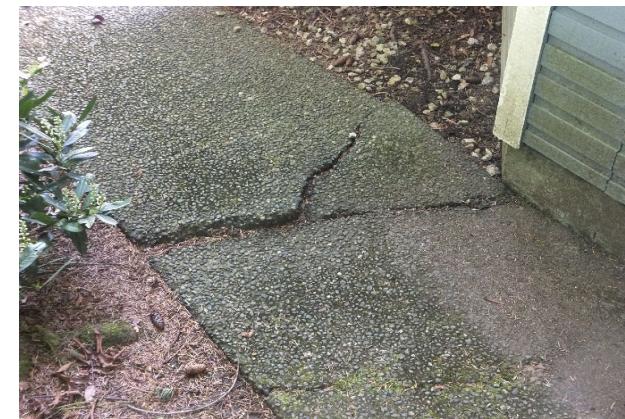
Cracks at concrete walkway

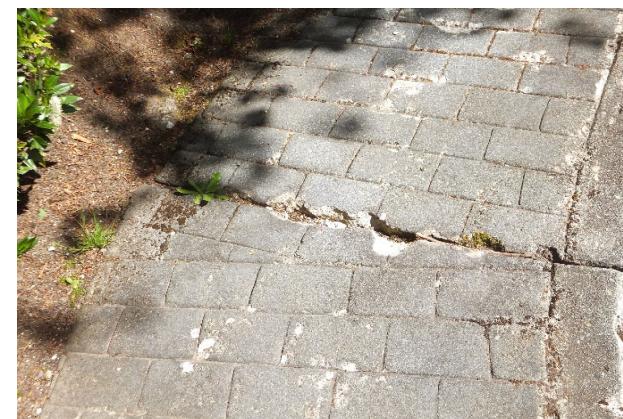
Cracks at concrete unit pavers

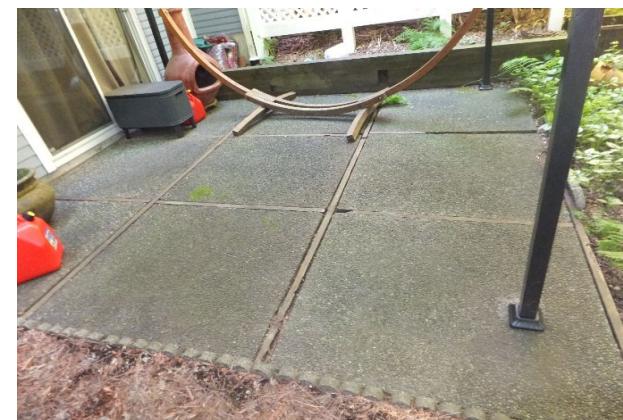
Patio flooring

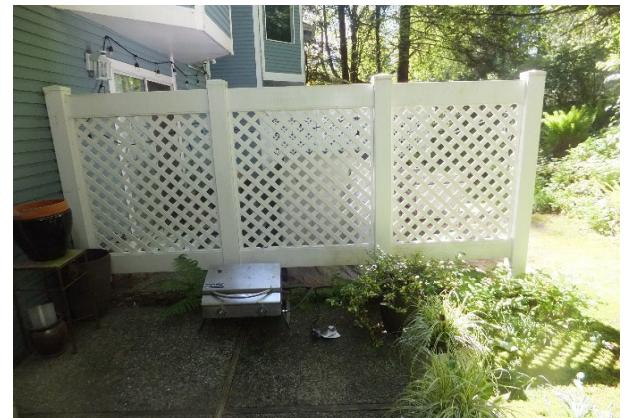
Vinyl privacy screens

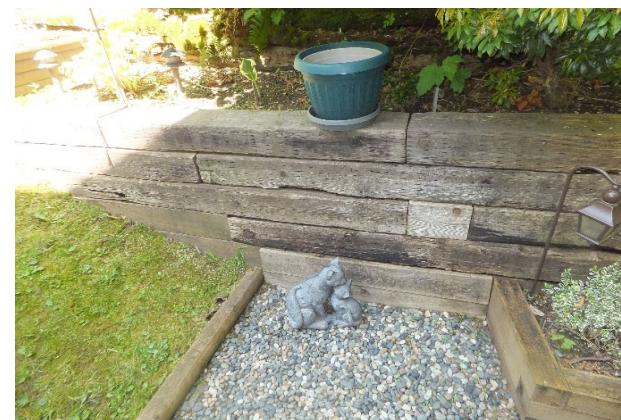
Wooden retaining wall

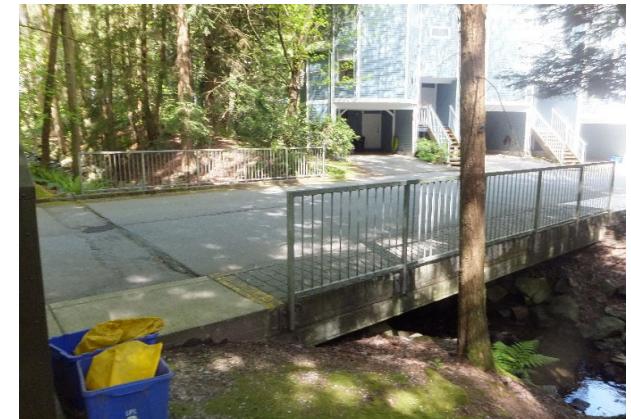
Pedestrian bridge

Vehicular bridge

Remarks An allowance has been included to address any engineering and construction costs of bridge repairs.

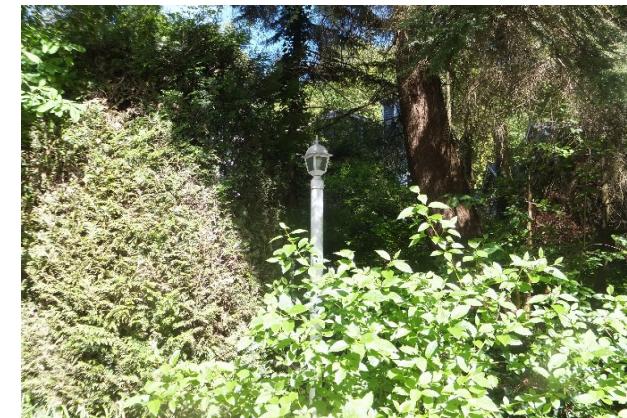
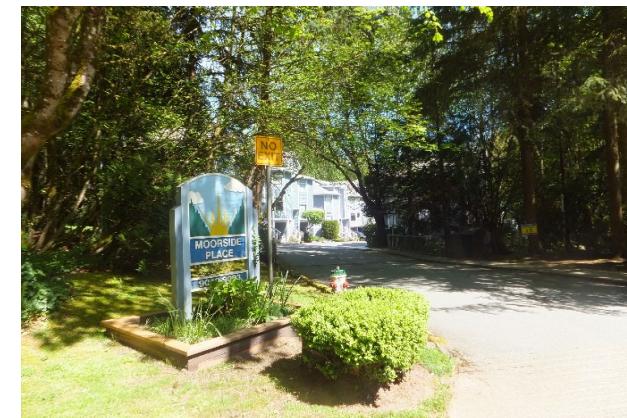
Landscaping

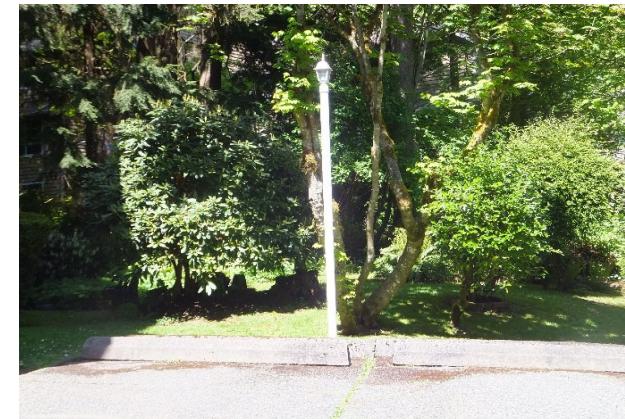
Site lighting
